Profile/Photo Observation Report

| Street: | OFF N DELAWARE ST | Flow Control: | Not Controlled |
| City: | Hobart, IN | Year Renewed: | |

| US MH: | M-504-013 | DS MH: | M-504-015 |

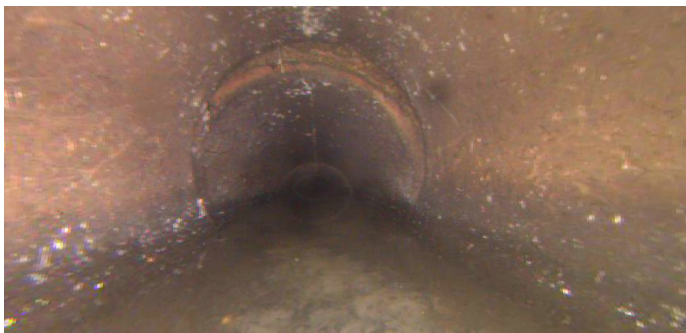
Code: **AMH**
Description: **Manhole**

Distance (ft): **.0**
Structural Grade: **0**
O&M Grade: **0**
Clock Start/From:
Clock To:
1st Value:
2nd Value:
Value Percent:
Continuous Index:
Within 8" of Joint: **NO**
Remarks: **M-504-013**

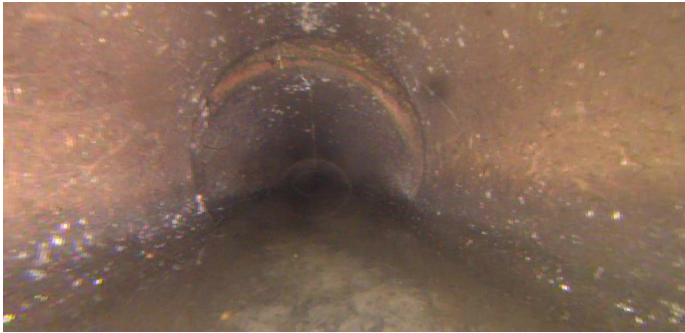
| Description: | Water Level |

| Value Percent: | 5.000 |

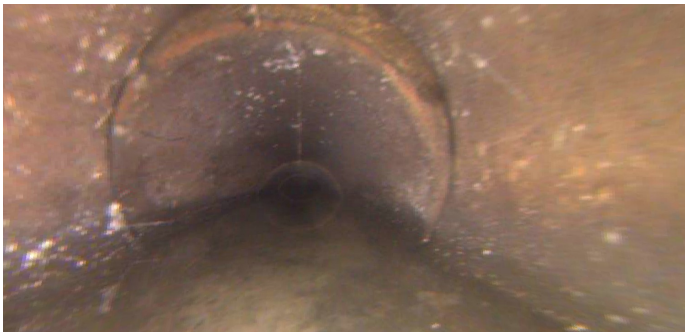
| Description: | Crack Longitudinal |

| Structural Grade: | 2 |
| Clock Start/From: | 9 |
| Within 8" of Joint: | YES |

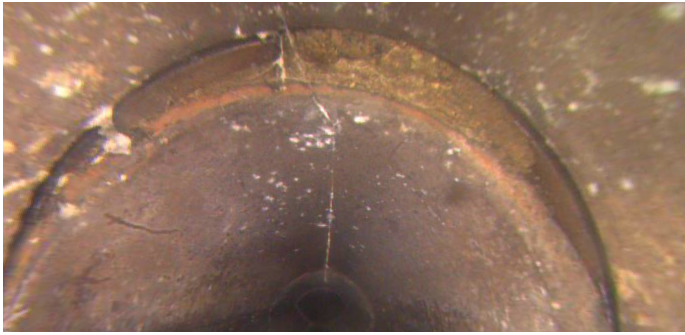
Code: **JOM**
Description: **Joint Offset Medium**

Distance (ft): **1.6**
Structural Grade: **1**
O&M Grade: **0**
Clock Start/From:
Clock To:
1st Value:
2nd Value:
Value Percent:
Continuous Index:
Within 8" of Joint: **NO**
Remarks:

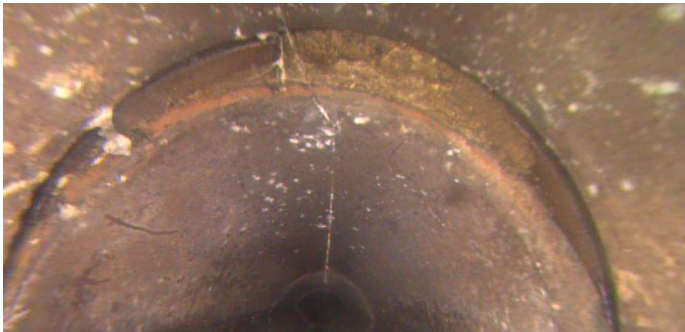
Code: **RFJ**
Description: **Roots Fine Joint**

Distance (ft): **1.6**
Structural Grade: **0**
O&M Grade: **1**
Clock Start/From: **8**
Clock To: **4**
1st Value:
2nd Value:
Value Percent:
Continuous Index:
Within 8" of Joint: **YES**
Remarks:

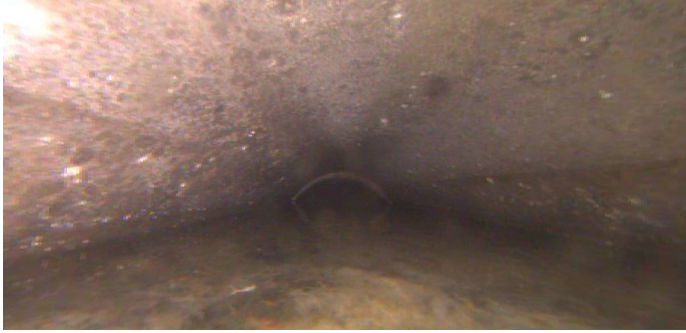
Code: **MWL**
Description: **Water Level**

Distance (ft): **4.4**
Structural Grade: **0**
O&M Grade: **0**
Clock Start/From:
Clock To:
1st Value:
2nd Value:
Value Percent: **75.000**
Continuous Index:
Within 8" of Joint: **NO**
Remarks:

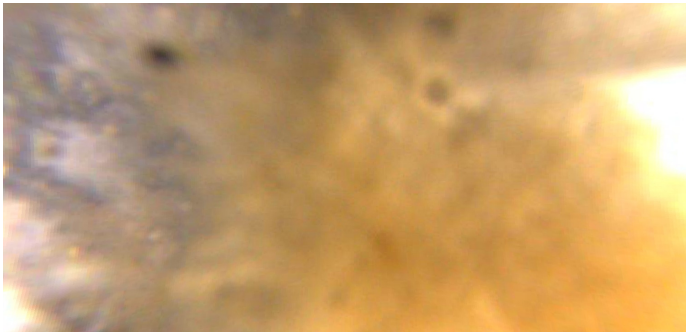
Code: **MCU**
Description: **Camera Underwater**

Distance (ft): **5.7**
Structural Grade: **0**
O&M Grade: **4**
Clock Start/From:
Clock To:
1st Value:
2nd Value:
Value Percent:
Continuous Index:
Within 8" of Joint: **NO**
Remarks:

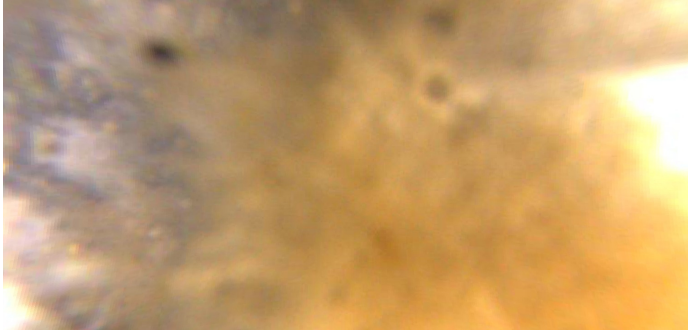
| Description: | Abandoned Survey |
| Remarks: | mcu |
