Profile/Photo Observation Report

Date:	04/18/2018	Weather:		Coding:	PACP 6.0
Pipe Length (ft):	159.1	Owner:	NA	Pre Clean:	Not Known
P.O.#:		Surveyor:	Byrd Fitzgerald	PSR:	P-504-015-013
Customer:		Clean Date:	01/01/1900	Shape:	C

Street:	Summerlin	Flow Control:	Not Controlled
City:	Hobart, IN	Year Renewed:	
Location:	Light Highway	Tape/Media #:	
Purpose:	Not Known	Dia/Height:	10"
Use:	Sanitary	Material:	VCP
Drain Area:	NA	Lining:	
Category:	NA		
Comment:

Location Details:		Direction of Survey:	Downstream
US MH:	M-504-013	DS MH:	M-504-015
		Total Length Surveyed (ft):	5.7

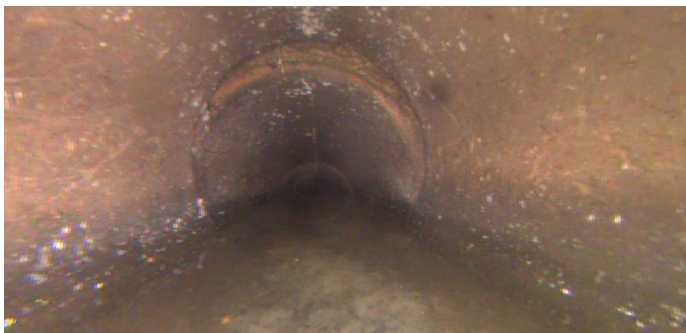
Code: **AMH**
Description: **Manhole**

Distance (ft): **.0**
Structural Grade: **0**
O&M Grade: **0**
Clock Start/From:
Clock To:
1st Value:
2nd Value:
Value Percent:
Continuous Index:
Within 8" of Joint: **NO**
Remarks: **M-504-013**

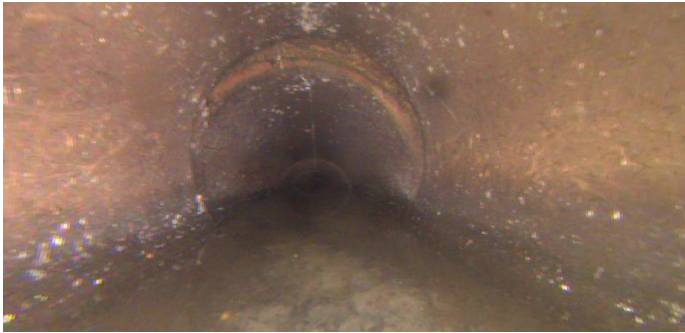
Code:	MWL
Description:	Water Level

Distance (ft):	.0
Structural Grade:	0
O&M Grade:	0
Clock Start/From:	
Clock To:	
1st Value:	
2nd Value:	
Value Percent:	5.000
Continuous Index:	
Within 8" of Joint:	NO
Remarks:

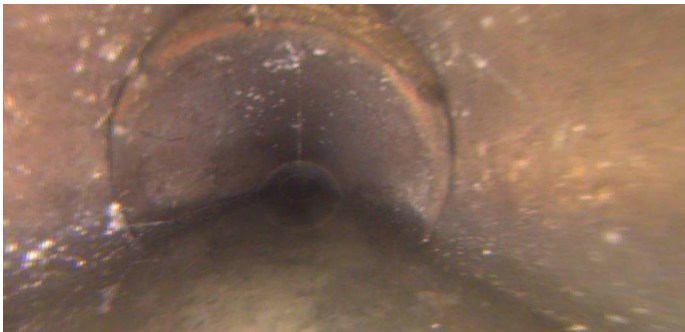
Code:	CL
Description:	Crack Longitudinal

Distance (ft):	.9
Structural Grade:	2
O&M Grade:	0
Clock Start/From:	9
Clock To:	
1st Value:	
2nd Value:	
Value Percent:	
Continuous Index:	
Within 8" of Joint:	YES
Remarks:

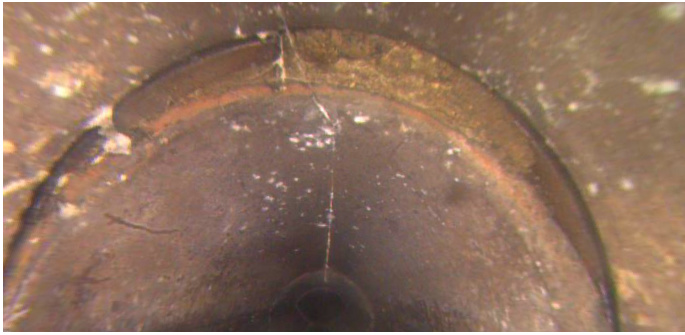
Code: **JOM**
Description: **Joint Offset Medium**

Distance (ft): **1.6**
Structural Grade: **1**
O&M Grade: **0**
Clock Start/From:
Clock To:
1st Value:
2nd Value:
Value Percent:
Continuous Index:
Within 8" of Joint: **NO**
Remarks:

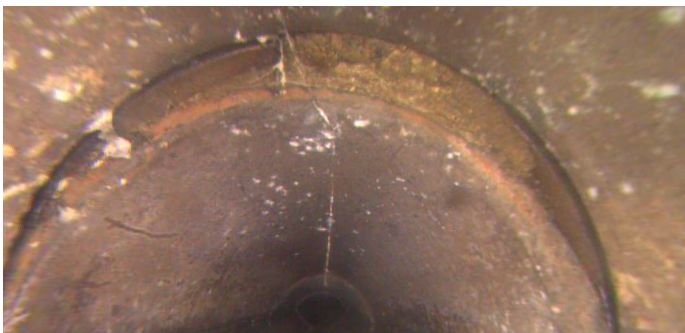
Code: **RFJ**
Description: **Roots Fine Joint**

Distance (ft): **1.6**
Structural Grade: **0**
O&M Grade: **1**
Clock Start/From: **8**
Clock To: **4**
1st Value:
2nd Value:
Value Percent:
Continuous Index:
Within 8" of Joint: **YES**
Remarks:

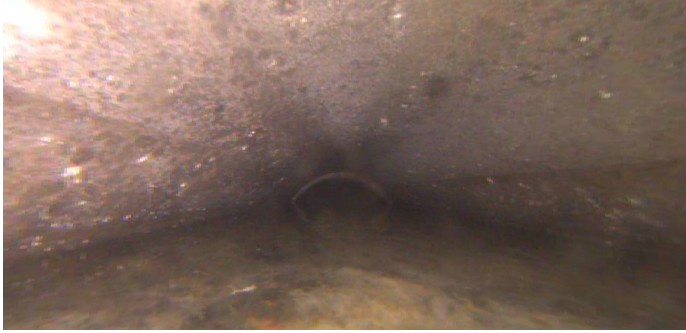
Code: **MWL**
Description: **Water Level**

Distance (ft): **4.4**
Structural Grade: **0**
O&M Grade: **0**
Clock Start/From:
Clock To:
1st Value:
2nd Value:
Value Percent: **75.000**
Continuous Index:
Within 8" of Joint: **NO**
Remarks:

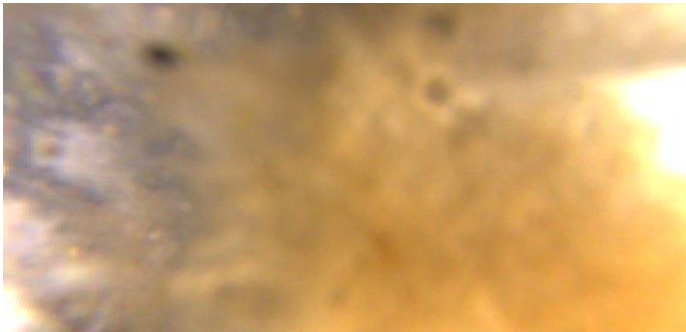
Code: **MCU**
Description: **Camera Underwater**

Distance (ft): **5.7**
Structural Grade: **0**
O&M Grade: **4**
Clock Start/From:
Clock To:
1st Value:
2nd Value:
Value Percent:
Continuous Index:
Within 8" of Joint: **NO**
Remarks:

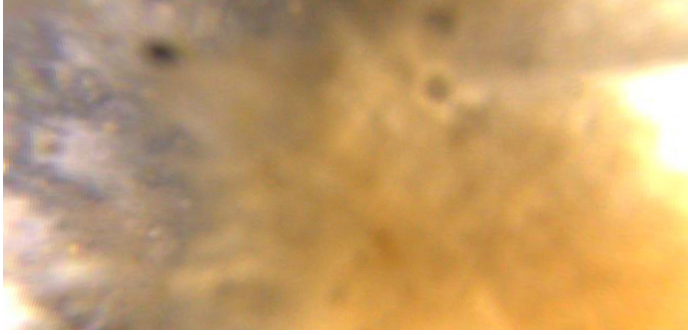
Code:	MSA
Description:	Abandoned Survey
Distance (ft):	5.7
Structural Grade:	0
O&M Grade:	0
Clock Start/From:	
Clock To:	
1st Value:	
2nd Value:	
Value Percent:	
Continuous Index:	
Within 8" of Joint:	NO
Remarks:	mcu
