Profile/Photo Observation Report

Date:	04/18/2018	Weather:		Coding:	PACP 6.0
Pipe Length (ft):	159.1	Owner:	NA	Pre Clean:	Not Known
P.O.#:		Surveyor:	Byrd Fitzgerald	PSR:	P-504-015-013
Customer:		Clean Date:	01/01/1900	Shape:	C

Street:	Summerlin	Flow Control:	Not Controlled
City:	Hobart, IN	Year Renewed:	
Location:	Light Highway	Tape/Media #:	
Purpose:	Not Known	Dia/Height:	10"
Use:	Sanitary	Material:	VCP
Drain Area:	NA	Lining:	
Category:	NA		
Comment:

Location Details:		Direction of Survey:	Downstream
US MH:	M-504-013	DS MH:	M-504-015
		Total Length Surveyed (ft):	5.0

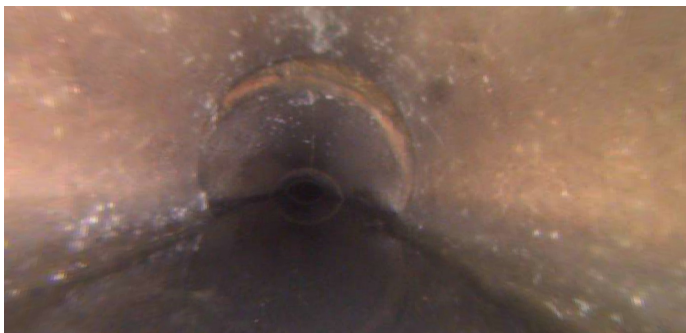
Code: **AMH**
Description: **Manhole**

Distance (ft): **.0**
Structural Grade: **0**
O&M Grade: **0**
Clock Start/From:
Clock To:
1st Value:
2nd Value:
Value Percent:
Continuous Index:
Within 8" of Joint: **NO**
Remarks: **M-504-013**

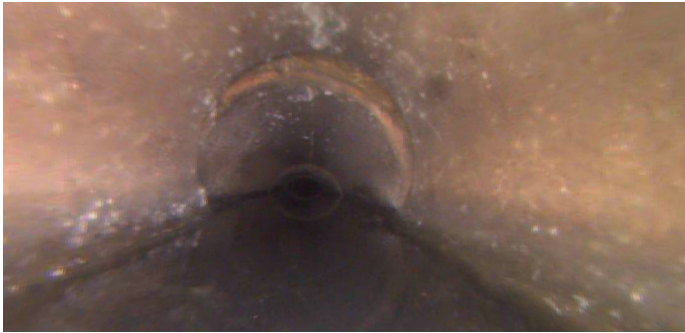
Code:	MWL
Description:	Water Level

Distance (ft):	.0
Structural Grade:	0
O&M Grade:	0
Clock Start/From:	
Clock To:	
1st Value:	
2nd Value:	
Value Percent:	5.000
Continuous Index:	
Within 8" of Joint:	NO
Remarks:

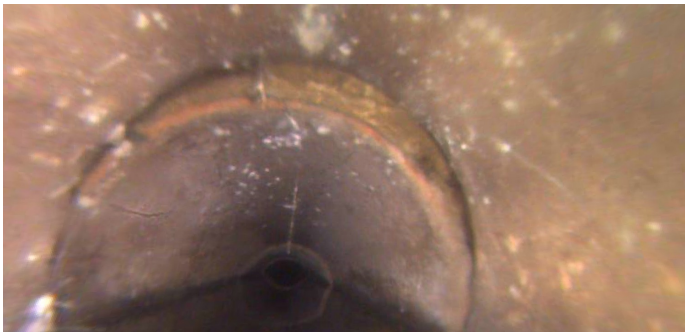
Code:	JOM
Description:	Joint Offset Medium

Distance (ft):	.9
Structural Grade:	1
O&M Grade:	0
Clock Start/From:	
Clock To:	
1st Value:	
2nd Value:	
Value Percent:	
Continuous Index:	
Within 8" of Joint:	NO
Remarks:

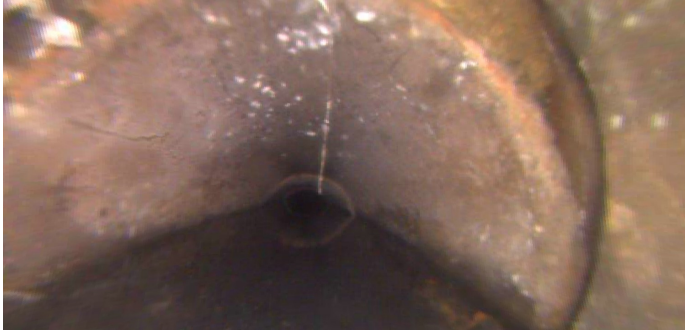
Code: **CM**
Description: **Crack Multiple**

Distance (ft): **1.9**
Structural Grade: **3**
O&M Grade: **0**
Clock Start/From: **8**
Clock To: **4**
1st Value:
2nd Value:
Value Percent:
Continuous Index:
Within 8" of Joint: **YES**
Remarks:

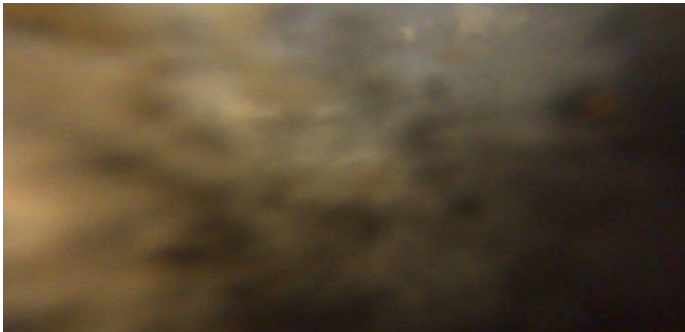
Code: **MCU**
Description: **Camera Underwater**

Distance (ft): **5.0**
Structural Grade: **0**
O&M Grade: **4**
Clock Start/From:
Clock To:
1st Value:
2nd Value:
Value Percent:
Continuous Index:
Within 8" of Joint: **NO**
Remarks:

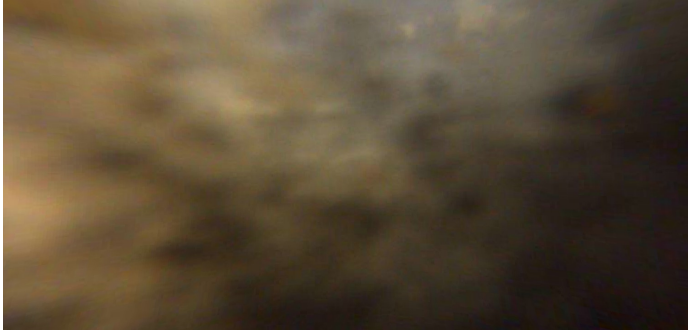
Code:	MSA
Description:	Abandoned Survey
Distance (ft):	5.0
Structural Grade:	0
O&M Grade:	0
Clock Start/From:	
Clock To:	
1st Value:	
2nd Value:	
Value Percent:	
Continuous Index:	
Within 8" of Joint:	NO
Remarks:	mcu
