RedZone
ROBOTICS

Street:	N DELAWARE ST		Flow Control:	Not Controlled	
City:	Hobart, IN		Year Renewed:		
Location:	Alley		Tape/Media #:		
Purpose:	Routine Assessment		Dia/Height:	10"	
Use:	Sanitary Sewage Pipe		Material:	VCP	
Drain Area:			Lining:	None	
Category:	NA				
Comment:					
Location Details:			Direction of Survey:	Downstream	
US MH:	M-504-013	DS MH:	M-504-015	Total Length Surveyed (ft):	158.7

Friday, April 26, 2024

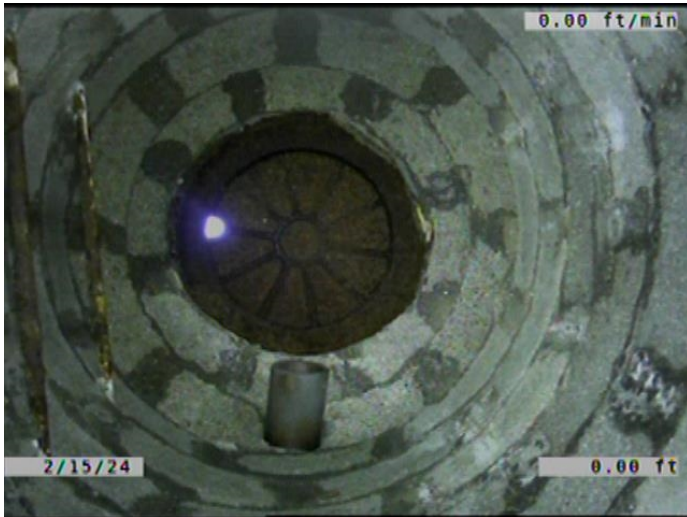
Code: **AMH**
Description: **Manhole**

Distance (ft): **.0**
Structural Grade: **0**
O&M Grade: **0**
Clock Start/From:
Clock To:
1st Value:
2nd Value:
Value Percent:
Continuous Index:
Within 8" of Joint: **NO**
Remarks: **M-504-013**

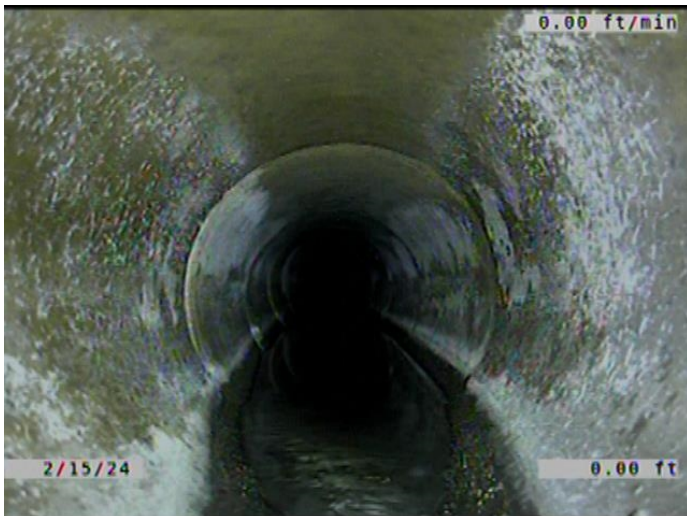
Code: **MWL**
Description: **Miscellaneous Water Level**

Distance (ft): **.0**
Structural Grade: **0**
O&M Grade: **0**
Clock Start/From:
Clock To:
1st Value:
2nd Value:
Value Percent: **5.000**
Continuous Index:
Within 8" of Joint: **NO**
Remarks:

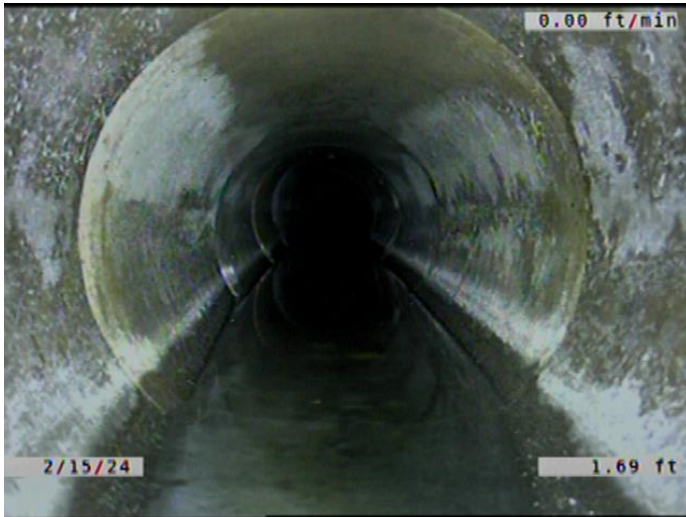
Code: **MWLS**
Description: **Miscellaneous Water Level Sag**

Distance (ft): **1.7**
Structural Grade: **2**
O&M Grade: **0**
Clock Start/From:
Clock To:
1st Value:
2nd Value:
Value Percent: **15.000**
Continuous Index: **S01**
Within 8" of Joint: **NO**
Remarks:

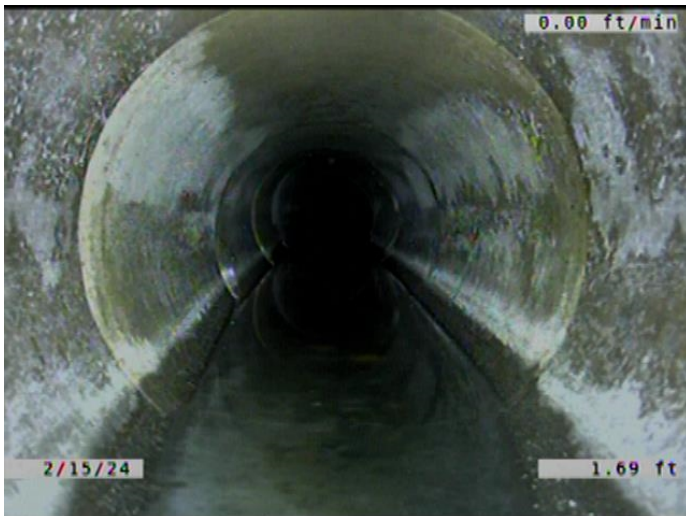
Code: **DSF**
Description: **Deposits Settled Fine**

Distance (ft): **1.7**
Structural Grade: **0**
O&M Grade: **2**
Clock Start/From: **5**
Clock To: **7**
1st Value:
2nd Value:
Value Percent: **5.000**
Continuous Index: **S02**
Within 8" of Joint: **YES**
Remarks:

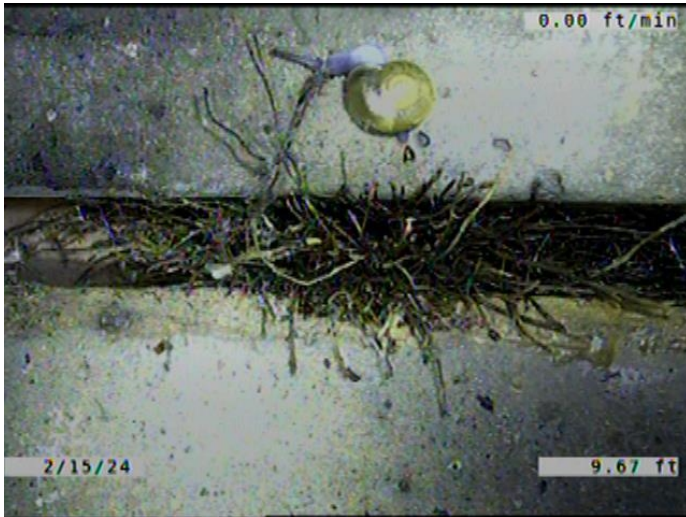
Code: **RFJ**
Description: **Roots Fine Joint**

Distance (ft): **9.7**
Structural Grade: **0**
O&M Grade: **1**
Clock Start/From: **7**
Clock To: **9**
1st Value:
2nd Value:
Value Percent:
Continuous Index:
Within 8" of Joint: **YES**
Remarks:

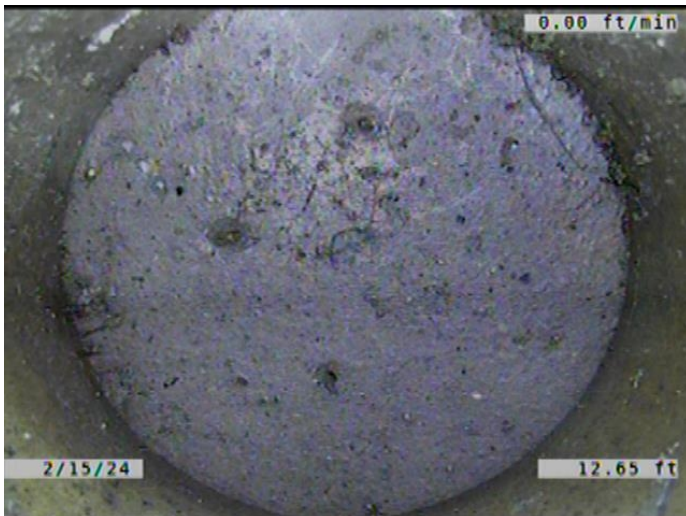
Code: **TFC**
Description: **Tap Factory Capped**

Distance (ft): **12.6**
Structural Grade: **0**
O&M Grade: **0**
Clock Start/From: **1**
Clock To:
1st Value: **6.000**
2nd Value:
Value Percent:
Continuous Index:
Within 8" of Joint: **YES**
Remarks:

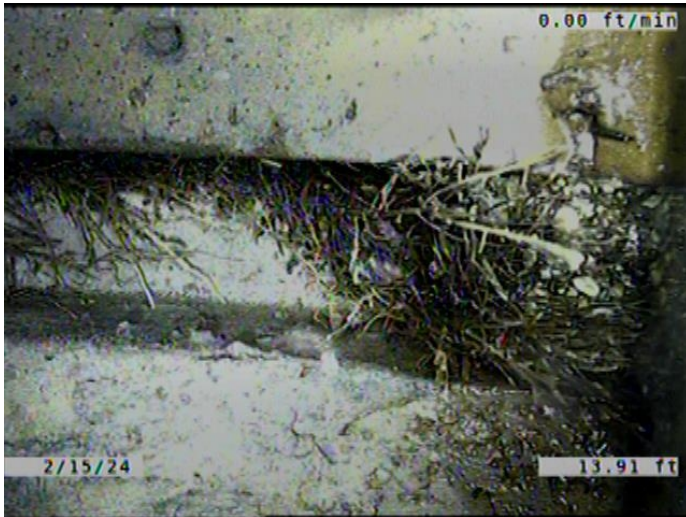
Code: **RFJ**
Description: **Roots Fine Joint**

Distance (ft): **13.9**
Structural Grade: **0**
O&M Grade: **1**
Clock Start/From: **2**
Clock To: **4**
1st Value:
2nd Value:
Value Percent:
Continuous Index:
Within 8" of Joint: **YES**
Remarks:

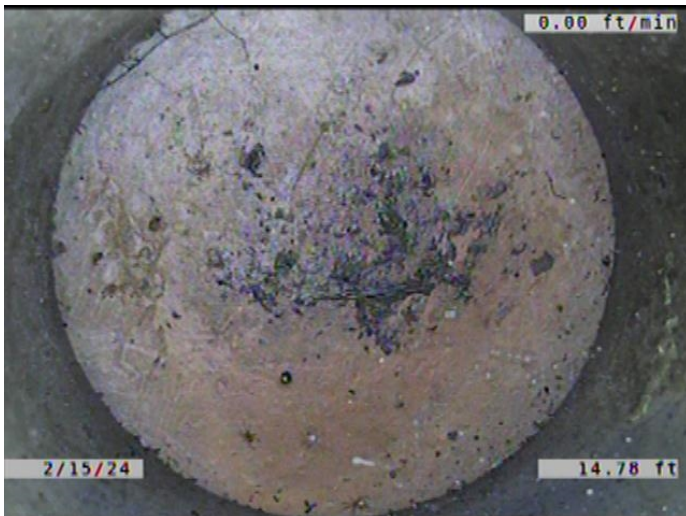
Code: **TFD**
Description: **Tap Factory Defective**

Distance (ft): **14.8**
Structural Grade: **0**
O&M Grade: **3**
Clock Start/From: **11**
Clock To:
1st Value: **6.000**
2nd Value:
Value Percent:
Continuous Index:
Within 8" of Joint: **YES**
Remarks: **CAPPED. TAP CRACKED.**

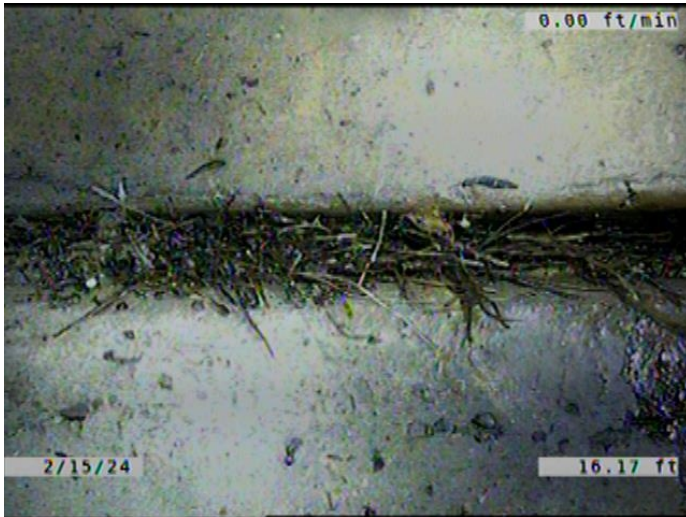
Code: **RFJ**
Description: **Roots Fine Joint**

Distance (ft): **16.2**
Structural Grade: **0**
O&M Grade: **1**
Clock Start/From: **1**
Clock To: **4**
1st Value:
2nd Value:
Value Percent:
Continuous Index:
Within 8" of Joint: **YES**
Remarks:

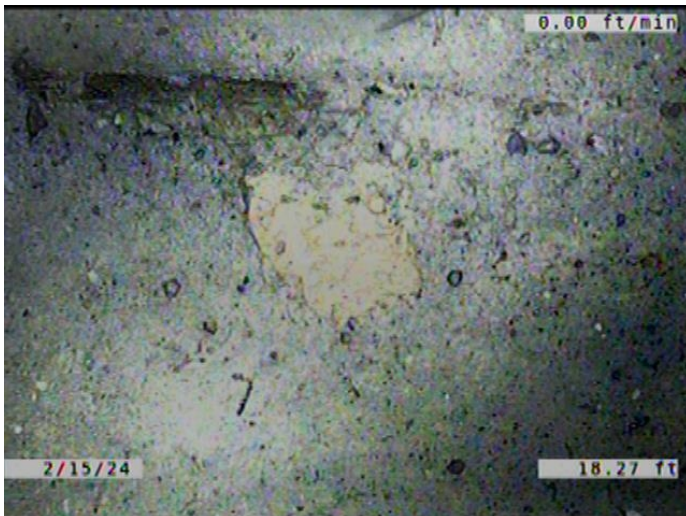
Code: **SSC**
Description: **Surface Spalling of Damage Coating**

Distance (ft): **18.3**
Structural Grade: **1**
O&M Grade: **0**
Clock Start/From: **9**
Clock To:
1st Value:
2nd Value:
Value Percent:
Continuous Index:
Within 8" of Joint: **YES**
Remarks:

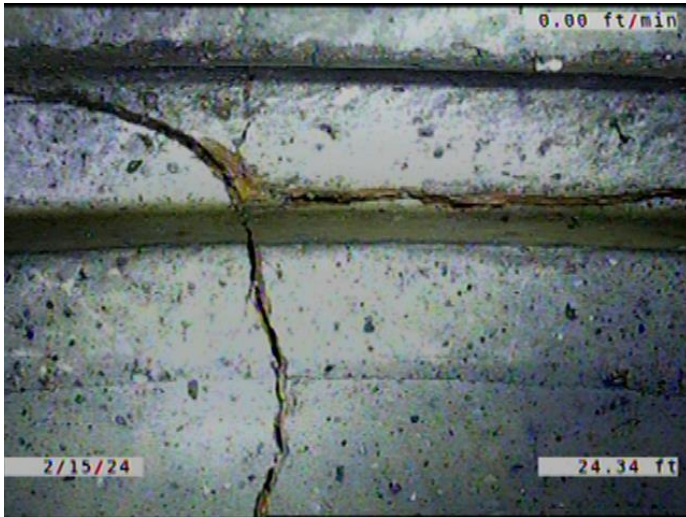
Code: **FM**
Description: **Fracture Multiple**

Distance (ft): **24.3**
Structural Grade: **4**
O&M Grade: **0**
Clock Start/From: **7**
Clock To: **5**
1st Value:
2nd Value:
Value Percent:
Continuous Index: **S03**
Within 8" of Joint: **YES**
Remarks:

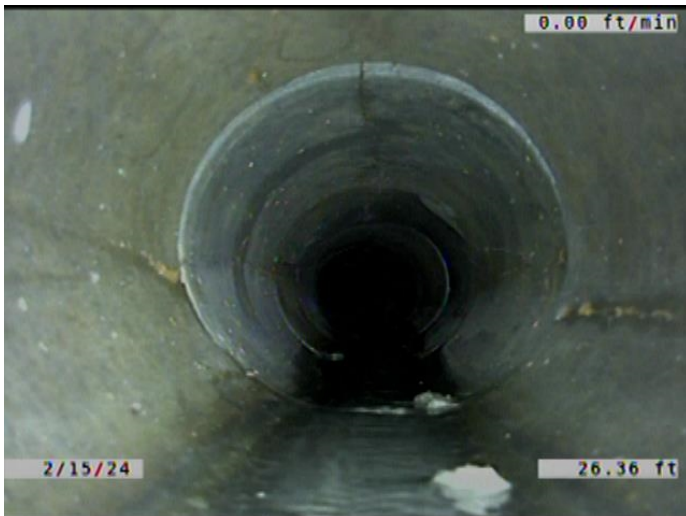
Code: **MWLS**
Description: **Miscellaneous Water Level Sag**

Distance (ft): **26.4**
Structural Grade: **2**
O&M Grade: **0**
Clock Start/From:
Clock To:
1st Value:
2nd Value:
Value Percent: **15.000**
Continuous Index: **F01**
Within 8" of Joint: **NO**
Remarks:

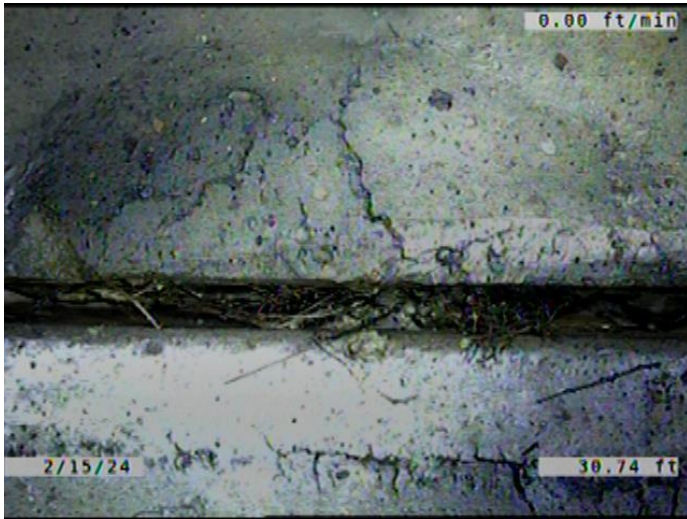
Code: **RFJ**
Description: **Roots Fine Joint**

Distance (ft): **30.7**
Structural Grade: **0**
O&M Grade: **1**
Clock Start/From: **9**
Clock To: **3**
1st Value:
2nd Value:
Value Percent:
Continuous Index:
Within 8" of Joint: **YES**
Remarks:

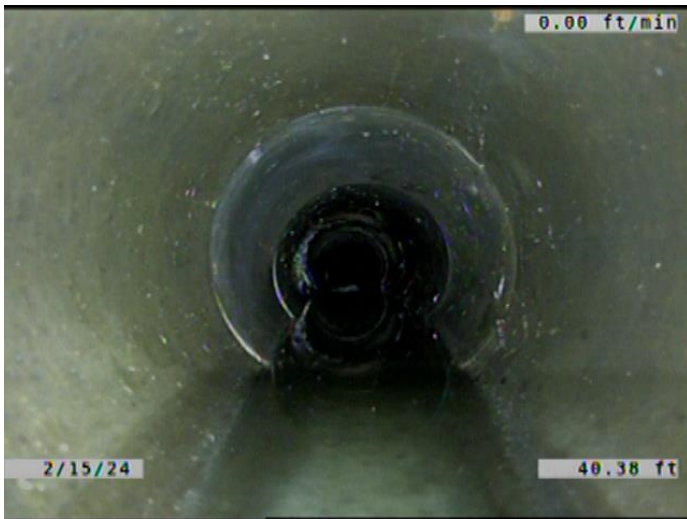
Code: **MWLS**
Description: **Miscellaneous Water Level Sag**

Distance (ft): **40.4**
Structural Grade: **2**
O&M Grade: **0**
Clock Start/From:
Clock To:
1st Value:
2nd Value:
Value Percent: **15.000**
Continuous Index: **S04**
Within 8" of Joint: **NO**
Remarks:

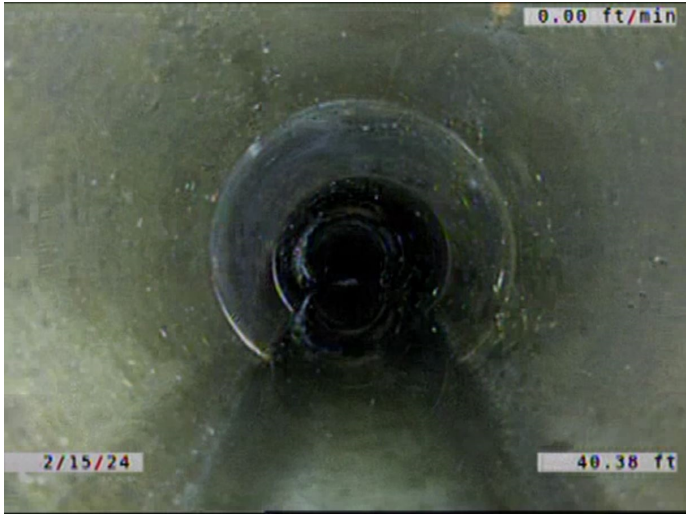
Code: **FM**
Description: **Fracture Multiple**

Distance (ft): **40.4**
Structural Grade: **4**
O&M Grade: **0**
Clock Start/From: **7**
Clock To: **5**
1st Value:
2nd Value:
Value Percent:
Continuous Index: **F03**
Within 8" of Joint: **YES**
Remarks:

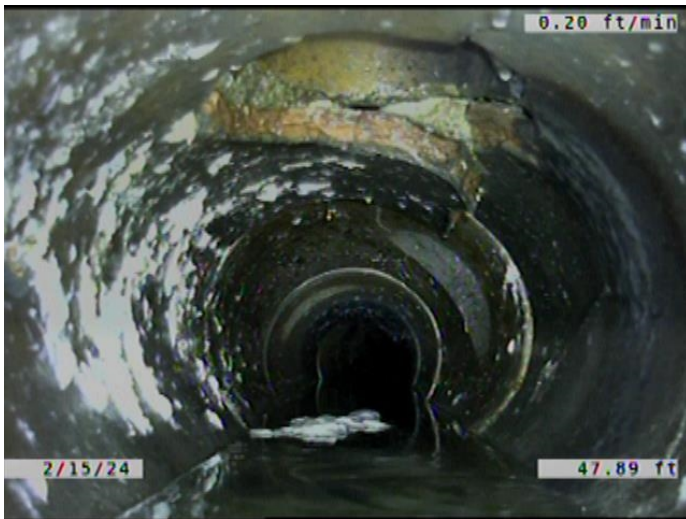
Code: **DR**
Description: **Deformed Rigid**

Distance (ft): **47.9**
Structural Grade: **4**
O&M Grade: **0**
Clock Start/From:
Clock To:
1st Value:
2nd Value:
Value Percent: **5.000**
Continuous Index:
Within 8" of Joint: **NO**
Remarks:

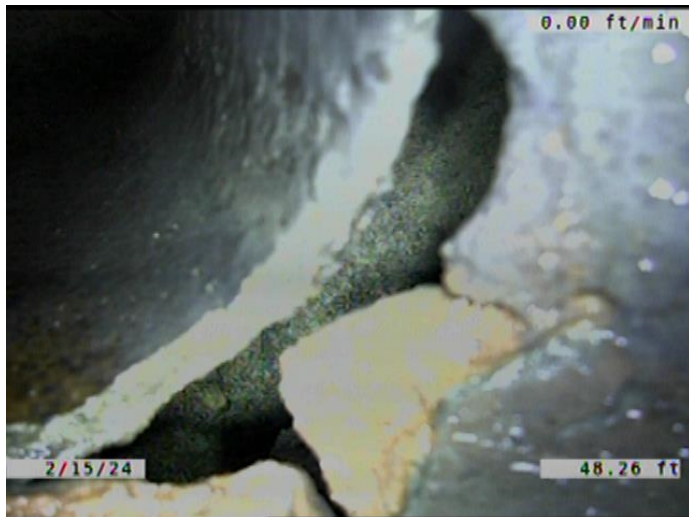
Code: **BVV**
Description: **Broken Void Visible**

Distance (ft): **48.3**
Structural Grade: **5**
O&M Grade: **0**
Clock Start/From: **11**
Clock To: **1**
1st Value:
2nd Value:
Value Percent:
Continuous Index:
Within 8" of Joint: **YES**
Remarks: **SOIL VISIBLE ALSO.**

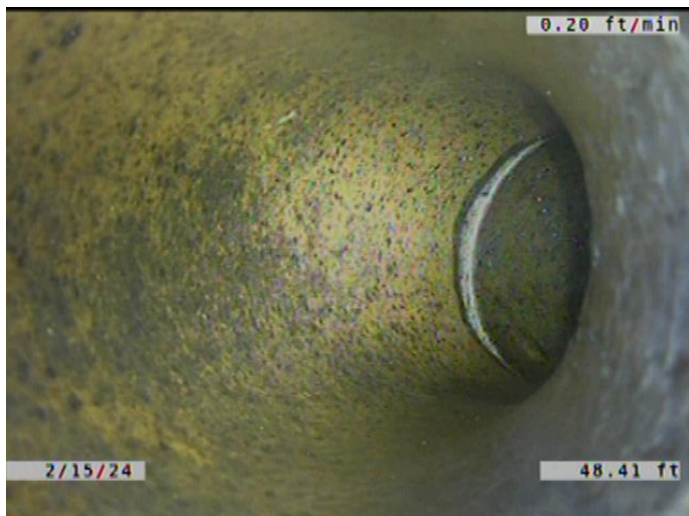
Code: **TBD**
Description: **Tap Break-in/Hammer Defective**

Distance (ft): **48.4**
Structural Grade: **0**
O&M Grade: **3**
Clock Start/From: **12**
Clock To:
1st Value: **6.000**
2nd Value:
Value Percent:
Continuous Index:
Within 8" of Joint: **YES**
Remarks: **COMES FROM THE RIGHT (WEST).
ACTIVITY.**

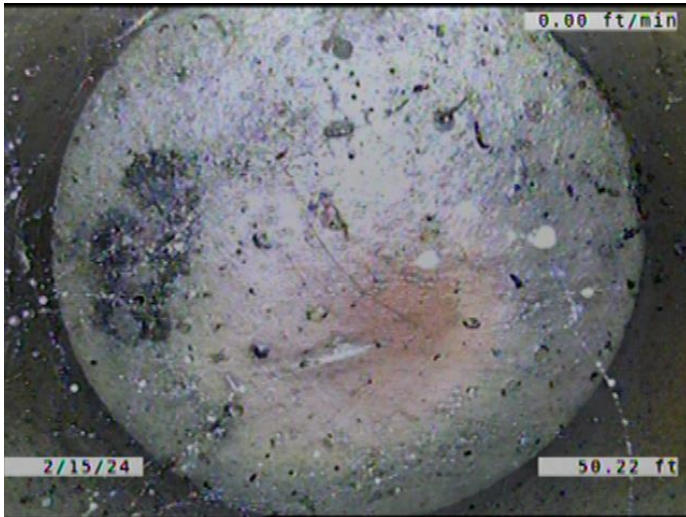
Code: **TFD**
Description: **Tap Factory Defective**

Distance (ft): **50.2**
Structural Grade: **0**
O&M Grade: **3**
Clock Start/From: **2**
Clock To:
1st Value: **6.000**
2nd Value:
Value Percent:
Continuous Index:
Within 8" of Joint: **YES**
Remarks: **CAPPED. TAP BROKEN.**

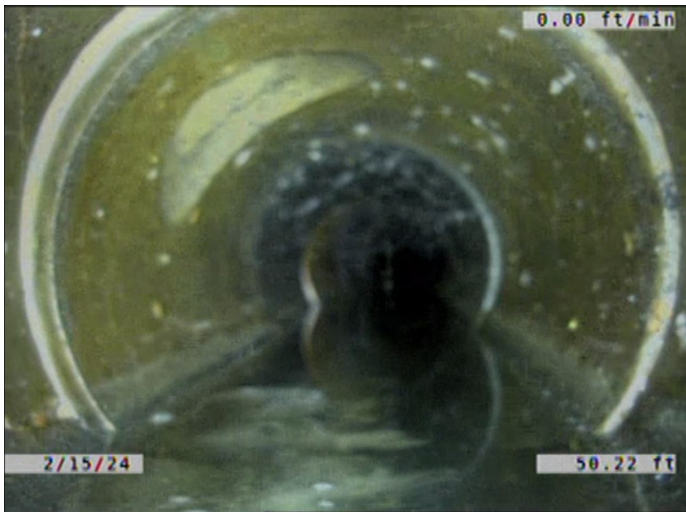
50.2	CM	Crack Multiple	917	S 3
52.5	TFD	Tap Factory Defective	960	M 3
58.6	MWLS(F04)	Miscellaneous Water Level Sag	1007	S 2
59.9	JAM	Joint Angular Medium	1054	S 3

Code: **CM**
Description: **Crack Multiple**

Distance (ft): **50.2**
Structural Grade: **3**
O&M Grade: **0**
Clock Start/From: **10**
Clock To: **2**
1st Value:
2nd Value:
Value Percent:
Continuous Index:
Within 8" of Joint: **YES**
Remarks:

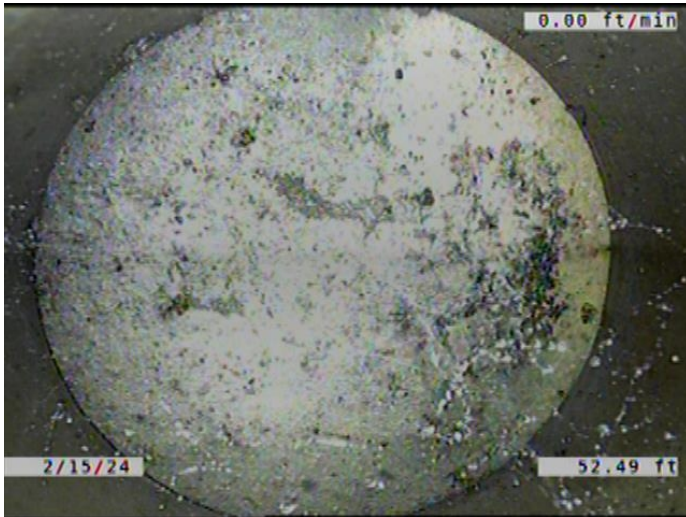
Code: **TFD**
Description: **Tap Factory Defective**

Distance (ft): **52.5**
Structural Grade: **0**
O&M Grade: **3**
Clock Start/From: **11**
Clock To:
1st Value: **6.000**
2nd Value:
Value Percent:
Continuous Index:
Within 8" of Joint: **YES**
Remarks: **CAPPED. TAP BROKEN.**

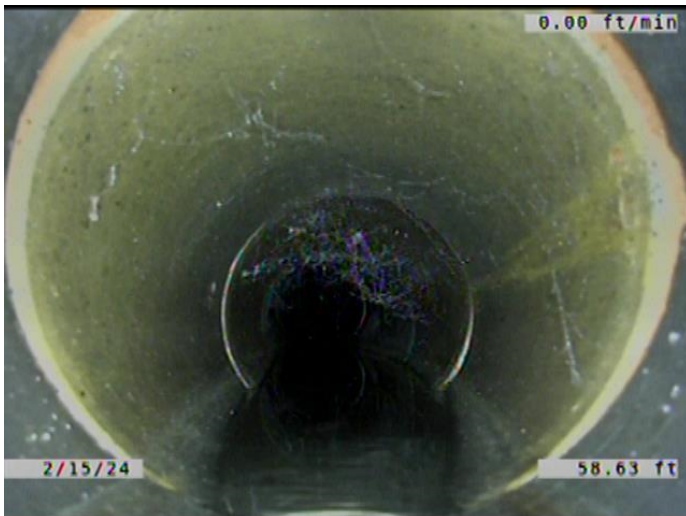
Code: **MWLS**
Description: **Miscellaneous Water Level Sag**

Distance (ft): **58.6**
Structural Grade: **2**
O&M Grade: **0**
Clock Start/From:
Clock To:
1st Value:
2nd Value:
Value Percent: **15.000**
Continuous Index: **F04**
Within 8" of Joint: **NO**
Remarks:

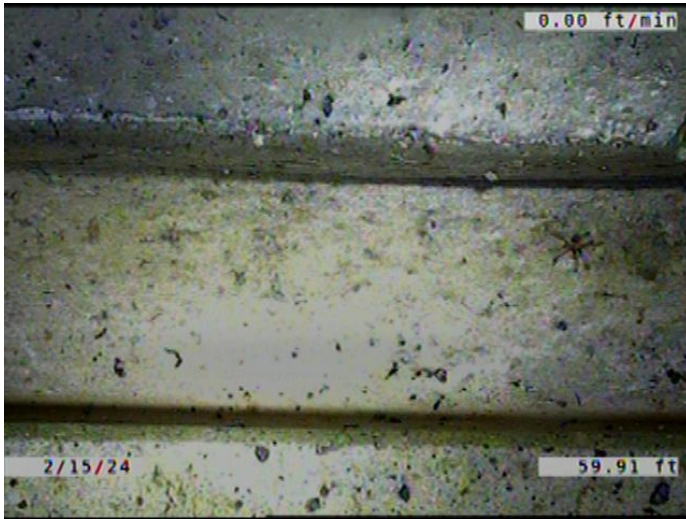
Code: **JAM**
Description: **Joint Angular Medium**

Distance (ft): **59.9**
Structural Grade: **3**
O&M Grade: **0**
Clock Start/From:
Clock To:
1st Value:
2nd Value:
Value Percent:
Continuous Index:
Within 8" of Joint: **NO**
Remarks:

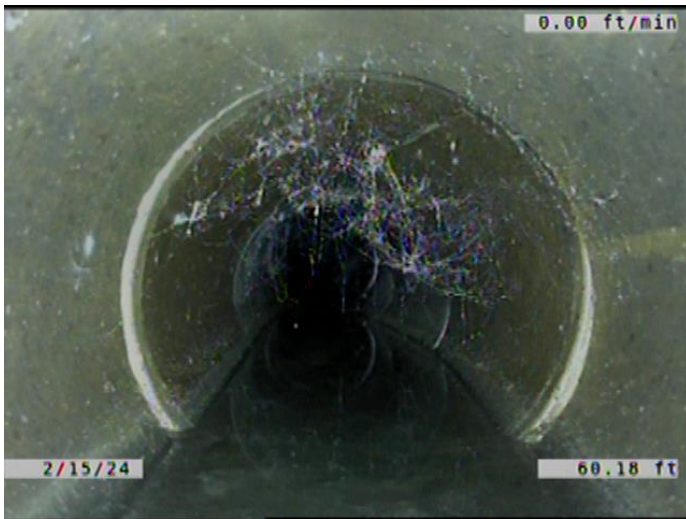
Code: **MWLS**
Description: **Miscellaneous Water Level Sag**

Distance (ft): **60.2**
Structural Grade: **2**
O&M Grade: **0**
Clock Start/From:
Clock To:
1st Value:
2nd Value:
Value Percent: **10.000**
Continuous Index: **S05**
Within 8" of Joint: **NO**
Remarks:

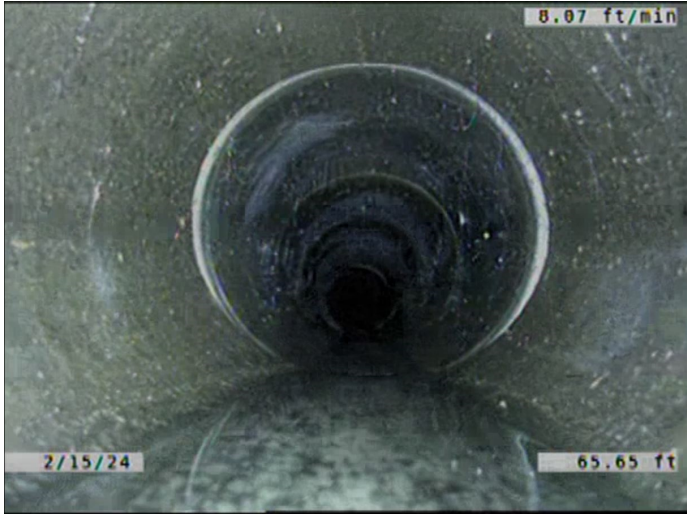
Code: **CH3**
Description: **Crack Longitudinal Hinge, 3**

Distance (ft): **65.7**
Structural Grade: **3**
O&M Grade: **0**
Clock Start/From: **9**
Clock To: **3**
1st Value:
2nd Value:
Value Percent:
Continuous Index:
Within 8" of Joint: **YES**
Remarks:

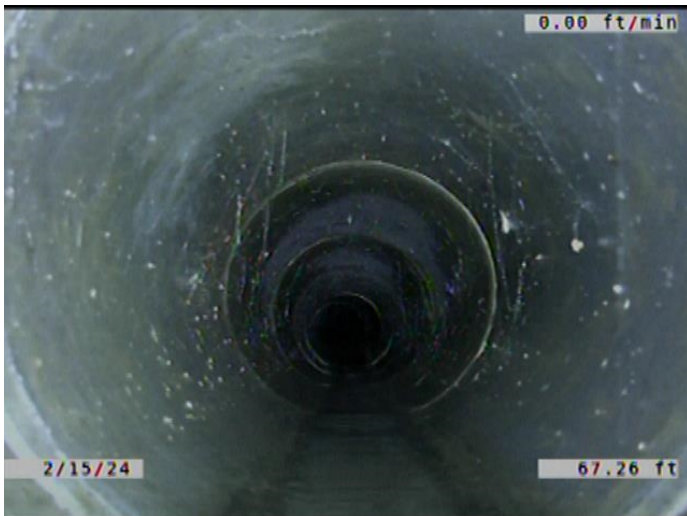
Code: **MWLS**
Description: **Miscellaneous Water Level Sag**

Distance (ft): **67.3**
Structural Grade: **2**
O&M Grade: **0**
Clock Start/From:
Clock To:
1st Value:
2nd Value:
Value Percent: **10.000**
Continuous Index: **F05**
Within 8" of Joint: **NO**
Remarks:

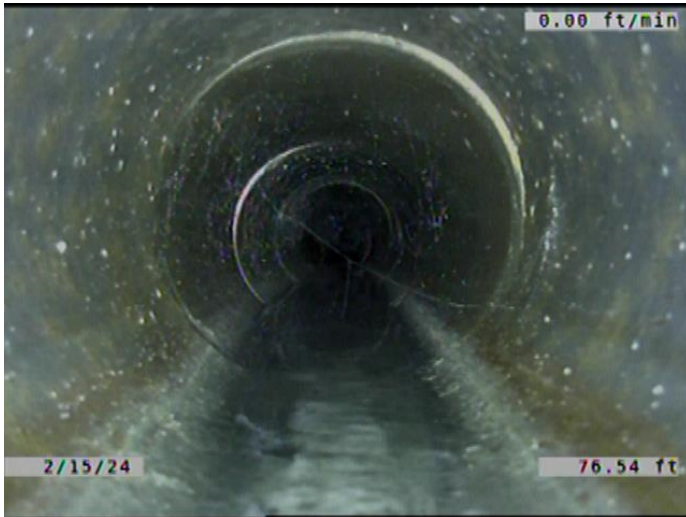
Code: **MWLS**
Description: **Miscellaneous Water Level Sag**

Distance (ft): **76.5**
Structural Grade: **2**
O&M Grade: **0**
Clock Start/From:
Clock To:
1st Value:
2nd Value:
Value Percent: **5.000**
Continuous Index: **S06**
Within 8" of Joint: **NO**
Remarks:

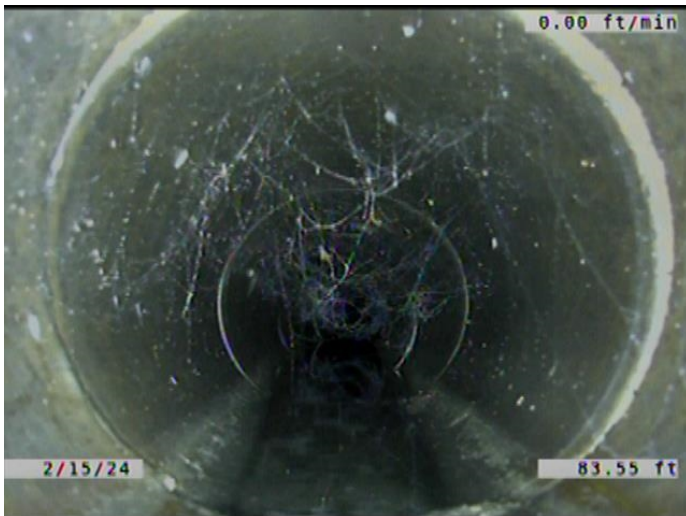
Code: **MWLS**
Description: **Miscellaneous Water Level Sag**

Distance (ft): **83.6**
Structural Grade: **2**
O&M Grade: **0**
Clock Start/From:
Clock To:
1st Value:
2nd Value:
Value Percent: **5.000**
Continuous Index: **F06**
Within 8" of Joint: **NO**
Remarks:

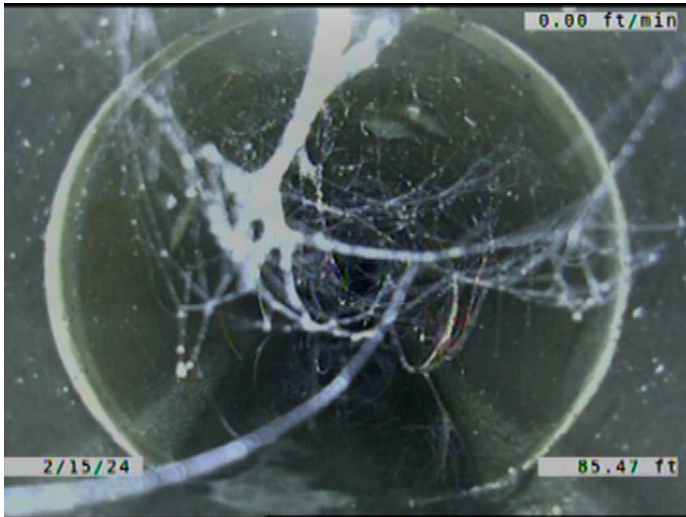
Code: **MWLS**
 Description: **Miscellaneous Water Level Sag**

Distance (ft): **85.5**
 Structural Grade: **2**
 O&M Grade: **0**
 Clock Start/From:
 Clock To:
 1st Value:
 2nd Value:
 Value Percent: **10.000**
 Continuous Index: **S07**
 Within 8" of Joint: **NO**
 Remarks:

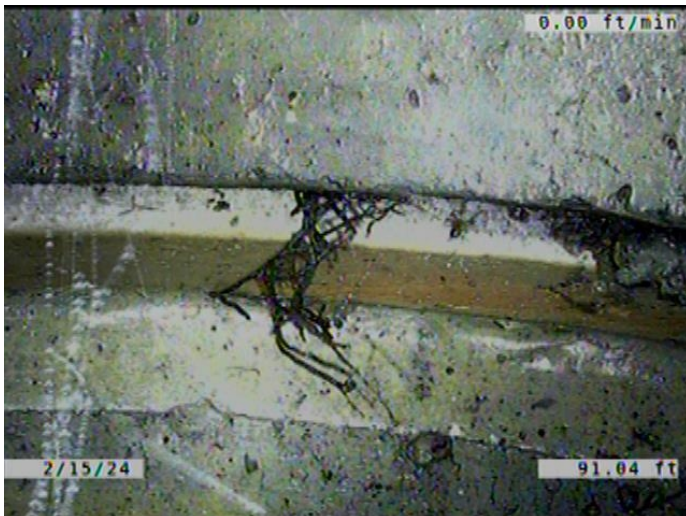
Code: **RFJ**
 Description: **Roots Fine Joint**

Distance (ft): **91.0**
 Structural Grade: **0**
 O&M Grade: **1**
 Clock Start/From: **3**
 Clock To:
 1st Value:
 2nd Value:
 Value Percent:
 Continuous Index:
 Within 8" of Joint: **YES**
 Remarks:

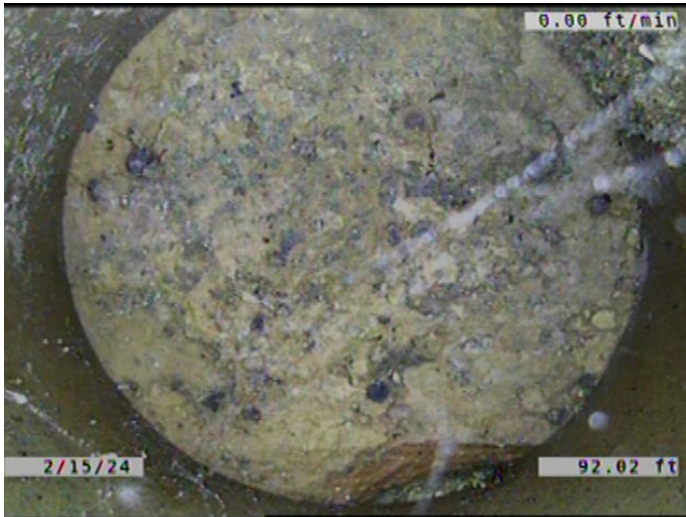
Code: **TFD**
Description: **Tap Factory Defective**

Distance (ft): **92.0**
Structural Grade: **0**
O&M Grade: **3**
Clock Start/From: **1**
Clock To:
1st Value: **6.000**
2nd Value:
Value Percent:
Continuous Index:
Within 8" of Joint: **YES**
Remarks: **CAPPED. CAP BROKEN. SOIL VISIBLE.**

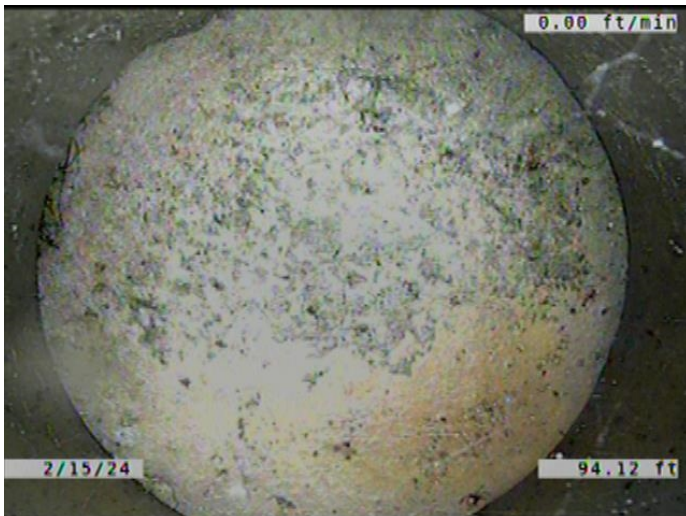
Code: **TFC**
Description: **Tap Factory Capped**

Distance (ft): **94.1**
Structural Grade: **0**
O&M Grade: **0**
Clock Start/From: **11**
Clock To:
1st Value: **6.000**
2nd Value:
Value Percent:
Continuous Index:
Within 8" of Joint: **YES**
Remarks:

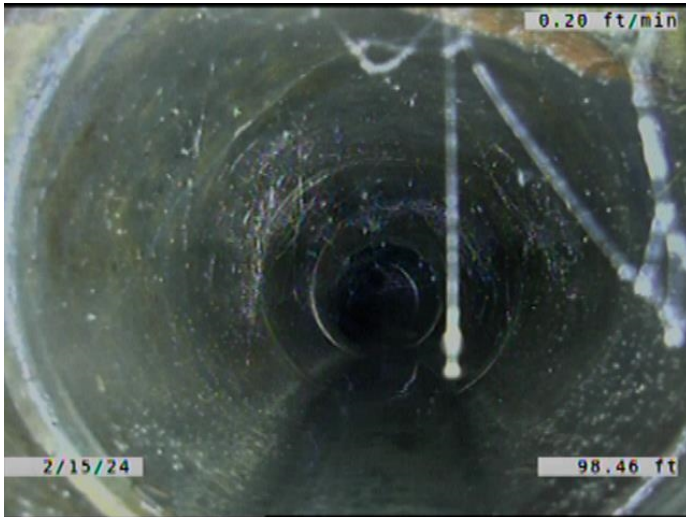
Code: **MWLS**
 Description: **Miscellaneous Water Level Sag**

Distance (ft): **98.5**
 Structural Grade: **2**
 O&M Grade: **0**
 Clock Start/From:
 Clock To:
 1st Value:
 2nd Value:
 Value Percent: **10.000**
 Continuous Index: **F07**
 Within 8" of Joint: **NO**
 Remarks:

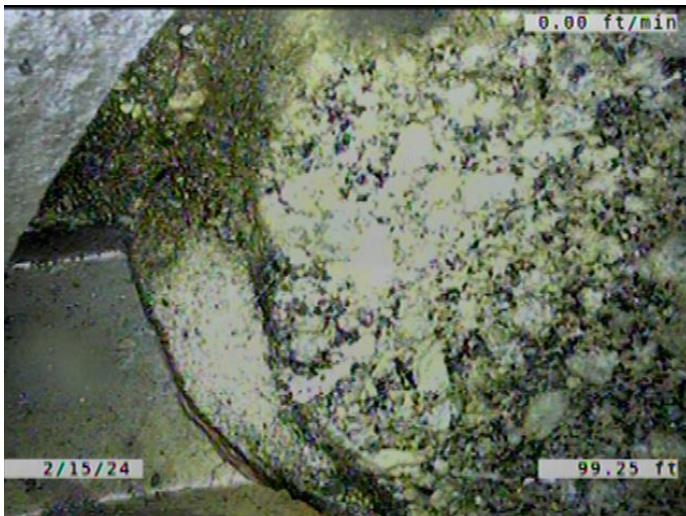
Code: **HSV**
 Description: **Hole Soil Visible**

Distance (ft): **99.3**
 Structural Grade: **5**
 O&M Grade: **0**
 Clock Start/From: **10**
 Clock To: **3**
 1st Value:
 2nd Value:
 Value Percent:
 Continuous Index:
 Within 8" of Joint: **YES**
 Remarks:

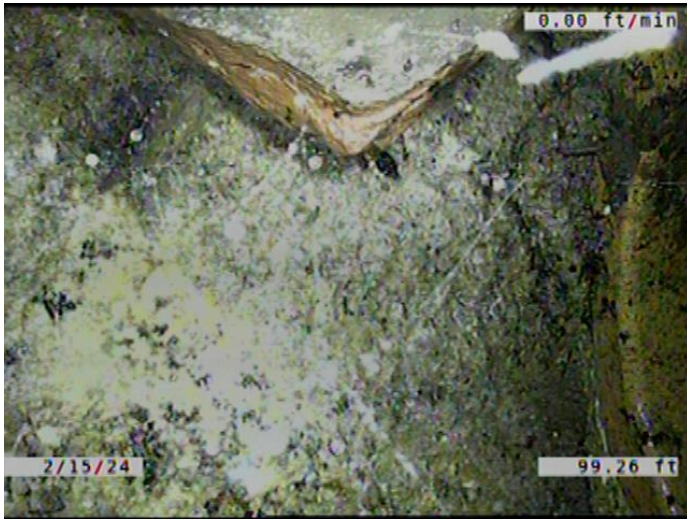
Code: **RPPD**
 Description: **Point Repair Patch Patch Defective**

Distance (ft): **99.3**
 Structural Grade: **4**
 O&M Grade: **0**
 Clock Start/From: **10**
 Clock To: **3**
 1st Value:
 2nd Value:
 Value Percent:
 Continuous Index:
 Within 8" of Joint: **YES**
 Remarks: **LOOKS TO BE MORTAR ON TOP OF THE MISSING PIPE SECTION AND AR**

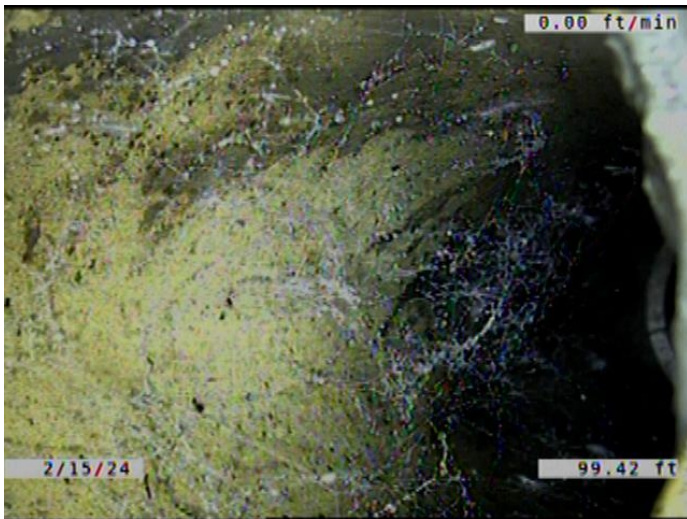
Code: **TBD**
 Description: **Tap Break-in/Hammer Defective**

Distance (ft): **99.4**
 Structural Grade: **0**
 O&M Grade: **3**
 Clock Start/From: **2**
 Clock To:
 1st Value: **6.000**
 2nd Value:
 Value Percent:
 Continuous Index:
 Within 8" of Joint: **YES**
 Remarks: **CONSTANTLY RUNNING WATER.**

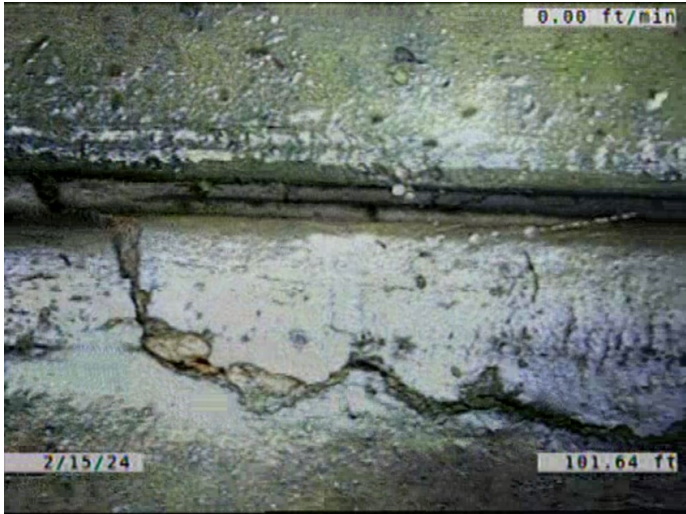
Code: **B**
Description: **Broken**

Distance (ft): **101.6**
Structural Grade: **4**
O&M Grade: **0**
Clock Start/From: **7**
Clock To: **5**
1st Value:
2nd Value:
Value Percent:
Continuous Index:
Within 8" of Joint: **YES**
Remarks:

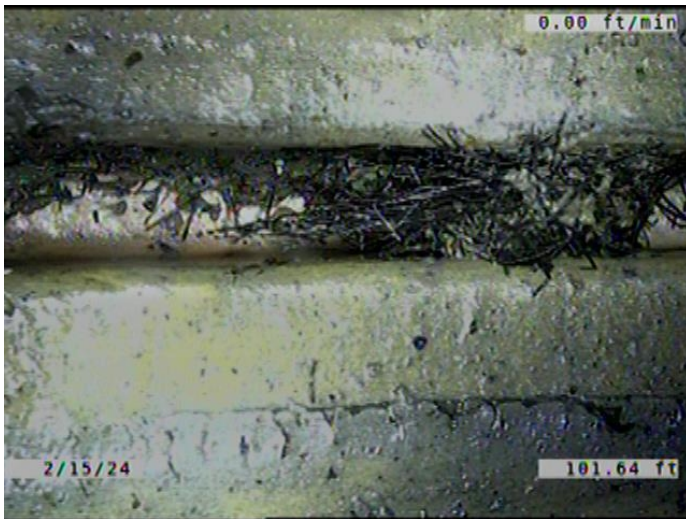
Code: **RFJ**
Description: **Roots Fine Joint**

Distance (ft): **101.6**
Structural Grade: **0**
O&M Grade: **1**
Clock Start/From: **7**
Clock To: **5**
1st Value:
2nd Value:
Value Percent:
Continuous Index:
Within 8" of Joint: **YES**
Remarks:

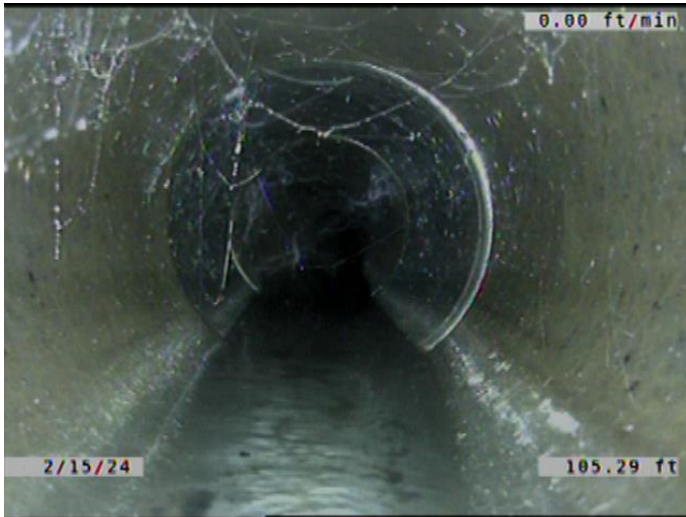
Code: **MWLS**
Description: **Miscellaneous Water Level Sag**

Distance (ft): **105.3**
Structural Grade: **4**
O&M Grade: **0**
Clock Start/From:
Clock To:
1st Value:
2nd Value:
Value Percent: **55.000**
Continuous Index: **S08**
Within 8" of Joint: **NO**
Remarks:

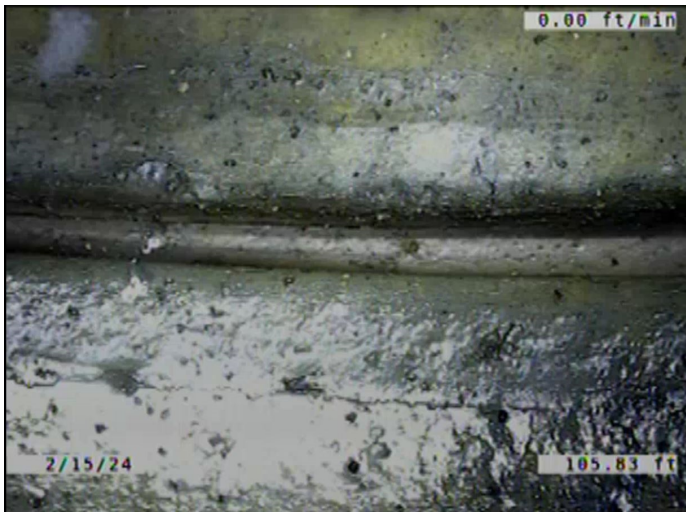
Code: **FM**
Description: **Fracture Multiple**

Distance (ft): **105.8**
Structural Grade: **4**
O&M Grade: **0**
Clock Start/From: **7**
Clock To: **5**
1st Value:
2nd Value:
Value Percent:
Continuous Index:
Within 8" of Joint: **YES**
Remarks:

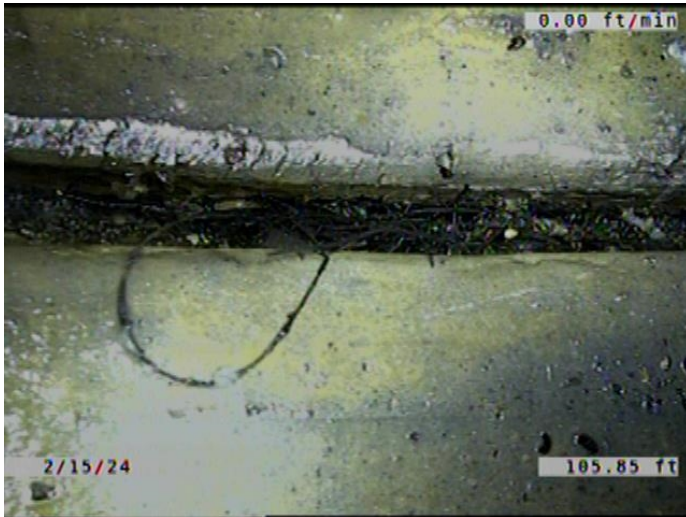
Code: **RFJ**
Description: **Roots Fine Joint**

Distance (ft): **105.8**
Structural Grade: **0**
O&M Grade: **1**
Clock Start/From: **7**
Clock To: **5**
1st Value:
2nd Value:
Value Percent:
Continuous Index:
Within 8" of Joint: **YES**
Remarks:

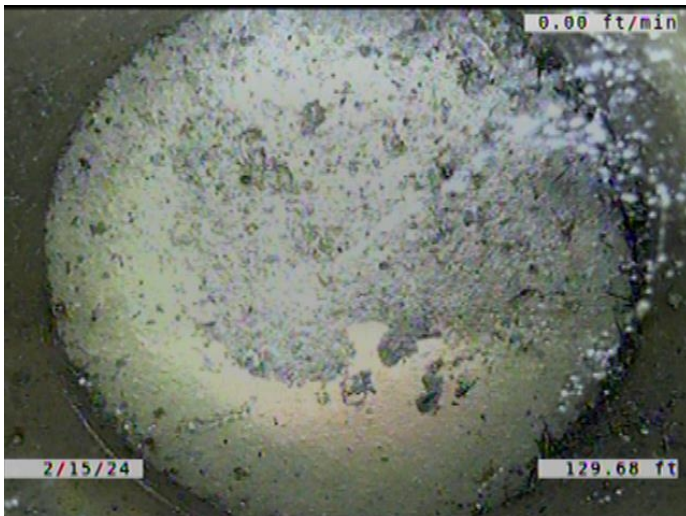
Code: **TFD**
Description: **Tap Factory Defective**

Distance (ft): **129.7**
Structural Grade: **0**
O&M Grade: **3**
Clock Start/From: **1**
Clock To:
1st Value: **6.000**
2nd Value:
Value Percent:
Continuous Index:
Within 8" of Joint: **YES**
Remarks: **CAPPED. ROOTS GROWING AROUND THE CAP.**

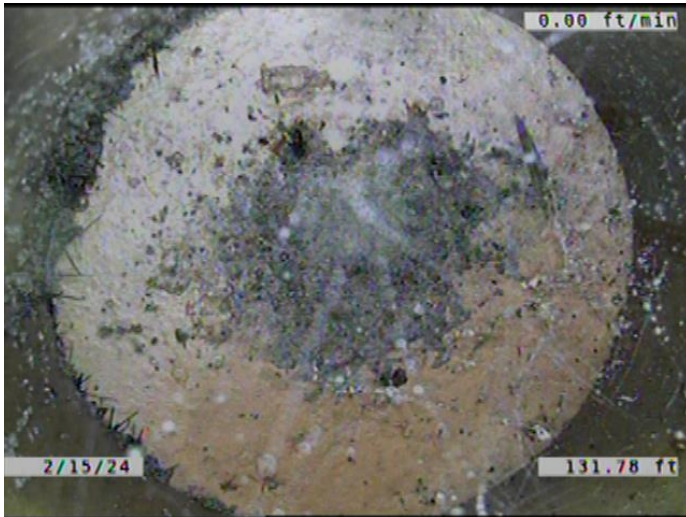
Code:	TFD
Description:	Tap Factory Defective
Distance (ft):	131.8
Structural Grade:	0
O&M Grade:	3
Clock Start/From:	11
Clock To:	
1st Value:	6.000
2nd Value:	
Value Percent:	
Continuous Index:	
Within 8" of Joint:	YES
Remarks:	CAPPED. ROOTS GROWING AROUND THE CAP.

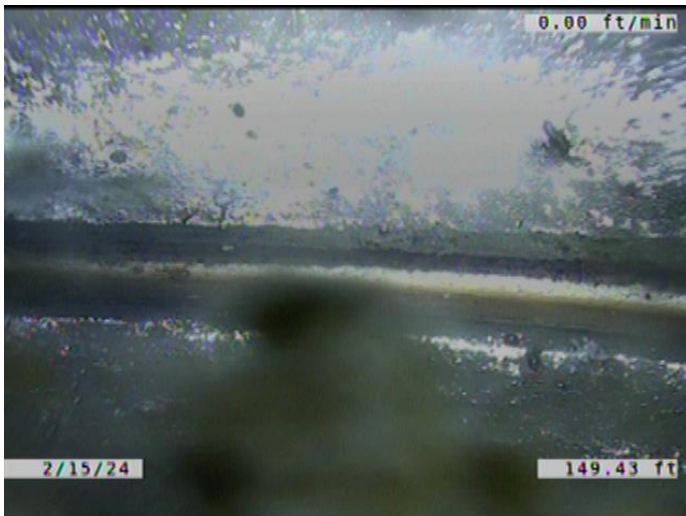
Code:	MCU
Description:	Miscellaneous Camera Underwater
Distance (ft):	149.4
Structural Grade:	0
O&M Grade:	4
Clock Start/From:	
Clock To:	
1st Value:	
2nd Value:	
Value Percent:	
Continuous Index:	S09
Within 8" of Joint:	NO
Remarks:

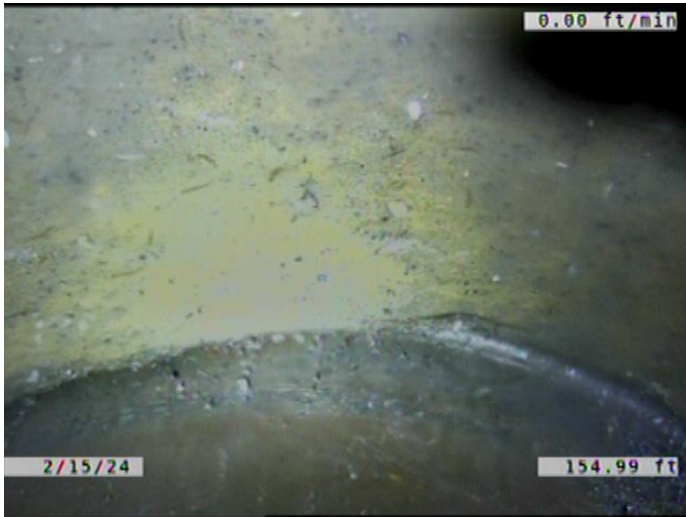
Code:	MCU
Description:	Miscellaneous Camera Underwater
Distance (ft):	155.0
Structural Grade:	0
O&M Grade:	4
Clock Start/From:	
Clock To:	
1st Value:	
2nd Value:	
Value Percent:	
Continuous Index:	F09
Within 8" of Joint:	NO
Remarks:

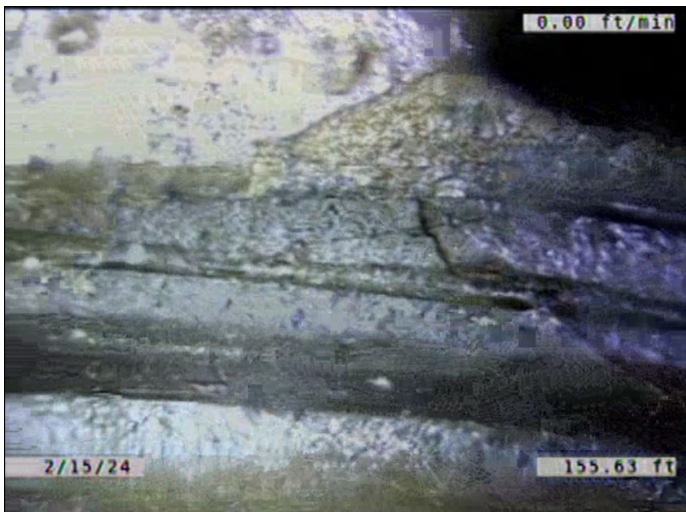
Code:	FM
Description:	Fracture Multiple
Distance (ft):	155.6
Structural Grade:	4
O&M Grade:	0
Clock Start/From:	10
Clock To:	11
1st Value:	
2nd Value:	
Value Percent:	
Continuous Index:	
Within 8" of Joint:	YES
Remarks:

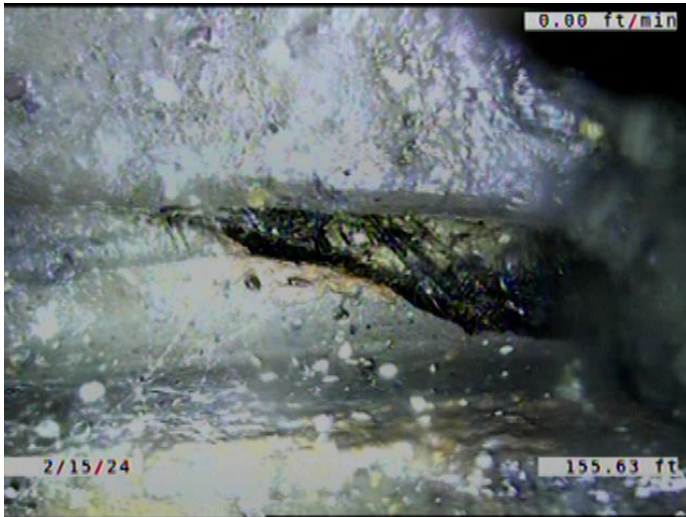
Code: HSV
Description: Hole Soil Visible

Distance (ft): 155.6
Structural Grade: 5
O&M Grade: 0
Clock Start/From: 3
Clock To: 4
1st Value:
2nd Value:
Value Percent:
Continuous Index:
Within 8" of Joint: YES
Remarks: THE BELL/ OUTSIDE OF THE JOINT.

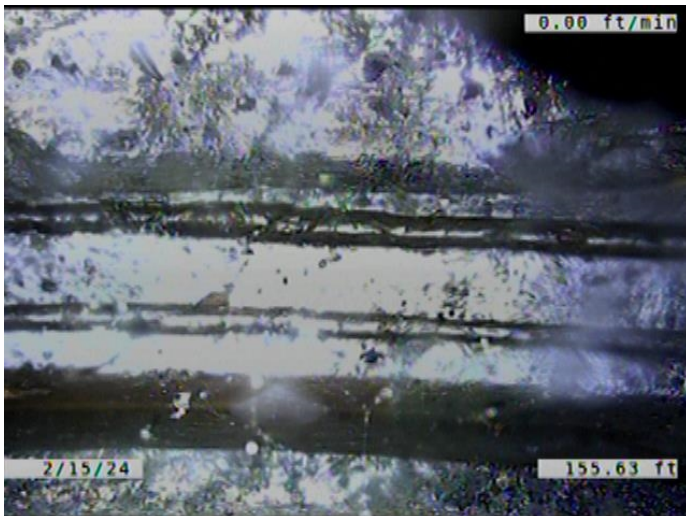
Code: JAL
Description: Joint Angular Large

Distance (ft): 155.6
Structural Grade: 4
O&M Grade: 0
Clock Start/From:
Clock To:
1st Value:
2nd Value:
Value Percent:
Continuous Index:
Within 8" of Joint: NO
Remarks:

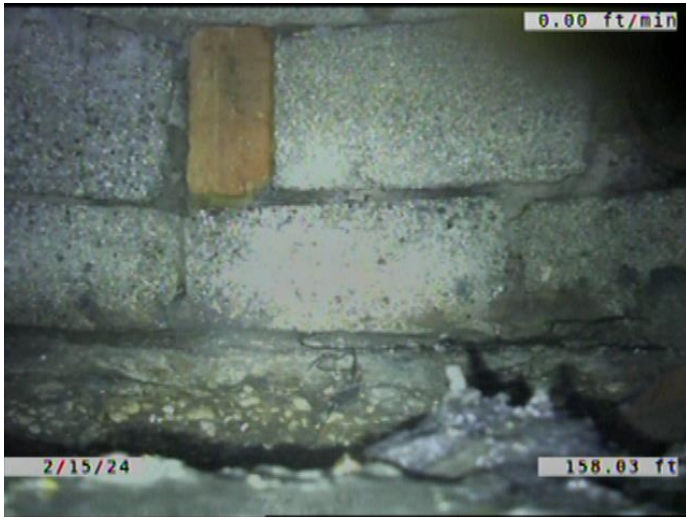
Code: **MWLS**
Description: **Miscellaneous Water Level Sag**

Distance (ft): **158.0**
Structural Grade: **4**
O&M Grade: **0**
Clock Start/From:
Clock To:
1st Value:
2nd Value:
Value Percent: **55.000**
Continuous Index: **F08**
Within 8" of Joint: **NO**
Remarks:

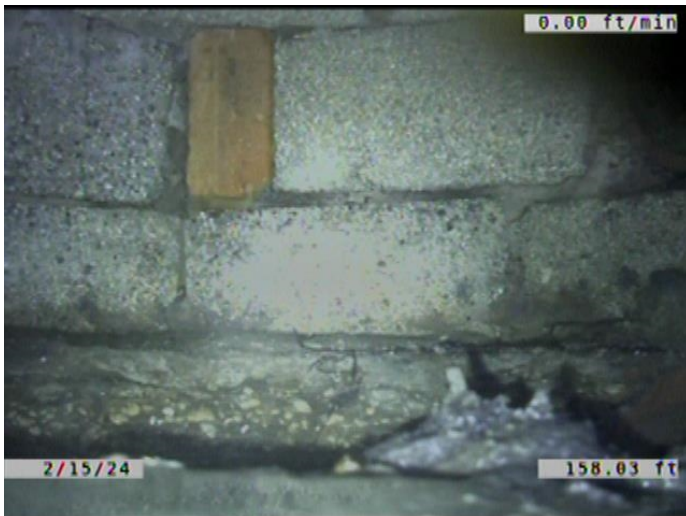
Code: **DSF**
Description: **Deposits Settled Fine**

Distance (ft): **158.0**
Structural Grade: **0**
O&M Grade: **2**
Clock Start/From: **5**
Clock To: **7**
1st Value:
2nd Value:
Value Percent: **5.000**
Continuous Index: **F02**
Within 8" of Joint: **YES**
Remarks:

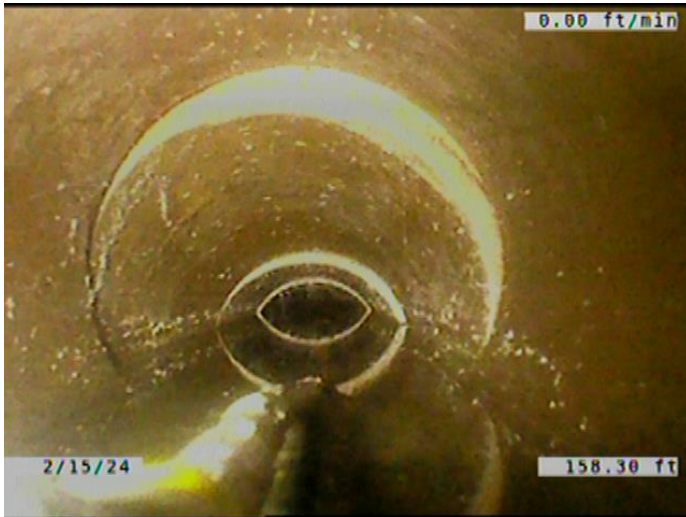
Code:	MGO
Description:	Miscellaneous General Observation
Distance (ft):	158.3
Structural Grade:	0
O&M Grade:	0
Clock Start/From:	
Clock To:	
1st Value:	
2nd Value:	
Value Percent:	
Continuous Index:	
Within 8" of Joint:	NO
Remarks:	A VIEW OF THE SAG FROM THE BACK UP CAMERA.

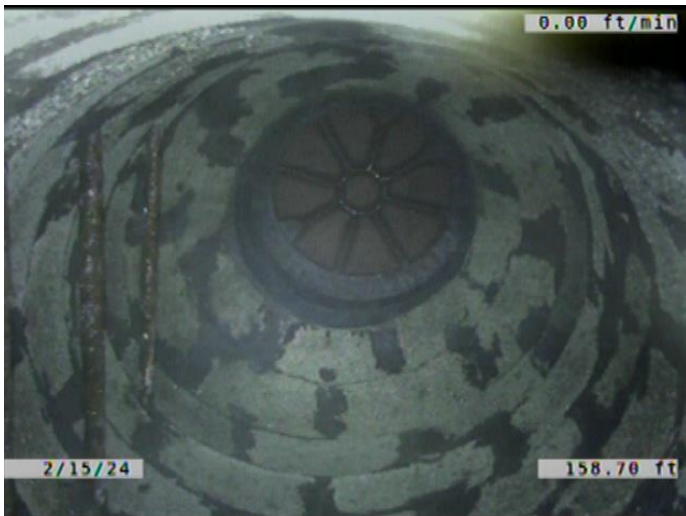
Code:	AMH
Description:	Manhole
Distance (ft):	158.7
Structural Grade:	0
O&M Grade:	0
Clock Start/From:	
Clock To:	
1st Value:	
2nd Value:	
Value Percent:	
Continuous Index:	
Within 8" of Joint:	NO
Remarks:	M-504-015
