Profile/Photo Observation Report

Date:	02/15/2024	Weather:		Coding:	PACP 7.0
Pipe Length (ft):	142.0	Owner:	City of Hobart	Pre Clean:	Heavy Cleaning
P.O.#:	YES502259	Surveyor:	S. Bucklin	PSR:	P-504-017-015
Customer:	City of Hobart	Clean Date:	10/17/2022	Shape:	C

Street:	N DELAWARE ST	Flow Control:	Not Controlled
City:	Hobart, IN	Year Renewed:	
Location:	Alley	Tape/Media #:	
Purpose:	Routine Assessment	Dia/Height:	10"
Use:	Sanitary Sewage Pipe	Material:	VCP
Drain Area:		Lining:	None
Category:	NA		
Comment:			
Location Details:		Direction of Survey:	Downstream
US MH:	M-504-015	DS MH:	M-504-017
		Total Length Surveyed (ft):	141.6

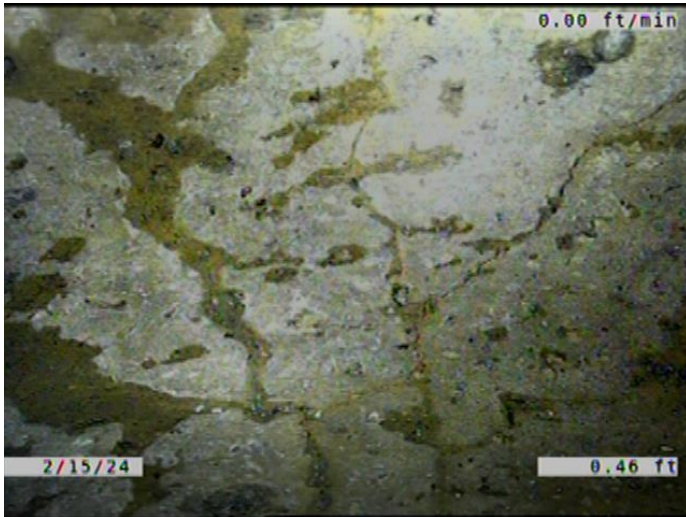
Code: **CM**
Description: **Crack Multiple**

Distance (ft): **.5**
Structural Grade: **3**
O&M Grade: **0**
Clock Start/From: **12**
Clock To: **12**
1st Value:
2nd Value:
Value Percent:
Continuous Index:
Within 8" of Joint: **YES**
Remarks:

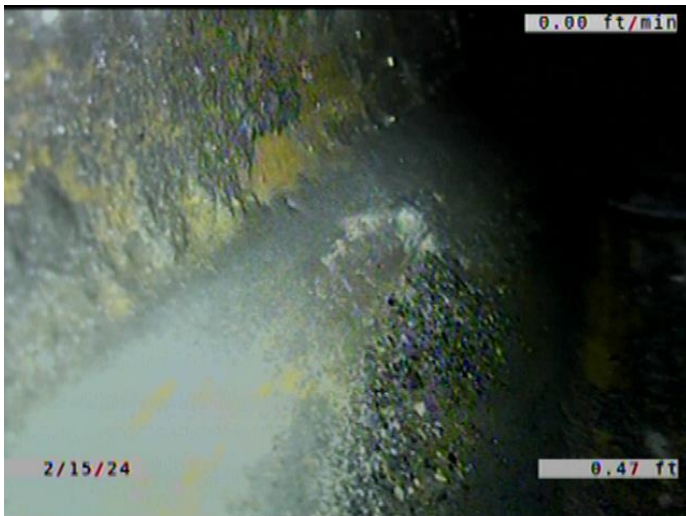
Code: **DSF**
Description: **Deposits Settled Fine**

Distance (ft): **.5**
Structural Grade: **0**
O&M Grade: **2**
Clock Start/From: **5**
Clock To: **7**
1st Value:
2nd Value:
Value Percent: **5.000**
Continuous Index: **S01**
Within 8" of Joint: **YES**
Remarks:

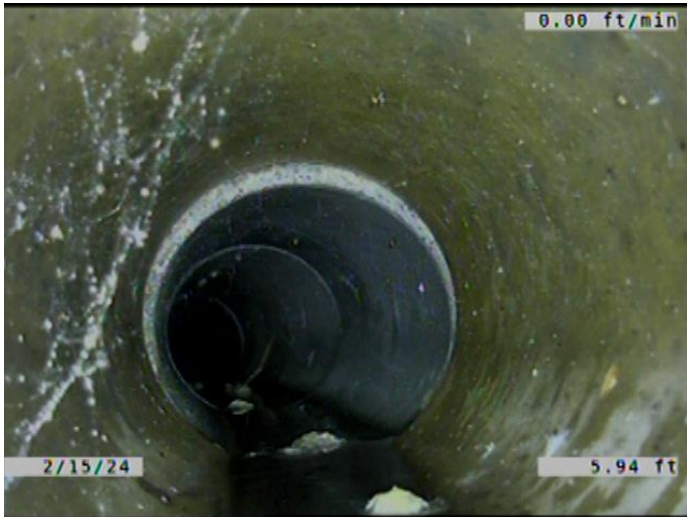
Code: **LL**
Description: **Line Left**

Distance (ft): **5.9**
Structural Grade: **0**
O&M Grade: **1**
Clock Start/From:
Clock To:
1st Value:
2nd Value:
Value Percent: **10.000**
Continuous Index:
Within 8" of Joint: **NO**
Remarks:

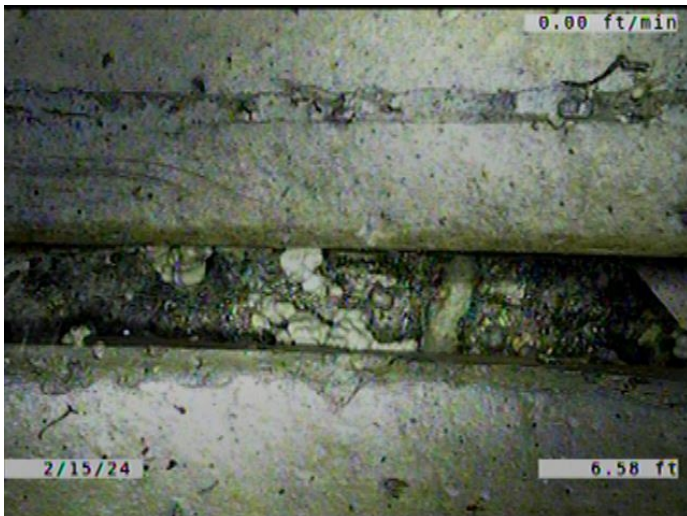
Code: **HSV**
Description: **Hole Soil Visible**

Distance (ft): **6.6**
Structural Grade: **5**
O&M Grade: **0**
Clock Start/From: **1**
Clock To: **2**
1st Value:
2nd Value:
Value Percent:
Continuous Index:
Within 8" of Joint: **YES**
Remarks: **THE BELL/ OUTSIDE OF THE JOINTS IS MISSING.**

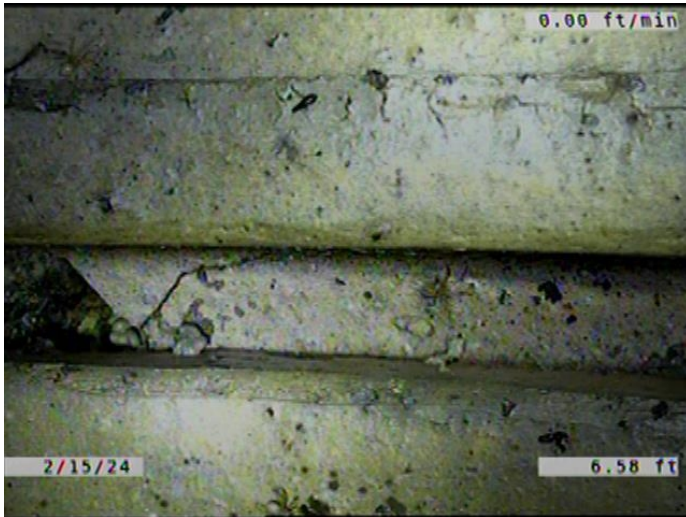
Code: **CS**
Description: **Crack Spiral**

Distance (ft): **6.6**
Structural Grade: **2**
O&M Grade: **0**
Clock Start/From: **2**
Clock To: **5**
1st Value:
2nd Value:
Value Percent:
Continuous Index:
Within 8" of Joint: **YES**
Remarks:

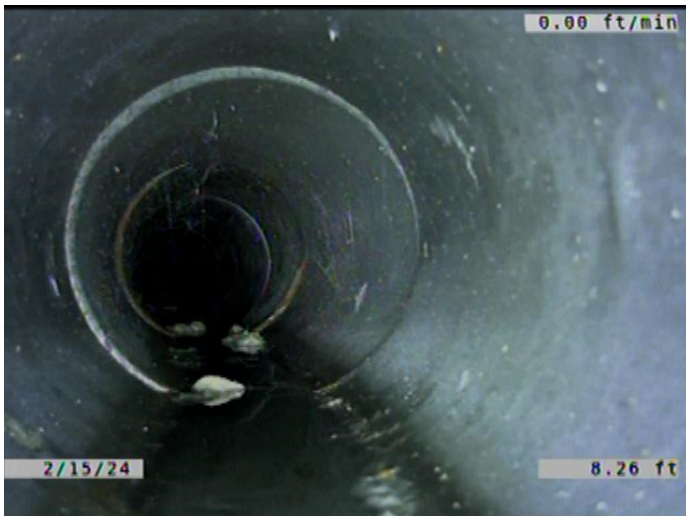
Code: **LL**
Description: **Line Left**

Distance (ft): **8.3**
Structural Grade: **0**
O&M Grade: **1**
Clock Start/From:
Clock To:
1st Value:
2nd Value:
Value Percent: **10.000**
Continuous Index:
Within 8" of Joint: **NO**
Remarks:

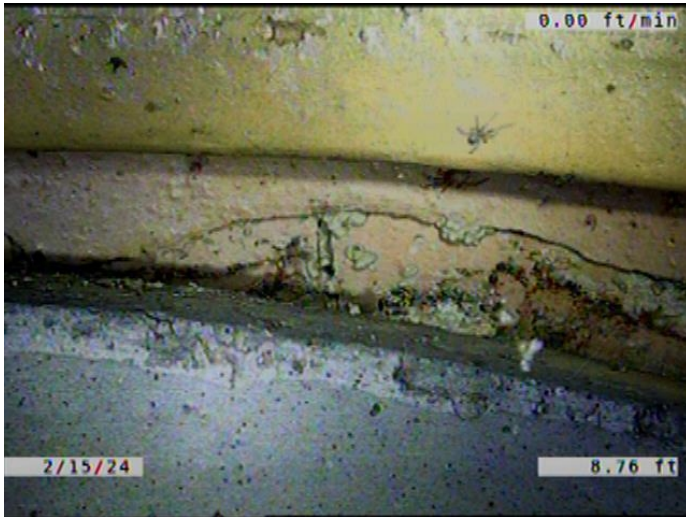
Code: **CM**
Description: **Crack Multiple**

Distance (ft): **8.8**
Structural Grade: **3**
O&M Grade: **0**
Clock Start/From: **11**
Clock To: **5**
1st Value:
2nd Value:
Value Percent:
Continuous Index:
Within 8" of Joint: **YES**
Remarks:

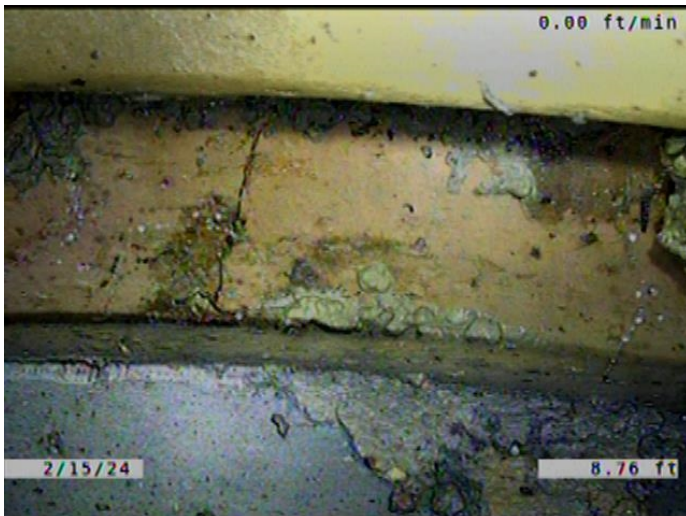
Code: **JAL**
Description: **Joint Angular Large**

Distance (ft): **8.8**
Structural Grade: **4**
O&M Grade: **0**
Clock Start/From:
Clock To:
1st Value:
2nd Value:
Value Percent:
Continuous Index:
Within 8" of Joint: **NO**
Remarks:

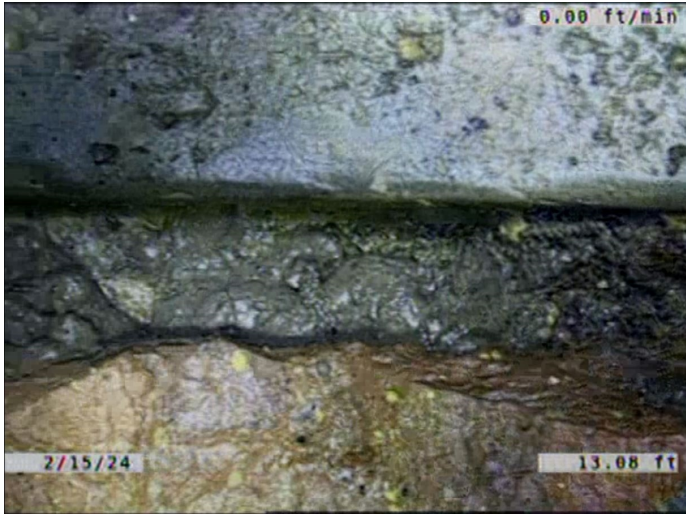
Code: **SMW**
Description: **Surface Damage Missing Wall**

Distance (ft): **13.1**
Structural Grade: **5**
O&M Grade: **0**
Clock Start/From: **12**
Clock To: **12**
1st Value:
2nd Value:
Value Percent:
Continuous Index:
Within 8" of Joint: **YES**
Remarks:

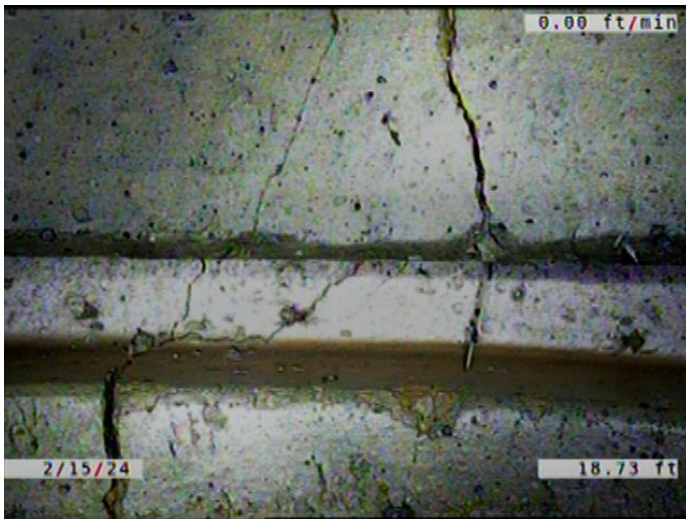
Code: **FM**
Description: **Fracture Multiple**

Distance (ft): **18.7**
Structural Grade: **4**
O&M Grade: **0**
Clock Start/From: **7**
Clock To: **5**
1st Value:
2nd Value:
Value Percent:
Continuous Index: **S02**
Within 8" of Joint: **YES**
Remarks:

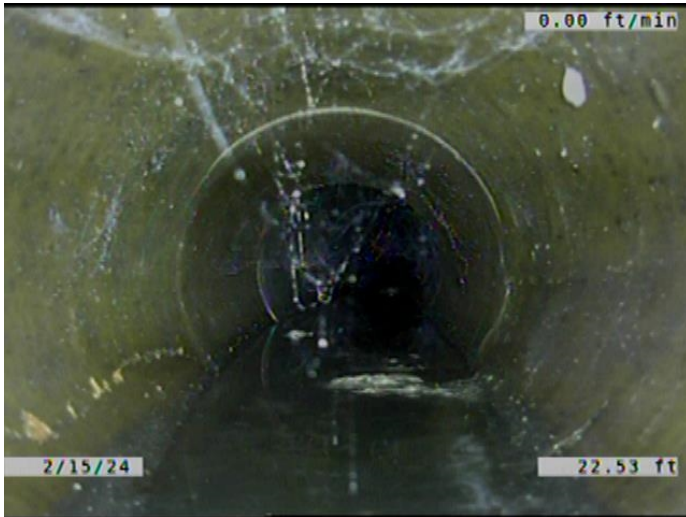
Code: **MWLS**
Description: **Miscellaneous Water Level Sag**

Distance (ft): **22.5**
Structural Grade: **2**
O&M Grade: **0**
Clock Start/From:
Clock To:
1st Value:
2nd Value:
Value Percent: **15.000**
Continuous Index: **S03**
Within 8" of Joint: **NO**
Remarks:

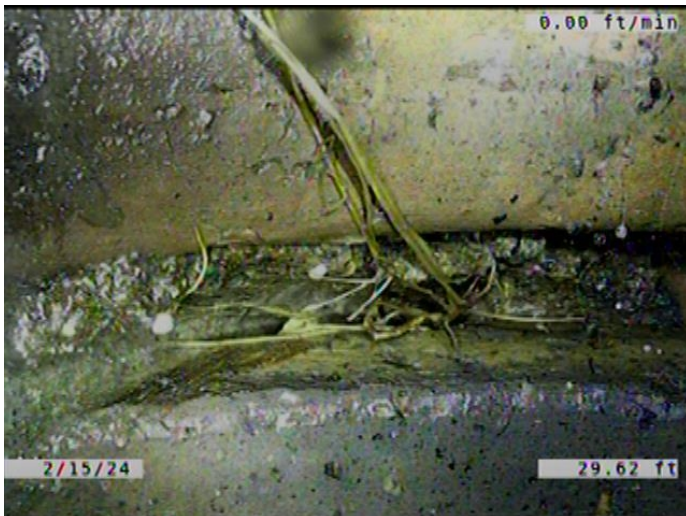
Code: **RFJ**
Description: **Roots Fine Joint**

Distance (ft): **29.6**
Structural Grade: **0**
O&M Grade: **1**
Clock Start/From: **4**
Clock To:
1st Value:
2nd Value:
Value Percent:
Continuous Index:
Within 8" of Joint: **YES**
Remarks:

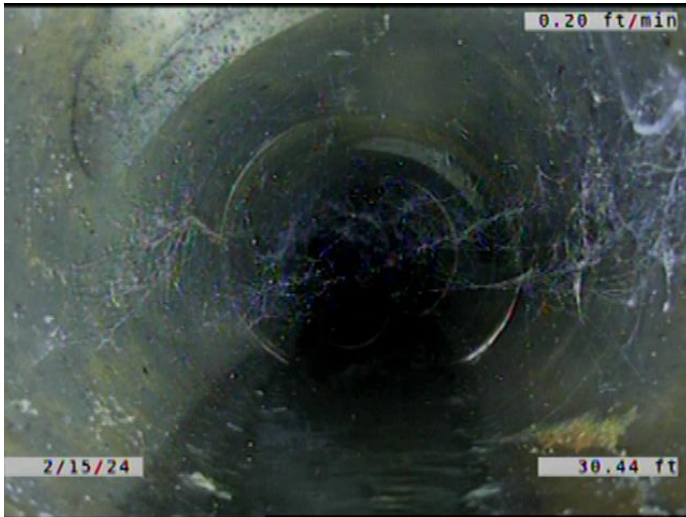
Code: **MWLS**
Description: **Miscellaneous Water Level Sag**

Distance (ft): **30.4**
Structural Grade: **2**
O&M Grade: **0**
Clock Start/From:
Clock To:
1st Value:
2nd Value:
Value Percent: **15.000**
Continuous Index: **F03**
Within 8" of Joint: **NO**
Remarks:

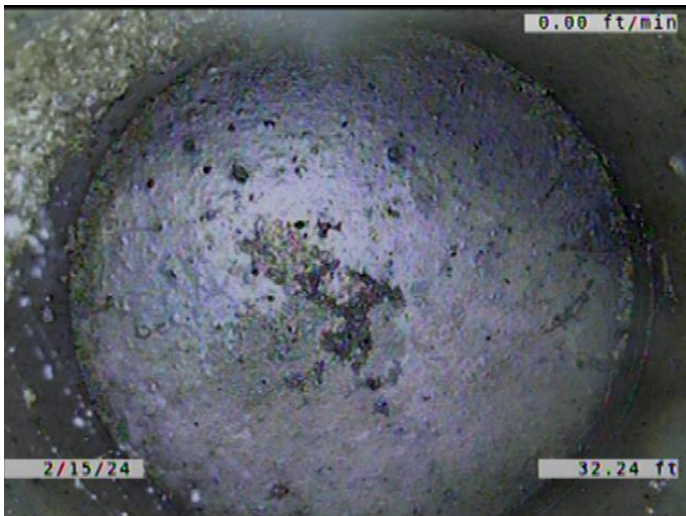
Code: **TFD**
Description: **Tap Factory Defective**

Distance (ft): **32.2**
Structural Grade: **0**
O&M Grade: **3**
Clock Start/From: **11**
Clock To:
1st Value: **6.000**
2nd Value:
Value Percent:
Continuous Index:
Within 8" of Joint: **YES**
Remarks: **CAPPED. TAP BROKEN.**

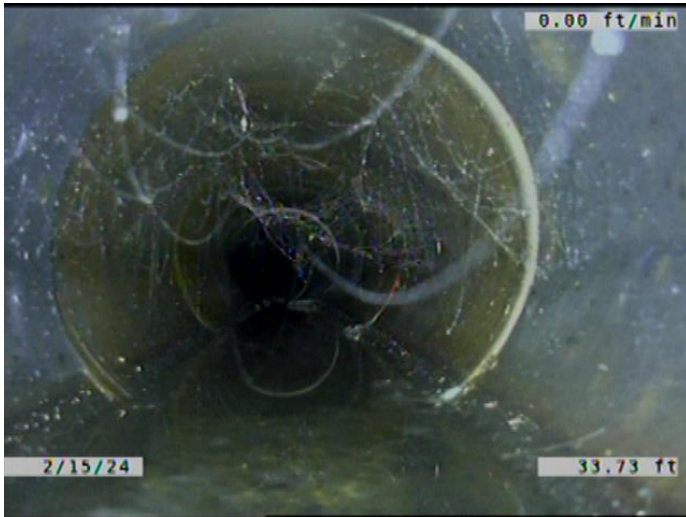
Code: **MWLS**
Description: **Miscellaneous Water Level Sag**

Distance (ft): **33.7**
Structural Grade: **2**
O&M Grade: **0**
Clock Start/From:
Clock To:
1st Value:
2nd Value:
Value Percent: **10.000**
Continuous Index: **S04**
Within 8" of Joint: **NO**
Remarks:

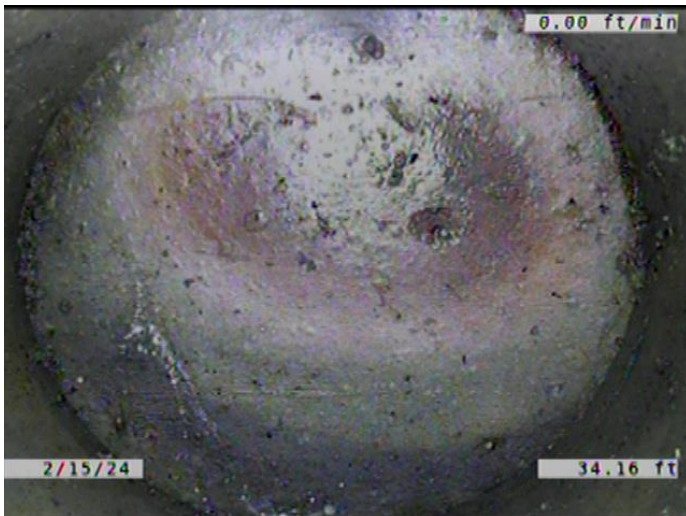
Code: **TFD**
Description: **Tap Factory Defective**

Distance (ft): **34.2**
Structural Grade: **0**
O&M Grade: **3**
Clock Start/From: **1**
Clock To:
1st Value: **6.000**
2nd Value:
Value Percent:
Continuous Index:
Within 8" of Joint: **YES**
Remarks: **CAPPED. TAP BROKEN.**

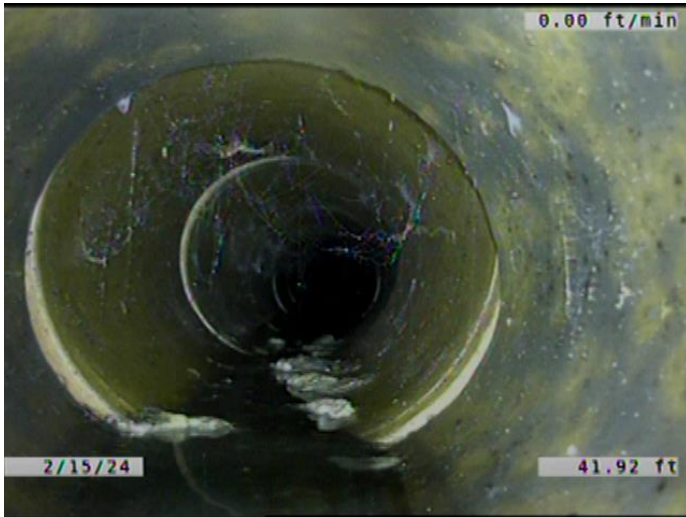
Code: **MWLS**
Description: **Miscellaneous Water Level Sag**

Distance (ft): **41.9**
Structural Grade: **2**
O&M Grade: **0**
Clock Start/From:
Clock To:
1st Value:
2nd Value:
Value Percent: **10.000**
Continuous Index: **F04**
Within 8" of Joint: **NO**
Remarks:

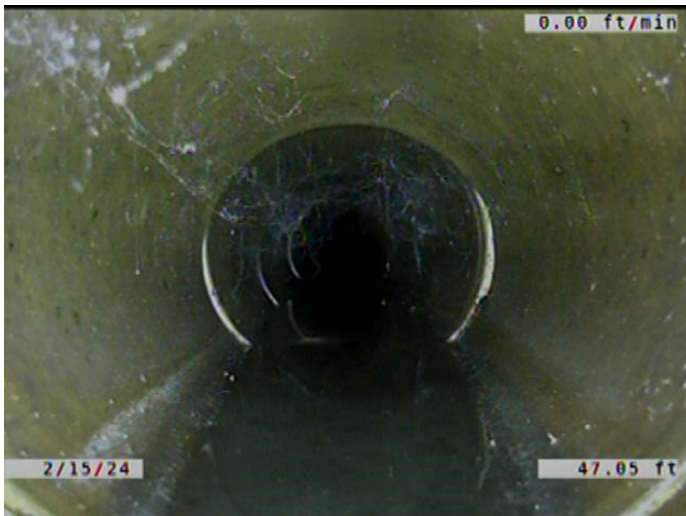
Code: **MWLS**
Description: **Miscellaneous Water Level Sag**

Distance (ft): **47.0**
Structural Grade: **2**
O&M Grade: **0**
Clock Start/From:
Clock To:
1st Value:
2nd Value:
Value Percent: **10.000**
Continuous Index: **S05**
Within 8" of Joint: **NO**
Remarks:

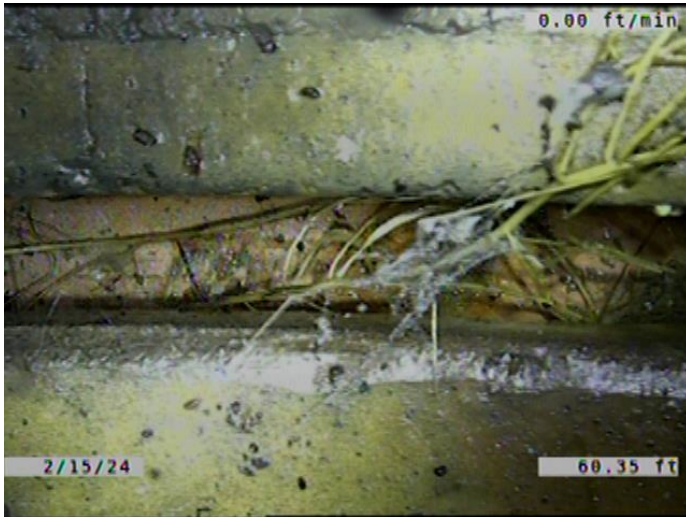
Code: **RFJ**
Description: **Roots Fine Joint**

Distance (ft): **60.4**
Structural Grade: **0**
O&M Grade: **1**
Clock Start/From: **7**
Clock To: **10**
1st Value:
2nd Value:
Value Percent:
Continuous Index:
Within 8" of Joint: **YES**
Remarks:

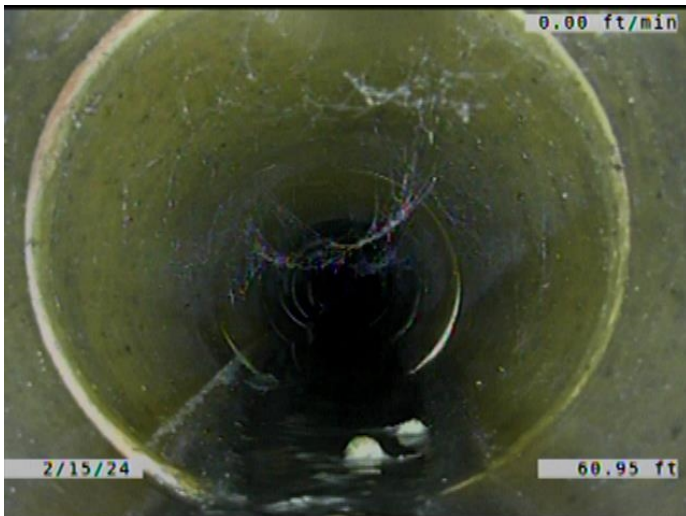
Code: **MWLS**
Description: **Miscellaneous Water Level Sag**

Distance (ft): **60.9**
Structural Grade: **2**
O&M Grade: **0**
Clock Start/From:
Clock To:
1st Value:
2nd Value:
Value Percent: **10.000**
Continuous Index: **F05**
Within 8" of Joint: **NO**
Remarks:

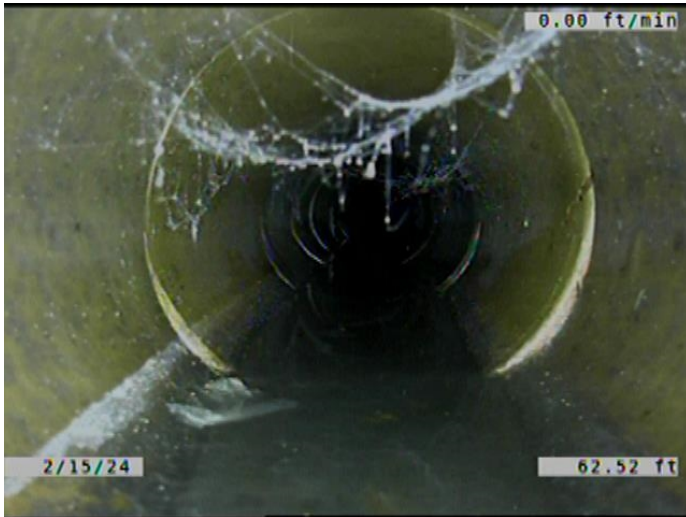
Code: **MWLS**
Description: **Miscellaneous Water Level Sag**

Distance (ft): **62.5**
Structural Grade: **2**
O&M Grade: **0**
Clock Start/From:
Clock To:
1st Value:
2nd Value:
Value Percent: **10.000**
Continuous Index: **S06**
Within 8" of Joint: **NO**
Remarks:

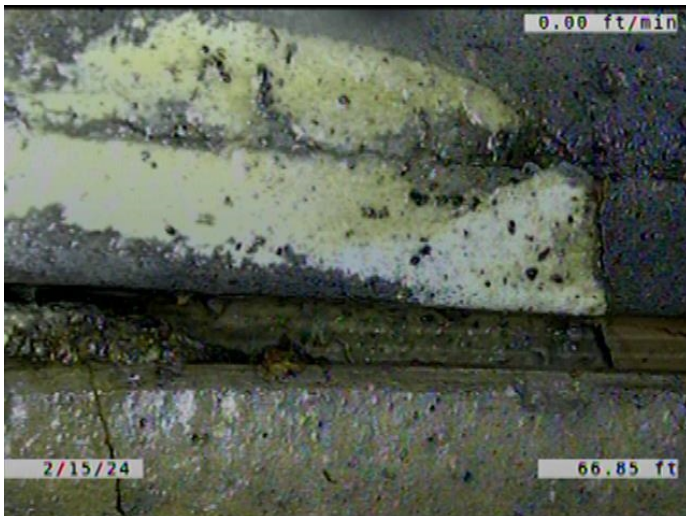
Code: **DAE**
Description: **Deposits Attached Encrustation**

Distance (ft): **66.8**
Structural Grade: **0**
O&M Grade: **2**
Clock Start/From: **3**
Clock To: **5**
1st Value:
2nd Value:
Value Percent: **5.000**
Continuous Index:
Within 8" of Joint: **YES**
Remarks:

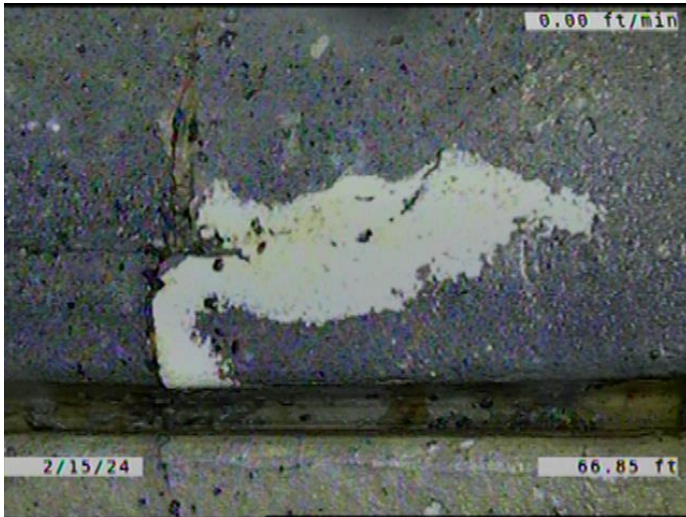
Code: **DAE**
Description: **Deposits Attached Encrustation**

Distance (ft): **66.8**
Structural Grade: **0**
O&M Grade: **2**
Clock Start/From: **8**
Clock To: **9**
1st Value:
2nd Value:
Value Percent: **5.000**
Continuous Index:
Within 8" of Joint: **YES**
Remarks:

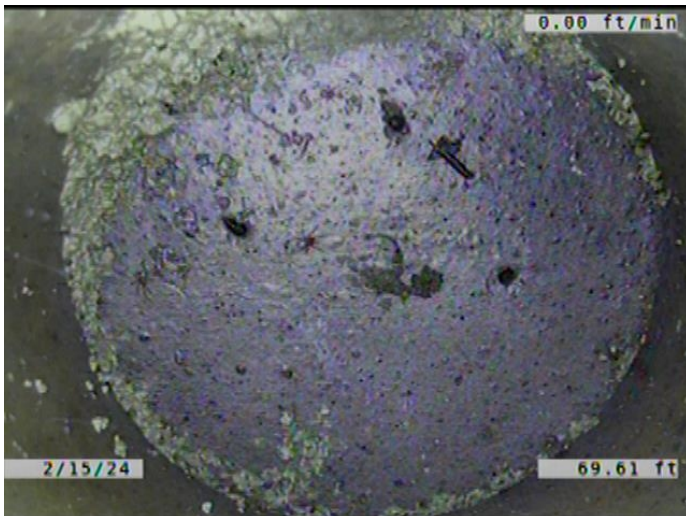
Code: **TFD**
Description: **Tap Factory Defective**

Distance (ft): **69.6**
Structural Grade: **0**
O&M Grade: **3**
Clock Start/From: **11**
Clock To:
1st Value: **6.000**
2nd Value:
Value Percent:
Continuous Index:
Within 8" of Joint: **YES**
Remarks: **CAPPED. TAP BROKEN.**

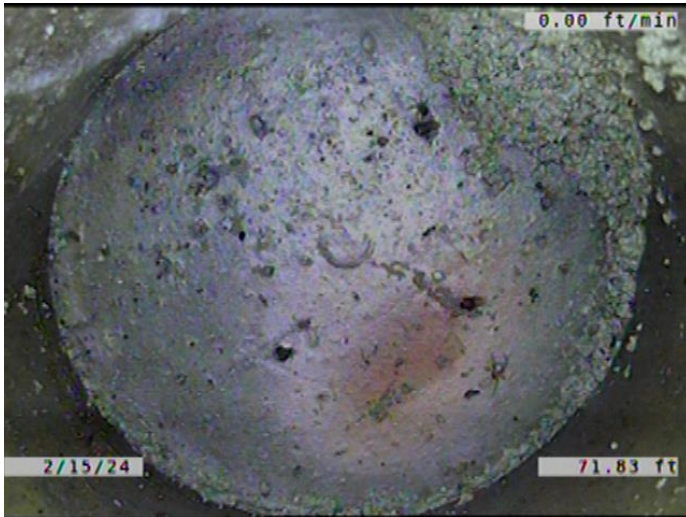
Code: **TFD**
Description: **Tap Factory Defective**

Distance (ft): **71.8**
Structural Grade: **0**
O&M Grade: **3**
Clock Start/From: **1**
Clock To:
1st Value: **6.000**
2nd Value:
Value Percent:
Continuous Index:
Within 8" of Joint: **YES**
Remarks: **CAPPED. TAP BROKEN.**

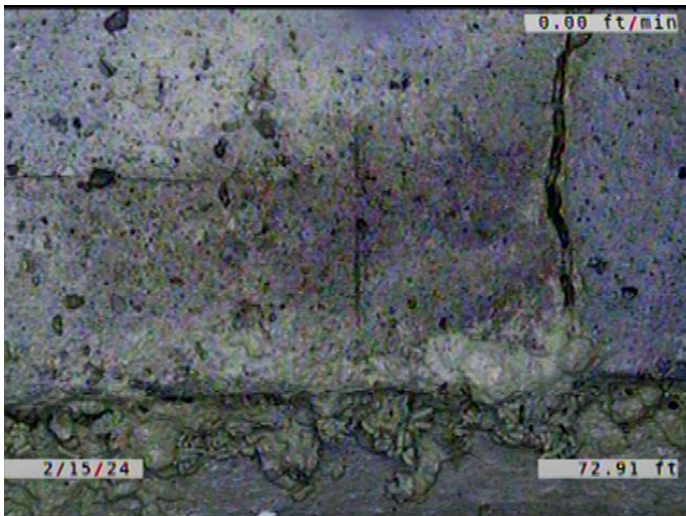
Code: **ISB**
Description: **Infiltration Stain Barrel**

Distance (ft): **72.9**
Structural Grade: **0**
O&M Grade: **1**
Clock Start/From: **10**
Clock To: **11**
1st Value:
2nd Value:
Value Percent:
Continuous Index:
Within 8" of Joint: **YES**
Remarks:

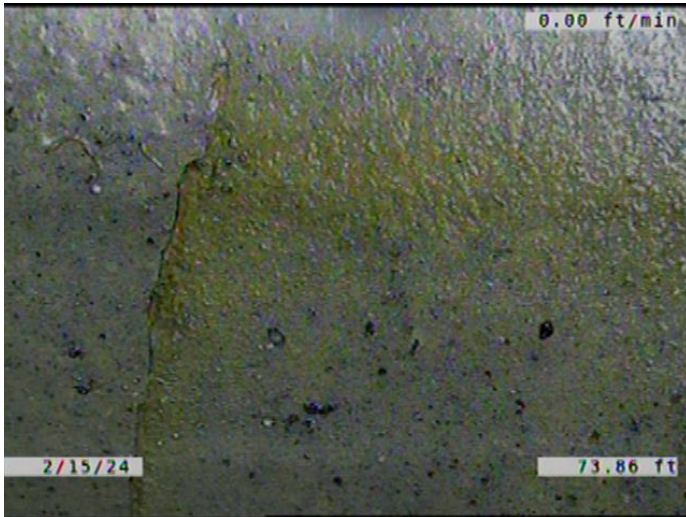
Code: **ISB**
Description: **Infiltration Stain Barrel**

Distance (ft): **73.9**
Structural Grade: **0**
O&M Grade: **1**
Clock Start/From: **12**
Clock To: **5**
1st Value:
2nd Value:
Value Percent:
Continuous Index: **S07**
Within 8" of Joint: **YES**
Remarks:

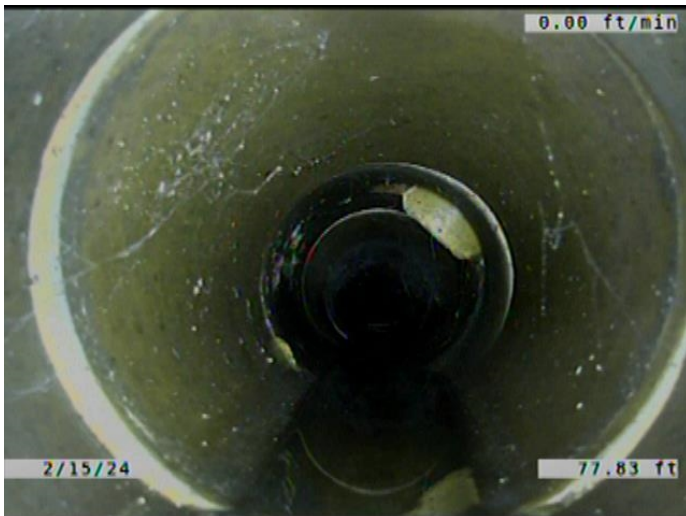
Code: **ISB**
Description: **Infiltration Stain Barrel**

Distance (ft): **77.8**
Structural Grade: **0**
O&M Grade: **1**
Clock Start/From: **12**
Clock To: **5**
1st Value:
2nd Value:
Value Percent:
Continuous Index: **F07**
Within 8" of Joint: **YES**
Remarks:

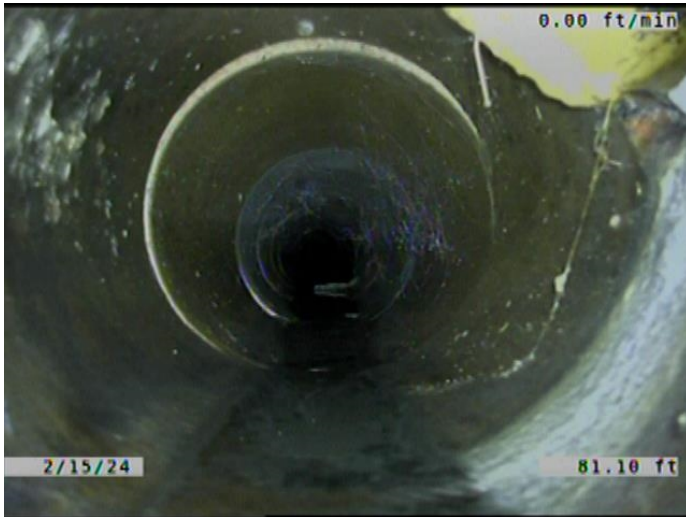
Code: **MWLS**
Description: **Miscellaneous Water Level Sag**

Distance (ft): **81.1**
Structural Grade: **2**
O&M Grade: **0**
Clock Start/From:
Clock To:
1st Value:
2nd Value:
Value Percent: **10.000**
Continuous Index: **F06**
Within 8" of Joint: **NO**
Remarks:

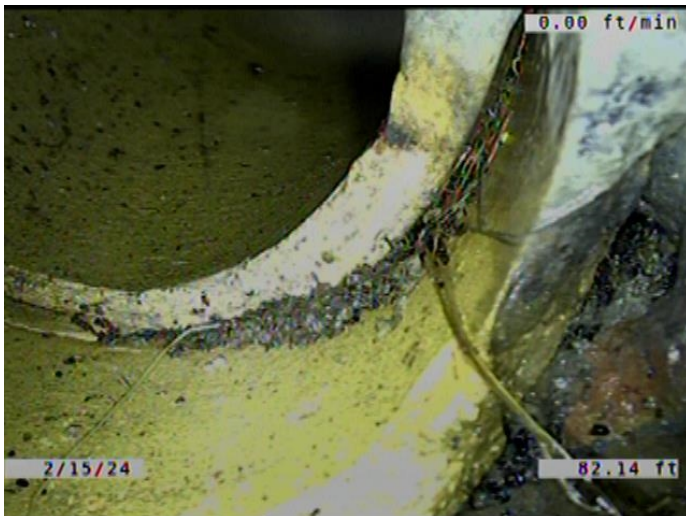
Code: **RFL**
Description: **Roots Fine Lateral**

Distance (ft): **82.1**
Structural Grade: **0**
O&M Grade: **1**
Clock Start/From: **2**
Clock To:
1st Value:
2nd Value:
Value Percent:
Continuous Index:
Within 8" of Joint: **NO**
Remarks:

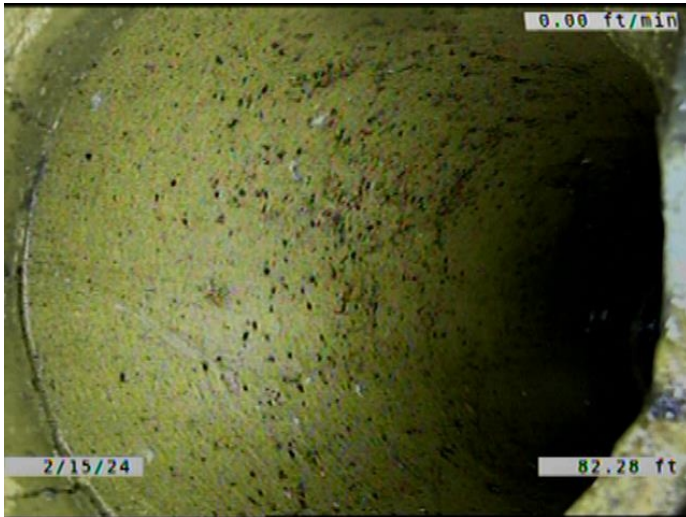
Code: **TBI**
Description: **Tap Break-in Intruding**

Distance (ft): **82.3**
Structural Grade: **0**
O&M Grade: **2**
Clock Start/From: **1**
Clock To:
1st Value: **6.000**
2nd Value: **1.000**
Value Percent:
Continuous Index:
Within 8" of Joint: **YES**
Remarks: **CONSTANTLY RUNNING WATER.**

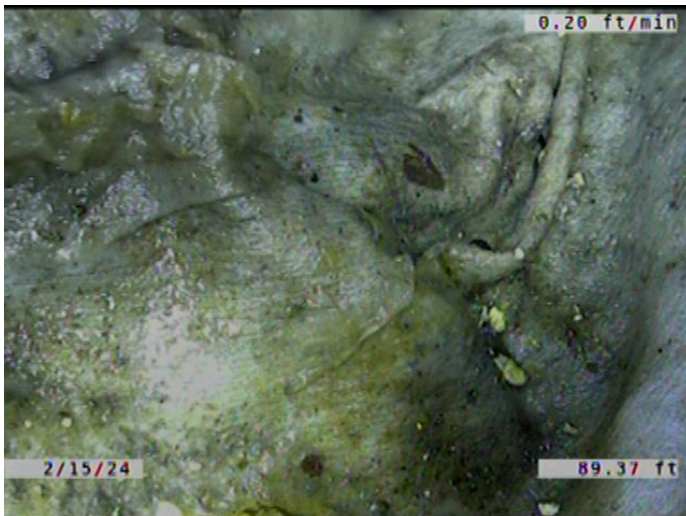
Code: **DAR**
Description: **Deposits Attached Ragging**

Distance (ft): **89.3**
Structural Grade: **0**
O&M Grade: **2**
Clock Start/From: **4**
Clock To: **6**
1st Value:
2nd Value:
Value Percent: **5.000**
Continuous Index:
Within 8" of Joint: **YES**
Remarks:

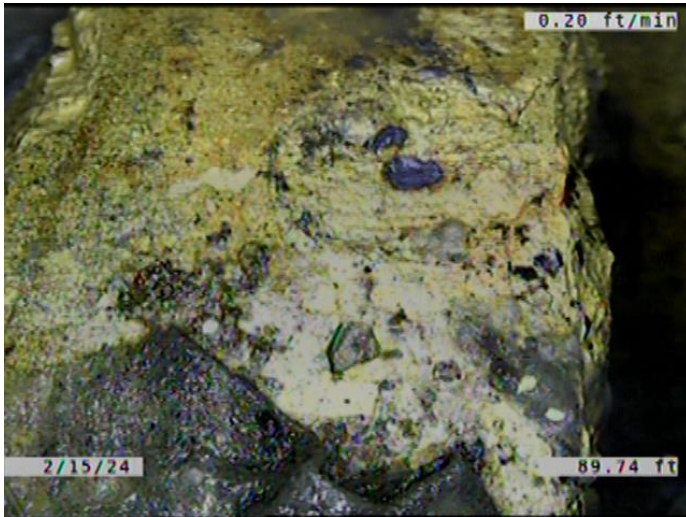
Code:	OBM
Description:	Obstruction Pipe Material in Invert
Distance (ft):	89.7
Structural Grade:	0
O&M Grade:	2
Clock Start/From:	5
Clock To:	6
1st Value:	
2nd Value:	
Value Percent:	5.000
Continuous Index:	
Within 8" of Joint:	YES
Remarks:

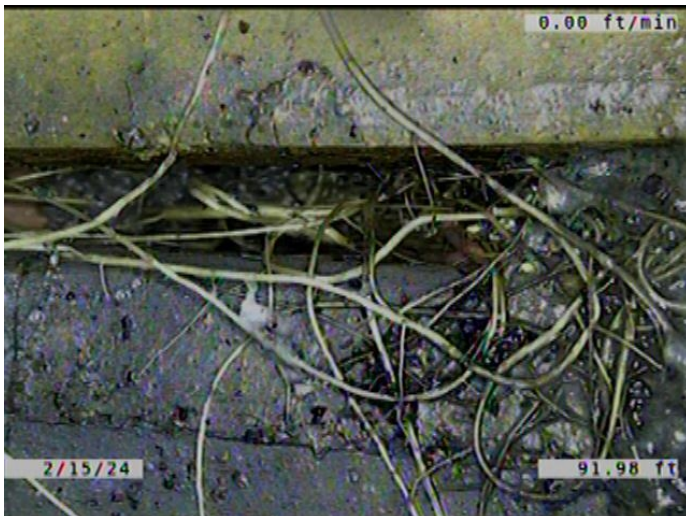
Code:	RFJ
Description:	Roots Fine Joint
Distance (ft):	92.0
Structural Grade:	0
O&M Grade:	1
Clock Start/From:	12
Clock To:	5
1st Value:	
2nd Value:	
Value Percent:	
Continuous Index:	
Within 8" of Joint:	YES
Remarks:

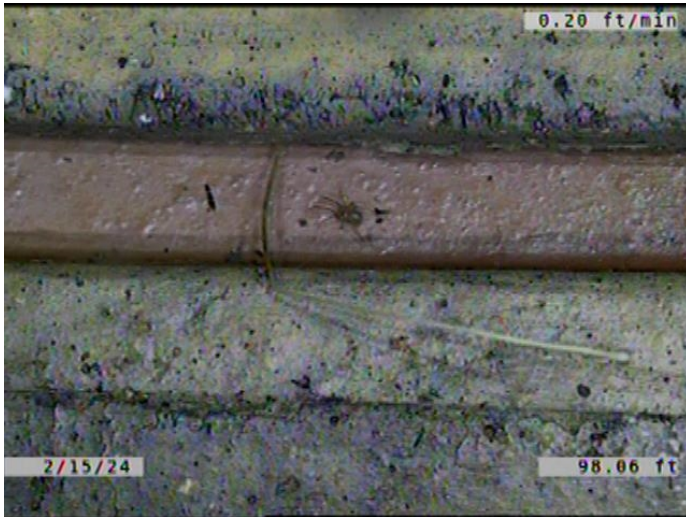
Code: **RFJ**
Description: **Roots Fine Joint**

Distance (ft): **98.0**
Structural Grade: **0**
O&M Grade: **1**
Clock Start/From: **2**
Clock To:
1st Value:
2nd Value:
Value Percent:
Continuous Index:
Within 8" of Joint: **YES**
Remarks:

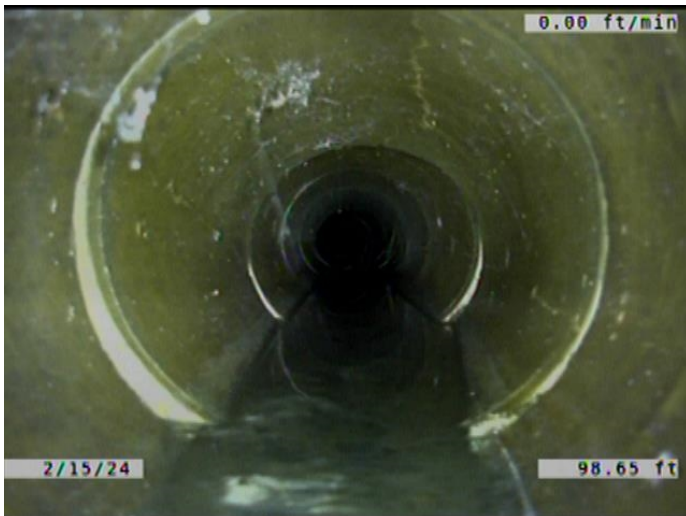
Code: **MWLS**
Description: **Miscellaneous Water Level Sag**

Distance (ft): **98.7**
Structural Grade: **2**
O&M Grade: **0**
Clock Start/From:
Clock To:
1st Value:
2nd Value:
Value Percent: **10.000**
Continuous Index: **S08**
Within 8" of Joint: **NO**
Remarks:

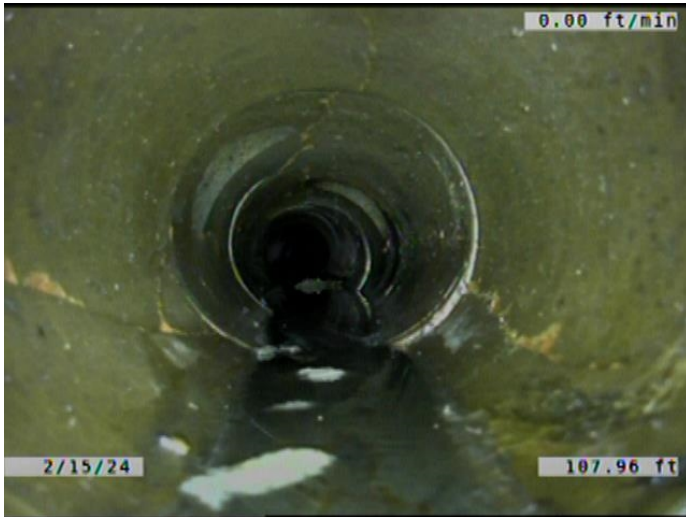
Code: **MWLS**
Description: **Miscellaneous Water Level Sag**

Distance (ft): **108.0**
Structural Grade: **2**
O&M Grade: **0**
Clock Start/From:
Clock To:
1st Value:
2nd Value:
Value Percent: **10.000**
Continuous Index: **F08**
Within 8" of Joint: **NO**
Remarks:

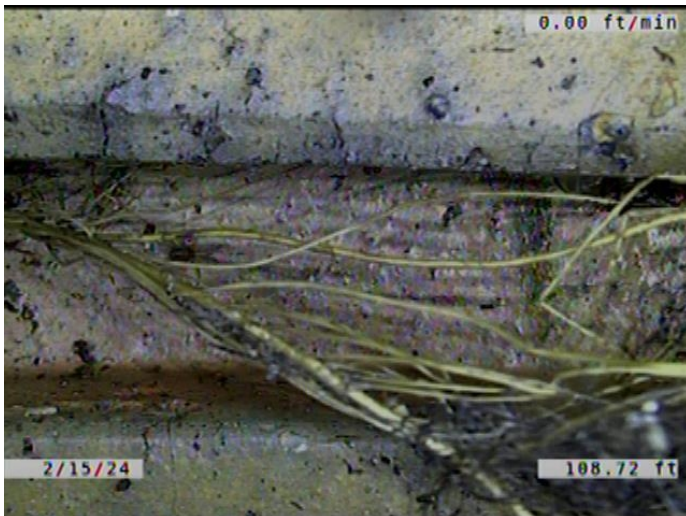
Code: **RFJ**
Description: **Roots Fine Joint**

Distance (ft): **108.7**
Structural Grade: **0**
O&M Grade: **1**
Clock Start/From: **10**
Clock To: **5**
1st Value:
2nd Value:
Value Percent:
Continuous Index:
Within 8" of Joint: **YES**
Remarks:

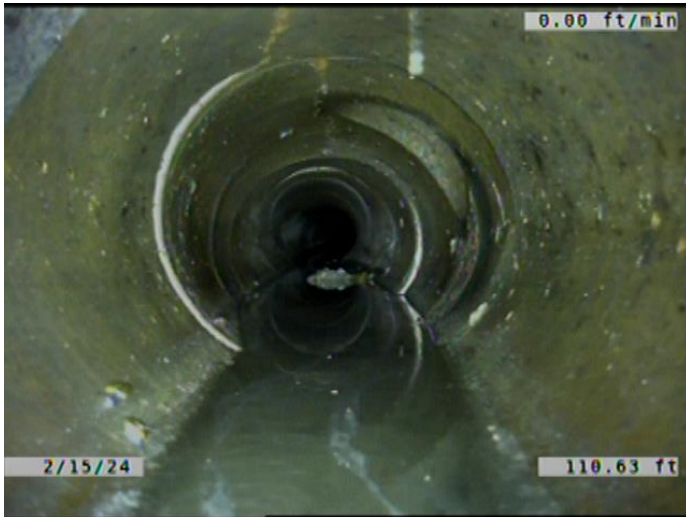
Code: **MWLS**
Description: **Miscellaneous Water Level Sag**

Distance (ft): **110.6**
Structural Grade: **2**
O&M Grade: **0**
Clock Start/From:
Clock To:
1st Value:
2nd Value:
Value Percent: **10.000**
Continuous Index: **S09**
Within 8" of Joint: **NO**
Remarks:

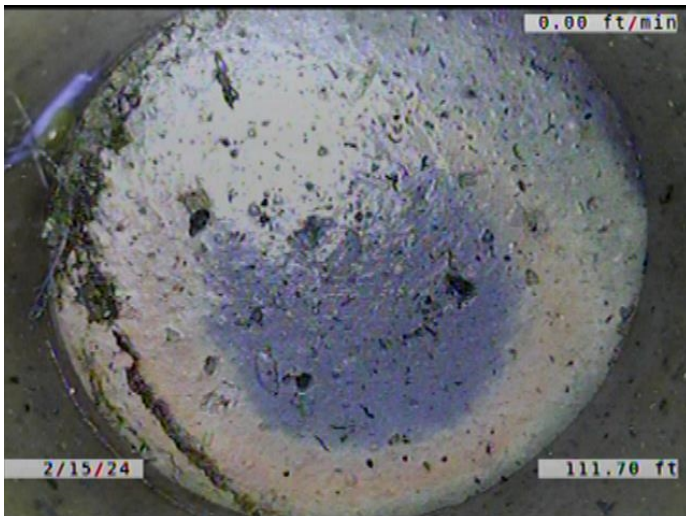
Code: **TFD**
Description: **Tap Factory Defective**

Distance (ft): **111.7**
Structural Grade: **0**
O&M Grade: **3**
Clock Start/From: **10**
Clock To:
1st Value: **6.000**
2nd Value:
Value Percent:
Continuous Index:
Within 8" of Joint: **YES**
Remarks: **CAPPED. TAP BROKEN.**

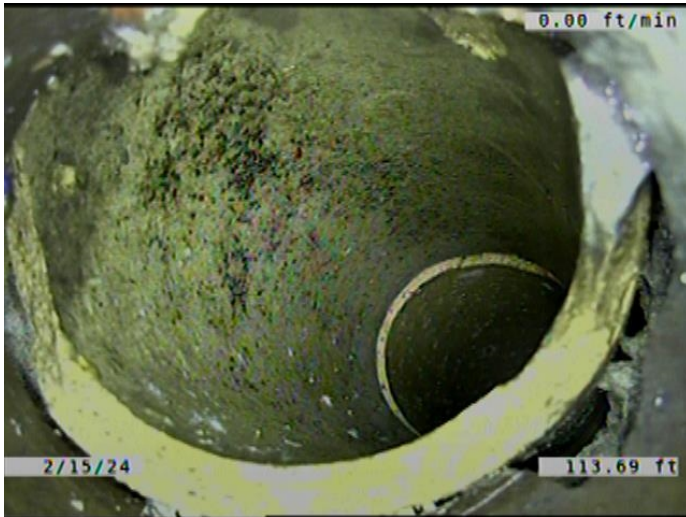
Code:	TFD
Description:	Tap Factory Defective
Distance (ft):	113.7
Structural Grade:	0
O&M Grade:	3
Clock Start/From:	1
Clock To:	
1st Value:	6.000
2nd Value:	
Value Percent:	
Continuous Index:	
Within 8" of Joint:	YES
Remarks:	TAP BROKEN. SERVICE OFFSET. PIECE OF THE TAP TO SERVICE CONNECTIO

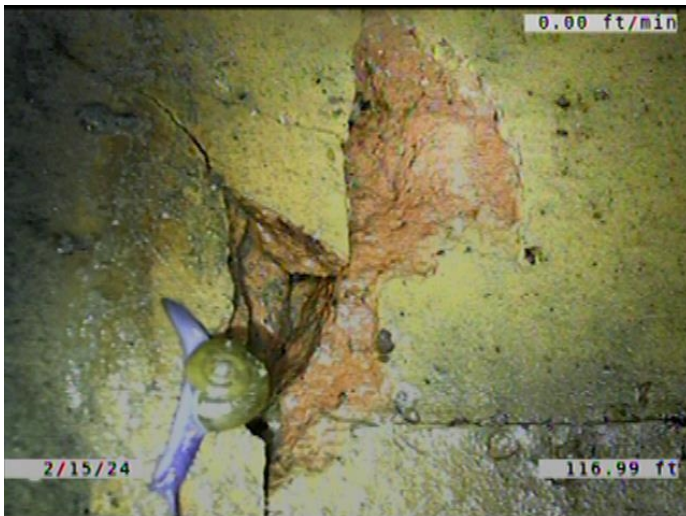
Code:	SSS
Description:	Surface Damage Surface Spalling
Distance (ft):	117.0
Structural Grade:	2
O&M Grade:	0
Clock Start/From:	4
Clock To:	
1st Value:	
2nd Value:	
Value Percent:	
Continuous Index:	
Within 8" of Joint:	YES
Remarks:

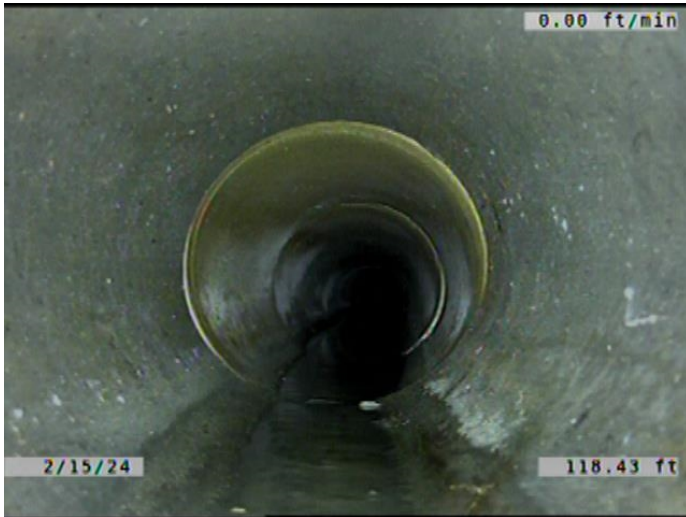
Code: **MWLS**
Description: **Miscellaneous Water Level Sag**

Distance (ft): **118.4**
Structural Grade: **2**
O&M Grade: **0**
Clock Start/From:
Clock To:
1st Value:
2nd Value:
Value Percent: **10.000**
Continuous Index: **F09**
Within 8" of Joint: **NO**
Remarks:

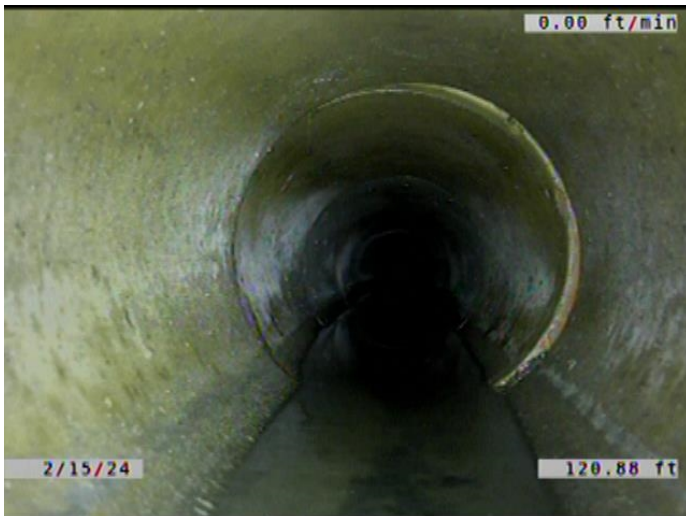
Code: **MWLS**
Description: **Miscellaneous Water Level Sag**

Distance (ft): **120.9**
Structural Grade: **2**
O&M Grade: **0**
Clock Start/From:
Clock To:
1st Value:
2nd Value:
Value Percent: **10.000**
Continuous Index: **S10**
Within 8" of Joint: **NO**
Remarks:

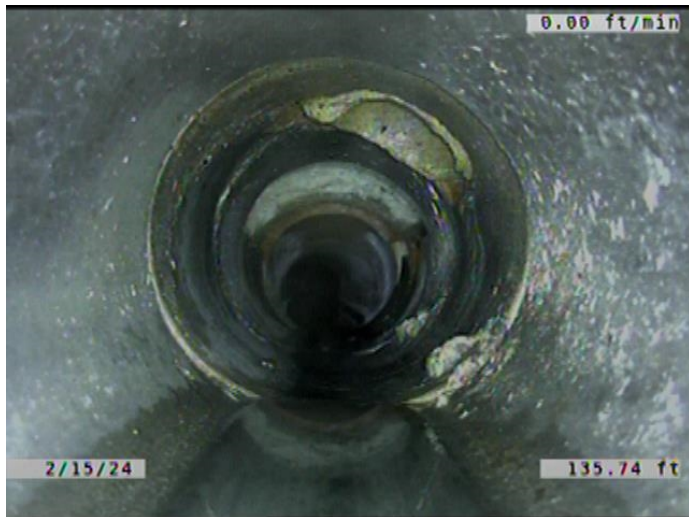
Code: **MWLS**
Description: **Miscellaneous Water Level Sag**

Distance (ft): **135.7**
Structural Grade: **2**
O&M Grade: **0**
Clock Start/From:
Clock To:
1st Value:
2nd Value:
Value Percent: **10.000**
Continuous Index: **F10**
Within 8" of Joint: **NO**
Remarks:

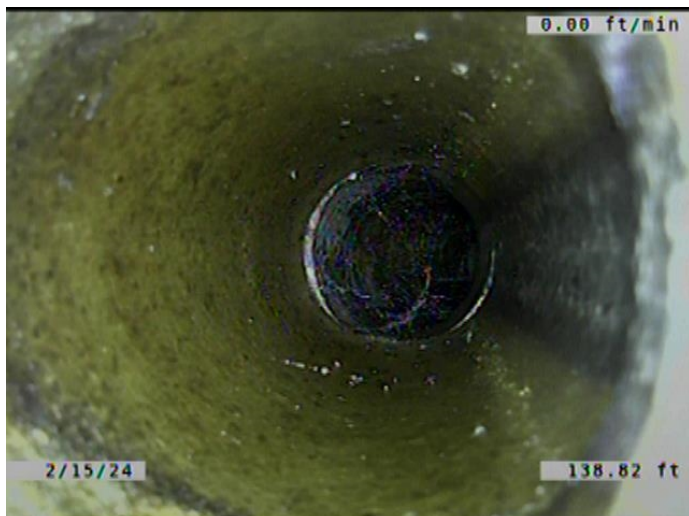
Code: **TBI**
Description: **Tap Break-in Intruding**

Distance (ft): **138.8**
Structural Grade: **0**
O&M Grade: **2**
Clock Start/From: **1**
Clock To:
1st Value: **6.000**
2nd Value: **1.000**
Value Percent:
Continuous Index:
Within 8" of Joint: **YES**
Remarks:

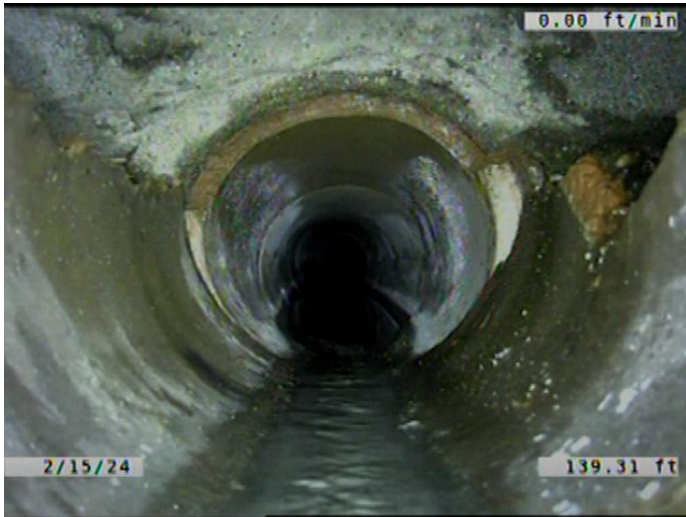
Code: **DSF**
Description: **Deposits Settled Fine**

Distance (ft): **139.3**
Structural Grade: **0**
O&M Grade: **2**
Clock Start/From: **5**
Clock To: **7**
1st Value:
2nd Value:
Value Percent: **5.000**
Continuous Index: **F01**
Within 8" of Joint: **YES**
Remarks:

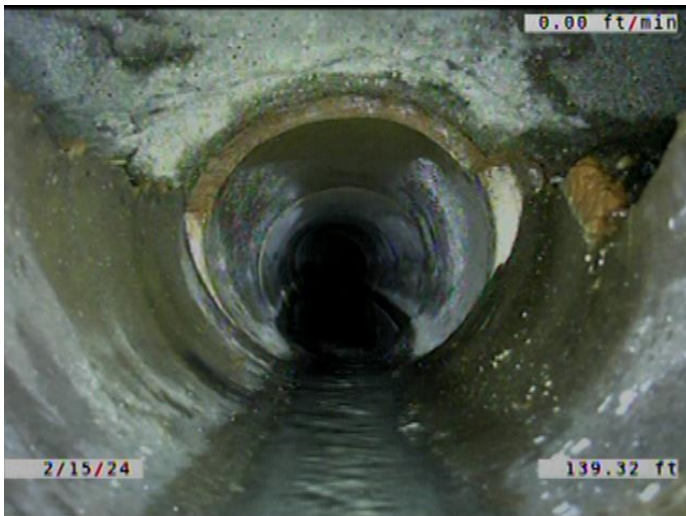
Code: **FM**
Description: **Fracture Multiple**

Distance (ft): **139.3**
Structural Grade: **4**
O&M Grade: **0**
Clock Start/From: **7**
Clock To: **5**
1st Value:
2nd Value:
Value Percent:
Continuous Index: **F02**
Within 8" of Joint: **YES**
Remarks:
