Profile/Photo Observation Report

Date:	02/15/2024	Weather:		Coding:	PACP 7.0
Pipe Length (ft):	117.0	Owner:	City of Hobart	Pre Clean:	Heavy Cleaning
P.O.#:	YES502259	Surveyor:	S. Bucklin	PSR:	P-504-018-017
Customer:	City of Hobart	Clean Date:	10/09/2022	Shape:	C

Street:	N DELAWARE ST	Flow Control:	Not Controlled
City:	Hobart, IN	Year Renewed:	
Location:	Alley	Tape/Media #:	
Purpose:	Routine Assessment	Dia/Height:	10"
Use:	Sanitary Sewage Pipe	Material:	VCP
Drain Area:		Lining:	None
Category:	NA		
Comment:			
Location Details:		Direction of Survey:	Upstream
US MH:	M-504-017	DS MH:	M-504-018
		Total Length Surveyed (ft):	117.6

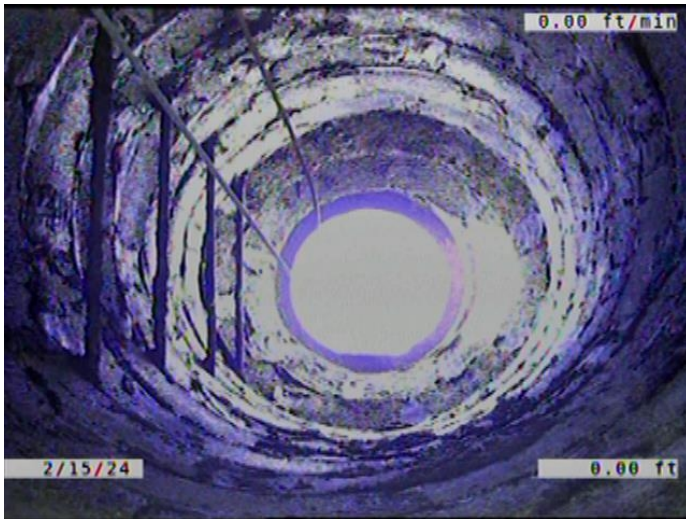
Code: **AMH**
Description: **Manhole**

Distance (ft): **.0**
Structural Grade: **0**
O&M Grade: **0**
Clock Start/From:
Clock To:
1st Value:
2nd Value:
Value Percent:
Continuous Index:
Within 8" of Joint: **NO**
Remarks: **M-504-018**

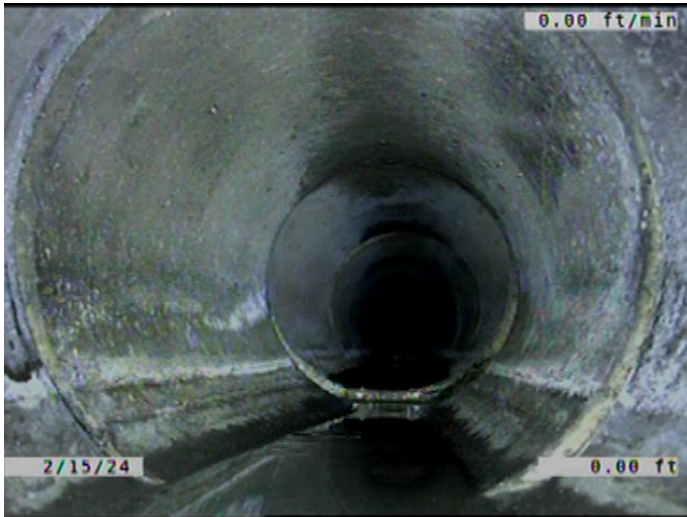
Code: **MWL**
 Description: **Miscellaneous Water Level**

Distance (ft): **.0**
 Structural Grade: **0**
 O&M Grade: **0**
 Clock Start/From:
 Clock To:
 1st Value:
 2nd Value:
 Value Percent: **5.000**
 Continuous Index:
 Within 8" of Joint: **NO**
 Remarks:

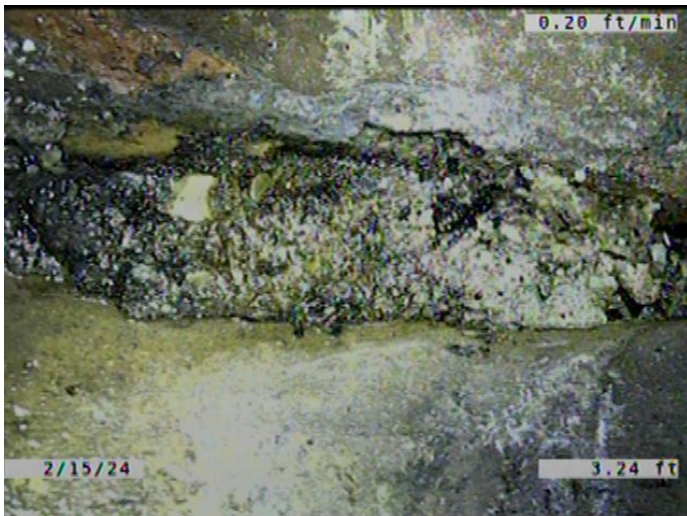
Code: **DAE**
 Description: **Deposits Attached Encrustation**

Distance (ft): **3.2**
 Structural Grade: **0**
 O&M Grade: **2**
 Clock Start/From: **4**
 Clock To: **5**
 1st Value:
 2nd Value:
 Value Percent: **5.000**
 Continuous Index:
 Within 8" of Joint: **YES**
 Remarks:

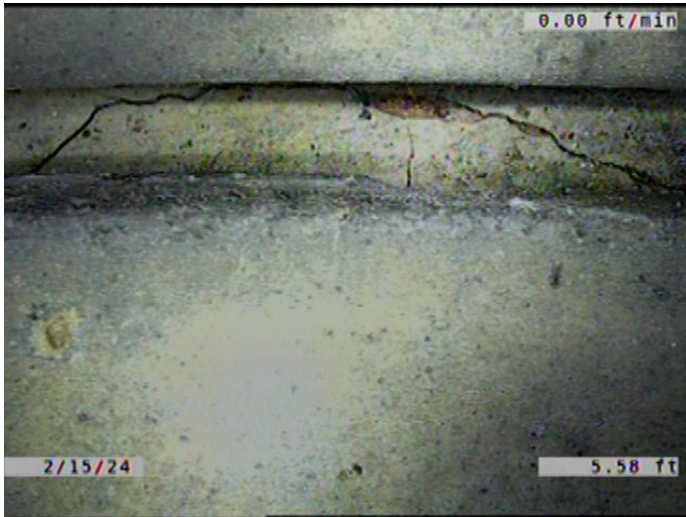
Code: **CM**
Description: **Crack Multiple**

Distance (ft): **5.6**
Structural Grade: **3**
O&M Grade: **0**
Clock Start/From: **9**
Clock To: **11**
1st Value:
2nd Value:
Value Percent:
Continuous Index:
Within 8" of Joint: **YES**
Remarks:

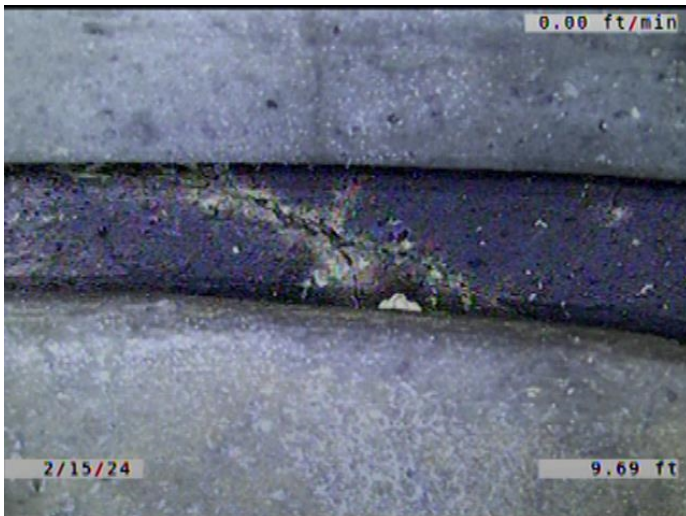
Code: **FM**
Description: **Fracture Multiple**

Distance (ft): **9.7**
Structural Grade: **4**
O&M Grade: **0**
Clock Start/From: **7**
Clock To: **5**
1st Value:
2nd Value:
Value Percent:
Continuous Index: **S01**
Within 8" of Joint: **YES**
Remarks: **Wandering**

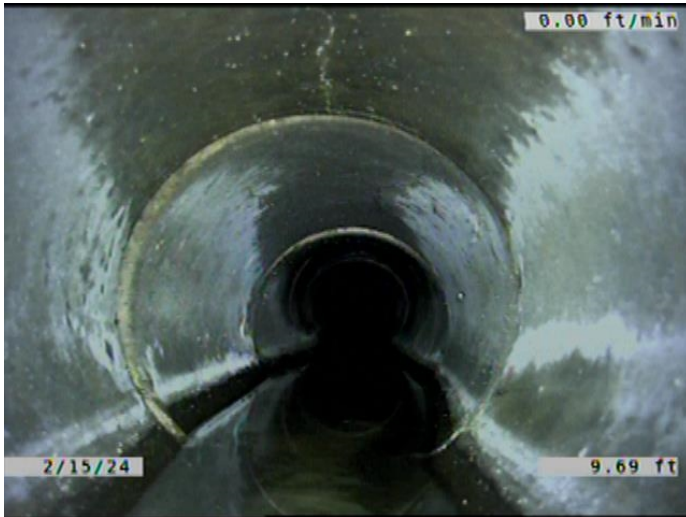
Code: **MWLS**
Description: **Miscellaneous Water Level Sag**

Distance (ft): **9.7**
Structural Grade: **2**
O&M Grade: **0**
Clock Start/From:
Clock To:
1st Value:
2nd Value:
Value Percent: **10.000**
Continuous Index: **S02**
Within 8" of Joint: **NO**
Remarks:

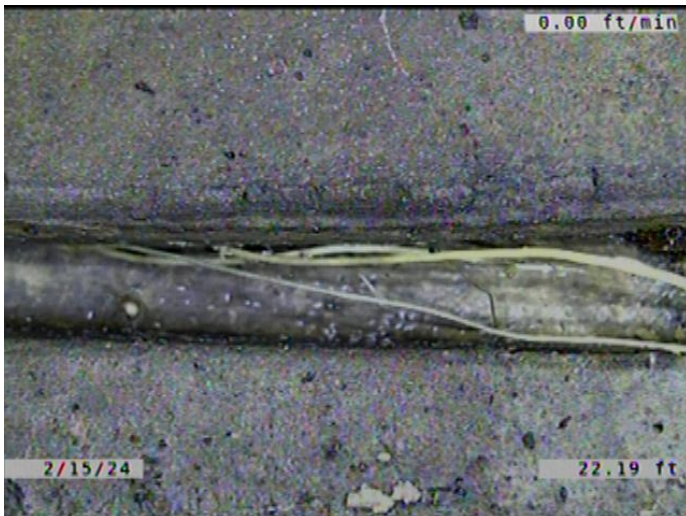
Code: **RFJ**
Description: **Roots Fine Joint**

Distance (ft): **22.2**
Structural Grade: **0**
O&M Grade: **1**
Clock Start/From: **7**
Clock To: **5**
1st Value:
2nd Value:
Value Percent:
Continuous Index: **S03**
Within 8" of Joint: **YES**
Remarks:

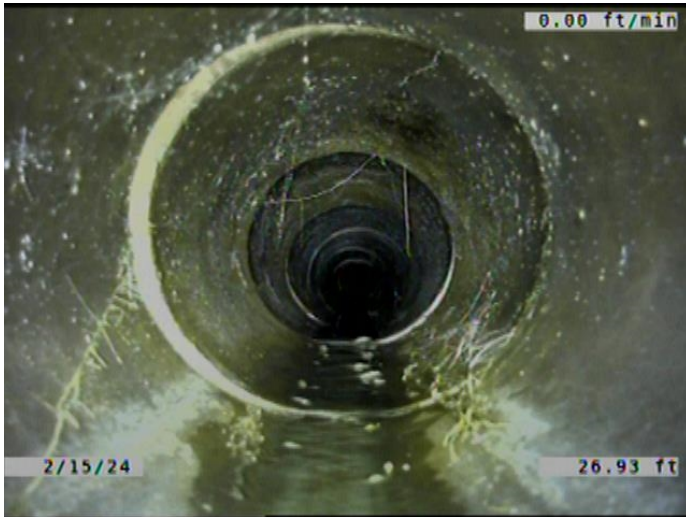
Code: **MWLS**
Description: **Miscellaneous Water Level Sag**

Distance (ft): **26.9**
Structural Grade: **2**
O&M Grade: **0**
Clock Start/From:
Clock To:
1st Value:
2nd Value:
Value Percent: **10.000**
Continuous Index: **F02**
Within 8" of Joint: **NO**
Remarks:

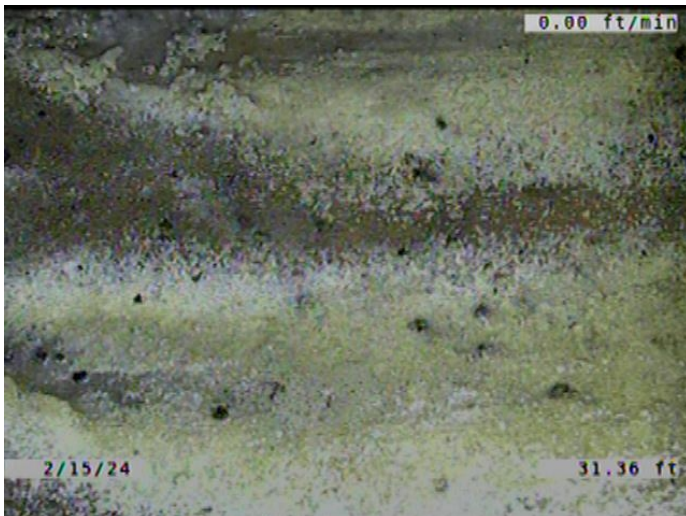
Code: **DAE**
Description: **Deposits Attached Encrustation**

Distance (ft): **31.4**
Structural Grade: **0**
O&M Grade: **2**
Clock Start/From: **7**
Clock To: **9**
1st Value:
2nd Value:
Value Percent: **5.000**
Continuous Index:
Within 8" of Joint: **YES**
Remarks:

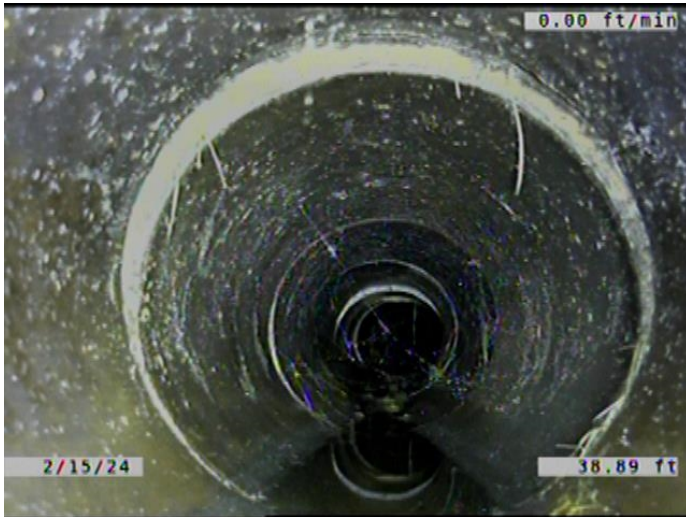
Code: **JOMD**
Description: **Joint Offset Medium Defective**

Distance (ft): **38.9**
Structural Grade: **3**
O&M Grade: **0**
Clock Start/From:
Clock To:
1st Value:
2nd Value:
Value Percent:
Continuous Index:
Within 8" of Joint: **NO**
Remarks:

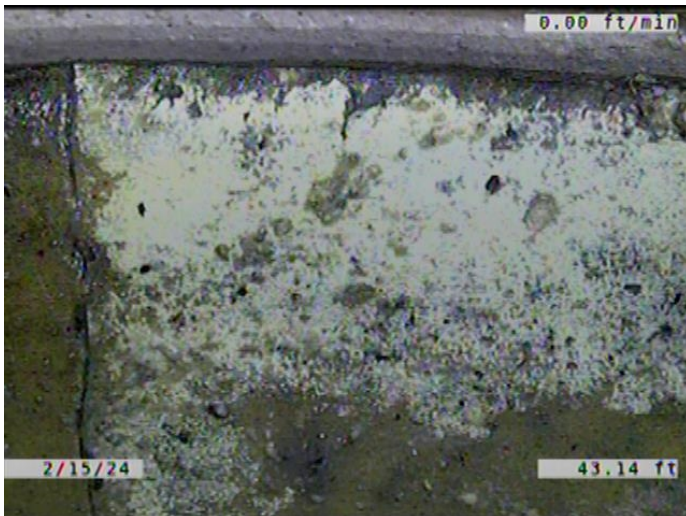
Code: **DAE**
Description: **Deposits Attached Encrustation**

Distance (ft): **43.1**
Structural Grade: **0**
O&M Grade: **2**
Clock Start/From: **7**
Clock To: **5**
1st Value:
2nd Value:
Value Percent: **5.000**
Continuous Index: **S04**
Within 8" of Joint: **YES**
Remarks:

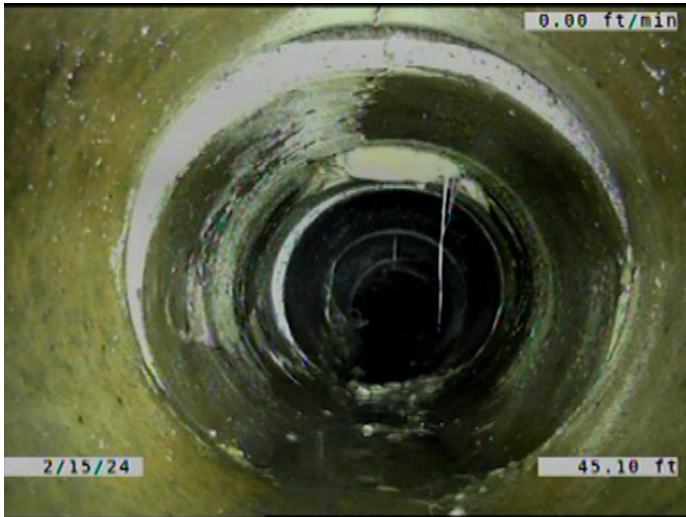
Code: **JOMD**
Description: **Joint Offset Medium Defective**

Distance (ft): **45.1**
Structural Grade: **3**
O&M Grade: **0**
Clock Start/From:
Clock To:
1st Value:
2nd Value:
Value Percent:
Continuous Index:
Within 8" of Joint: **NO**
Remarks:

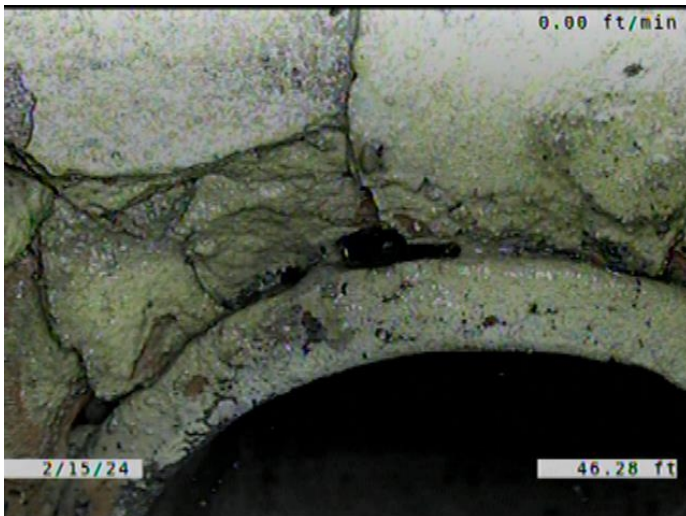
Code: **B**
Description: **Broken**

Distance (ft): **46.3**
Structural Grade: **4**
O&M Grade: **0**
Clock Start/From: **11**
Clock To: **1**
1st Value:
2nd Value:
Value Percent:
Continuous Index:
Within 8" of Joint: **YES**
Remarks:

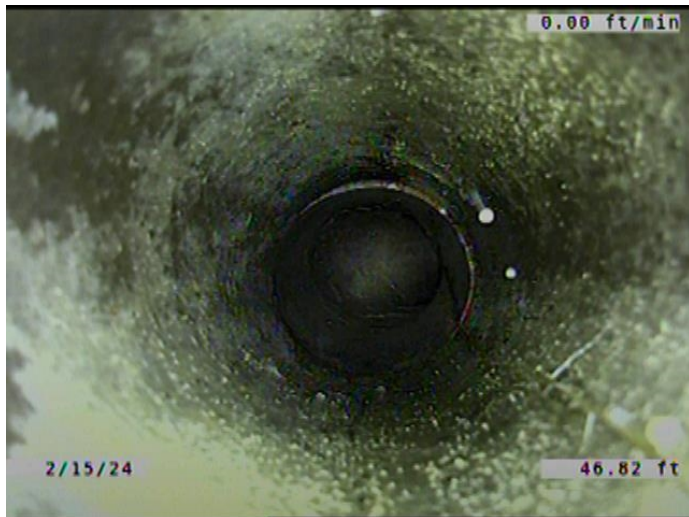
Code: **TBD**
 Description: **Tap Break-in/Hammer Defective**

Distance (ft): **46.8**
 Structural Grade: **0**
 O&M Grade: **3**
 Clock Start/From: **12**
 Clock To:
 1st Value: **6.000**
 2nd Value:
 Value Percent:
 Continuous Index:
 Within 8" of Joint: **YES**
 Remarks: **CONSTANTLY DRIPPING WATER. SERVICE COMES FROM THE RIGHT (**

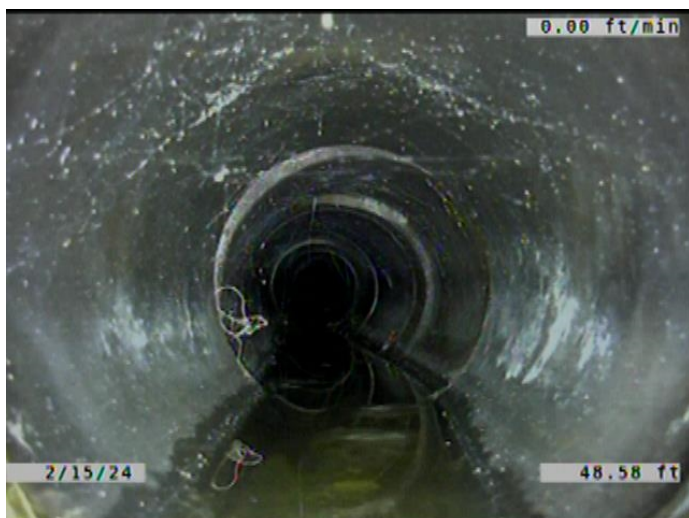
Code: **DAE**
 Description: **Deposits Attached Encrustation**

Distance (ft): **48.6**
 Structural Grade: **0**
 O&M Grade: **2**
 Clock Start/From: **7**
 Clock To: **5**
 1st Value:
 2nd Value:
 Value Percent: **5.000**
 Continuous Index: **F04**
 Within 8" of Joint: **YES**
 Remarks:

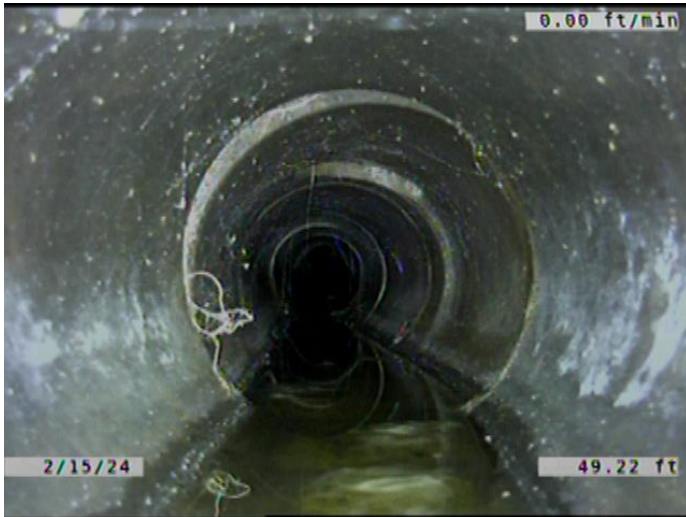
Code: **MWLS**
Description: **Miscellaneous Water Level Sag**

Distance (ft): **49.2**
Structural Grade: **2**
O&M Grade: **0**
Clock Start/From:
Clock To:
1st Value:
2nd Value:
Value Percent: **10.000**
Continuous Index: **S05**
Within 8" of Joint: **NO**
Remarks:

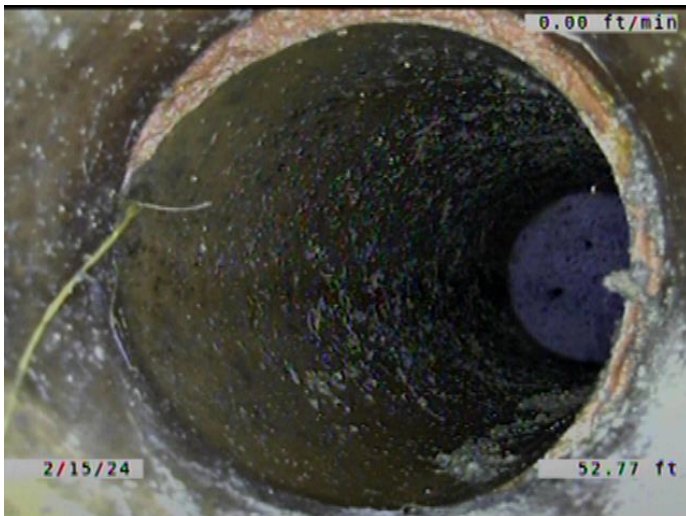
Code: **TFD**
Description: **Tap Factory Defective**

Distance (ft): **52.8**
Structural Grade: **0**
O&M Grade: **3**
Clock Start/From: **1**
Clock To:
1st Value: **6.000**
2nd Value:
Value Percent:
Continuous Index:
Within 8" of Joint: **YES**
Remarks: **CAPPED. SERVICE OFFSET. ROOTS GROWING IN THE JOINTS.**

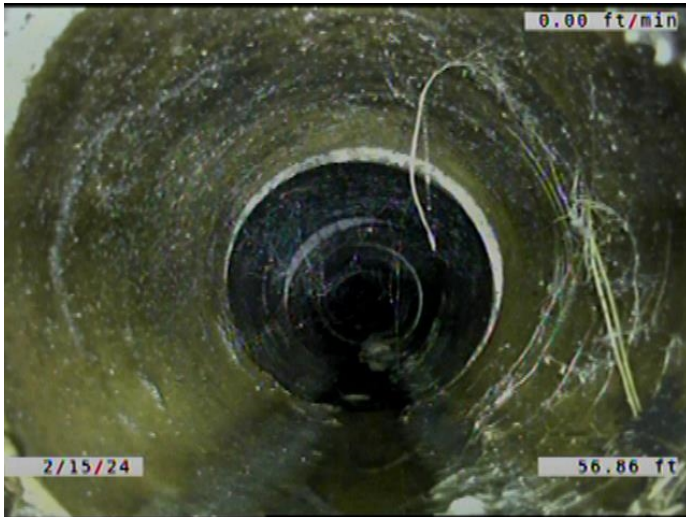
Code: **MWLS**
Description: **Miscellaneous Water Level Sag**

Distance (ft): **56.9**
Structural Grade: **2**
O&M Grade: **0**
Clock Start/From:
Clock To:
1st Value:
2nd Value:
Value Percent: **10.000**
Continuous Index: **F05**
Within 8" of Joint: **NO**
Remarks:

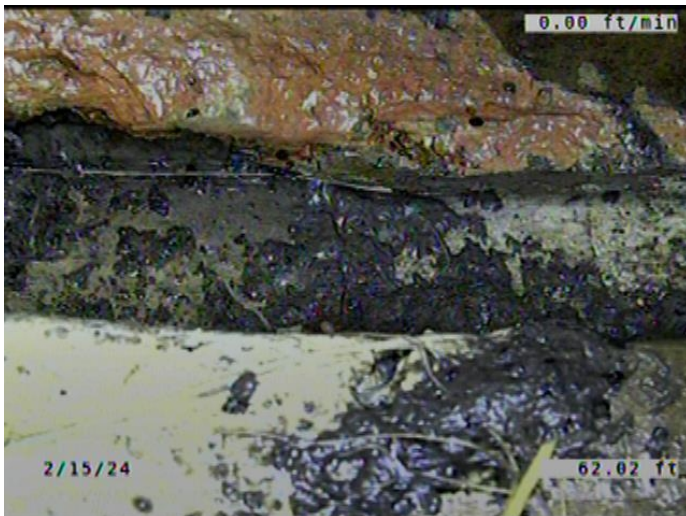
Code: **DAE**
Description: **Deposits Attached Encrustation**

Distance (ft): **62.0**
Structural Grade: **0**
O&M Grade: **2**
Clock Start/From: **3**
Clock To: **5**
1st Value:
2nd Value:
Value Percent: **5.000**
Continuous Index:
Within 8" of Joint: **YES**
Remarks:

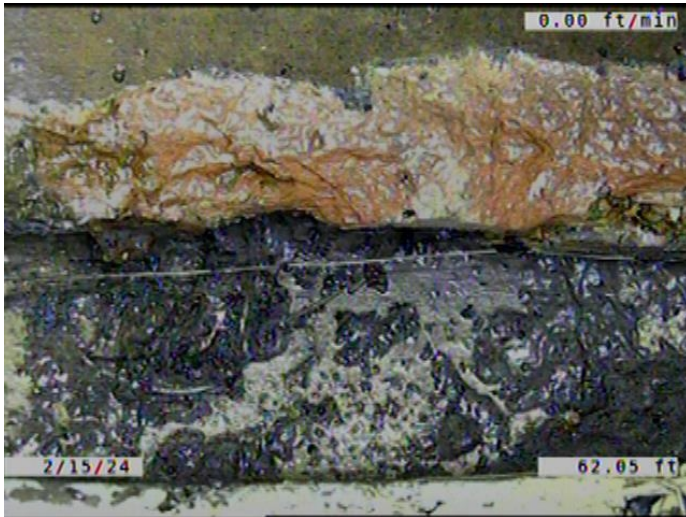
Code: **SZ**
Description: **Surface Damage Other**

Distance (ft): **62.1**
Structural Grade: **0**
O&M Grade: **0**
Clock Start/From: **3**
Clock To: **5**
1st Value:
2nd Value:
Value Percent:
Continuous Index:
Within 8" of Joint: **YES**
Remarks: **A PIECE CHIPPED AWAY FROM THE JOINT.**

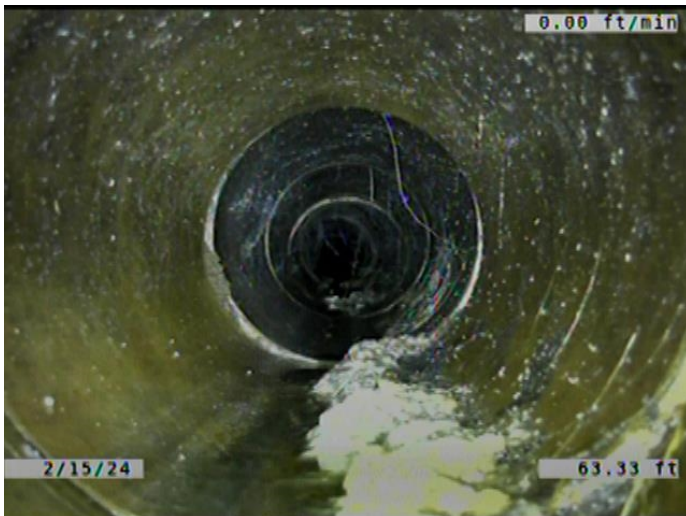
Code: **DSF**
Description: **Deposits Settled Fine**

Distance (ft): **63.3**
Structural Grade: **0**
O&M Grade: **2**
Clock Start/From: **5**
Clock To: **7**
1st Value:
2nd Value:
Value Percent: **5.000**
Continuous Index: **S06**
Within 8" of Joint: **YES**
Remarks:

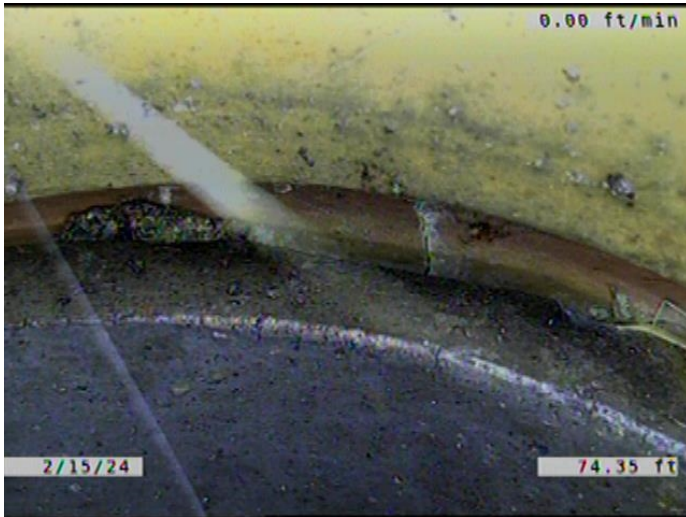
Code: **JOMD**
Description: **Joint Offset Medium Defective**

Distance (ft): **74.3**
Structural Grade: **3**
O&M Grade: **0**
Clock Start/From:
Clock To:
1st Value:
2nd Value:
Value Percent:
Continuous Index:
Within 8" of Joint: **NO**
Remarks:

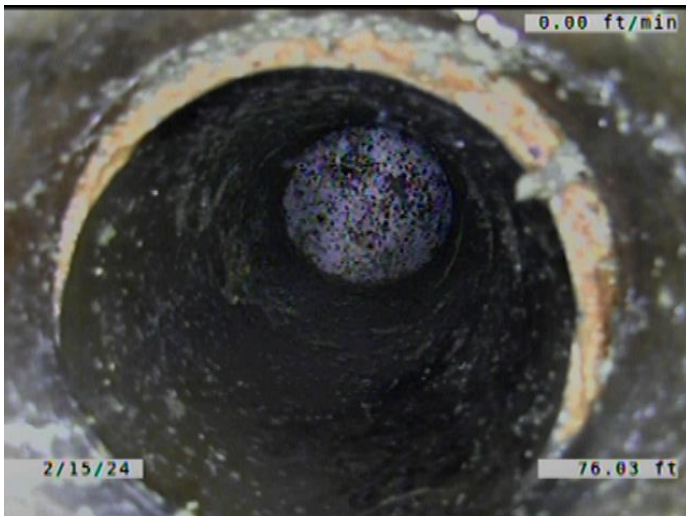
Code: **TFD**
Description: **Tap Factory Defective**

Distance (ft): **76.0**
Structural Grade: **0**
O&M Grade: **3**
Clock Start/From: **11**
Clock To:
1st Value: **6.000**
2nd Value:
Value Percent:
Continuous Index:
Within 8" of Joint: **YES**
Remarks: **CAPPED. SERVICE OFFSET. ROOTS GROWING IN THE JOINTS INTO THE**

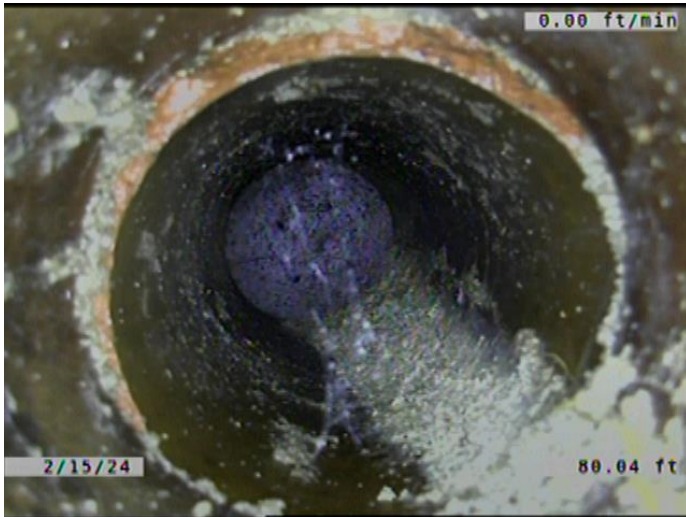
Code:	TFD
Description:	Tap Factory Defective
Distance (ft):	80.0
Structural Grade:	0
O&M Grade:	3
Clock Start/From:	1
Clock To:	
1st Value:	6.000
2nd Value:	
Value Percent:	
Continuous Index:	
Within 8" of Joint:	YES
Remarks:	CAPPED. SERVICE OFFSET. ROOTS GROWING IN THE JOINTS INTO THE

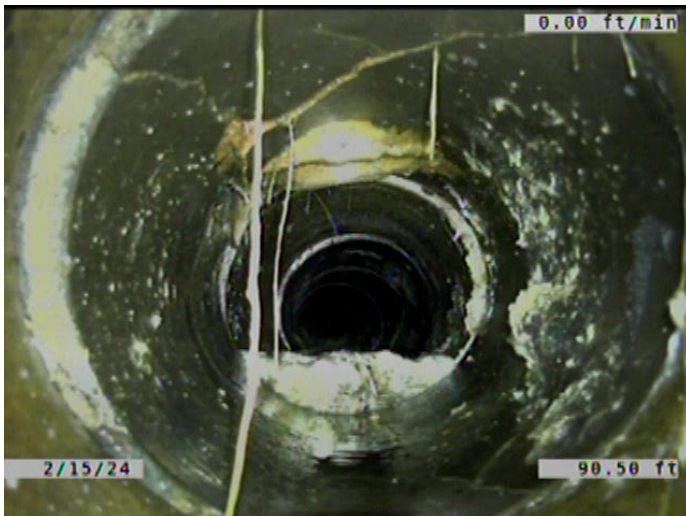
Code:	DR
Description:	Deformed Rigid
Distance (ft):	90.5
Structural Grade:	4
O&M Grade:	0
Clock Start/From:	
Clock To:	
1st Value:	
2nd Value:	
Value Percent:	5.000
Continuous Index:	
Within 8" of Joint:	NO
Remarks:

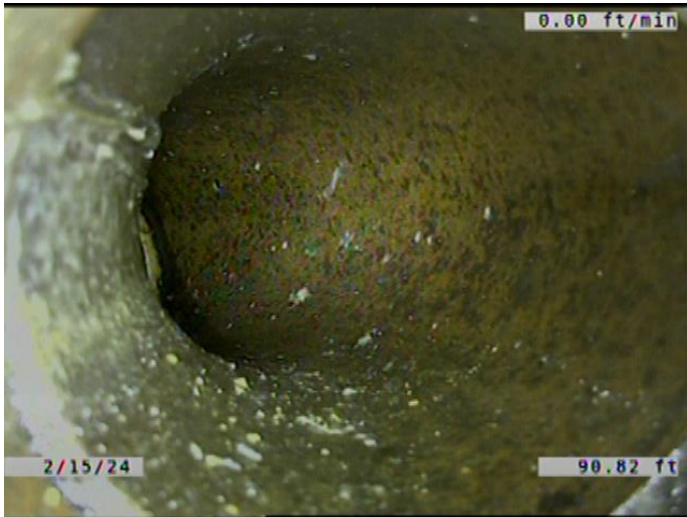
Code: **TBI**
Description: **Tap Break-in Intruding**

Distance (ft): **90.8**
Structural Grade: **0**
O&M Grade: **2**
Clock Start/From: **11**
Clock To:
1st Value: **6.000**
2nd Value: **1.000**
Value Percent:
Continuous Index:
Within 8" of Joint: **YES**
Remarks: **CONSTANLY DRIPPING WATER.**

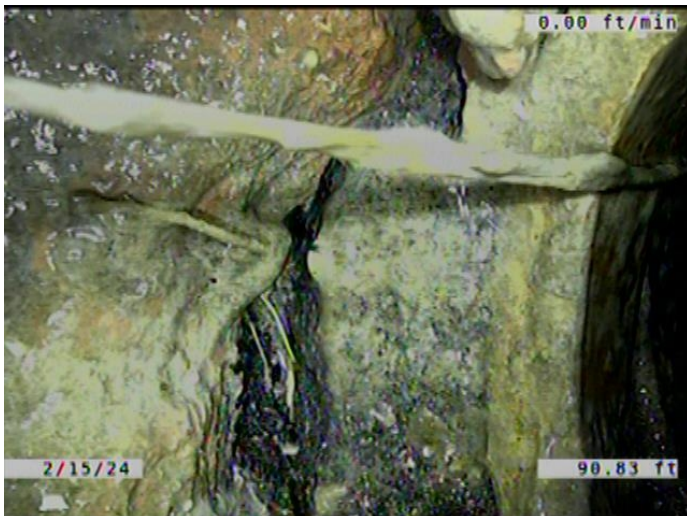
Code: **RFC**
Description: **Roots Fine Connection**

Distance (ft): **90.8**
Structural Grade: **0**
O&M Grade: **1**
Clock Start/From: **10**
Clock To: **12**
1st Value:
2nd Value:
Value Percent:
Continuous Index:
Within 8" of Joint: **NO**
Remarks:

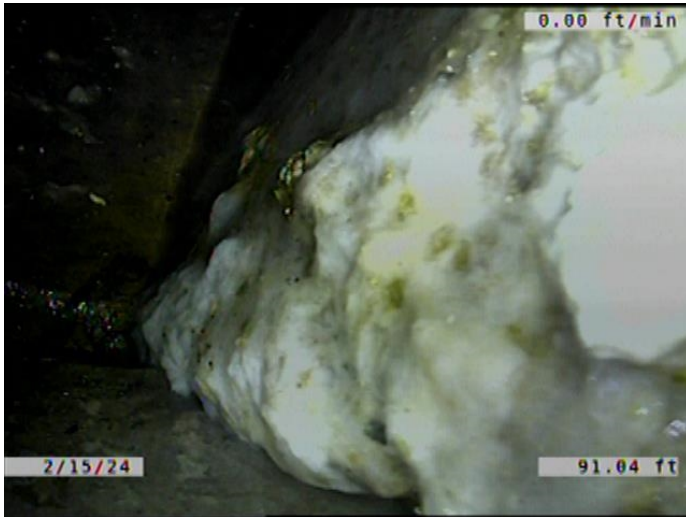
Code:	DAR
Description:	Deposits Attached Ragging
Distance (ft):	91.0
Structural Grade:	0
O&M Grade:	2
Clock Start/From:	4
Clock To:	8
1st Value:	
2nd Value:	
Value Percent:	10.000
Continuous Index:	
Within 8" of Joint:	YES
Remarks:	RAGS TP AND SEWER DEBRIS.

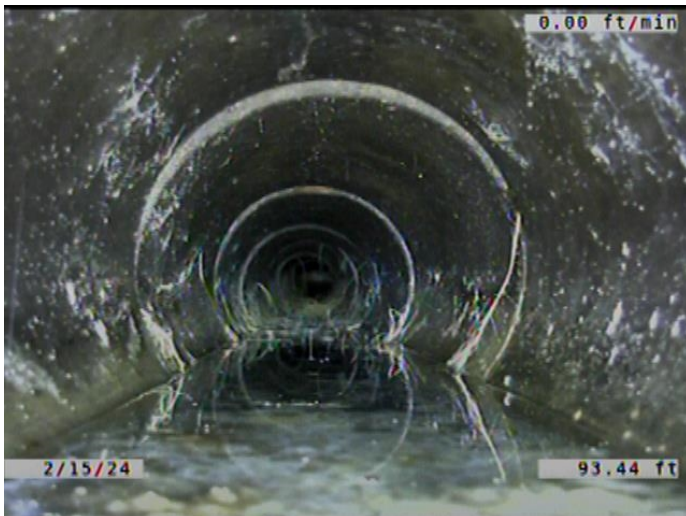
Code:	MWL
Description:	Miscellaneous Water Level
Distance (ft):	93.4
Structural Grade:	0
O&M Grade:	0
Clock Start/From:	
Clock To:	
1st Value:	
2nd Value:	
Value Percent:	15.000
Continuous Index:	
Within 8" of Joint:	NO
Remarks:

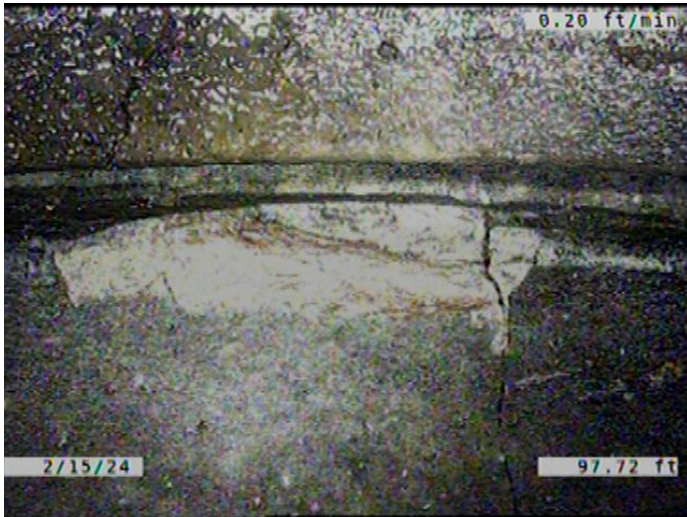
Code:	SZ
Description:	Surface Damage Other
Distance (ft):	97.7
Structural Grade:	0
O&M Grade:	0
Clock Start/From:	12
Clock To:	
1st Value:	
2nd Value:	
Value Percent:	
Continuous Index:	
Within 8" of Joint:	YES
Remarks:	A PIECE CHIPPED AWAY FROM THE JOINT.

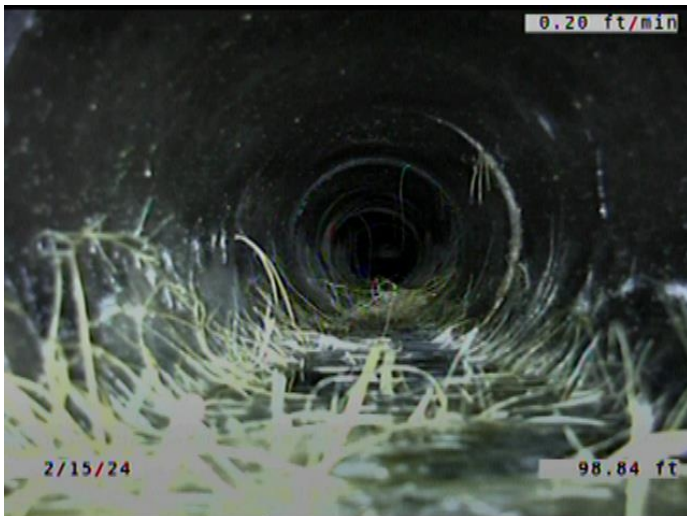
Code:	RFJ
Description:	Roots Fine Joint
Distance (ft):	98.8
Structural Grade:	0
O&M Grade:	1
Clock Start/From:	7
Clock To:	5
1st Value:	
2nd Value:	
Value Percent:	
Continuous Index:	F03
Within 8" of Joint:	YES
Remarks:

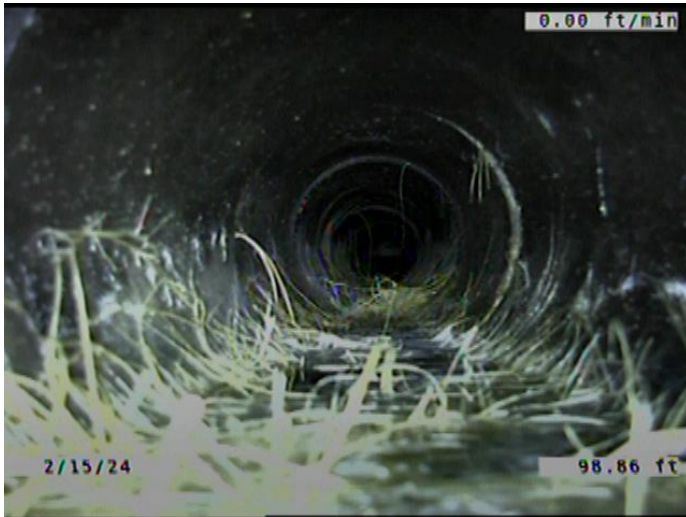
Code: **RMJ**
Description: **Roots Medium Joint**

Distance (ft): **98.8**
Structural Grade: **0**
O&M Grade: **3**
Clock Start/From: **12**
Clock To: **12**
1st Value:
2nd Value:
Value Percent: **5.000**
Continuous Index: **S08**
Within 8" of Joint: **YES**
Remarks:

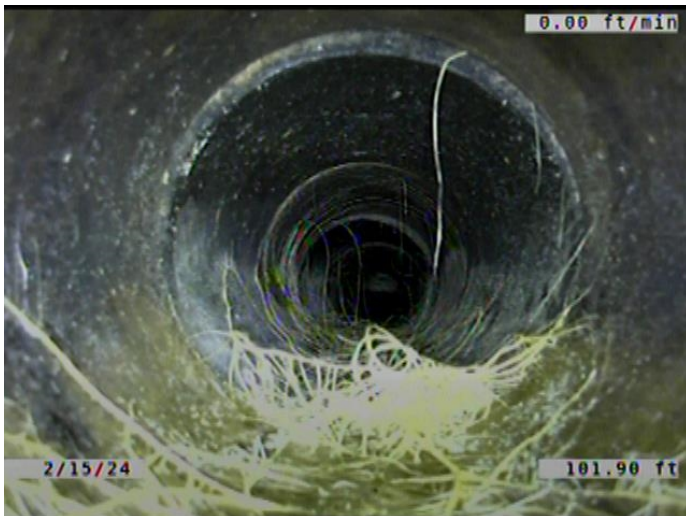
Code: **MWL**
Description: **Miscellaneous Water Level**

Distance (ft): **101.9**
Structural Grade: **0**
O&M Grade: **0**
Clock Start/From:
Clock To:
1st Value:
2nd Value:
Value Percent: **5.000**
Continuous Index:
Within 8" of Joint: **NO**
Remarks:

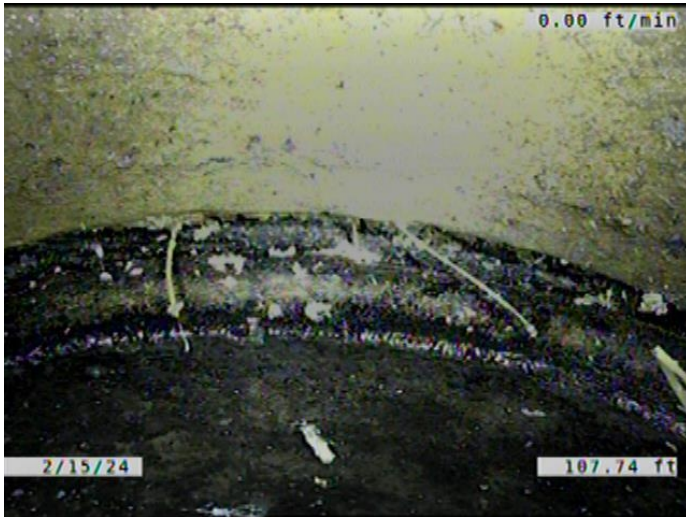
Code: **JOMD**
Description: **Joint Offset Medium Defective**

Distance (ft): **107.7**
Structural Grade: **3**
O&M Grade: **0**
Clock Start/From:
Clock To:
1st Value:
2nd Value:
Value Percent:
Continuous Index:
Within 8" of Joint: **NO**
Remarks:

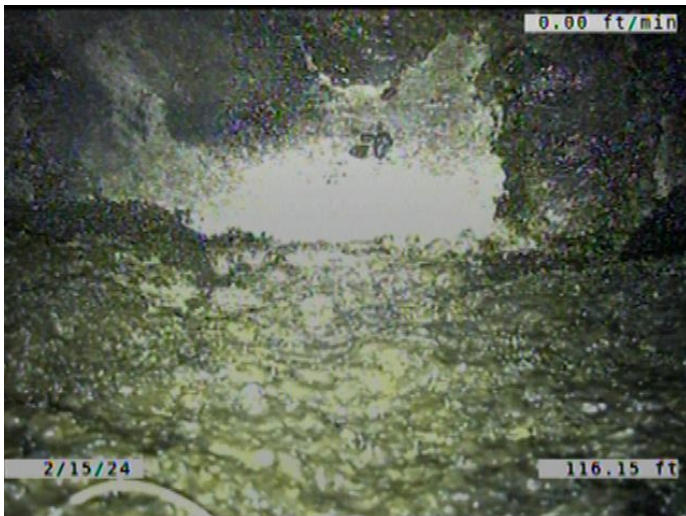
Code: **FM**
Description: **Fracture Multiple**

Distance (ft): **116.1**
Structural Grade: **4**
O&M Grade: **0**
Clock Start/From: **7**
Clock To: **5**
1st Value:
2nd Value:
Value Percent:
Continuous Index: **F01**
Within 8" of Joint: **YES**
Remarks: **Wandering**

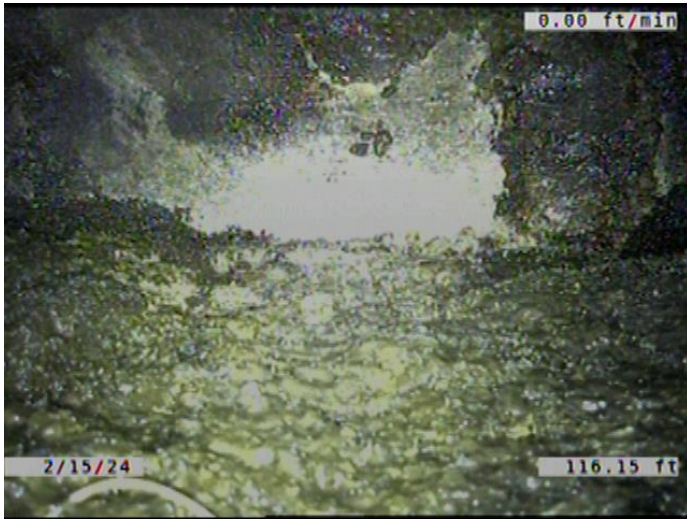
Code: **DSF**
Description: **Deposits Settled Fine**

Distance (ft): **116.1**
Structural Grade: **0**
O&M Grade: **2**
Clock Start/From: **5**
Clock To: **7**
1st Value:
2nd Value:
Value Percent: **5.000**
Continuous Index: **F06**
Within 8" of Joint: **YES**
Remarks:

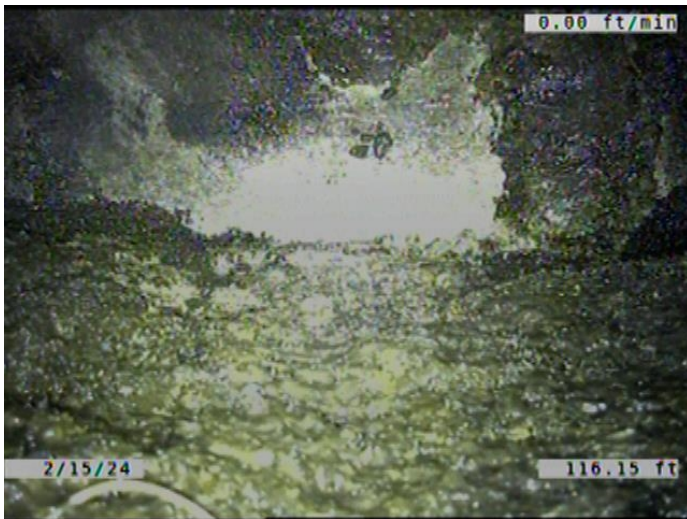
Code: **RMJ**
Description: **Roots Medium Joint**

Distance (ft): **116.2**
Structural Grade: **0**
O&M Grade: **3**
Clock Start/From: **12**
Clock To: **12**
1st Value:
2nd Value:
Value Percent: **5.000**
Continuous Index: **F08**
Within 8" of Joint: **YES**
Remarks:

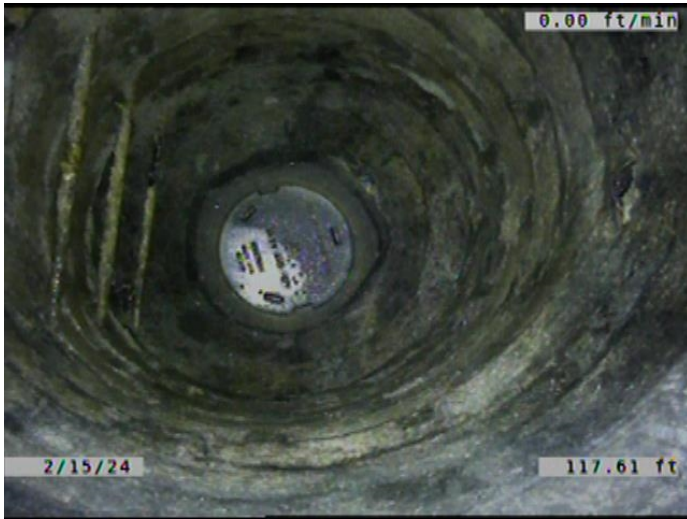
Code:	AMH
Description:	Manhole
Distance (ft):	117.6
Structural Grade:	0
O&M Grade:	0
Clock Start/From:	
Clock To:	
1st Value:	
2nd Value:	
Value Percent:	
Continuous Index:	
Within 8" of Joint:	NO
Remarks:	M-504-017
