Profile/Photo Observation Report

| P.O.#: | 31-1 | Surveyor: | M. Pielacha | PSR: | M-504-019-M-504-004 |

| Street: | Wisconsin Street | Flow Control: | Not Controlled |

US MH: **M-504-019** DS MH: **M-504-004** Total Length Surveyed (ft): **110.7**

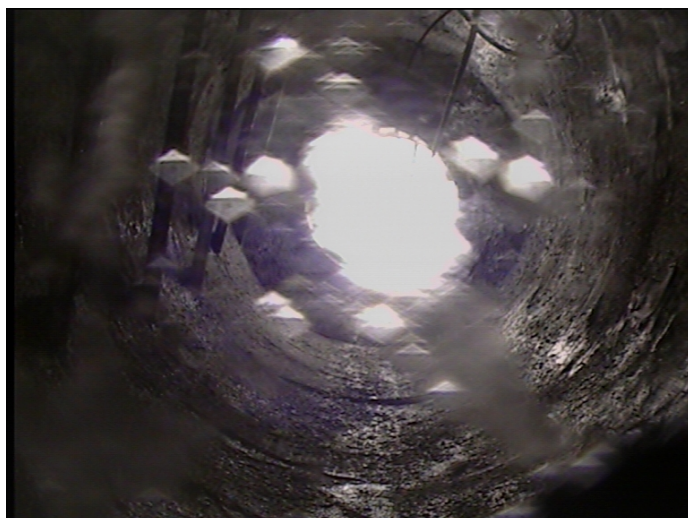
Code: **AMH**
 Description: **Manhole**

Distance (ft): **.0**
 Structural Grade: **0**
 O&M Grade: **0**
 Clock Start/From:
 Clock To:
 1st Value:
 2nd Value:
 Value Percent:
 Continuous Index:
 Within 8" of Joint: **NO**
 Remarks: **M-504-019**

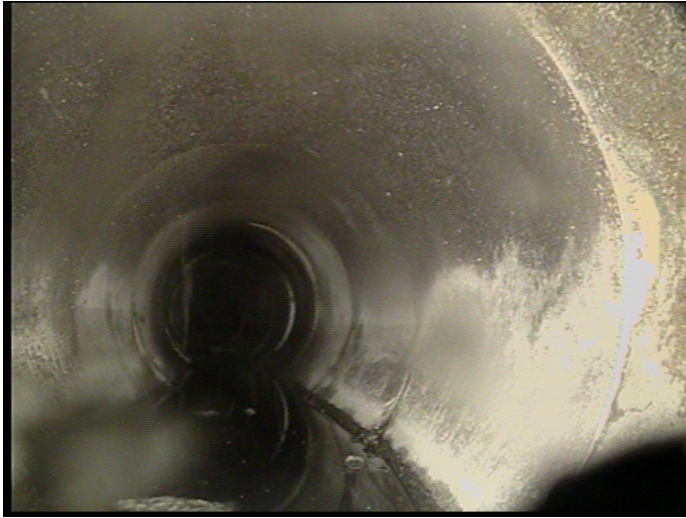
Code: **MWL**
Description: **Water Level**

Distance (ft): **.0**
Structural Grade: **0**
O&M Grade: **0**
Clock Start/From:
Clock To:
1st Value:
2nd Value:
Value Percent: **10.000**
Continuous Index:
Within 8" of Joint: **NO**
Remarks:

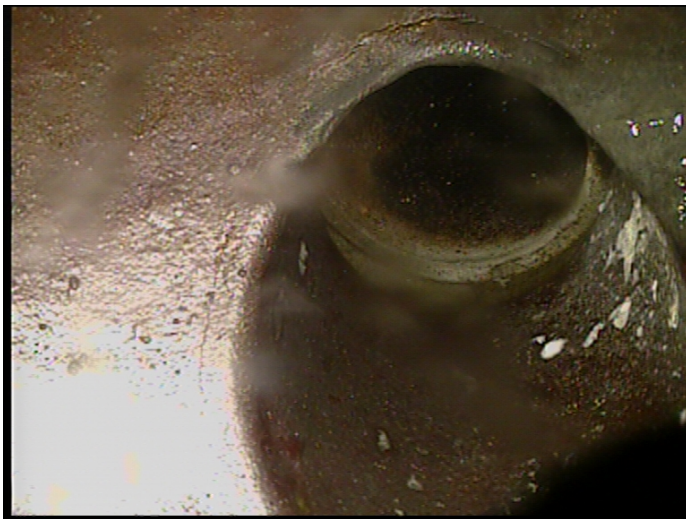
Code: **TFA**
Description: **Tap Factory Active**

Distance (ft): **9.8**
Structural Grade: **0**
O&M Grade: **0**
Clock Start/From: **2**
Clock To:
1st Value: **4.000**
2nd Value:
Value Percent:
Continuous Index:
Within 8" of Joint: **NO**
Remarks:

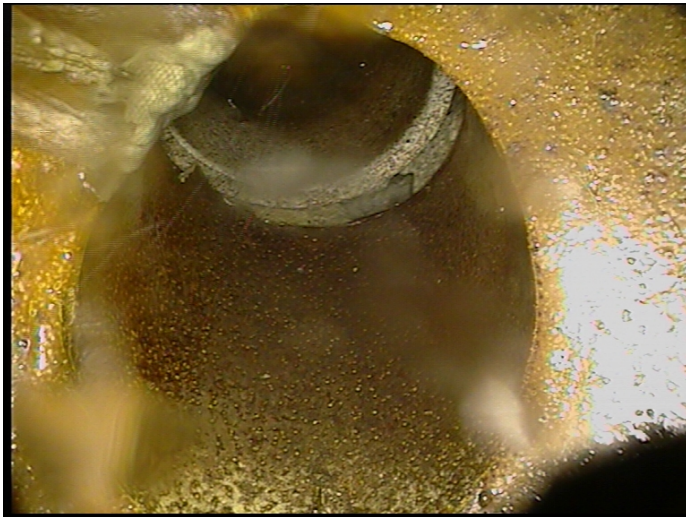
Code: **TFA**
Description: **Tap Factory Active**

Distance (ft): **12.0**
Structural Grade: **0**
O&M Grade: **0**
Clock Start/From: **10**
Clock To:
1st Value: **4.000**
2nd Value:
Value Percent:
Continuous Index:
Within 8" of Joint: **NO**
Remarks:

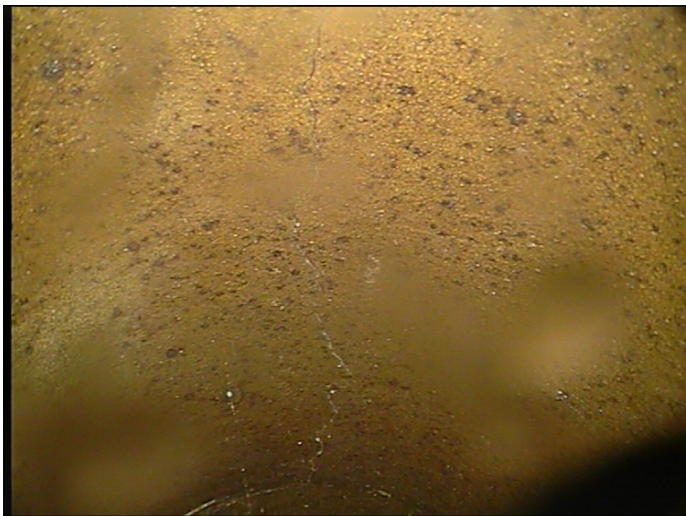
| | Position | Code | Observation | Video (sec) | Grade |
|--|---|---|---|---|---|
| | 18.8 | CL | Crack Longitudinal | 64 | S 2 |

Code: **CL**
Description: **Crack Longitudinal**

Distance (ft): **18.8**
Structural Grade: **2**
O&M Grade: **0**
Clock Start/From: **12**
Clock To:
1st Value:
2nd Value:
Value Percent:
Continuous Index:
Within 8" of Joint: **YES**
Remarks:

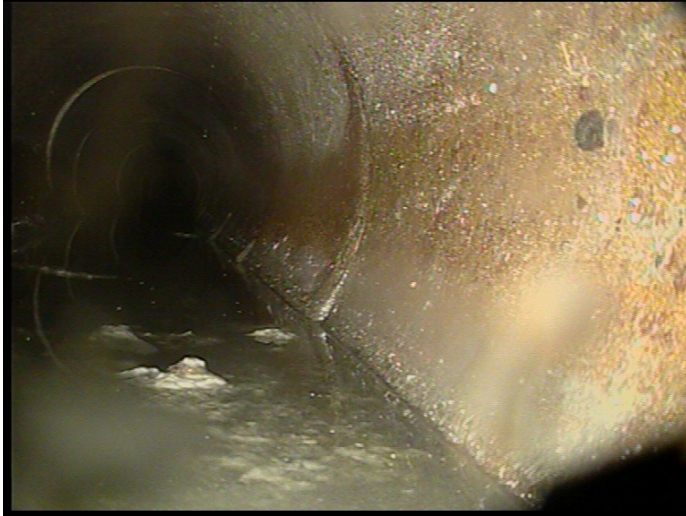
| | Position | Code | Observation | Video (sec) | Grade |
|--|---|---|---|---|---|
| | 31.4 | DSF(S01) | Deposits Settled Fine | 91 | M 3 |

Code: **DSF**
Description: **Deposits Settled Fine**

Distance (ft): **31.4**
Structural Grade: **0**
O&M Grade: **3**
Clock Start/From: **5**
Clock To: **7**
1st Value:
2nd Value:
Value Percent: **15.000**
Continuous Index: **S01**
Within 8" of Joint: **YES**
Remarks:

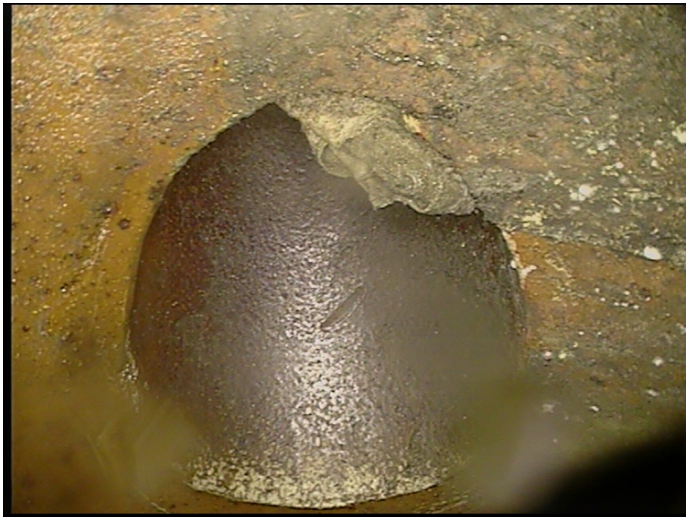
Code: **TF**
Description: **Tap Factory**

Distance (ft): **48.4**
Structural Grade: **0**
O&M Grade: **0**
Clock Start/From: **2**
Clock To:
1st Value: **4.000**
2nd Value:
Value Percent:
Continuous Index:
Within 8" of Joint: **NO**
Remarks:

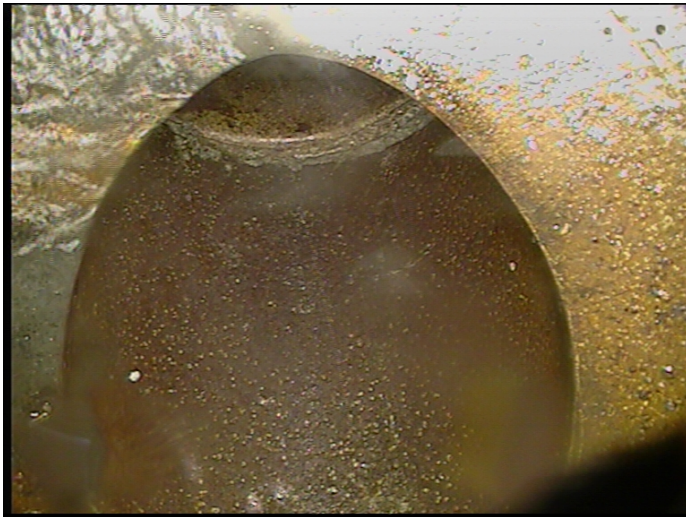
| Code: | TFA |
| Description: | Tap Factory Active |
| Distance (ft): | 50.3 |

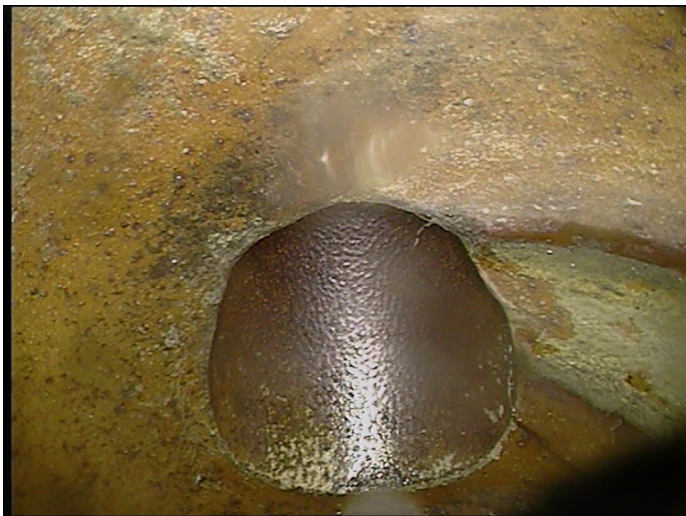
| Code: | TF |
| Description: | Tap Factory |
| Distance (ft): | 84.7 |

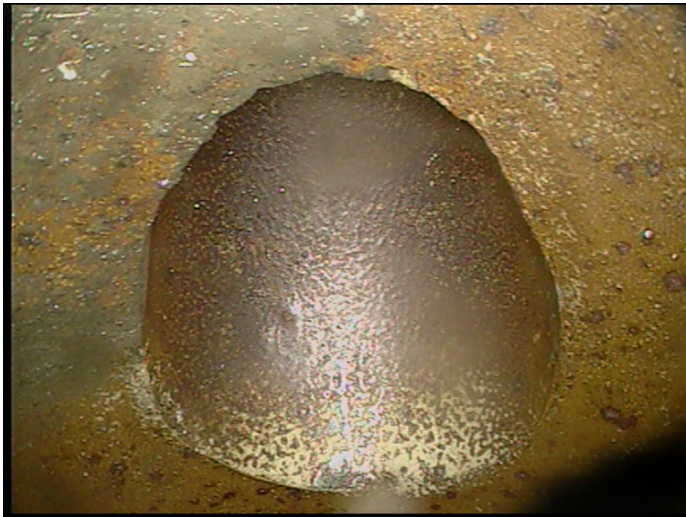
Code: **TF**
Description: **Tap Factory**

Distance (ft): **87.7**
Structural Grade: **0**
O&M Grade: **0**
Clock Start/From: **10**
Clock To:
1st Value: **4.000**
2nd Value:
Value Percent:
Continuous Index:
Within 8" of Joint: **NO**
Remarks:

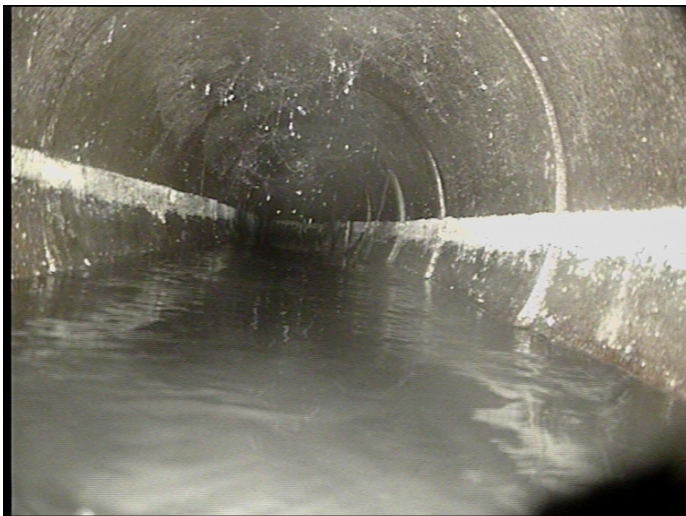
| | Position | Code | Observation | Video (sec) | Grade |
|--|---|---|---|---|---|
| | 110.0 | DSF(F01) | Deposits Settled Fine | 2246 | M 3 |

Code: **DSF**
Description: **Deposits Settled Fine**

Distance (ft): **110.0**
Structural Grade: **0**
O&M Grade: **3**
Clock Start/From: **5**
Clock To: **7**
1st Value:
2nd Value:
Value Percent: **20.000**
Continuous Index: **F01**
Within 8" of Joint: **NO**
Remarks:

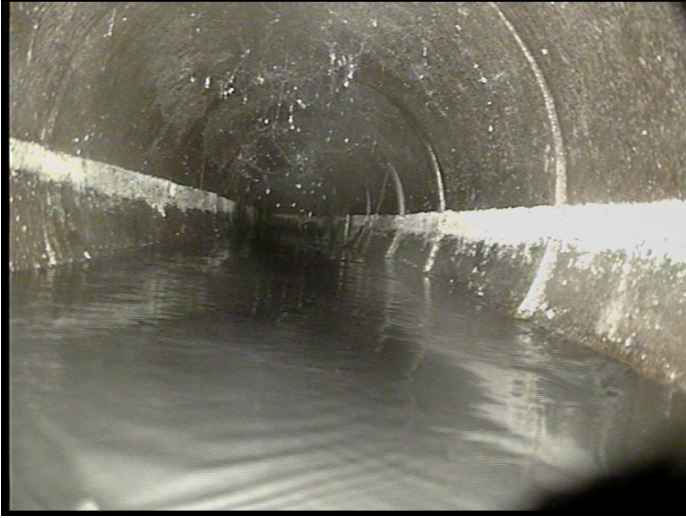
| Code: | MSA |
| Description: | Abandoned Survey |
| Distance (ft): | 110.0 |
| Remarks: | sediment |
