Profile/Photo Observation Report

Street:	Wisconsin Street	Flow Control:	Not Controlled
City:	Hobart, IN	Year Renewed:	
Location:	Light Highway	Tape/Media #:	DEP 31
Purpose:	Routine Assessment	Dia/Height:	18"
Use:	Sanitary	Material:	VCP
Drain Area:		Lining:	
Category:	NA		
Comment:

Location Details:		Direction of Survey:	Downstream
US MH:	M-504-019	DS MH:	M-504-004
		Total Length Surveyed (ft):	110.7

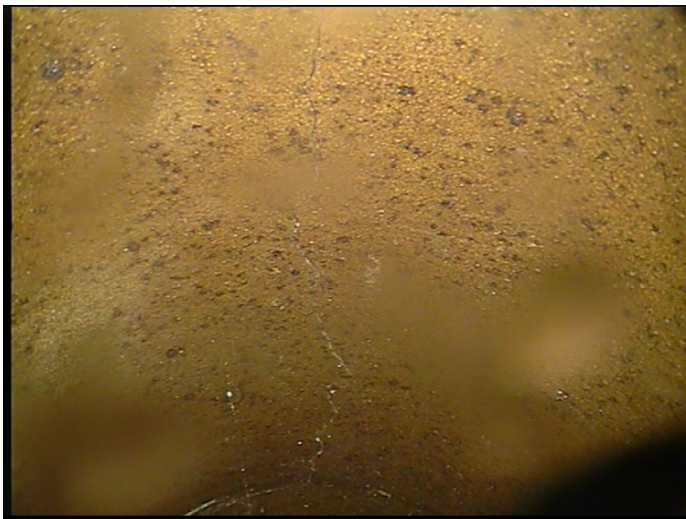
Code: **CL**
Description: **Crack Longitudinal**

Distance (ft): **18.8**
Structural Grade: **2**
O&M Grade: **0**
Clock Start/From: **12**
Clock To:
1st Value:
2nd Value:
Value Percent:
Continuous Index:
Within 8" of Joint: **YES**
Remarks:
