Profile/Photo Observation Report

Date:	04/20/2018	Weather:		Coding:	PACP 6.0
Pipe Length (ft):	273.5	Owner:	NA	Pre Clean:	Not Known
P.O.#:		Surveyor:	Byrd Fitzgerald	PSR:	P-504-082-020
Customer:		Clean Date:	01/01/1900	Shape:	C

Street:	N WISCONSIN ST	Flow Control:	Not Controlled
City:	Hobart, IN	Year Renewed:	
Location:	Light Highway	Tape/Media #:	
Purpose:	Not Known	Dia/Height:	10"
Use:	Sanitary	Material:	VCP
Drain Area:	NA	Lining:	
Category:	NA		
Comment:

Location Details:		Direction of Survey:	Downstream
US MH:	M-504-020	DS MH:	M-604-082
		Total Length Surveyed (ft):	269.4

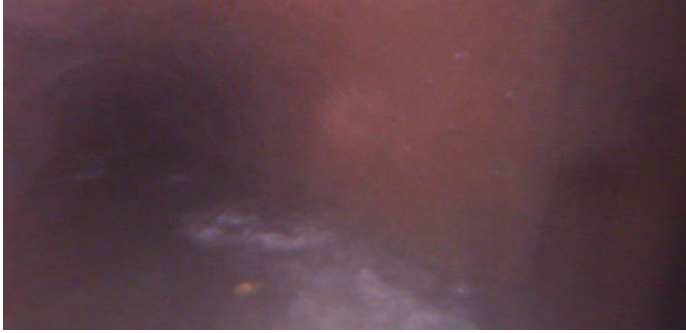
Code: **DSZ**
Description: **Deposits Settled Other**

Distance (ft): **7.4**
Structural Grade: **0**
O&M Grade: **2**
Clock Start/From: **6**
Clock To:
1st Value:
2nd Value:
Value Percent: **5.000**
Continuous Index: **S01**
Within 8" of Joint: **NO**
Remarks: **tissue**

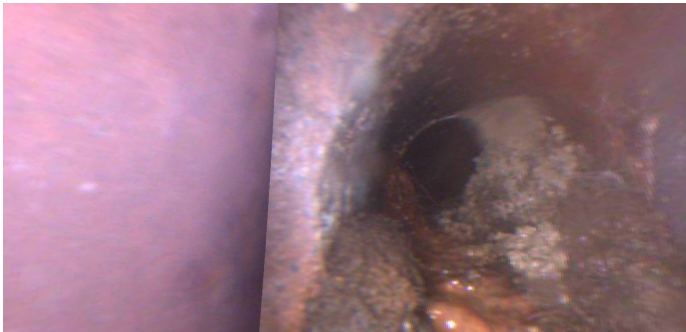
Code: **TFD**
Description: **Tap Factory Defective**

Distance (ft): **12.4**
Structural Grade: **0**
O&M Grade: **2**
Clock Start/From: **3**
Clock To:
1st Value: **4.000**
2nd Value:
Value Percent:
Continuous Index:
Within 8" of Joint: **YES**
Remarks: **blocked by deposits**

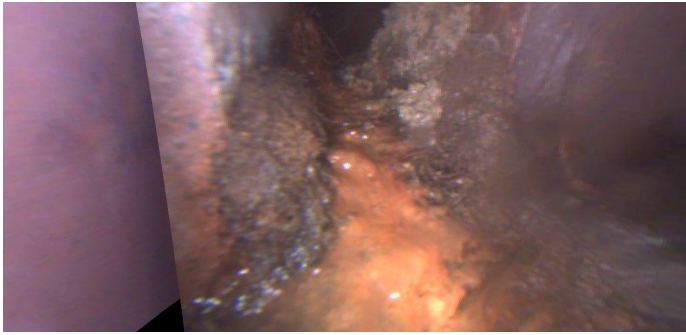
Code: **DAE**
Description: **Deposits Attached Encrustation**

Distance (ft): **12.4**
Structural Grade: **0**
O&M Grade: **2**
Clock Start/From: **5**
Clock To:
1st Value:
2nd Value:
Value Percent: **5.000**
Continuous Index:
Within 8" of Joint: **NO**
Remarks:

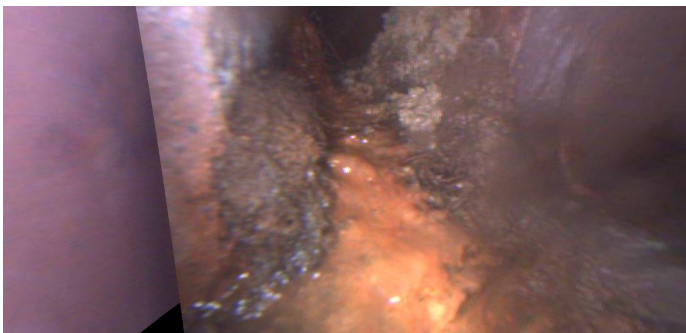
Code: **RML**
Description: **Roots Medium Lateral**

Distance (ft): **12.4**
Structural Grade: **0**
O&M Grade: **3**
Clock Start/From: **3**
Clock To:
1st Value:
2nd Value:
Value Percent: **5.000**
Continuous Index:
Within 8" of Joint: **NO**
Remarks:

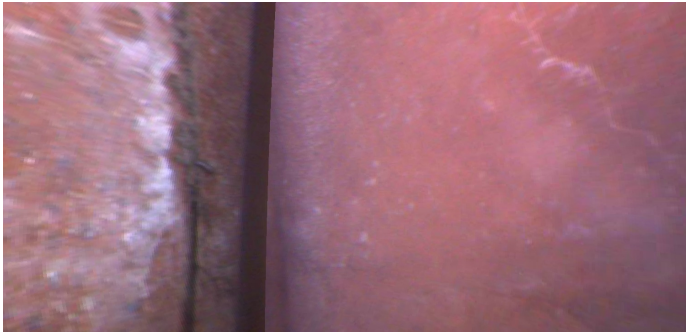
Code: **RFJ**
Description: **Roots Fine Joint**

Distance (ft): **13.4**
Structural Grade: **0**
O&M Grade: **1**
Clock Start/From: **7**
Clock To: **5**
1st Value:
2nd Value:
Value Percent:
Continuous Index: **S02**
Within 8" of Joint: **YES**
Remarks: **wandering**

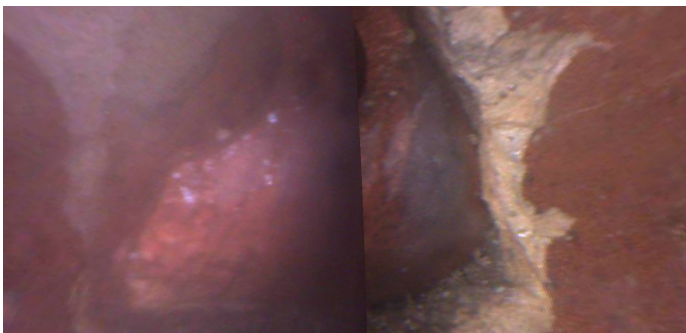
Code: **TBI**
Description: **Tap Break-in Intruding**

Distance (ft): **83.8**
Structural Grade: **0**
O&M Grade: **2**
Clock Start/From: **2**
Clock To:
1st Value: **4.000**
2nd Value: **2.000**
Value Percent:
Continuous Index:
Within 8" of Joint:
Remarks:

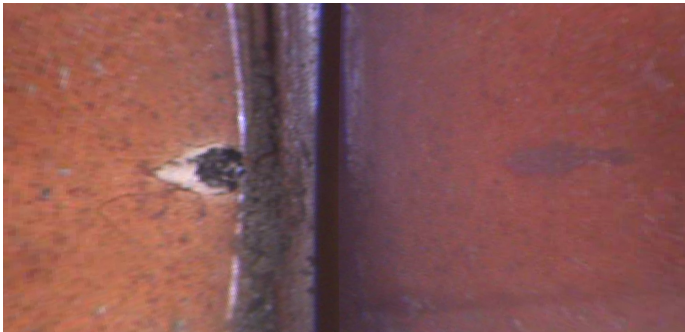
Code: **MGO**
Description: **General Observation**

Distance (ft): **165.9**
Structural Grade: **0**
O&M Grade: **0**
Clock Start/From:
Clock To:
1st Value:
2nd Value:
Value Percent:
Continuous Index:
Within 8" of Joint: **NO**
Remarks: **chipped?**

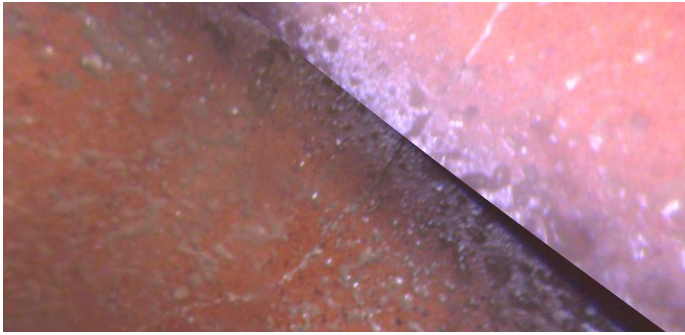
Code: **CL**
Description: **Crack Longitudinal**

Distance (ft): **168.9**
Structural Grade: **2**
O&M Grade: **0**
Clock Start/From: **12**
Clock To:
1st Value:
2nd Value:
Value Percent:
Continuous Index: **S03**
Within 8" of Joint: **YES**
Remarks:

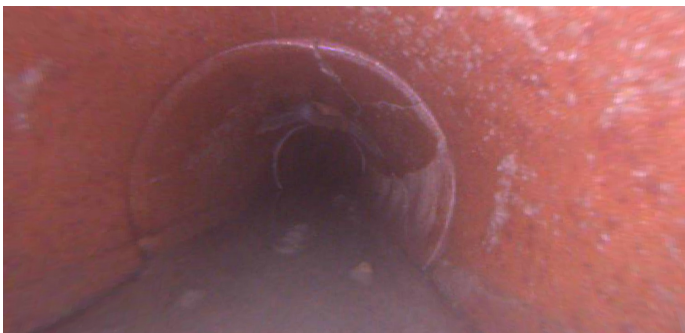
Code: **CM**
Description: **Crack Multiple**

Distance (ft): **171.2**
Structural Grade: **3**
O&M Grade: **0**
Clock Start/From: **7**
Clock To: **3**
1st Value:
2nd Value:
Value Percent:
Continuous Index: **S04**
Within 8" of Joint: **YES**
Remarks: **wandering**

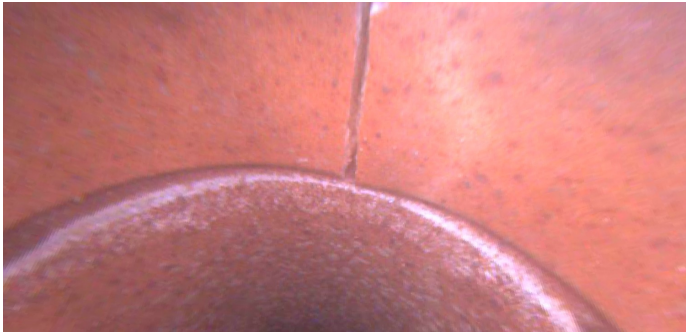
Code: **FL**
Description: **Fracture Longitudinal**

Distance (ft): **173.6**
Structural Grade: **3**
O&M Grade: **0**
Clock Start/From: **12**
Clock To:
1st Value:
2nd Value:
Value Percent:
Continuous Index:
Within 8" of Joint:
Remarks:

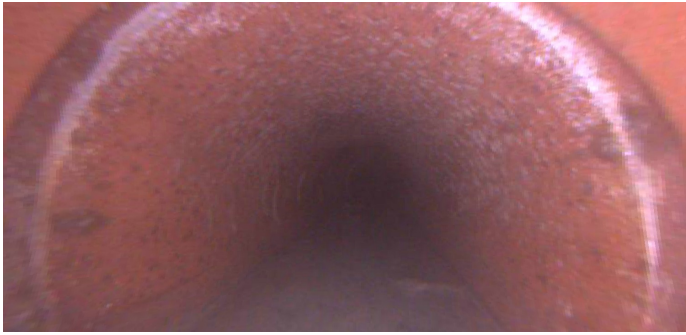
Code: **CL**
Description: **Crack Longitudinal**

Distance (ft): **173.6**
Structural Grade: **2**
O&M Grade: **0**
Clock Start/From: **12**
Clock To:
1st Value:
2nd Value:
Value Percent:
Continuous Index: **F03**
Within 8" of Joint: **YES**
Remarks:

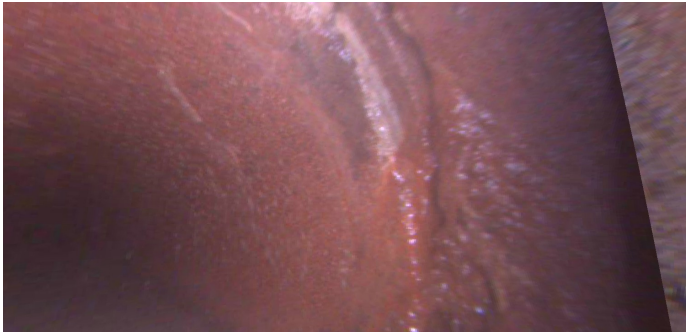
Code: **DAE**
Description: **Deposits Attached Encrustation**

Distance (ft): **192.0**
Structural Grade: **0**
O&M Grade: **2**
Clock Start/From: **3**
Clock To: **5**
1st Value:
2nd Value:
Value Percent: **5.000**
Continuous Index:
Within 8" of Joint: **YES**
Remarks:

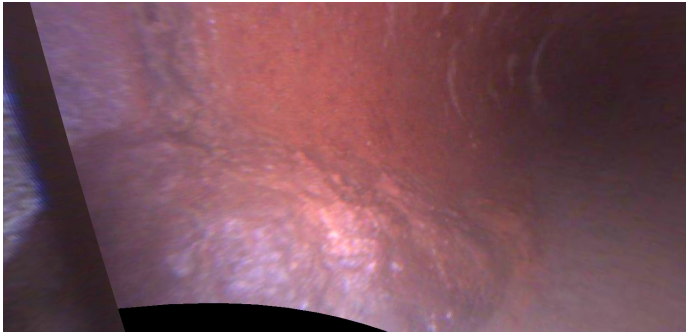
Code: **DAE**
Description: **Deposits Attached Encrustation**

Distance (ft): **226.5**
Structural Grade: **0**
O&M Grade: **2**
Clock Start/From: **8**
Clock To:
1st Value:
2nd Value:
Value Percent: **10.000**
Continuous Index:
Within 8" of Joint: **YES**
Remarks:

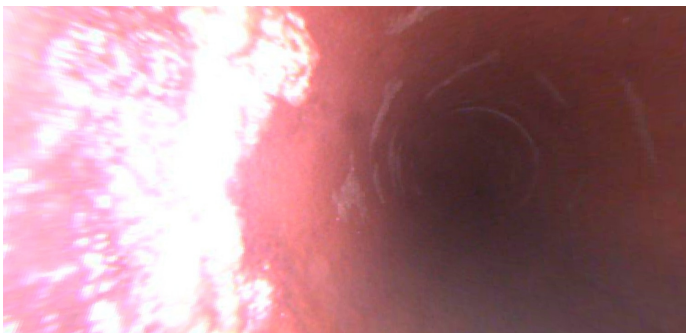
Code: **DAE**
Description: **Deposits Attached Encrustation**

Distance (ft): **234.6**
Structural Grade: **0**
O&M Grade: **2**
Clock Start/From: **7**
Clock To: **10**
1st Value:
2nd Value:
Value Percent: **5.000**
Continuous Index:
Within 8" of Joint: **YES**
Remarks:

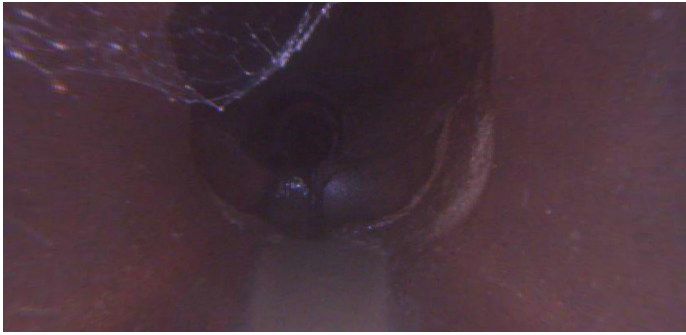
Code: **RFJ**
Description: **Roots Fine Joint**

Distance (ft): **267.2**
Structural Grade: **0**
O&M Grade: **1**
Clock Start/From: **7**
Clock To: **5**
1st Value:
2nd Value:
Value Percent:
Continuous Index: **F02**
Within 8" of Joint: **YES**
Remarks: **wandering**

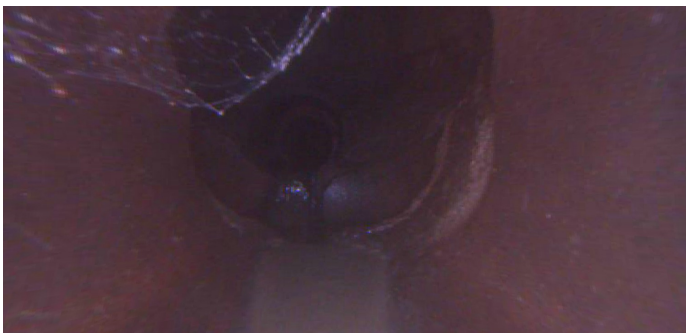
Code: **CM**
Description: **Crack Multiple**

Distance (ft): **267.2**
Structural Grade: **3**
O&M Grade: **0**
Clock Start/From: **7**
Clock To: **3**
1st Value:
2nd Value:
Value Percent:
Continuous Index: **F04**
Within 8" of Joint: **YES**
Remarks: **wandering**

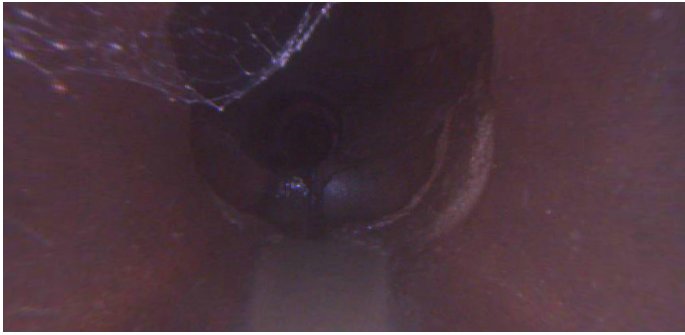
Code: **DSZ**
Description: **Deposits Settled Other**

Distance (ft): **267.2**
Structural Grade: **0**
O&M Grade: **2**
Clock Start/From: **6**
Clock To:
1st Value:
2nd Value:
Value Percent: **5.000**
Continuous Index: **F01**
Within 8" of Joint: **NO**
Remarks: **tissue**
