Profile/Photo Observation Report

Date:	04/20/2018	Weather:		Coding:	PACP 6.0
Pipe Length (ft):	273.5	Owner:	NA	Pre Clean:	Not Known
P.O.#:		Surveyor:	Byrd Fitzgerald	PSR:	P-504-082-020
Customer:		Clean Date:	01/01/1900	Shape:	C

Street:	Summerlin	Flow Control:	Not Controlled
City:	Hobart, IN	Year Renewed:	
Location:	Light Highway	Tape/Media #:	
Purpose:	Not Known	Dia/Height:	10"
Use:	Sanitary	Material:	VCP
Drain Area:	NA	Lining:	
Category:	NA		
Comment:

Location Details:		Direction of Survey:	Downstream
US MH:	M-504-020	DS MH:	M-604-082
		Total Length Surveyed (ft):	269.4

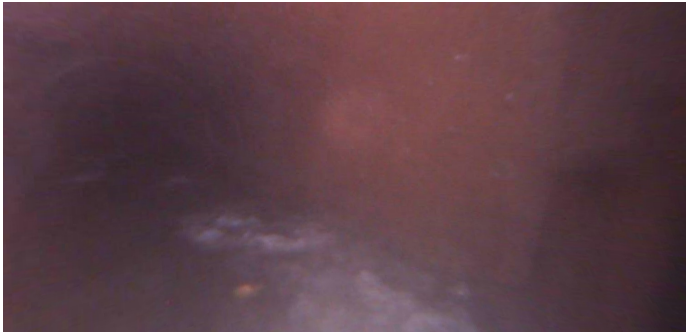
Code: **DSZ**
Description: **Deposits Settled Other**

Distance (ft): **7.4**
Structural Grade: **0**
O&M Grade: **2**
Clock Start/From: **6**
Clock To:
1st Value:
2nd Value:
Value Percent: **5.000**
Continuous Index: **S01**
Within 8" of Joint: **NO**
Remarks: **tissue**

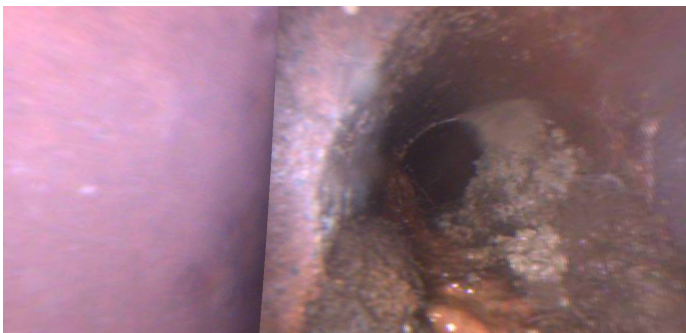
Code: **TFD**
Description: **Tap Factory Defective**

Distance (ft): **12.4**
Structural Grade: **0**
O&M Grade: **2**
Clock Start/From: **3**
Clock To:
1st Value: **4.000**
2nd Value:
Value Percent:
Continuous Index:
Within 8" of Joint: **YES**
Remarks: **blocked by deposits**

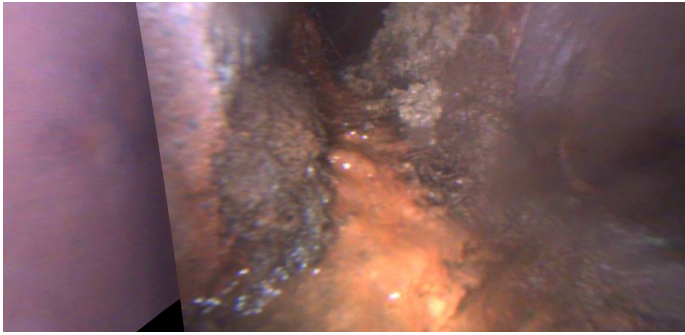
Code: **DAE**
Description: **Deposits Attached Encrustation**

Distance (ft): **12.4**
Structural Grade: **0**
O&M Grade: **2**
Clock Start/From: **5**
Clock To:
1st Value:
2nd Value:
Value Percent: **5.000**
Continuous Index:
Within 8" of Joint: **NO**
Remarks:

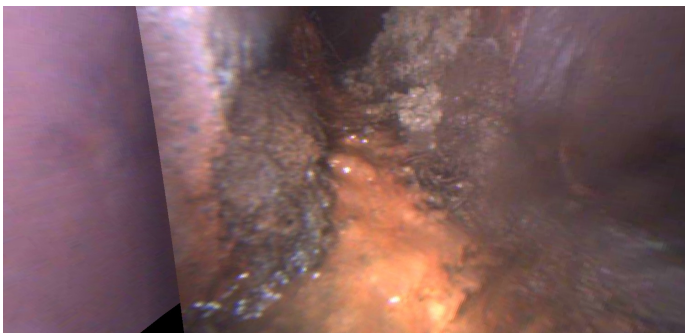
Code: **RML**
Description: **Roots Medium Lateral**

Distance (ft): **12.4**
Structural Grade: **0**
O&M Grade: **3**
Clock Start/From: **3**
Clock To:
1st Value:
2nd Value:
Value Percent: **5.000**
Continuous Index:
Within 8" of Joint: **NO**
Remarks:

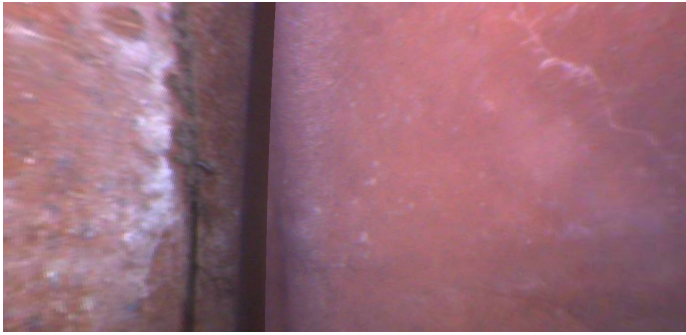
Code: **RFJ**
Description: **Roots Fine Joint**

Distance (ft): **13.4**
Structural Grade: **0**
O&M Grade: **1**
Clock Start/From: **7**
Clock To: **5**
1st Value:
2nd Value:
Value Percent:
Continuous Index: **S02**
Within 8" of Joint: **YES**
Remarks: **wandering**

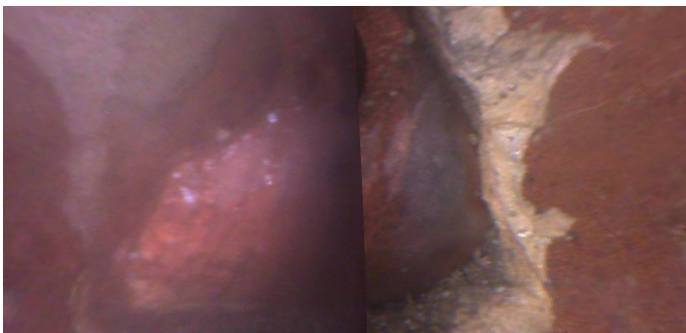
Code: **TBI**
Description: **Tap Break-in Intruding**

Distance (ft): **83.8**
Structural Grade: **0**
O&M Grade: **2**
Clock Start/From: **2**
Clock To:
1st Value: **4.000**
2nd Value: **2.000**
Value Percent:
Continuous Index:
Within 8" of Joint:
Remarks:

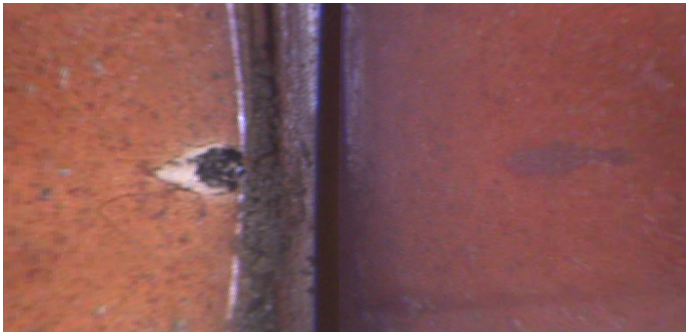
Code: **MGO**
Description: **General Observation**

Distance (ft): **165.9**
Structural Grade: **0**
O&M Grade: **0**
Clock Start/From:
Clock To:
1st Value:
2nd Value:
Value Percent:
Continuous Index:
Within 8" of Joint: **NO**
Remarks: **chipped?**

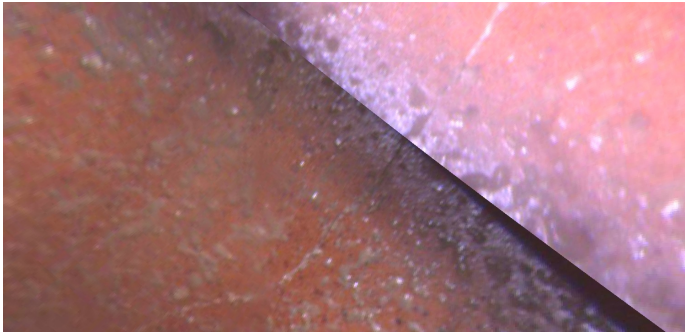
Code: **CL**
Description: **Crack Longitudinal**

Distance (ft): **168.9**
Structural Grade: **2**
O&M Grade: **0**
Clock Start/From: **12**
Clock To:
1st Value:
2nd Value:
Value Percent:
Continuous Index: **S03**
Within 8" of Joint: **YES**
Remarks:

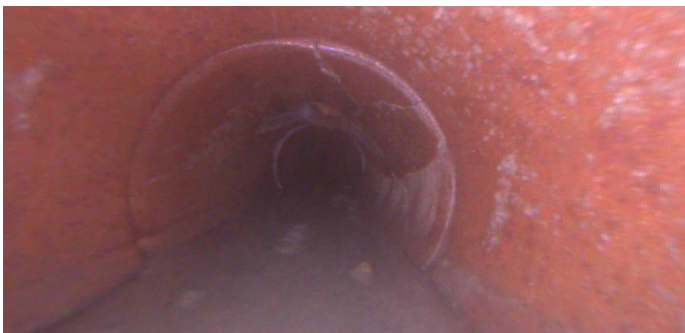
Code: **CM**
Description: **Crack Multiple**

Distance (ft): **171.2**
Structural Grade: **3**
O&M Grade: **0**
Clock Start/From: **7**
Clock To: **3**
1st Value:
2nd Value:
Value Percent:
Continuous Index: **S04**
Within 8" of Joint: **YES**
Remarks: **wandering**

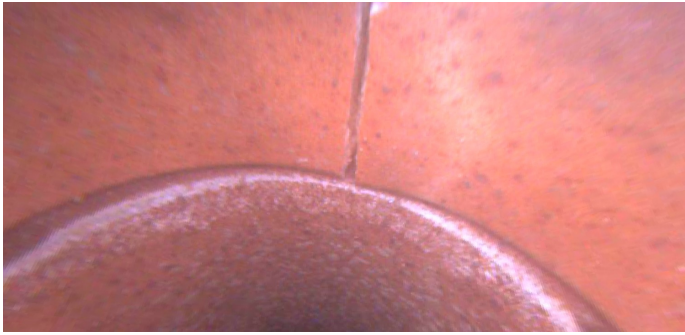
Code: **FL**
Description: **Fracture Longitudinal**

Distance (ft): **173.6**
Structural Grade: **3**
O&M Grade: **0**
Clock Start/From: **12**
Clock To:
1st Value:
2nd Value:
Value Percent:
Continuous Index:
Within 8" of Joint:
Remarks:

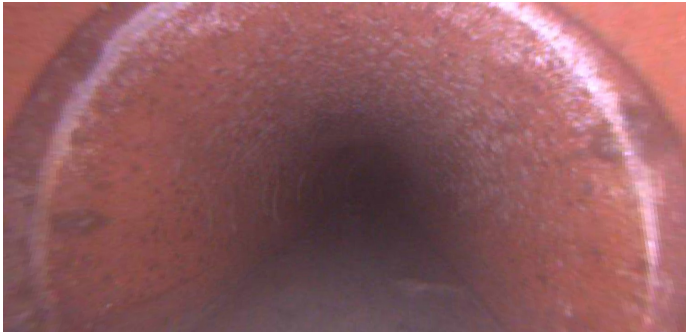
Code: **CL**
Description: **Crack Longitudinal**

Distance (ft): **173.6**
Structural Grade: **2**
O&M Grade: **0**
Clock Start/From: **12**
Clock To:
1st Value:
2nd Value:
Value Percent:
Continuous Index: **F03**
Within 8" of Joint: **YES**
Remarks:

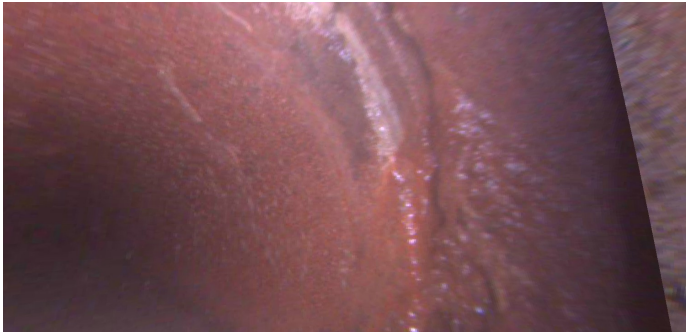
Code: **DAE**
Description: **Deposits Attached Encrustation**

Distance (ft): **192.0**
Structural Grade: **0**
O&M Grade: **2**
Clock Start/From: **3**
Clock To: **5**
1st Value:
2nd Value:
Value Percent: **5.000**
Continuous Index:
Within 8" of Joint: **YES**
Remarks:

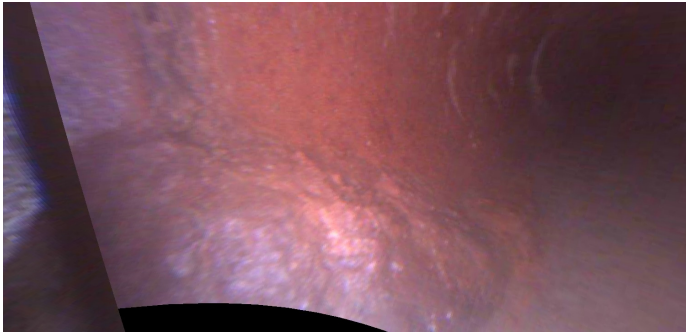
Code: **DAE**
Description: **Deposits Attached Encrustation**

Distance (ft): **226.5**
Structural Grade: **0**
O&M Grade: **2**
Clock Start/From: **8**
Clock To:
1st Value:
2nd Value:
Value Percent: **10.000**
Continuous Index:
Within 8" of Joint: **YES**
Remarks:

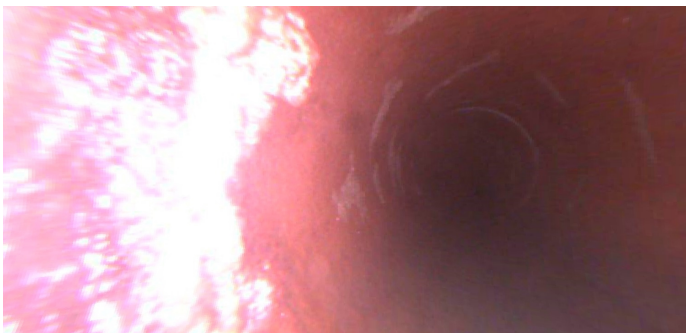
Code: **DAE**
Description: **Deposits Attached Encrustation**

Distance (ft): **234.6**
Structural Grade: **0**
O&M Grade: **2**
Clock Start/From: **7**
Clock To: **10**
1st Value:
2nd Value:
Value Percent: **5.000**
Continuous Index:
Within 8" of Joint: **YES**
Remarks:

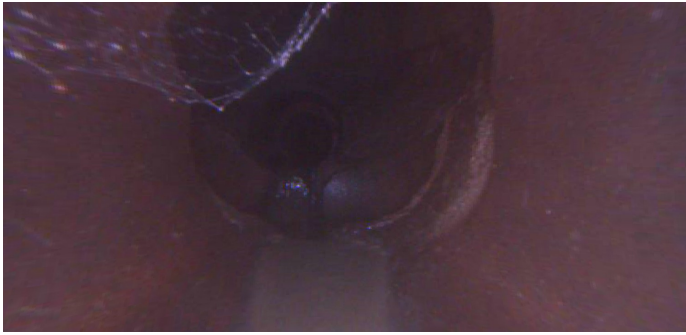
Code: **RFJ**
Description: **Roots Fine Joint**

Distance (ft): **267.2**
Structural Grade: **0**
O&M Grade: **1**
Clock Start/From: **7**
Clock To: **5**
1st Value:
2nd Value:
Value Percent:
Continuous Index: **F02**
Within 8" of Joint: **YES**
Remarks: **wandering**

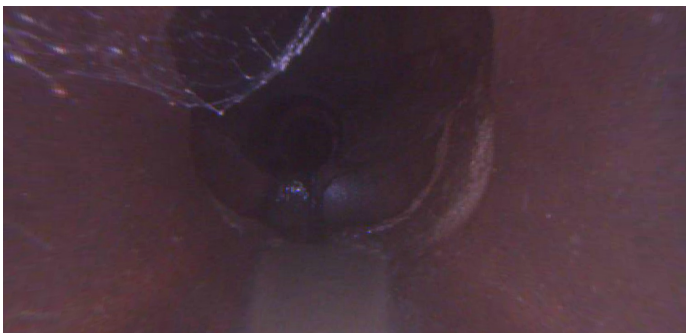
Code: **CM**
Description: **Crack Multiple**

Distance (ft): **267.2**
Structural Grade: **3**
O&M Grade: **0**
Clock Start/From: **7**
Clock To: **3**
1st Value:
2nd Value:
Value Percent:
Continuous Index: **F04**
Within 8" of Joint: **YES**
Remarks: **wandering**

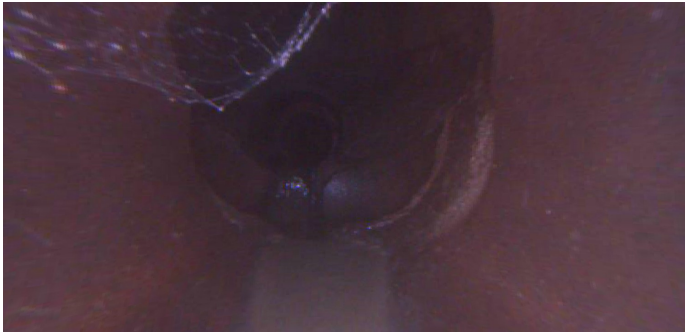
Code: **DSZ**
Description: **Deposits Settled Other**

Distance (ft): **267.2**
Structural Grade: **0**
O&M Grade: **2**
Clock Start/From: **6**
Clock To:
1st Value:
2nd Value:
Value Percent: **5.000**
Continuous Index: **F01**
Within 8" of Joint: **NO**
Remarks: **tissue**
