Profile/Photo Observation Report

| Street: | W CLEVELAND AVE | Flow Control: | Not Controlled |
| City: | Hobart, IN | Year Renewed: | |
| US MH: | M-504-023 | DS MH: | M-504-030 |

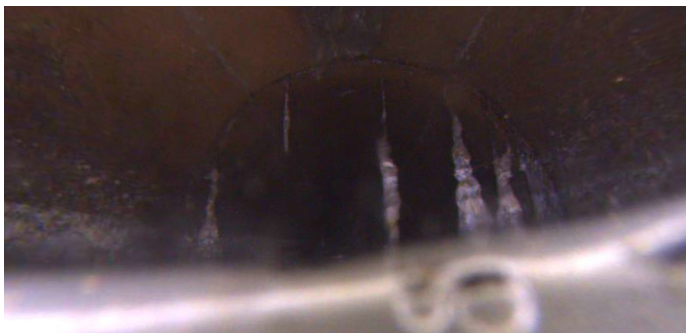
Code: **AMH**
Description: **Manhole**

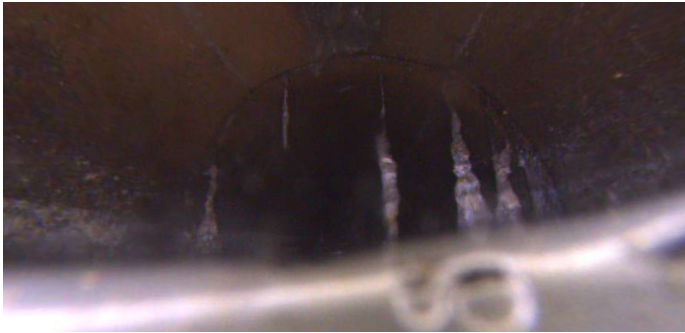
| Code: | MWL |
| Description: | Water Level |

| Distance (ft): | .0 |
| Value Percent: | 40.000 |

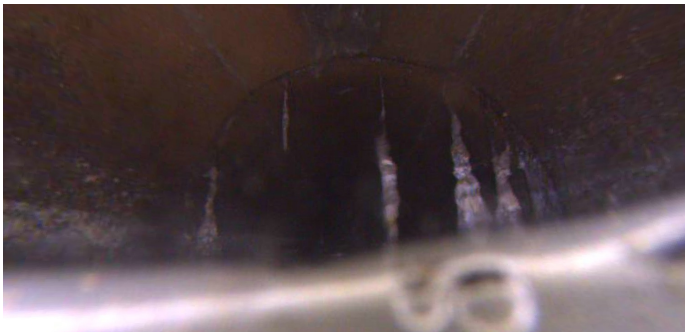
| Code: | RMJ |
| Description: | Roots Medium Joint |

| Distance (ft): | .0 |
| O&M Grade: | 3 |
| Clock Start/From: | 8 |
| Clock To: | 4 |
| Value Percent: | 5.000 |

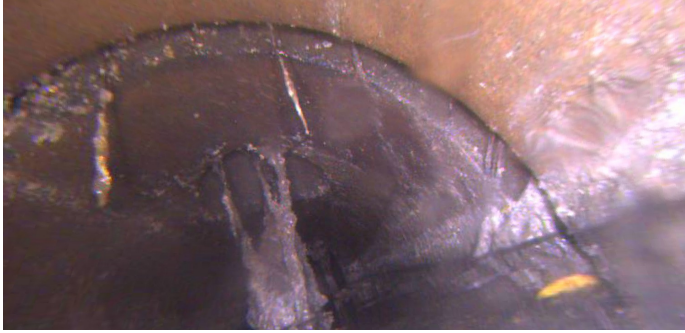
Code: **RFJ**
Description: **Roots Fine Joint**

Distance (ft): **4.1**
Structural Grade: **0**
O&M Grade: **1**
Clock Start/From: **8**
Clock To: **4**
1st Value:
2nd Value:
Value Percent:
Continuous Index:
Within 8" of Joint: **YES**
Remarks:

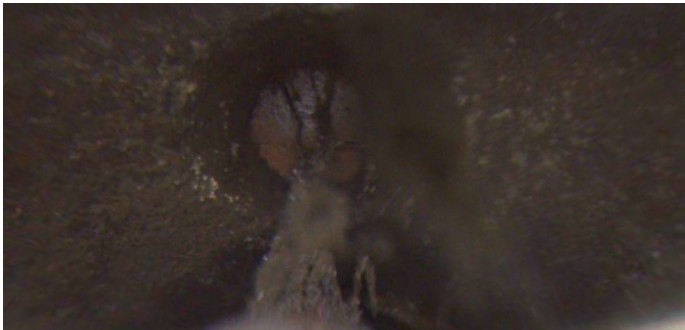
Code: **TFD**
Description: **Tap Factory Defective**

Distance (ft): **5.4**
Structural Grade: **0**
O&M Grade: **2**
Clock Start/From: **12**
Clock To:
1st Value: **4.000**
2nd Value:
Value Percent:
Continuous Index:
Within 8" of Joint:
Remarks: **roots, capped**

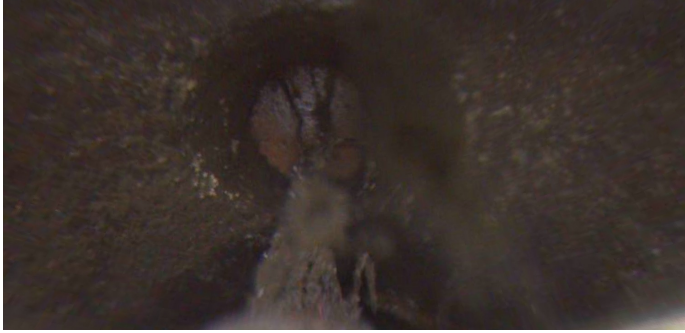
Code: **RML**
Description: **Roots Medium Lateral**

Distance (ft): **5.4**
Structural Grade: **0**
O&M Grade: **3**
Clock Start/From: **12**
Clock To:
1st Value:
2nd Value:
Value Percent: **10.000**
Continuous Index:
Within 8" of Joint: **NO**
Remarks:

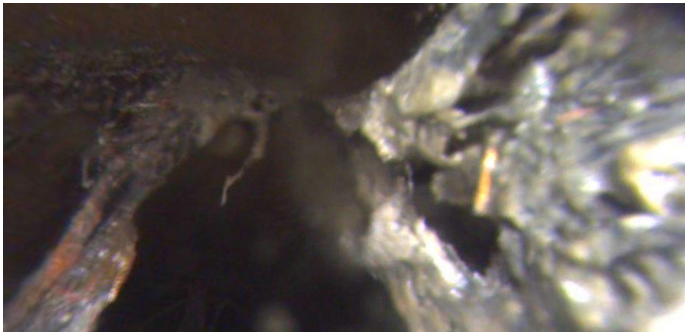
Code: **RMJ**
Description: **Roots Medium Joint**

Distance (ft): **7.3**
Structural Grade: **0**
O&M Grade: **3**
Clock Start/From: **8**
Clock To: **4**
1st Value:
2nd Value:
Value Percent: **20.000**
Continuous Index:
Within 8" of Joint: **YES**
Remarks:

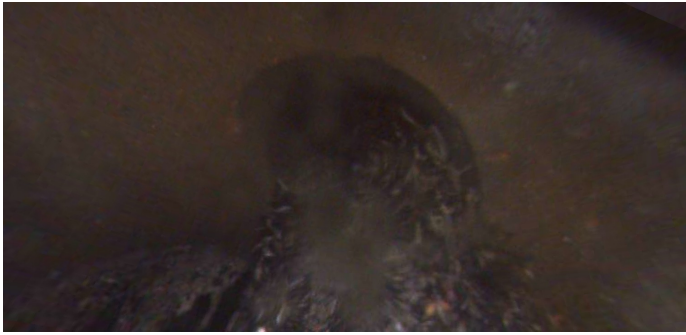
Code: **TFD**
Description: **Tap Factory Defective**

Distance (ft): **8.0**
Structural Grade: **0**
O&M Grade: **2**
Clock Start/From: **11**
Clock To:
1st Value: **4.000**
2nd Value:
Value Percent:
Continuous Index:
Within 8" of Joint:
Remarks: **roots**

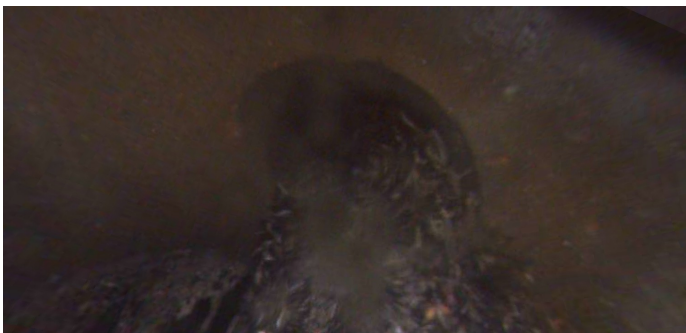
Code: **RML**
Description: **Roots Medium Lateral**

Distance (ft): **8.0**
Structural Grade: **0**
O&M Grade: **3**
Clock Start/From: **10**
Clock To: **11**
1st Value:
2nd Value:
Value Percent: **20.000**
Continuous Index:
Within 8" of Joint: **NO**
Remarks:

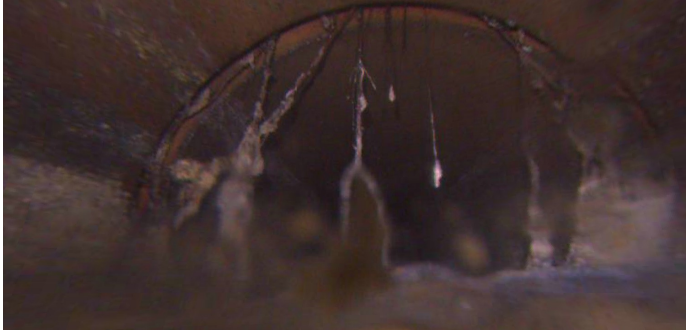
Code: **RMJ**
Description: **Roots Medium Joint**

Distance (ft): **8.9**
Structural Grade: **0**
O&M Grade: **3**
Clock Start/From: **8**
Clock To: **4**
1st Value:
2nd Value:
Value Percent: **5.000**
Continuous Index:
Within 8" of Joint: **YES**
Remarks:

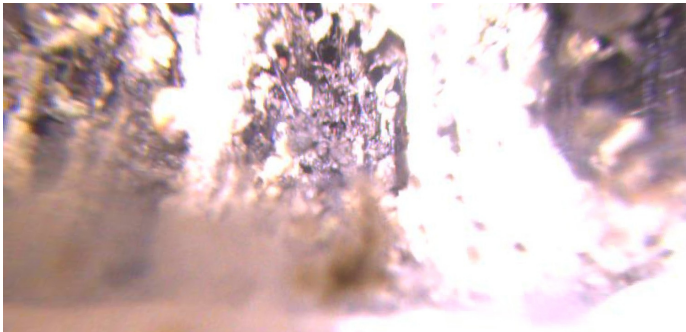
| Comment: | P_C at 11 ft unknow obstruction . flow direction wrong | | |

Code: **RBJ**
Description: **Roots Ball Joint**

Distance (ft): **11.8**
Structural Grade: **0**
O&M Grade: **4**
Clock Start/From: **8**
Clock To: **4**
1st Value:
2nd Value:
Value Percent: **60.000**
Continuous Index:
Within 8" of Joint: **YES**
Remarks:
