Profile/Photo Observation Report

Date:	04/25/2018	Weather:		Coding:	PACP 6.0
Pipe Length (ft):	174.3	Owner:	NA	Pre Clean:	No Pre-Cleaning
P.O.#:		Surveyor:	Jen Costello	PSR:	P-504-030-023
Customer:		Clean Date:	01/01/1900	Shape:	C

Street:	W CLEVELAND AVE	Flow Control:	Not Controlled
City:	Hobart, IN	Year Renewed:	
Location:	Alley	Tape/Media #:	
Purpose:	Routine Assessment	Dia/Height:	12"
Use:	Sanitary	Material:	VCP
Drain Area:	NA	Lining:	
Category:	NA		
Comment:	P_C at 145 ft debris . Flow direction wrong		
Location Details:		Direction of Survey:	Downstream
US MH:	M-504-023	DS MH:	M-504-030
		Total Length Surveyed (ft):	146.8

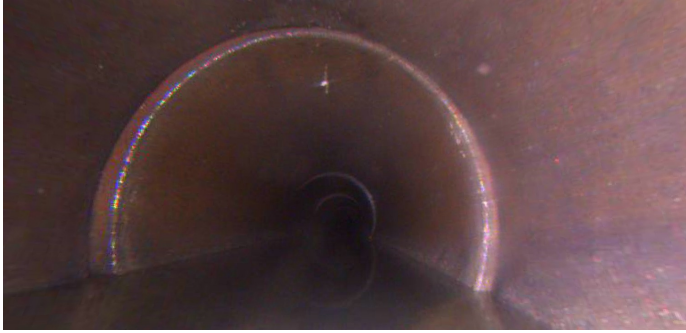
Code: **AMH**
Description: **Manhole**

Distance (ft): **.0**
Structural Grade: **0**
O&M Grade: **0**
Clock Start/From:
Clock To:
1st Value:
2nd Value:
Value Percent:
Continuous Index:
Within 8" of Joint: **NO**
Remarks: **M-504-023**

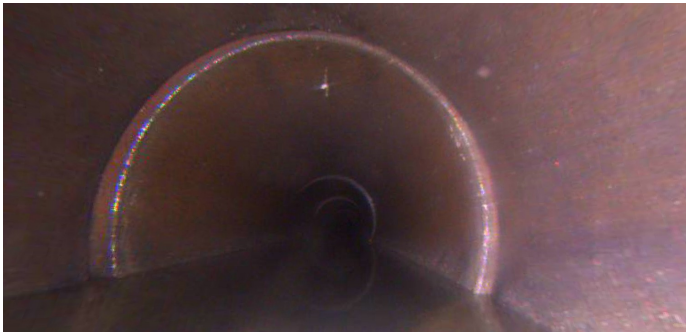
Code: **MWL**
Description: **Water Level**

Distance (ft): **.0**
Structural Grade: **0**
O&M Grade: **0**
Clock Start/From:
Clock To:
1st Value:
2nd Value:
Value Percent: **30.000**
Continuous Index:
Within 8" of Joint: **NO**
Remarks:

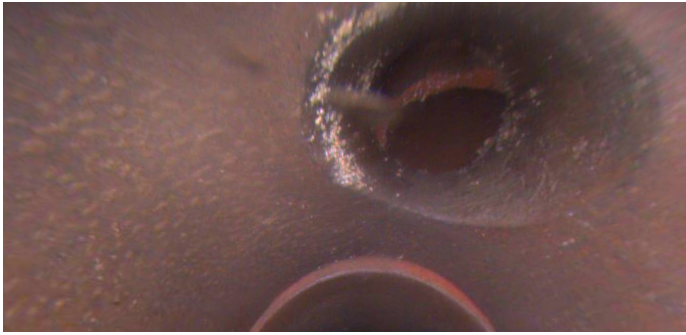
Code: **TF**
Description: **Tap Factory**

Distance (ft): **44.1**
Structural Grade: **0**
O&M Grade: **0**
Clock Start/From: **1**
Clock To:
1st Value: **4.000**
2nd Value:
Value Percent:
Continuous Index:
Within 8" of Joint:
Remarks:

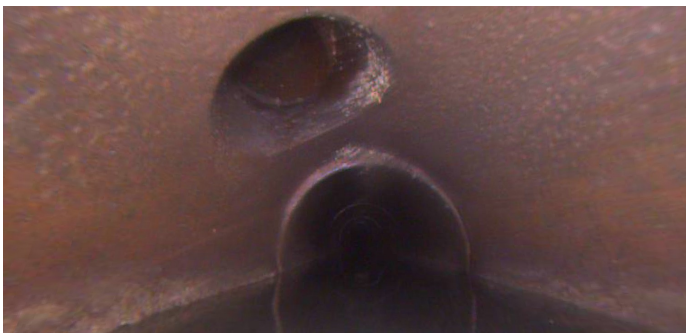
Code: **TF**
Description: **Tap Factory**

Distance (ft): **46.4**
Structural Grade: **0**
O&M Grade: **0**
Clock Start/From: **11**
Clock To:
1st Value: **4.000**
2nd Value:
Value Percent:
Continuous Index:
Within 8" of Joint:
Remarks:

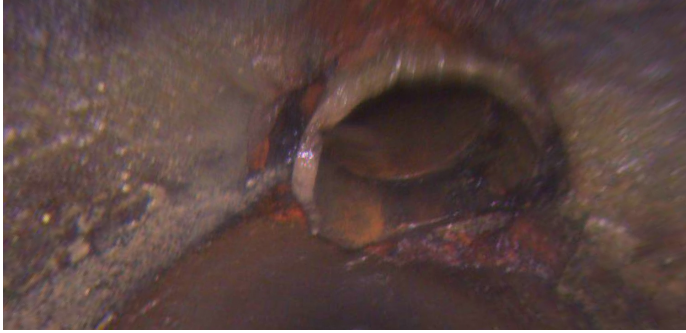
Code: **TBI**
Description: **Tap Break-in Intruding**

Distance (ft): **51.3**
Structural Grade: **0**
O&M Grade: **2**
Clock Start/From: **12**
Clock To:
1st Value: **4.000**
2nd Value: **1.000**
Value Percent:
Continuous Index:
Within 8" of Joint:
Remarks:

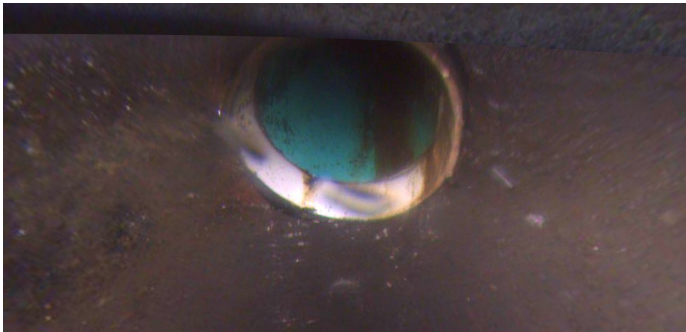
Code: **TBA**
Description: **Tap Break-in Active**

Distance (ft): **54.1**
Structural Grade: **0**
O&M Grade: **0**
Clock Start/From: **12**
Clock To:
1st Value: **4.000**
2nd Value:
Value Percent:
Continuous Index:
Within 8" of Joint:
Remarks:

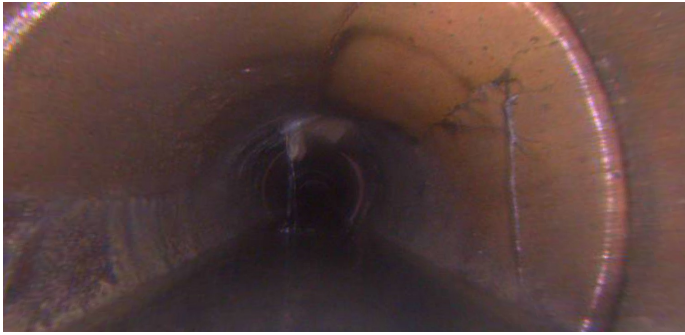
Code: **RFB**
Description: **Roots Fine Barrel**

Distance (ft): **73.4**
Structural Grade: **0**
O&M Grade: **2**
Clock Start/From: **2**
Clock To:
1st Value:
2nd Value:
Value Percent:
Continuous Index:
Within 8" of Joint: **NO**
Remarks:

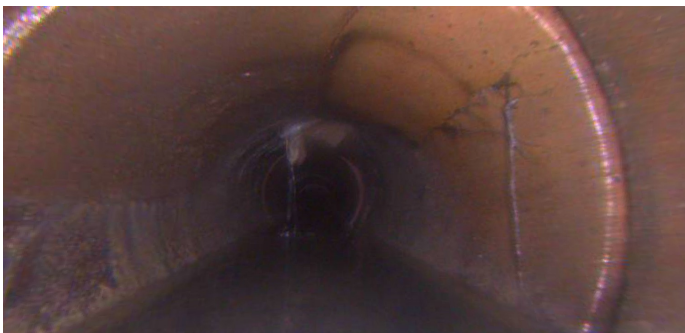
Code: **FM**
Description: **Fracture Multiple**

Distance (ft): **73.4**
Structural Grade: **4**
O&M Grade: **0**
Clock Start/From: **8**
Clock To: **4**
1st Value:
2nd Value:
Value Percent:
Continuous Index:
Within 8" of Joint: **YES**
Remarks:

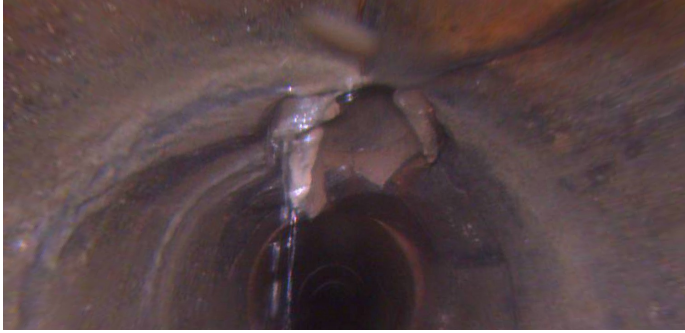
Code: **FM**
Description: **Fracture Multiple**

Distance (ft): **74.5**
Structural Grade: **4**
O&M Grade: **0**
Clock Start/From: **8**
Clock To: **4**
1st Value:
2nd Value:
Value Percent:
Continuous Index:
Within 8" of Joint:
Remarks:

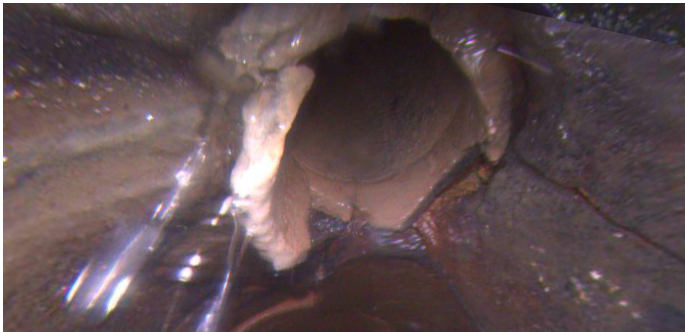
Code: **TBI**
Description: **Tap Break-in Intruding**

Distance (ft): **75.1**
Structural Grade: **0**
O&M Grade: **2**
Clock Start/From: **12**
Clock To:
1st Value: **4.000**
2nd Value: **1.000**
Value Percent:
Continuous Index:
Within 8" of Joint:
Remarks:

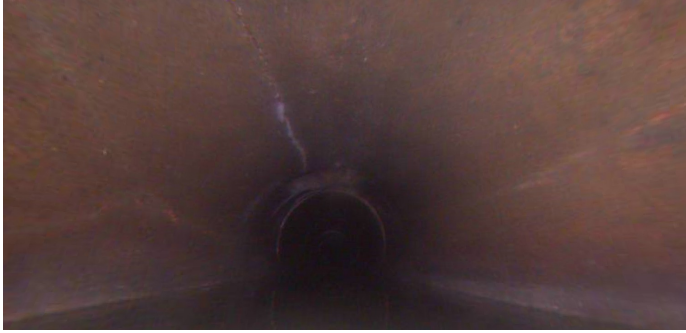
Code: **FM**
Description: **Fracture Multiple**

Distance (ft): **83.9**
Structural Grade: **4**
O&M Grade: **0**
Clock Start/From: **8**
Clock To: **4**
1st Value:
2nd Value:
Value Percent:
Continuous Index:
Within 8" of Joint: **YES**
Remarks:

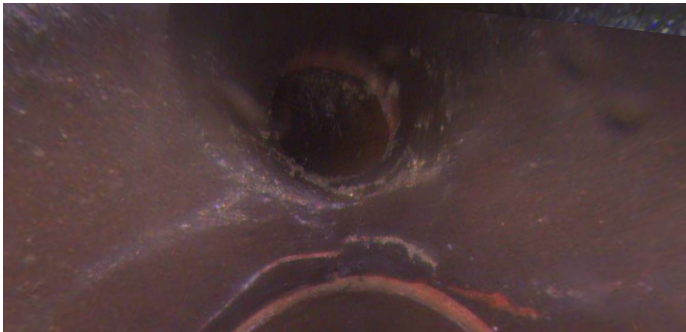
Code: **TFD**
Description: **Tap Factory Defective**

Distance (ft): **85.8**
Structural Grade: **0**
O&M Grade: **2**
Clock Start/From: **12**
Clock To:
1st Value: **4.000**
2nd Value:
Value Percent:
Continuous Index:
Within 8" of Joint:
Remarks: **fractured**

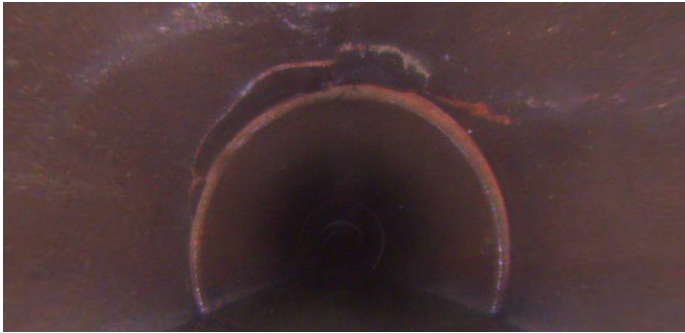
Code: **FM**
Description: **Fracture Multiple**

Distance (ft): **85.8**
Structural Grade: **4**
O&M Grade: **0**
Clock Start/From: **8**
Clock To: **4**
1st Value:
2nd Value:
Value Percent:
Continuous Index:
Within 8" of Joint: **YES**
Remarks:

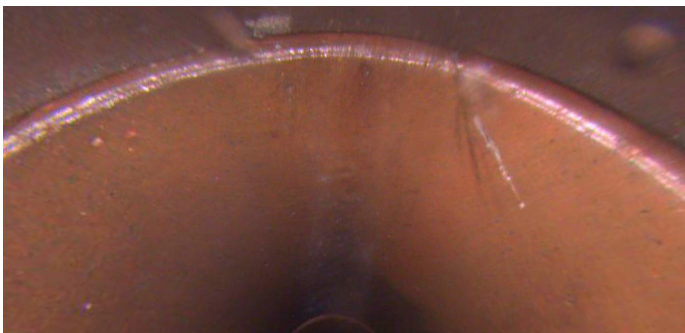
Code: **RFJ**
Description: **Roots Fine Joint**

Distance (ft): **94.3**
Structural Grade: **0**
O&M Grade: **1**
Clock Start/From: **1**
Clock To:
1st Value:
2nd Value:
Value Percent:
Continuous Index:
Within 8" of Joint: **YES**
Remarks:

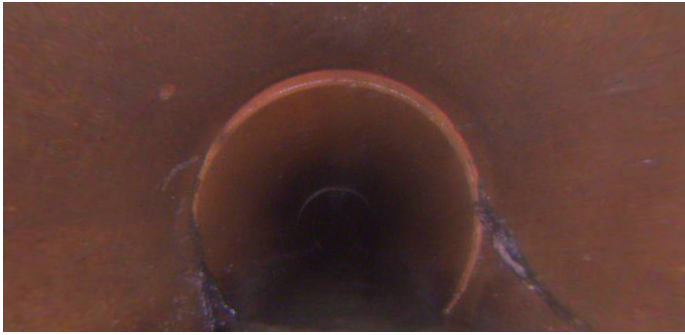
Code: **RFJ**
Description: **Roots Fine Joint**

Distance (ft): **96.2**
Structural Grade: **0**
O&M Grade: **1**
Clock Start/From: **8**
Clock To: **4**
1st Value:
2nd Value:
Value Percent:
Continuous Index:
Within 8" of Joint: **YES**
Remarks:

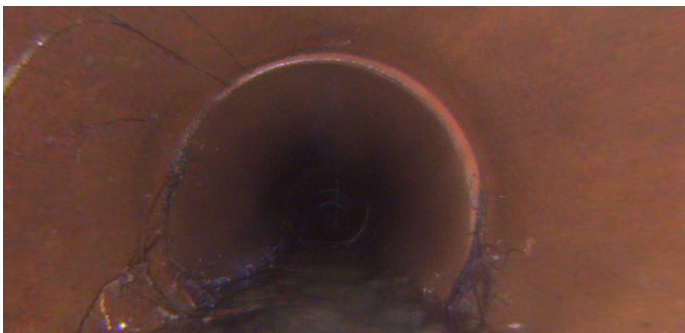
Code: **RFJ**
Description: **Roots Fine Joint**

Distance (ft): **104.0**
Structural Grade: **0**
O&M Grade: **1**
Clock Start/From: **8**
Clock To: **4**
1st Value:
2nd Value:
Value Percent:
Continuous Index:
Within 8" of Joint: **YES**
Remarks:

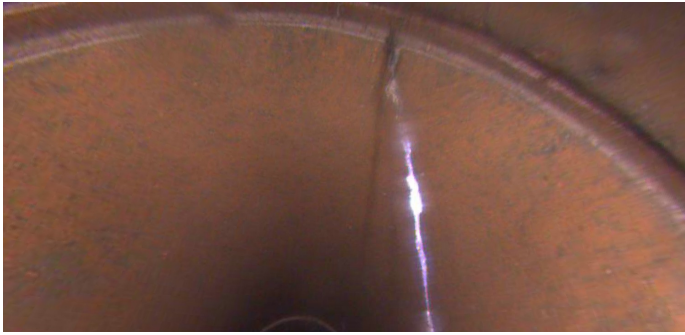
Code: **RFJ**
Description: **Roots Fine Joint**

Distance (ft): **107.3**
Structural Grade: **0**
O&M Grade: **1**
Clock Start/From: **8**
Clock To: **4**
1st Value:
2nd Value:
Value Percent:
Continuous Index: **S01**
Within 8" of Joint: **YES**
Remarks:

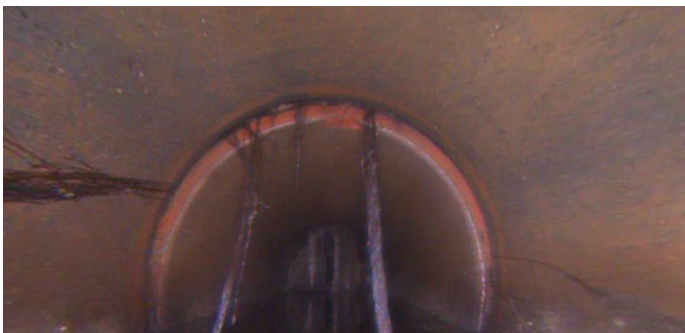
Code: **RMJ**
Description: **Roots Medium Joint**

Distance (ft): **114.5**
Structural Grade: **0**
O&M Grade: **3**
Clock Start/From: **8**
Clock To: **4**
1st Value:
2nd Value:
Value Percent: **5.000**
Continuous Index:
Within 8" of Joint: **YES**
Remarks:

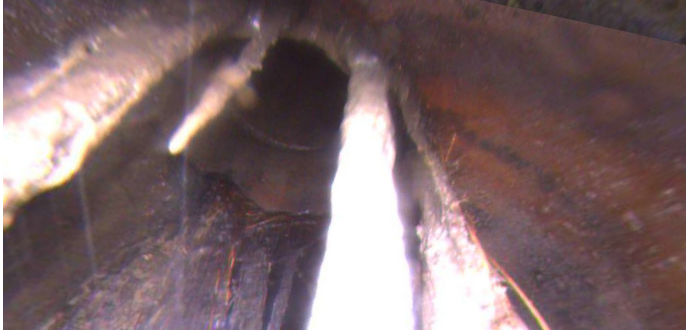
Code: **TBD**
Description: **Tap Break-in Defective**

Distance (ft): **117.1**
Structural Grade: **0**
O&M Grade: **3**
Clock Start/From: **12**
Clock To:
1st Value: **4.000**
2nd Value:
Value Percent:
Continuous Index:
Within 8" of Joint:
Remarks: **ROOTS**

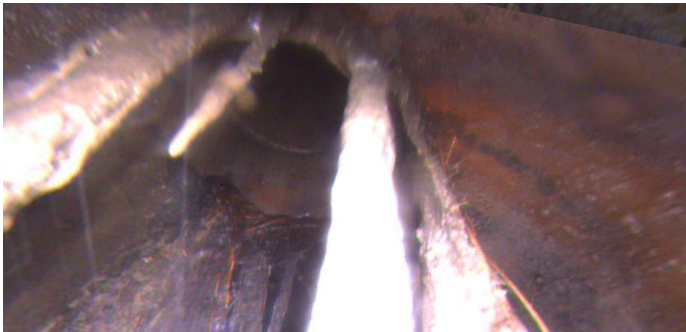
Code: **RMC**
Description: **Roots Medium Connection**

Distance (ft): **117.1**
Structural Grade: **0**
O&M Grade: **3**
Clock Start/From: **11**
Clock To: **1**
1st Value:
2nd Value:
Value Percent: **20.000**
Continuous Index:
Within 8" of Joint: **NO**
Remarks:

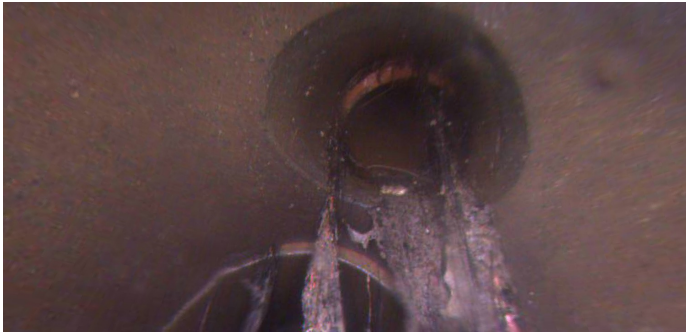
Code: **TFD**
Description: **Tap Factory Defective**

Distance (ft): **119.3**
Structural Grade: **0**
O&M Grade: **2**
Clock Start/From: **1**
Clock To:
1st Value: **4.000**
2nd Value:
Value Percent:
Continuous Index:
Within 8" of Joint:
Remarks: **ROOTS**

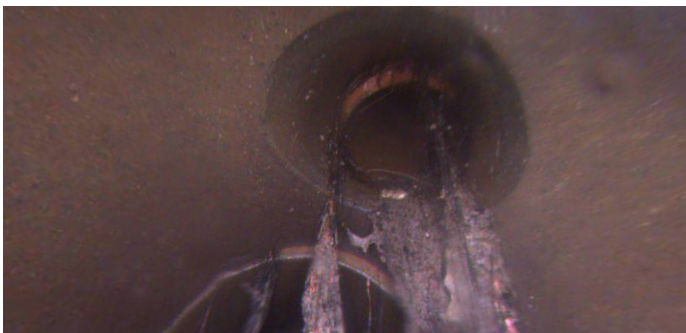
Code: **RML**
Description: **Roots Medium Lateral**

Distance (ft): **119.3**
Structural Grade: **0**
O&M Grade: **3**
Clock Start/From: **12**
Clock To: **1**
1st Value:
2nd Value:
Value Percent: **10.000**
Continuous Index:
Within 8" of Joint: **NO**
Remarks:

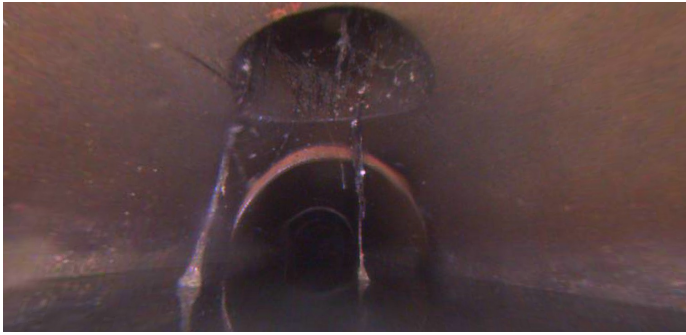
Code: **TFD**
Description: **Tap Factory Defective**

Distance (ft): **121.6**
Structural Grade: **0**
O&M Grade: **2**
Clock Start/From: **12**
Clock To:
1st Value: **4.000**
2nd Value:
Value Percent:
Continuous Index:
Within 8" of Joint:
Remarks: **ROOTS**

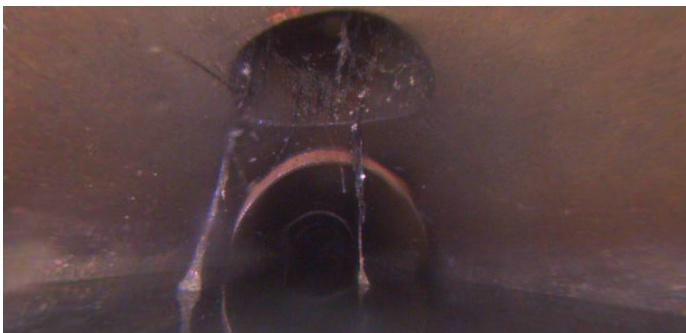
Code: **RFL**
Description: **Roots Fine Lateral**

Distance (ft): **121.6**
Structural Grade: **0**
O&M Grade: **1**
Clock Start/From: **12**
Clock To:
1st Value:
2nd Value:
Value Percent:
Continuous Index:
Within 8" of Joint: **NO**
Remarks:

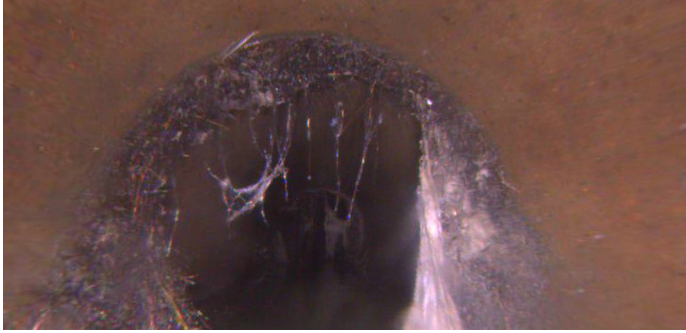
Code: **RMJ**
Description: **Roots Medium Joint**

Distance (ft): **135.3**
Structural Grade: **0**
O&M Grade: **3**
Clock Start/From: **8**
Clock To: **4**
1st Value:
2nd Value:
Value Percent: **20.000**
Continuous Index:
Within 8" of Joint: **YES**
Remarks:

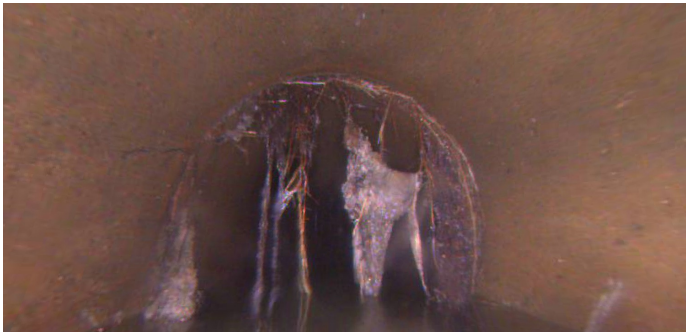
Code: **RMJ**
Description: **Roots Medium Joint**

Distance (ft): **137.7**
Structural Grade: **0**
O&M Grade: **3**
Clock Start/From: **8**
Clock To: **4**
1st Value:
2nd Value:
Value Percent: **20.000**
Continuous Index: **S02**
Within 8" of Joint: **YES**
Remarks:

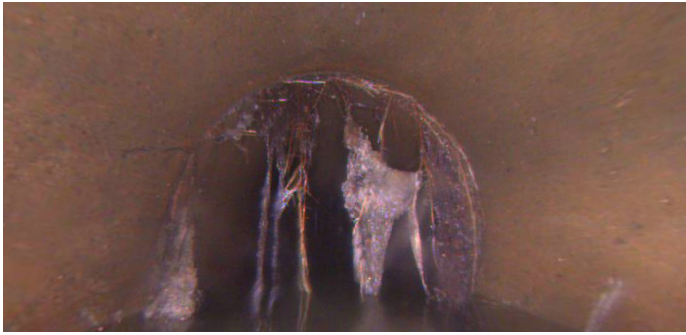
Code: **RFJ**
Description: **Roots Fine Joint**

Distance (ft): **137.7**
Structural Grade: **0**
O&M Grade: **1**
Clock Start/From: **8**
Clock To: **4**
1st Value:
2nd Value:
Value Percent:
Continuous Index: **F01**
Within 8" of Joint: **YES**
Remarks:

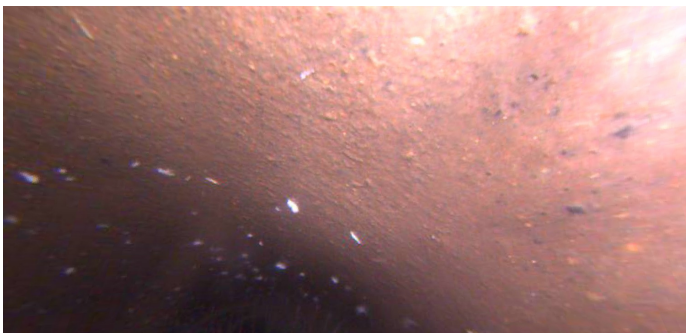
Code: **RMJ**
Description: **Roots Medium Joint**

Distance (ft): **146.8**
Structural Grade: **0**
O&M Grade: **3**
Clock Start/From: **8**
Clock To: **4**
1st Value:
2nd Value:
Value Percent: **20.000**
Continuous Index: **F02**
Within 8" of Joint: **YES**
Remarks:

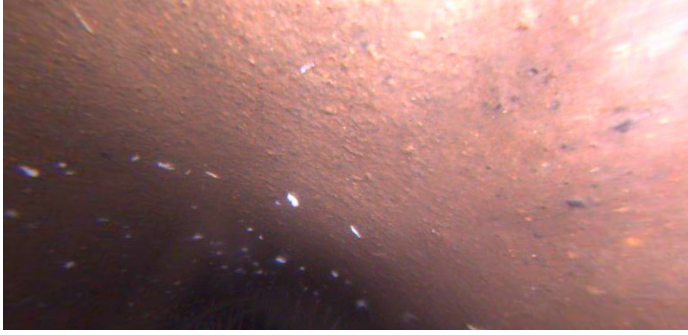
Code:	MSA
Description:	Abandoned Survey
Distance (ft):	146.8
Structural Grade:	0
O&M Grade:	0
Clock Start/From:	
Clock To:	
1st Value:	
2nd Value:	
Value Percent:	
Continuous Index:	
Within 8" of Joint:	NO
Remarks:	ROOTS
