Profile/Photo Observation Report

Date:	04/25/2018	Weather:		Coding:	PACP 6.0
Pipe Length (ft):	174.3	Owner:	NA	Pre Clean:	No Pre-Cleaning
P.O.#:		Surveyor:	Jen Costello	PSR:	P-504-030-023
Customer:		Clean Date:	01/01/1900	Shape:	C

Street:	FOXCROFT STREET	Flow Control:	Not Controlled
City:	Hobart, IN	Year Renewed:	
Location:	Alley	Tape/Media #:	
Purpose:	Routine Assessment	Dia/Height:	12"
Use:	Sanitary	Material:	VCP
Drain Area:	NA	Lining:	
Category:	NA		
Comment:	P_C at 145 ft debris . Flow direction wrong		
Location Details:		Direction of Survey:	Downstream
US MH:	M-504-023	DS MH:	M-504-030
		Total Length Surveyed (ft):	146.8

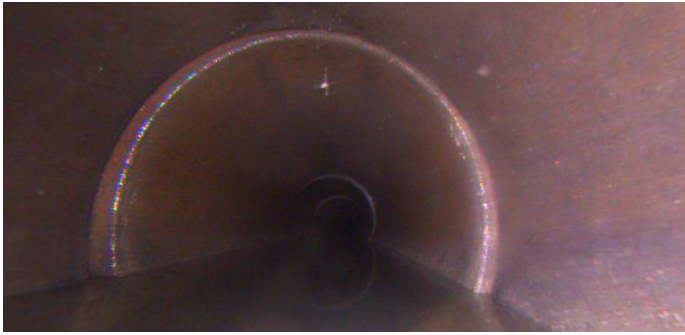
Code: **AMH**
Description: **Manhole**

Distance (ft): **.0**
Structural Grade: **0**
O&M Grade: **0**
Clock Start/From:
Clock To:
1st Value:
2nd Value:
Value Percent:
Continuous Index:
Within 8" of Joint: **NO**
Remarks: **M-504-023**

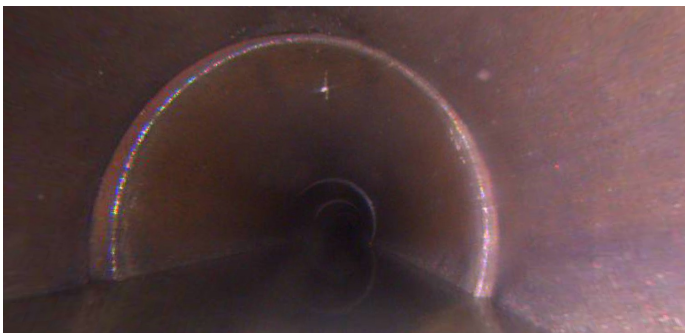
Code: **MWL**
Description: **Water Level**

Distance (ft): **.0**
Structural Grade: **0**
O&M Grade: **0**
Clock Start/From:
Clock To:
1st Value:
2nd Value:
Value Percent: **30.000**
Continuous Index:
Within 8" of Joint: **NO**
Remarks:

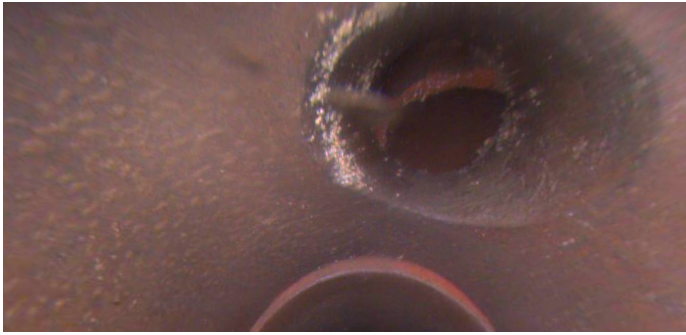
Code: **TF**
Description: **Tap Factory**

Distance (ft): **44.1**
Structural Grade: **0**
O&M Grade: **0**
Clock Start/From: **1**
Clock To:
1st Value: **4.000**
2nd Value:
Value Percent:
Continuous Index:
Within 8" of Joint:
Remarks:

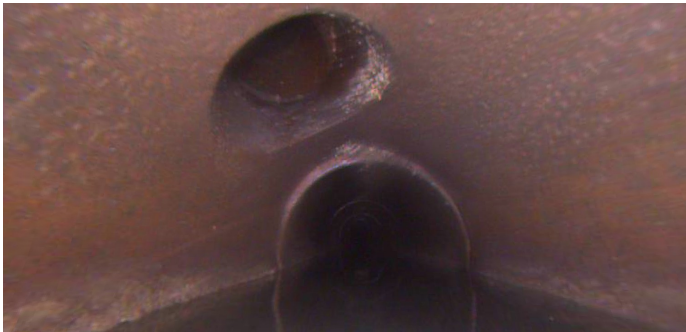
Code: **TF**
Description: **Tap Factory**

Distance (ft): **46.4**
Structural Grade: **0**
O&M Grade: **0**
Clock Start/From: **11**
Clock To:
1st Value: **4.000**
2nd Value:
Value Percent:
Continuous Index:
Within 8" of Joint:
Remarks:

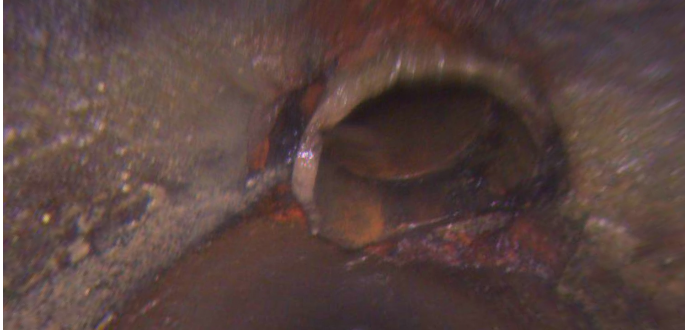
Code: **TBI**
Description: **Tap Break-in Intruding**

Distance (ft): **51.3**
Structural Grade: **0**
O&M Grade: **2**
Clock Start/From: **12**
Clock To:
1st Value: **4.000**
2nd Value: **1.000**
Value Percent:
Continuous Index:
Within 8" of Joint:
Remarks:

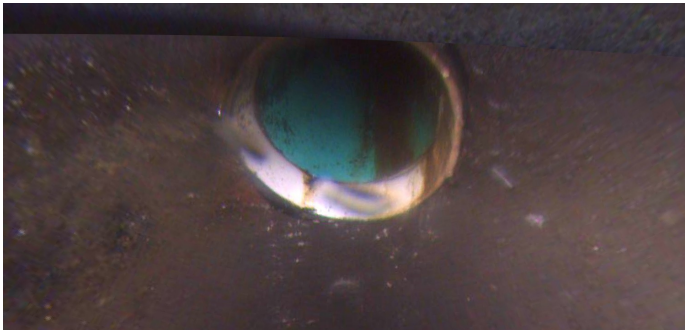
Code: **TBA**
Description: **Tap Break-in Active**

Distance (ft): **54.1**
Structural Grade: **0**
O&M Grade: **0**
Clock Start/From: **12**
Clock To:
1st Value: **4.000**
2nd Value:
Value Percent:
Continuous Index:
Within 8" of Joint:
Remarks:

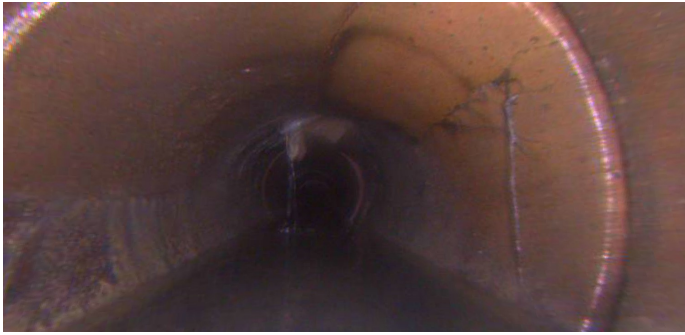
Code: **RFB**
Description: **Roots Fine Barrel**

Distance (ft): **73.4**
Structural Grade: **0**
O&M Grade: **2**
Clock Start/From: **2**
Clock To:
1st Value:
2nd Value:
Value Percent:
Continuous Index:
Within 8" of Joint: **NO**
Remarks:

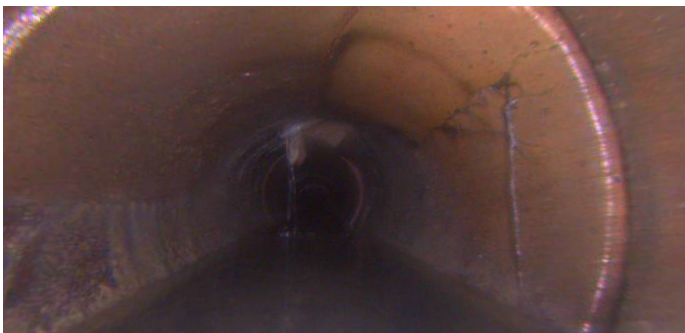
Code: **FM**
Description: **Fracture Multiple**

Distance (ft): **73.4**
Structural Grade: **4**
O&M Grade: **0**
Clock Start/From: **8**
Clock To: **4**
1st Value:
2nd Value:
Value Percent:
Continuous Index:
Within 8" of Joint: **YES**
Remarks:

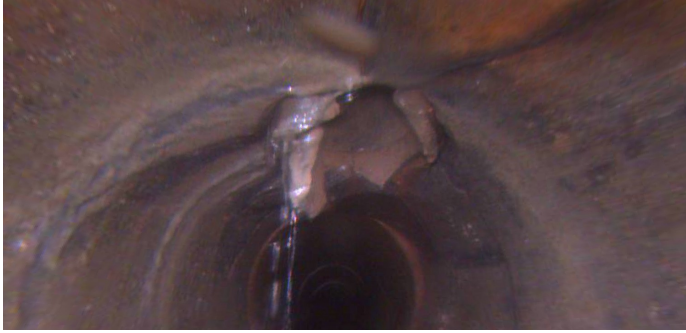
Code: **FM**
Description: **Fracture Multiple**

Distance (ft): **74.5**
Structural Grade: **4**
O&M Grade: **0**
Clock Start/From: **8**
Clock To: **4**
1st Value:
2nd Value:
Value Percent:
Continuous Index:
Within 8" of Joint:
Remarks:

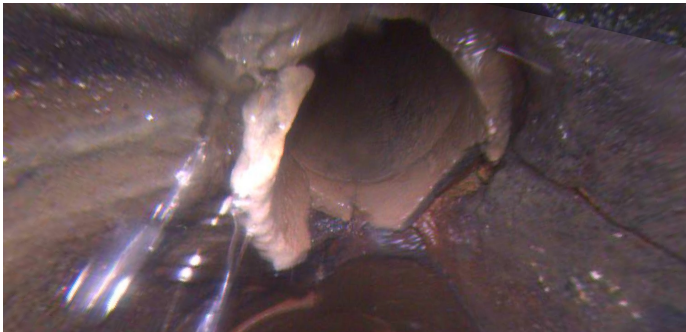
Code: **TBI**
Description: **Tap Break-in Intruding**

Distance (ft): **75.1**
Structural Grade: **0**
O&M Grade: **2**
Clock Start/From: **12**
Clock To:
1st Value: **4.000**
2nd Value: **1.000**
Value Percent:
Continuous Index:
Within 8" of Joint:
Remarks:

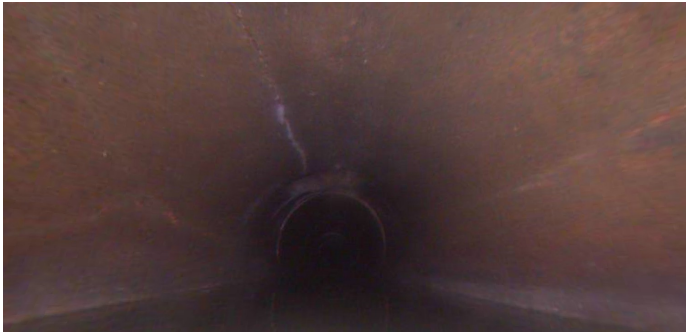
Code: **FM**
Description: **Fracture Multiple**

Distance (ft): **83.9**
Structural Grade: **4**
O&M Grade: **0**
Clock Start/From: **8**
Clock To: **4**
1st Value:
2nd Value:
Value Percent:
Continuous Index:
Within 8" of Joint: **YES**
Remarks:

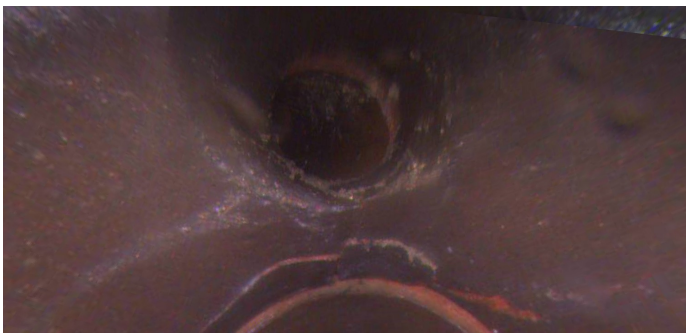
Code: **TFD**
Description: **Tap Factory Defective**

Distance (ft): **85.8**
Structural Grade: **0**
O&M Grade: **2**
Clock Start/From: **12**
Clock To:
1st Value: **4.000**
2nd Value:
Value Percent:
Continuous Index:
Within 8" of Joint:
Remarks: **fractured**

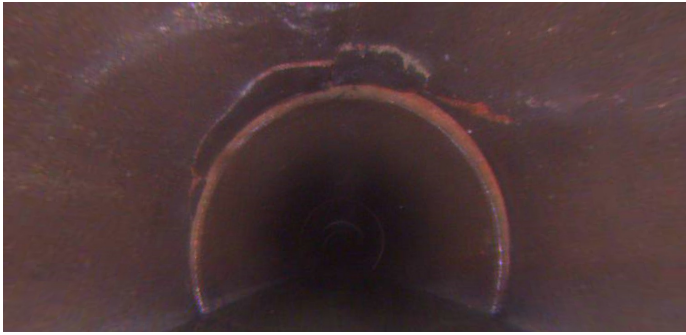
Code: **FM**
Description: **Fracture Multiple**

Distance (ft): **85.8**
Structural Grade: **4**
O&M Grade: **0**
Clock Start/From: **8**
Clock To: **4**
1st Value:
2nd Value:
Value Percent:
Continuous Index:
Within 8" of Joint: **YES**
Remarks:

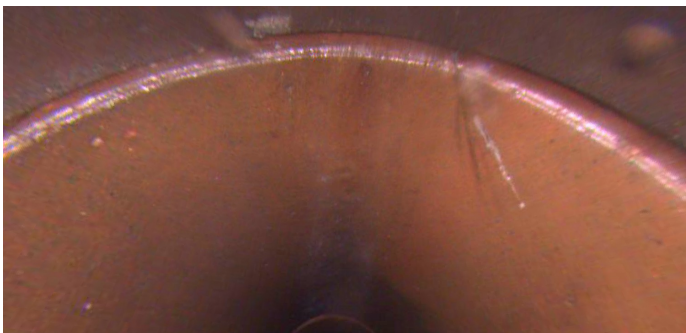
Code: **RFJ**
Description: **Roots Fine Joint**

Distance (ft): **94.3**
Structural Grade: **0**
O&M Grade: **1**
Clock Start/From: **1**
Clock To:
1st Value:
2nd Value:
Value Percent:
Continuous Index:
Within 8" of Joint: **YES**
Remarks:

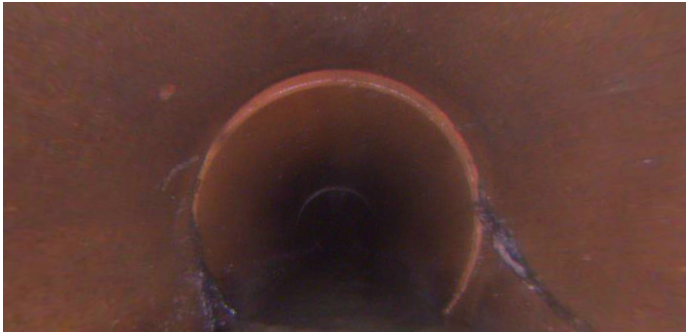
Code: **RFJ**
Description: **Roots Fine Joint**

Distance (ft): **96.2**
Structural Grade: **0**
O&M Grade: **1**
Clock Start/From: **8**
Clock To: **4**
1st Value:
2nd Value:
Value Percent:
Continuous Index:
Within 8" of Joint: **YES**
Remarks:

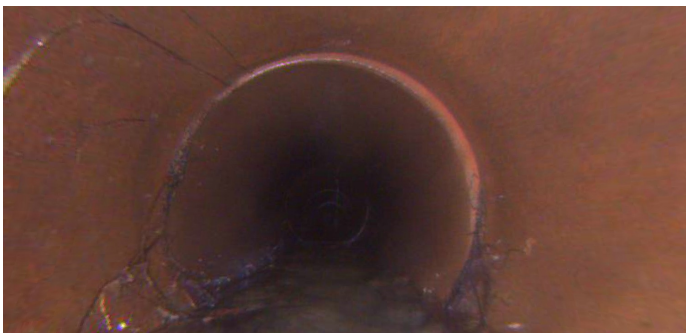
Code: **RFJ**
Description: **Roots Fine Joint**

Distance (ft): **104.0**
Structural Grade: **0**
O&M Grade: **1**
Clock Start/From: **8**
Clock To: **4**
1st Value:
2nd Value:
Value Percent:
Continuous Index:
Within 8" of Joint: **YES**
Remarks:

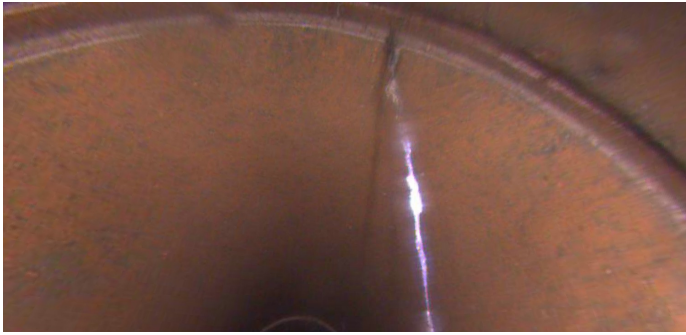
Code: **RFJ**
Description: **Roots Fine Joint**

Distance (ft): **107.3**
Structural Grade: **0**
O&M Grade: **1**
Clock Start/From: **8**
Clock To: **4**
1st Value:
2nd Value:
Value Percent:
Continuous Index: **S01**
Within 8" of Joint: **YES**
Remarks:

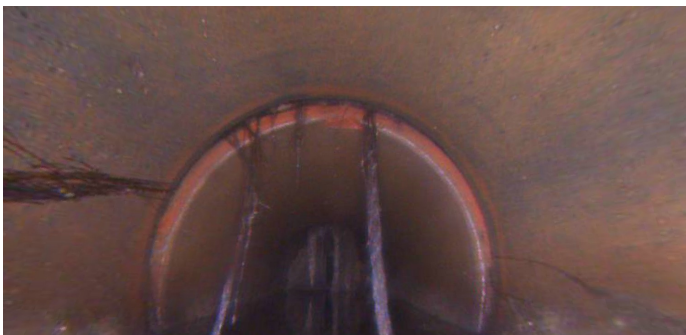
Code: **RMJ**
Description: **Roots Medium Joint**

Distance (ft): **114.5**
Structural Grade: **0**
O&M Grade: **3**
Clock Start/From: **8**
Clock To: **4**
1st Value:
2nd Value:
Value Percent: **5.000**
Continuous Index:
Within 8" of Joint: **YES**
Remarks:

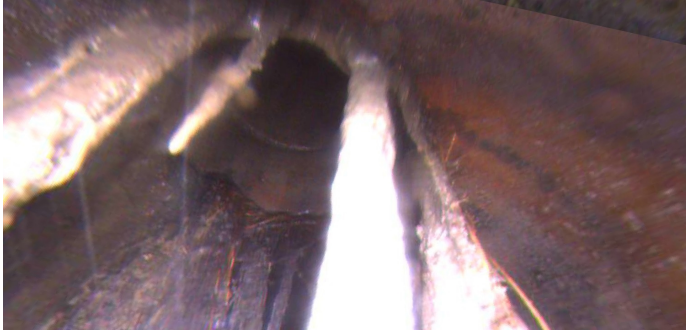
Code: **TBD**
Description: **Tap Break-in Defective**

Distance (ft): **117.1**
Structural Grade: **0**
O&M Grade: **3**
Clock Start/From: **12**
Clock To:
1st Value: **4.000**
2nd Value:
Value Percent:
Continuous Index:
Within 8" of Joint:
Remarks: **ROOTS**

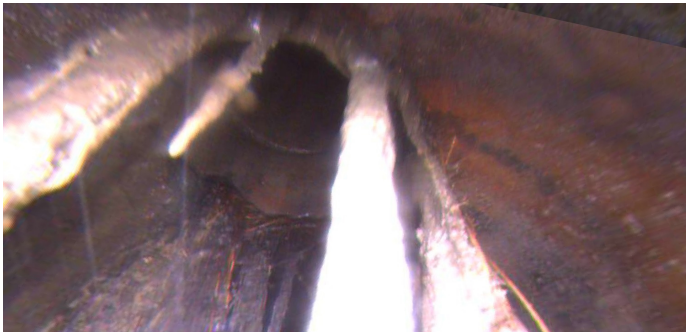
Code: **RMC**
Description: **Roots Medium Connection**

Distance (ft): **117.1**
Structural Grade: **0**
O&M Grade: **3**
Clock Start/From: **11**
Clock To: **1**
1st Value:
2nd Value:
Value Percent: **20.000**
Continuous Index:
Within 8" of Joint: **NO**
Remarks:

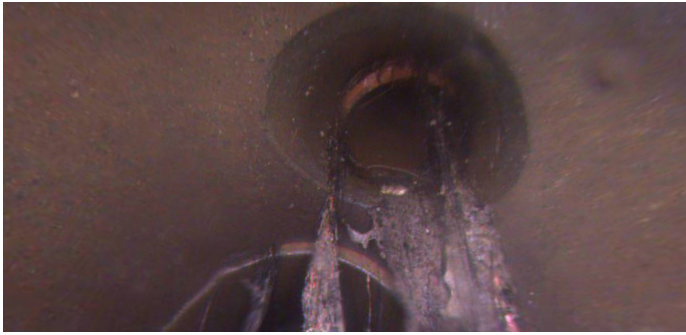
Code: **TFD**
Description: **Tap Factory Defective**

Distance (ft): **119.3**
Structural Grade: **0**
O&M Grade: **2**
Clock Start/From: **1**
Clock To:
1st Value: **4.000**
2nd Value:
Value Percent:
Continuous Index:
Within 8" of Joint:
Remarks: **ROOTS**

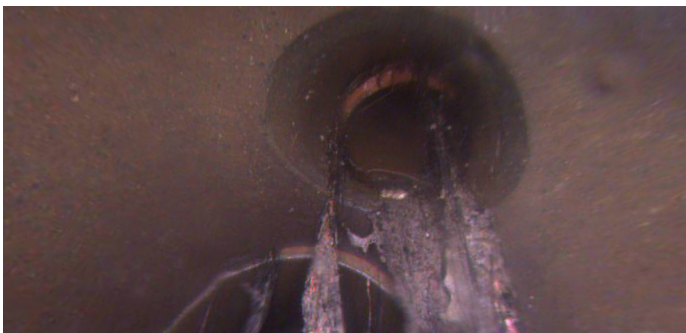
Code: **RML**
Description: **Roots Medium Lateral**

Distance (ft): **119.3**
Structural Grade: **0**
O&M Grade: **3**
Clock Start/From: **12**
Clock To: **1**
1st Value:
2nd Value:
Value Percent: **10.000**
Continuous Index:
Within 8" of Joint: **NO**
Remarks:

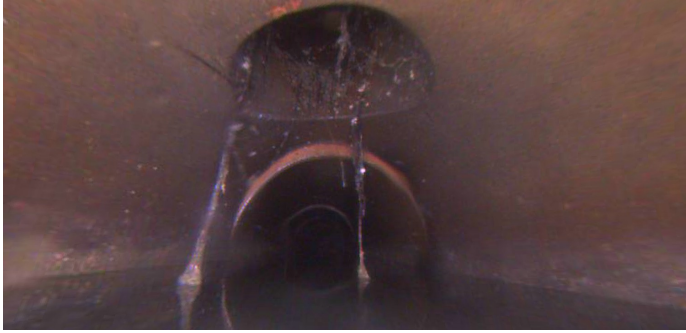
Code: **TFD**
Description: **Tap Factory Defective**

Distance (ft): **121.6**
Structural Grade: **0**
O&M Grade: **2**
Clock Start/From: **12**
Clock To:
1st Value: **4.000**
2nd Value:
Value Percent:
Continuous Index:
Within 8" of Joint:
Remarks: **ROOTS**

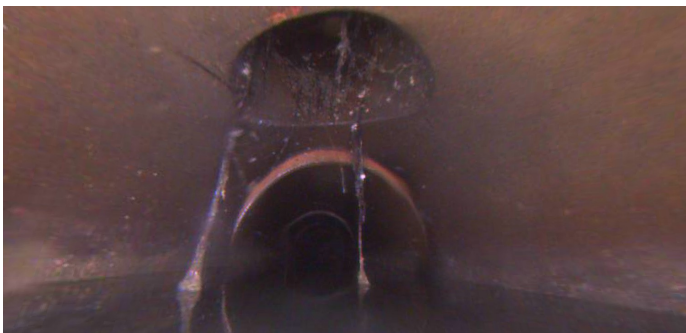
Code: **RFL**
Description: **Roots Fine Lateral**

Distance (ft): **121.6**
Structural Grade: **0**
O&M Grade: **1**
Clock Start/From: **12**
Clock To:
1st Value:
2nd Value:
Value Percent:
Continuous Index:
Within 8" of Joint: **NO**
Remarks:

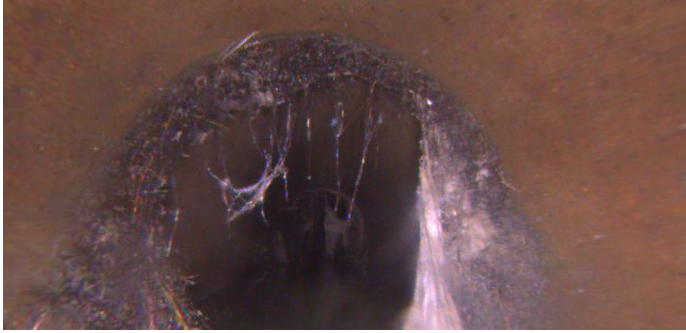
Code: **RMJ**
Description: **Roots Medium Joint**

Distance (ft): **135.3**
Structural Grade: **0**
O&M Grade: **3**
Clock Start/From: **8**
Clock To: **4**
1st Value:
2nd Value:
Value Percent: **20.000**
Continuous Index:
Within 8" of Joint: **YES**
Remarks:

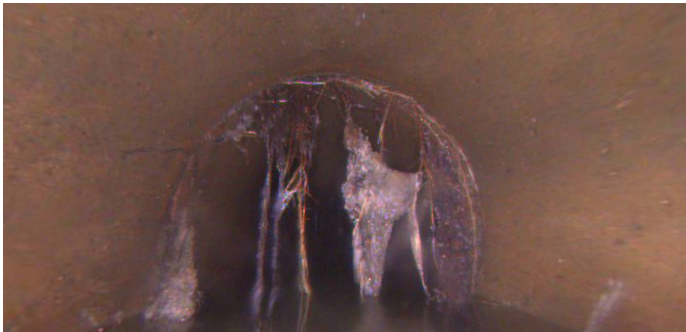
Code: **RMJ**
Description: **Roots Medium Joint**

Distance (ft): **137.7**
Structural Grade: **0**
O&M Grade: **3**
Clock Start/From: **8**
Clock To: **4**
1st Value:
2nd Value:
Value Percent: **20.000**
Continuous Index: **S02**
Within 8" of Joint: **YES**
Remarks:

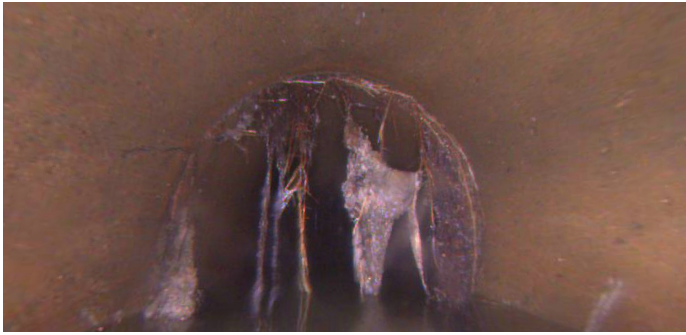
Code: **RFJ**
Description: **Roots Fine Joint**

Distance (ft): **137.7**
Structural Grade: **0**
O&M Grade: **1**
Clock Start/From: **8**
Clock To: **4**
1st Value:
2nd Value:
Value Percent:
Continuous Index: **F01**
Within 8" of Joint: **YES**
Remarks:

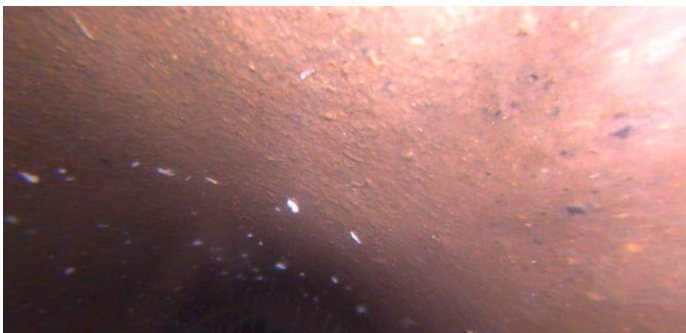
Code: **RMJ**
Description: **Roots Medium Joint**

Distance (ft): **146.8**
Structural Grade: **0**
O&M Grade: **3**
Clock Start/From: **8**
Clock To: **4**
1st Value:
2nd Value:
Value Percent: **20.000**
Continuous Index: **F02**
Within 8" of Joint: **YES**
Remarks:

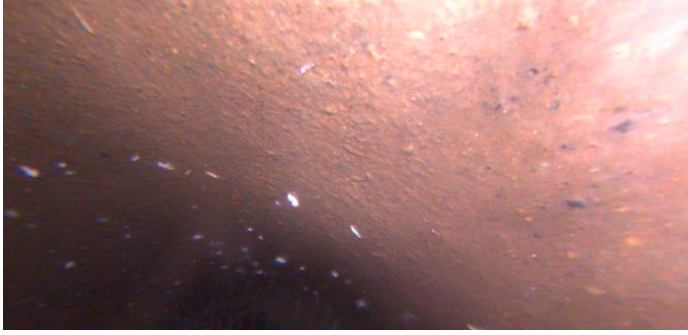
Code:	MSA
Description:	Abandoned Survey
Distance (ft):	146.8
Structural Grade:	0
O&M Grade:	0
Clock Start/From:	
Clock To:	
1st Value:	
2nd Value:	
Value Percent:	
Continuous Index:	
Within 8" of Joint:	NO
Remarks:	ROOTS
