Profile/Photo Observation Report

| Pipe Length (ft): | 171.7 | Owner: | City of Hobart | Pre Clean: | Heavy Cleaning |

| Street: | North Colorado Street | Flow Control: | Not Controlled |

| US MH: | M-504-023 | DS MH: | M-504-030 |

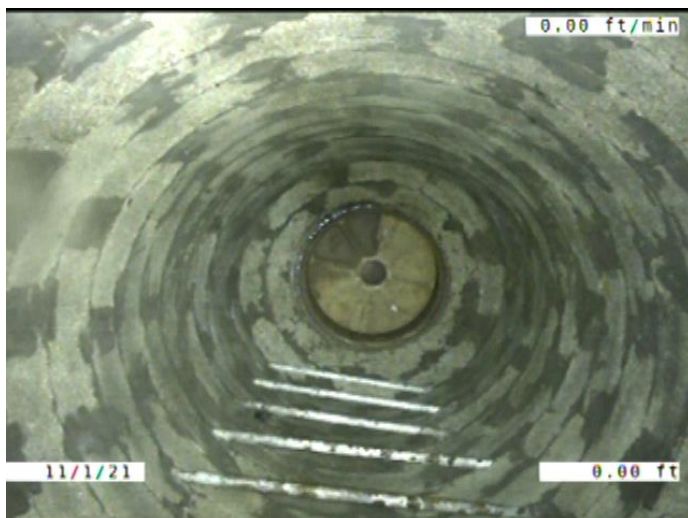
Code: **AMH**
 Description: **Manhole**

Distance (ft): **.0**
 Structural Grade: **0**
 O&M Grade: **0**
 Clock Start/From:
 Clock To:
 1st Value:
 2nd Value:
 Value Percent:
 Continuous Index:
 Within 8" of Joint: **NO**
 Remarks: **M-504-023**

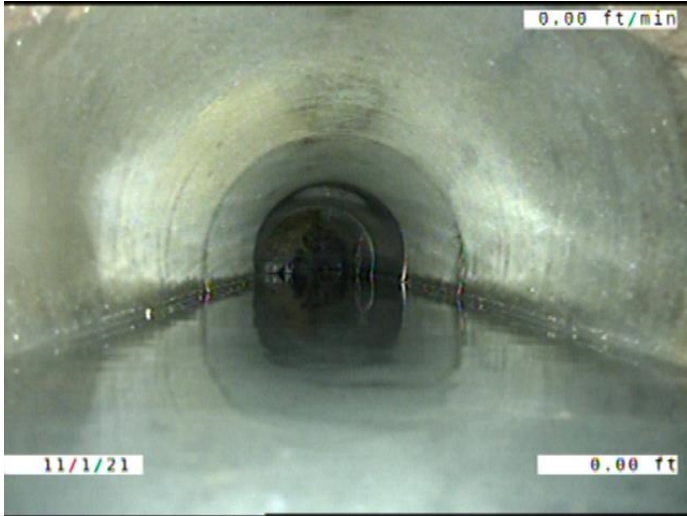
Code: **MWL**
Description: **Miscellaneous Water Level**

Distance (ft): **.0**
Structural Grade: **0**
O&M Grade: **0**
Clock Start/From:
Clock To:
1st Value:
2nd Value:
Value Percent: **10.000**
Continuous Index:
Within 8" of Joint: **NO**
Remarks:

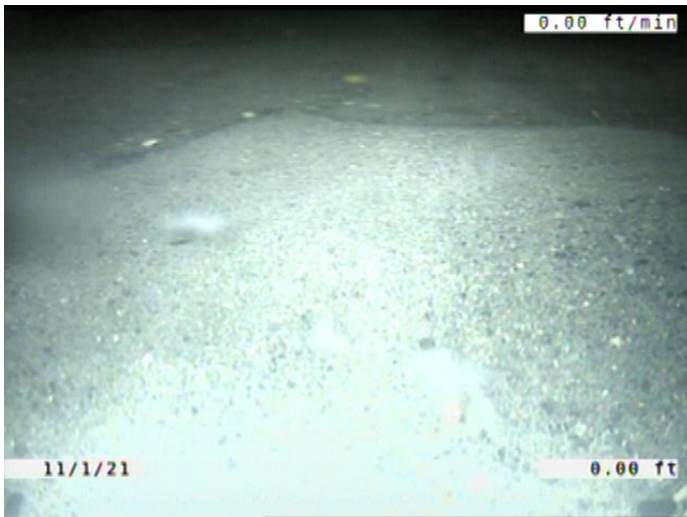
| | Position | Code | Observation | Video (sec) | Grade |
|--|---|---|---|---|---|
| | .0 | DSF(S01) | Deposits Settled Fine | 81 | M 2 |

Code: **DSF**
Description: **Deposits Settled Fine**

Distance (ft): **.0**
Structural Grade: **0**
O&M Grade: **2**
Clock Start/From: **5**
Clock To: **7**
1st Value:
2nd Value:
Value Percent: **5.000**
Continuous Index: **S01**
Within 8" of Joint: **YES**
Remarks:

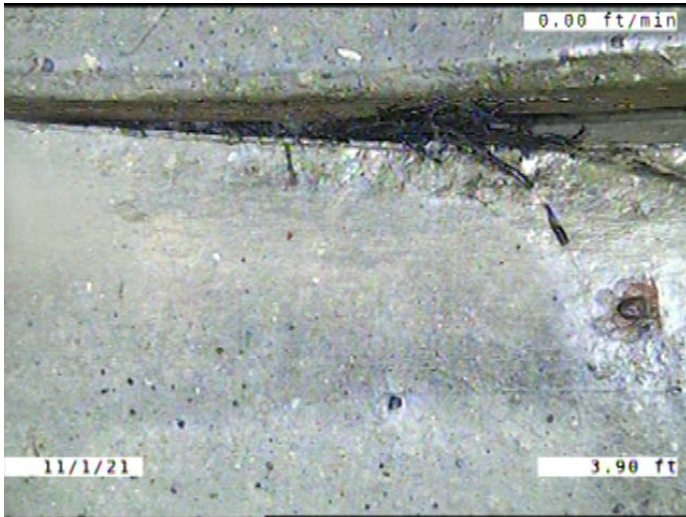
| | Position | Code | Observation | Video (sec) | Grade |
|--|---|---|---|---|---|
| | 3.9 | RFJ | Roots Fine Joint | 138 | M 1 |

Code: **RFJ**
Description: **Roots Fine Joint**

Distance (ft): **3.9**
Structural Grade: **0**
O&M Grade: **1**
Clock Start/From: **11**
Clock To: **2**
1st Value:
2nd Value:
Value Percent:
Continuous Index:
Within 8" of Joint: **YES**
Remarks:

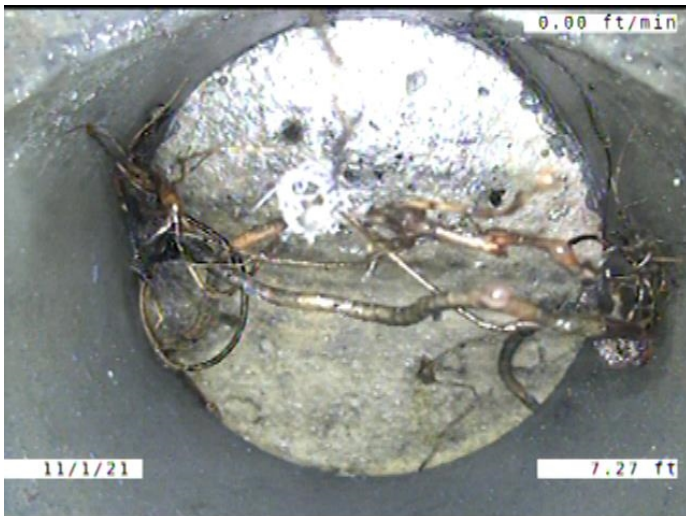
Code: **TFC**
Description: **Tap Factory Capped**

Distance (ft): **7.3**
Structural Grade: **0**
O&M Grade: **0**
Clock Start/From: **12**
Clock To:
1st Value: **4.000**
2nd Value:
Value Percent:
Continuous Index:
Within 8" of Joint: **YES**
Remarks: **ROOTS GROWING AROUND THE CAP**

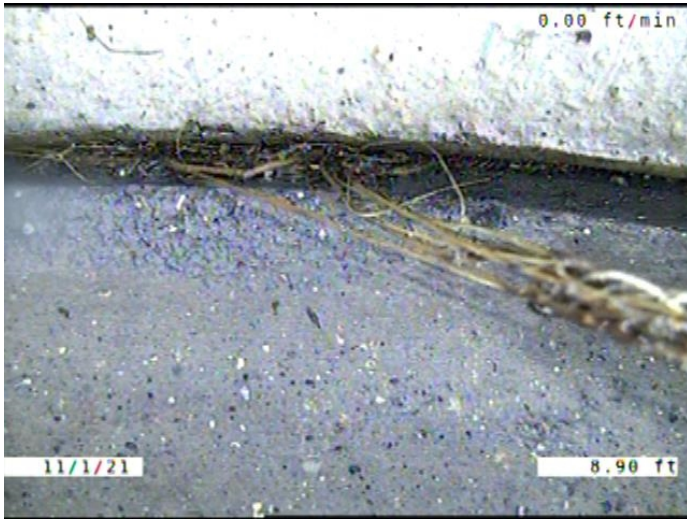
| | Position | Code | Observation | Video (sec) | Grade |
|--|---|---|---|---|---|
| | 8.9 | RFJ | Roots Fine Joint | 238 | M 1 |

Code: **RFJ**
 Description: **Roots Fine Joint**

Distance (ft): **8.9**
 Structural Grade: **0**
 O&M Grade: **1**
 Clock Start/From: **10**
 Clock To: **2**
 1st Value:
 2nd Value:
 Value Percent:
 Continuous Index:
 Within 8" of Joint: **YES**
 Remarks:

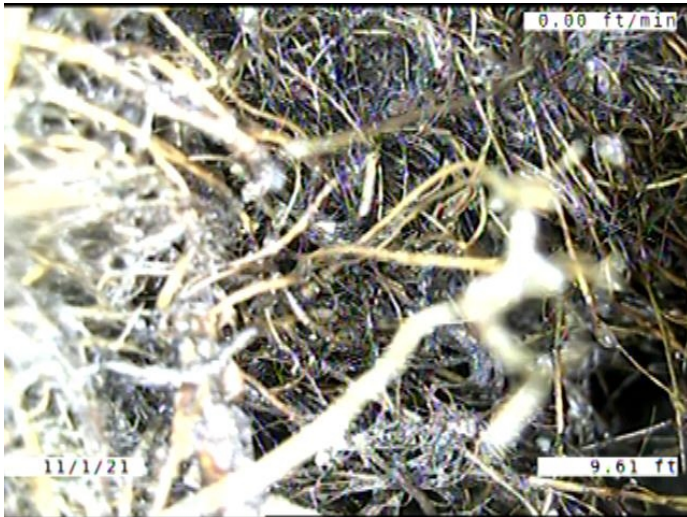
| | Position | Code | Observation | Video (sec) | Grade |
|--|---|---|---|---|---|
| | 9.6 | RMC | Roots Medium Connection | 282 | M 3 |

Code: **RMC**
 Description: **Roots Medium Connection**

Distance (ft): **9.6**
 Structural Grade: **0**
 O&M Grade: **3**
 Clock Start/From: **10**
 Clock To: **11**
 1st Value:
 2nd Value:
 Value Percent: **20.000**
 Continuous Index:
 Within 8" of Joint: **NO**
 Remarks:

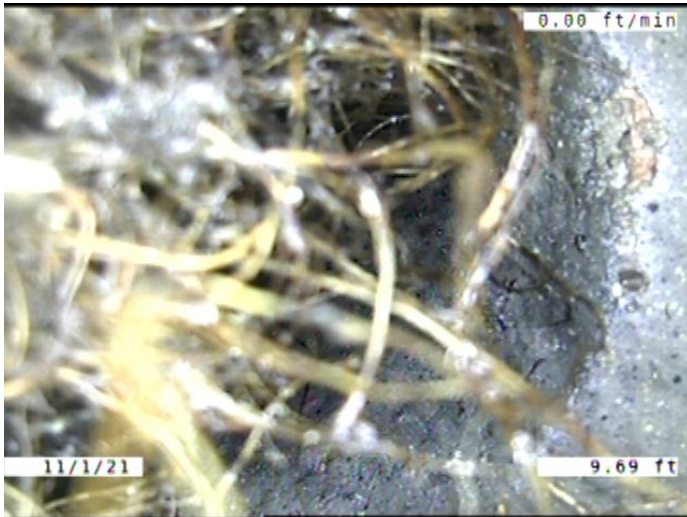
| | Position | Code | Observation | Video (sec) | Grade |
|--|---|---|---|---|---|
| | 9.7 | TFD | Tap Factory Defective | 308 | M 3 |

| Code: | TFD |
| Description: | Tap Factory Defective |
| O&M Grade: | 3 |
| Remarks: | LOOKS TO BE 100% PLUGGED WITH ROOTS. ROOTS GROWING INTO THE |

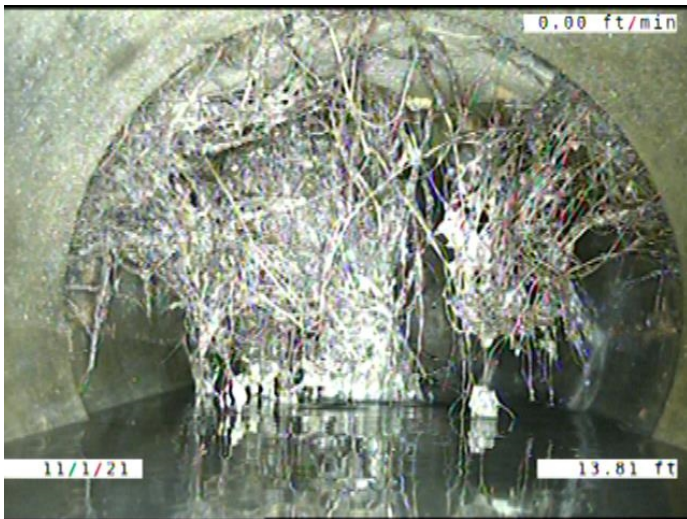
| | Position | Code | Observation | Video (sec) | Grade |
|--|---|---|---|---|---|
| | 13.8 | RMJ | Roots Medium Joint | 406 | M 3 |

| Code: | RMJ |
| Description: | Roots Medium Joint |
| O&M Grade: | 3 |
| Value Percent: | 10.000 |

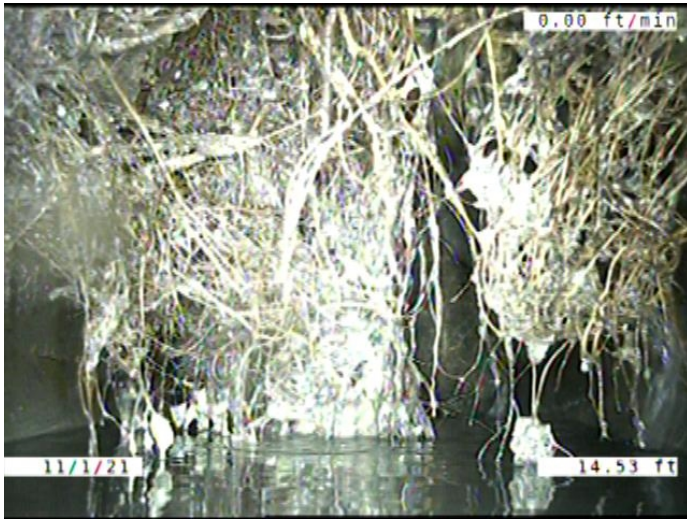
| | Position | Code | Observation | Video (sec) | Grade |
|--|---|---|---|---|---|
| | 14.5 | RMC | Roots Medium Connection | 507 | M 3 |

Code: **RMC**
 Description: **Roots Medium Connection**

Distance (ft): **14.5**
 Structural Grade: **0**
 O&M Grade: **3**
 Clock Start/From: **10**
 Clock To: **1**
 1st Value:
 2nd Value:
 Value Percent: **40.000**
 Continuous Index:
 Within 8" of Joint: **NO**
 Remarks:

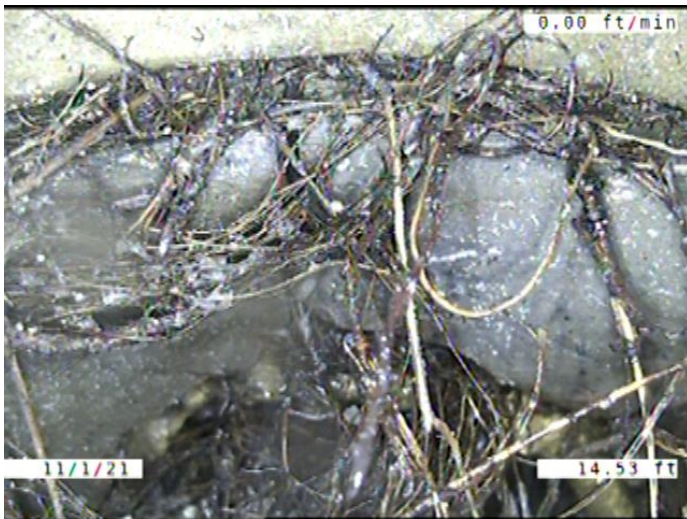
| | Position | Code | Observation | Video (sec) | Grade |
|--|---|---|---|---|---|
| | 14.5 | B | Broken | 524 | S 4 |

Code: **B**
 Description: **Broken**

Distance (ft): **14.5**
 Structural Grade: **4**
 O&M Grade: **0**
 Clock Start/From: **8**
 Clock To: **4**
 1st Value:
 2nd Value:
 Value Percent:
 Continuous Index:
 Within 8" of Joint: **YES**
 Remarks:

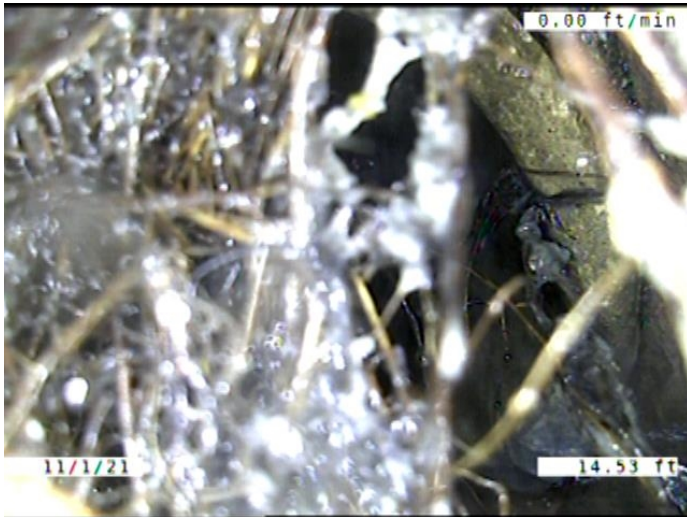
| | Position | Code | Observation | Video (sec) | Grade |
|--|---|---|---|---|---|
| | 14.5 | TBD | Tap Break-in/Hammer Defective | 548 | M 3 |

Code: **TBD**
 Description: **Tap Break-in/Hammer Defective**

Distance (ft): **14.5**
 Structural Grade: **0**
 O&M Grade: **3**
 Clock Start/From: **12**
 Clock To:
 1st Value: **4.000**
 2nd Value:
 Value Percent:
 Continuous Index:
 Within 8" of Joint: **YES**
 Remarks: **BROKEN. ROOTS GROWING OUT OF AND AROUND THE TAP. CONSTANTLY**

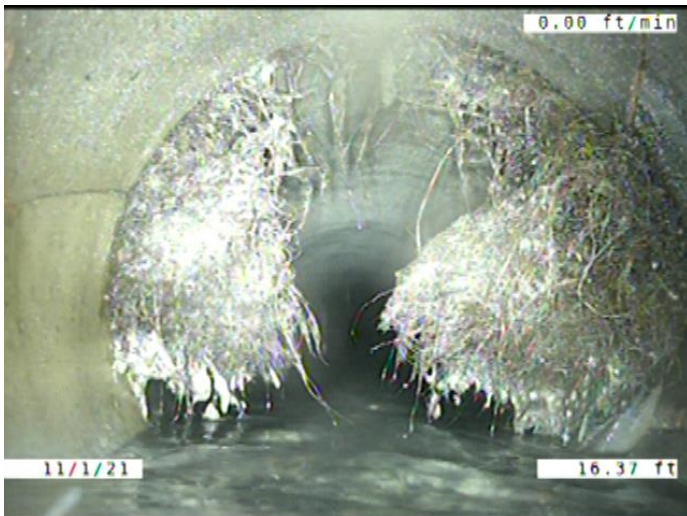
| | Position | Code | Observation | Video (sec) | Grade |
|--|---|---|---|---|---|
| | 16.4 | RMJ | Roots Medium Joint | 627 | M 3 |

Code: **RMJ**
 Description: **Roots Medium Joint**

Distance (ft): **16.4**
 Structural Grade: **0**
 O&M Grade: **3**
 Clock Start/From: **8**
 Clock To: **4**
 1st Value:
 2nd Value:
 Value Percent: **50.000**
 Continuous Index:
 Within 8" of Joint: **YES**
 Remarks:

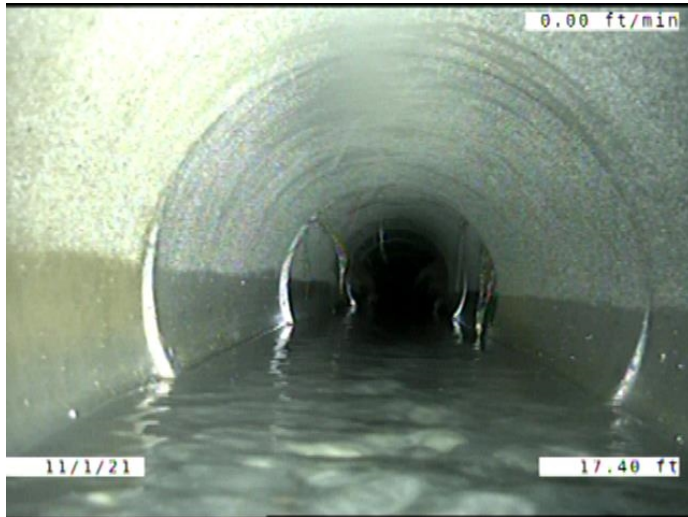
| | Position | Code | Observation | Video (sec) | Grade |
|--|---|---|---|---|---|
| | 17.4 | DSF(F01) | Deposits Settled Fine | 713 | M 2 |

Code: **DSF**
 Description: **Deposits Settled Fine**

Distance (ft): **17.4**
 Structural Grade: **0**
 O&M Grade: **2**
 Clock Start/From: **5**
 Clock To: **7**
 1st Value:
 2nd Value:
 Value Percent: **5.000**
 Continuous Index: **F01**
 Within 8" of Joint: **YES**
 Remarks:

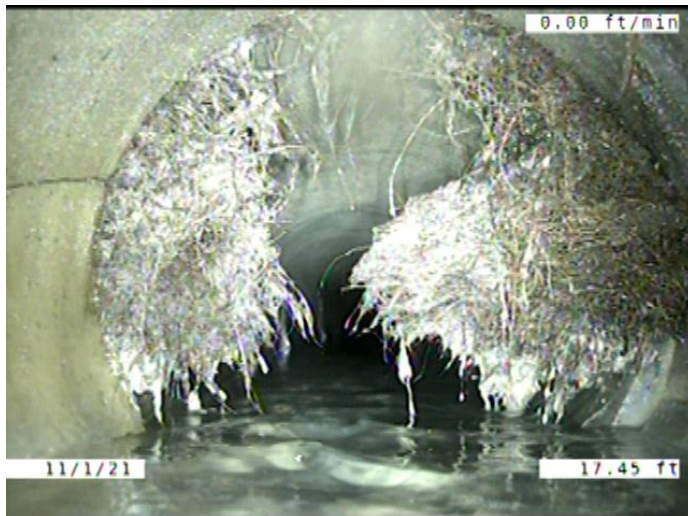
Code: **MSA**
 Description: **Miscellaneous Survey Abandoned**

Distance (ft): **17.5**
 Structural Grade: **0**
 O&M Grade: **0**
 Clock Start/From:
 Clock To:
 1st Value:
 2nd Value:
 Value Percent:
 Continuous Index:
 Within 8" of Joint: **NO**
 Remarks: **CAMERA CANT MAKE IT PAST ROOTS**
