## Profile/Photo Observation Report

Date:	<b>11/01/2021</b>	Weather:		Coding:	<b>PACP 7.0</b>
Pipe Length (ft):	<b>171.7</b>	Owner:	<b>City of Hobart</b>	Pre Clean:	<b>Heavy Cleaning</b>
P.O.#:	<b>YES502259</b>	Surveyor:	<b>S. Bucklin</b>	PSR:	<b>P-504-030-023</b>
Customer:	<b>City of Hobart</b>	Clean Date:	<b>10/28/2021</b>	Shape:	<b>C</b>

Street:	<b>North Colorado Street</b>	Flow Control:	<b>Not Controlled</b>
City:	<b>Hobart, IN</b>	Year Renewed:	
Location:	<b>Alley</b>	Tape/Media #:	
Purpose:	<b>Routine Assessment</b>	Dia/Height:	<b>12"</b>
Use:	<b>Sanitary Sewage Pipe</b>	Material:	<b>VCP</b>
Drain Area:		Lining:	<b>None</b>
Category:	<b>NA</b>		
Comment:

Location Details:		Direction of Survey:	<b>Downstream</b>
US MH:	<b>M-504-023</b>	DS MH:	<b>M-504-030</b>
		Total Length Surveyed (ft):	<b>17.5</b>

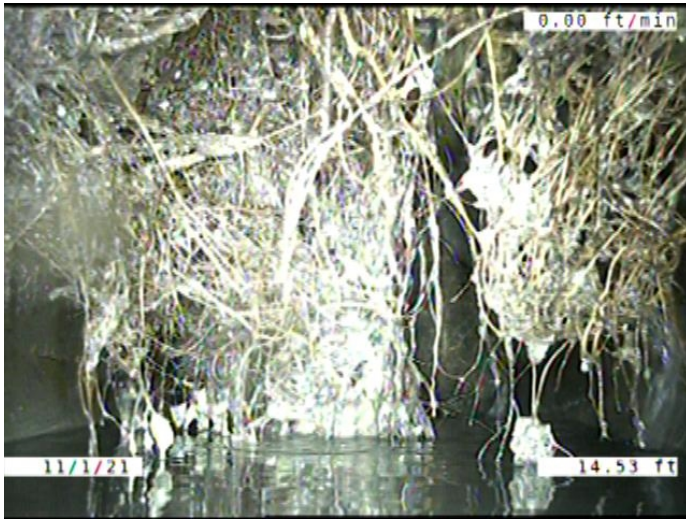
Code: **RMC**  
 Description: **Roots Medium Connection**

Distance (ft): **14.5**  
 Structural Grade: **0**  
 O&M Grade: **3**  
 Clock Start/From: **10**  
 Clock To: **1**  
 1st Value:  
 2nd Value:  
 Value Percent: **40.000**  
 Continuous Index:  
 Within 8" of Joint: **NO**  
 Remarks:

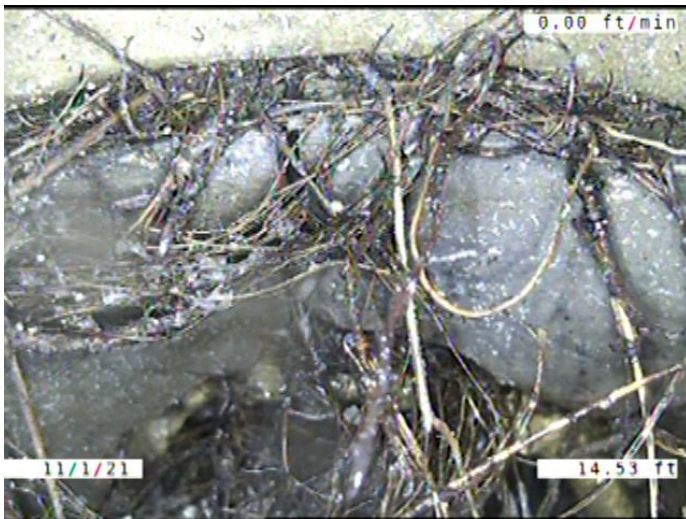
Code: **B**  
 Description: **Broken**

Distance (ft): **14.5**  
 Structural Grade: **4**  
 O&M Grade: **0**  
 Clock Start/From: **8**  
 Clock To: **4**  
 1st Value:  
 2nd Value:  
 Value Percent:  
 Continuous Index:  
 Within 8" of Joint: **YES**  
 Remarks:

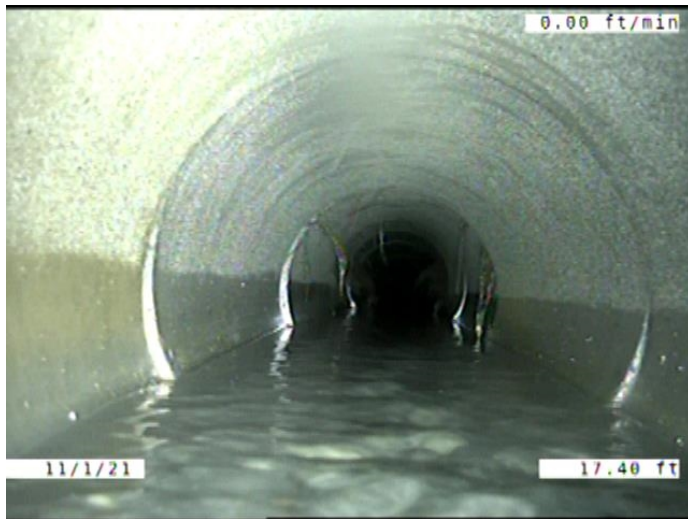
Code: **DSF**  
 Description: **Deposits Settled Fine**

Distance (ft): **17.4**  
 Structural Grade: **0**  
 O&M Grade: **2**  
 Clock Start/From: **5**  
 Clock To: **7**  
 1st Value:  
 2nd Value:  
 Value Percent: **5.000**  
 Continuous Index: **F01**  
 Within 8" of Joint: **YES**  
 Remarks:

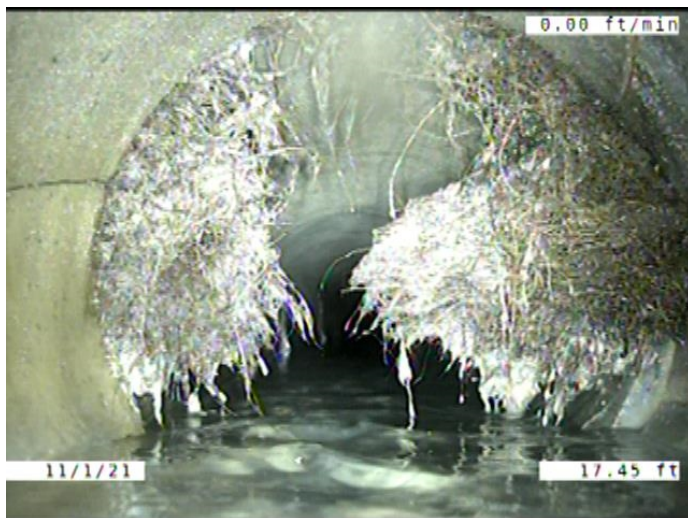
Code: **MSA**  
 Description: **Miscellaneous Survey Abandoned**

Distance (ft): **17.5**  
 Structural Grade: **0**  
 O&M Grade: **0**  
 Clock Start/From:  
 Clock To:  
 1st Value:  
 2nd Value:  
 Value Percent:  
 Continuous Index:  
 Within 8" of Joint: **NO**  
 Remarks: **CAMERA CANT MAKE IT PAST ROOTS**
