Profile/Photo Observation Report

Date:	11/01/2021	Weather:		Coding:	PACP 7.0
Pipe Length (ft):	171.7	Owner:	City of Hobart	Pre Clean:	Heavy Cleaning
P.O.#:	YES502259	Surveyor:	S. Bucklin	PSR:	P-504-030-023
Customer:	City of Hobart	Clean Date:	10/28/2021	Shape:	C

Street:	North Colorado Street	Flow Control:	Not Controlled
City:	Hobart, IN	Year Renewed:	
Location:	Alley	Tape/Media #:	
Purpose:	Routine Assessment	Dia/Height:	12"
Use:	Sanitary Sewage Pipe	Material:	VCP
Drain Area:		Lining:	None
Category:	NA		
Comment:			
Location Details:		Direction of Survey:	Upstream
US MH:	M-504-023	DS MH:	M-504-030
		Total Length Surveyed (ft):	171.7

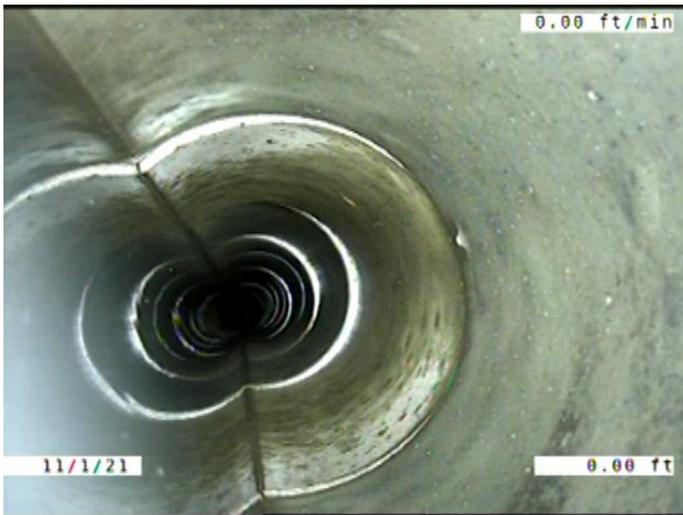
Code: **MWL**
Description: **Miscellaneous Water Level**

Distance (ft): **.0**
Structural Grade: **0**
O&M Grade: **0**
Clock Start/From:
Clock To:
1st Value:
2nd Value:
Value Percent: **10.000**
Continuous Index:
Within 8" of Joint: **NO**
Remarks:

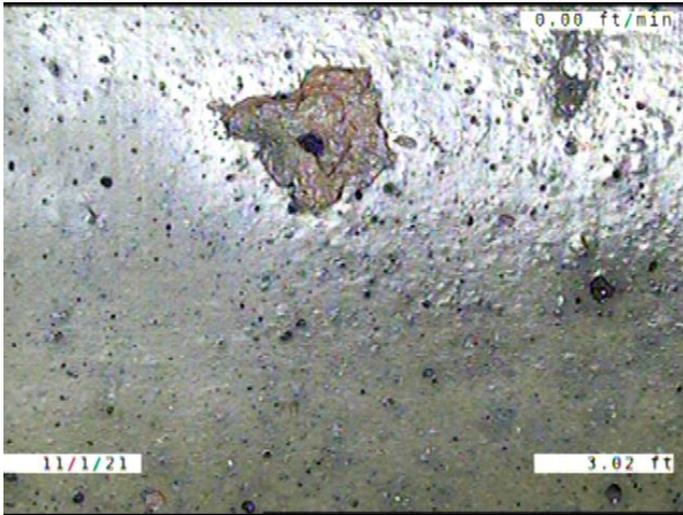
Code: **SSS**
Description: **Surface Damage Surface Spalling**

Distance (ft): **3.0**
Structural Grade: **2**
O&M Grade: **0**
Clock Start/From: **11**
Clock To:
1st Value:
2nd Value:
Value Percent:
Continuous Index:
Within 8" of Joint: **NO**
Remarks:

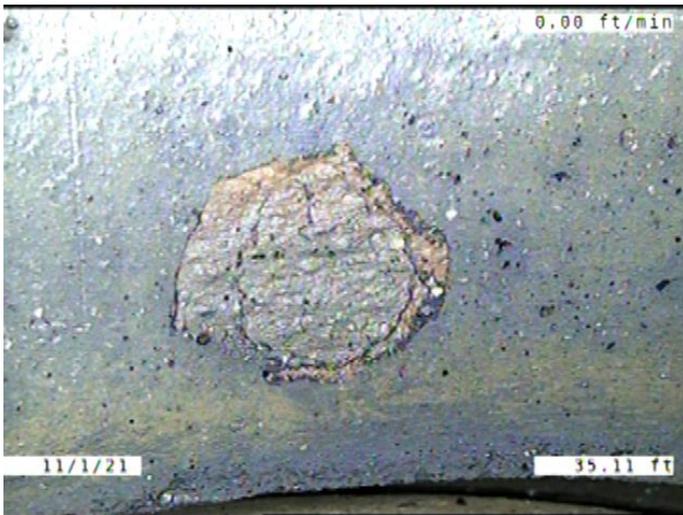
Code: **SSS**
Description: **Surface Damage Surface Spalling**

Distance (ft): **35.1**
Structural Grade: **2**
O&M Grade: **0**
Clock Start/From: **9**
Clock To:
1st Value:
2nd Value:
Value Percent:
Continuous Index:
Within 8" of Joint: **YES**
Remarks:

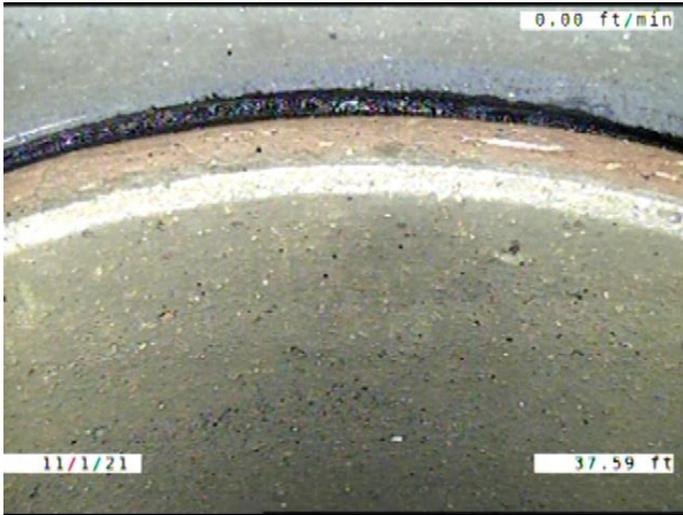
Code: **JOM**
 Description: **Joint Offset Medium**

Distance (ft): **37.6**
 Structural Grade: **3**
 O&M Grade: **0**
 Clock Start/From:
 Clock To:
 1st Value:
 2nd Value:
 Value Percent:
 Continuous Index:
 Within 8" of Joint: **NO**
 Remarks:

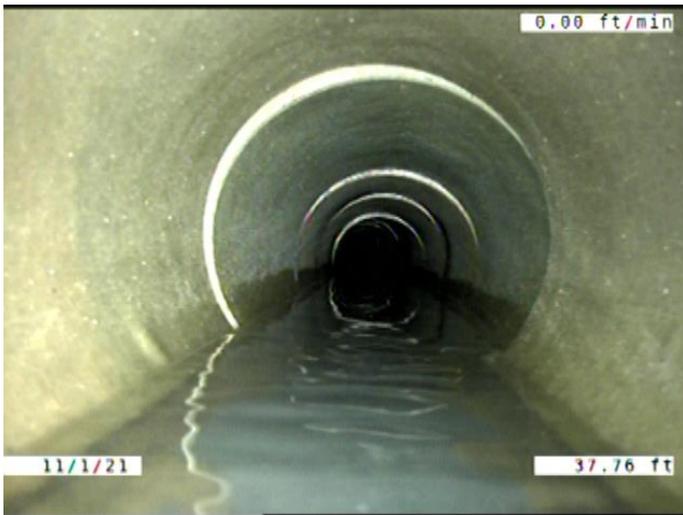
Code: **DSF**
 Description: **Deposits Settled Fine**

Distance (ft): **37.8**
 Structural Grade: **0**
 O&M Grade: **2**
 Clock Start/From: **5**
 Clock To: **7**
 1st Value:
 2nd Value:
 Value Percent: **5.000**
 Continuous Index: **S01**
 Within 8" of Joint: **YES**
 Remarks:

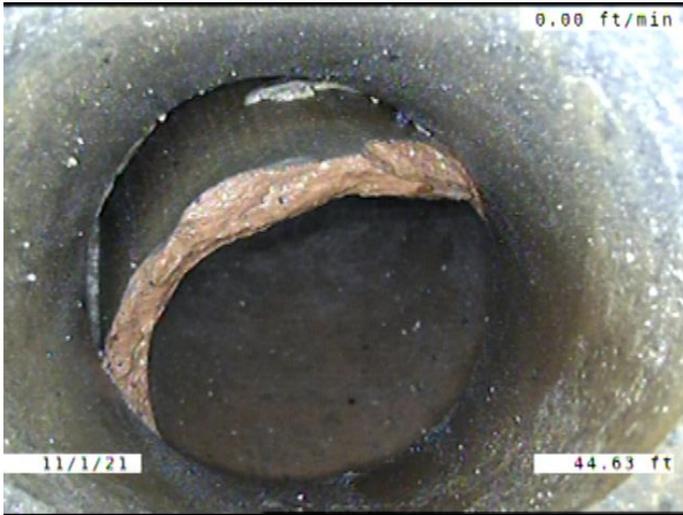
Code: **TFD**
Description: **Tap Factory Defective**

Distance (ft): **44.6**
Structural Grade: **0**
O&M Grade: **3**
Clock Start/From: **1**
Clock To:
1st Value: **4.000**

2nd Value:
Value Percent:
Continuous Index:
Within 8" of Joint: **YES**
Remarks: **LARGE OFFSET. ANGLED JOINT**

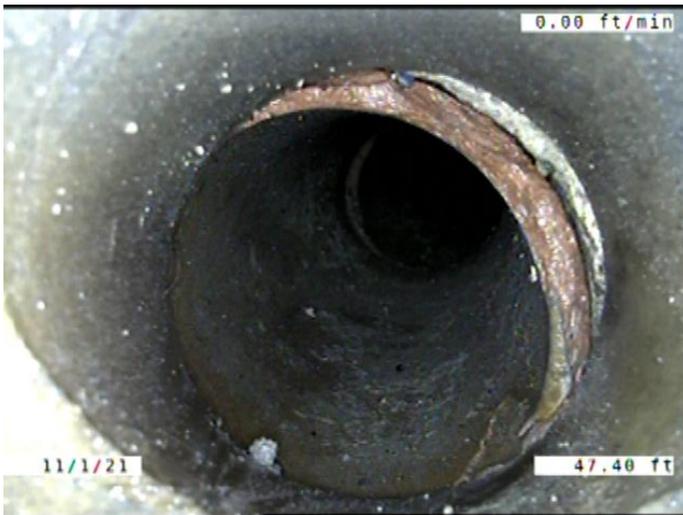
Code: **TFD**
Description: **Tap Factory Defective**

Distance (ft): **47.4**
Structural Grade: **0**
O&M Grade: **3**
Clock Start/From: **11**
Clock To:
1st Value: **4.000**

2nd Value:
Value Percent:
Continuous Index:
Within 8" of Joint: **YES**
Remarks: **LARGE OFFSET. SOIL VISIBLE.**

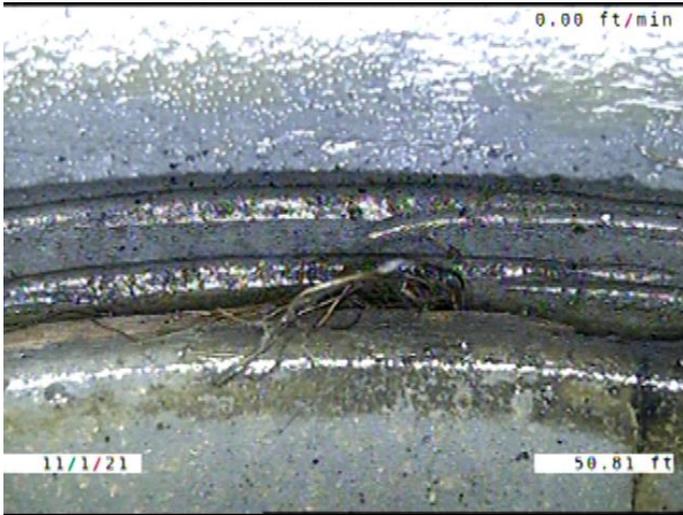
Code: **RFJ**
Description: **Roots Fine Joint**

Distance (ft): **50.8**
Structural Grade: **0**
O&M Grade: **1**
Clock Start/From: **12**
Clock To:
1st Value:
2nd Value:
Value Percent:
Continuous Index:
Within 8" of Joint: **YES**
Remarks:

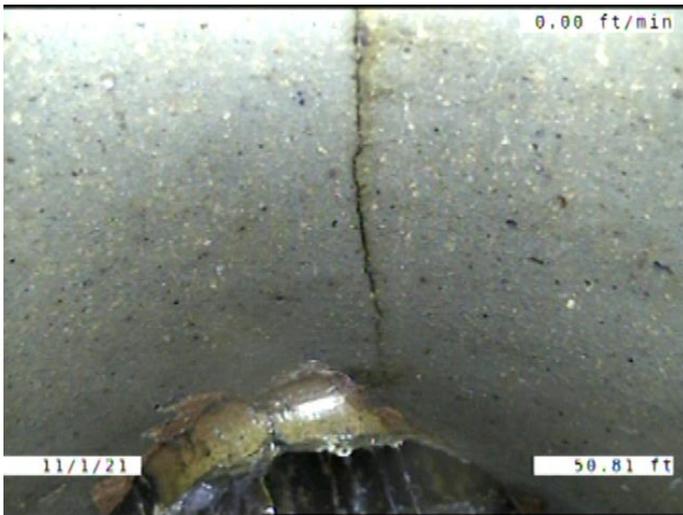
Code: **FM**
Description: **Fracture Multiple**

Distance (ft): **50.8**
Structural Grade: **4**
O&M Grade: **0**
Clock Start/From: **11**
Clock To: **2**
1st Value:
2nd Value:
Value Percent:
Continuous Index:
Within 8" of Joint: **YES**
Remarks:

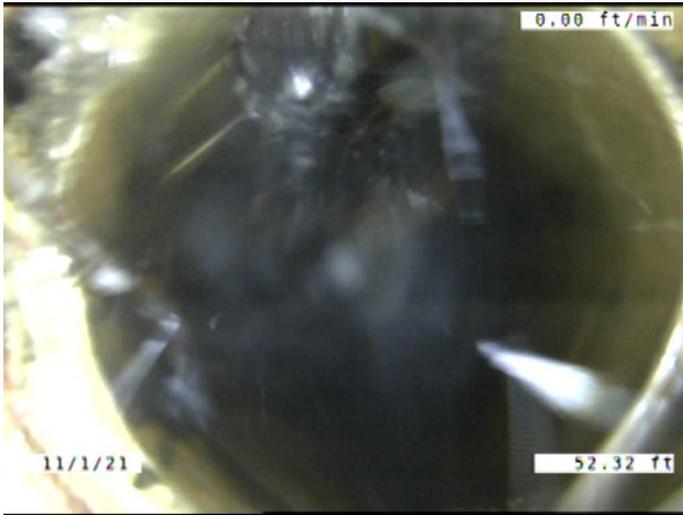
Code: **TBI**
 Description: **Tap Break-in Intruding**

Distance (ft): **52.3**
 Structural Grade: **0**
 O&M Grade: **2**
 Clock Start/From: **12**
 Clock To:
 1st Value: **4.000**
 2nd Value: **1.000**

Value Percent:
 Continuous Index:
 Within 8" of Joint: **YES**
 Remarks: **ROOTS GROWING INTO THE MAIN.**

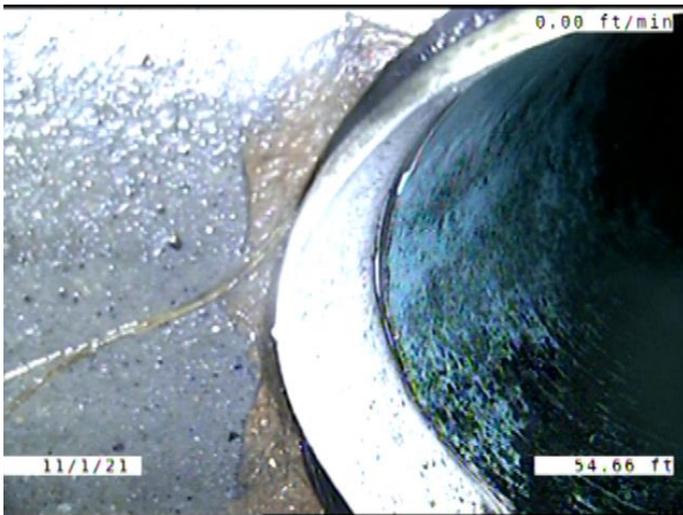
Code: **SSS**
 Description: **Surface Damage Surface Spalling**

Distance (ft): **54.7**
 Structural Grade: **2**
 O&M Grade: **0**
 Clock Start/From: **11**
 Clock To: **1**

1st Value:
 2nd Value:
 Value Percent:
 Continuous Index:
 Within 8" of Joint: **YES**
 Remarks:

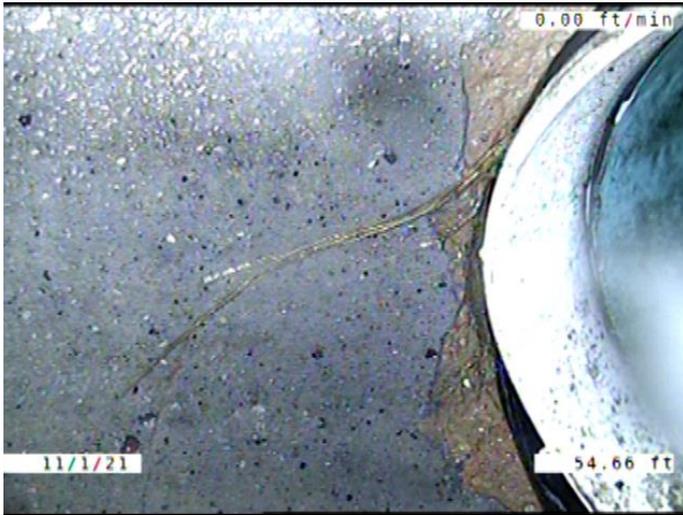
Code: **RFC**
Description: **Roots Fine Connection**

Distance (ft): **54.7**
Structural Grade: **0**
O&M Grade: **1**
Clock Start/From: **11**
Clock To:
1st Value:
2nd Value:
Value Percent:
Continuous Index:
Within 8" of Joint: **NO**
Remarks:

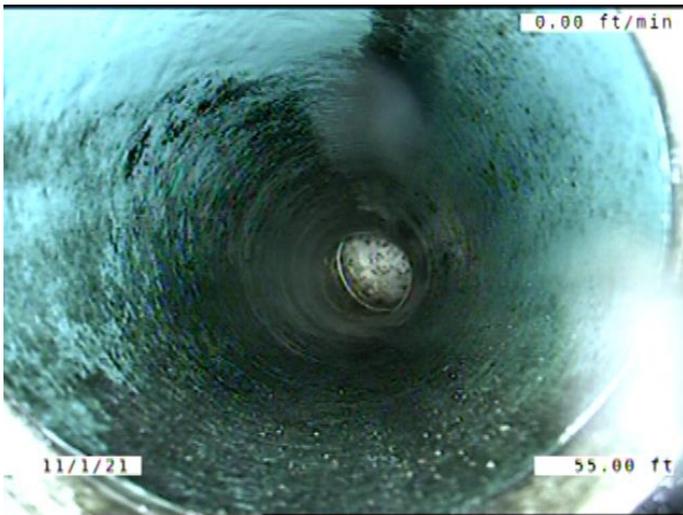
Code: **TBI**
Description: **Tap Break-in Intruding**

Distance (ft): **55.0**
Structural Grade: **0**
O&M Grade: **2**
Clock Start/From: **12**
Clock To:
1st Value: **4.000**
2nd Value: **1.000**
Value Percent:
Continuous Index:
Within 8" of Joint: **YES**
Remarks:

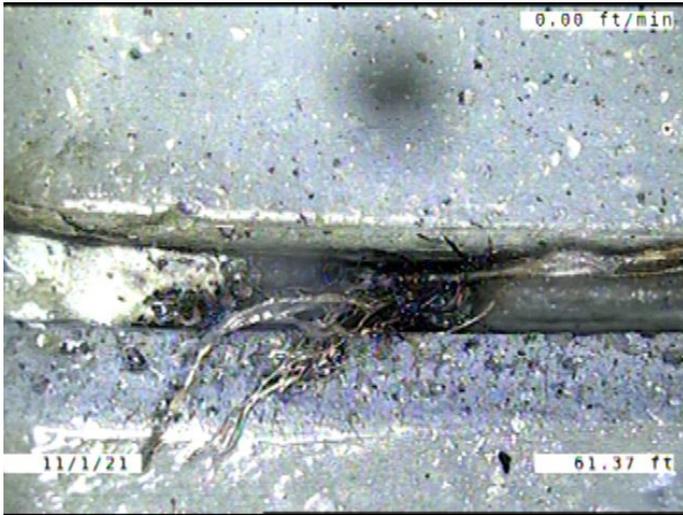
Code: **RFJ**
 Description: **Roots Fine Joint**

Distance (ft): **61.4**
 Structural Grade: **0**
 O&M Grade: **1**
 Clock Start/From: **1**
 Clock To: **4**
 1st Value:
 2nd Value:
 Value Percent:
 Continuous Index:
 Within 8" of Joint: **YES**
 Remarks:

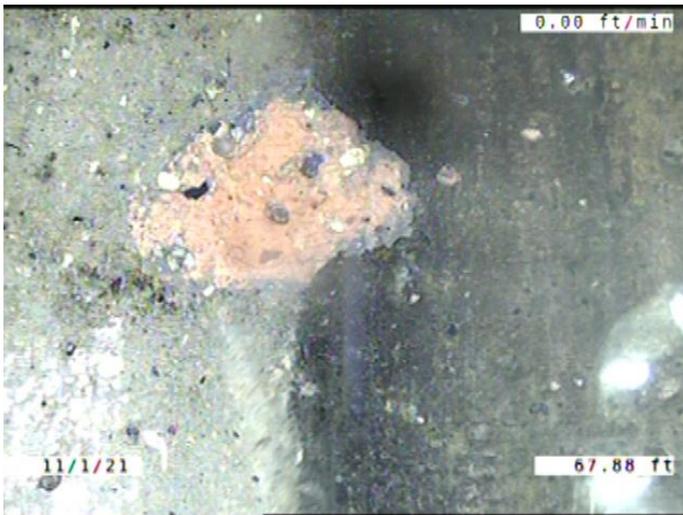
Code: **SSS**
 Description: **Surface Damage Surface Spalling**

Distance (ft): **67.9**
 Structural Grade: **2**
 O&M Grade: **0**
 Clock Start/From: **7**
 Clock To:
 1st Value:
 2nd Value:
 Value Percent:
 Continuous Index:
 Within 8" of Joint: **YES**
 Remarks:

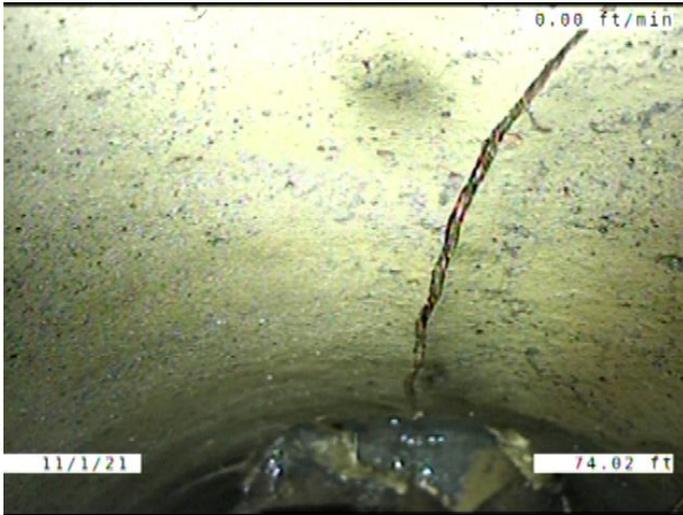
Code: **BVV**
Description: **Broken Void Visible**

Distance (ft): **74.0**
Structural Grade: **5**
O&M Grade: **0**
Clock Start/From: **8**
Clock To: **3**
1st Value:
2nd Value:
Value Percent:
Continuous Index:
Within 8" of Joint: **YES**
Remarks: **SOIL VISIBLE TOO**

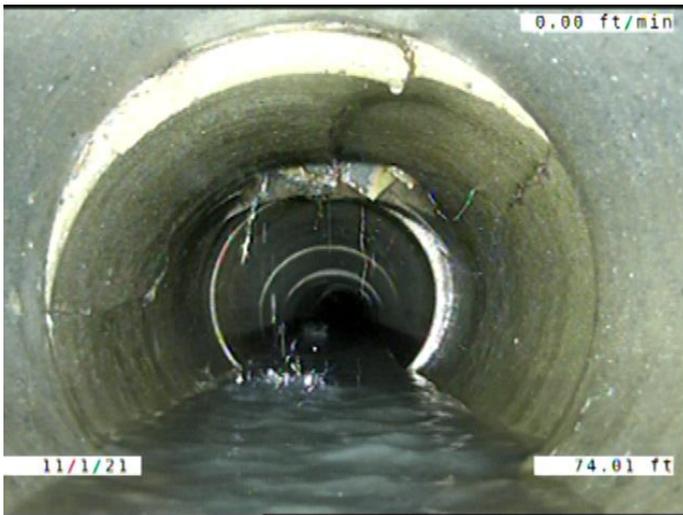
Code: **DR**
Description: **Deformed Rigid**

Distance (ft): **74.0**
Structural Grade: **4**
O&M Grade: **0**
Clock Start/From:
Clock To:
1st Value:
2nd Value:
Value Percent: **5.000**
Continuous Index:
Within 8" of Joint: **NO**
Remarks:

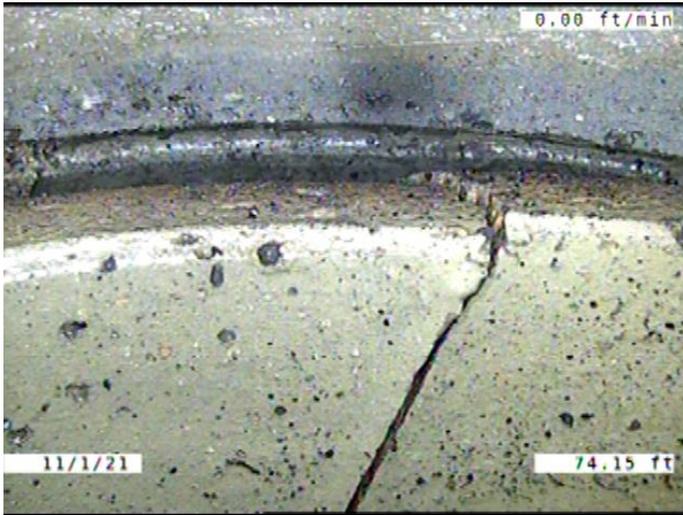
Code: **IWB**
Description: **Infiltration Weeper Barrel**

Distance (ft): **74.1**
Structural Grade: **0**
O&M Grade: **2**
Clock Start/From: **12**
Clock To:
1st Value:
2nd Value:
Value Percent:
Continuous Index:
Within 8" of Joint: **YES**
Remarks:

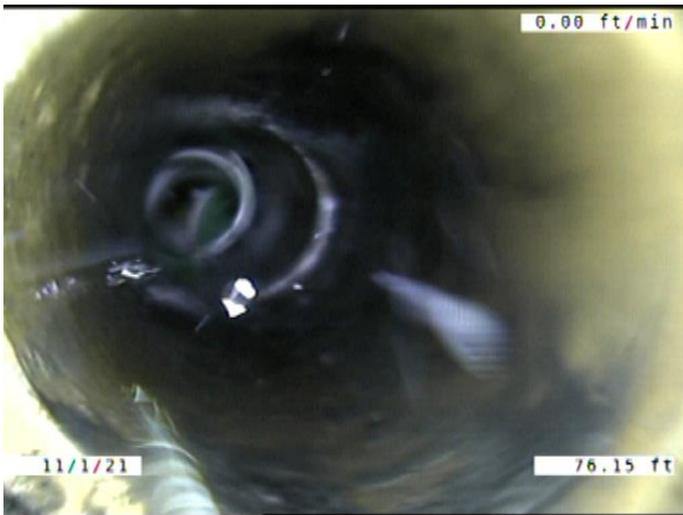
Code: **TBI**
Description: **Tap Break-in Intruding**

Distance (ft): **76.1**
Structural Grade: **0**
O&M Grade: **2**
Clock Start/From: **12**
Clock To:
1st Value: **4.000**
2nd Value: **1.000**
Value Percent:
Continuous Index:
Within 8" of Joint: **YES**
Remarks: **CONSTANTLY RUNNING WATER**

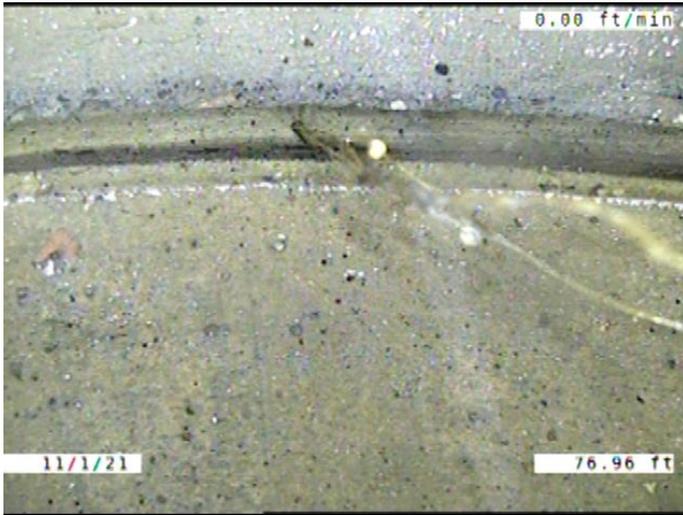
Code: **RFJ**
 Description: **Roots Fine Joint**

Distance (ft): **77.0**
 Structural Grade: **0**
 O&M Grade: **1**
 Clock Start/From: **1**
 Clock To:
 1st Value:
 2nd Value:
 Value Percent:
 Continuous Index:
 Within 8" of Joint: **YES**
 Remarks:

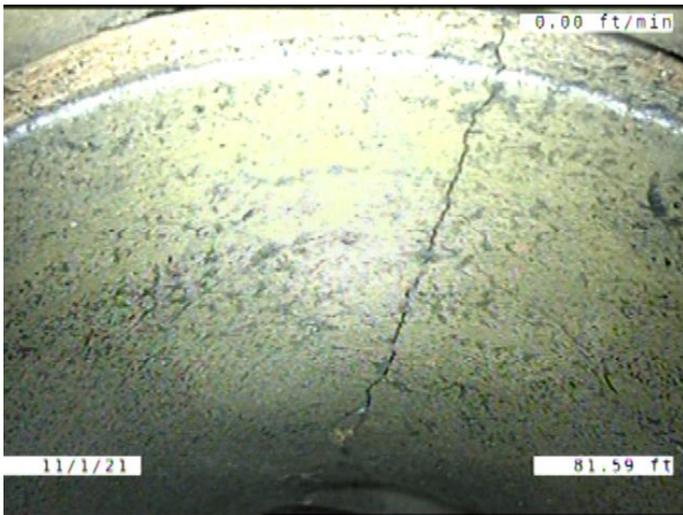
Code: **FM**
 Description: **Fracture Multiple**

Distance (ft): **81.6**
 Structural Grade: **4**
 O&M Grade: **0**
 Clock Start/From: **9**
 Clock To: **2**
 1st Value:
 2nd Value:
 Value Percent:
 Continuous Index: **S02**
 Within 8" of Joint: **YES**
 Remarks:

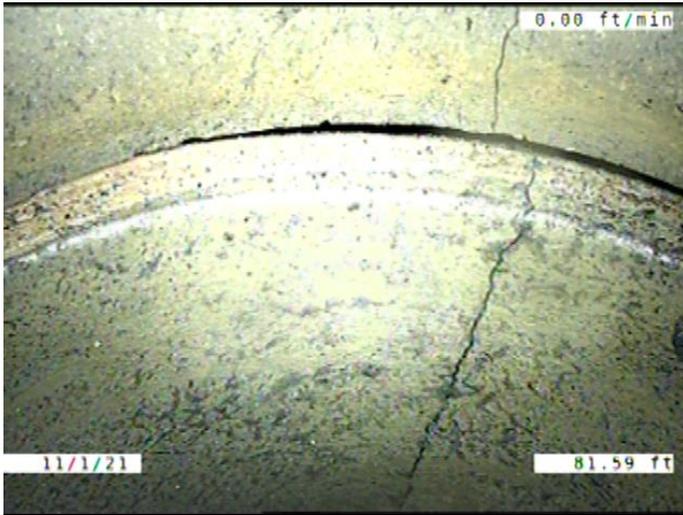
Code: **JOM**
Description: **Joint Offset Medium**

Distance (ft): **81.6**
Structural Grade: **3**
O&M Grade: **0**
Clock Start/From:
Clock To:
1st Value:
2nd Value:
Value Percent:
Continuous Index:
Within 8" of Joint: **NO**
Remarks:

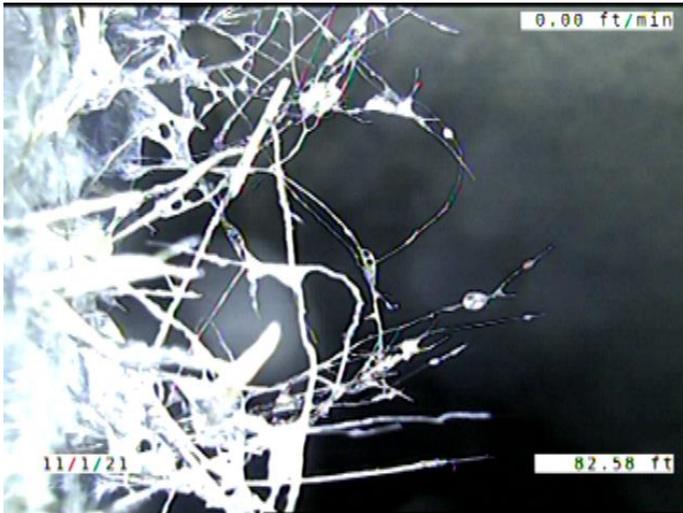
Code: **OBZ**
Description: **Obstruction Other**

Distance (ft): **82.6**
Structural Grade: **0**
O&M Grade: **2**
Clock Start/From: **6**
Clock To: **7**
1st Value:
2nd Value:
Value Percent: **5.000**
Continuous Index:
Within 8" of Joint: **YES**
Remarks: **ROOTS THAT HAVE BEEN CUT**

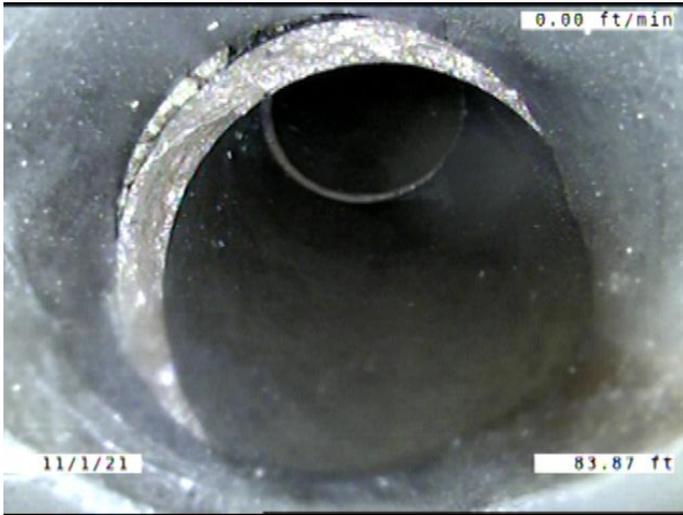
Code: **TFD**
Description: **Tap Factory Defective**

Distance (ft): **83.9**
Structural Grade: **0**
O&M Grade: **3**
Clock Start/From: **1**
Clock To:
1st Value: **4.000**
2nd Value:
Value Percent:
Continuous Index:
Within 8" of Joint: **YES**
Remarks: **CRACKED. OFFSET. SOIL VISIBLE.**

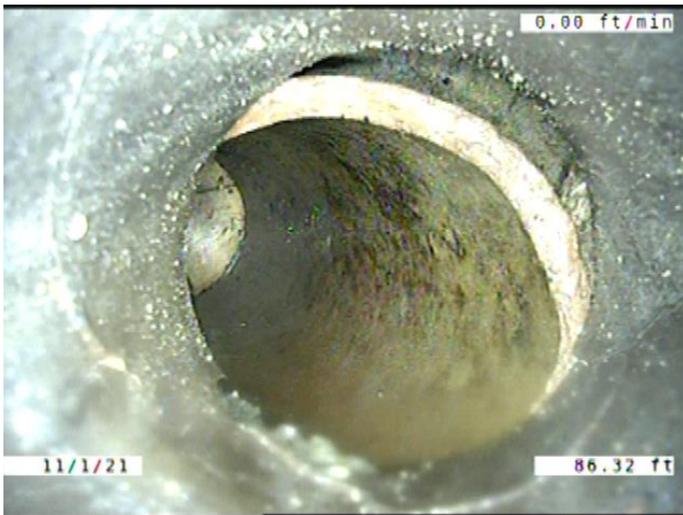
Code: **TFD**
Description: **Tap Factory Defective**

Distance (ft): **86.3**
Structural Grade: **0**
O&M Grade: **3**
Clock Start/From: **11**
Clock To:
1st Value: **4.000**
2nd Value:
Value Percent:
Continuous Index:
Within 8" of Joint: **YES**
Remarks: **LOOKS TO BE CAPPED. LARGE OFFSET. SOIL VISIBLE**

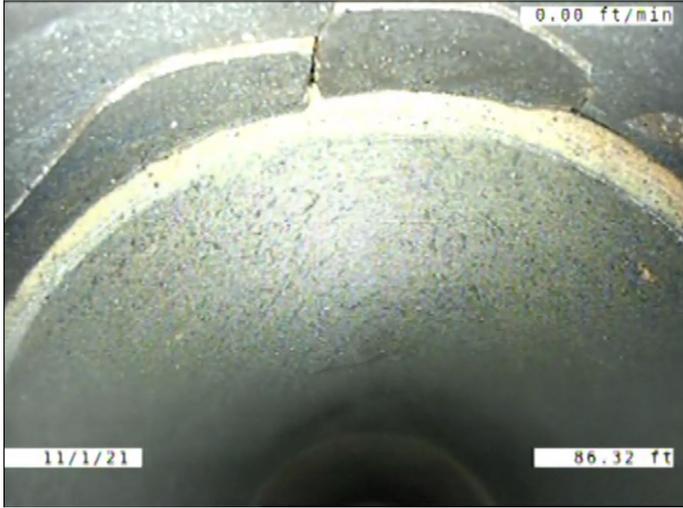
Code: **B**
Description: **Broken**

Distance (ft): **86.3**
Structural Grade: **4**
O&M Grade: **0**
Clock Start/From: **10**
Clock To: **1**
1st Value:
2nd Value:
Value Percent:
Continuous Index:
Within 8" of Joint: **YES**
Remarks:

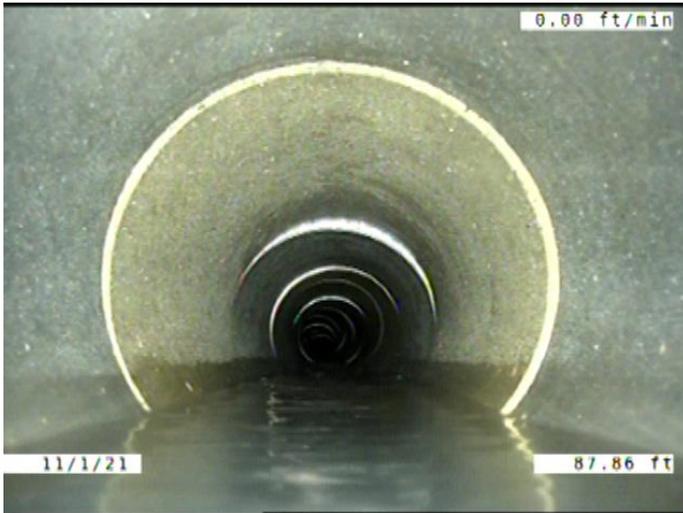
Code: **FM**
Description: **Fracture Multiple**

Distance (ft): **87.9**
Structural Grade: **4**
O&M Grade: **0**
Clock Start/From: **9**
Clock To: **2**
1st Value:
2nd Value:
Value Percent:
Continuous Index: **F02**
Within 8" of Joint: **YES**
Remarks:

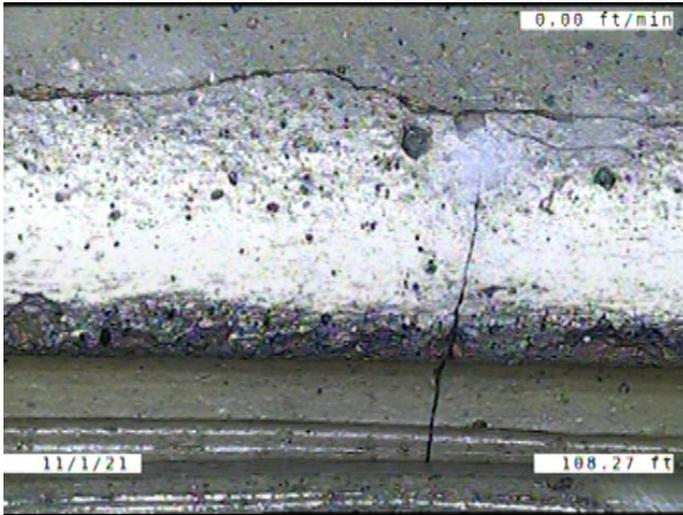
Code: **CM**
Description: **Crack Multiple**

Distance (ft): **108.3**
Structural Grade: **3**
O&M Grade: **0**
Clock Start/From: **9**
Clock To: **1**
1st Value:
2nd Value:
Value Percent:
Continuous Index:
Within 8" of Joint: **YES**
Remarks:

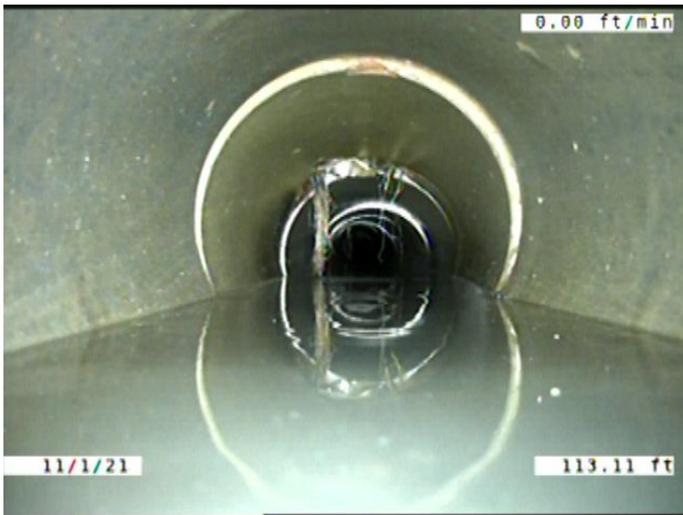
Code: **MWLS**
Description: **Miscellaneous Water Level Sag**

Distance (ft): **113.1**
Structural Grade: **2**
O&M Grade: **0**
Clock Start/From:
Clock To:
1st Value:
2nd Value:
Value Percent: **15.000**
Continuous Index: **S03**
Within 8" of Joint: **NO**
Remarks:

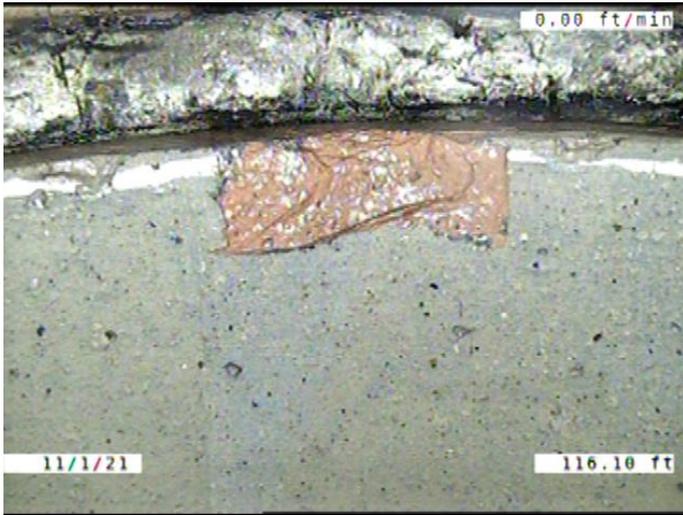
Code: **SZ**
Description: **Surface Damage Other**

Distance (ft): **116.1**
Structural Grade: **0**
O&M Grade: **0**
Clock Start/From: **12**
Clock To:
1st Value:
2nd Value:
Value Percent:
Continuous Index:
Within 8" of Joint: **YES**
Remarks: **A PIECE CHIPPED OFF THE JOINT**

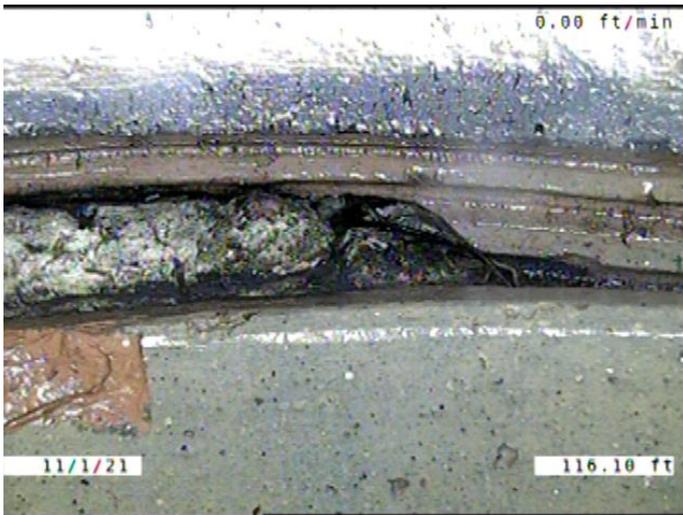
Code: **JAM**
Description: **Joint Angular Medium**

Distance (ft): **116.1**
Structural Grade: **3**
O&M Grade: **0**
Clock Start/From:
Clock To:
1st Value:
2nd Value:
Value Percent:
Continuous Index:
Within 8" of Joint: **NO**
Remarks:

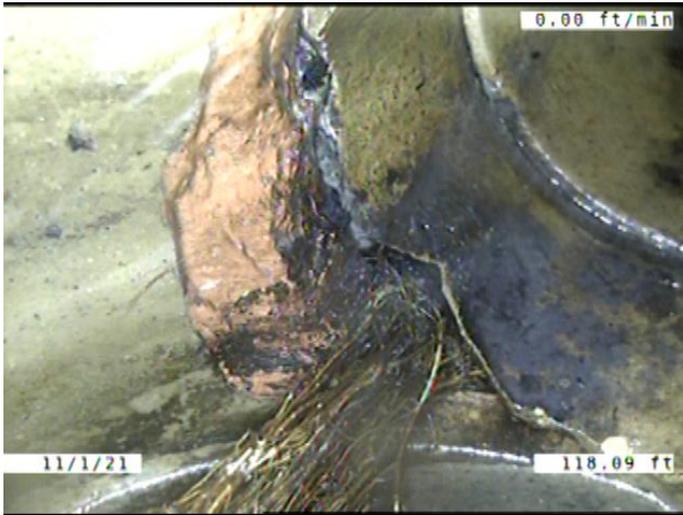
Code: **SSS**
 Description: **Surface Damage Surface Spalling**

Distance (ft): **118.1**
 Structural Grade: **2**
 O&M Grade: **0**
 Clock Start/From: **11**
 Clock To: **1**
 1st Value:
 2nd Value:
 Value Percent:
 Continuous Index:
 Within 8" of Joint: **YES**
 Remarks:

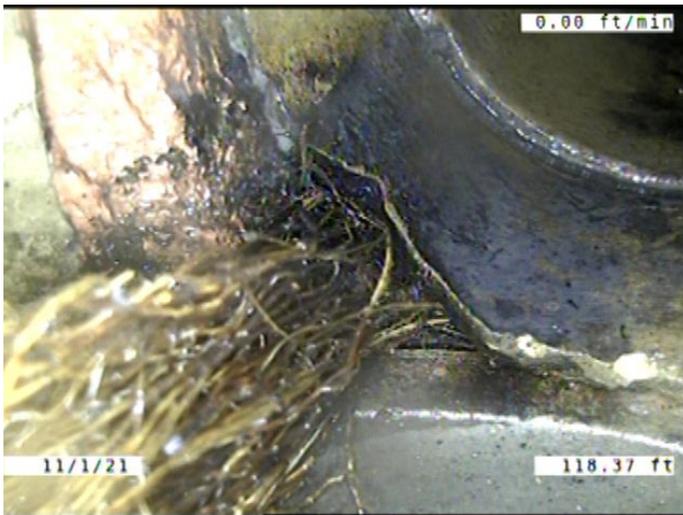
Code: **RMB**
 Description: **Roots Medium Barrel**

Distance (ft): **118.4**
 Structural Grade: **0**
 O&M Grade: **4**
 Clock Start/From: **11**
 Clock To: **1**
 1st Value:
 2nd Value:
 Value Percent: **5.000**
 Continuous Index:
 Within 8" of Joint: **NO**
 Remarks:

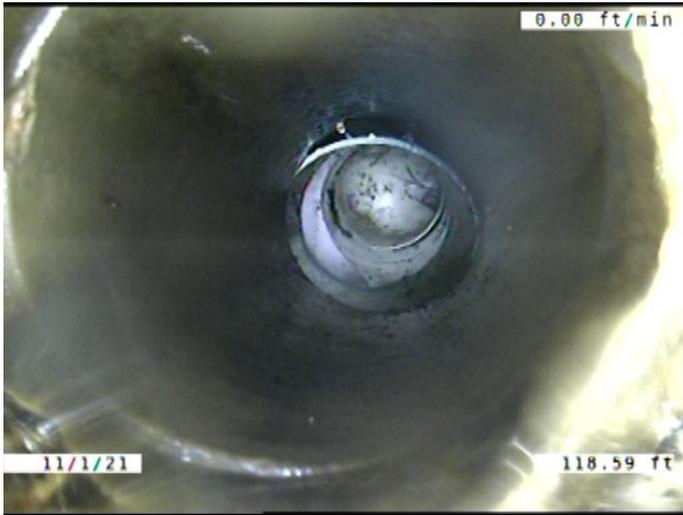
Code: **TBI**
 Description: **Tap Break-in Intruding**

Distance (ft): **118.6**
 Structural Grade: **0**
 O&M Grade: **2**
 Clock Start/From: **12**
 Clock To:
 1st Value: **4.000**
 2nd Value: **1.000**
 Value Percent:
 Continuous Index:
 Within 8" of Joint: **YES**
 Remarks: **CONSTANTLY RUNNING WATER.**

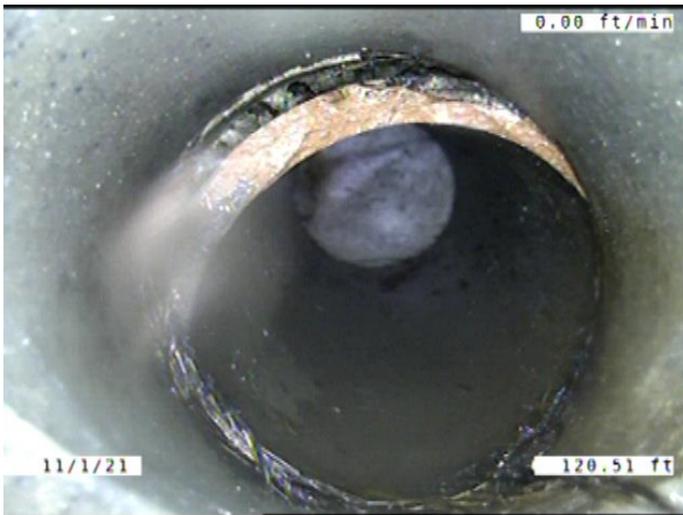
Code: **TFD**
 Description: **Tap Factory Defective**

Distance (ft): **120.5**
 Structural Grade: **0**
 O&M Grade: **3**
 Clock Start/From: **1**
 Clock To:
 1st Value: **4.000**
 2nd Value:
 Value Percent:
 Continuous Index:
 Within 8" of Joint: **YES**
 Remarks: **CAPPED. LARGE OFFSET. SOIL
 VISIBLE. CAP BROKEN. ROOTS GRO**

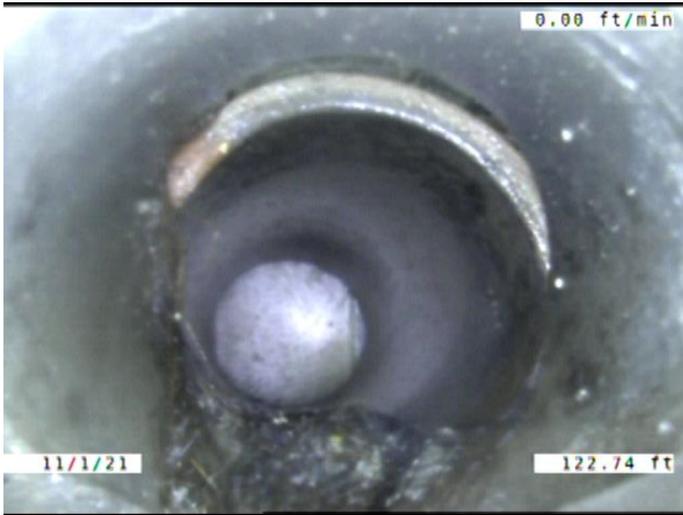
Code: **TFD**
Description: **Tap Factory Defective**

Distance (ft): **122.7**
Structural Grade: **0**
O&M Grade: **3**
Clock Start/From: **12**
Clock To:
1st Value: **4.000**
2nd Value:
Value Percent:
Continuous Index:
Within 8" of Joint: **YES**
Remarks: **LOOKS CAPPED. LARGE OFFSET. SOIL VISIBLE. ROOTS GROWING IN THE JO**

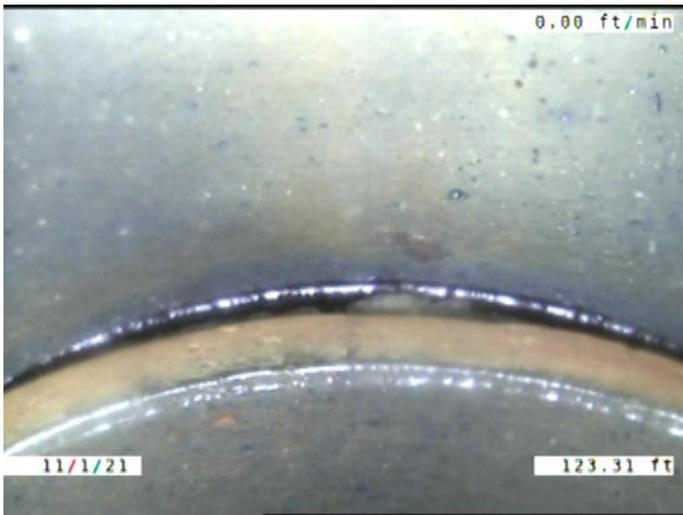
Code: **JOM**
Description: **Joint Offset Medium**

Distance (ft): **123.3**
Structural Grade: **3**
O&M Grade: **0**
Clock Start/From:
Clock To:
1st Value:
2nd Value:
Value Percent:
Continuous Index:
Within 8" of Joint: **NO**
Remarks:

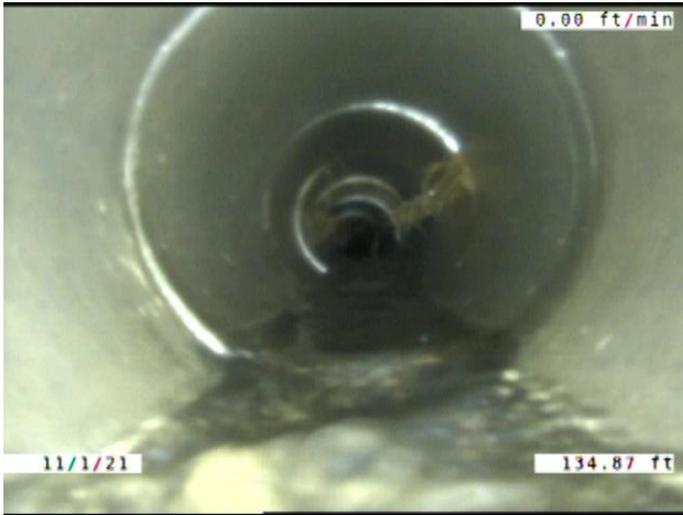
Code: **MWLS**
Description: **Miscellaneous Water Level Sag**

Distance (ft): **134.9**
Structural Grade: **2**
O&M Grade: **0**
Clock Start/From:
Clock To:
1st Value:
2nd Value:
Value Percent: **15.000**
Continuous Index: **F03**
Within 8" of Joint: **NO**
Remarks:

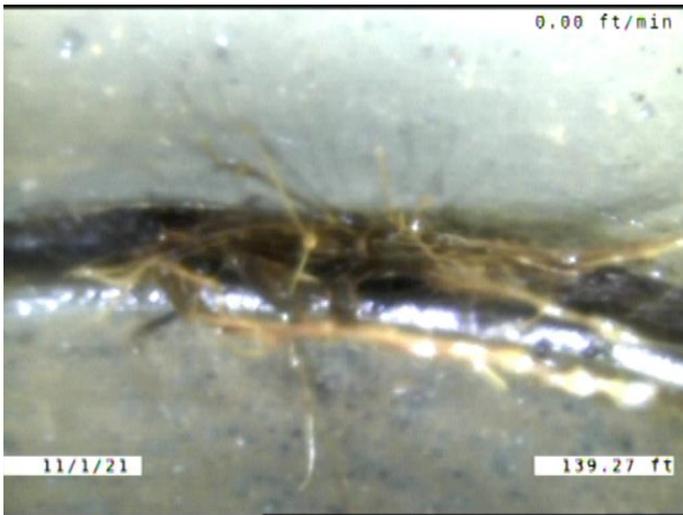
Code: **RFJ**
Description: **Roots Fine Joint**

Distance (ft): **139.3**
Structural Grade: **0**
O&M Grade: **1**
Clock Start/From: **1**
Clock To: **3**
1st Value:
2nd Value:
Value Percent:
Continuous Index:
Within 8" of Joint: **YES**
Remarks:

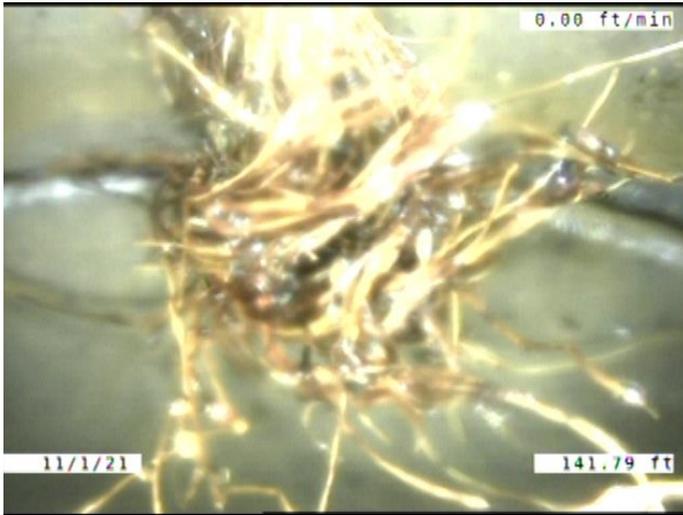
Code: **RMJ**
Description: **Roots Medium Joint**

Distance (ft): **141.8**
Structural Grade: **0**
O&M Grade: **3**
Clock Start/From: **9**
Clock To: **3**
1st Value:
2nd Value:
Value Percent: **5.000**
Continuous Index:
Within 8" of Joint: **YES**
Remarks:

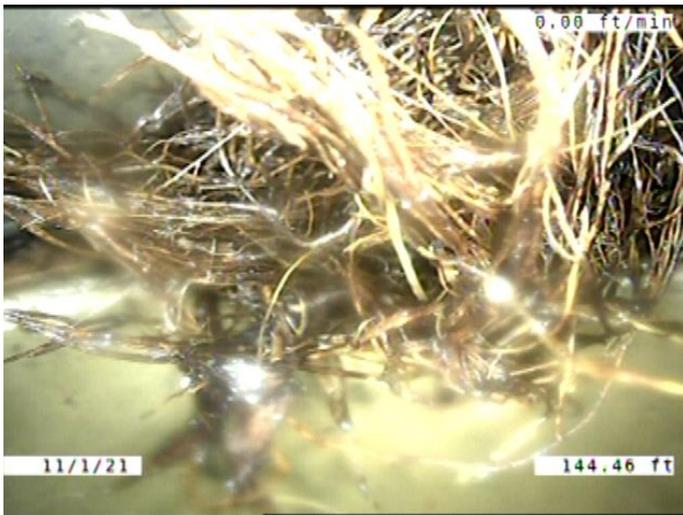
Code: **RMJ**
Description: **Roots Medium Joint**

Distance (ft): **144.5**
Structural Grade: **0**
O&M Grade: **3**
Clock Start/From: **9**
Clock To: **2**
1st Value:
2nd Value:
Value Percent: **5.000**
Continuous Index:
Within 8" of Joint: **YES**
Remarks:

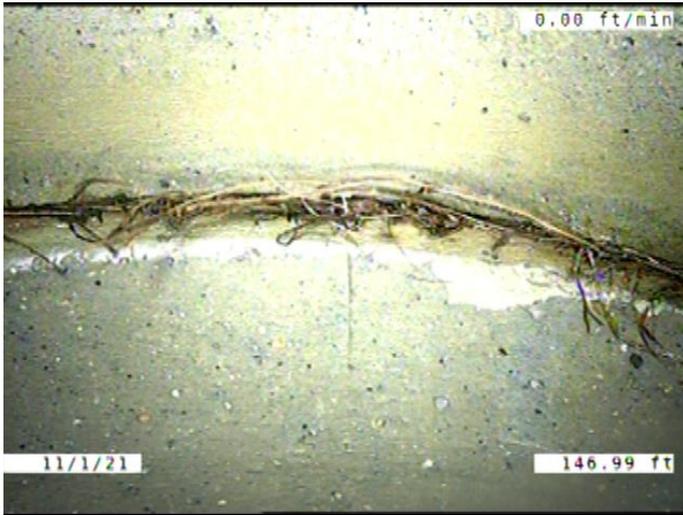
Code: **RFJ**
 Description: **Roots Fine Joint**

Distance (ft): **147.0**
 Structural Grade: **0**
 O&M Grade: **1**
 Clock Start/From: **12**
 Clock To: **3**
 1st Value:
 2nd Value:
 Value Percent:
 Continuous Index:
 Within 8" of Joint: **YES**
 Remarks:

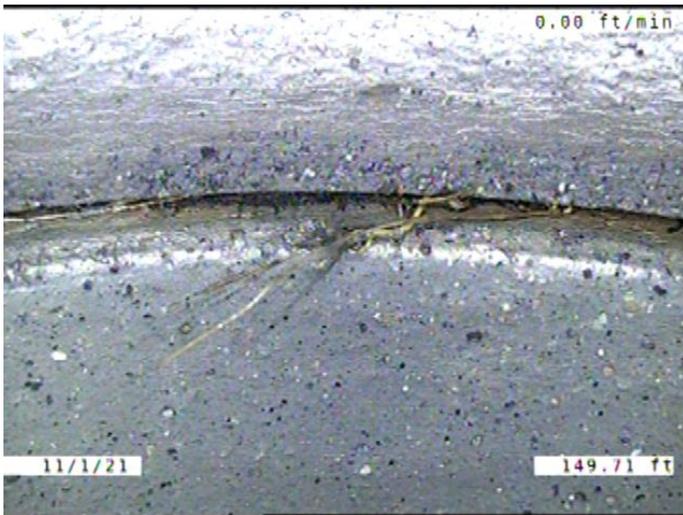
Code: **RFJ**
 Description: **Roots Fine Joint**

Distance (ft): **149.7**
 Structural Grade: **0**
 O&M Grade: **1**
 Clock Start/From: **10**
 Clock To: **2**
 1st Value:
 2nd Value:
 Value Percent:
 Continuous Index:
 Within 8" of Joint: **YES**
 Remarks:

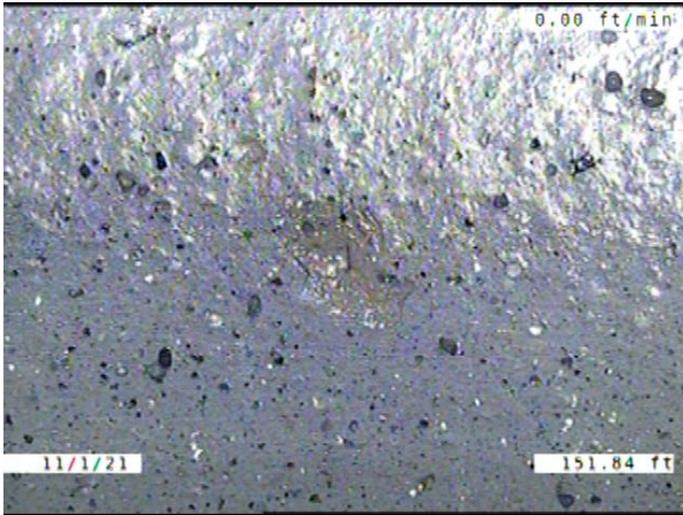
Code: **SSS**
Description: **Surface Damage Surface Spalling**

Distance (ft): **151.8**
Structural Grade: **2**
O&M Grade: **0**
Clock Start/From: **2**
Clock To:
1st Value:
2nd Value:
Value Percent:
Continuous Index:
Within 8" of Joint: **NO**
Remarks:

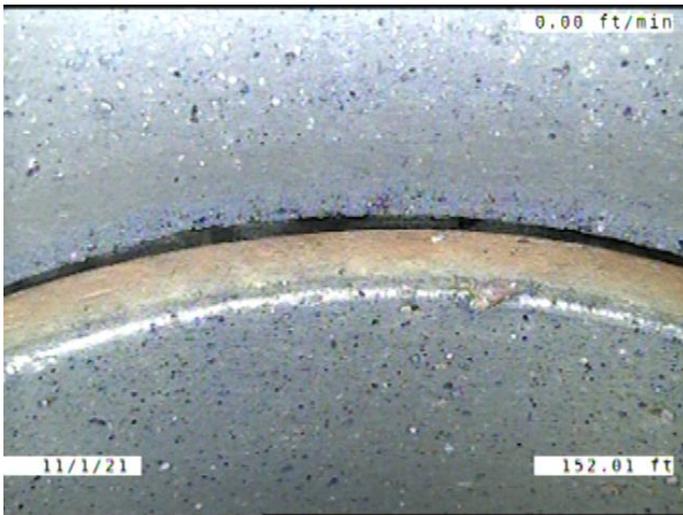
Code: **JOM**
Description: **Joint Offset Medium**

Distance (ft): **152.0**
Structural Grade: **3**
O&M Grade: **0**
Clock Start/From:
Clock To:
1st Value:
2nd Value:
Value Percent:
Continuous Index:
Within 8" of Joint: **NO**
Remarks:

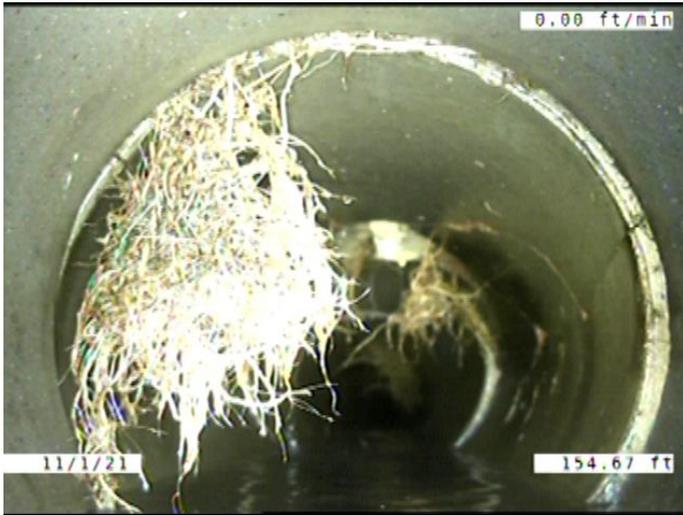
Code: **RMJ**
Description: **Roots Medium Joint**

Distance (ft): **154.7**
Structural Grade: **0**
O&M Grade: **3**
Clock Start/From: **9**
Clock To: **1**
1st Value:
2nd Value:
Value Percent: **25.000**
Continuous Index:
Within 8" of Joint: **YES**
Remarks:

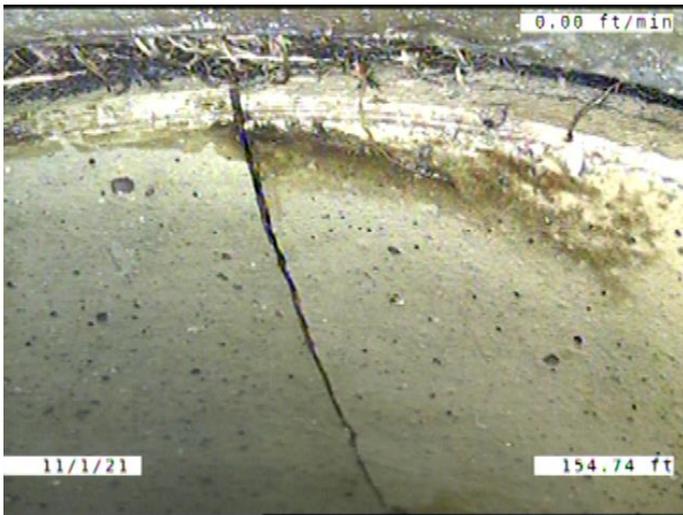
Code: **B**
Description: **Broken**

Distance (ft): **154.7**
Structural Grade: **4**
O&M Grade: **0**
Clock Start/From: **8**
Clock To: **4**
1st Value:
2nd Value:
Value Percent:
Continuous Index:
Within 8" of Joint: **YES**
Remarks:

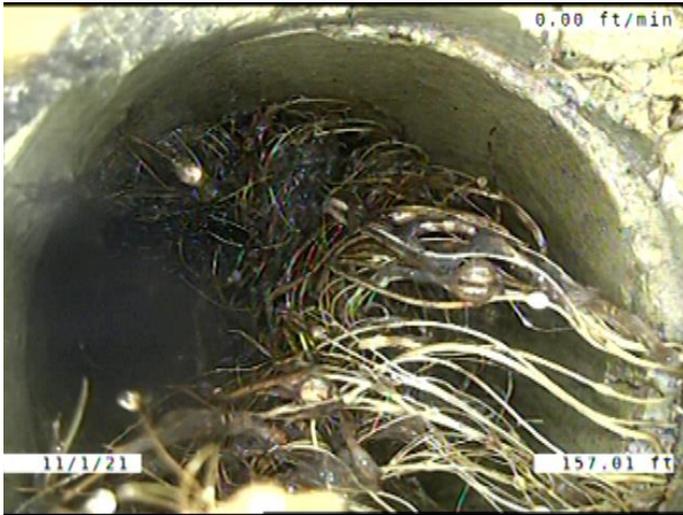
Code: **TBI**
 Description: **Tap Break-in Intruding**

Distance (ft): **157.0**
 Structural Grade: **0**
 O&M Grade: **2**
 Clock Start/From: **12**
 Clock To:
 1st Value: **4.000**
 2nd Value: **1.000**
 Value Percent:
 Continuous Index:
 Within 8" of Joint: **YES**
 Remarks: **CONSTANTLY RUNNING WATER. ROOTS GOWING INTO THE MAIN**

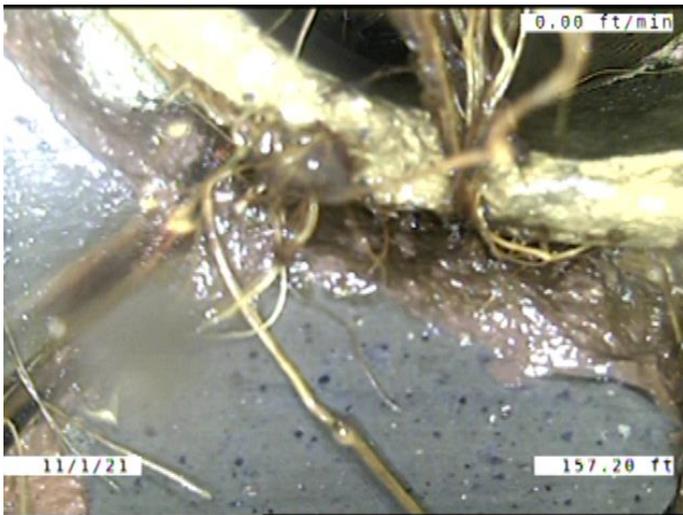
Code: **RFC**
 Description: **Roots Fine Connection**

Distance (ft): **157.2**
 Structural Grade: **0**
 O&M Grade: **1**
 Clock Start/From: **11**
 Clock To: **1**
 1st Value:
 2nd Value:
 Value Percent:
 Continuous Index:
 Within 8" of Joint: **NO**
 Remarks:

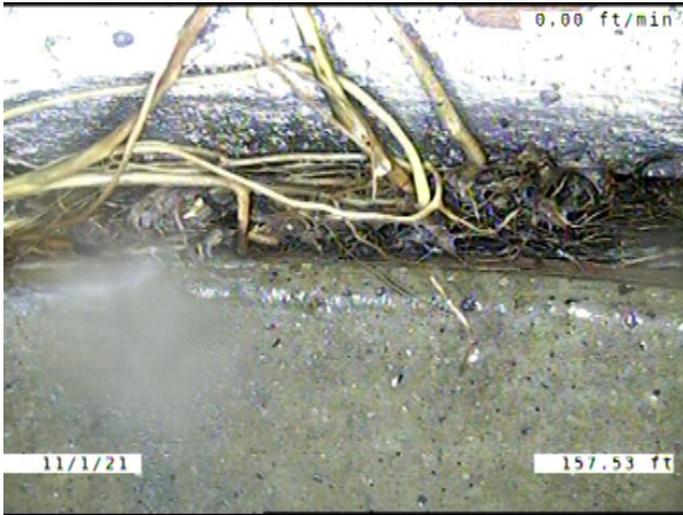
Code: **RFJ**
 Description: **Roots Fine Joint**

Distance (ft): **157.5**
 Structural Grade: **0**
 O&M Grade: **1**
 Clock Start/From: **9**
 Clock To: **3**
 1st Value:
 2nd Value:
 Value Percent:
 Continuous Index:
 Within 8" of Joint: **YES**
 Remarks:

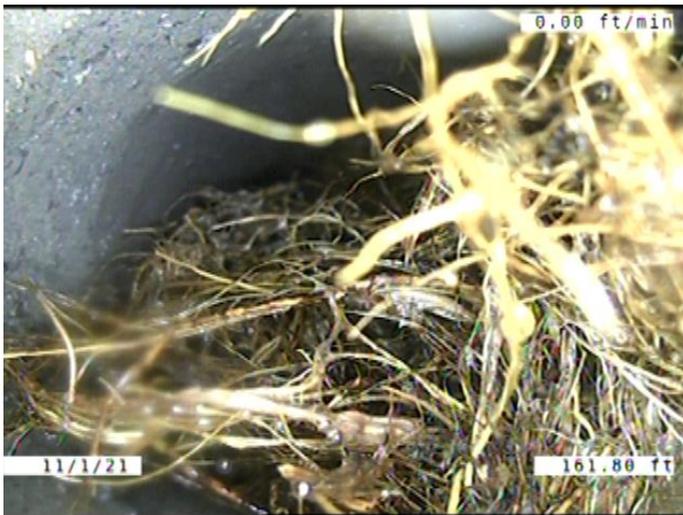
Code: **TFD**
 Description: **Tap Factory Defective**

Distance (ft): **161.8**
 Structural Grade: **0**
 O&M Grade: **3**
 Clock Start/From: **1**
 Clock To:
 1st Value: **4.000**
 2nd Value:
 Value Percent:
 Continuous Index:
 Within 8" of Joint: **YES**
 Remarks: **LOOKS TO BE 100% PLUGGED WITH ROOTS**

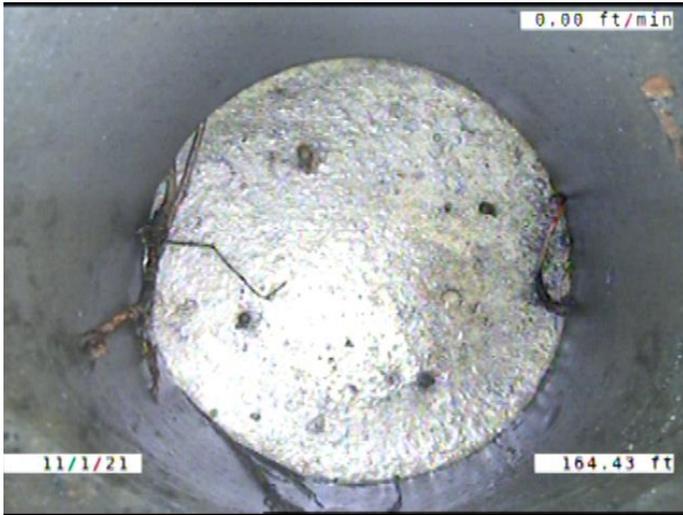
Code: **TFC**
 Description: **Tap Factory Capped**

Distance (ft): **164.4**
 Structural Grade: **0**
 O&M Grade: **0**
 Clock Start/From: **11**
 Clock To:
 1st Value: **4.000**
 2nd Value:
 Value Percent:
 Continuous Index:
 Within 8" of Joint: **YES**
 Remarks: **ROOTS GROWING AROUND THE CAP**

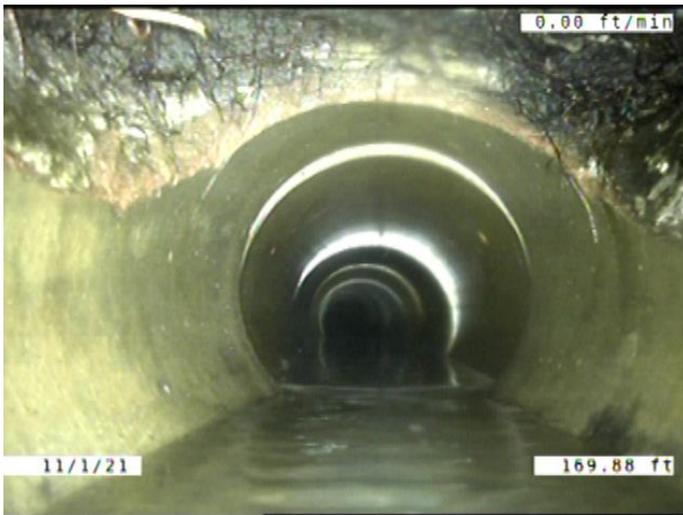
Code: **DSF**
 Description: **Deposits Settled Fine**

Distance (ft): **169.9**
 Structural Grade: **0**
 O&M Grade: **2**
 Clock Start/From: **5**
 Clock To: **7**
 1st Value:
 2nd Value:
 Value Percent: **5.000**
 Continuous Index: **F01**
 Within 8" of Joint: **YES**
 Remarks:
