Profile/Photo Observation Report

Street:	W CLEVELAND AVE & N COLORADO	Flow Control:	Not Controlled
City:	Hobart, IN	Year Renewed:	
Location:	Light Highway	Tape/Media #:	
Purpose:	Routine Assessment	Dia/Height:	12"
Use:	Sanitary	Material:	VCP
Drain Area:	NA	Lining:	
Category:	NA		
Comment:	P_C at 10 ft nothing visible grit in the pipe . Flow direction wrong		
Location Details:		Direction of Survey:	Upstream
US MH:	M-504-024	DS MH:	M-504-023
		Total Length Surveyed (ft):	11.6

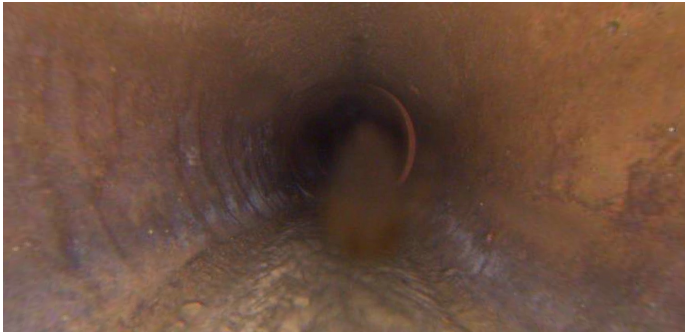
Code:	MWL
Description:	Water Level

Distance (ft):	.0
Structural Grade:	0
O&M Grade:	0
Clock Start/From:	
Clock To:	
1st Value:	
2nd Value:	
Value Percent:	5.000
Continuous Index:	
Within 8" of Joint:	NO
Remarks:

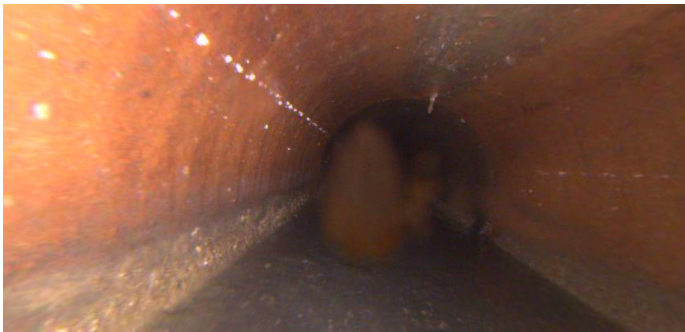
Code:	MSA
Description:	Abandoned Survey

Distance (ft):	11.6
Structural Grade:	0
O&M Grade:	0
Clock Start/From:	
Clock To:	
1st Value:	
2nd Value:	
Value Percent:	
Continuous Index:	
Within 8" of Joint:	NO
Remarks:	debris under water
