Profile/Photo Observation Report

| Street: | FOXCROFT STREET | Flow Control: | Not Controlled |
| City: | Hobart, IN | Year Renewed: | |
| US MH: | M-504-024 | DS MH: | M-504-023 |

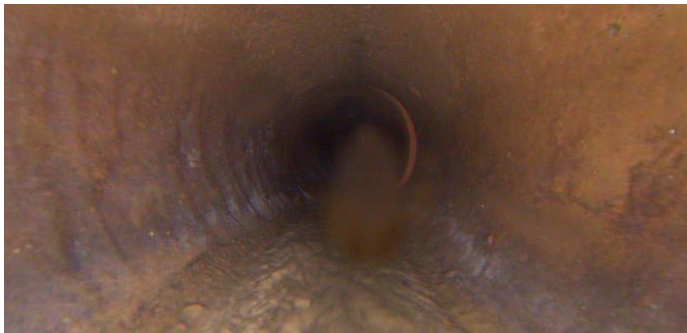
Code: **AMH**
 Description: **Manhole**
 Distance (ft): **.0**
 Structural Grade: **0**
 O&M Grade: **0**
 Clock Start/From:
 Clock To:
 1st Value:
 2nd Value:
 Value Percent:
 Continuous Index:
 Within 8" of Joint: **NO**
 Remarks: **M-504-023**

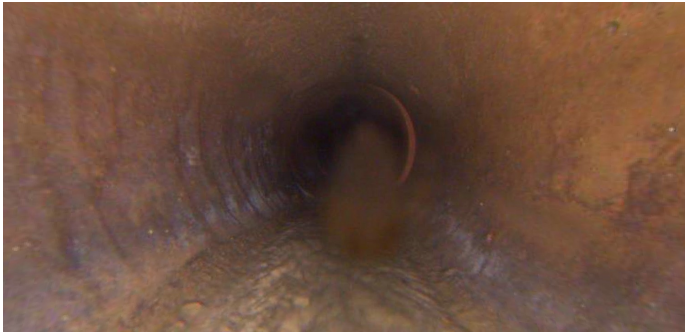
| Code: | MWL |
| Description: | Water Level |

| Distance (ft): | .0 |
| Value Percent: | 5.000 |

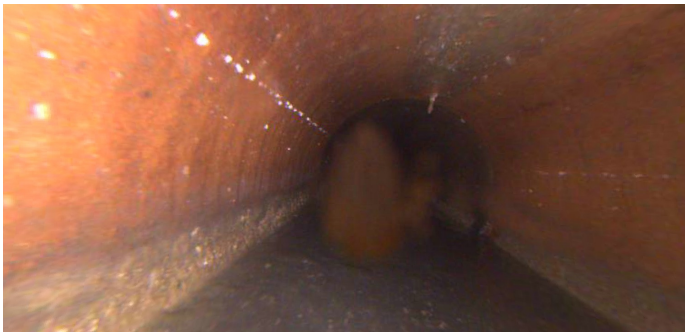
| Comment: | P_C at 10 ft nothing visible grit in the pipe . Flow direction wrong | | |

| Code: | MSA |
| Description: | Abandoned Survey |

| Distance (ft): | 11.6 |
| Remarks: | debris under water |
