Profile/Photo Observation Report

Street:	W CLEVELAND AVE & N COLORADO	Flow Control:	Not Controlled
City:	Hobart, IN	Year Renewed:	
Location:	Light Highway	Tape/Media #:	
Purpose:	Routine Assessment	Dia/Height:	12"
Use:	Sanitary	Material:	VCP
Drain Area:	NA	Lining:	
Category:	NA		
Comment:	P_C at 44 ft roots . Flow direction wrong		
Location Details:		Direction of Survey:	Downstream
US MH:	M-504-024	DS MH:	M-504-023
		Total Length Surveyed (ft):	44.9

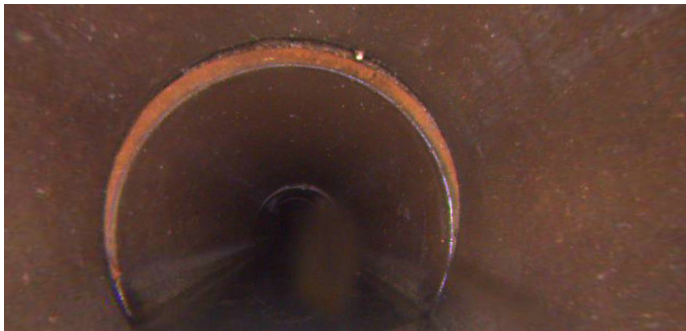
Code: **AMH**
Description: **Manhole**

Distance (ft): **.0**
Structural Grade: **0**
O&M Grade: **0**
Clock Start/From:
Clock To:
1st Value:
2nd Value:
Value Percent:
Continuous Index:
Within 8" of Joint: **NO**
Remarks: **M-504-024**

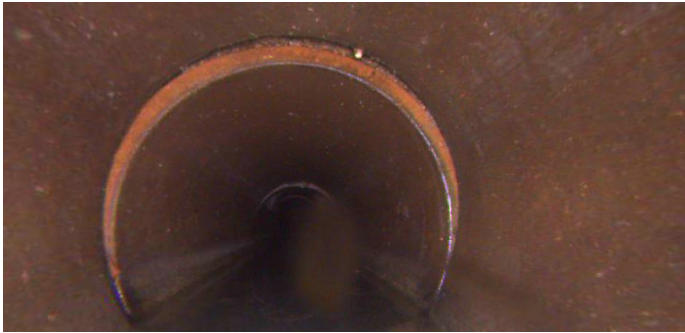
Code:	MWL
Description:	Water Level

Distance (ft):	.0
Structural Grade:	0
O&M Grade:	0
Clock Start/From:	
Clock To:	
1st Value:	
2nd Value:	
Value Percent:	5.000
Continuous Index:	
Within 8" of Joint:	NO
Remarks:

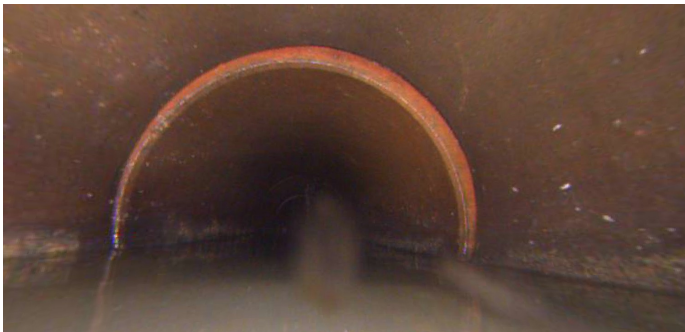
Code:	MWL
Description:	Water Level

Distance (ft):	34.6
Structural Grade:	0
O&M Grade:	0
Clock Start/From:	
Clock To:	
1st Value:	
2nd Value:	
Value Percent:	30.000
Continuous Index:	
Within 8" of Joint:	NO
Remarks:

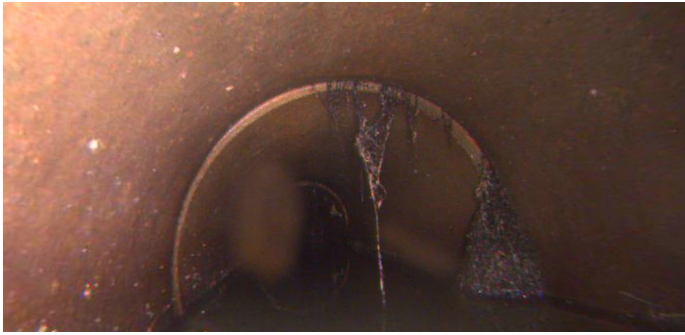
Code: **RMJ**
Description: **Roots Medium Joint**

Distance (ft): **37.2**
Structural Grade: **0**
O&M Grade: **3**
Clock Start/From: **12**
Clock To: **4**
1st Value:
2nd Value:
Value Percent: **5.000**
Continuous Index:
Within 8" of Joint: **YES**
Remarks:

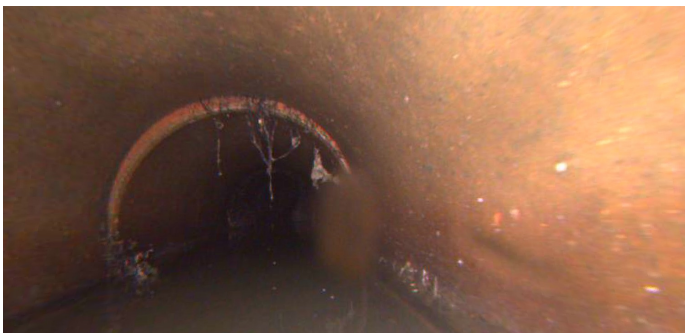
Code: **RFJ**
Description: **Roots Fine Joint**

Distance (ft): **39.2**
Structural Grade: **0**
O&M Grade: **1**
Clock Start/From: **8**
Clock To: **4**
1st Value:
2nd Value:
Value Percent:
Continuous Index:
Within 8" of Joint: **YES**
Remarks:

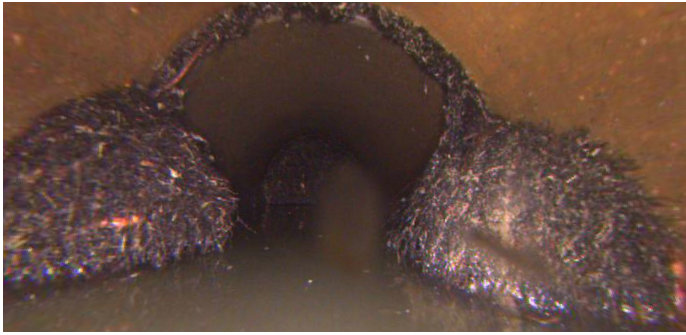
Code: **RMJ**
Description: **Roots Medium Joint**

Distance (ft): **42.3**
Structural Grade: **0**
O&M Grade: **3**
Clock Start/From: **8**
Clock To: **4**
1st Value:
2nd Value:
Value Percent: **20.000**
Continuous Index:
Within 8" of Joint: **YES**
Remarks:

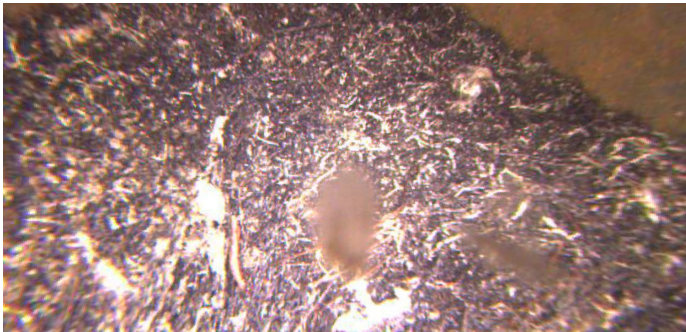
Code: **RBJ**
Description: **Roots Ball Joint**

Distance (ft): **44.9**
Structural Grade: **0**
O&M Grade: **4**
Clock Start/From: **12**
Clock To: **12**
1st Value:
2nd Value:
Value Percent: **100.000**
Continuous Index:
Within 8" of Joint: **YES**
Remarks:

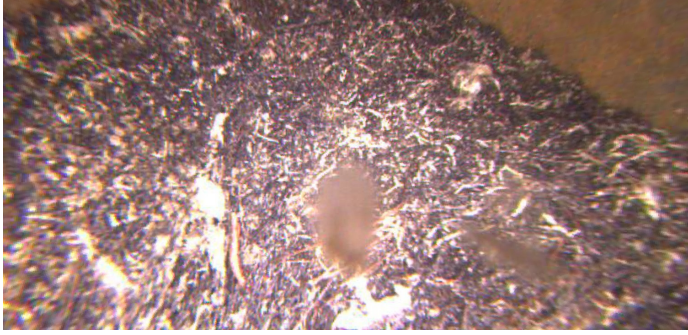
Code:	MSA
Description:	Abandoned Survey
Distance (ft):	44.9
Structural Grade:	0
O&M Grade:	0
Clock Start/From:	
Clock To:	
1st Value:	
2nd Value:	
Value Percent:	
Continuous Index:	
Within 8" of Joint:	NO
Remarks:	roots
