Profile/Photo Observation Report

Date:	11/01/2021	Weather:		Coding:	PACP 7.0
Pipe Length (ft):	153.3	Owner:	City of Hobart	Pre Clean:	Heavy Cleaning
P.O.#:	YES502259	Surveyor:	S. Bucklin	PSR:	P-504-023-024
Customer:	City of Hobart	Clean Date:	10/28/2021	Shape:	C

Street:	West Cleveland Avenue	Flow Control:	Not Controlled
City:	Hobart, IN	Year Renewed:	
Location:	Local rural streets with light traffic, t	Tape/Media #:	
Purpose:	Routine Assessment	Dia/Height:	12"
Use:	Sanitary Sewage Pipe	Material:	VCP
Drain Area:		Lining:	None
Category:	NA		
Comment:			
Location Details:		Direction of Survey:	Downstream
US MH:	M-504-024	DS MH:	M-504-023
		Total Length Surveyed (ft):	153.3

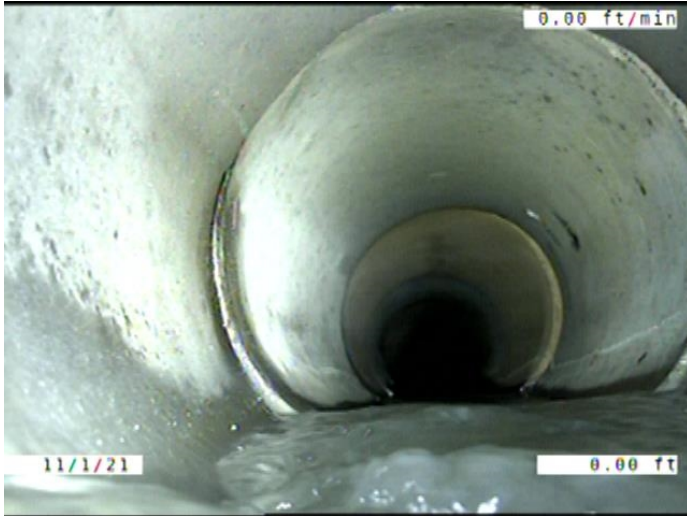
Code: **MWL**
Description: **Miscellaneous Water Level**

Distance (ft): **.0**
Structural Grade: **0**
O&M Grade: **0**
Clock Start/From:
Clock To:
1st Value:
2nd Value:
Value Percent: **5.000**
Continuous Index:
Within 8" of Joint: **NO**
Remarks:

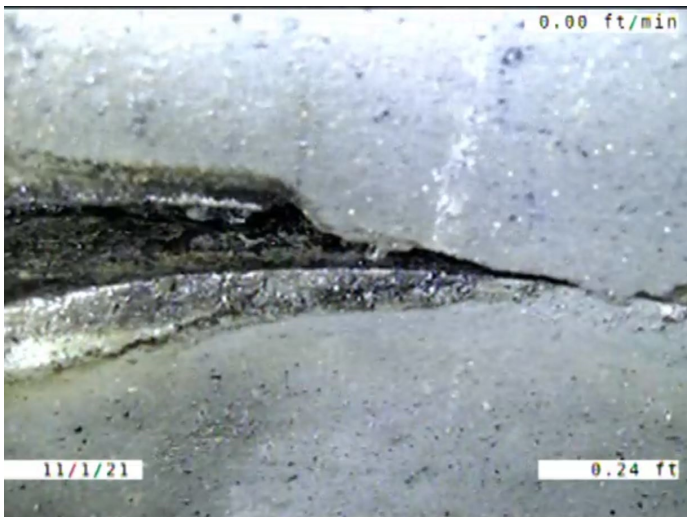
Code: **SMW**
Description: **Surface Damage Missing Wall**

Distance (ft): **.2**
Structural Grade: **5**
O&M Grade: **0**
Clock Start/From: **8**
Clock To: **3**
1st Value:
2nd Value:
Value Percent:
Continuous Index:
Within 8" of Joint: **YES**
Remarks:

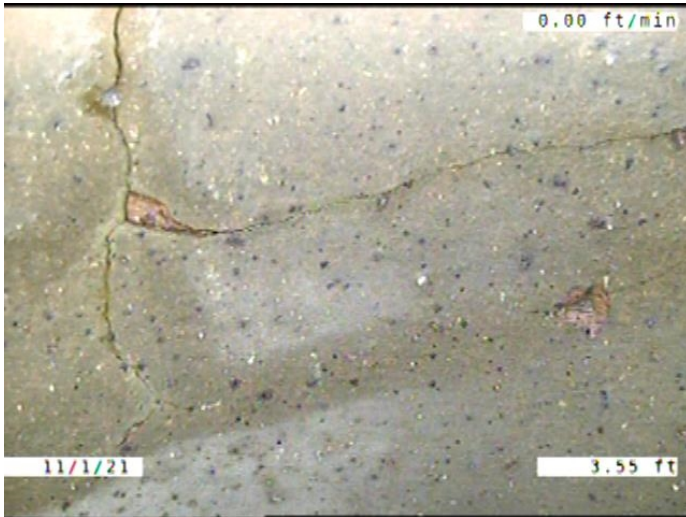
Code: **FM**
Description: **Fracture Multiple**

Distance (ft): **3.5**
Structural Grade: **4**
O&M Grade: **0**
Clock Start/From: **10**
Clock To: **1**
1st Value:
2nd Value:
Value Percent:
Continuous Index:
Within 8" of Joint: **YES**
Remarks:

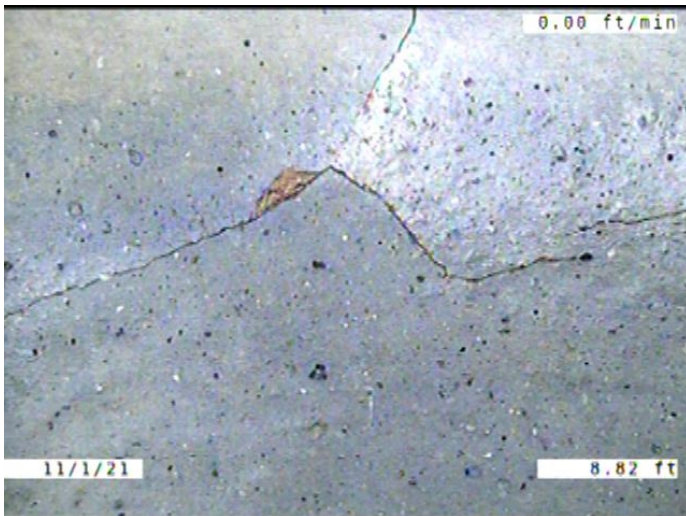
Code: **FM**
Description: **Fracture Multiple**

Distance (ft): **8.8**
Structural Grade: **4**
O&M Grade: **0**
Clock Start/From: **10**
Clock To: **3**
1st Value:
2nd Value:
Value Percent:
Continuous Index:
Within 8" of Joint: **YES**
Remarks:

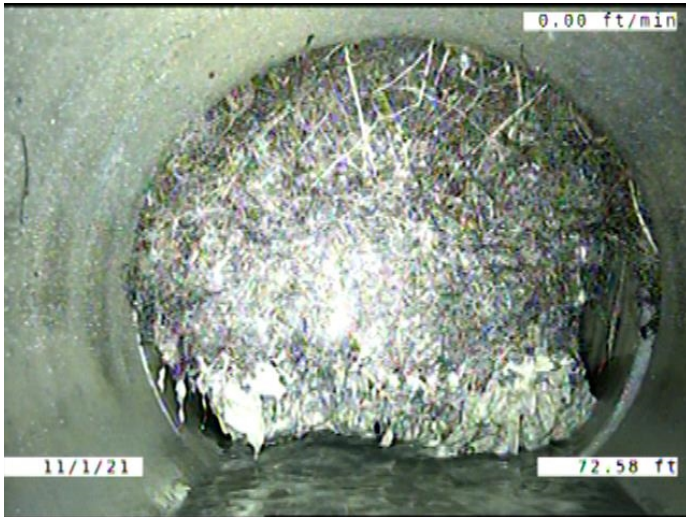
Code: **RBJ**
 Description: **Roots Ball Joint**

Distance (ft): **72.6**
 Structural Grade: **0**
 O&M Grade: **4**
 Clock Start/From: **8**
 Clock To: **3**
 1st Value:
 2nd Value:
 Value Percent: **95.000**
 Continuous Index:
 Within 8" of Joint: **YES**
 Remarks:

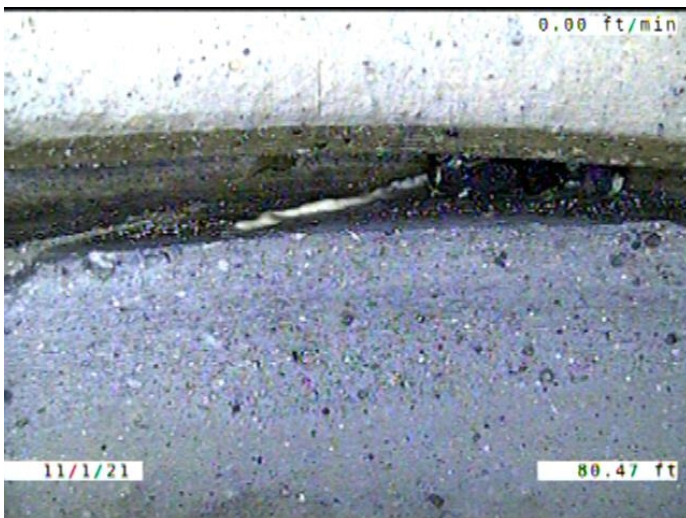
Code: **RFJ**
 Description: **Roots Fine Joint**

Distance (ft): **80.5**
 Structural Grade: **0**
 O&M Grade: **1**
 Clock Start/From: **10**
 Clock To:
 1st Value:
 2nd Value:
 Value Percent:
 Continuous Index:
 Within 8" of Joint: **YES**
 Remarks:

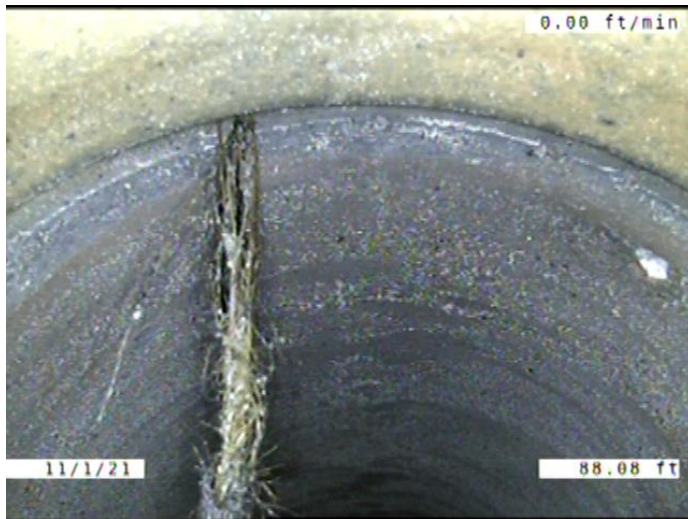
Code: **RMJ**
 Description: **Roots Medium Joint**

Distance (ft): **88.1**
 Structural Grade: **0**
 O&M Grade: **3**
 Clock Start/From: **11**
 Clock To: **12**
 1st Value:
 2nd Value:
 Value Percent: **5.000**
 Continuous Index:
 Within 8" of Joint: **YES**
 Remarks:

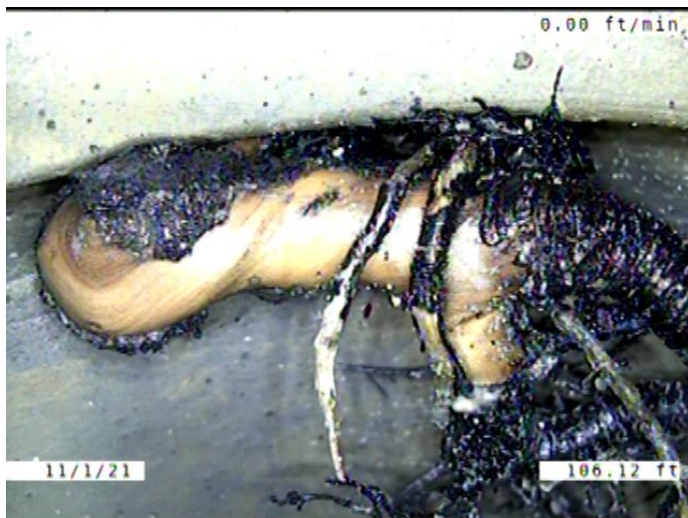
Code: **RTJ**
 Description: **Roots Tap Joint**

Distance (ft): **106.1**
 Structural Grade: **0**
 O&M Grade: **2**
 Clock Start/From: **8**
 Clock To: **2**
 1st Value:
 2nd Value:
 Value Percent: **5.000**
 Continuous Index:
 Within 8" of Joint: **YES**
 Remarks:

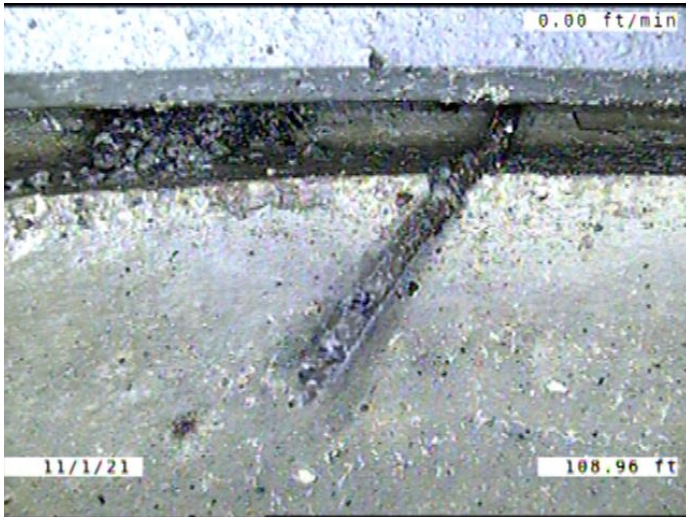
Code: **RFJ**
 Description: **Roots Fine Joint**

Distance (ft): **109.0**
 Structural Grade: **0**
 O&M Grade: **1**
 Clock Start/From: **10**
 Clock To: **11**
 1st Value:
 2nd Value:
 Value Percent:
 Continuous Index:
 Within 8" of Joint: **YES**
 Remarks:

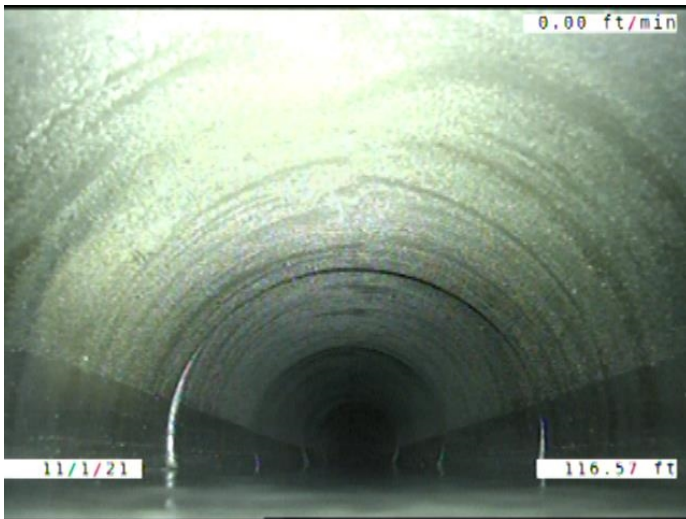
Code: **MWL**
 Description: **Miscellaneous Water Level**

Distance (ft): **116.6**
 Structural Grade: **0**
 O&M Grade: **0**
 Clock Start/From:
 Clock To:
 1st Value:
 2nd Value:
 Value Percent: **15.000**
 Continuous Index:
 Within 8" of Joint: **NO**
 Remarks:

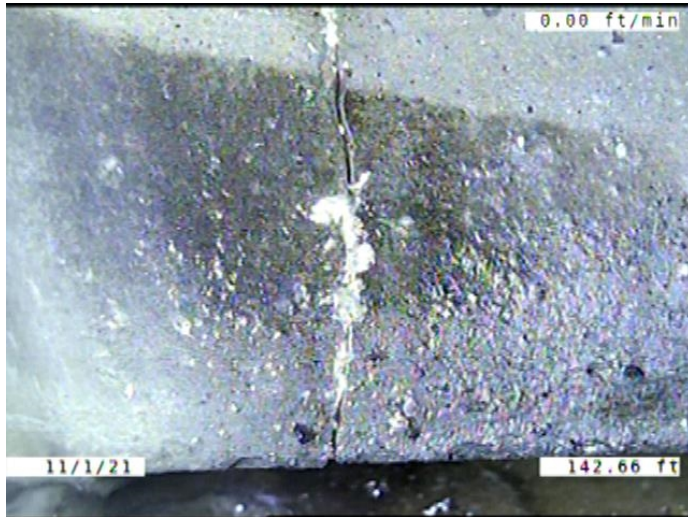
Code: **FM**
 Description: **Fracture Multiple**

Distance (ft): **142.7**
 Structural Grade: **4**
 O&M Grade: **0**
 Clock Start/From: **3**
 Clock To: **9**
 1st Value:
 2nd Value:
 Value Percent:
 Continuous Index:
 Within 8" of Joint: **YES**
 Remarks:

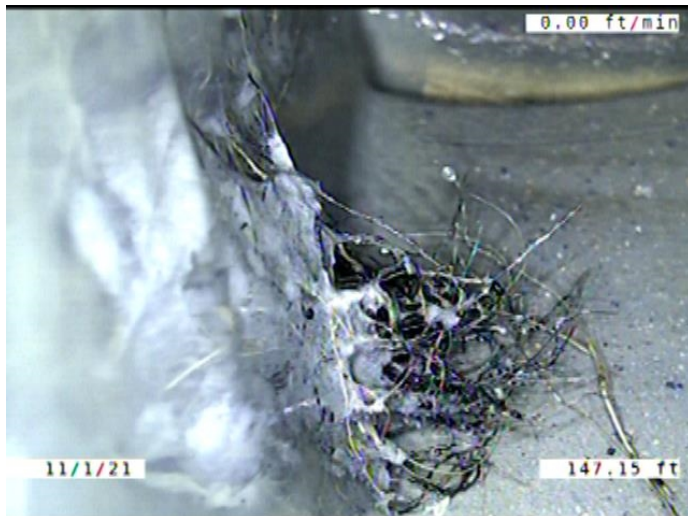
Code: **OBZ**
 Description: **Obstruction Other**

Distance (ft): **147.2**
 Structural Grade: **0**
 O&M Grade: **2**
 Clock Start/From: **4**
 Clock To: **5**
 1st Value:
 2nd Value:
 Value Percent: **5.000**
 Continuous Index:
 Within 8" of Joint: **YES**
 Remarks: **ROOTS THAT HAVE BEEN CUT**

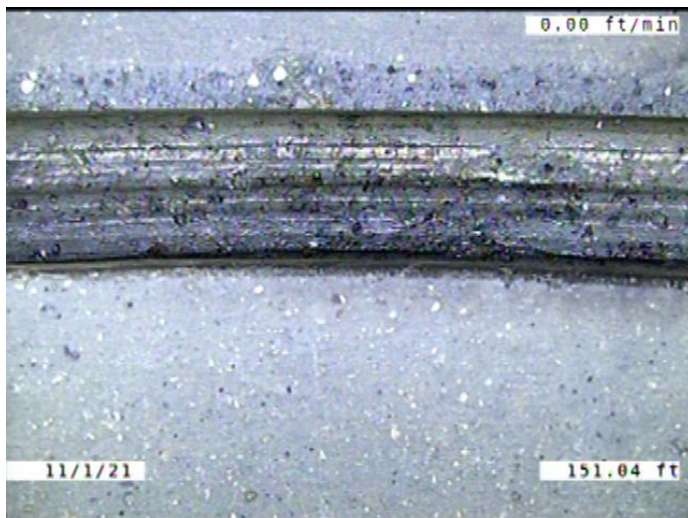
Code: **JAM**
 Description: **Joint Angular Medium**

Distance (ft): **151.0**
 Structural Grade: **3**
 O&M Grade: **0**
 Clock Start/From:
 Clock To:
 1st Value:
 2nd Value:
 Value Percent:
 Continuous Index:
 Within 8" of Joint: **NO**
 Remarks:
