Profile/Photo Observation Report

Date:	11/01/2021	Weather:		Coding:	PACP 7.0
Pipe Length (ft):	153.3	Owner:	City of Hobart	Pre Clean:	Heavy Cleaning
P.O.#:	YES502259	Surveyor:	S. Bucklin	PSR:	P-504-023-024
Customer:	City of Hobart	Clean Date:	10/28/2021	Shape:	C

Street:	West Cleveland Avenue	Flow Control:	Not Controlled
City:	Hobart, IN	Year Renewed:	
Location:	Local rural streets with light traffic, t	Tape/Media #:	
Purpose:	Routine Assessment	Dia/Height:	12"
Use:	Sanitary Sewage Pipe	Material:	VCP
Drain Area:		Lining:	None
Category:	NA		
Comment:			
Location Details:		Direction of Survey:	Downstream
US MH:	M-504-024	DS MH:	M-504-023
		Total Length Surveyed (ft):	153.3

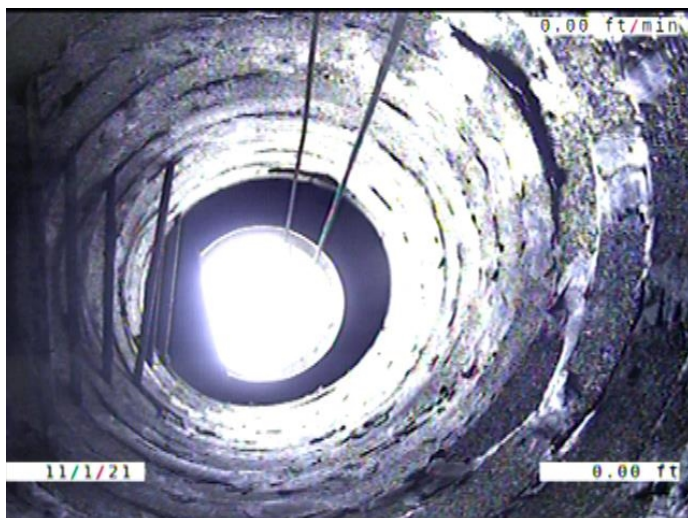
Code: **AMH**
 Description: **Manhole**

Distance (ft): **.0**
 Structural Grade: **0**
 O&M Grade: **0**
 Clock Start/From:
 Clock To:
 1st Value:
 2nd Value:
 Value Percent:
 Continuous Index:
 Within 8" of Joint: **NO**
 Remarks: **M-504-024**

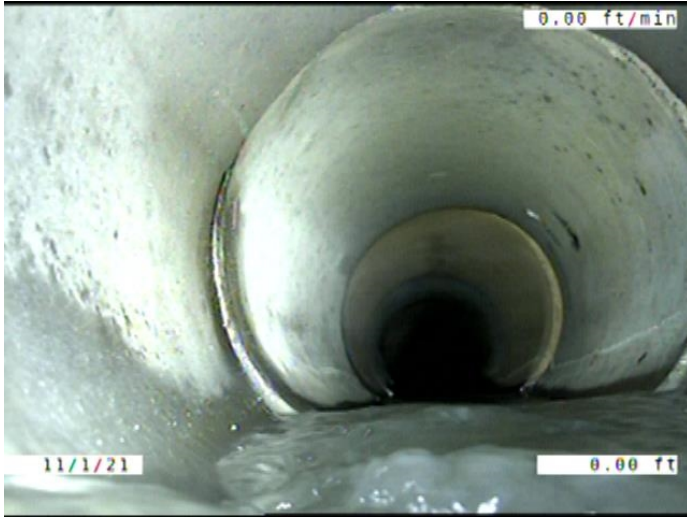
Code: **MWL**
Description: **Miscellaneous Water Level**

Distance (ft): **.0**
Structural Grade: **0**
O&M Grade: **0**
Clock Start/From:
Clock To:
1st Value:
2nd Value:
Value Percent: **5.000**
Continuous Index:
Within 8" of Joint: **NO**
Remarks:

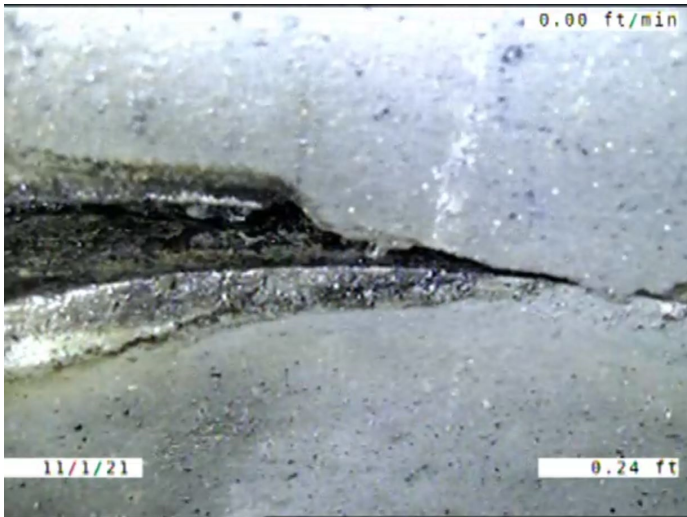
Code: **SMW**
Description: **Surface Damage Missing Wall**

Distance (ft): **.2**
Structural Grade: **5**
O&M Grade: **0**
Clock Start/From: **8**
Clock To: **3**
1st Value:
2nd Value:
Value Percent:
Continuous Index:
Within 8" of Joint: **YES**
Remarks:

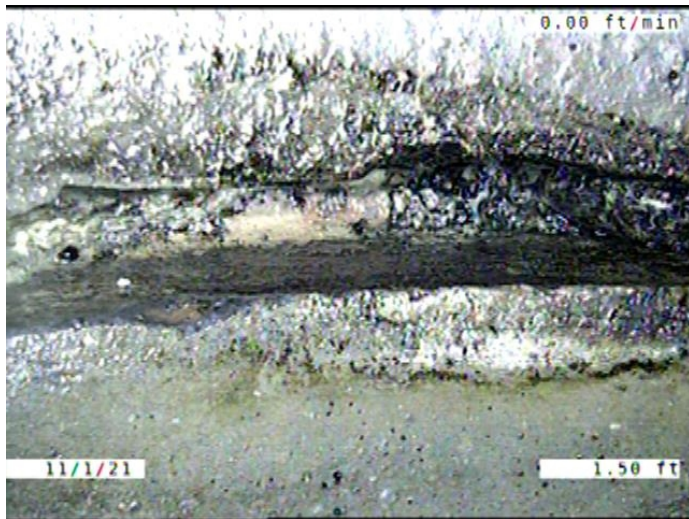
Code: **ISJ**
 Description: **Infiltration Stain Joint**

Distance (ft): **1.5**
 Structural Grade: **0**
 O&M Grade: **1**
 Clock Start/From: **8**
 Clock To: **10**
 1st Value:
 2nd Value:
 Value Percent:
 Continuous Index:
 Within 8" of Joint: **YES**
 Remarks:

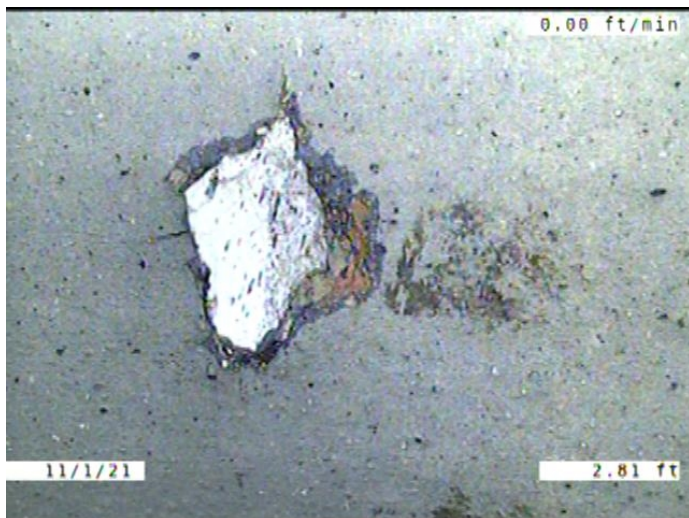
Code: **H**
 Description: **Hole**

Distance (ft): **2.8**
 Structural Grade: **4**
 O&M Grade: **0**
 Clock Start/From: **2**
 Clock To:
 1st Value:
 2nd Value:
 Value Percent:
 Continuous Index:
 Within 8" of Joint: **NO**
 Remarks:

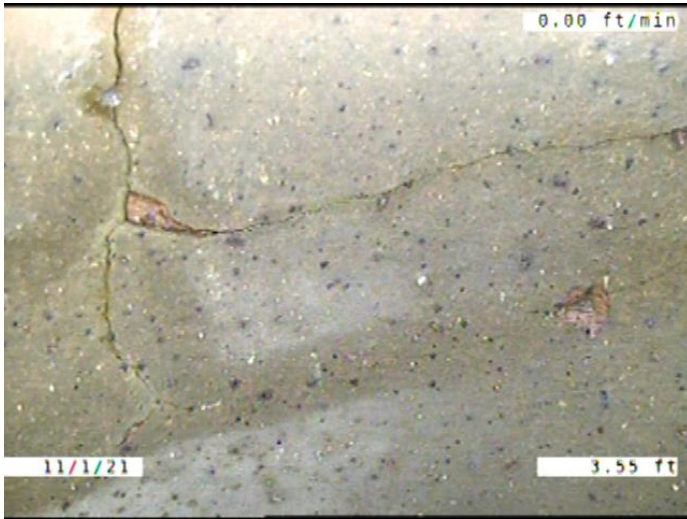
Code: **FM**
Description: **Fracture Multiple**

Distance (ft): **3.5**
Structural Grade: **4**
O&M Grade: **0**
Clock Start/From: **10**
Clock To: **1**
1st Value:
2nd Value:
Value Percent:
Continuous Index:
Within 8" of Joint: **YES**
Remarks:

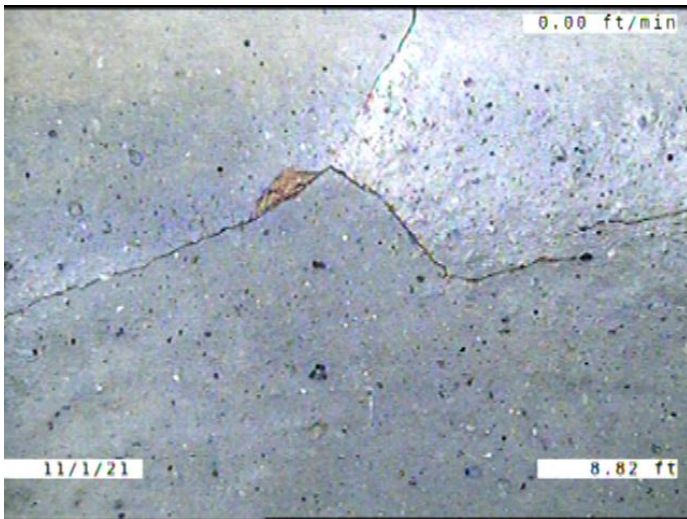
Code: **FM**
Description: **Fracture Multiple**

Distance (ft): **8.8**
Structural Grade: **4**
O&M Grade: **0**
Clock Start/From: **10**
Clock To: **3**
1st Value:
2nd Value:
Value Percent:
Continuous Index:
Within 8" of Joint: **YES**
Remarks:

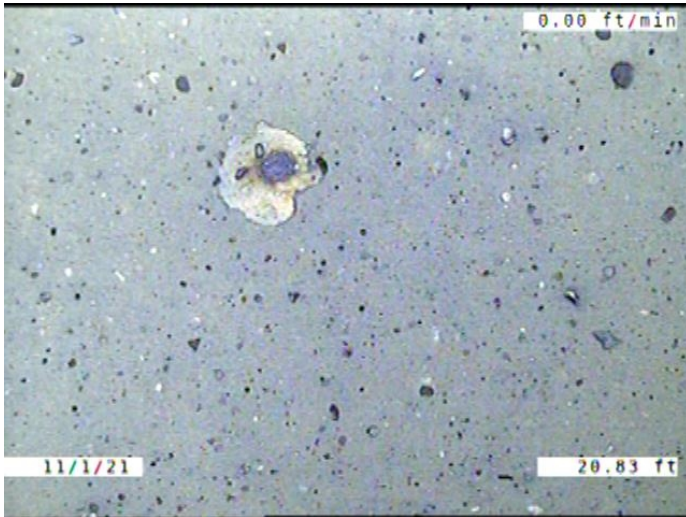
Code: **SSS**
 Description: **Surface Damage Surface Spalling**

Distance (ft): **20.8**
 Structural Grade: **2**
 O&M Grade: **0**
 Clock Start/From: **10**
 Clock To:
 1st Value:
 2nd Value:
 Value Percent:
 Continuous Index:
 Within 8" of Joint: **YES**
 Remarks:

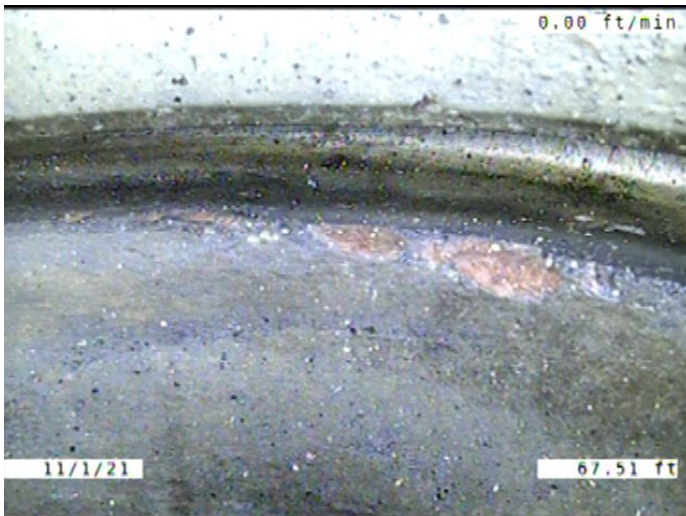
Code: **SZ**
 Description: **Surface Damage Other**

Distance (ft): **67.5**
 Structural Grade: **0**
 O&M Grade: **0**
 Clock Start/From: **2**
 Clock To: **3**
 1st Value:
 2nd Value:
 Value Percent:
 Continuous Index:
 Within 8" of Joint: **YES**
 Remarks: **A FEW PIECES CHIPPED AWAY FROM THE JOINT**

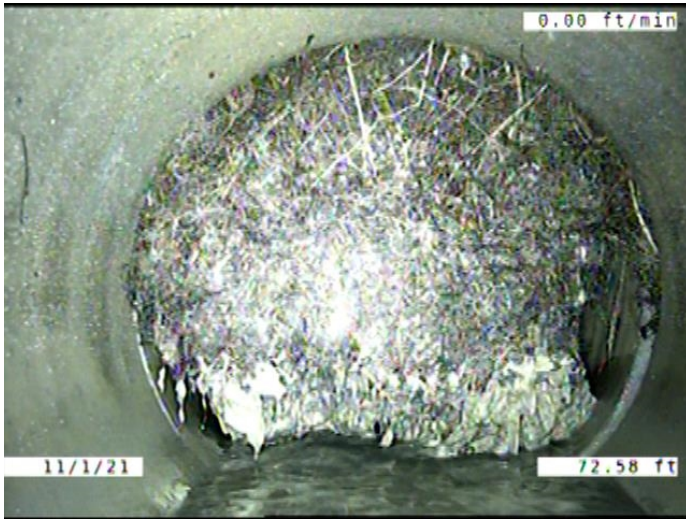
Code: **RBJ**
Description: **Roots Ball Joint**

Distance (ft): **72.6**
Structural Grade: **0**
O&M Grade: **4**
Clock Start/From: **8**
Clock To: **3**
1st Value:
2nd Value:
Value Percent: **95.000**
Continuous Index:
Within 8" of Joint: **YES**
Remarks:

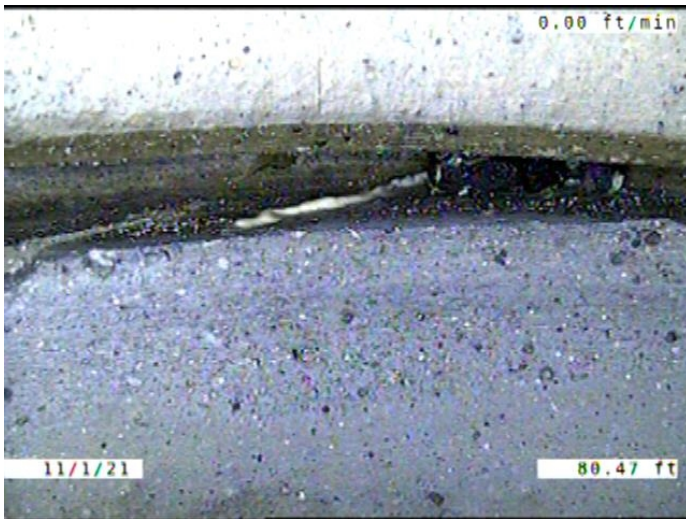
Code: **RFJ**
Description: **Roots Fine Joint**

Distance (ft): **80.5**
Structural Grade: **0**
O&M Grade: **1**
Clock Start/From: **10**
Clock To:
1st Value:
2nd Value:
Value Percent:
Continuous Index:
Within 8" of Joint: **YES**
Remarks:

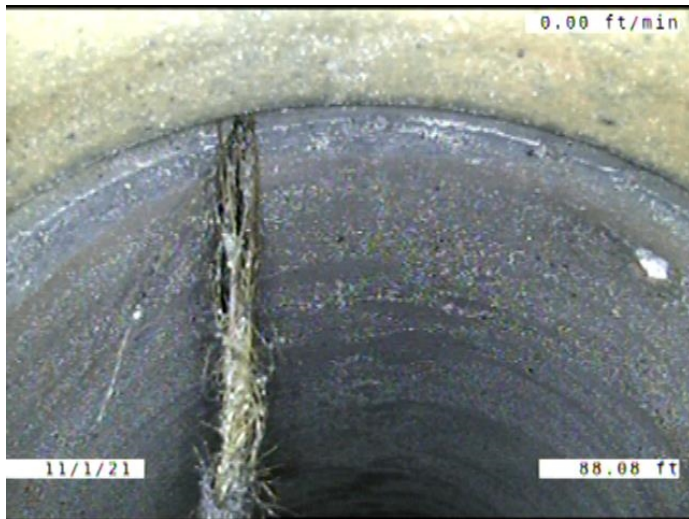
Code: **RMJ**
 Description: **Roots Medium Joint**

Distance (ft): **88.1**
 Structural Grade: **0**
 O&M Grade: **3**
 Clock Start/From: **11**
 Clock To: **12**
 1st Value:
 2nd Value:
 Value Percent: **5.000**
 Continuous Index:
 Within 8" of Joint: **YES**
 Remarks:

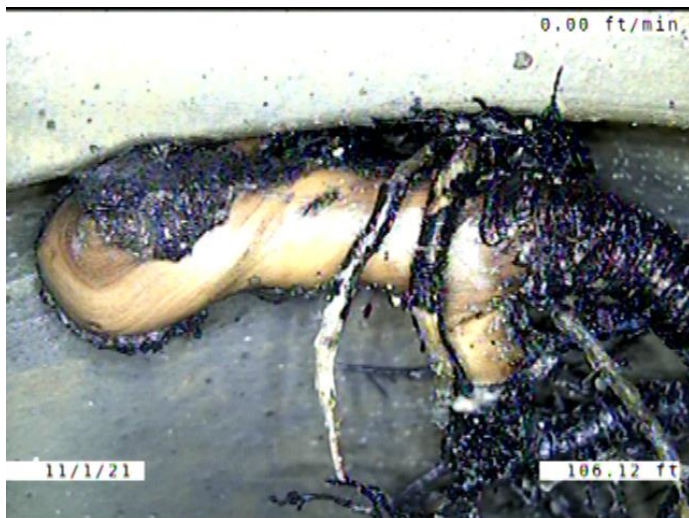
Code: **RTJ**
 Description: **Roots Tap Joint**

Distance (ft): **106.1**
 Structural Grade: **0**
 O&M Grade: **2**
 Clock Start/From: **8**
 Clock To: **2**
 1st Value:
 2nd Value:
 Value Percent: **5.000**
 Continuous Index:
 Within 8" of Joint: **YES**
 Remarks:

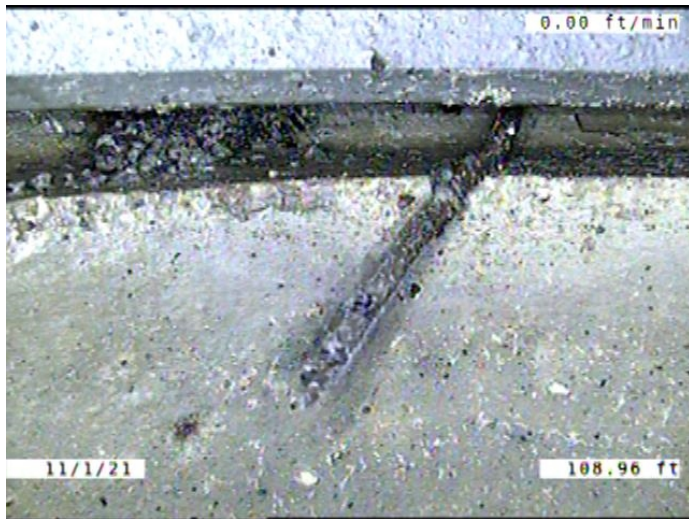
Code: **RFJ**
 Description: **Roots Fine Joint**

Distance (ft): **109.0**
 Structural Grade: **0**
 O&M Grade: **1**
 Clock Start/From: **10**
 Clock To: **11**
 1st Value:
 2nd Value:
 Value Percent:
 Continuous Index:
 Within 8" of Joint: **YES**
 Remarks:

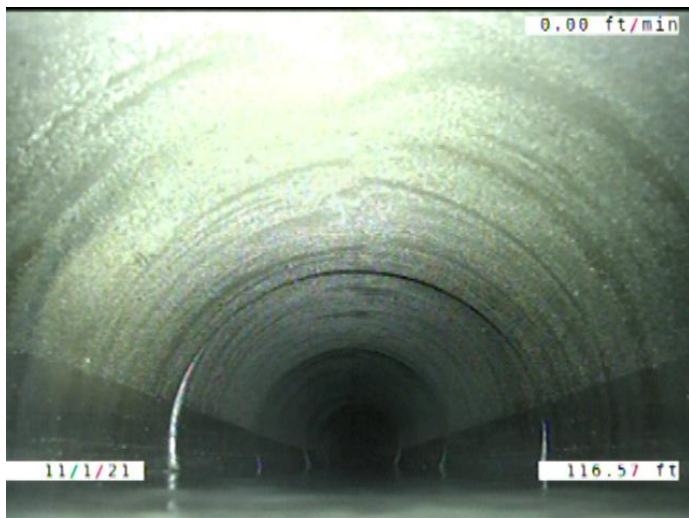
Code: **MWL**
 Description: **Miscellaneous Water Level**

Distance (ft): **116.6**
 Structural Grade: **0**
 O&M Grade: **0**
 Clock Start/From:
 Clock To:
 1st Value:
 2nd Value:
 Value Percent: **15.000**
 Continuous Index:
 Within 8" of Joint: **NO**
 Remarks:

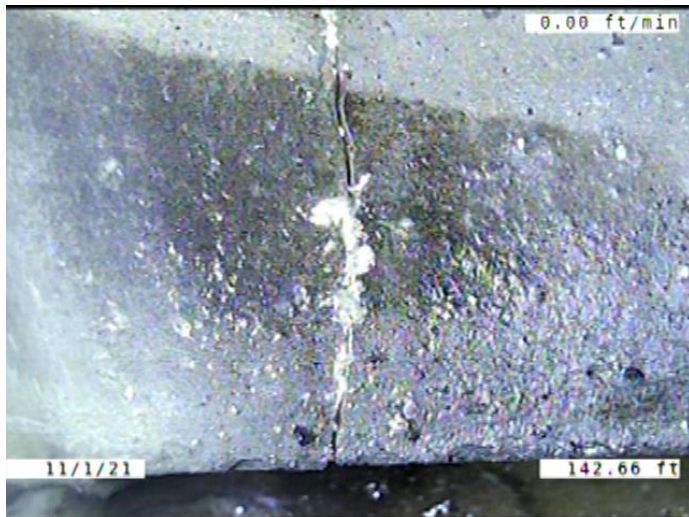
Code: **FM**
 Description: **Fracture Multiple**

Distance (ft): **142.7**
 Structural Grade: **4**
 O&M Grade: **0**
 Clock Start/From: **3**
 Clock To: **9**
 1st Value:
 2nd Value:
 Value Percent:
 Continuous Index:
 Within 8" of Joint: **YES**
 Remarks:

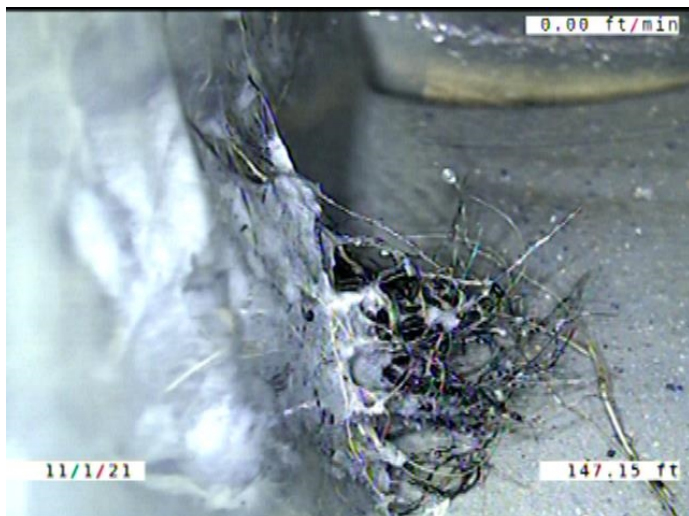
Code: **OBZ**
 Description: **Obstruction Other**

Distance (ft): **147.2**
 Structural Grade: **0**
 O&M Grade: **2**
 Clock Start/From: **4**
 Clock To: **5**
 1st Value:
 2nd Value:
 Value Percent: **5.000**
 Continuous Index:
 Within 8" of Joint: **YES**
 Remarks: **ROOTS THAT HAVE BEEN CUT**

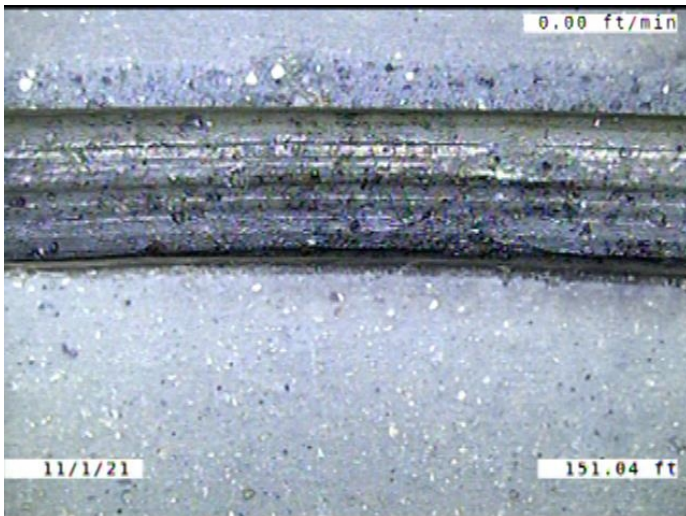
Code: **JAM**
 Description: **Joint Angular Medium**

Distance (ft): **151.0**
 Structural Grade: **3**
 O&M Grade: **0**
 Clock Start/From:
 Clock To:
 1st Value:
 2nd Value:
 Value Percent:
 Continuous Index:
 Within 8" of Joint: **NO**
 Remarks:

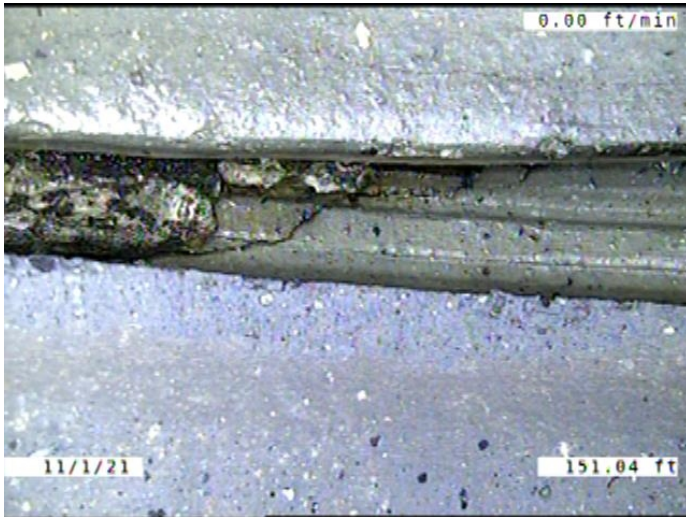
Code: **CS**
 Description: **Crack Spiral**

Distance (ft): **151.0**
 Structural Grade: **2**
 O&M Grade: **0**
 Clock Start/From: **9**
 Clock To: **10**
 1st Value:
 2nd Value:
 Value Percent:
 Continuous Index:
 Within 8" of Joint: **YES**
 Remarks:

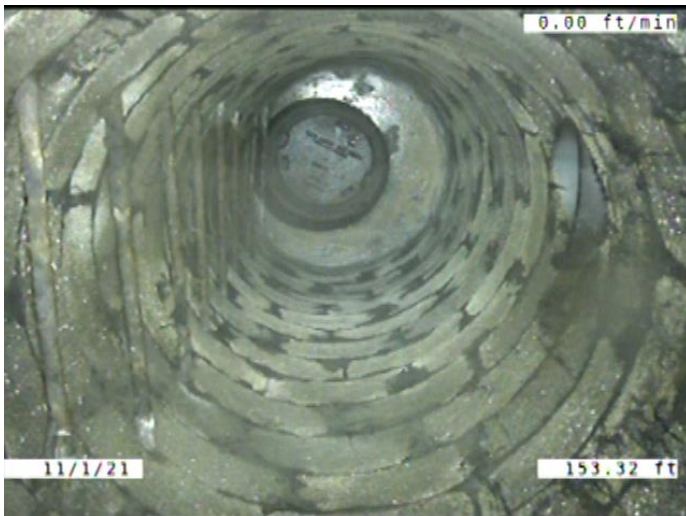
Code: **AMH**
 Description: **Manhole**

Distance (ft): **153.3**
 Structural Grade: **0**
 O&M Grade: **0**
 Clock Start/From:
 Clock To:
 1st Value:
 2nd Value:
 Value Percent:
 Continuous Index:
 Within 8" of Joint: **NO**
 Remarks: **M-504-023**
