RedZone  
ROBOTICS

| Street: | North Colorado Street | | Flow Control: | Not Controlled | |
| City: | Hobart, IN | | Year Renewed: | | |
| US MH: | M-504-024 | DS MH: | M-504-038 | Total Length Surveyed (ft): | 155.9 |

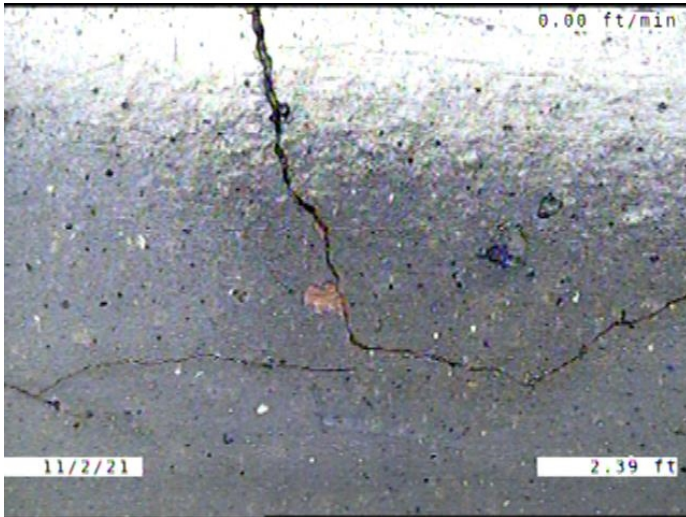
Code: **FM**  
 Description: **Fracture Multiple**

Distance (ft): **2.4**  
 Structural Grade: **4**  
 O&M Grade: **0**  
 Clock Start/From: **10**  
 Clock To: **2**  
 1st Value:  
 2nd Value:  
 Value Percent:  
 Continuous Index:  
 Within 8" of Joint: **YES**  
 Remarks:

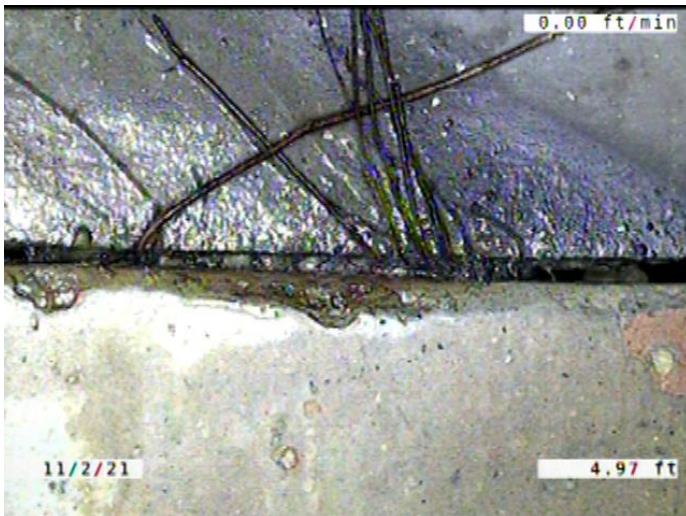
Code: **RFJ**  
 Description: **Roots Fine Joint**

Distance (ft): **5.0**  
 Structural Grade: **0**  
 O&M Grade: **1**  
 Clock Start/From: **3**  
 Clock To: **4**  
 1st Value:  
 2nd Value:  
 Value Percent:  
 Continuous Index:  
 Within 8" of Joint: **YES**  
 Remarks:

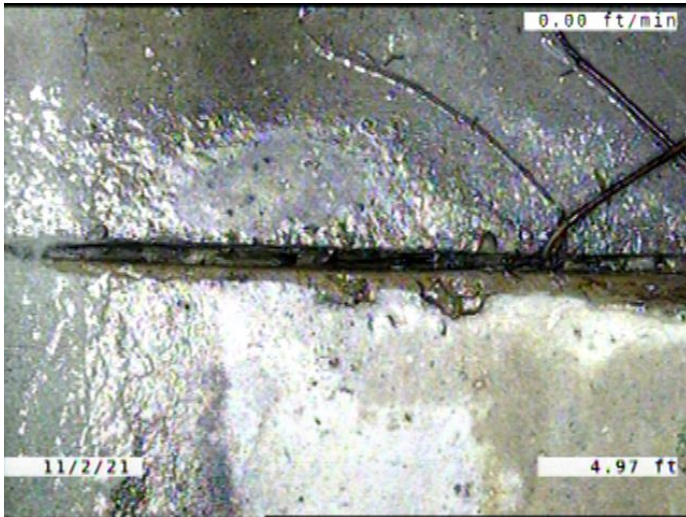
Code: **IDJ**  
 Description: **Infiltration Dripper Joint**

Distance (ft): **5.0**  
 Structural Grade: **0**  
 O&M Grade: **3**  
 Clock Start/From: **4**  
 Clock To:  
 1st Value:  
 2nd Value:  
 Value Percent:  
 Continuous Index:  
 Within 8" of Joint: **YES**  
 Remarks:

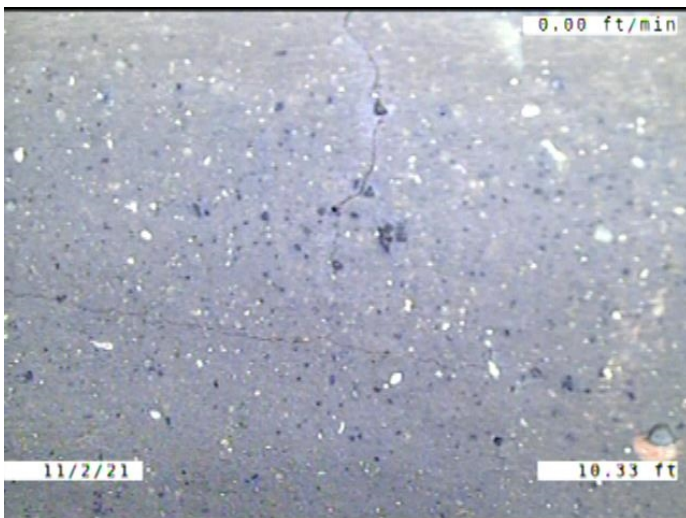
Code: **CM**  
 Description: **Crack Multiple**

Distance (ft): **10.3**  
 Structural Grade: **3**  
 O&M Grade: **0**  
 Clock Start/From: **11**  
 Clock To: **4**  
 1st Value:  
 2nd Value:  
 Value Percent:  
 Continuous Index:  
 Within 8" of Joint: **YES**  
 Remarks:

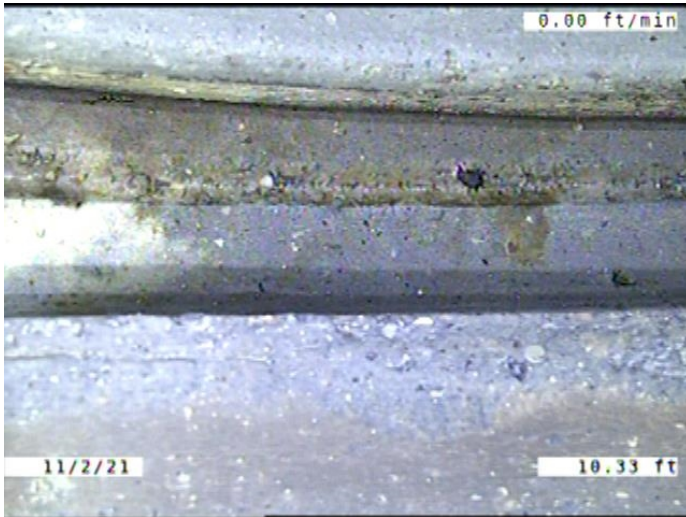
Code: **JSM**  
 Description: **Joint Separated Medium**

Distance (ft): **10.3**  
 Structural Grade: **3**  
 O&M Grade: **0**  
 Clock Start/From:  
 Clock To:  
 1st Value:  
 2nd Value:  
 Value Percent:  
 Continuous Index:  
 Within 8" of Joint: **NO**  
 Remarks:

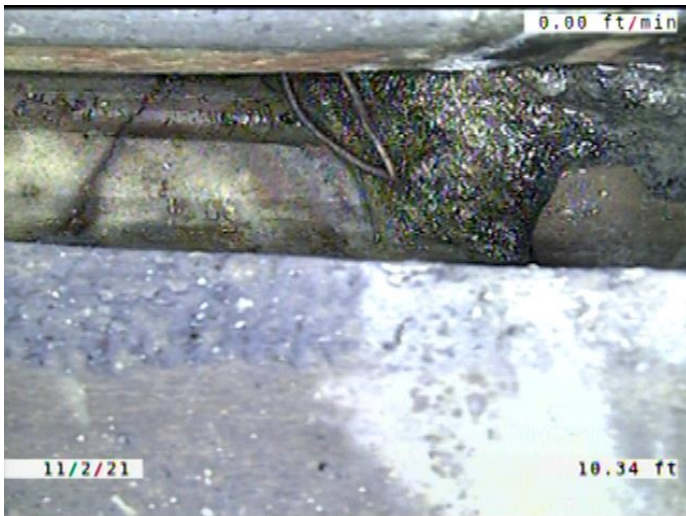
Code: **RFJ**  
 Description: **Roots Fine Joint**

Distance (ft): **10.3**  
 Structural Grade: **0**  
 O&M Grade: **1**  
 Clock Start/From: **4**  
 Clock To:  
 1st Value:  
 2nd Value:  
 Value Percent:  
 Continuous Index:  
 Within 8" of Joint: **YES**  
 Remarks:

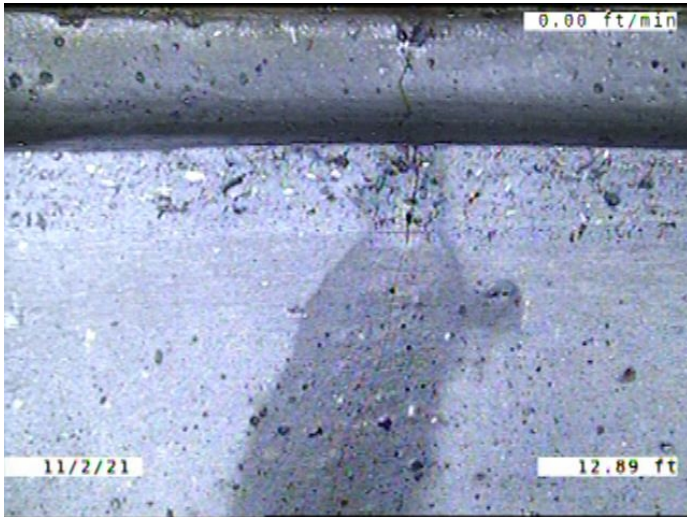
Code: **CM**  
Description: **Crack Multiple**

Distance (ft): **12.9**  
Structural Grade: **3**  
O&M Grade: **0**  
Clock Start/From: **8**  
Clock To: **10**  
1st Value:  
2nd Value:  
Value Percent:  
Continuous Index:  
Within 8" of Joint: **YES**  
Remarks:

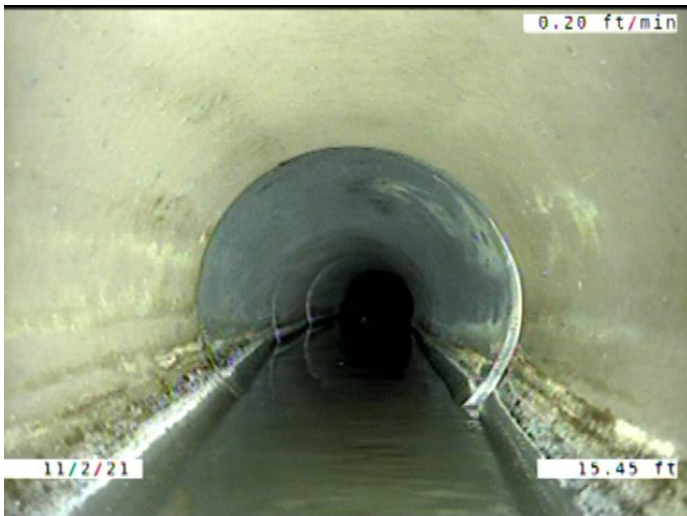
Code: **MWLS**  
Description: **Miscellaneous Water Level Sag**

Distance (ft): **15.4**  
Structural Grade: **2**  
O&M Grade: **0**  
Clock Start/From:  
Clock To:  
1st Value:  
2nd Value:  
Value Percent: **10.000**  
Continuous Index: **S01**  
Within 8" of Joint: **NO**  
Remarks:

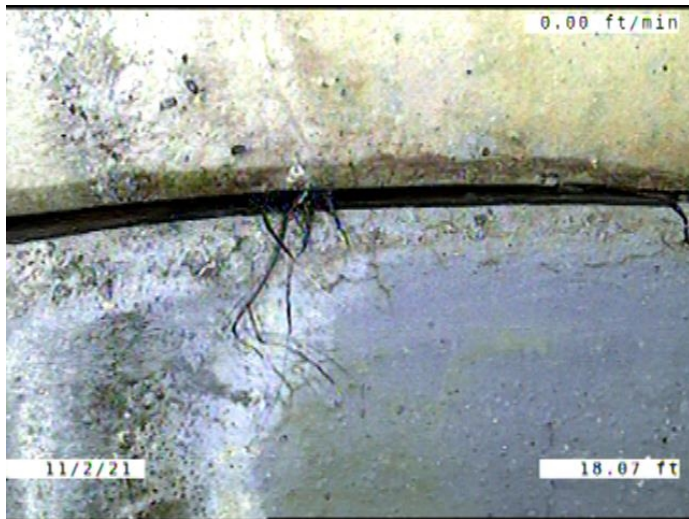
Code: **RFJ**  
 Description: **Roots Fine Joint**

Distance (ft): **18.1**  
 Structural Grade: **0**  
 O&M Grade: **1**  
 Clock Start/From: **9**  
 Clock To:  
 1st Value:  
 2nd Value:  
 Value Percent:  
 Continuous Index:  
 Within 8" of Joint: **YES**  
 Remarks:

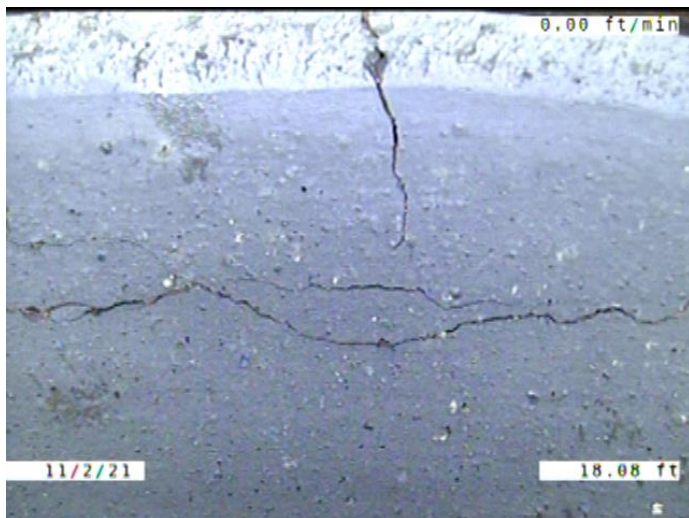
Code: **FM**  
 Description: **Fracture Multiple**

Distance (ft): **18.1**  
 Structural Grade: **4**  
 O&M Grade: **0**  
 Clock Start/From: **10**  
 Clock To: **2**  
 1st Value:  
 2nd Value:  
 Value Percent:  
 Continuous Index:  
 Within 8" of Joint: **YES**  
 Remarks:

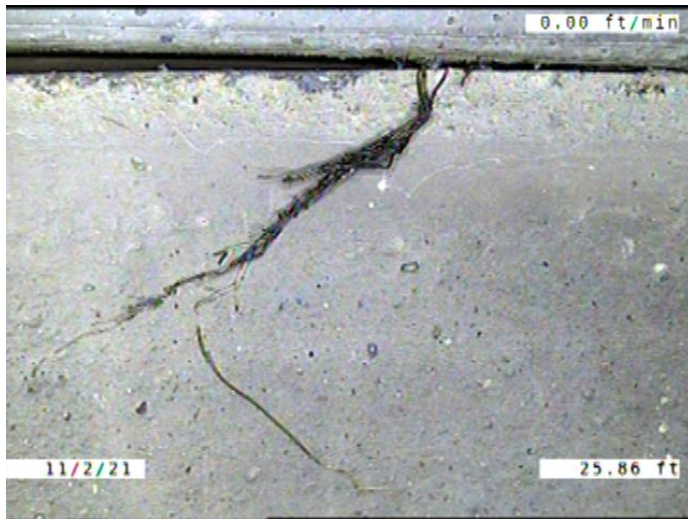
Code: **RFJ**  
 Description: **Roots Fine Joint**

Distance (ft): **25.9**  
 Structural Grade: **0**  
 O&M Grade: **1**  
 Clock Start/From: **11**  
 Clock To:  
 1st Value:  
 2nd Value:  
 Value Percent:  
 Continuous Index:  
 Within 8" of Joint: **YES**  
 Remarks:

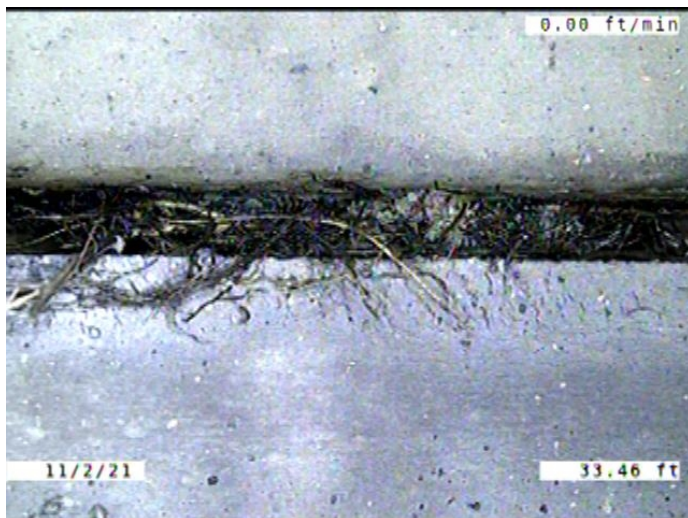
Code: **RFJ**  
 Description: **Roots Fine Joint**

Distance (ft): **33.5**  
 Structural Grade: **0**  
 O&M Grade: **1**  
 Clock Start/From: **9**  
 Clock To: **11**  
 1st Value:  
 2nd Value:  
 Value Percent:  
 Continuous Index:  
 Within 8" of Joint: **YES**  
 Remarks:

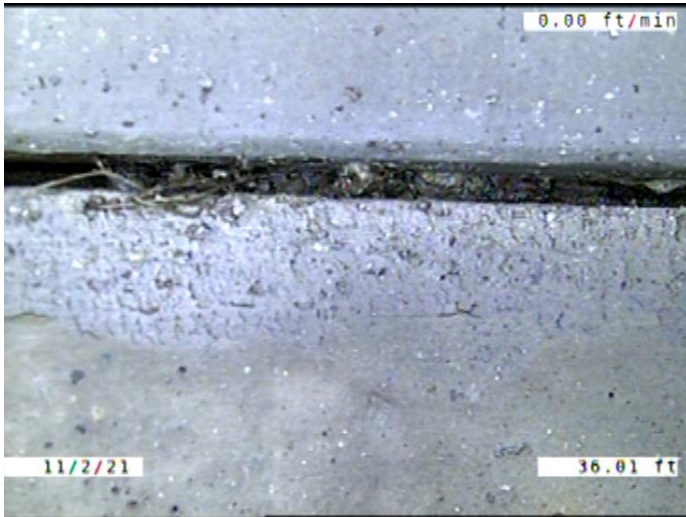
Code: **RFJ**  
 Description: **Roots Fine Joint**

Distance (ft): **36.0**  
 Structural Grade: **0**  
 O&M Grade: **1**  
 Clock Start/From: **9**  
 Clock To: **12**  
 1st Value:  
 2nd Value:  
 Value Percent:  
 Continuous Index:  
 Within 8" of Joint: **YES**  
 Remarks:

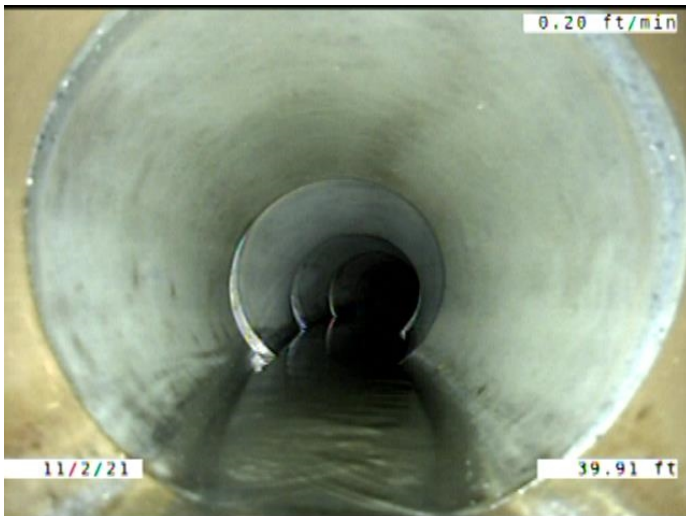
Code: **MWLS**  
 Description: **Miscellaneous Water Level Sag**

Distance (ft): **39.9**  
 Structural Grade: **2**  
 O&M Grade: **0**  
 Clock Start/From:  
 Clock To:  
 1st Value:  
 2nd Value:  
 Value Percent: **10.000**  
 Continuous Index: **F01**  
 Within 8" of Joint: **NO**  
 Remarks:

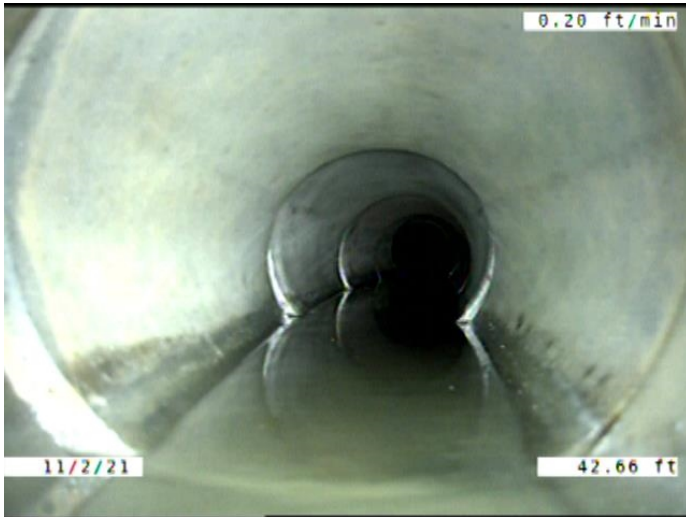
Code: **MWLS**  
Description: **Miscellaneous Water Level Sag**

Distance (ft): **42.7**  
Structural Grade: **2**  
O&M Grade: **0**  
Clock Start/From:  
Clock To:  
1st Value:  
2nd Value:  
Value Percent: **5.000**  
Continuous Index: **S02**  
Within 8" of Joint: **NO**  
Remarks:

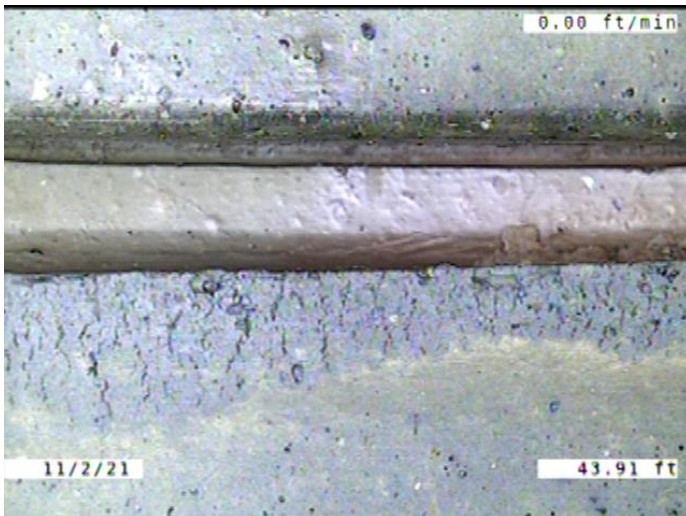
Code: **JAM**  
Description: **Joint Angular Medium**

Distance (ft): **43.9**  
Structural Grade: **3**  
O&M Grade: **0**  
Clock Start/From:  
Clock To:  
1st Value:  
2nd Value:  
Value Percent:  
Continuous Index:  
Within 8" of Joint: **NO**  
Remarks:

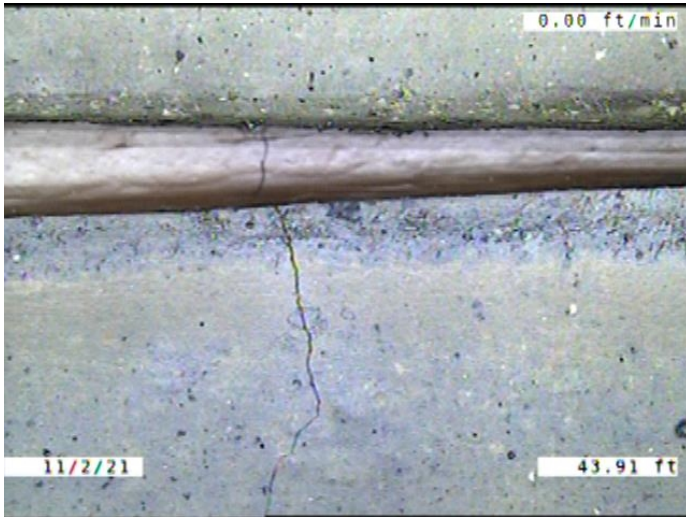
Code: **CM**  
Description: **Crack Multiple**

Distance (ft): **43.9**  
Structural Grade: **3**  
O&M Grade: **0**  
Clock Start/From: **2**  
Clock To: **4**  
1st Value:  
2nd Value:  
Value Percent:  
Continuous Index:  
Within 8" of Joint: **YES**  
Remarks:

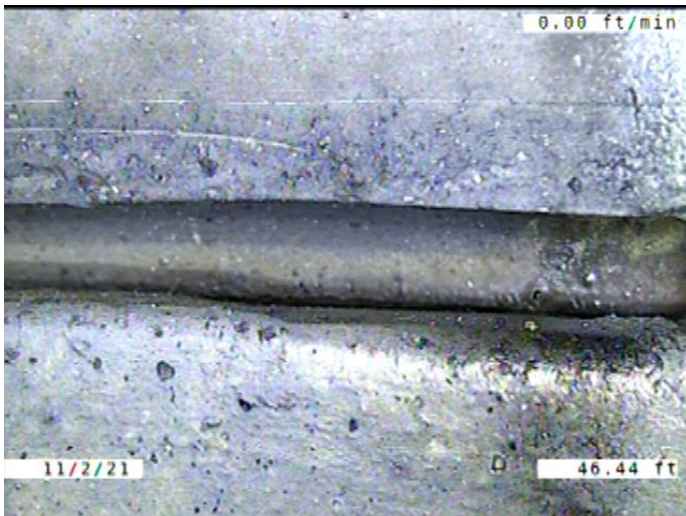
| 46.4 | JAM | Joint Angular Medium | 830 | S 3 |

Code: **JAM**  
Description: **Joint Angular Medium**

Distance (ft): **46.4**  
Structural Grade: **3**  
O&M Grade: **0**  
Clock Start/From:  
Clock To:  
1st Value:  
2nd Value:  
Value Percent:  
Continuous Index:  
Within 8" of Joint: **NO**  
Remarks:

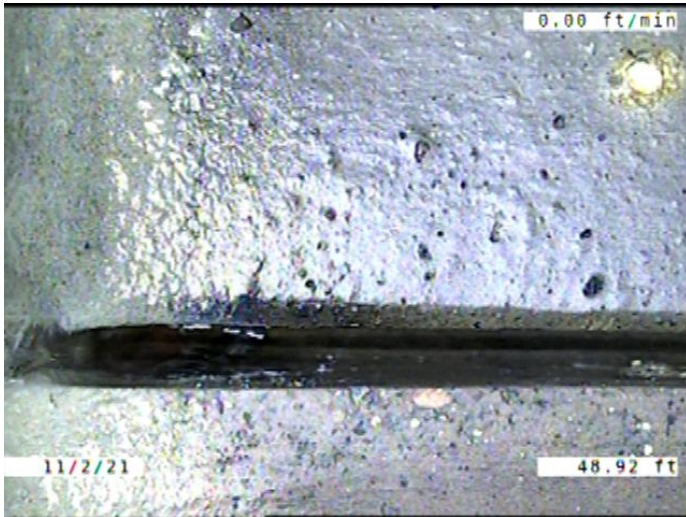
| 48.9 | IRJ | Infiltration Runner Joint | 875 | M 4 |

Code: **IRJ**  
Description: **Infiltration Runner Joint**

Distance (ft): **48.9**  
Structural Grade: **0**  
O&M Grade: **4**  
Clock Start/From: **8**  
Clock To:  
1st Value:  
2nd Value:  
Value Percent:  
Continuous Index:  
Within 8" of Joint: **YES**  
Remarks:

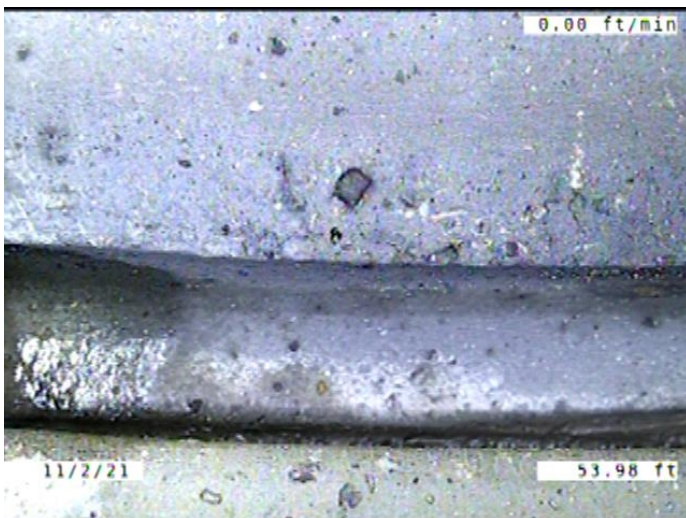
| 54.0 | JAM | Joint Angular Medium | 920 | S 3 |

Code: **JAM**  
Description: **Joint Angular Medium**

Distance (ft): **54.0**  
Structural Grade: **3**  
O&M Grade: **0**  
Clock Start/From:  
Clock To:  
1st Value:  
2nd Value:  
Value Percent:  
Continuous Index:  
Within 8" of Joint: **NO**  
Remarks:

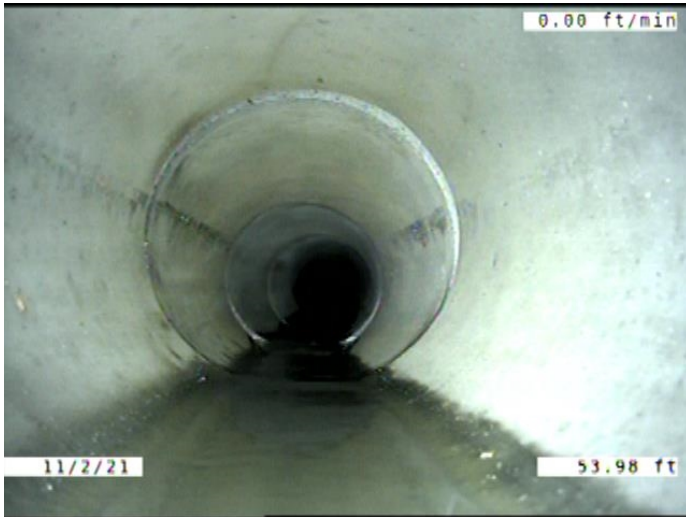
| 54.0 | MWLS(F02) | Miscellaneous Water Level Sag | 934 | S 2 |

Code: **MWLS**  
Description: **Miscellaneous Water Level Sag**

Distance (ft): **54.0**  
Structural Grade: **2**  
O&M Grade: **0**  
Clock Start/From:  
Clock To:  
1st Value:  
2nd Value:  
Value Percent: **5.000**  
Continuous Index: **F02**  
Within 8" of Joint: **NO**  
Remarks:

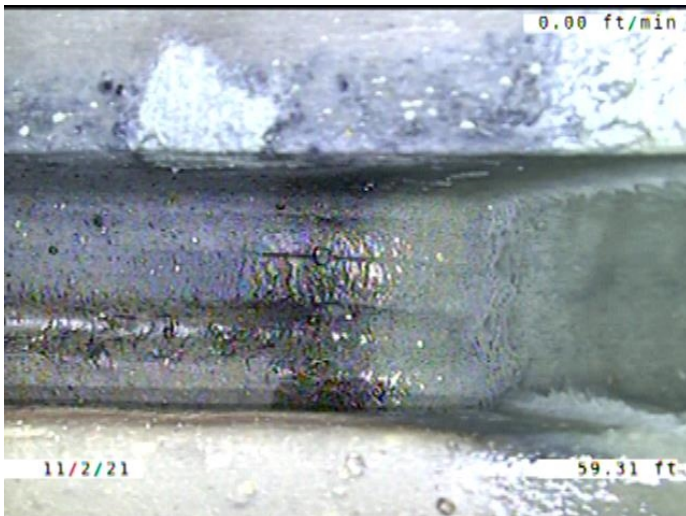
| 59.3 | JAM | Joint Angular Medium | 972 | S 3 |

Code: **JAM**  
Description: **Joint Angular Medium**

Distance (ft): **59.3**  
Structural Grade: **3**  
O&M Grade: **0**  
Clock Start/From:  
Clock To:  
1st Value:  
2nd Value:  
Value Percent:  
Continuous Index:  
Within 8" of Joint: **NO**  
Remarks:

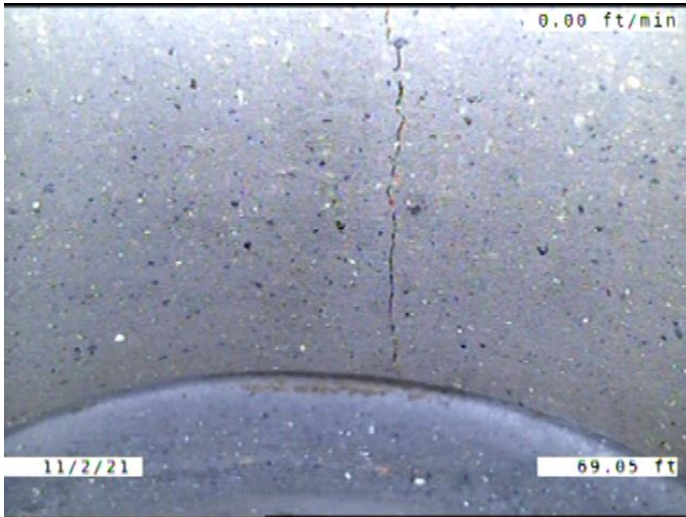
| 69.0 | CL | Crack Longitudinal | 1041 | S 2 |

Code: **CL**  
Description: **Crack Longitudinal**

Distance (ft): **69.0**  
Structural Grade: **2**  
O&M Grade: **0**  
Clock Start/From: **12**  
Clock To:  
1st Value:  
2nd Value:  
Value Percent:  
Continuous Index:  
Within 8" of Joint: **YES**  
Remarks:

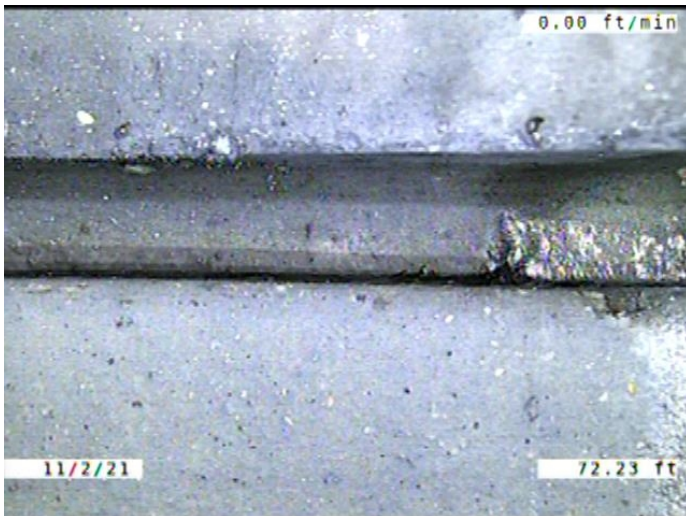
| 72.2 | JAM | Joint Angular Medium | 1080 | S 3 |

Code: **JAM**  
Description: **Joint Angular Medium**

Distance (ft): **72.2**  
Structural Grade: **3**  
O&M Grade: **0**  
Clock Start/From:  
Clock To:  
1st Value:  
2nd Value:  
Value Percent:  
Continuous Index:  
Within 8" of Joint: **NO**  
Remarks:

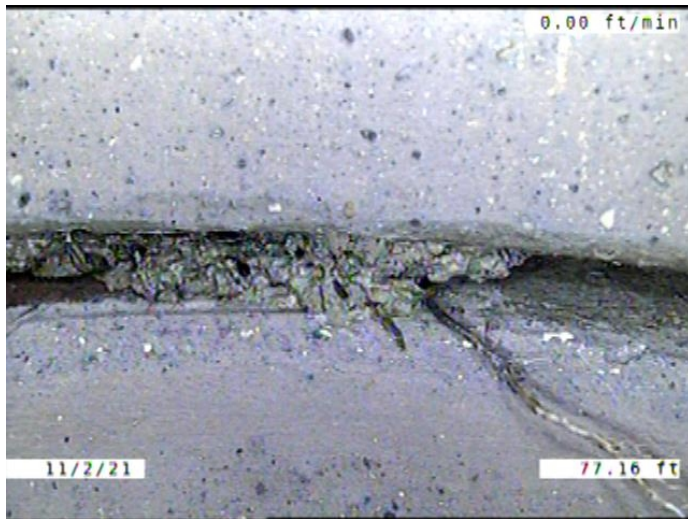
| 77.2 | RFJ | Roots Fine Joint | 1135 | M 1 |

Code: **RFJ**  
Description: **Roots Fine Joint**

Distance (ft): **77.2**  
Structural Grade: **0**  
O&M Grade: **1**  
Clock Start/From: **12**  
Clock To: **2**  
1st Value:  
2nd Value:  
Value Percent:  
Continuous Index:  
Within 8" of Joint: **YES**  
Remarks:

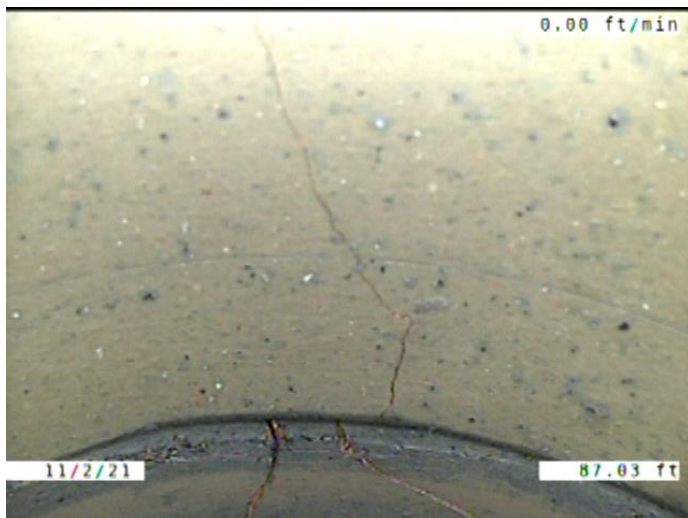
| 87.0 | B | Broken | 1269 | S 4 |

Code: **B**  
Description: **Broken**

Distance (ft): **87.0**  
Structural Grade: **4**  
O&M Grade: **0**  
Clock Start/From: **7**  
Clock To: **2**  
1st Value:  
2nd Value:  
Value Percent:  
Continuous Index:  
Within 8" of Joint: **YES**  
Remarks:

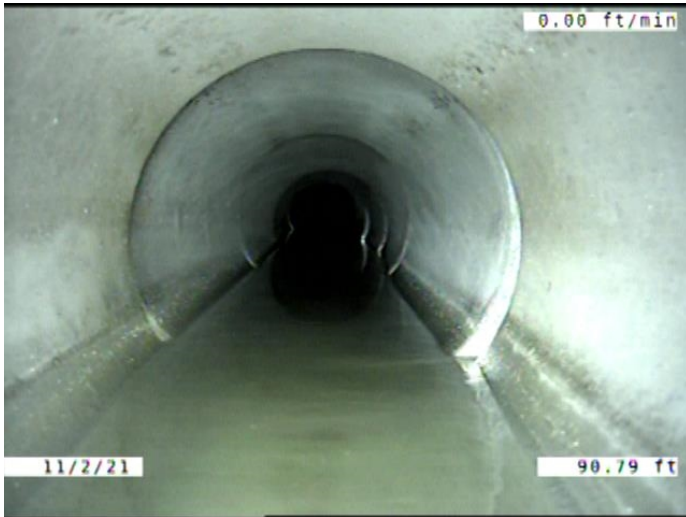
| 90.8 | MWLS(S03) | Miscellaneous Water Level Sag | 1300 | S 2 |

Code: **MWLS**  
 Description: **Miscellaneous Water Level Sag**

Distance (ft): **90.8**  
 Structural Grade: **2**  
 O&M Grade: **0**  
 Clock Start/From:  
 Clock To:  
 1st Value:  
 2nd Value:  
 Value Percent: **10.000**  
 Continuous Index: **S03**  
 Within 8" of Joint: **NO**  
 Remarks:

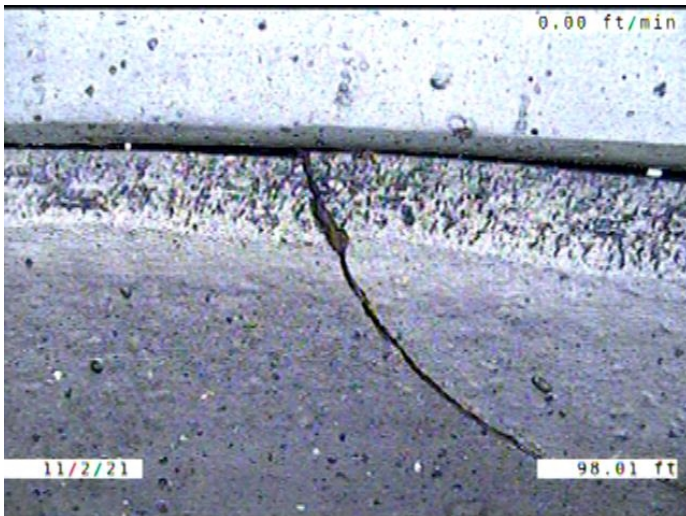
| 98.0 | B | Broken | 1387 | S 4 |

Code: **B**  
 Description: **Broken**

Distance (ft): **98.0**  
 Structural Grade: **4**  
 O&M Grade: **0**  
 Clock Start/From: **10**  
 Clock To: **3**  
 1st Value:  
 2nd Value:  
 Value Percent:  
 Continuous Index:  
 Within 8" of Joint: **YES**  
 Remarks:

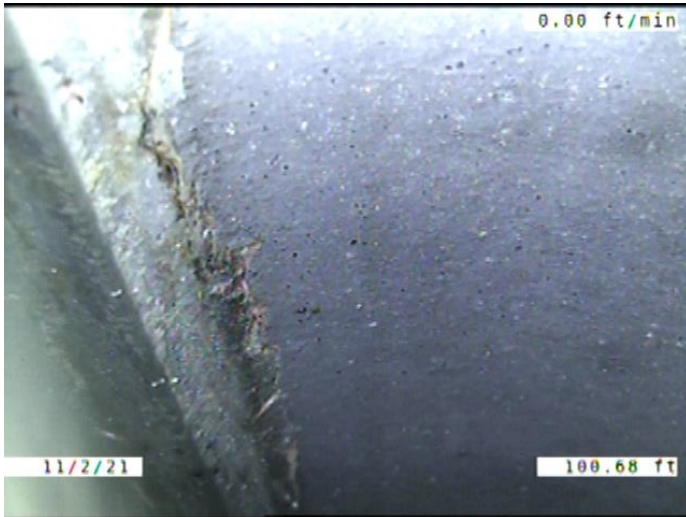
| 100.7 | FM(S04) | Fracture Multiple | 1492 | S 4 |

Code: **FM**  
 Description: **Fracture Multiple**

Distance (ft): **100.7**  
 Structural Grade: **4**  
 O&M Grade: **0**  
 Clock Start/From: **8**  
 Clock To: **4**  
 1st Value:  
 2nd Value:  
 Value Percent:  
 Continuous Index: **S04**  
 Within 8" of Joint: **YES**  
 Remarks:

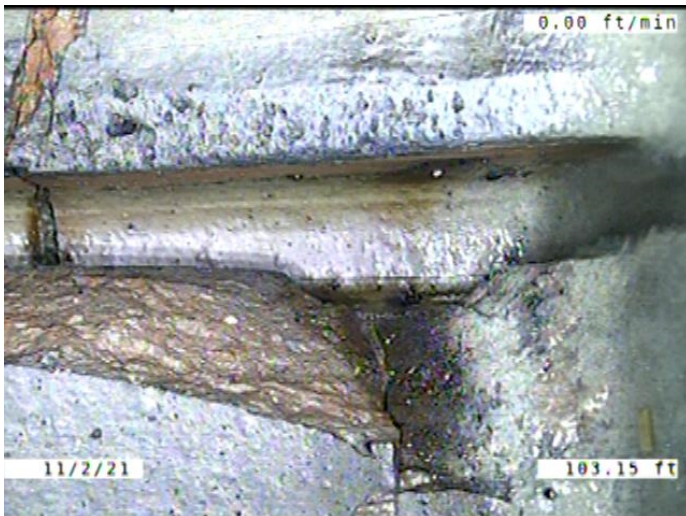
| 103.1 | SZ | Surface Damage Other | 1552 | NA |

Code: **SZ**  
 Description: **Surface Damage Other**

Distance (ft): **103.1**  
 Structural Grade: **0**  
 O&M Grade: **0**  
 Clock Start/From: **8**  
 Clock To: **10**  
 1st Value:  
 2nd Value:  
 Value Percent:  
 Continuous Index:  
 Within 8" of Joint: **YES**  
 Remarks: **A PIECE CHIPPED AWAY FROM THE JOINT**

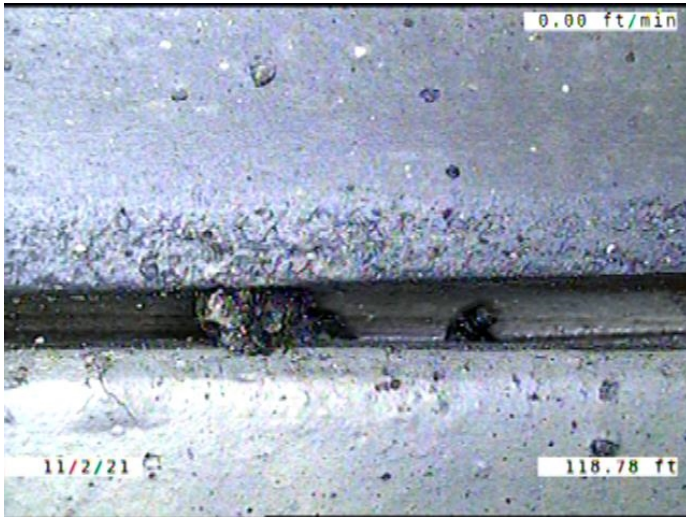
| 118.8 | RFJ | Roots Fine Joint | 1653 | M 1 |

Code: **RFJ**  
 Description: **Roots Fine Joint**

Distance (ft): **118.8**  
 Structural Grade: **0**  
 O&M Grade: **1**  
 Clock Start/From: **2**  
 Clock To: **3**  
 1st Value:  
 2nd Value:  
 Value Percent:  
 Continuous Index:  
 Within 8" of Joint: **YES**  
 Remarks:

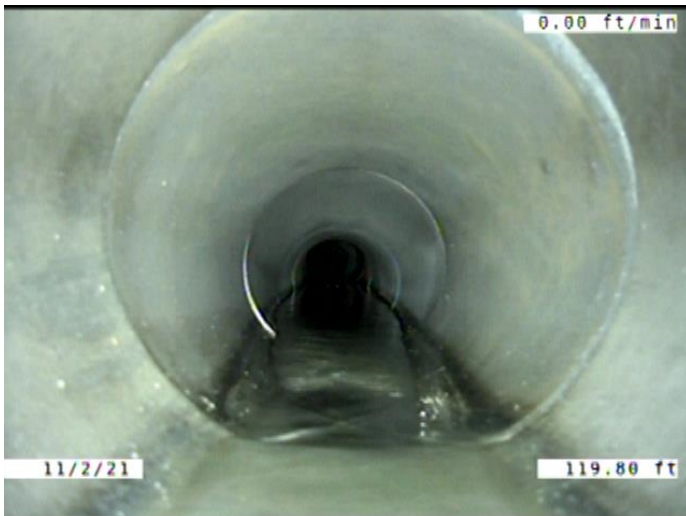
| 119.8 | MWLS(F03) | Miscellaneous Water Level Sag | 1678 | S 2 |

Code: **MWLS**  
 Description: **Miscellaneous Water Level Sag**

Distance (ft): **119.8**  
 Structural Grade: **2**  
 O&M Grade: **0**  
 Clock Start/From:  
 Clock To:  
 1st Value:  
 2nd Value:  
 Value Percent: **10.000**  
 Continuous Index: **F03**  
 Within 8" of Joint: **NO**  
 Remarks:

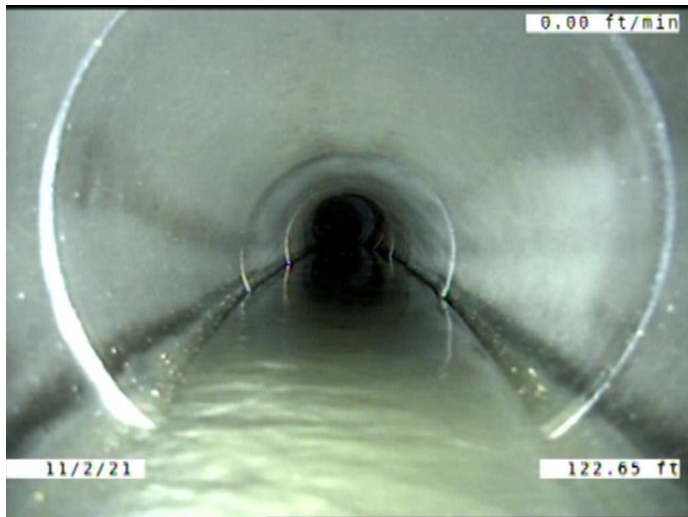
| 122.7 | MWLS(S05) | Miscellaneous Water Level Sag | 1703 | S 2 |

Code: **MWLS**  
 Description: **Miscellaneous Water Level Sag**

Distance (ft): **122.7**  
 Structural Grade: **2**  
 O&M Grade: **0**  
 Clock Start/From:  
 Clock To:  
 1st Value:  
 2nd Value:  
 Value Percent: **10.000**  
 Continuous Index: **S05**  
 Within 8" of Joint: **NO**  
 Remarks:

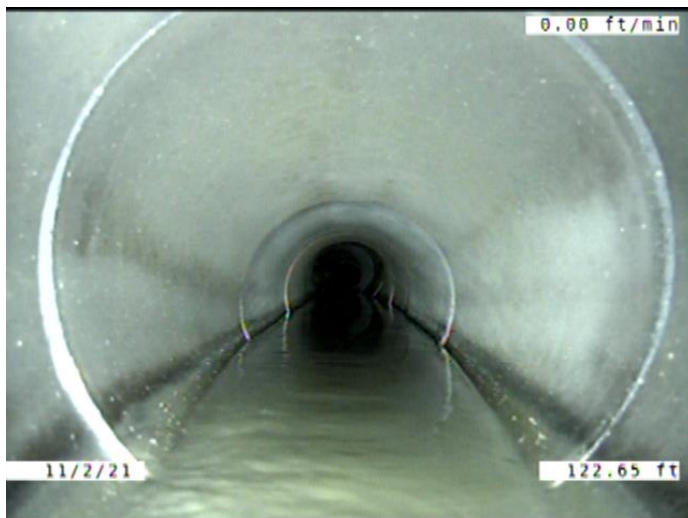
| 122.7 | FM(F04) | Fracture Multiple | 1711 | S 4 |

Code: **FM**  
 Description: **Fracture Multiple**

Distance (ft): **122.7**  
 Structural Grade: **4**  
 O&M Grade: **0**  
 Clock Start/From: **8**  
 Clock To: **4**  
 1st Value:  
 2nd Value:  
 Value Percent:  
 Continuous Index: **F04**  
 Within 8" of Joint: **YES**  
 Remarks:

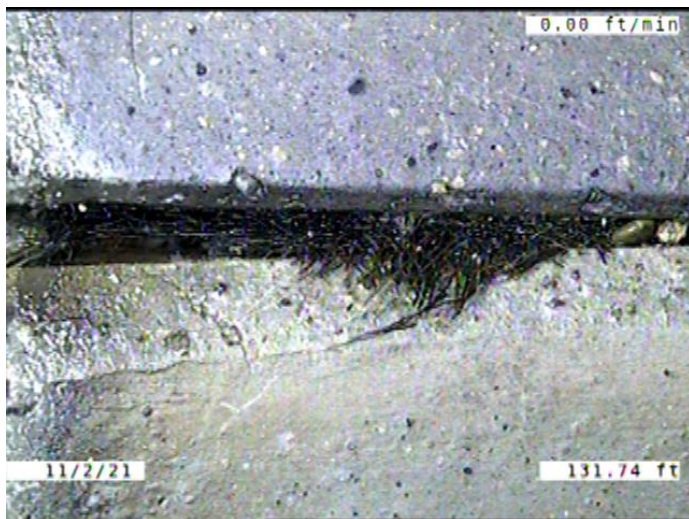
| 131.7 | RFJ | Roots Fine Joint | 1792 | M 1 |

Code: **RFJ**  
 Description: **Roots Fine Joint**

Distance (ft): **131.7**  
 Structural Grade: **0**  
 O&M Grade: **1**  
 Clock Start/From: **9**  
 Clock To:  
 1st Value:  
 2nd Value:  
 Value Percent:  
 Continuous Index:  
 Within 8" of Joint: **YES**  
 Remarks:

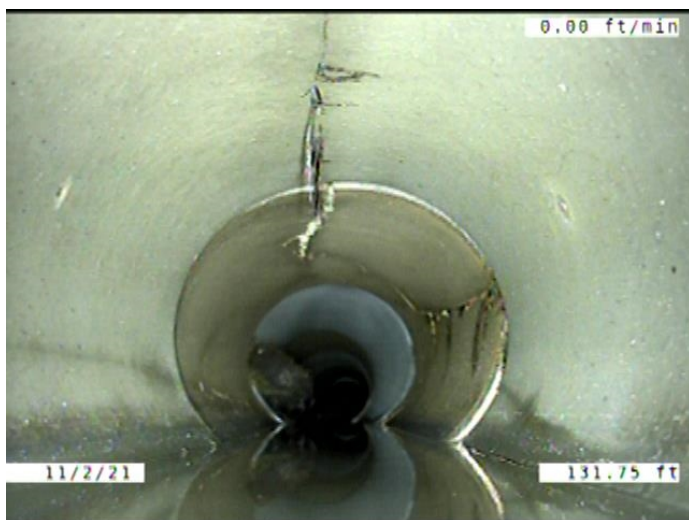
| 131.7 | FM(S06) | Fracture Multiple | 1844 | S 4 |

Code: **FM**  
 Description: **Fracture Multiple**

Distance (ft): **131.7**  
 Structural Grade: **4**  
 O&M Grade: **0**  
 Clock Start/From: **8**  
 Clock To: **4**  
 1st Value:  
 2nd Value:  
 Value Percent:  
 Continuous Index: **S06**  
 Within 8" of Joint: **YES**  
 Remarks:

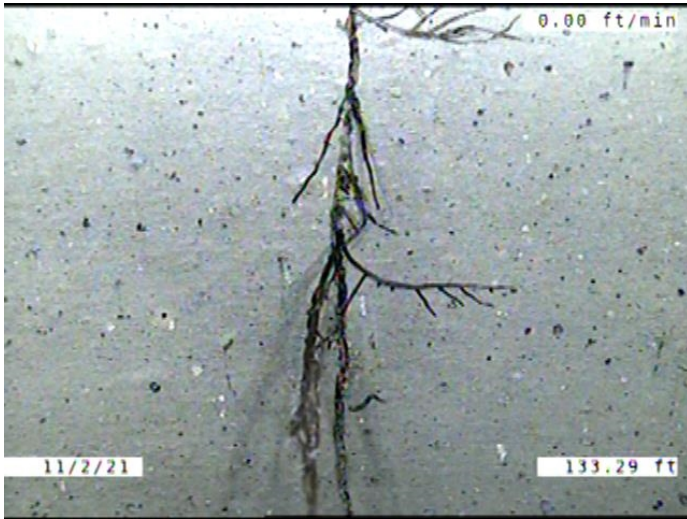
| 133.3 | RFB | Roots Fine Barrel | 1880 | M 2 |

Code: **RFB**  
 Description: **Roots Fine Barrel**

Distance (ft): **133.3**  
 Structural Grade: **0**  
 O&M Grade: **2**  
 Clock Start/From: **12**  
 Clock To:  
 1st Value:  
 2nd Value:  
 Value Percent:  
 Continuous Index:  
 Within 8" of Joint: **NO**  
 Remarks:

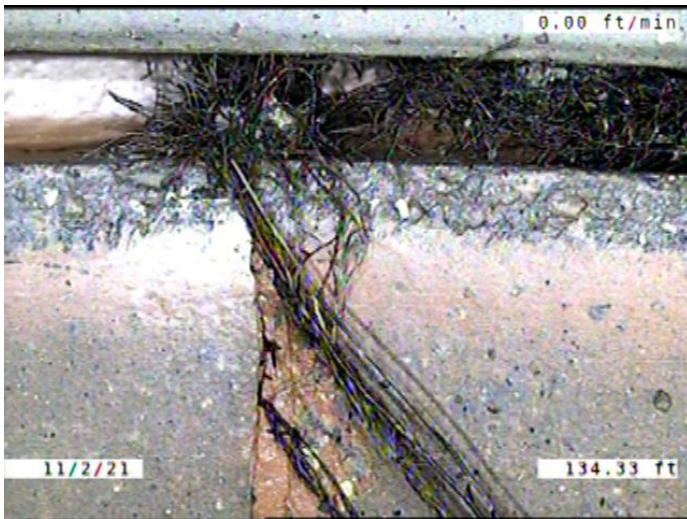
| 134.3 | RFB | Roots Fine Barrel | 1930 | M 2 |

Code: **RFB**  
 Description: **Roots Fine Barrel**

Distance (ft): **134.3**  
 Structural Grade: **0**  
 O&M Grade: **2**  
 Clock Start/From: **2**  
 Clock To: **3**  
 1st Value:  
 2nd Value:  
 Value Percent:  
 Continuous Index:  
 Within 8" of Joint: **NO**  
 Remarks:

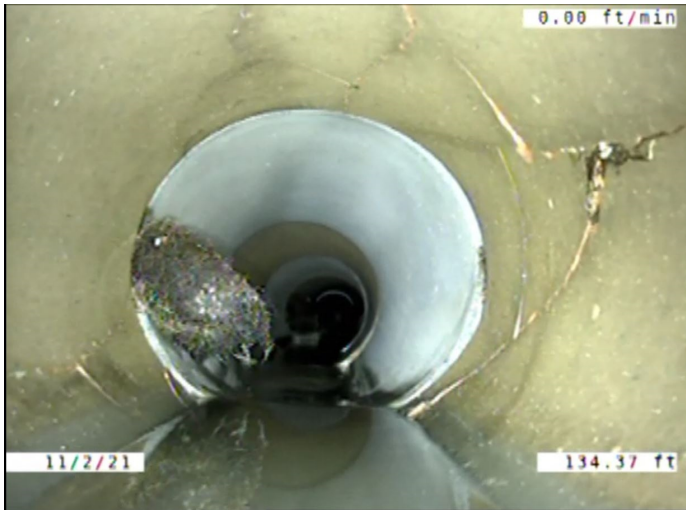
| 134.4 | B | Broken | 1943 | S 4 |

Code: **B**  
Description: **Broken**

Distance (ft): **134.4**  
Structural Grade: **4**  
O&M Grade: **0**  
Clock Start/From: **1**  
Clock To: **5**  
1st Value:  
2nd Value:  
Value Percent:  
Continuous Index:  
Within 8" of Joint: **YES**  
Remarks:

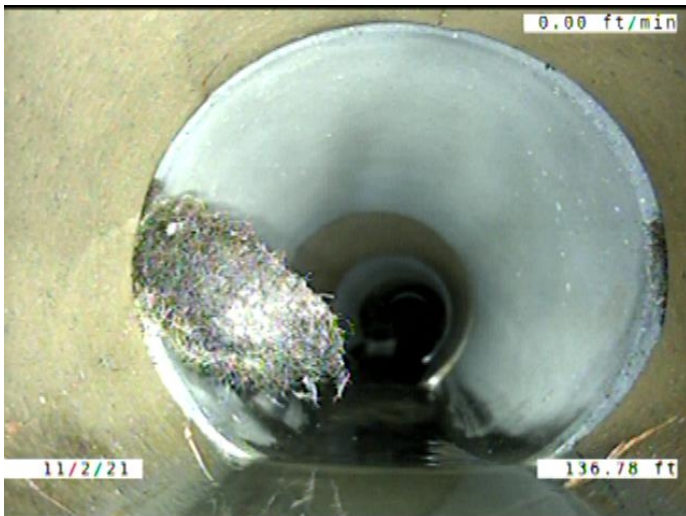
| 136.8 | RMJ | Roots Medium Joint | 1979 | M 3 |

Code: **RMJ**  
Description: **Roots Medium Joint**

Distance (ft): **136.8**  
Structural Grade: **0**  
O&M Grade: **3**  
Clock Start/From: **8**  
Clock To: **4**  
1st Value:  
2nd Value:  
Value Percent: **10.000**  
Continuous Index:  
Within 8" of Joint: **YES**  
Remarks:

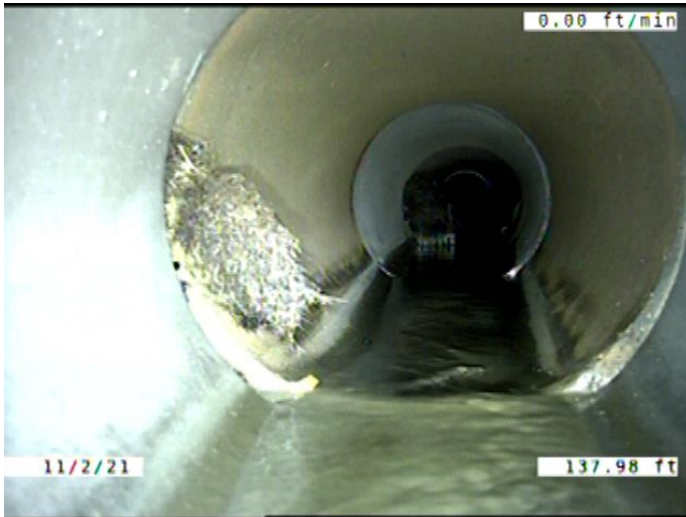
| 138.0 | MWLS(F05) | Miscellaneous Water Level Sag | 2033 | S 2 |

Code: **MWLS**  
 Description: **Miscellaneous Water Level Sag**

Distance (ft): **138.0**  
 Structural Grade: **2**  
 O&M Grade: **0**  
 Clock Start/From:  
 Clock To:  
 1st Value:  
 2nd Value:  
 Value Percent: **10.000**  
 Continuous Index: **F05**  
 Within 8" of Joint: **NO**  
 Remarks:

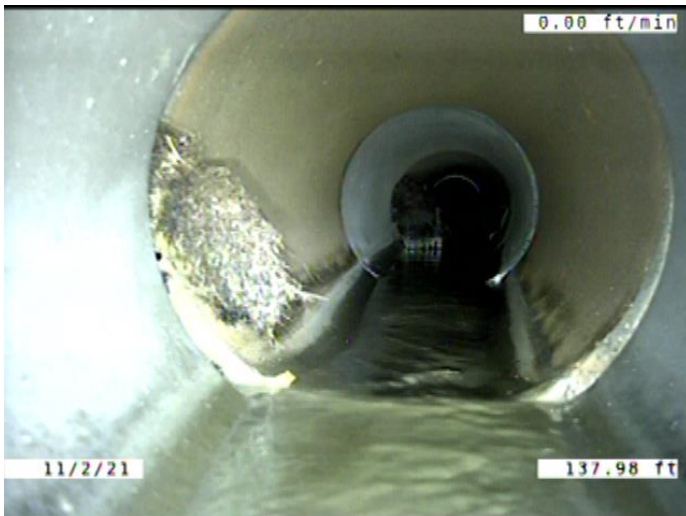
| 138.0 | FM(F06) | Fracture Multiple | 2045 | S 4 |

Code: **FM**  
 Description: **Fracture Multiple**

Distance (ft): **138.0**  
 Structural Grade: **4**  
 O&M Grade: **0**  
 Clock Start/From: **8**  
 Clock To: **4**  
 1st Value:  
 2nd Value:  
 Value Percent:  
 Continuous Index: **F06**  
 Within 8" of Joint: **YES**  
 Remarks:

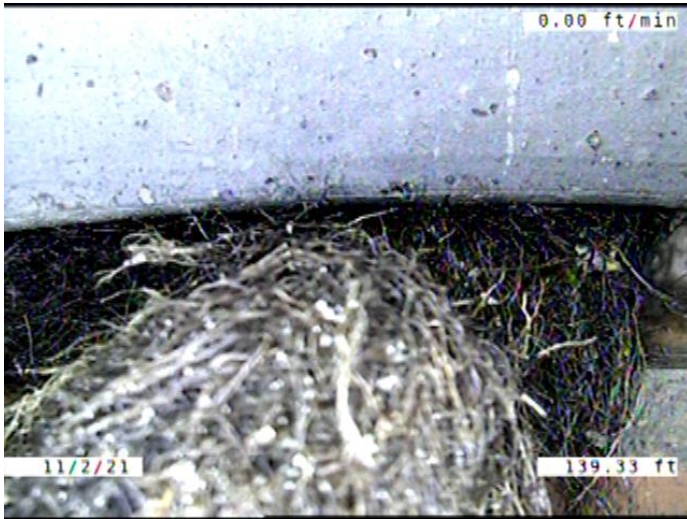
| 139.3 | RMJ | Roots Medium Joint | 2088 | M 3 |

Code: **RMJ**  
 Description: **Roots Medium Joint**

Distance (ft): **139.3**  
 Structural Grade: **0**  
 O&M Grade: **3**  
 Clock Start/From: **8**  
 Clock To: **11**  
 1st Value:  
 2nd Value:  
 Value Percent: **10.000**  
 Continuous Index:  
 Within 8" of Joint: **YES**  
 Remarks:

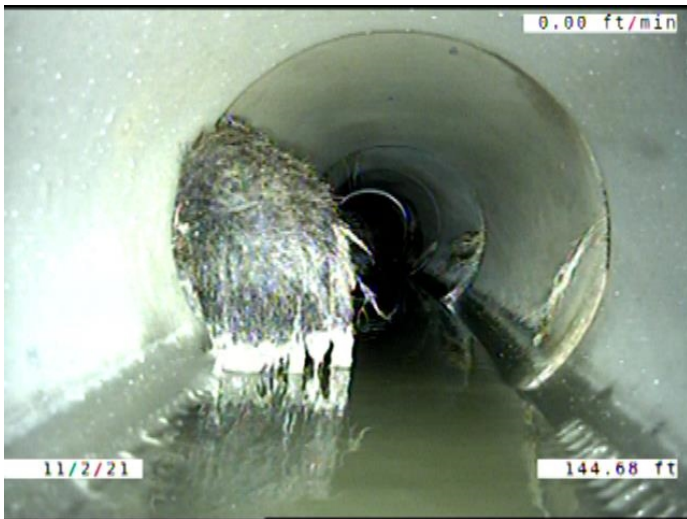
| 144.7 | RMJ | Roots Medium Joint | 2159 | M 3 |

Code: **RMJ**  
 Description: **Roots Medium Joint**

Distance (ft): **144.7**  
 Structural Grade: **0**  
 O&M Grade: **3**  
 Clock Start/From: **7**  
 Clock To: **3**  
 1st Value:  
 2nd Value:  
 Value Percent: **25.000**  
 Continuous Index:  
 Within 8" of Joint: **YES**  
 Remarks:

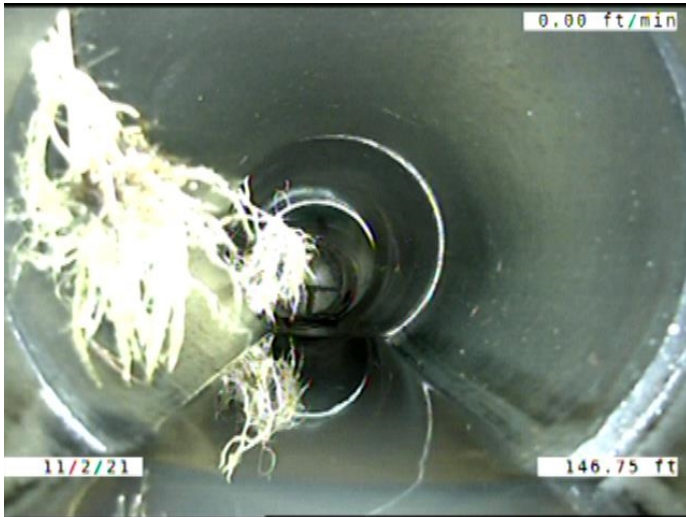
| 146.7 | RMJ | Roots Medium Joint | 2308 | M 3 |

| Code: | <b>RMJ</b> |
| Description: | <b>Roots Medium Joint</b> |
| Distance (ft): | <b>146.7</b> |
| O&M Grade: | <b>3</b> |
| Value Percent: | <b>5.000</b> |

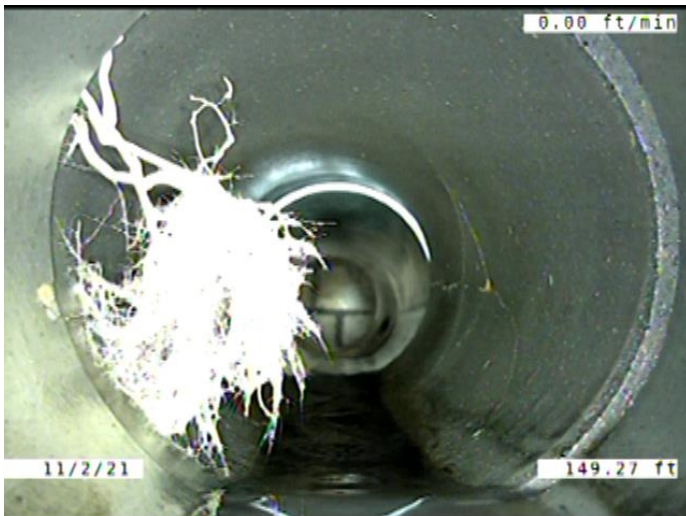
| 149.3 | RMJ | Roots Medium Joint | 2360 | M 3 |

| Code: | <b>RMJ</b> |
| Description: | <b>Roots Medium Joint</b> |
| Distance (ft): | <b>149.3</b> |
| O&M Grade: | <b>3</b> |
| Value Percent: | <b>10.000</b> |

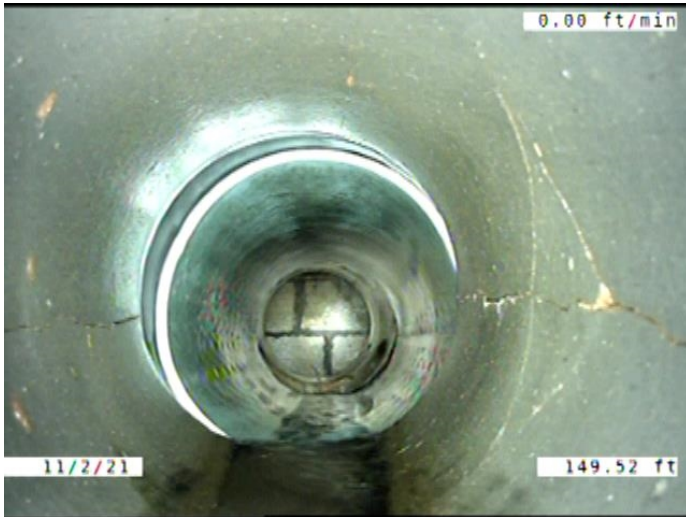
| 149.5 | B | Broken | 2437 | S 4 |

Code: **B**  
Description: **Broken**

Distance (ft): **149.5**  
Structural Grade: **4**  
O&M Grade: **0**  
Clock Start/From: **12**  
Clock To: **12**  
1st Value:  
2nd Value:  
Value Percent:  
Continuous Index:  
Within 8" of Joint: **YES**  
Remarks:

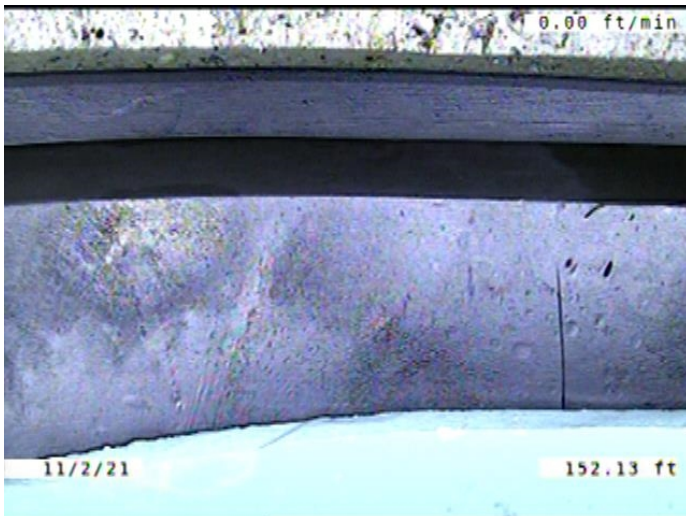
Code: **MMC**  
Description: **Miscellaneous Material Change**

Distance (ft): **152.1**  
Structural Grade: **0**  
O&M Grade: **0**  
Clock Start/From:  
Clock To:  
1st Value:  
2nd Value:  
Value Percent:  
Continuous Index:  
Within 8" of Joint: **NO**  
Remarks: **VCP TO PVC**

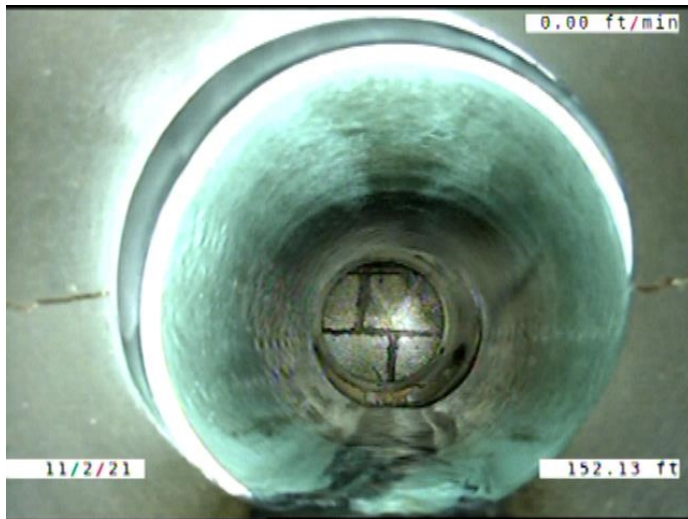
| 152.1 | JOM | Joint Offset Medium | 2508 | S 3 |

Code: **JOM**  
 Description: **Joint Offset Medium**

Distance (ft): **152.1**  
 Structural Grade: **3**  
 O&M Grade: **0**  
 Clock Start/From:  
 Clock To:  
 1st Value:  
 2nd Value:  
 Value Percent:  
 Continuous Index:  
 Within 8" of Joint: **NO**  
 Remarks:

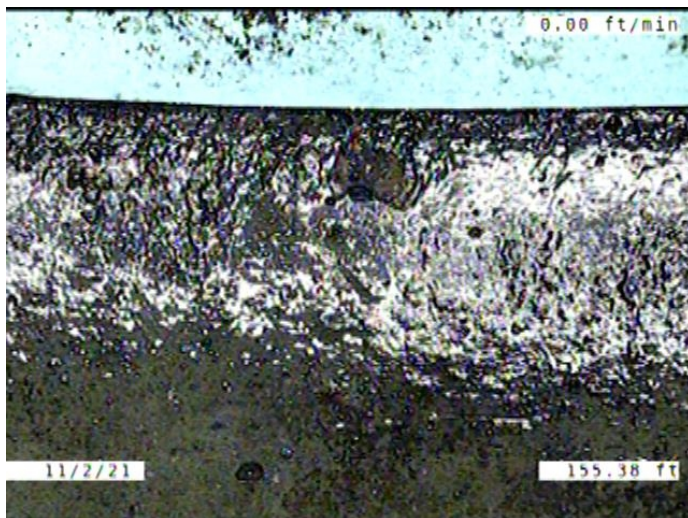
Code: **MMC**  
 Description: **Miscellaneous Material Change**

Distance (ft): **155.4**  
 Structural Grade: **0**  
 O&M Grade: **0**  
 Clock Start/From:  
 Clock To:  
 1st Value:  
 2nd Value:  
 Value Percent:  
 Continuous Index:  
 Within 8" of Joint: **NO**  
 Remarks: **PVC TO VCP**

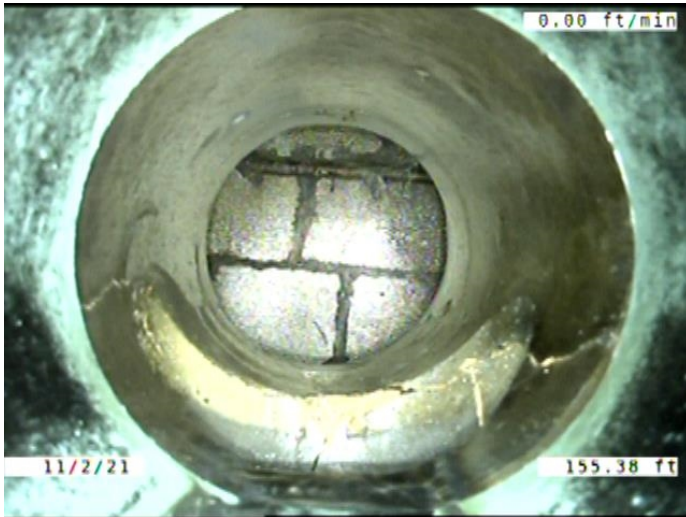
| 155.4 | FM | Fracture Multiple | 2591 | S 4 |

Code: **FM**  
 Description: **Fracture Multiple**

Distance (ft): **155.4**  
 Structural Grade: **4**  
 O&M Grade: **0**  
 Clock Start/From: **4**  
 Clock To: **8**  
 1st Value:  
 2nd Value:  
 Value Percent:  
 Continuous Index:  
 Within 8" of Joint: **YES**  
 Remarks:
