Profile/Photo Observation Report

Date:	04/14/2018	Weather:		Coding:	PACP 6.0
Pipe Length (ft):		Owner:	City of Hobart	Pre Clean:	No Pre-Cleaning
P.O.#:	50-1	Surveyor:	M. Pielacha	PSR:	M-504-024-M-505-057
Customer:	City of Hobart	Clean Date:		Shape:	C

Street:	Colorado Street	Flow Control:	Not Controlled
City:	Hobart, IN	Year Renewed:	
Location:	Light Highway	Tape/Media #:	DEP 50
Purpose:	Routine Assessment	Dia/Height:	18"
Use:	Sanitary	Material:	VCP
Drain Area:		Lining:

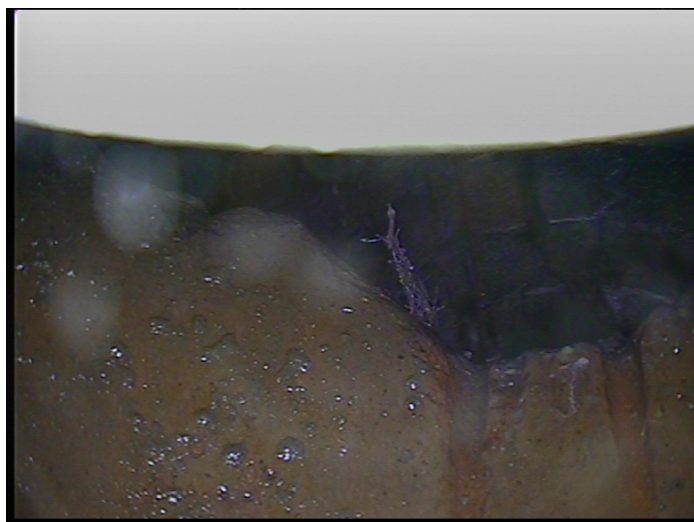
Code: **AMH**
 Description: **Manhole**

Distance (ft): **.0**
 Structural Grade: **0**
 O&M Grade: **0**
 Clock Start/From:
 Clock To:
 1st Value:
 2nd Value:
 Value Percent:
 Continuous Index:
 Within 8" of Joint: **NO**
 Remarks: **M-504-024**

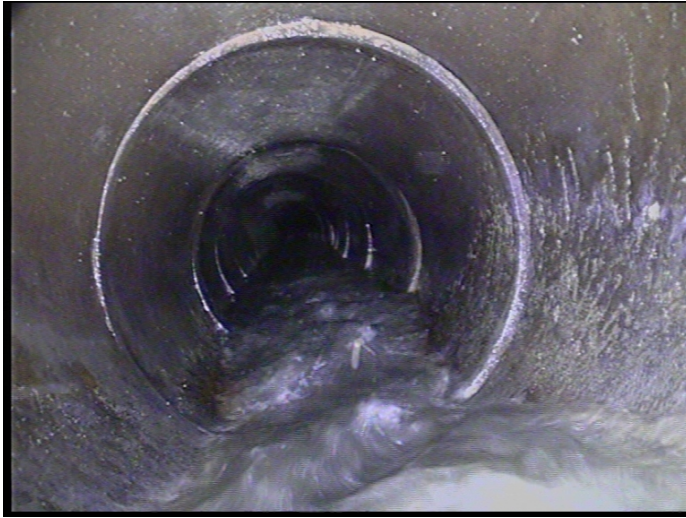
Code: **MWL**
Description: **Water Level**

Distance (ft): **.0**
Structural Grade: **0**
O&M Grade: **0**
Clock Start/From:
Clock To:
1st Value:
2nd Value:
Value Percent: **10.000**
Continuous Index:
Within 8" of Joint: **NO**
Remarks:

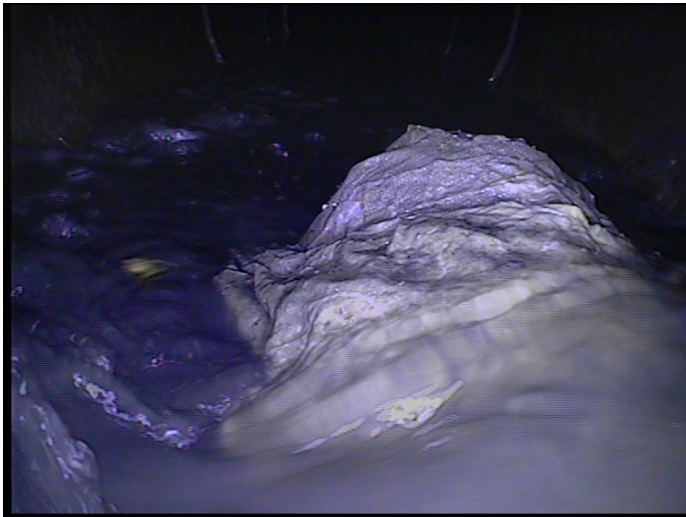
Code: **OBZ**
Description: **Obstacle Other**

Distance (ft): **29.0**
Structural Grade: **0**
O&M Grade: **3**
Clock Start/From: **5**
Clock To: **7**
1st Value:
2nd Value:
Value Percent: **15.000**
Continuous Index:
Within 8" of Joint: **NO**
Remarks: **Debris**

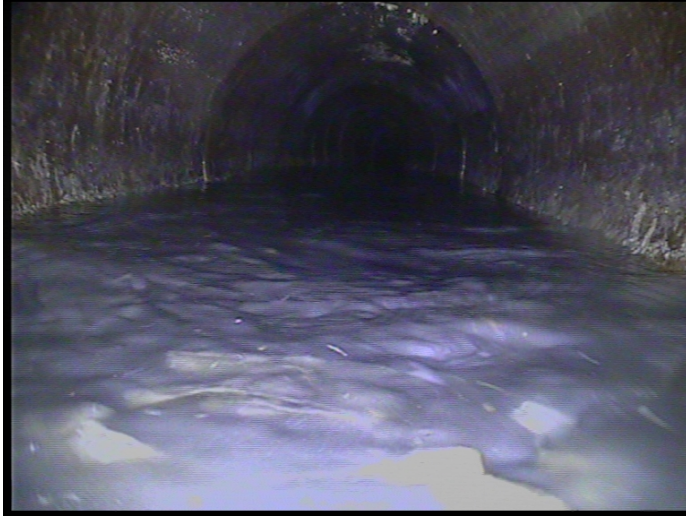
Code:	MSA
Description:	Abandoned Survey
Distance (ft):	38.8
Structural Grade:	0
O&M Grade:	0
Clock Start/From:	
Clock To:	
1st Value:	
2nd Value:	
Value Percent:	
Continuous Index:	
Within 8" of Joint:	NO
Remarks:	debris
