Profile/Photo Observation Report

Street:	Colorado Street	Flow Control:	Not Controlled
City:	Hobart, IN	Year Renewed:	
Location:	Light Highway	Tape/Media #:	DEP 50
Purpose:	Routine Assessment	Dia/Height:	18"
Use:	Sanitary	Material:	VCP
Drain Area:		Lining:

US MH: **M-504-024** DS MH: **M-505-057** Total Length Surveyed (ft): **38.8**

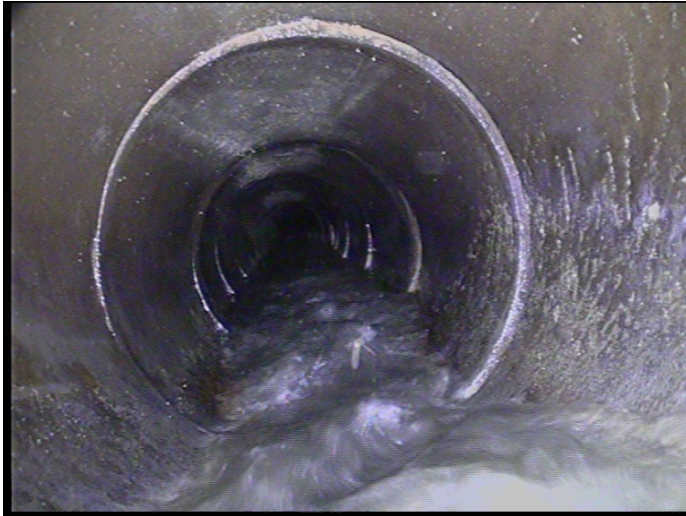
Code: **MWL**
Description: **Water Level**

Distance (ft): **.0**
Structural Grade: **0**
O&M Grade: **0**
Clock Start/From:
Clock To:
1st Value:
2nd Value:
Value Percent: **10.000**
Continuous Index:
Within 8" of Joint: **NO**
Remarks:

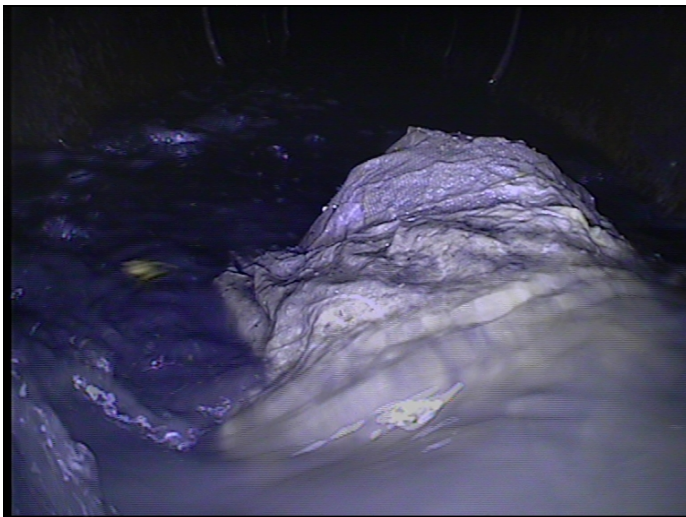
Code: **OBZ**
Description: **Obstacle Other**

Distance (ft): **29.0**
Structural Grade: **0**
O&M Grade: **3**
Clock Start/From: **5**
Clock To: **7**
1st Value:
2nd Value:
Value Percent: **15.000**
Continuous Index:
Within 8" of Joint: **NO**
Remarks: **Debris**
