## Profile/Photo Observation Report

Date:	<b>01/27/2025</b>	Weather:		Coding:	<b>PACP 7.0</b>
Pipe Length (ft):	<b>166.0</b>	Owner:	<b>City of Hobart</b>	Pre Clean:	<b>Heavy Cleaning</b>
P.O.#:	<b>YES502259</b>	Surveyor:	<b>S. Bucklin</b>	PSR:	<b>P-504-024-057</b>
Customer:	<b>City of Hobart</b>	Clean Date:	<b>01/06/2025</b>	Shape:	<b>C</b>

Street:	<b>South Colorado Street</b>	Flow Control:	<b>Not Controlled</b>
City:	<b>Hobart, IN</b>	Year Renewed:	
Location:	<b>Local rural streets with light traffic, t</b>	Tape/Media #:	
Purpose:	<b>Sewer System Evaluation Survey (SS</b>	Dia/Height:	<b>18"</b>
Use:	<b>Sanitary Sewage Pipe</b>	Material:	<b>VCP</b>
Drain Area:		Lining:	<b>None</b>
Category:	<b>NA</b>		
Comment:			
Location Details:		Direction of Survey:	<b>Downstream</b>
US MH:	<b>M-504-024</b>	DS MH:	<b>M-505-057</b>
		Total Length Surveyed (ft):	<b>166.2</b>

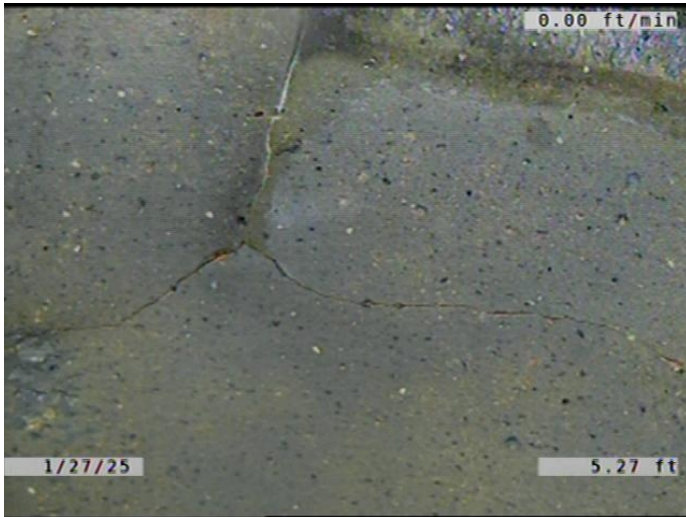
Code: **FM**  
 Description: **Fracture Multiple**

Distance (ft): **5.3**  
 Structural Grade: **4**  
 O&M Grade: **0**  
 Clock Start/From: **9**  
 Clock To: **3**  
 1st Value:  
 2nd Value:  
 Value Percent:  
 Continuous Index:  
 Within 8" of Joint: **YES**  
 Remarks:

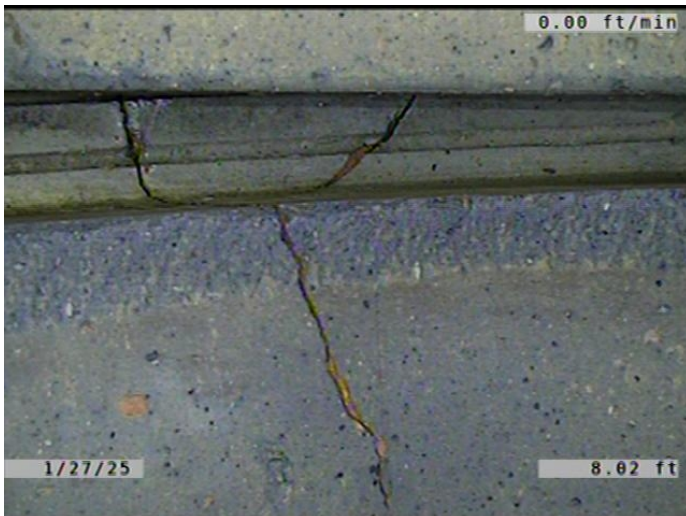
Code: **FM**  
 Description: **Fracture Multiple**

Distance (ft): **8.0**  
 Structural Grade: **4**  
 O&M Grade: **0**  
 Clock Start/From: **7**  
 Clock To: **5**  
 1st Value:  
 2nd Value:  
 Value Percent:  
 Continuous Index:  
 Within 8" of Joint: **YES**  
 Remarks:

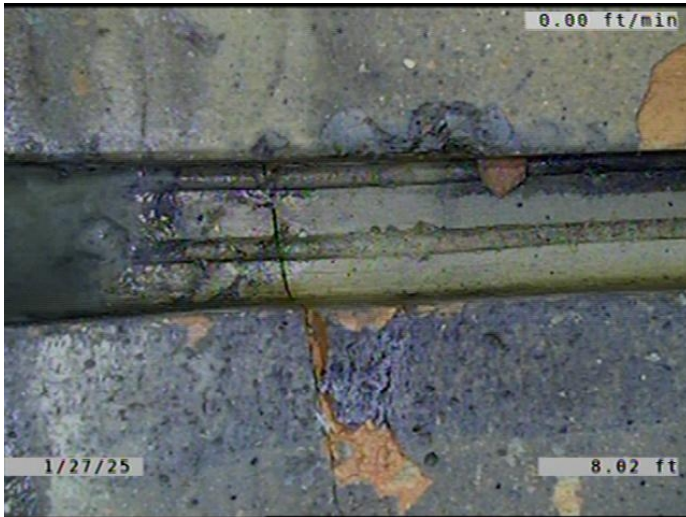
Code: **JAM**  
Description: **Joint Angular Medium**

Distance (ft): **8.0**  
Structural Grade: **3**  
O&M Grade: **0**  
Clock Start/From:  
Clock To:  
1st Value:  
2nd Value:  
Value Percent:  
Continuous Index:  
Within 8" of Joint: **NO**  
Remarks:

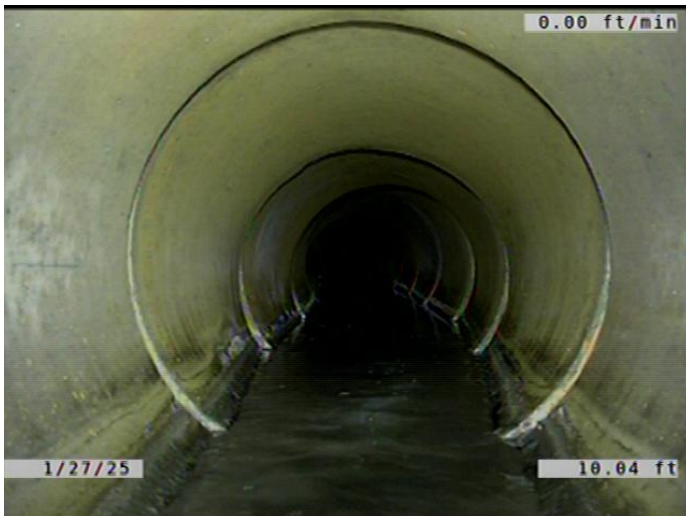
Code: **MWL**  
Description: **Miscellaneous Water Level**

Distance (ft): **10.0**  
Structural Grade: **0**  
O&M Grade: **0**  
Clock Start/From:  
Clock To:  
1st Value:  
2nd Value:  
Value Percent: **20.000**  
Continuous Index:  
Within 8" of Joint: **NO**  
Remarks:

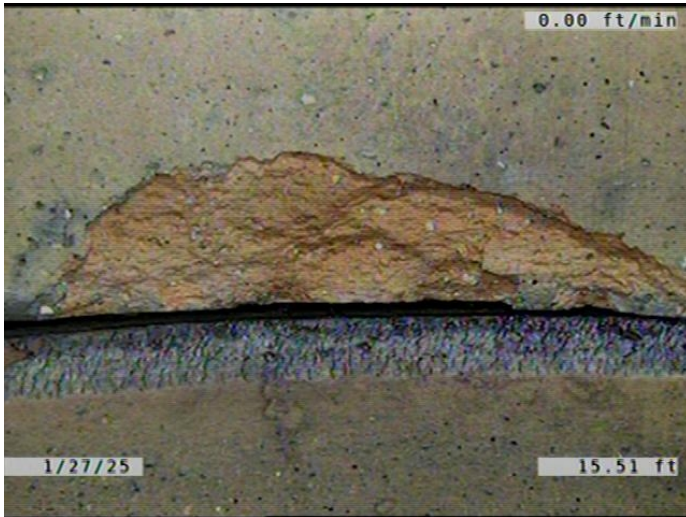
Code: **SSS**  
 Description: **Surface Damage Surface Spalling**

Distance (ft): **15.5**  
 Structural Grade: **2**  
 O&M Grade: **0**  
 Clock Start/From: **11**  
 Clock To: **12**  
 1st Value:  
 2nd Value:  
 Value Percent:  
 Continuous Index:  
 Within 8" of Joint: **YES**  
 Remarks:

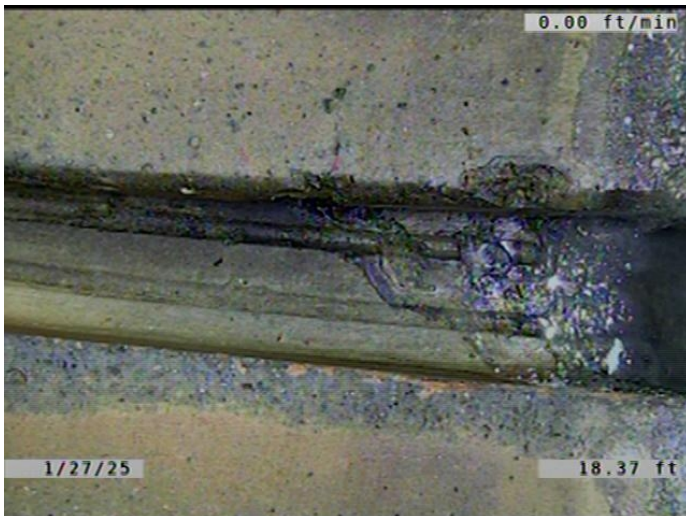
Code: **JAM**  
 Description: **Joint Angular Medium**

Distance (ft): **18.4**  
 Structural Grade: **3**  
 O&M Grade: **0**  
 Clock Start/From:  
 Clock To:  
 1st Value:  
 2nd Value:  
 Value Percent:  
 Continuous Index: **S01**  
 Within 8" of Joint: **NO**  
 Remarks:

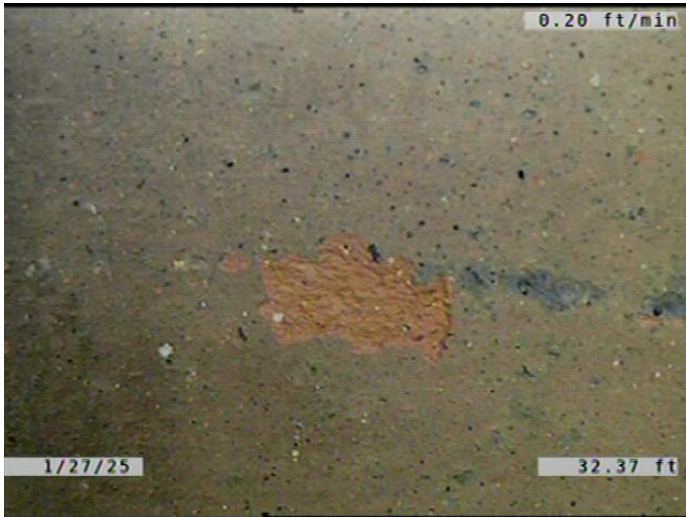
Code:	SSC
Description:	Surface Spalling of Damage Coating
Distance (ft):	32.4
Structural Grade:	1
O&M Grade:	0
Clock Start/From:	9
Clock To:	
1st Value:	
2nd Value:	
Value Percent:	
Continuous Index:	
Within 8" of Joint:	NO
Remarks:

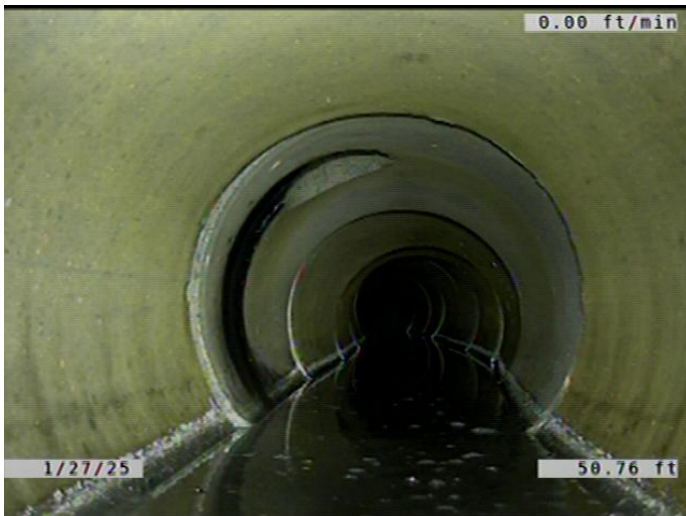
Code:	LR
Description:	Line Right
Distance (ft):	50.8
Structural Grade:	0
O&M Grade:	1
Clock Start/From:	
Clock To:	
1st Value:	
2nd Value:	
Value Percent:	10.000
Continuous Index:	
Within 8" of Joint:	NO
Remarks:

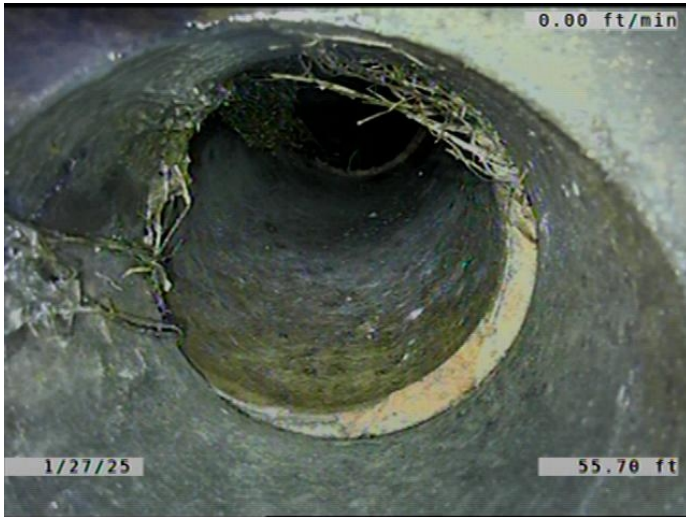
Code:	TFD
Description:	Tap Factory Defective
Distance (ft):	55.7
Structural Grade:	0
O&M Grade:	3
Clock Start/From:	11
Clock To:	
1st Value:	6.000
2nd Value:	
Value Percent:	
Continuous Index:	
Within 8" of Joint:	YES
Remarks:	ROOTS GROWING FROM THE JOINTS INTO THE MAIN.

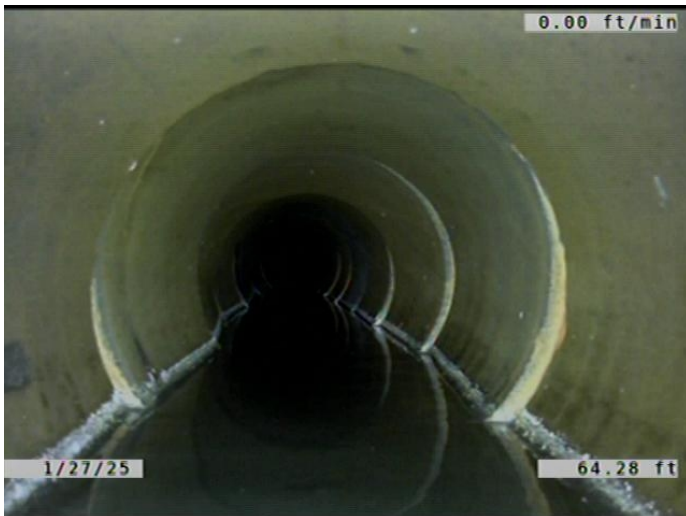
Code:	LL
Description:	Line Left
Distance (ft):	64.3
Structural Grade:	0
O&M Grade:	1
Clock Start/From:	
Clock To:	
1st Value:	
2nd Value:	
Value Percent:	5.000
Continuous Index:	
Within 8" of Joint:	NO
Remarks:

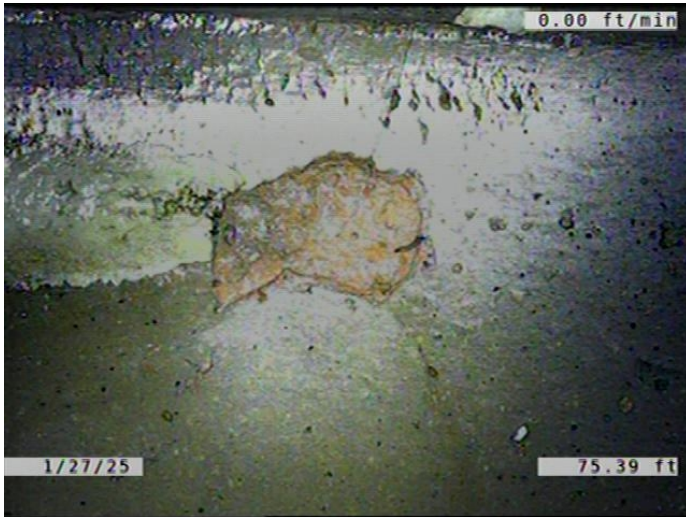
Code: **SSS**  
Description: **Surface Damage Surface Spalling**

Distance (ft): **75.4**  
Structural Grade: **2**  
O&M Grade: **0**  
Clock Start/From: **11**  
Clock To:  
1st Value:  
2nd Value:  
Value Percent:  
Continuous Index:  
Within 8" of Joint: **YES**  
Remarks:

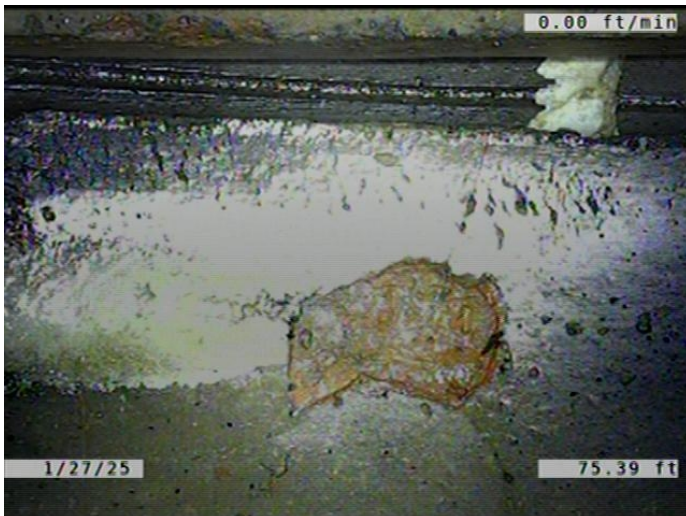
Code: **DAE**  
Description: **Deposits Attached Encrustation**

Distance (ft): **75.4**  
Structural Grade: **0**  
O&M Grade: **2**  
Clock Start/From: **7**  
Clock To: **10**  
1st Value:  
2nd Value:  
Value Percent: **5.000**  
Continuous Index:  
Within 8" of Joint: **YES**  
Remarks:

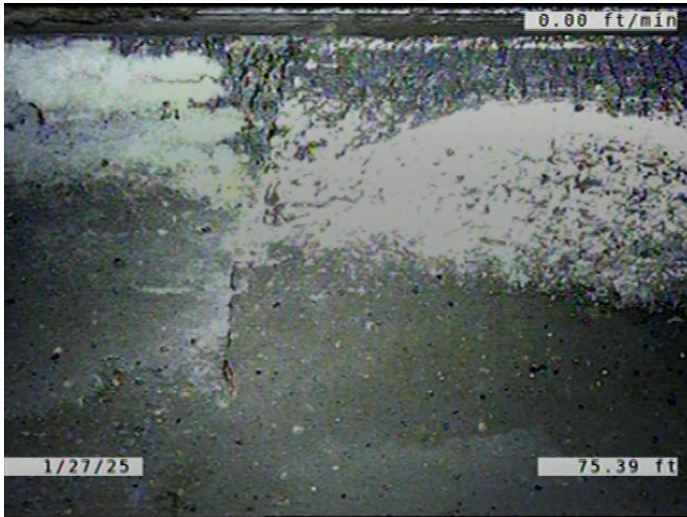
Code: **CM**  
 Description: **Crack Multiple**

Distance (ft): **75.4**  
 Structural Grade: **3**  
 O&M Grade: **0**  
 Clock Start/From: **8**  
 Clock To: **4**  
 1st Value:  
 2nd Value:  
 Value Percent:  
 Continuous Index:  
 Within 8" of Joint: **YES**  
 Remarks:

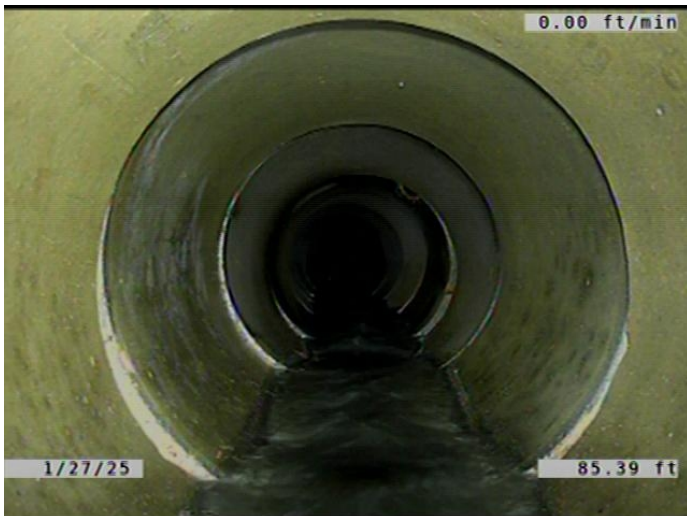
Code: **MWL**  
 Description: **Miscellaneous Water Level**

Distance (ft): **85.4**  
 Structural Grade: **0**  
 O&M Grade: **0**  
 Clock Start/From:  
 Clock To:  
 1st Value:  
 2nd Value:  
 Value Percent: **10.000**  
 Continuous Index:  
 Within 8" of Joint: **NO**  
 Remarks:

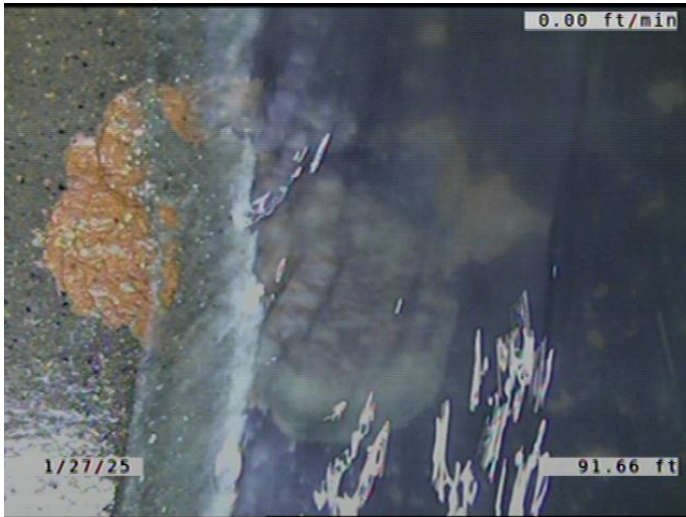
Code: **SSC**  
Description: **Surface Spalling of Damage Coating**

Distance (ft): **91.7**  
Structural Grade: **1**  
O&M Grade: **0**  
Clock Start/From: **7**  
Clock To:  
1st Value:  
2nd Value:  
Value Percent:  
Continuous Index:  
Within 8" of Joint: **YES**  
Remarks:

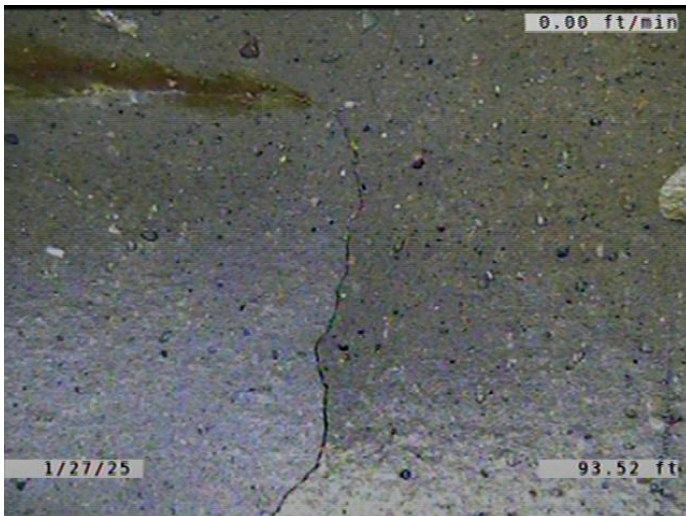
Code: **CM**  
Description: **Crack Multiple**

Distance (ft): **93.5**  
Structural Grade: **3**  
O&M Grade: **0**  
Clock Start/From: **3**  
Clock To: **5**  
1st Value:  
2nd Value:  
Value Percent:  
Continuous Index:  
Within 8" of Joint: **YES**  
Remarks:

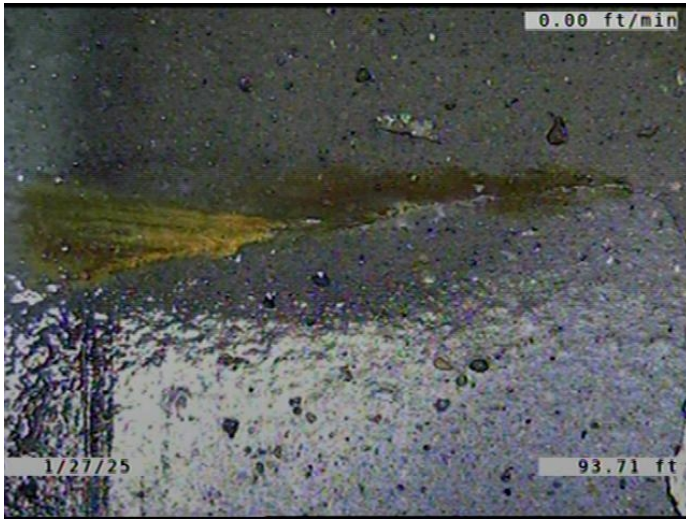
Code: **ISB**  
Description: **Infiltration Stain Barrel**

Distance (ft): **93.7**  
Structural Grade: **0**  
O&M Grade: **1**  
Clock Start/From: **3**  
Clock To: **5**  
1st Value:  
2nd Value:  
Value Percent:  
Continuous Index:  
Within 8" of Joint: **YES**  
Remarks:

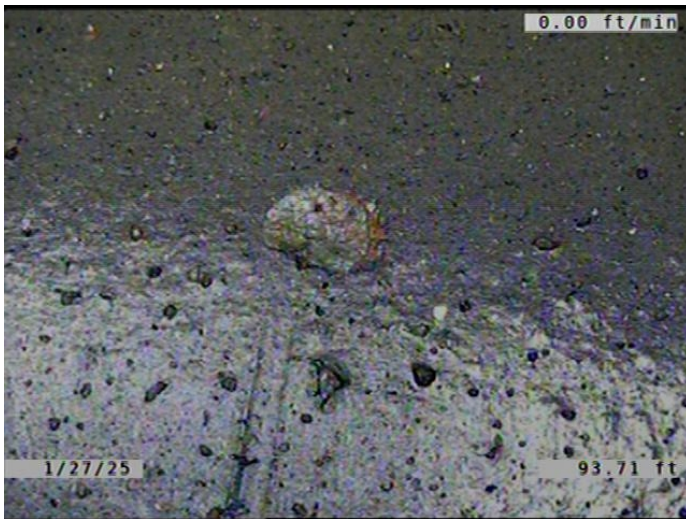
Code: **SSS**  
Description: **Surface Damage Surface Spalling**

Distance (ft): **93.7**  
Structural Grade: **2**  
O&M Grade: **0**  
Clock Start/From: **3**  
Clock To:  
1st Value:  
2nd Value:  
Value Percent:  
Continuous Index:  
Within 8" of Joint: **YES**  
Remarks:

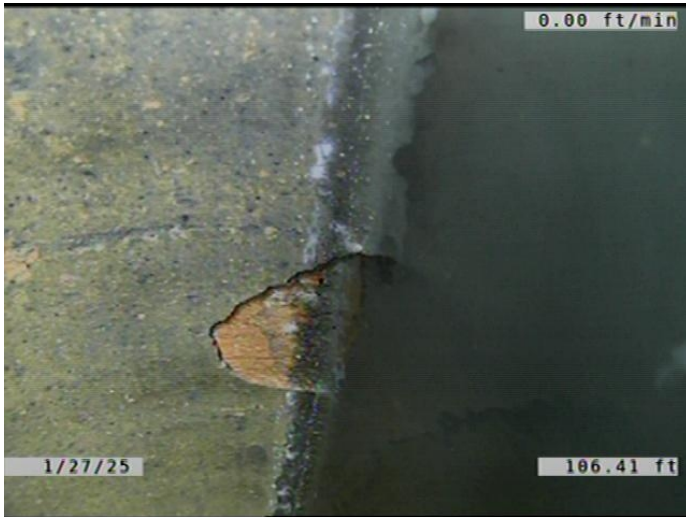
Code: **SSS**  
Description: **Surface Damage Surface Spalling**

Distance (ft): **106.4**  
Structural Grade: **2**  
O&M Grade: **0**  
Clock Start/From: **2**  
Clock To: **5**  
1st Value:  
2nd Value:  
Value Percent:  
Continuous Index:  
Within 8" of Joint: **YES**  
Remarks:

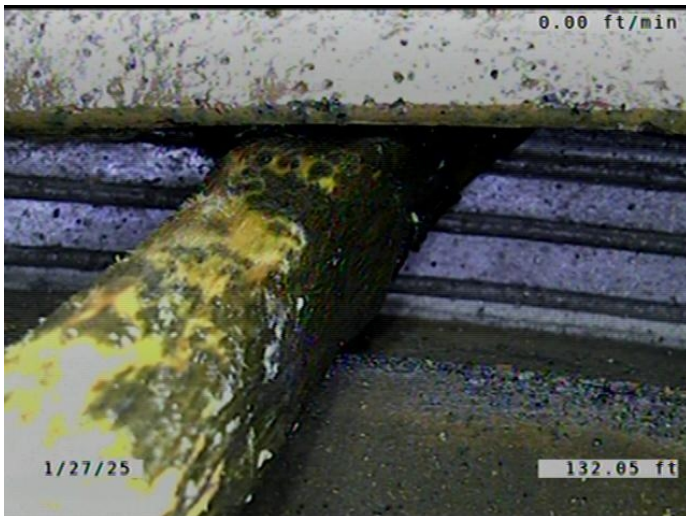
Code: **RTJ**  
Description: **Roots Tap Joint**

Distance (ft): **132.0**  
Structural Grade: **0**  
O&M Grade: **2**  
Clock Start/From: **10**  
Clock To: **12**  
1st Value:  
2nd Value:  
Value Percent: **5.000**  
Continuous Index:  
Within 8" of Joint: **YES**  
Remarks:

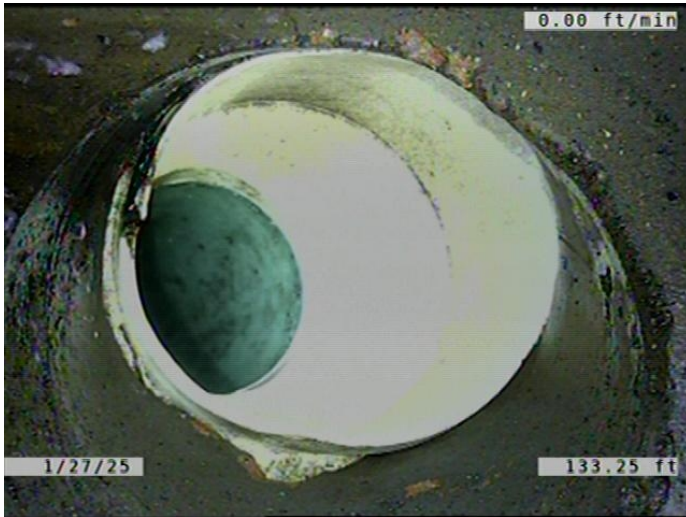
Code:	<b>TFD</b>
Description:	<b>Tap Factory Defective</b>
Distance (ft):	<b>133.2</b>
Structural Grade:	<b>0</b>
O&M Grade:	<b>3</b>
Clock Start/From:	<b>11</b>
Clock To:	
1st Value:	<b>6.000</b>
2nd Value:	
Value Percent:	
Continuous Index:	
Within 8" of Joint:	<b>YES</b>
Remarks:	<b>SERVICE IS PVC. ENCRUSTATION COMING FROM THE SERVICE TO MA</b>

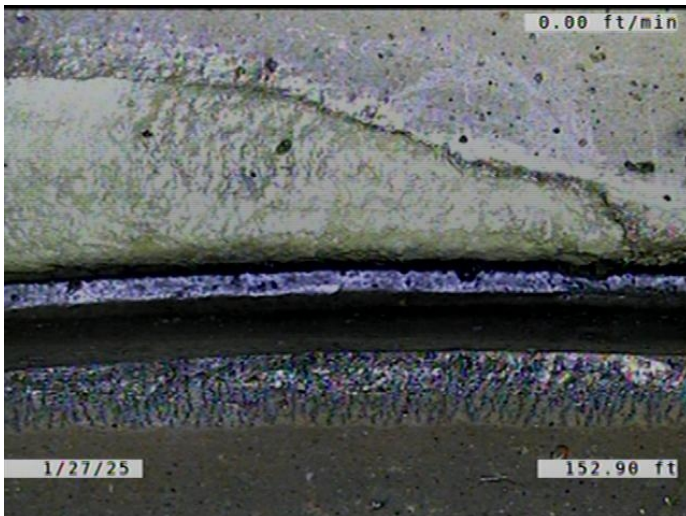
Code:	<b>DAE</b>
Description:	<b>Deposits Attached Encrustation</b>
Distance (ft):	<b>152.9</b>
Structural Grade:	<b>0</b>
O&M Grade:	<b>2</b>
Clock Start/From:	<b>8</b>
Clock To:	<b>11</b>
1st Value:	
2nd Value:	
Value Percent:	<b>5.000</b>
Continuous Index:	
Within 8" of Joint:	<b>YES</b>
Remarks:

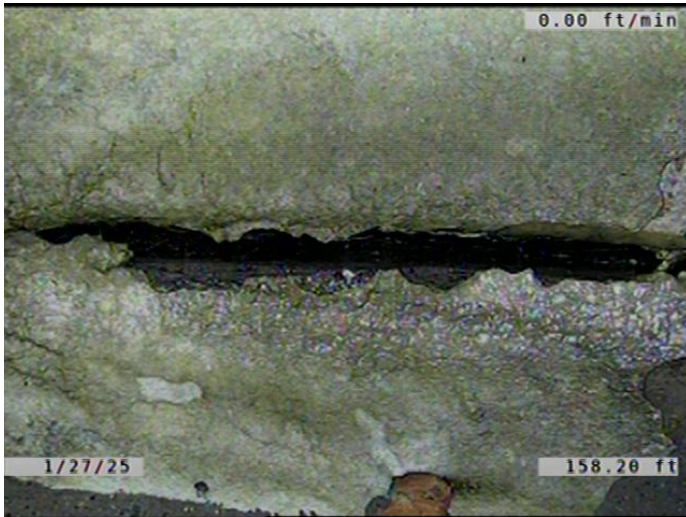
Code: **DAE**  
 Description: **Deposits Attached Encrustation**

Distance (ft): **158.2**  
 Structural Grade: **0**  
 O&M Grade: **2**  
 Clock Start/From: **9**  
 Clock To: **4**  
 1st Value:  
 2nd Value:  
 Value Percent: **5.000**  
 Continuous Index:  
 Within 8" of Joint: **YES**  
 Remarks:

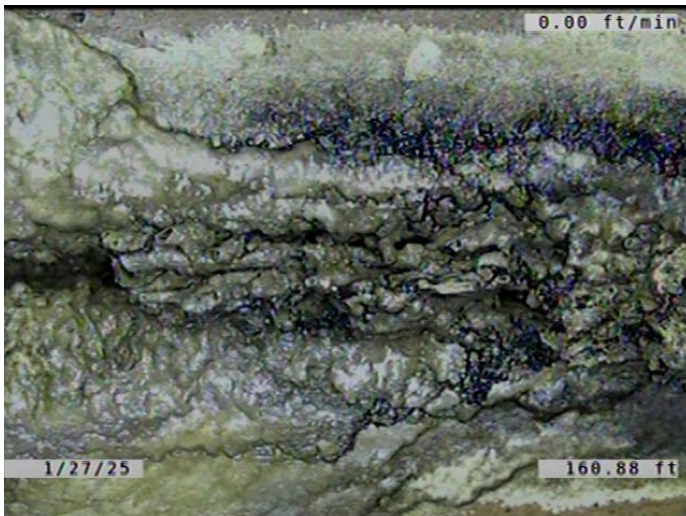
Code: **DAE**  
 Description: **Deposits Attached Encrustation**

Distance (ft): **160.9**  
 Structural Grade: **0**  
 O&M Grade: **2**  
 Clock Start/From: **8**  
 Clock To: **12**  
 1st Value:  
 2nd Value:  
 Value Percent: **5.000**  
 Continuous Index:  
 Within 8" of Joint: **YES**  
 Remarks:

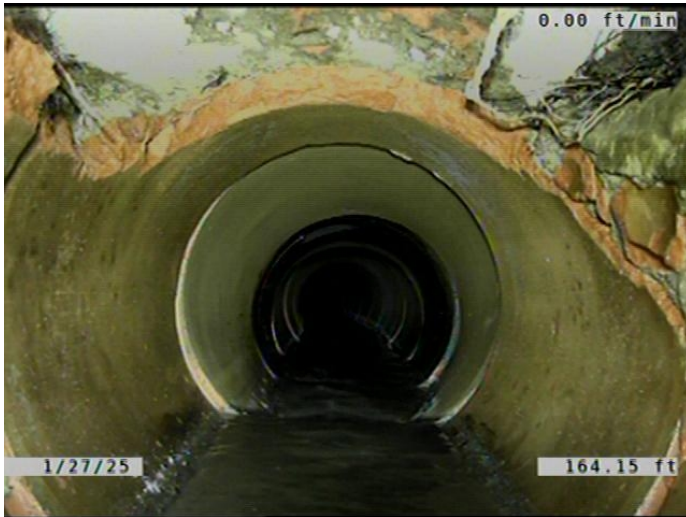
Code: **JAM**  
 Description: **Joint Angular Medium**

Distance (ft): **164.2**  
 Structural Grade: **3**  
 O&M Grade: **0**  
 Clock Start/From:  
 Clock To:  
 1st Value:  
 2nd Value:  
 Value Percent:  
 Continuous Index: **F01**  
 Within 8" of Joint: **NO**  
 Remarks:
