Profile/Photo Observation Report

Street:	W CLEVELAND AVE	Flow Control:	Not Controlled
City:	Hobart, IN	Year Renewed:	
Location:	Alley	Tape/Media #:	
Purpose:	Routine Assessment	Dia/Height:	12"
Use:	Sanitary	Material:	VCP
Drain Area:	NA	Lining:	
Category:	NA		
Comment:	P_C at 13 ft debris . Flow direction wrong		
Location Details:		Direction of Survey:	Upstream
US MH:	M-504-027	DS MH:	M-504-052
		Total Length Surveyed (ft):	14.1

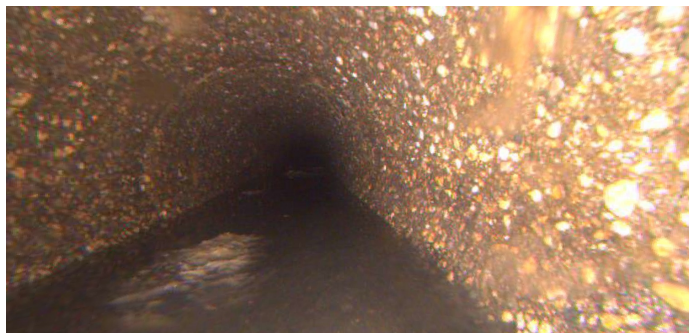
Code: **AMH**
Description: **Manhole**

Distance (ft): **.0**
Structural Grade: **0**
O&M Grade: **0**
Clock Start/From:
Clock To:
1st Value:
2nd Value:
Value Percent:
Continuous Index:
Within 8" of Joint: **NO**
Remarks: **M-504-052**

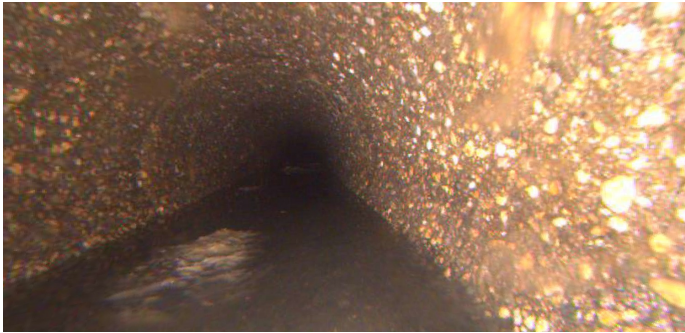
Code:	MWL
Description:	Water Level

Distance (ft):	.0
Structural Grade:	0
O&M Grade:	0
Clock Start/From:	
Clock To:	
1st Value:	
2nd Value:	
Value Percent:	20.000
Continuous Index:	
Within 8" of Joint:	NO
Remarks:

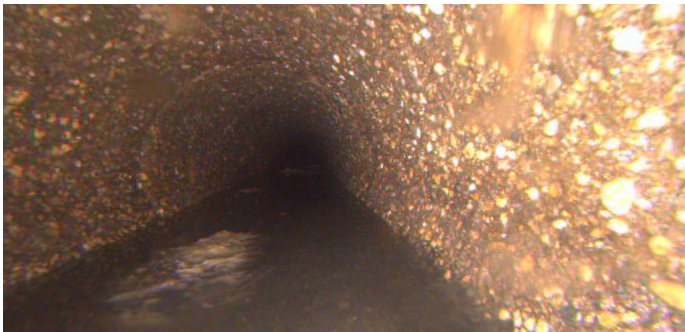
Code:	SAP
Description:	Surface Aggregate Projecting

Distance (ft):	.0
Structural Grade:	3
O&M Grade:	0
Clock Start/From:	8
Clock To:	4
1st Value:	
2nd Value:	
Value Percent:	
Continuous Index:	
Within 8" of Joint:	
Remarks:

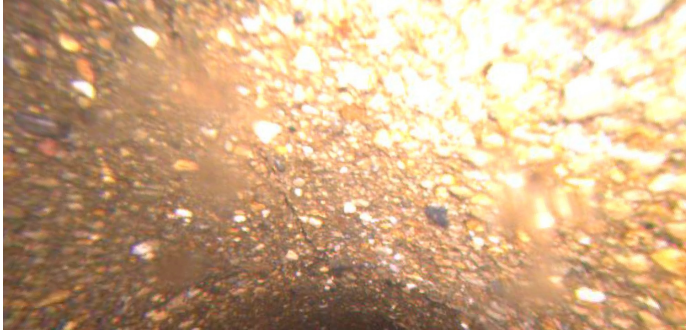
Code: **FL**
Description: **Fracture Longitudinal**

Distance (ft): **11.0**
Structural Grade: **3**
O&M Grade: **0**
Clock Start/From: **12**
Clock To:
1st Value:
2nd Value:
Value Percent:
Continuous Index:
Within 8" of Joint: **YES**
Remarks:

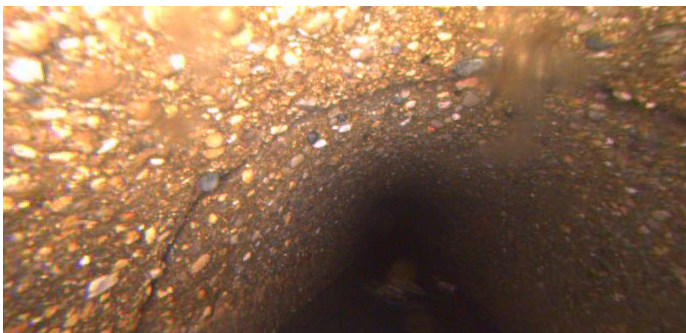
Code: **MSA**
Description: **Abandoned Survey**

Distance (ft): **14.1**
Structural Grade: **0**
O&M Grade: **0**
Clock Start/From:
Clock To:
1st Value:
2nd Value:
Value Percent:
Continuous Index:
Within 8" of Joint: **NO**
Remarks: **debris under water**
