Profile/Photo Observation Report

Street:	FOXCROFT STREET	Flow Control:	Not Controlled
City:	Hobart, IN	Year Renewed:	
Location:	Alley	Tape/Media #:	
Purpose:	Routine Assessment	Dia/Height:	12"
Use:	Sanitary	Material:	VCP
Drain Area:	NA	Lining:	
Category:	NA		
Comment:	P_C at 13 ft debris . Flow direction wrong		
Location Details:		Direction of Survey:	Upstream
US MH:	M-504-027	DS MH:	M-504-052
		Total Length Surveyed (ft):	14.1

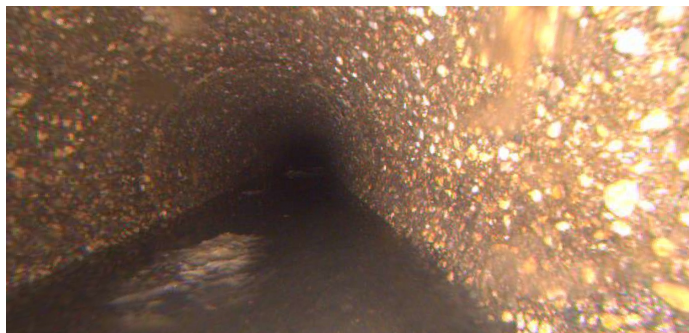
Code: **AMH**
Description: **Manhole**

Distance (ft): **.0**
Structural Grade: **0**
O&M Grade: **0**
Clock Start/From:
Clock To:
1st Value:
2nd Value:
Value Percent:
Continuous Index:
Within 8" of Joint: **NO**
Remarks: **M-504-052**

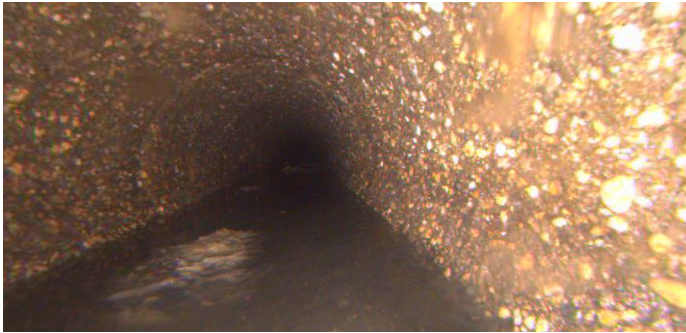
Code:	MWL
Description:	Water Level

Distance (ft):	.0
Structural Grade:	0
O&M Grade:	0
Clock Start/From:	
Clock To:	
1st Value:	
2nd Value:	
Value Percent:	20.000
Continuous Index:	
Within 8" of Joint:	NO
Remarks:

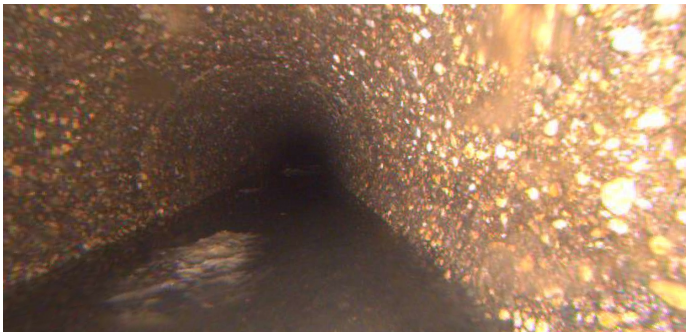
Code:	SAP
Description:	Surface Aggregate Projecting

Distance (ft):	.0
Structural Grade:	3
O&M Grade:	0
Clock Start/From:	8
Clock To:	4
1st Value:	
2nd Value:	
Value Percent:	
Continuous Index:	
Within 8" of Joint:	
Remarks:

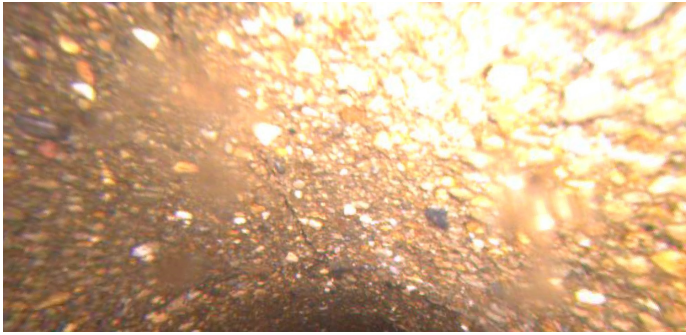
Code: **FL**
Description: **Fracture Longitudinal**

Distance (ft): **11.0**
Structural Grade: **3**
O&M Grade: **0**
Clock Start/From: **12**
Clock To:
1st Value:
2nd Value:
Value Percent:
Continuous Index:
Within 8" of Joint: **YES**
Remarks:

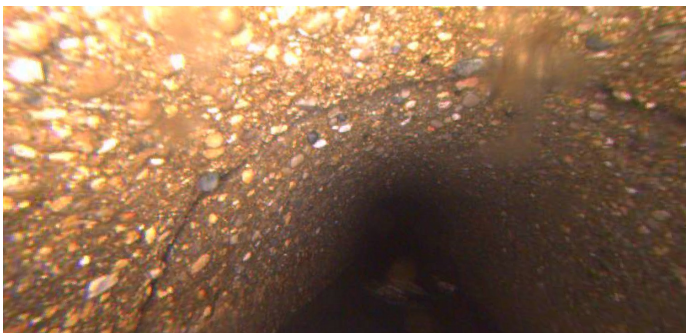
Code: **MSA**
Description: **Abandoned Survey**

Distance (ft): **14.1**
Structural Grade: **0**
O&M Grade: **0**
Clock Start/From:
Clock To:
1st Value:
2nd Value:
Value Percent:
Continuous Index:
Within 8" of Joint: **NO**
Remarks: **debris under water**
