Profile/Photo Observation Report

Date:	09/16/2021	Weather:		Coding:	PACP 7.0
Pipe Length (ft):	326.7	Owner:	City of Hobart	Pre Clean:	Light Cleaning
P.O.#:	YES502259	Surveyor:	S. Bucklin	PSR:	P-504-052-027
Customer:	City of Hobart	Clean Date:	09/07/2021	Shape:	C

Street:	North Guyer Street	Flow Control:	Not Controlled
City:	Hobart, IN	Year Renewed:	
Location:	Alley	Tape/Media #:	
Purpose:	Routine Assessment	Dia/Height:	12"
Use:	Sanitary Sewage Pipe	Material:	CP
Drain Area:		Lining:	None
Category:	NA		
Comment:			
Location Details:		Direction of Survey:	Downstream
US MH:	M-504-027	DS MH:	M-504-052
		Total Length Surveyed (ft):	326.7

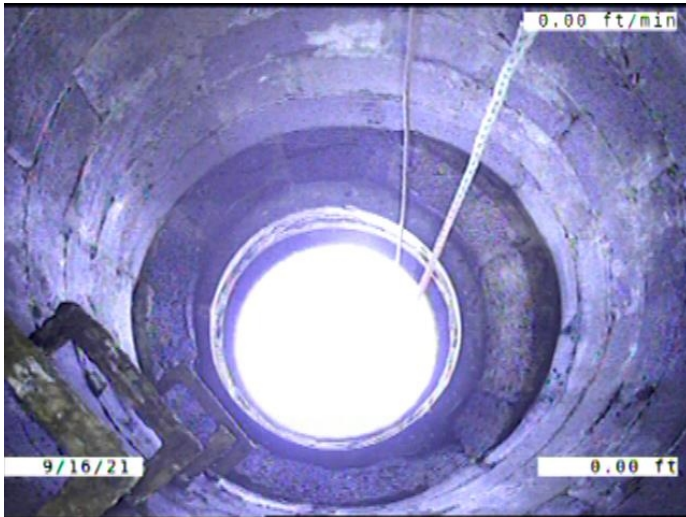
Code: **AMH**
 Description: **Manhole**

Distance (ft): **.0**
 Structural Grade: **0**
 O&M Grade: **0**
 Clock Start/From:
 Clock To:
 1st Value:
 2nd Value:
 Value Percent:
 Continuous Index:
 Within 8" of Joint: **NO**
 Remarks: **M-504-027**

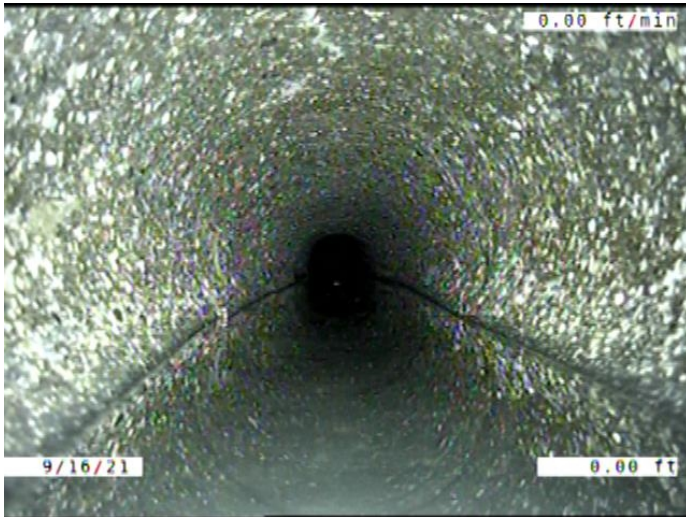
Code: **DSF**
 Description: **Deposits Settled Fine**

Distance (ft): **.0**
 Structural Grade: **0**
 O&M Grade: **2**
 Clock Start/From: **5**
 Clock To: **7**
 1st Value:
 2nd Value:
 Value Percent: **5.000**
 Continuous Index: **S01**
 Within 8" of Joint: **YES**
 Remarks:

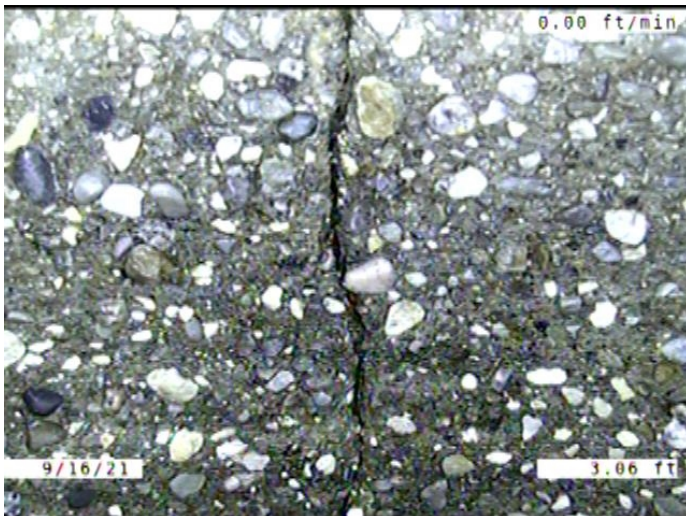
Code: **FM**
 Description: **Fracture Multiple**

Distance (ft): **3.1**
 Structural Grade: **4**
 O&M Grade: **0**
 Clock Start/From: **8**
 Clock To: **4**
 1st Value:
 2nd Value:
 Value Percent:
 Continuous Index: **S02**
 Within 8" of Joint: **YES**
 Remarks:

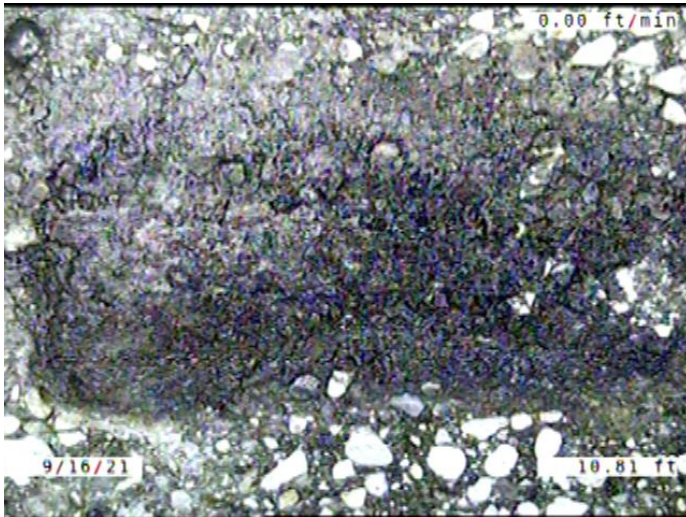
Code: **DAE**
 Description: **Deposits Attached Encrustation**

Distance (ft): **10.8**
 Structural Grade: **0**
 O&M Grade: **2**
 Clock Start/From: **1**
 Clock To: **2**
 1st Value:
 2nd Value:
 Value Percent: **5.000**
 Continuous Index:
 Within 8" of Joint: **NO**
 Remarks:

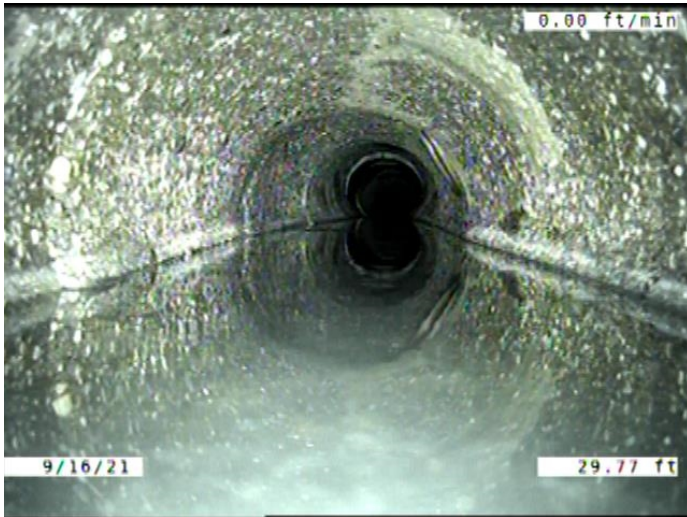
Code: **MWLS**
 Description: **Miscellaneous Water Level Sag**

Distance (ft): **29.8**
 Structural Grade: **2**
 O&M Grade: **0**
 Clock Start/From:
 Clock To:
 1st Value:
 2nd Value:
 Value Percent: **15.000**
 Continuous Index: **S04**
 Within 8" of Joint: **NO**
 Remarks:

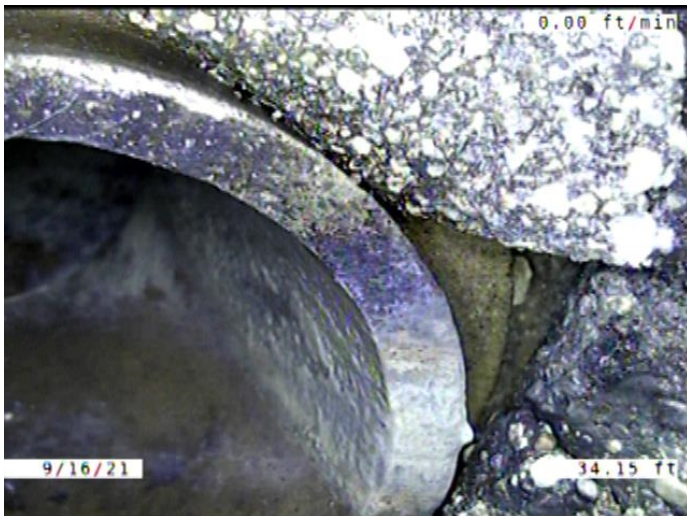
Code: **SMW**
 Description: **Surface Damage Missing Wall**

Distance (ft): **34.2**
 Structural Grade: **5**
 O&M Grade: **0**
 Clock Start/From: **12**
 Clock To: **3**
 1st Value:
 2nd Value:
 Value Percent:
 Continuous Index:
 Within 8" of Joint: **YES**
 Remarks:

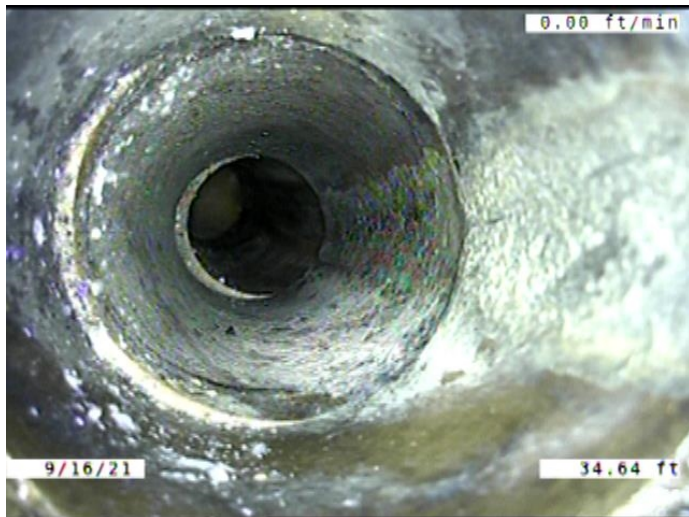
Code: **TBI**
 Description: **Tap Break-in Intruding**

Distance (ft): **34.6**
 Structural Grade: **0**
 O&M Grade: **2**
 Clock Start/From: **1**
 Clock To:
 1st Value: **4.000**
 2nd Value: **1.000**
 Value Percent:
 Continuous Index:
 Within 8" of Joint: **YES**
 Remarks:

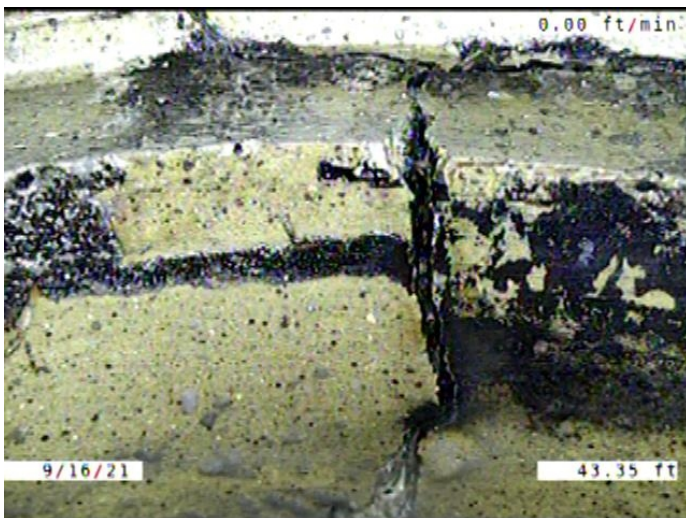
Code: **DR**
 Description: **Deformed Rigid**

Distance (ft): **43.3**
 Structural Grade: **4**
 O&M Grade: **0**
 Clock Start/From:
 Clock To:
 1st Value:
 2nd Value:
 Value Percent: **5.000**
 Continuous Index:
 Within 8" of Joint: **NO**
 Remarks:

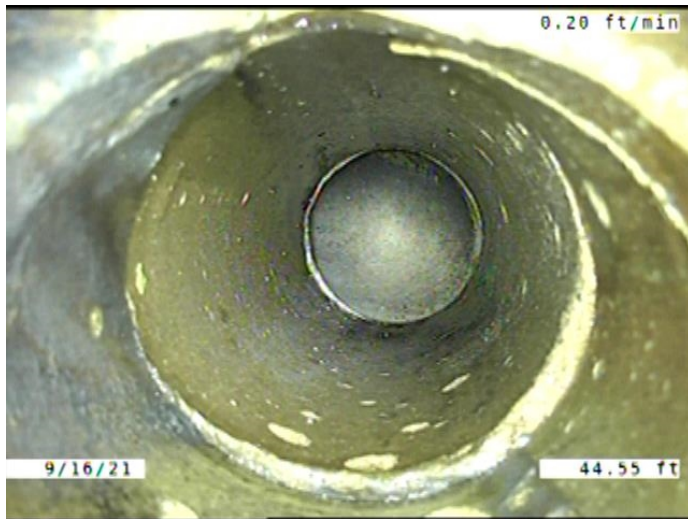
Code: **TFD**
 Description: **Tap Factory Defective**

Distance (ft): **44.5**
 Structural Grade: **0**
 O&M Grade: **3**
 Clock Start/From: **12**
 Clock To:
 1st Value: **4.000**
 2nd Value:
 Value Percent:
 Continuous Index:
 Within 8" of Joint: **YES**
 Remarks: **Defective**

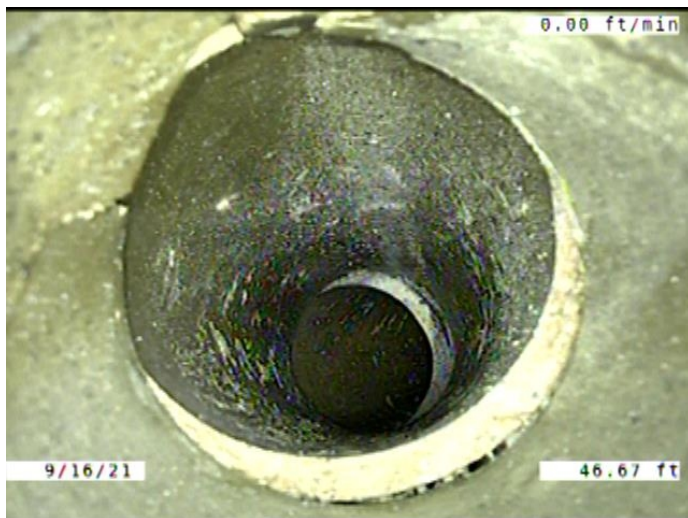
Code: **TFD**
 Description: **Tap Factory Defective**

Distance (ft): **46.7**
 Structural Grade: **0**
 O&M Grade: **3**
 Clock Start/From: **12**
 Clock To:
 1st Value: **4.000**
 2nd Value:
 Value Percent:
 Continuous Index:
 Within 8" of Joint: **YES**
 Remarks: **Defective**

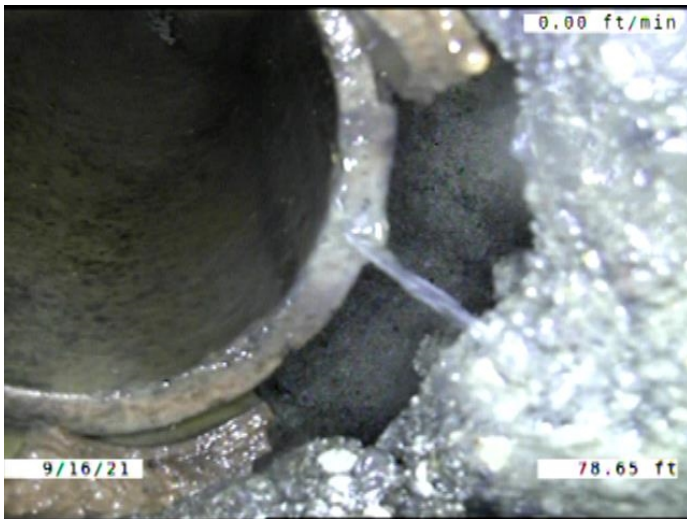
Code: **BSV**
Description: **Broken Soil Visible**

Distance (ft): **78.7**
Structural Grade: **5**
O&M Grade: **0**
Clock Start/From: **1**
Clock To:
1st Value:
2nd Value:
Value Percent:
Continuous Index:
Within 8" of Joint: **YES**
Remarks:

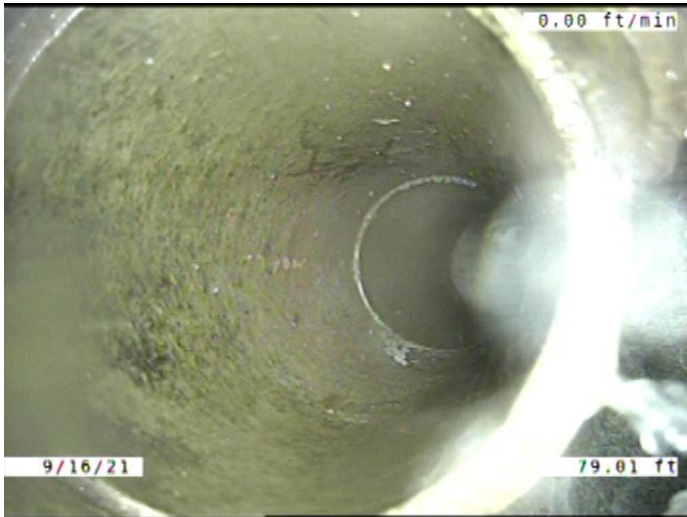
Code: **TBI**
 Description: **Tap Break-in Intruding**

Distance (ft): **79.0**
 Structural Grade: **0**
 O&M Grade: **2**
 Clock Start/From: **1**
 Clock To:
 1st Value: **4.000**
 2nd Value: **1.000**
 Value Percent:
 Continuous Index:
 Within 8" of Joint: **YES**
 Remarks: **CONSTANTLY RUNNING WATER. SOIL VISIBLE AROUND THE TAP CONNECT**

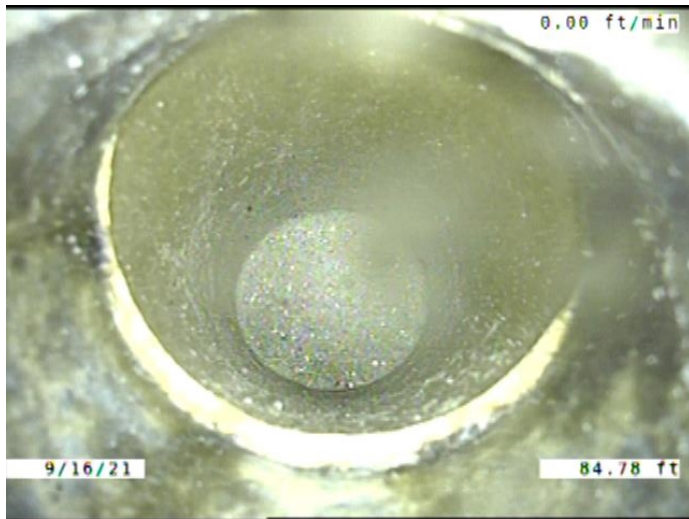
Code: **TFD**
 Description: **Tap Factory Defective**

Distance (ft): **84.8**
 Structural Grade: **0**
 O&M Grade: **3**
 Clock Start/From: **12**
 Clock To:
 1st Value: **4.000**
 2nd Value:
 Value Percent:
 Continuous Index:
 Within 8" of Joint: **YES**
 Remarks: **CAPPED**

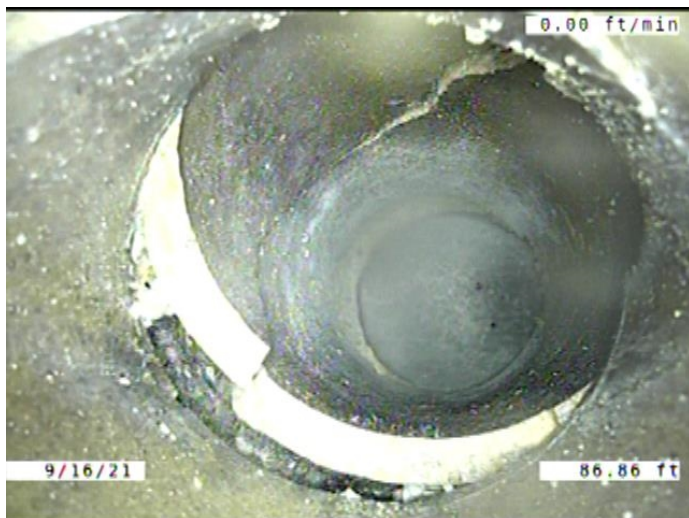
Code: **TFD**
 Description: **Tap Factory Defective**

Distance (ft): **86.9**
 Structural Grade: **0**
 O&M Grade: **3**
 Clock Start/From: **12**
 Clock To:
 1st Value: **4.000**
 2nd Value:
 Value Percent:
 Continuous Index:
 Within 8" of Joint: **YES**
 Remarks: **Defective**

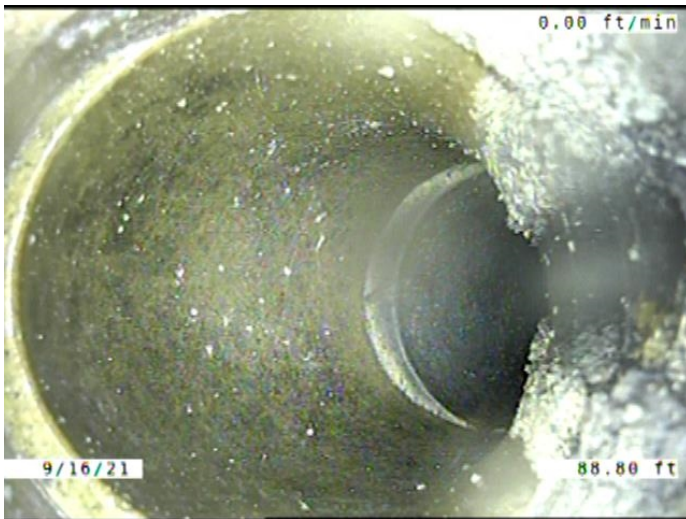
Code: **TBD**
Description: **Tap Break-in/Hammer Defective**

Distance (ft): **88.8**
Structural Grade: **0**
O&M Grade: **3**
Clock Start/From: **1**
Clock To:
1st Value: **4.000**
2nd Value:
Value Percent:
Continuous Index:
Within 8" of Joint: **YES**
Remarks: **Defective**

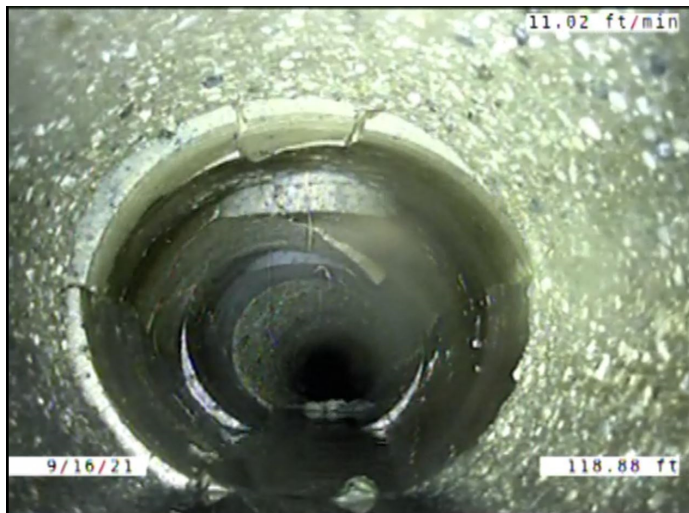
Code: **B**
 Description: **Broken**

Distance (ft): **118.9**
 Structural Grade: **4**
 O&M Grade: **0**
 Clock Start/From: **6**
 Clock To: **3**
 1st Value:
 2nd Value:
 Value Percent:
 Continuous Index:
 Within 8" of Joint: **NO**
 Remarks:

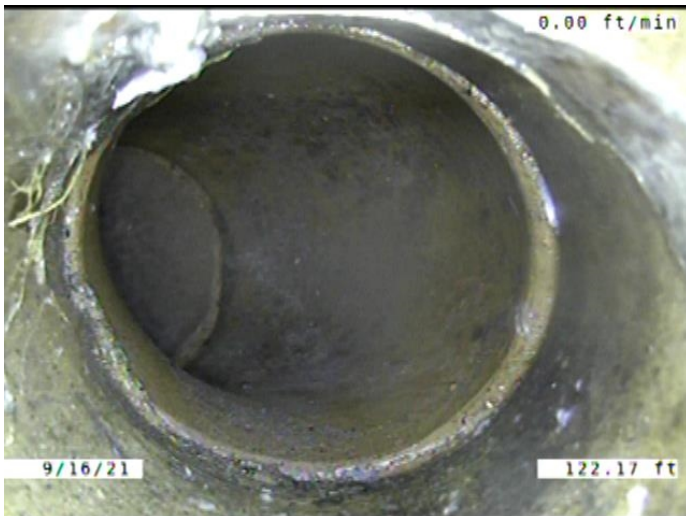
Code: **TFD**
Description: **Tap Factory Defective**

Distance (ft): **122.2**
Structural Grade: **0**
O&M Grade: **3**
Clock Start/From: **12**
Clock To:
1st Value: **4.000**
2nd Value:
Value Percent:
Continuous Index:
Within 8" of Joint: **YES**
Remarks: **Defective**

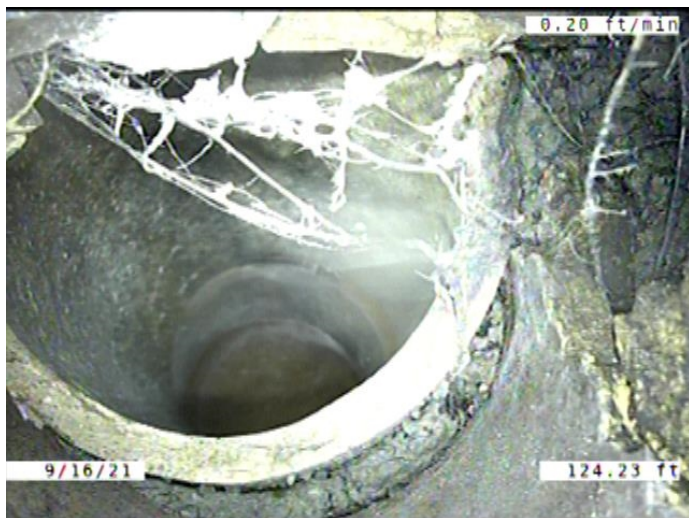
Code: **TFD**
 Description: **Tap Factory Defective**

Distance (ft): **124.2**
 Structural Grade: **0**
 O&M Grade: **3**
 Clock Start/From: **12**
 Clock To:
 1st Value: **4.000**
 2nd Value:
 Value Percent:
 Continuous Index:
 Within 8" of Joint: **YES**
 Remarks: **SOIL VISIBLE AROUND THE TAP**

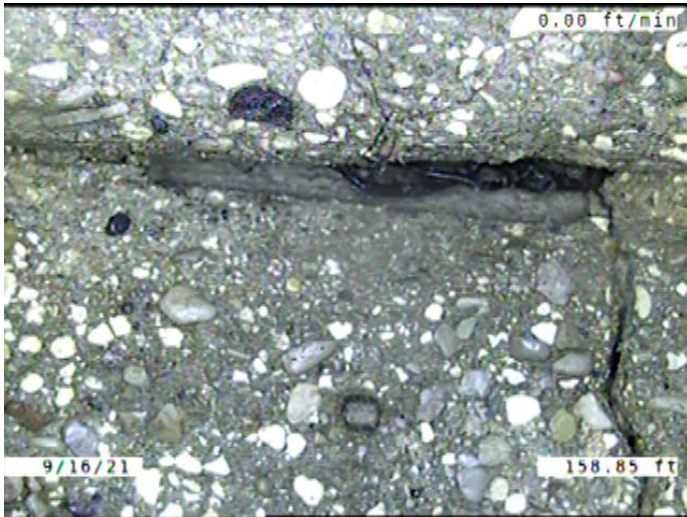
Code: **BSV**
 Description: **Broken Soil Visible**

Distance (ft): **158.9**
 Structural Grade: **5**
 O&M Grade: **0**
 Clock Start/From: **11**
 Clock To: **12**
 1st Value:
 2nd Value:
 Value Percent:
 Continuous Index:
 Within 8" of Joint: **YES**
 Remarks:

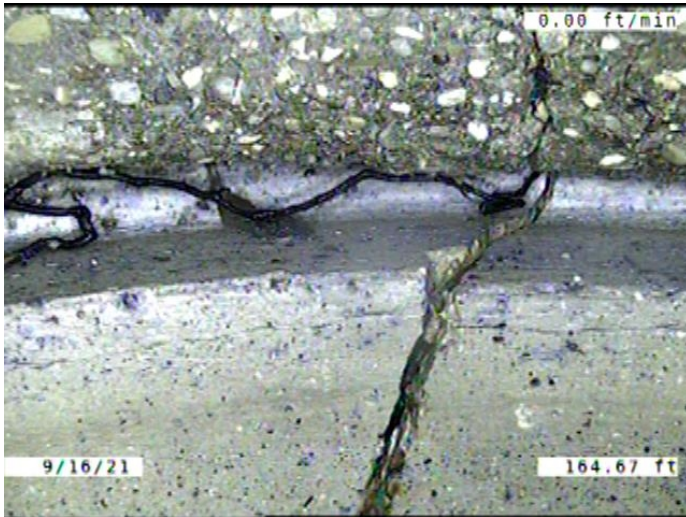
Code: **H**
 Description: **Hole**

Distance (ft): **164.7**
 Structural Grade: **5**
 O&M Grade: **0**
 Clock Start/From: **4**
 Clock To: **5**
 1st Value:
 2nd Value:
 Value Percent:
 Continuous Index:
 Within 8" of Joint: **YES**
 Remarks:

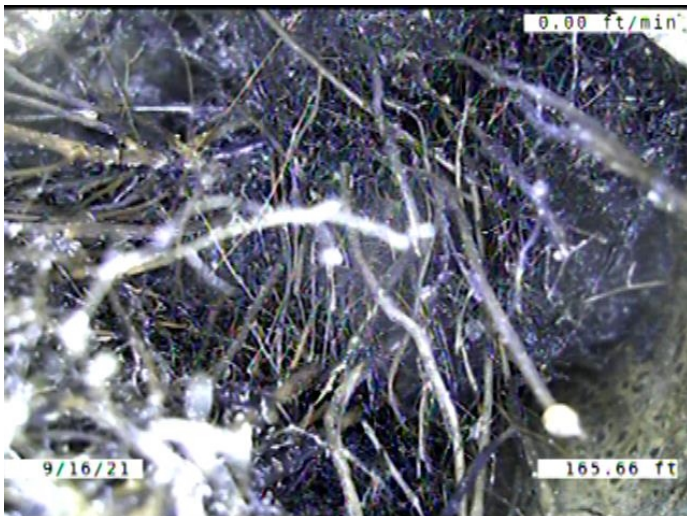
Code: **TFD**
 Description: **Tap Factory Defective**

Distance (ft): **165.7**
 Structural Grade: **0**
 O&M Grade: **3**
 Clock Start/From: **11**
 Clock To:
 1st Value: **4.000**
 2nd Value:
 Value Percent:
 Continuous Index:
 Within 8" of Joint: **YES**
 Remarks: **Defective**

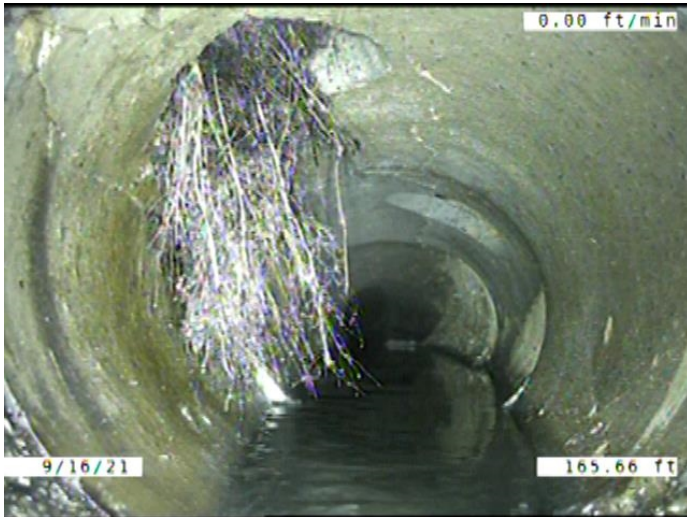
Code: **RML**
 Description: **Roots Medium Lateral**

Distance (ft): **165.7**
 Structural Grade: **0**
 O&M Grade: **3**
 Clock Start/From: **9**
 Clock To: **12**
 1st Value:
 2nd Value:
 Value Percent: **20.000**
 Continuous Index:
 Within 8" of Joint: **NO**
 Remarks:

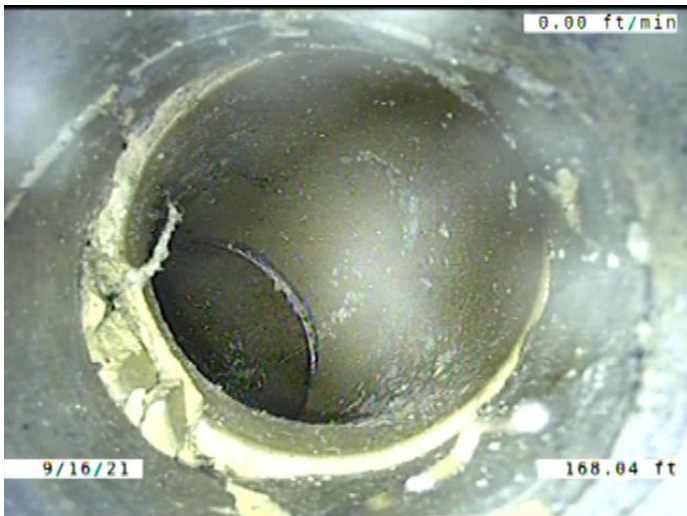
Code: **TFD**
 Description: **Tap Factory Defective**

Distance (ft): **168.0**
 Structural Grade: **0**
 O&M Grade: **3**
 Clock Start/From: **1**
 Clock To:
 1st Value: **4.000**
 2nd Value:
 Value Percent:
 Continuous Index:
 Within 8" of Joint: **YES**
 Remarks: **Defective**

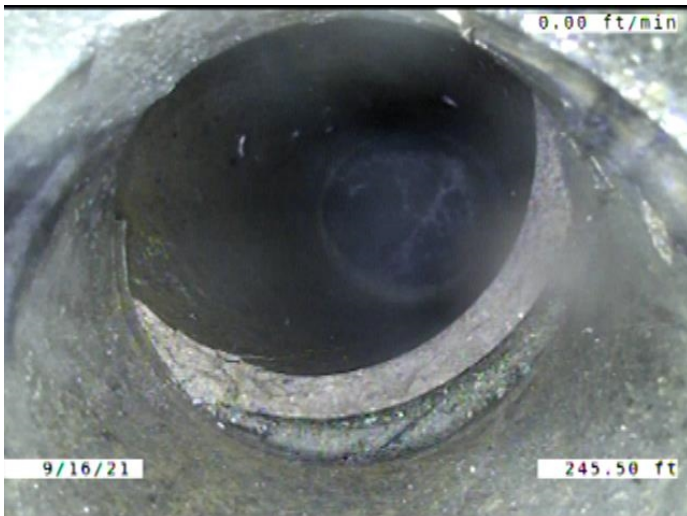
Code: **TFD**
 Description: **Tap Factory Defective**

Distance (ft): **245.5**
 Structural Grade: **0**
 O&M Grade: **3**
 Clock Start/From: **11**
 Clock To:
 1st Value: **4.000**
 2nd Value:
 Value Percent:
 Continuous Index:
 Within 8" of Joint: **YES**
 Remarks: **Defective**

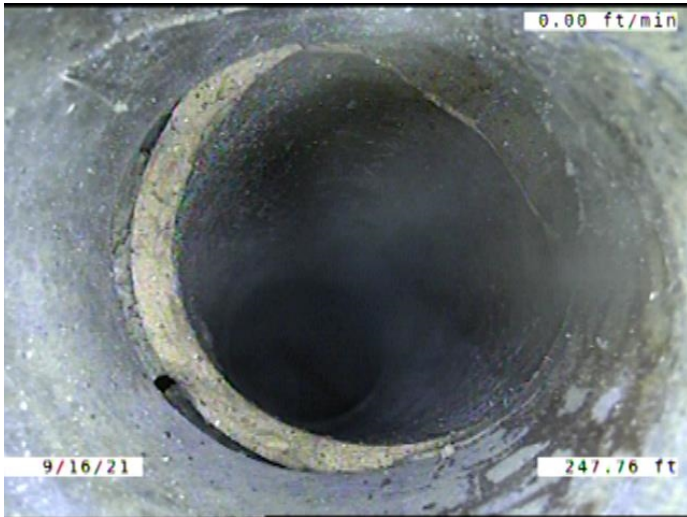
Code:	TFD
Description:	Tap Factory Defective
Distance (ft):	247.8
Structural Grade:	0
O&M Grade:	3
Clock Start/From:	1
Clock To:	
1st Value:	4.000
2nd Value:	
Value Percent:	
Continuous Index:	
Within 8" of Joint:	YES
Remarks:	SOIL VISIBLE AT THE FIRST JOINT BACK

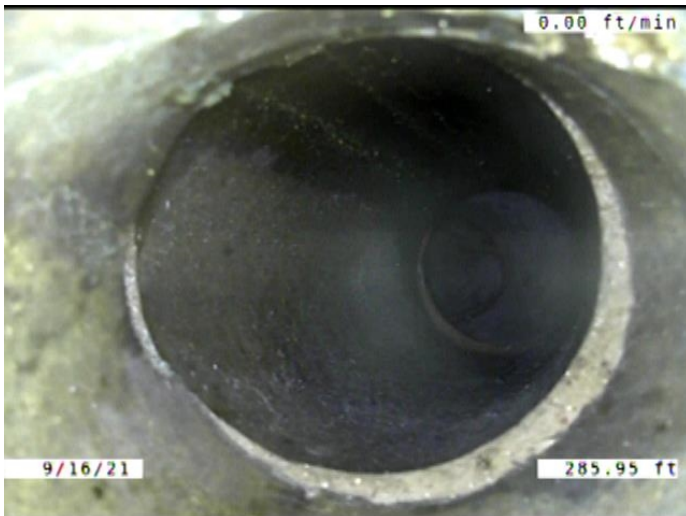
Code: **TFD**
 Description: **Tap Factory Defective**

Distance (ft): **286.0**
 Structural Grade: **0**
 O&M Grade: **3**
 Clock Start/From: **11**
 Clock To:
 1st Value: **4.000**
 2nd Value:
 Value Percent:
 Continuous Index:
 Within 8" of Joint: **YES**
 Remarks: **Defective**

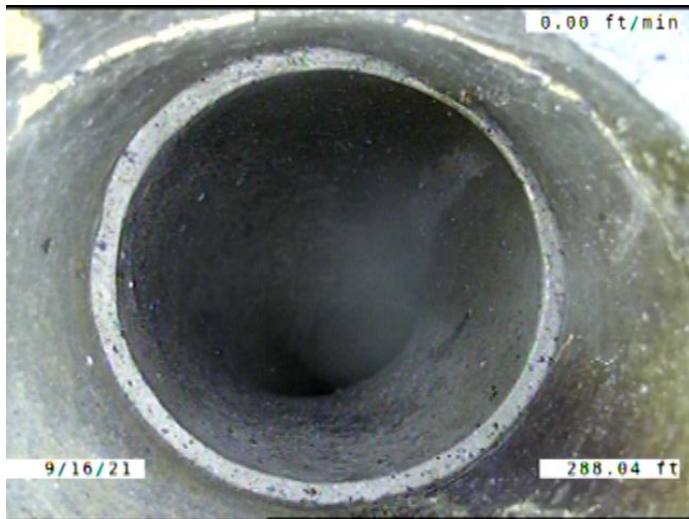
Code: **TFD**
Description: **Tap Factory Defective**

Distance (ft): **288.0**
Structural Grade: **0**
O&M Grade: **3**
Clock Start/From: **1**
Clock To:
1st Value: **4.000**
2nd Value:
Value Percent:
Continuous Index:
Within 8" of Joint: **YES**
Remarks: **Defective**

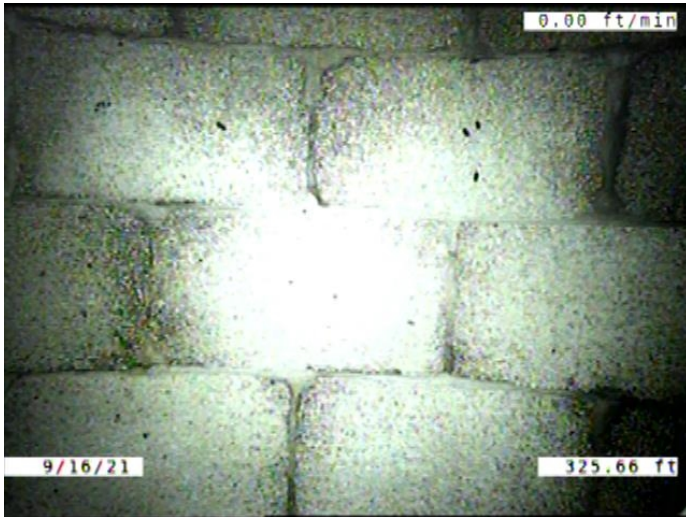
Code: **FM**
 Description: **Fracture Multiple**
