RedZone
ROBOTICS

Street:	North Guyer Street		Flow Control:	Not Controlled	
City:	Hobart, IN		Year Renewed:		
Location:	Alley		Tape/Media #:		
Purpose:	Routine Assessment		Dia/Height:	12"	
Use:	Sanitary Sewage Pipe		Material:	CP	
Drain Area:			Lining:	None	
Category:	NA				
Comment:					
Location Details:			Direction of Survey: Downstream		
US MH:	M-504-027	DS MH:	M-504-052	Total Length Surveyed (ft):	326.7

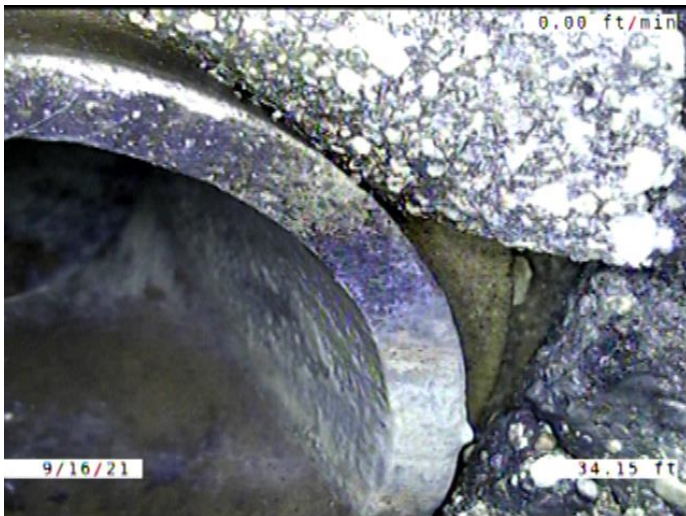
Code: **SMW**
 Description: **Surface Damage Missing Wall**

Distance (ft): **34.2**
 Structural Grade: **5**
 O&M Grade: **0**
 Clock Start/From: **12**
 Clock To: **3**
 1st Value:
 2nd Value:
 Value Percent:
 Continuous Index:
 Within 8" of Joint: **YES**
 Remarks:

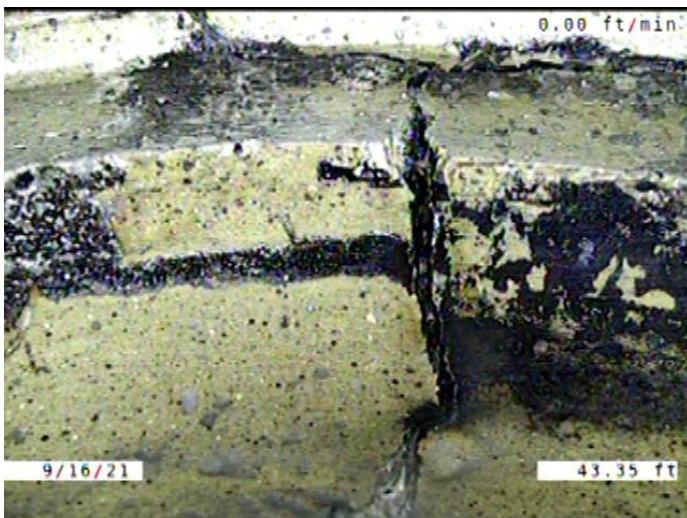
Code: **DR**
 Description: **Deformed Rigid**

Distance (ft): **43.3**
 Structural Grade: **4**
 O&M Grade: **0**
 Clock Start/From:
 Clock To:
 1st Value:
 2nd Value:
 Value Percent: **5.000**
 Continuous Index:
 Within 8" of Joint: **NO**
 Remarks:

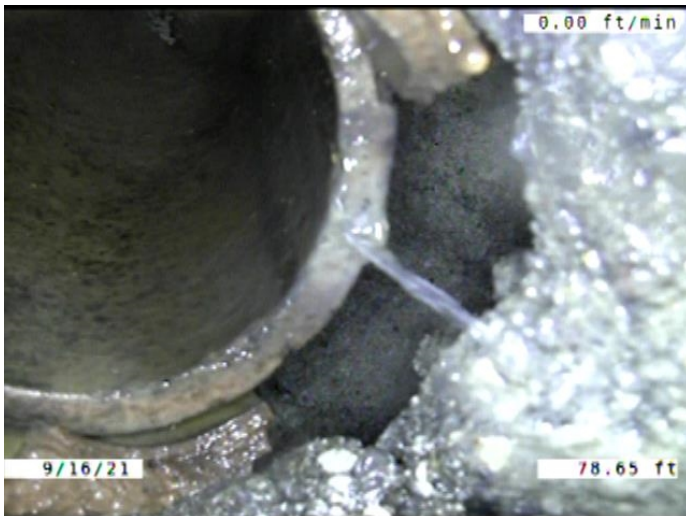
Code: **BSV**
 Description: **Broken Soil Visible**

Distance (ft): **78.7**
 Structural Grade: **5**
 O&M Grade: **0**
 Clock Start/From: **1**
 Clock To:
 1st Value:
 2nd Value:
 Value Percent:
 Continuous Index:
 Within 8" of Joint: **YES**
 Remarks:

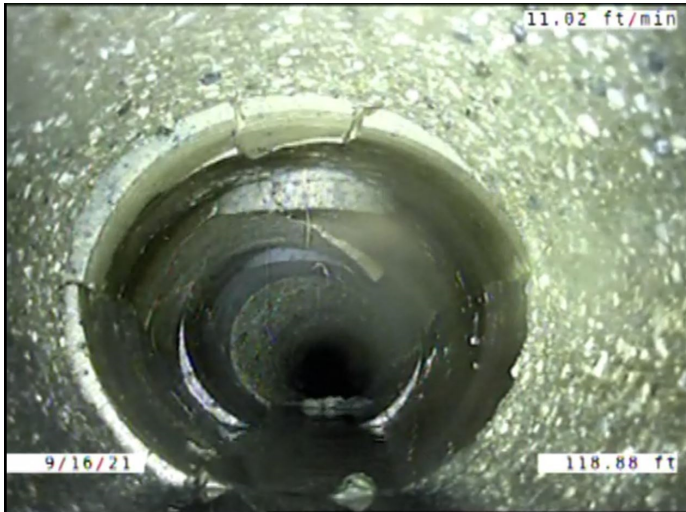
Code: **B**
Description: **Broken**

Distance (ft): **118.9**
Structural Grade: **4**
O&M Grade: **0**
Clock Start/From: **6**
Clock To: **3**
1st Value:
2nd Value:
Value Percent:
Continuous Index:
Within 8" of Joint: **NO**
Remarks:

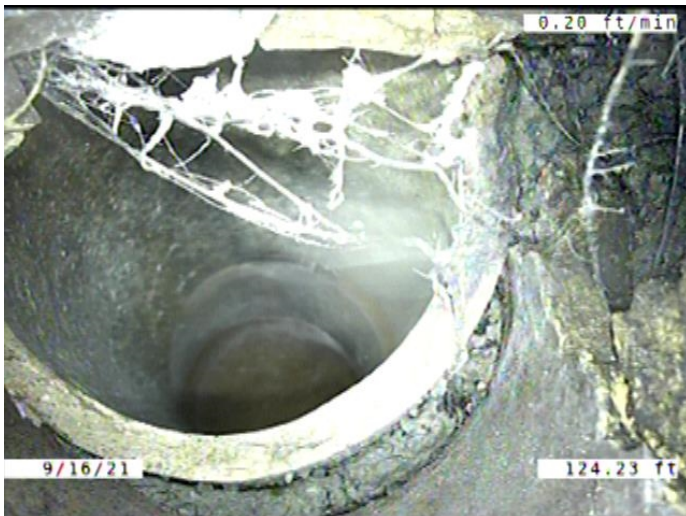
Code: **TFD**
 Description: **Tap Factory Defective**

Distance (ft): **124.2**
 Structural Grade: **0**
 O&M Grade: **3**
 Clock Start/From: **12**
 Clock To:
 1st Value: **4.000**
 2nd Value:
 Value Percent:
 Continuous Index:
 Within 8" of Joint: **YES**
 Remarks: **SOIL VISIBLE AROUND THE TAP**

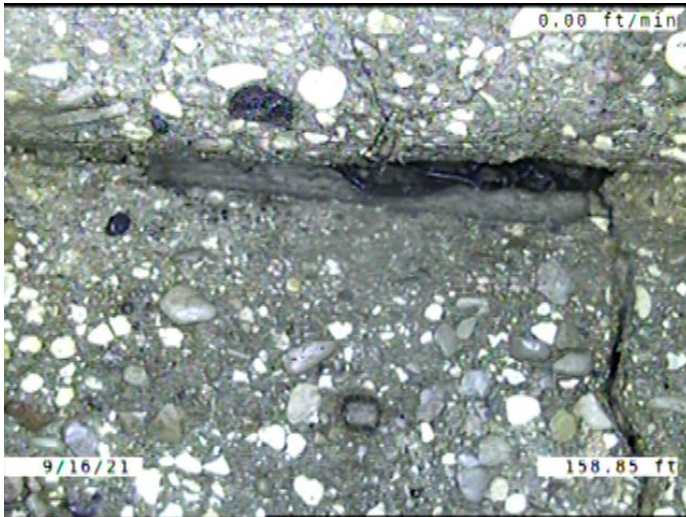
Code: **BSV**
 Description: **Broken Soil Visible**

Distance (ft): **158.9**
 Structural Grade: **5**
 O&M Grade: **0**
 Clock Start/From: **11**
 Clock To: **12**
 1st Value:
 2nd Value:
 Value Percent:
 Continuous Index:
 Within 8" of Joint: **YES**
 Remarks:

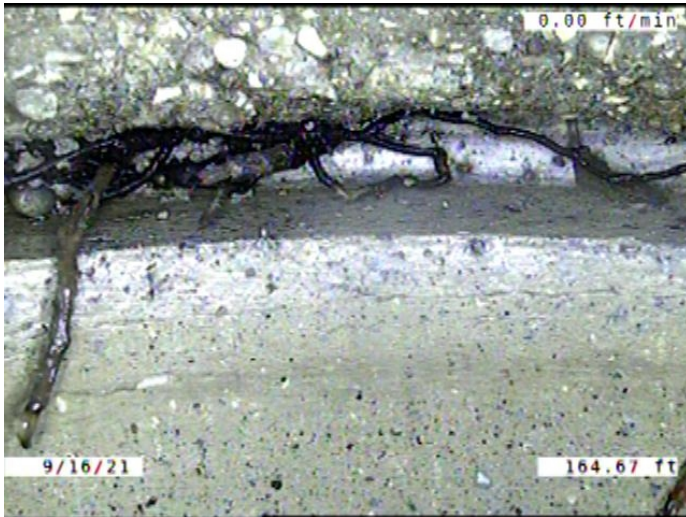
Code: **H**
 Description: **Hole**

Distance (ft): **164.7**
 Structural Grade: **5**
 O&M Grade: **0**
 Clock Start/From: **4**
 Clock To: **5**
 1st Value:
 2nd Value:
 Value Percent:
 Continuous Index:
 Within 8" of Joint: **YES**
 Remarks:

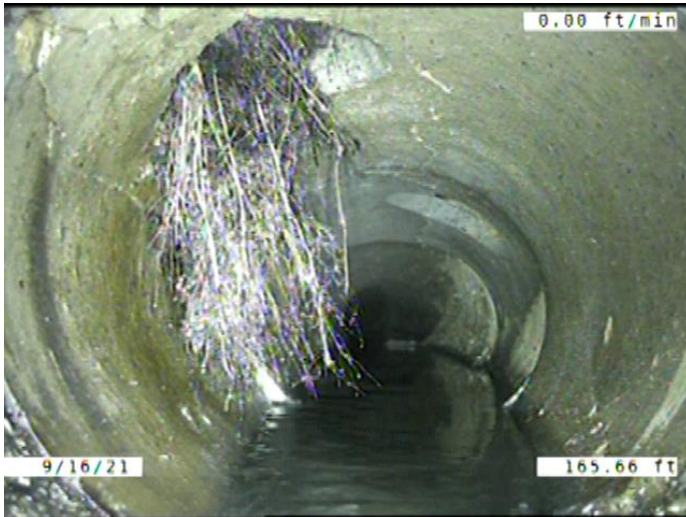
Code: **RML**
 Description: **Roots Medium Lateral**

Distance (ft): **165.7**
 Structural Grade: **0**
 O&M Grade: **3**
 Clock Start/From: **9**
 Clock To: **12**
 1st Value:
 2nd Value:
 Value Percent: **20.000**
 Continuous Index:
 Within 8" of Joint: **NO**
 Remarks:

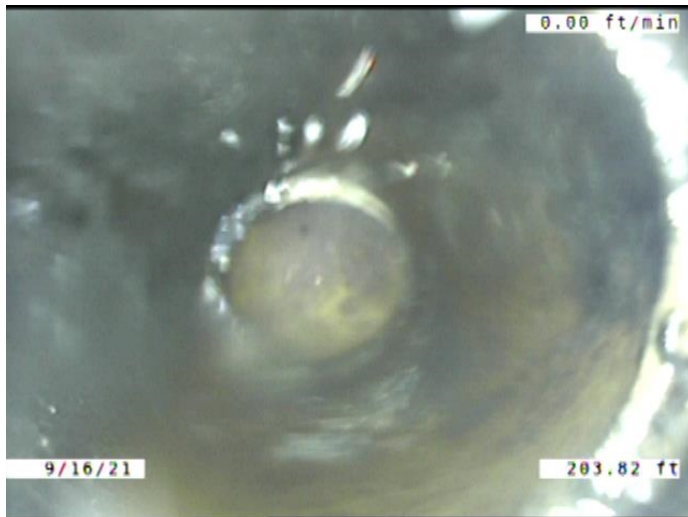
Code: **TB**
 Description: **Tap Break-in/Hammer**

Distance (ft): **203.8**
 Structural Grade: **0**
 O&M Grade: **0**
 Clock Start/From: **12**
 Clock To:
 1st Value: **4.000**
 2nd Value:
 Value Percent:
 Continuous Index:
 Within 8" of Joint: **YES**
 Remarks: **CONSTANTLY RUNNING WATER**
