## **Profile/Photo Observation Report**

Profile/Photo Observation Report								
Date: Pipe Length (f		Weather: Owner:	City of Hoba		Pre Clean:	PACP 6.0 No Pre-Cleaning		
P.O.#:	48-1	Surveyor:	M. Pielacha		_	M-504-028-M-504-027		
Customer:	City of Hobart	Clean Date:			Shape:	C		
Street:	<b>Cleveland Avenue</b>		Flow Control:		Not Controlled			
City:	Hobart, IN		Year Renewe	d:				
Location:	<b>Light Highway</b>		Tape/Media	<b>#</b> :	<b>DEP 48</b>			
Purpose:	Routine Assessment	t	Dia/Height:		18"			
Use:	Sanitary		Material:		VCP			
Drain Area:			Lining:					
Category:	NA							
Comment:								
Location Deta	ils:		Direction of S	urvey:	Downstream			
US MH:	M-504-028	DS MH:	M-504-027		Total Length Surveyed (ft):	319.2		
O&M Index:	0.00	O&M Quick:		0000	O&M Rating:	0.00		
Structural Index	0.00	Structural Q		0000	Structural Rating:	0.00		
Overall Index:	0.00	— Overall Quic	k:	0000	Overall Rating:	0.00

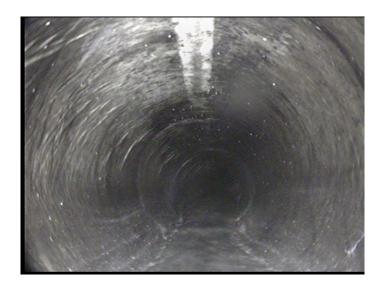
Code: MWL Description: **Water Level**

Distance (ft): .0 Structural Grade: 0

10.000

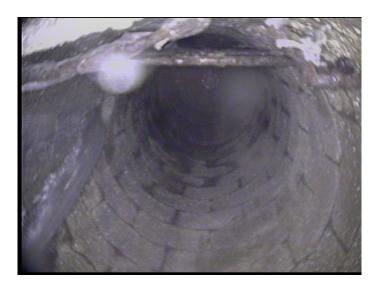
Code: AMH Description: Manhole

Distance (ft): 319.2 Structural Grade: 0 O&M Grade: 0

Remarks: M-504-027
