Profile/Photo Observation Report

Street:	W CLEVELAND AVE	Flow Control:	Not Controlled
City:	Hobart, IN	Year Renewed:	
Location:	Light Highway	Tape/Media #:	
Purpose:	Routine Assessment	Dia/Height:	12"
Use:	Sanitary	Material:	VCP
Drain Area:	NA	Lining:	
Category:	NA		
Comment:	P_C at 14 ft grit/debris . Flow direction wrong		
Location Details:		Direction of Survey:	Upstream
US MH:	M-504-028	DS MH:	M-504-056
		Total Length Surveyed (ft):	15.7

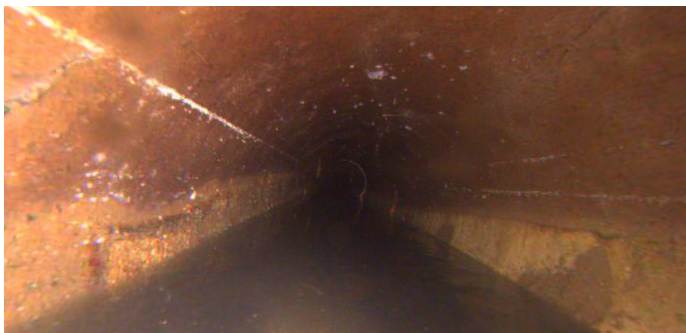
Code: **AMH**
Description: **Manhole**

Distance (ft): **.0**
Structural Grade: **0**
O&M Grade: **0**
Clock Start/From:
Clock To:
1st Value:
2nd Value:
Value Percent:
Continuous Index:
Within 8" of Joint: **NO**
Remarks: **M-504-056**

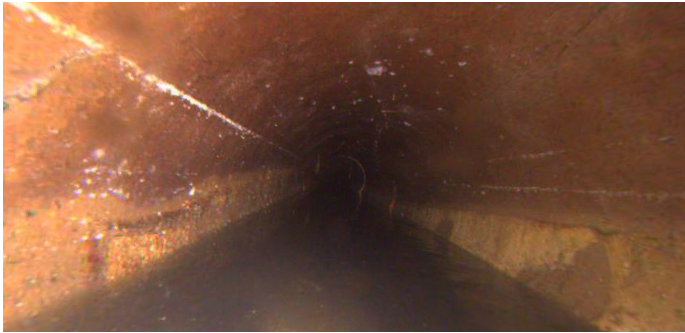
Code:	MWL
Description:	Water Level

Distance (ft):	.0
Structural Grade:	0
O&M Grade:	0
Clock Start/From:	
Clock To:	
1st Value:	
2nd Value:	
Value Percent:	30.000
Continuous Index:	
Within 8" of Joint:	NO
Remarks:

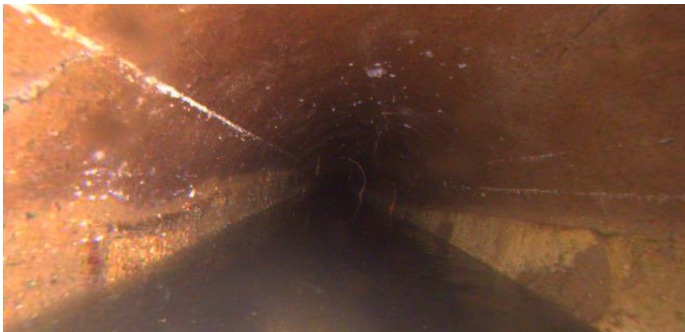
Code:	FM
Description:	Fracture Multiple

Distance (ft):	.0
Structural Grade:	4
O&M Grade:	0
Clock Start/From:	8
Clock To:	4
1st Value:	
2nd Value:	
Value Percent:	
Continuous Index:	S01
Within 8" of Joint:	YES
Remarks:

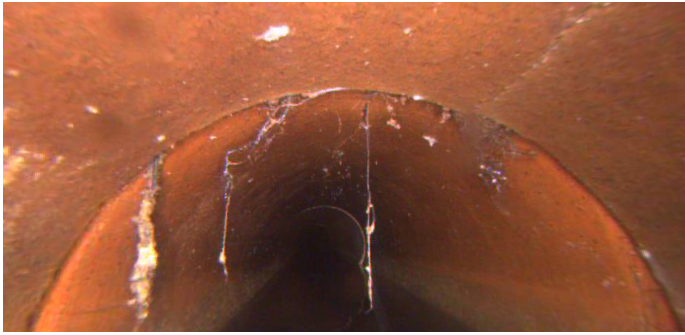
Code: **RFJ**
Description: **Roots Fine Joint**

Distance (ft): **3.9**
Structural Grade: **0**
O&M Grade: **1**
Clock Start/From: **11**
Clock To: **1**
1st Value:
2nd Value:
Value Percent:
Continuous Index:
Within 8" of Joint: **YES**
Remarks:

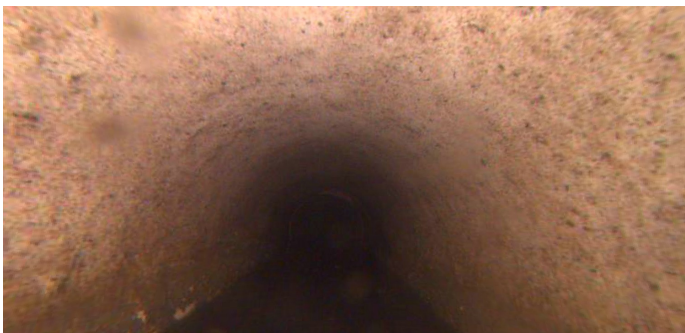
Code: **MMC**
Description: **Material Change**

Distance (ft): **8.0**
Structural Grade: **0**
O&M Grade: **0**
Clock Start/From:
Clock To:
1st Value:
2nd Value:
Value Percent:
Continuous Index:
Within 8" of Joint: **NO**
Remarks: **pvc**

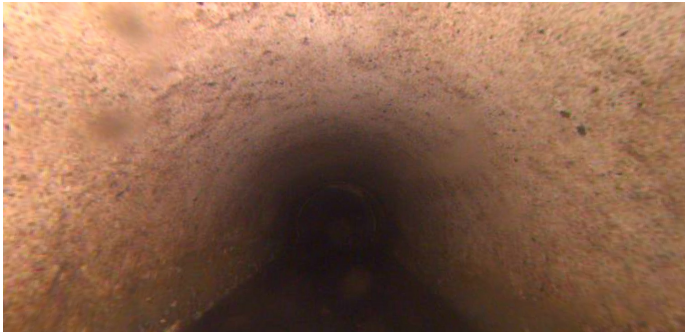
Code: **FM**
Description: **Fracture Multiple**

Distance (ft): **8.2**
Structural Grade: **4**
O&M Grade: **0**
Clock Start/From: **8**
Clock To: **4**
1st Value:
2nd Value:
Value Percent:
Continuous Index: **F01**
Within 8" of Joint: **YES**
Remarks:

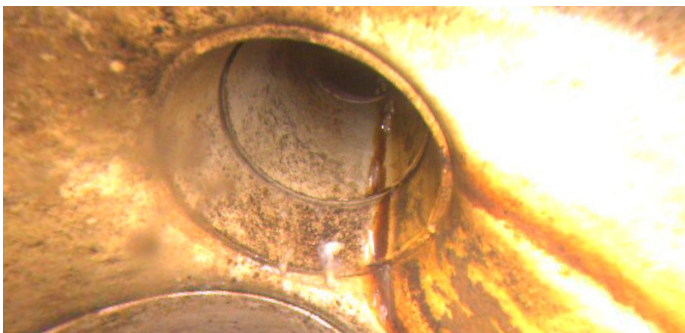
Code: **TF**
Description: **Tap Factory**

Distance (ft): **11.1**
Structural Grade: **0**
O&M Grade: **0**
Clock Start/From: **12**
Clock To:
1st Value: **4.000**
2nd Value:
Value Percent:
Continuous Index:
Within 8" of Joint:
Remarks:

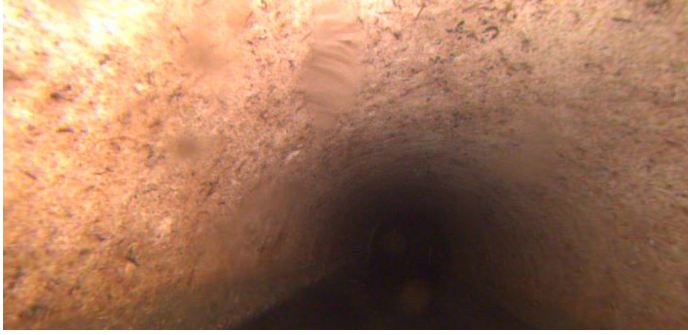
Code:	MSA
Description:	Abandoned Survey
Distance (ft):	15.7
Structural Grade:	0
O&M Grade:	0
Clock Start/From:	
Clock To:	
1st Value:	
2nd Value:	
Value Percent:	
Continuous Index:	
Within 8" of Joint:	NO
Remarks:	debris under water
