## Profile/Photo Observation Report

Date:	<b>04/22/2018</b>	Weather:		Coding:	<b>PACP 6.0</b>
Pipe Length (ft):	<b>331.1</b>	Owner:	<b>NA</b>	Pre Clean:	<b>No Pre-Cleaning</b>
P.O.#:		Surveyor:	<b>Jen Costello</b>	PSR:	<b>P-504-056-028</b>
Customer:		Clean Date:	<b>01/01/1900</b>	Shape:	<b>C</b>

Street:	<b>FOXCROFT STREET</b>	Flow Control:	<b>Not Controlled</b>
City:	<b>Hobart, IN</b>	Year Renewed:	
Location:	<b>Light Highway</b>	Tape/Media #:	
Purpose:	<b>Routine Assessment</b>	Dia/Height:	<b>12"</b>
Use:	<b>Sanitary</b>	Material:	<b>VCP</b>
Drain Area:	<b>NA</b>	Lining:	
Category:	<b>NA</b>		
Comment:	<b>P_C at 14 ft grit/debris . Flow direction wrong</b>		
Location Details:		Direction of Survey:	<b>Upstream</b>
US MH:	<b>M-504-028</b>	DS MH:	<b>M-504-056</b>
		Total Length Surveyed (ft):	<b>15.7</b>

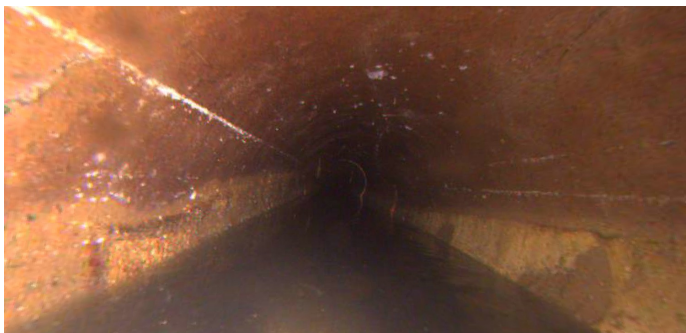
Code: **AMH**  
Description: **Manhole**

Distance (ft): **.0**  
Structural Grade: **0**  
O&M Grade: **0**  
Clock Start/From:  
Clock To:  
1st Value:  
2nd Value:  
Value Percent:  
Continuous Index:  
Within 8" of Joint: **NO**  
Remarks: **M-504-056**

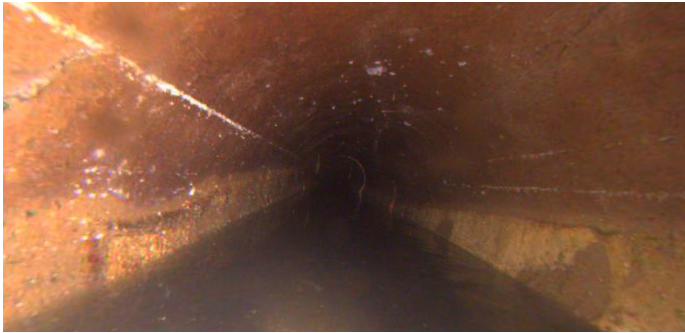
Code:	<b>MWL</b>
Description:	<b>Water Level</b>

Distance (ft):	<b>.0</b>
Structural Grade:	<b>0</b>
O&M Grade:	<b>0</b>
Clock Start/From:	
Clock To:	
1st Value:	
2nd Value:	
Value Percent:	<b>30.000</b>
Continuous Index:	
Within 8" of Joint:	<b>NO</b>
Remarks:

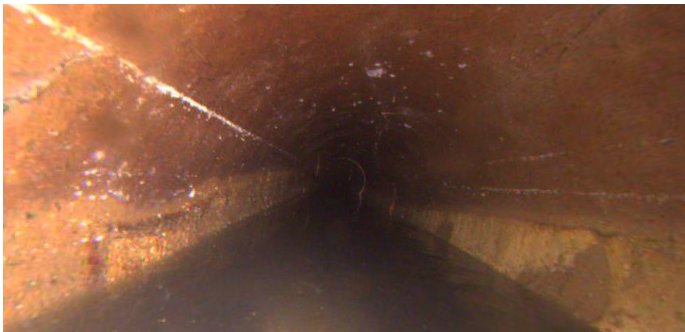
Code:	<b>FM</b>
Description:	<b>Fracture Multiple</b>

Distance (ft):	<b>.0</b>
Structural Grade:	<b>4</b>
O&M Grade:	<b>0</b>
Clock Start/From:	<b>8</b>
Clock To:	<b>4</b>
1st Value:	
2nd Value:	
Value Percent:	
Continuous Index:	<b>S01</b>
Within 8" of Joint:	<b>YES</b>
Remarks:

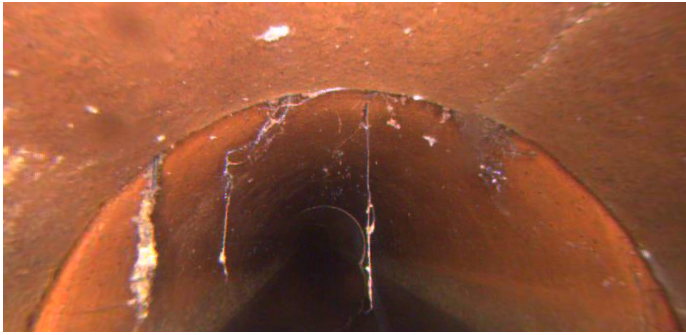
Code: **RFJ**  
Description: **Roots Fine Joint**

Distance (ft): **3.9**  
Structural Grade: **0**  
O&M Grade: **1**  
Clock Start/From: **11**  
Clock To: **1**  
1st Value:  
2nd Value:  
Value Percent:  
Continuous Index:  
Within 8" of Joint: **YES**  
Remarks:

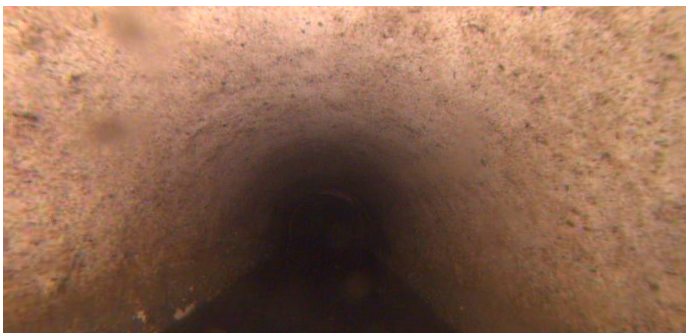
Code: **MMC**  
Description: **Material Change**

Distance (ft): **8.0**  
Structural Grade: **0**  
O&M Grade: **0**  
Clock Start/From:  
Clock To:  
1st Value:  
2nd Value:  
Value Percent:  
Continuous Index:  
Within 8" of Joint: **NO**  
Remarks: **pvc**

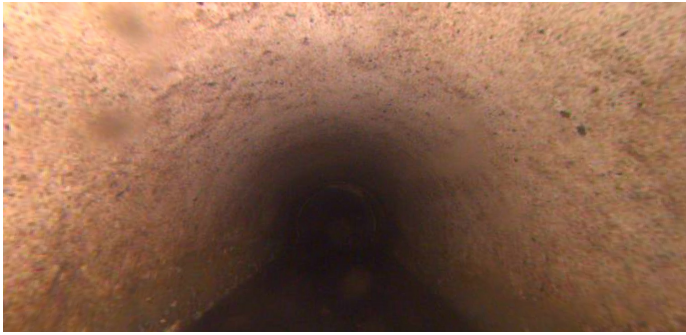
Code: **FM**  
Description: **Fracture Multiple**

Distance (ft): **8.2**  
Structural Grade: **4**  
O&M Grade: **0**  
Clock Start/From: **8**  
Clock To: **4**  
1st Value:  
2nd Value:  
Value Percent:  
Continuous Index: **F01**  
Within 8" of Joint: **YES**  
Remarks:

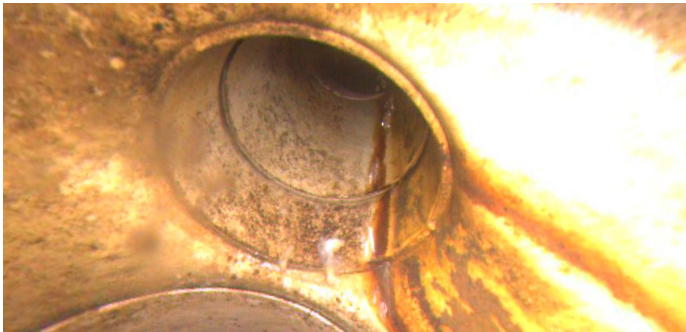
Code: **TF**  
Description: **Tap Factory**

Distance (ft): **11.1**  
Structural Grade: **0**  
O&M Grade: **0**  
Clock Start/From: **12**  
Clock To:  
1st Value: **4.000**  
2nd Value:  
Value Percent:  
Continuous Index:  
Within 8" of Joint:  
Remarks:

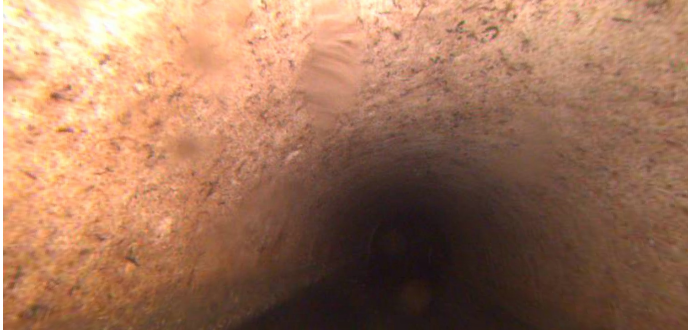
Code:	<b>MSA</b>
Description:	<b>Abandoned Survey</b>
Distance (ft):	<b>15.7</b>
Structural Grade:	<b>0</b>
O&M Grade:	<b>0</b>
Clock Start/From:	
Clock To:	
1st Value:	
2nd Value:	
Value Percent:	
Continuous Index:	
Within 8" of Joint:	<b>NO</b>
Remarks:	<b>debris under water</b>
