Profile/Photo Observation Report

Date:	04/22/2018	Weather:		Coding:	PACP 6.0
Pipe Length (ft):	331.1	Owner:	NA	Pre Clean:	No Pre-Cleaning
P.O.#:		Surveyor:	Byrd Fitzgerald	PSR:	P-504-056-028
Customer:		Clean Date:	01/01/1900	Shape:	C

Street:	W CLEVELAND AVE	Flow Control:	Not Controlled
City:	Hobart, IN	Year Renewed:	
Location:	Light Highway	Tape/Media #:	
Purpose:	Routine Assessment	Dia/Height:	12"
Use:	Sanitary	Material:	VCP
Drain Area:	NA	Lining:	
Category:	NA		
Comment:			
Location Details:		Direction of Survey:	Downstream
US MH:	M-504-028	DS MH:	M-504-056
		Total Length Surveyed (ft):	278.8

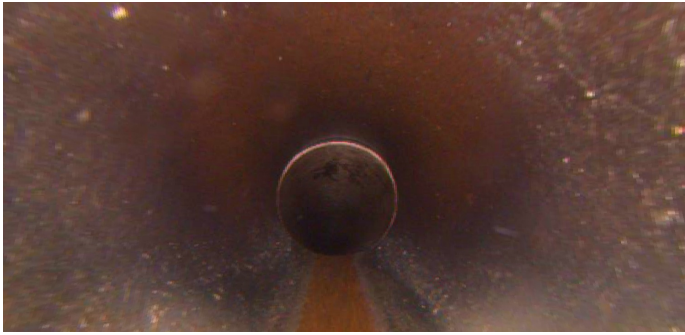
Code: **AMH**
Description: **Manhole**

Distance (ft): **.0**
Structural Grade: **0**
O&M Grade: **0**
Clock Start/From:
Clock To:
1st Value:
2nd Value:
Value Percent:
Continuous Index:
Within 8" of Joint: **NO**
Remarks: **M-504-028**

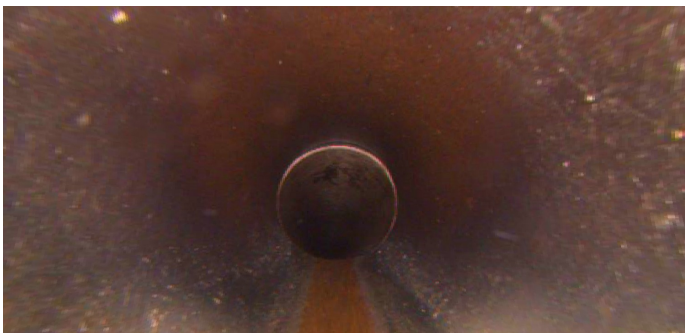
Code: **MWL**
Description: **Water Level**

Distance (ft): **.0**
Structural Grade: **0**
O&M Grade: **0**
Clock Start/From:
Clock To:
1st Value:
2nd Value:
Value Percent: **5.000**
Continuous Index:
Within 8" of Joint: **NO**
Remarks:

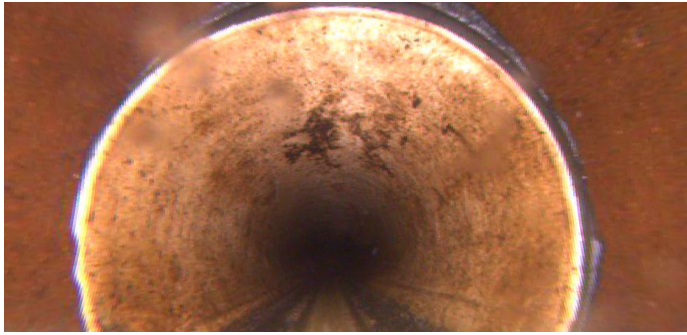
Code: **MMC**
Description: **Material Change**

Distance (ft): **3.1**
Structural Grade: **0**
O&M Grade: **0**
Clock Start/From:
Clock To:
1st Value:
2nd Value:
Value Percent:
Continuous Index:
Within 8" of Joint: **NO**
Remarks: **pvc**

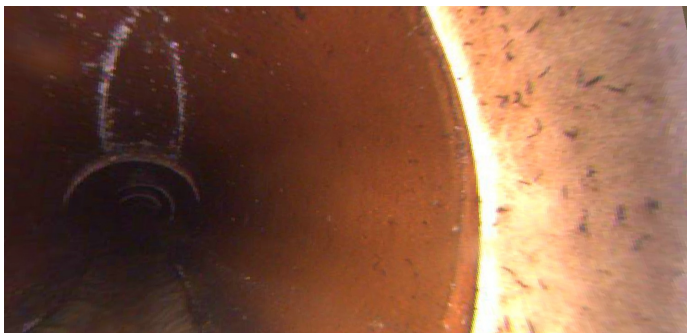
Code: **MMC**
Description: **Material Change**

Distance (ft): **19.1**
Structural Grade: **0**
O&M Grade: **0**
Clock Start/From:
Clock To:
1st Value:
2nd Value:
Value Percent:
Continuous Index:
Within 8" of Joint: **NO**
Remarks: **vcp**

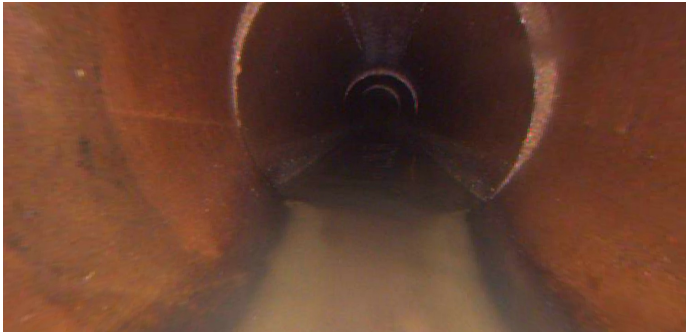
Code: **CM**
Description: **Crack Multiple**

Distance (ft): **30.2**
Structural Grade: **3**
O&M Grade: **0**
Clock Start/From: **7**
Clock To: **11**
1st Value:
2nd Value:
Value Percent:
Continuous Index: **S01**
Within 8" of Joint: **YES**
Remarks: **wandering**

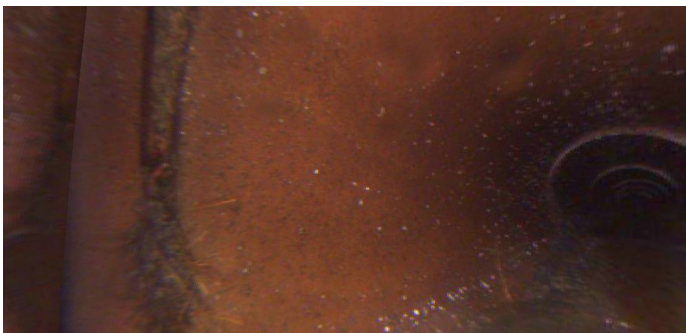
Code: **RFJ**
Description: **Roots Fine Joint**

Distance (ft): **40.0**
Structural Grade: **0**
O&M Grade: **1**
Clock Start/From: **8**
Clock To:
1st Value:
2nd Value:
Value Percent:
Continuous Index: **S02**
Within 8" of Joint: **YES**
Remarks: **wandering**

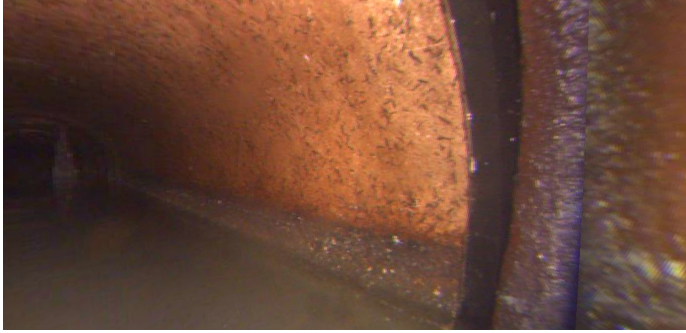
Code: **MMC**
Description: **Material Change**

Distance (ft): **54.8**
Structural Grade: **0**
O&M Grade: **0**
Clock Start/From:
Clock To:
1st Value:
2nd Value:
Value Percent:
Continuous Index:
Within 8" of Joint: **NO**
Remarks: **pvc**

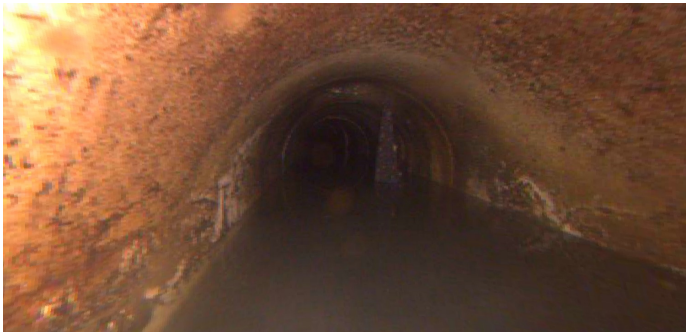
Code: **MWL**
Description: **Water Level**

Distance (ft): **57.2**
Structural Grade: **0**
O&M Grade: **0**
Clock Start/From:
Clock To:
1st Value:
2nd Value:
Value Percent: **25.000**
Continuous Index:
Within 8" of Joint: **NO**
Remarks:

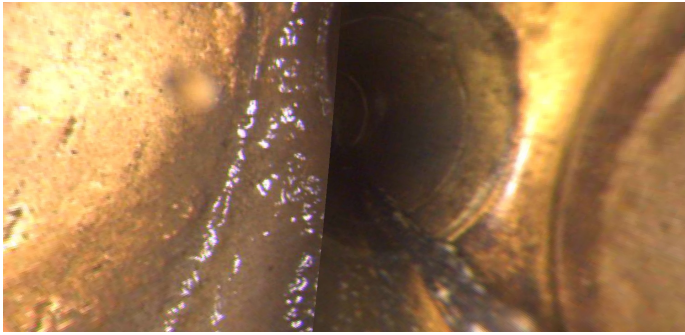
Code: **TF**
Description: **Tap Factory**

Distance (ft): **59.0**
Structural Grade: **0**
O&M Grade: **0**
Clock Start/From: **2**
Clock To:
1st Value: **4.000**
2nd Value:
Value Percent:
Continuous Index:
Within 8" of Joint: **YES**
Remarks:

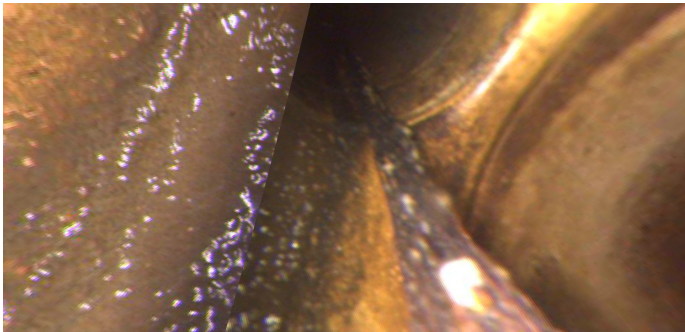
Code: **RML**
Description: **Roots Medium Lateral**

Distance (ft): **59.0**
Structural Grade: **0**
O&M Grade: **3**
Clock Start/From: **2**
Clock To:
1st Value:
2nd Value:
Value Percent: **10.000**
Continuous Index:
Within 8" of Joint: **NO**
Remarks:

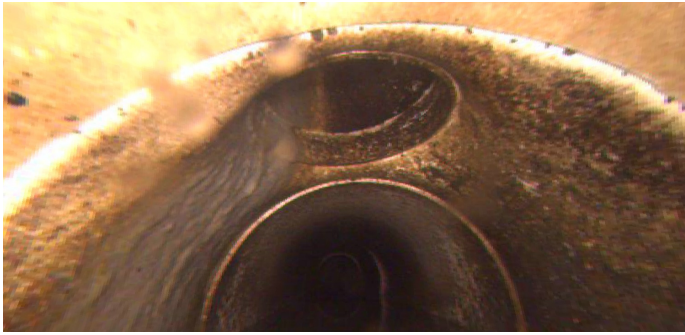
Code: **TF**
Description: **Tap Factory**

Distance (ft): **60.3**
Structural Grade: **0**
O&M Grade: **0**
Clock Start/From: **12**
Clock To:
1st Value: **4.000**
2nd Value:
Value Percent:
Continuous Index:
Within 8" of Joint: **YES**
Remarks:

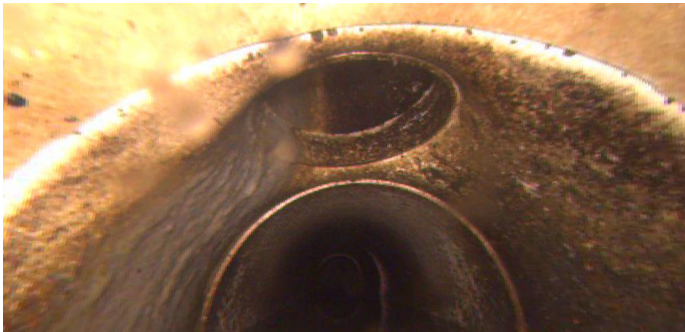
Code: **DAGS**
Description: **Deposits Attached Grease**

Distance (ft): **60.3**
Structural Grade: **0**
O&M Grade: **2**
Clock Start/From: **8**
Clock To: **11**
1st Value:
2nd Value:
Value Percent: **5.000**
Continuous Index:
Within 8" of Joint: **NO**
Remarks:

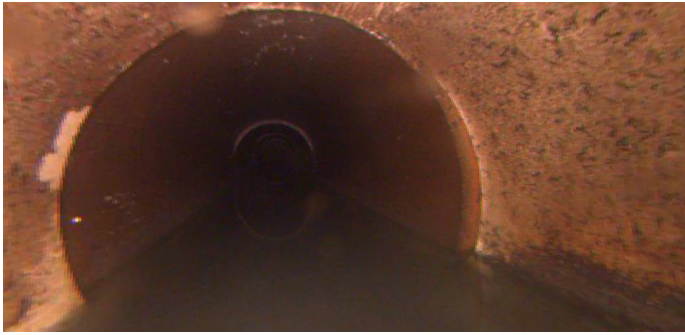
Code: **MMC**
Description: **Material Change**

Distance (ft): **63.3**
Structural Grade: **0**
O&M Grade: **0**
Clock Start/From:
Clock To:
1st Value:
2nd Value:
Value Percent:
Continuous Index:
Within 8" of Joint: **NO**
Remarks: **vcp**

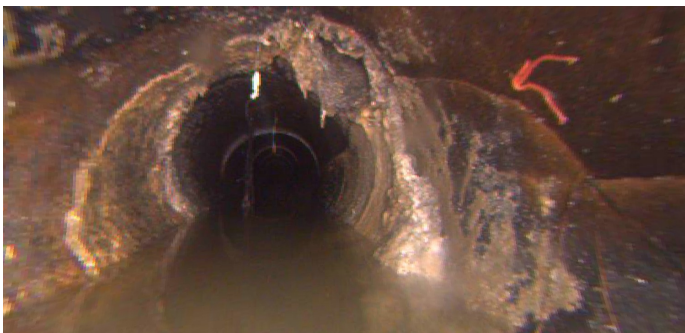
Code: **DAGS**
Description: **Deposits Attached Grease**

Distance (ft): **93.6**
Structural Grade: **0**
O&M Grade: **2**
Clock Start/From: **7**
Clock To: **5**
1st Value:
2nd Value:
Value Percent: **5.000**
Continuous Index:
Within 8" of Joint: **NO**
Remarks:

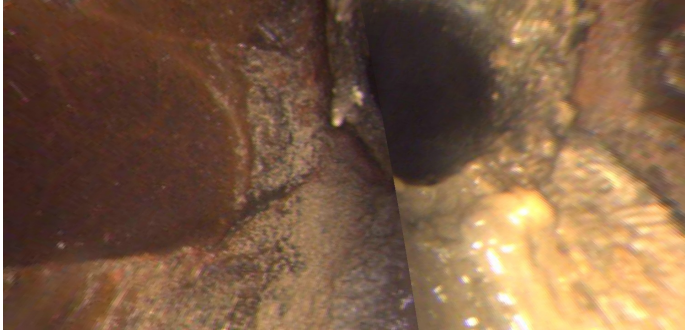
Code: **TF**
Description: **Tap Factory**

Distance (ft): **94.8**
Structural Grade: **0**
O&M Grade: **0**
Clock Start/From: **2**
Clock To:
1st Value: **4.000**
2nd Value:
Value Percent:
Continuous Index:
Within 8" of Joint:
Remarks:

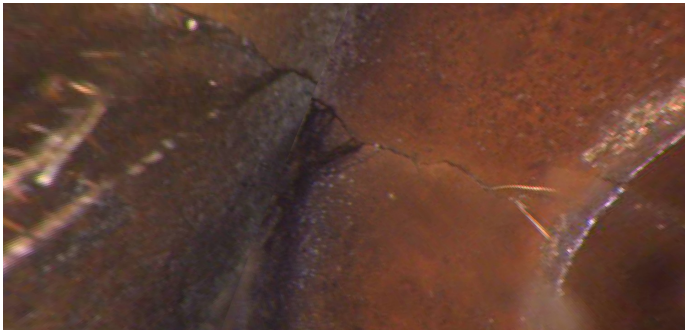
Code: **RFB**
Description: **Roots Fine Barrel**

Distance (ft): **96.0**
Structural Grade: **0**
O&M Grade: **2**
Clock Start/From: **11**
Clock To:
1st Value:
2nd Value:
Value Percent:
Continuous Index:
Within 8" of Joint: **NO**
Remarks:

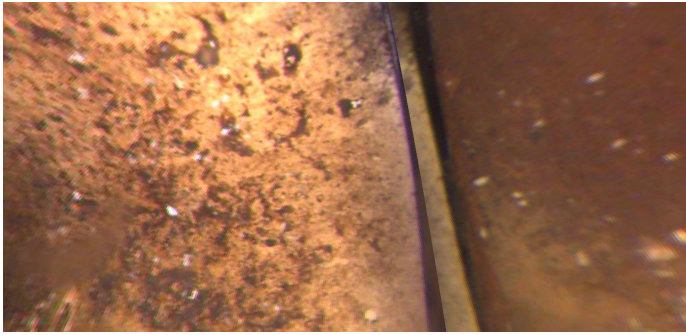
Code: **MMC**
Description: **Material Change**

Distance (ft): **108.3**
Structural Grade: **0**
O&M Grade: **0**
Clock Start/From:
Clock To:
1st Value:
2nd Value:
Value Percent:
Continuous Index:
Within 8" of Joint: **NO**
Remarks: **pvc**

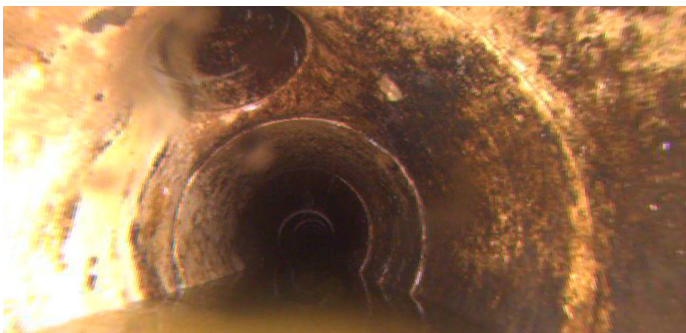
Code: **TF**
Description: **Tap Factory**

Distance (ft): **109.6**
Structural Grade: **0**
O&M Grade: **0**
Clock Start/From: **11**
Clock To:
1st Value: **4.000**
2nd Value:
Value Percent:
Continuous Index:
Within 8" of Joint: **YES**
Remarks:

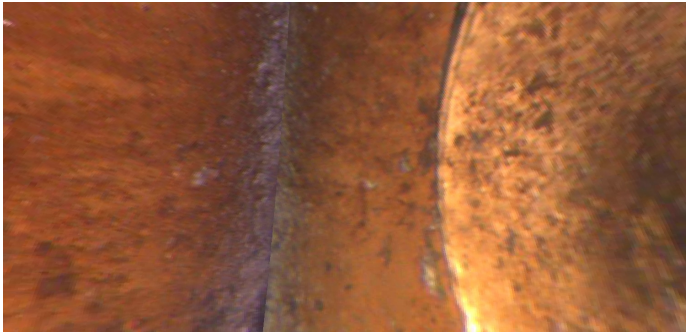
Code: **MMC**
Description: **Material Change**

Distance (ft): **112.1**
Structural Grade: **0**
O&M Grade: **0**
Clock Start/From:
Clock To:
1st Value:
2nd Value:
Value Percent:
Continuous Index:
Within 8" of Joint: **NO**
Remarks: **vcp**

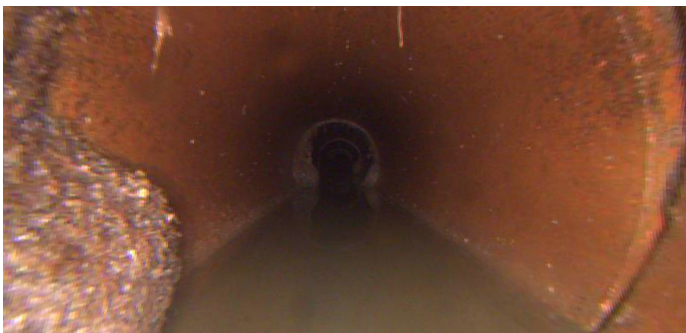
Code: **RMJ**
Description: **Roots Medium Joint**

Distance (ft): **126.3**
Structural Grade: **0**
O&M Grade: **3**
Clock Start/From: **8**
Clock To:
1st Value:
2nd Value:
Value Percent: **5.000**
Continuous Index: **S03**
Within 8" of Joint: **YES**
Remarks: **wandering**

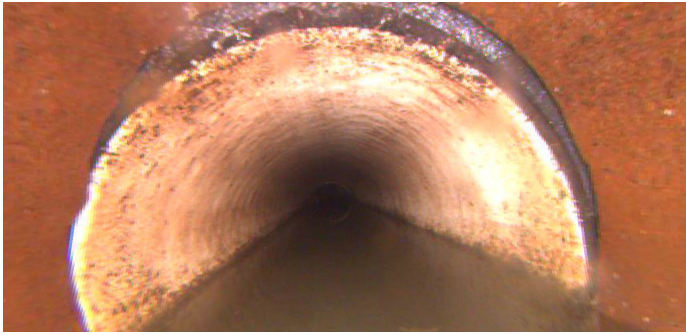
Code: **MMC**
Description: **Material Change**

Distance (ft): **139.1**
Structural Grade: **0**
O&M Grade: **0**
Clock Start/From:
Clock To:
1st Value:
2nd Value:
Value Percent:
Continuous Index:
Within 8" of Joint: **NO**
Remarks: **pvc**

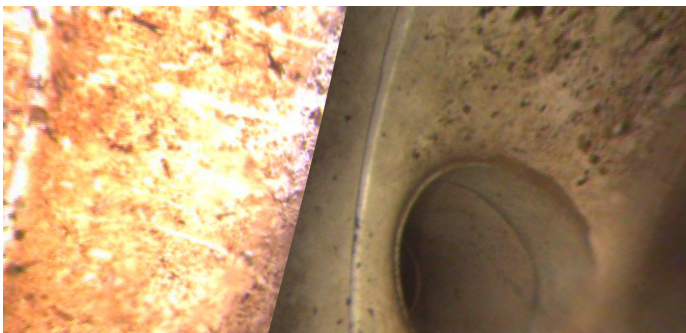
Code: **TF**
Description: **Tap Factory**

Distance (ft): **147.3**
Structural Grade: **0**
O&M Grade: **0**
Clock Start/From: **2**
Clock To:
1st Value: **4.000**
2nd Value:
Value Percent:
Continuous Index:
Within 8" of Joint: **YES**
Remarks:

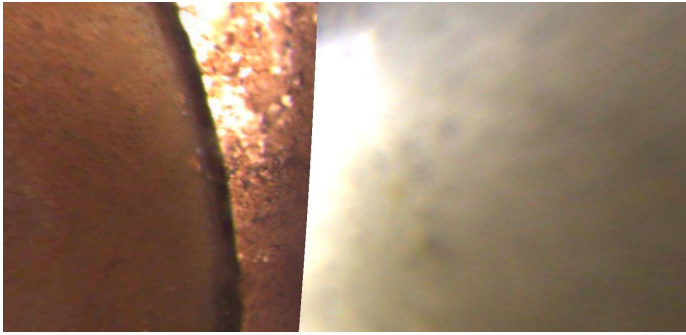
Code: **MMC**
Description: **Material Change**

Distance (ft): **151.0**
Structural Grade: **0**
O&M Grade: **0**
Clock Start/From:
Clock To:
1st Value:
2nd Value:
Value Percent:
Continuous Index:
Within 8" of Joint: **NO**
Remarks: **vcp**

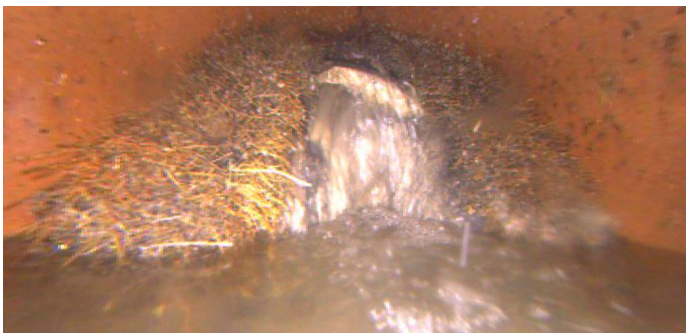
Code: **RBJ**
Description: **Roots Ball Joint**

Distance (ft): **160.7**
Structural Grade: **0**
O&M Grade: **4**
Clock Start/From: **7**
Clock To: **5**
1st Value:
2nd Value:
Value Percent: **55.000**
Continuous Index:
Within 8" of Joint: **YES**
Remarks:

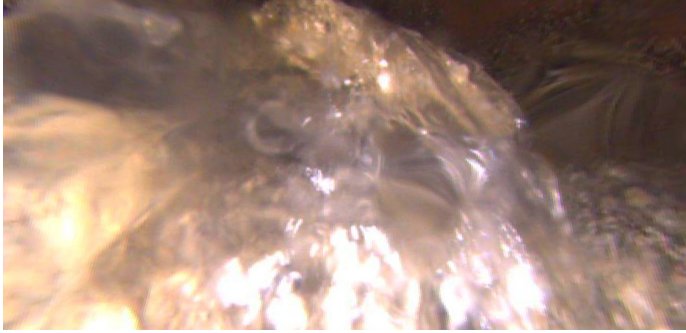
Code: **MSA**
Description: **Abandoned Survey**

Distance (ft): **278.8**
Structural Grade: **0**
O&M Grade: **0**
Clock Start/From:
Clock To:
1st Value:
2nd Value:
Value Percent:
Continuous Index:
Within 8" of Joint: **NO**
Remarks: **rbj**

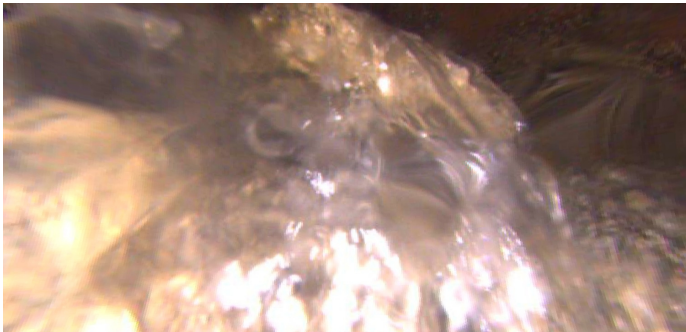
Code: **RMJ**
Description: **Roots Medium Joint**

Distance (ft): **278.8**
Structural Grade: **0**
O&M Grade: **3**
Clock Start/From: **8**
Clock To:
1st Value:
2nd Value:
Value Percent: **5.000**
Continuous Index: **F03**
Within 8" of Joint: **YES**
Remarks: **wandering**

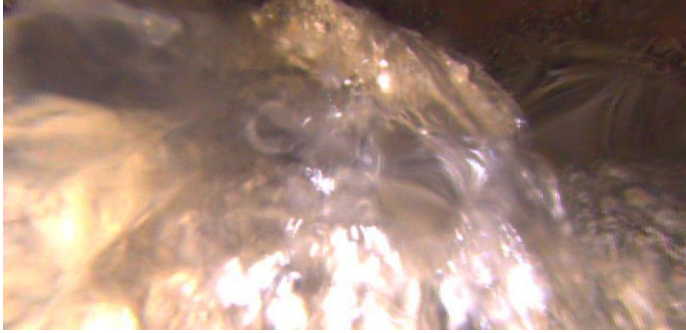
Code: **RFJ**
Description: **Roots Fine Joint**

Distance (ft): **278.8**
Structural Grade: **0**
O&M Grade: **1**
Clock Start/From: **8**
Clock To:
1st Value:
2nd Value:
Value Percent:
Continuous Index: **F02**
Within 8" of Joint: **YES**
Remarks: **wandering**

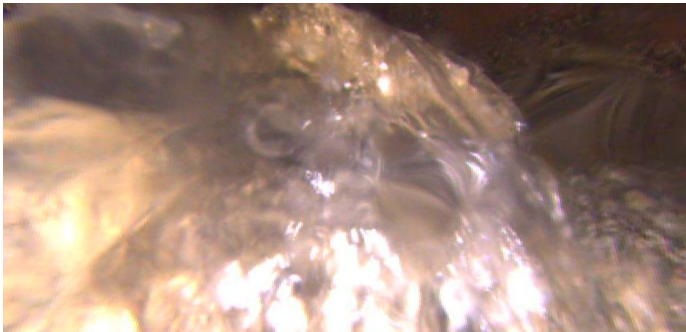
Code: **CM**
Description: **Crack Multiple**

Distance (ft): **278.8**
Structural Grade: **3**
O&M Grade: **0**
Clock Start/From: **7**
Clock To: **11**
1st Value:
2nd Value:
Value Percent:
Continuous Index: **F01**
Within 8" of Joint: **YES**
Remarks: **wandering**
