## Profile/Photo Observation Report

Date:	<b>04/22/2018</b>	Weather:		Coding:	<b>PACP 6.0</b>
Pipe Length (ft):	<b>331.1</b>	Owner:	<b>NA</b>	Pre Clean:	<b>No Pre-Cleaning</b>
P.O.#:		Surveyor:	<b>Byrd Fitzgerald</b>	PSR:	<b>P-504-056-028</b>
Customer:		Clean Date:	<b>01/01/1900</b>	Shape:	<b>C</b>

Street:	<b>FOXCROFT STREET</b>	Flow Control:	<b>Not Controlled</b>
City:	<b>Hobart, IN</b>	Year Renewed:	
Location:	<b>Light Highway</b>	Tape/Media #:	
Purpose:	<b>Routine Assessment</b>	Dia/Height:	<b>12"</b>
Use:	<b>Sanitary</b>	Material:	<b>VCP</b>
Drain Area:	<b>NA</b>	Lining:	
Category:	<b>NA</b>		
Comment:

Location Details:		Direction of Survey:	<b>Downstream</b>
US MH:	<b>M-504-028</b>	DS MH:	<b>M-504-056</b>
		Total Length Surveyed (ft):	<b>278.8</b>

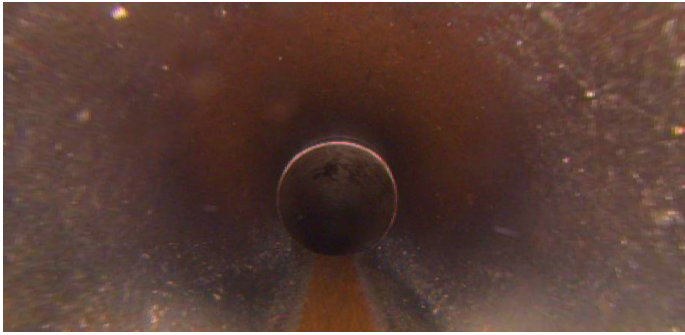
Code: **AMH**  
Description: **Manhole**

Distance (ft): **.0**  
Structural Grade: **0**  
O&M Grade: **0**  
Clock Start/From:  
Clock To:  
1st Value:  
2nd Value:  
Value Percent:  
Continuous Index:  
Within 8" of Joint: **NO**  
Remarks: **M-504-028**

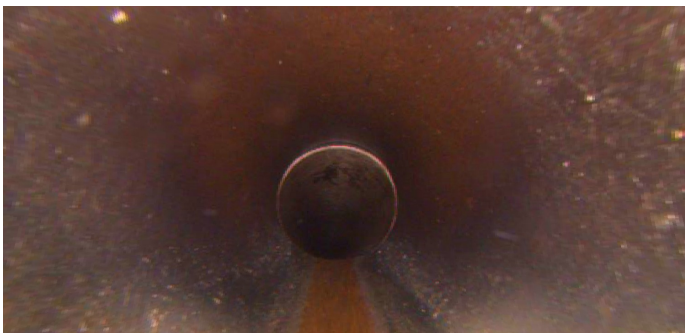
Code: **MWL**  
Description: **Water Level**

Distance (ft): **.0**  
Structural Grade: **0**  
O&M Grade: **0**  
Clock Start/From:  
Clock To:  
1st Value:  
2nd Value:  
Value Percent: **5.000**  
Continuous Index:  
Within 8" of Joint: **NO**  
Remarks:

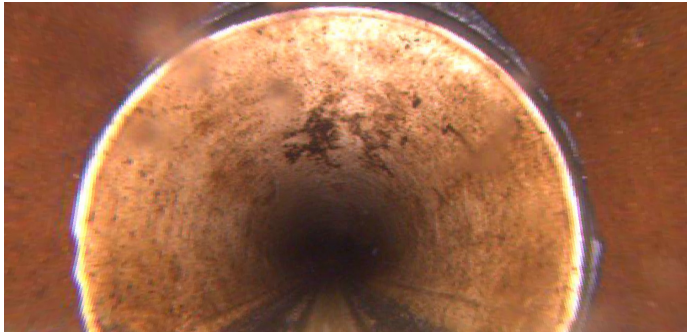
Code: **MMC**  
Description: **Material Change**

Distance (ft): **3.1**  
Structural Grade: **0**  
O&M Grade: **0**  
Clock Start/From:  
Clock To:  
1st Value:  
2nd Value:  
Value Percent:  
Continuous Index:  
Within 8" of Joint: **NO**  
Remarks: **pvc**

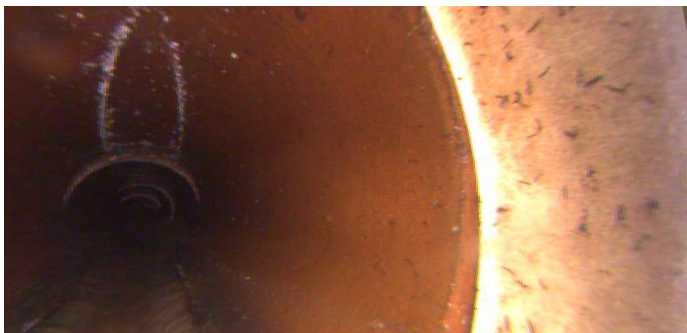
Code: **MMC**  
Description: **Material Change**

Distance (ft): **19.1**  
Structural Grade: **0**  
O&M Grade: **0**  
Clock Start/From:  
Clock To:  
1st Value:  
2nd Value:  
Value Percent:  
Continuous Index:  
Within 8" of Joint: **NO**  
Remarks: **vcp**

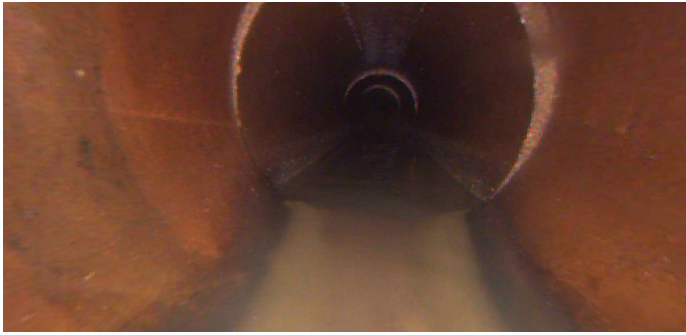
Code: **CM**  
Description: **Crack Multiple**

Distance (ft): **30.2**  
Structural Grade: **3**  
O&M Grade: **0**  
Clock Start/From: **7**  
Clock To: **11**  
1st Value:  
2nd Value:  
Value Percent:  
Continuous Index: **S01**  
Within 8" of Joint: **YES**  
Remarks: **wandering**

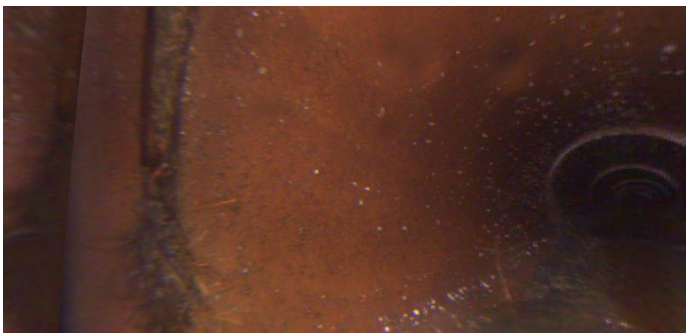
Code: **RFJ**  
Description: **Roots Fine Joint**

Distance (ft): **40.0**  
Structural Grade: **0**  
O&M Grade: **1**  
Clock Start/From: **8**  
Clock To:  
1st Value:  
2nd Value:  
Value Percent:  
Continuous Index: **S02**  
Within 8" of Joint: **YES**  
Remarks: **wandering**

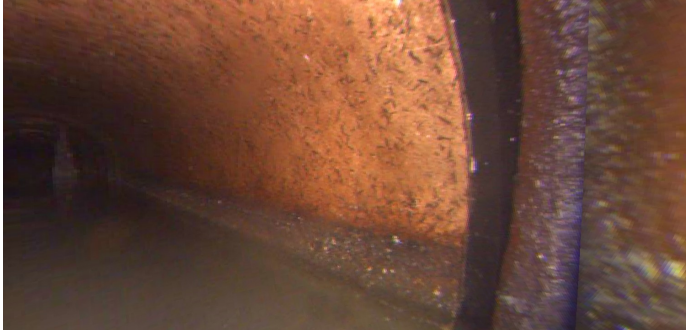
Code: **MMC**  
Description: **Material Change**

Distance (ft): **54.8**  
Structural Grade: **0**  
O&M Grade: **0**  
Clock Start/From:  
Clock To:  
1st Value:  
2nd Value:  
Value Percent:  
Continuous Index:  
Within 8" of Joint: **NO**  
Remarks: **pvc**

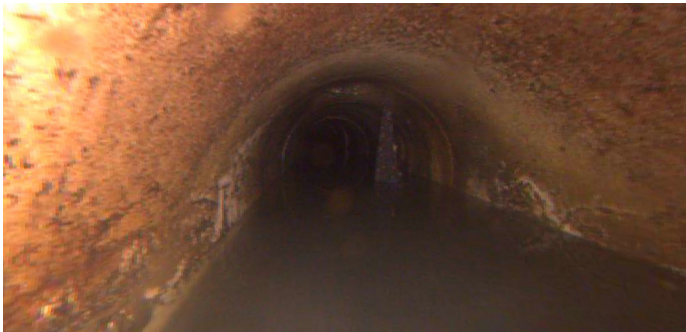
Code: **MWL**  
Description: **Water Level**

Distance (ft): **57.2**  
Structural Grade: **0**  
O&M Grade: **0**  
Clock Start/From:  
Clock To:  
1st Value:  
2nd Value:  
Value Percent: **25.000**  
Continuous Index:  
Within 8" of Joint: **NO**  
Remarks:

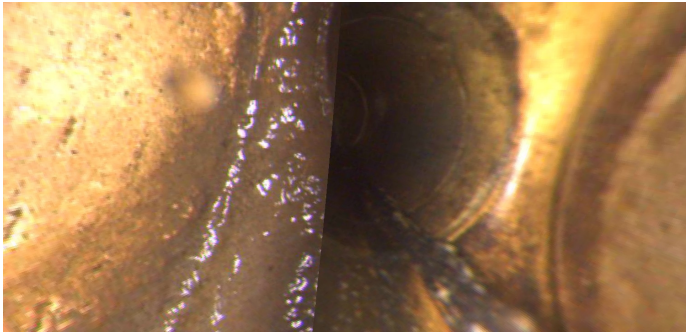
Code: **TF**  
Description: **Tap Factory**

Distance (ft): **59.0**  
Structural Grade: **0**  
O&M Grade: **0**  
Clock Start/From: **2**  
Clock To:  
1st Value: **4.000**  
2nd Value:  
Value Percent:  
Continuous Index:  
Within 8" of Joint: **YES**  
Remarks:

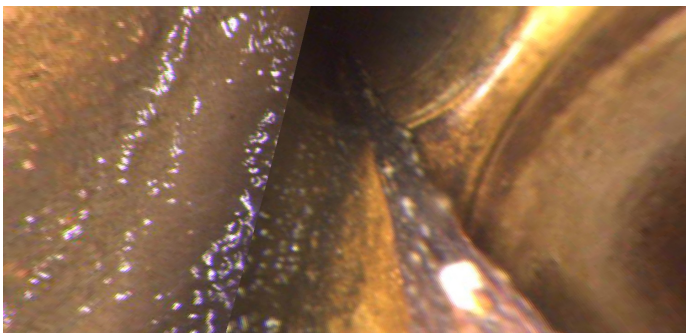
Code: **RML**  
Description: **Roots Medium Lateral**

Distance (ft): **59.0**  
Structural Grade: **0**  
O&M Grade: **3**  
Clock Start/From: **2**  
Clock To:  
1st Value:  
2nd Value:  
Value Percent: **10.000**  
Continuous Index:  
Within 8" of Joint: **NO**  
Remarks:

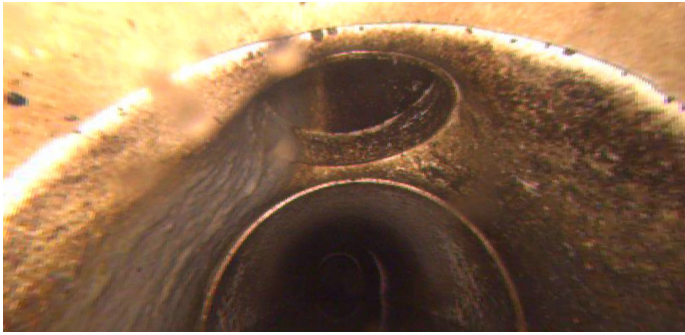
Code: **TF**  
Description: **Tap Factory**

Distance (ft): **60.3**  
Structural Grade: **0**  
O&M Grade: **0**  
Clock Start/From: **12**  
Clock To:  
1st Value: **4.000**  
2nd Value:  
Value Percent:  
Continuous Index:  
Within 8" of Joint: **YES**  
Remarks:

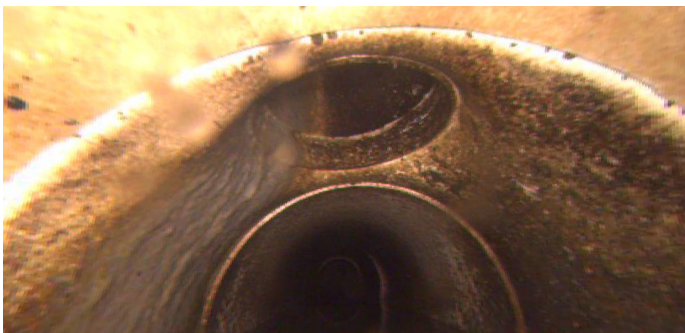
Code: **DAGS**  
Description: **Deposits Attached Grease**

Distance (ft): **60.3**  
Structural Grade: **0**  
O&M Grade: **2**  
Clock Start/From: **8**  
Clock To: **11**  
1st Value:  
2nd Value:  
Value Percent: **5.000**  
Continuous Index:  
Within 8" of Joint: **NO**  
Remarks:

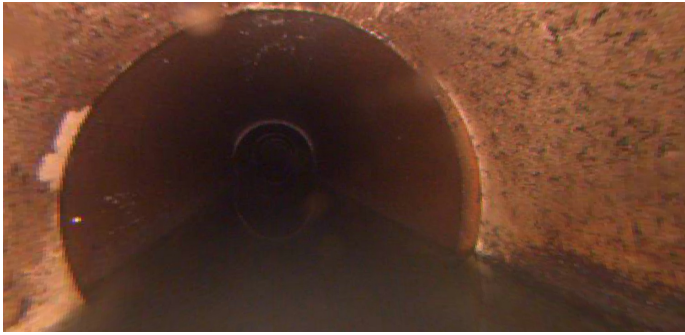
Code: **MMC**  
Description: **Material Change**

Distance (ft): **63.3**  
Structural Grade: **0**  
O&M Grade: **0**  
Clock Start/From:  
Clock To:  
1st Value:  
2nd Value:  
Value Percent:  
Continuous Index:  
Within 8" of Joint: **NO**  
Remarks: **vcp**

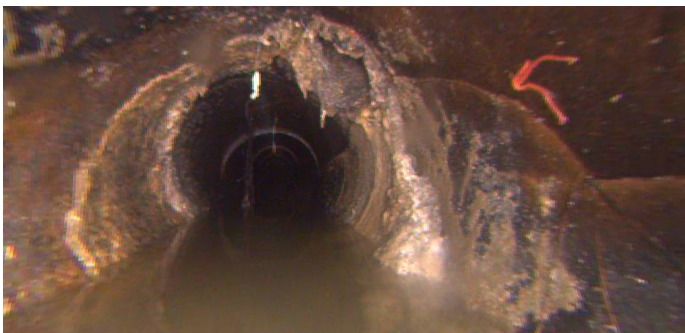
Code: **DAGS**  
Description: **Deposits Attached Grease**

Distance (ft): **93.6**  
Structural Grade: **0**  
O&M Grade: **2**  
Clock Start/From: **7**  
Clock To: **5**  
1st Value:  
2nd Value:  
Value Percent: **5.000**  
Continuous Index:  
Within 8" of Joint: **NO**  
Remarks:

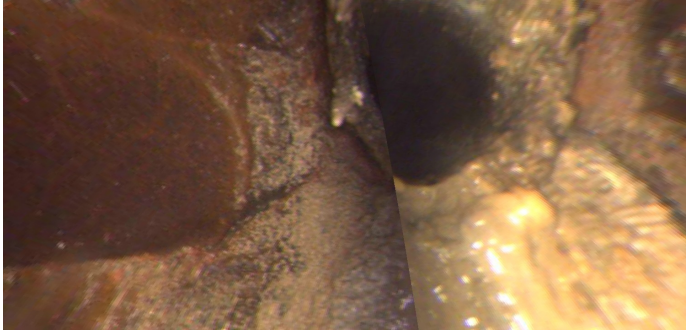
Code: **TF**  
Description: **Tap Factory**

Distance (ft): **94.8**  
Structural Grade: **0**  
O&M Grade: **0**  
Clock Start/From: **2**  
Clock To:  
1st Value: **4.000**  
2nd Value:  
Value Percent:  
Continuous Index:  
Within 8" of Joint:  
Remarks:

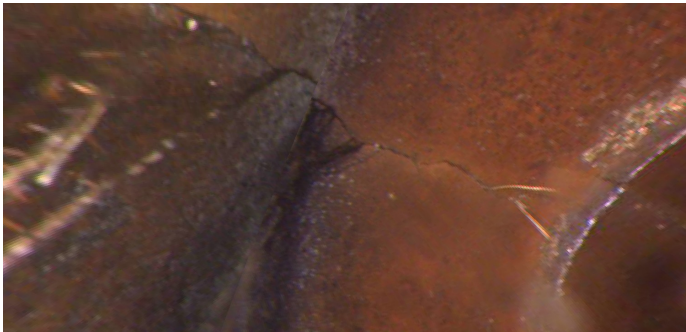
Code: **RFB**  
Description: **Roots Fine Barrel**

Distance (ft): **96.0**  
Structural Grade: **0**  
O&M Grade: **2**  
Clock Start/From: **11**  
Clock To:  
1st Value:  
2nd Value:  
Value Percent:  
Continuous Index:  
Within 8" of Joint: **NO**  
Remarks:

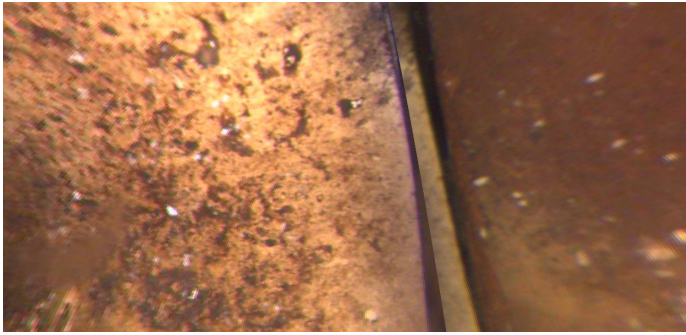
Code: **MMC**  
Description: **Material Change**

Distance (ft): **108.3**  
Structural Grade: **0**  
O&M Grade: **0**  
Clock Start/From:  
Clock To:  
1st Value:  
2nd Value:  
Value Percent:  
Continuous Index:  
Within 8" of Joint: **NO**  
Remarks: **pvc**

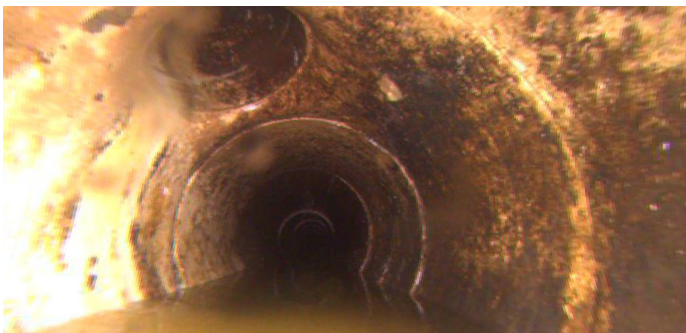
Code: **TF**  
Description: **Tap Factory**

Distance (ft): **109.6**  
Structural Grade: **0**  
O&M Grade: **0**  
Clock Start/From: **11**  
Clock To:  
1st Value: **4.000**  
2nd Value:  
Value Percent:  
Continuous Index:  
Within 8" of Joint: **YES**  
Remarks:

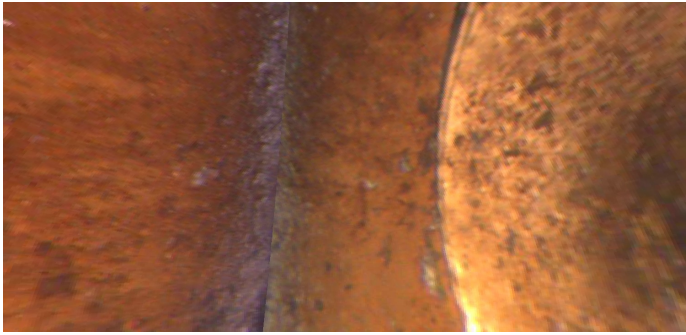
Code: **MMC**  
Description: **Material Change**

Distance (ft): **112.1**  
Structural Grade: **0**  
O&M Grade: **0**  
Clock Start/From:  
Clock To:  
1st Value:  
2nd Value:  
Value Percent:  
Continuous Index:  
Within 8" of Joint: **NO**  
Remarks: **vcp**

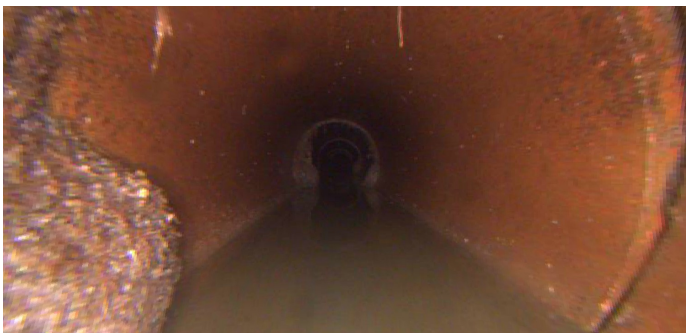
Code: **RMJ**  
Description: **Roots Medium Joint**

Distance (ft): **126.3**  
Structural Grade: **0**  
O&M Grade: **3**  
Clock Start/From: **8**  
Clock To:  
1st Value:  
2nd Value:  
Value Percent: **5.000**  
Continuous Index: **S03**  
Within 8" of Joint: **YES**  
Remarks: **wandering**

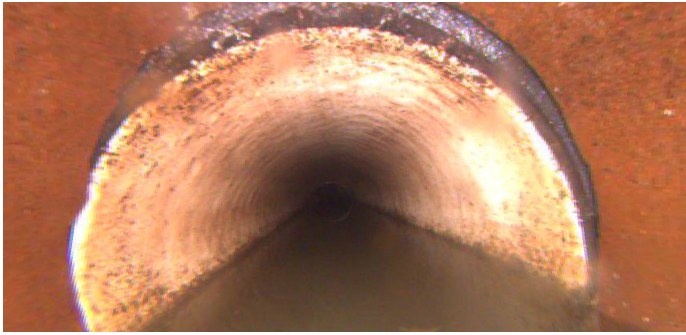
Code: **MMC**  
Description: **Material Change**

Distance (ft): **139.1**  
Structural Grade: **0**  
O&M Grade: **0**  
Clock Start/From:  
Clock To:  
1st Value:  
2nd Value:  
Value Percent:  
Continuous Index:  
Within 8" of Joint: **NO**  
Remarks: **pvc**

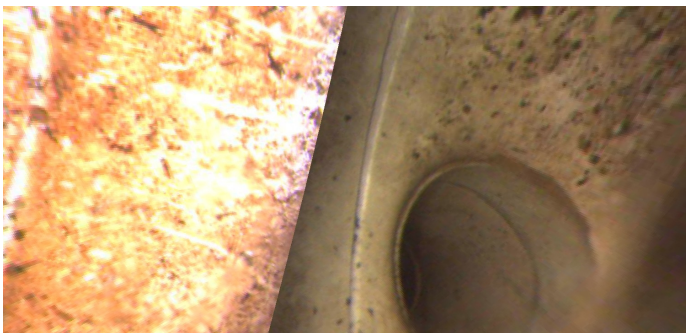
Code: **TF**  
Description: **Tap Factory**

Distance (ft): **147.3**  
Structural Grade: **0**  
O&M Grade: **0**  
Clock Start/From: **2**  
Clock To:  
1st Value: **4.000**  
2nd Value:  
Value Percent:  
Continuous Index:  
Within 8" of Joint: **YES**  
Remarks:

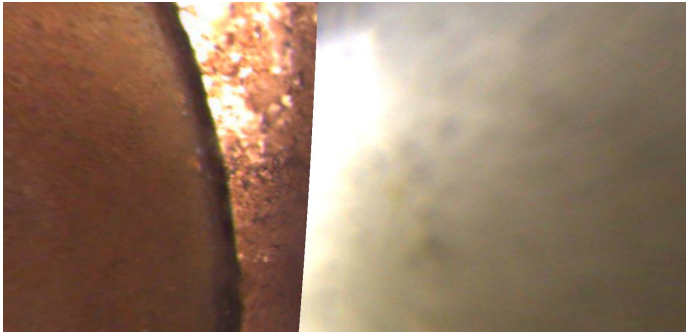
Code: **MMC**  
Description: **Material Change**

Distance (ft): **151.0**  
Structural Grade: **0**  
O&M Grade: **0**  
Clock Start/From:  
Clock To:  
1st Value:  
2nd Value:  
Value Percent:  
Continuous Index:  
Within 8" of Joint: **NO**  
Remarks: **vcp**

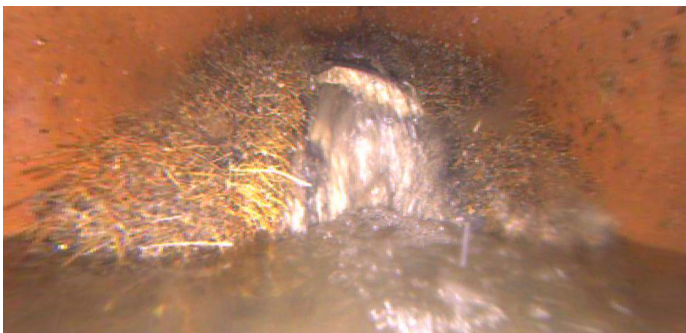
Code: **RBJ**  
Description: **Roots Ball Joint**

Distance (ft): **160.7**  
Structural Grade: **0**  
O&M Grade: **4**  
Clock Start/From: **7**  
Clock To: **5**  
1st Value:  
2nd Value:  
Value Percent: **55.000**  
Continuous Index:  
Within 8" of Joint: **YES**  
Remarks:

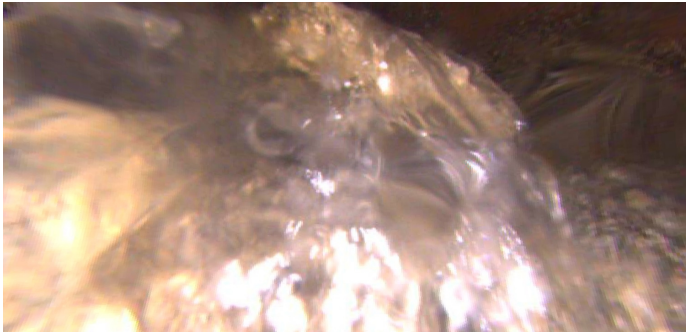
Code: **MSA**  
Description: **Abandoned Survey**

Distance (ft): **278.8**  
Structural Grade: **0**  
O&M Grade: **0**  
Clock Start/From:  
Clock To:  
1st Value:  
2nd Value:  
Value Percent:  
Continuous Index:  
Within 8" of Joint: **NO**  
Remarks: **rbj**

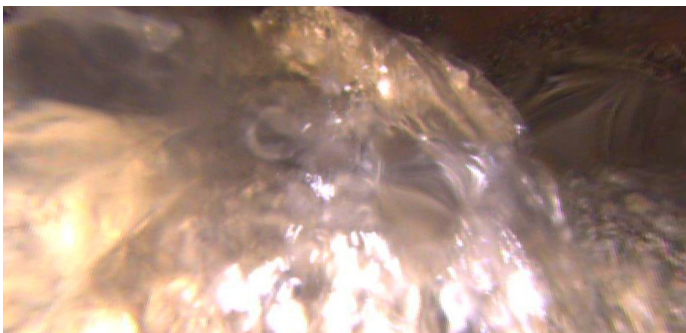
Code: **RMJ**  
Description: **Roots Medium Joint**

Distance (ft): **278.8**  
Structural Grade: **0**  
O&M Grade: **3**  
Clock Start/From: **8**  
Clock To:  
1st Value:  
2nd Value:  
Value Percent: **5.000**  
Continuous Index: **F03**  
Within 8" of Joint: **YES**  
Remarks: **wandering**

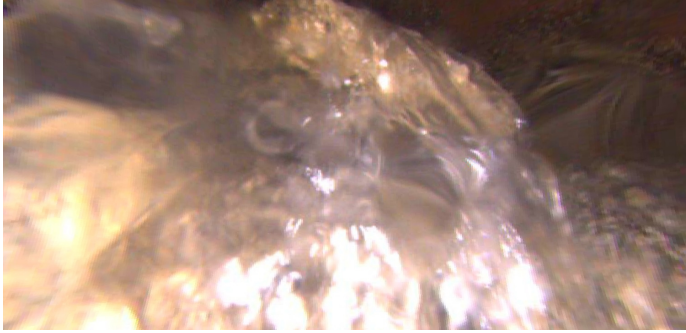
Code: **RFJ**  
Description: **Roots Fine Joint**

Distance (ft): **278.8**  
Structural Grade: **0**  
O&M Grade: **1**  
Clock Start/From: **8**  
Clock To:  
1st Value:  
2nd Value:  
Value Percent:  
Continuous Index: **F02**  
Within 8" of Joint: **YES**  
Remarks: **wandering**

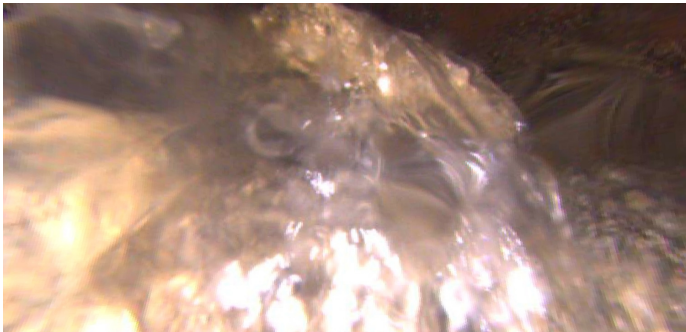
Code: **CM**  
Description: **Crack Multiple**

Distance (ft): **278.8**  
Structural Grade: **3**  
O&M Grade: **0**  
Clock Start/From: **7**  
Clock To: **11**  
1st Value:  
2nd Value:  
Value Percent:  
Continuous Index: **F01**  
Within 8" of Joint: **YES**  
Remarks: **wandering**
