Profile/Photo Observation Report

Date:	09/21/2021	Weather:		Coding:	PACP 7.0
Pipe Length (ft):	331.0	Owner:	City of Hobart	Pre Clean:	Heavy Cleaning
P.O.#:	YES502259	Surveyor:	S. Bucklin	PSR:	P-504-056-028
Customer:	City of Hobart	Clean Date:	09/08/2021	Shape:	C

Street:	North Wilson Street	Flow Control:	Not Controlled
City:	Hobart, IN	Year Renewed:	
Location:	Alley	Tape/Media #:	
Purpose:	Routine Assessment	Dia/Height:	12"
Use:	Sanitary Sewage Pipe	Material:	VCP
Drain Area:		Lining:	None
Category:	NA		
Comment:

Location Details:		Direction of Survey:	Downstream
US MH:	M-504-028	DS MH:	M-504-056
		Total Length Surveyed (ft):	102.7

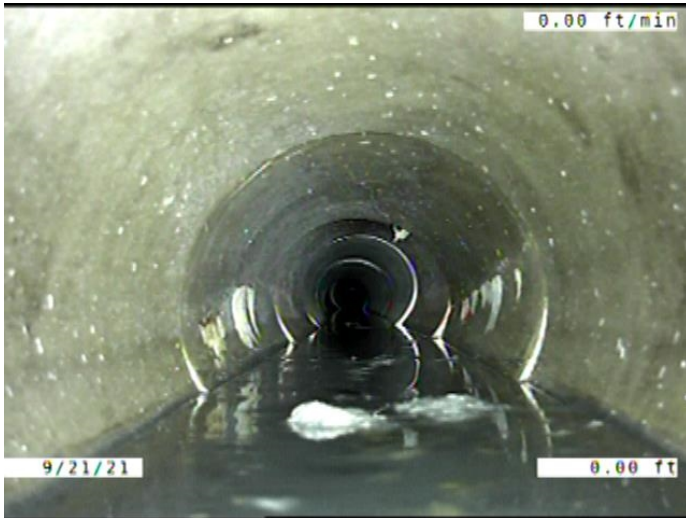
Code: **MWL**
Description: **Miscellaneous Water Level**

Distance (ft): **.0**
Structural Grade: **0**
O&M Grade: **0**
Clock Start/From:
Clock To:
1st Value:
2nd Value:
Value Percent: **5.000**
Continuous Index:
Within 8" of Joint: **NO**
Remarks:

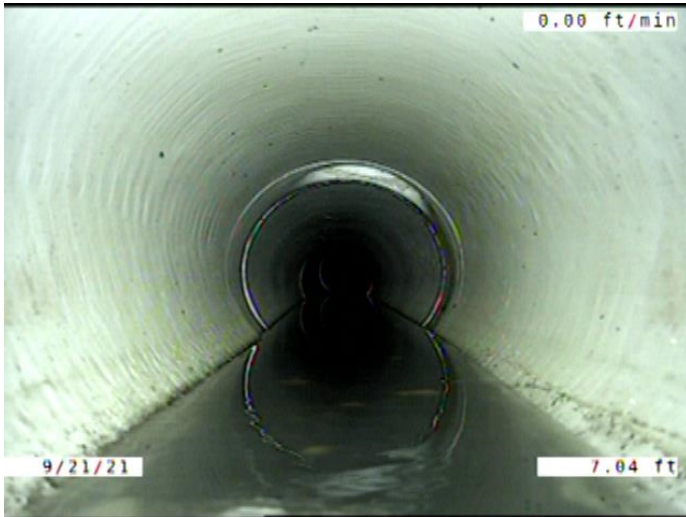
Code: **B**
Description: **Broken**

Distance (ft): **7.0**
Structural Grade: **4**
O&M Grade: **0**
Clock Start/From: **8**
Clock To: **4**
1st Value:
2nd Value:
Value Percent:
Continuous Index: **F02**
Within 8" of Joint: **YES**
Remarks:

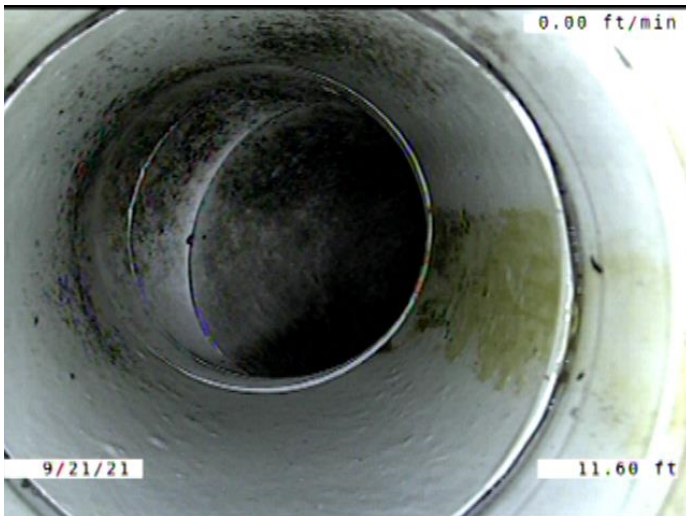
Code: **TF**
Description: **Tap Factory**

Distance (ft): **11.6**
Structural Grade: **0**
O&M Grade: **0**
Clock Start/From: **1**
Clock To:
1st Value: **4.000**
2nd Value:
Value Percent:
Continuous Index:
Within 8" of Joint: **YES**
Remarks:

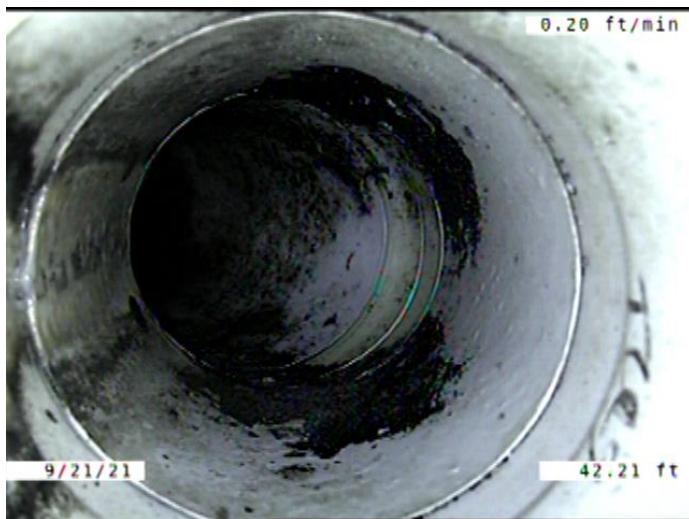
Code: **TF**
Description: **Tap Factory**

Distance (ft): **42.2**
Structural Grade: **0**
O&M Grade: **0**
Clock Start/From: **10**
Clock To:
1st Value: **4.000**
2nd Value:
Value Percent:
Continuous Index:
Within 8" of Joint: **YES**
Remarks:

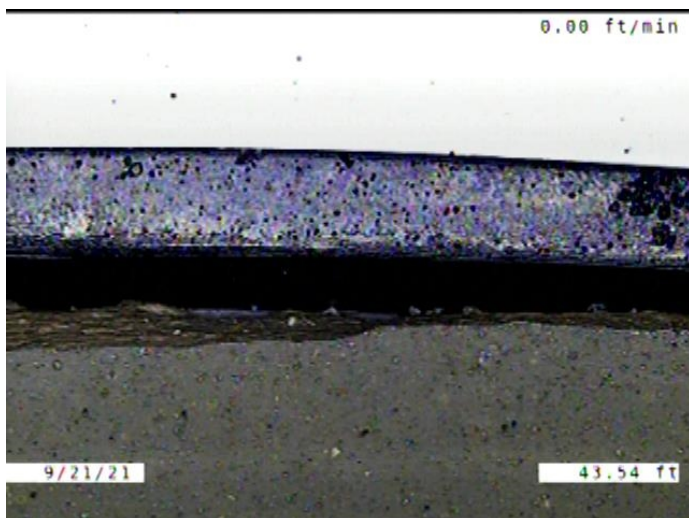
Code: **MMC**
Description: **Miscellaneous Material Change**

Distance (ft): **43.5**
Structural Grade: **0**
O&M Grade: **0**
Clock Start/From:
Clock To:
1st Value:
2nd Value:
Value Percent:
Continuous Index:
Within 8" of Joint: **NO**
Remarks: **PVC TO VCP**

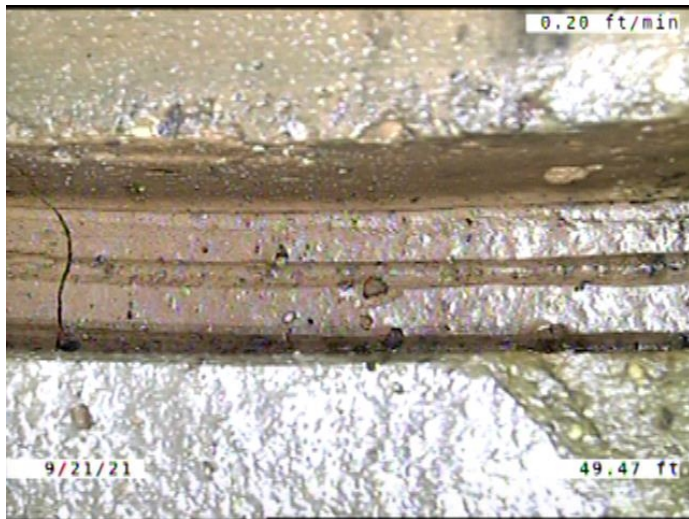
Code: **JAM**
 Description: **Joint Angular Medium**

Distance (ft): **49.5**
 Structural Grade: **3**
 O&M Grade: **0**
 Clock Start/From:
 Clock To:
 1st Value:
 2nd Value:
 Value Percent:
 Continuous Index:
 Within 8" of Joint: **NO**
 Remarks:

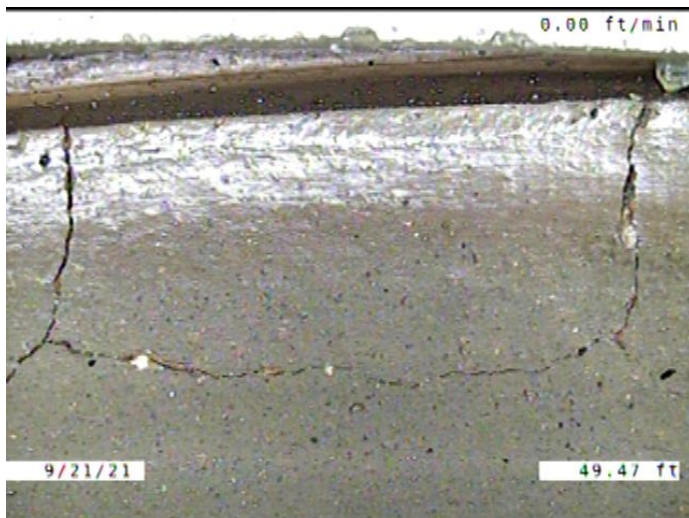
Code: **CM**
 Description: **Crack Multiple**

Distance (ft): **49.5**
 Structural Grade: **3**
 O&M Grade: **0**
 Clock Start/From: **9**
 Clock To: **2**
 1st Value:
 2nd Value:
 Value Percent:
 Continuous Index:
 Within 8" of Joint: **YES**
 Remarks:

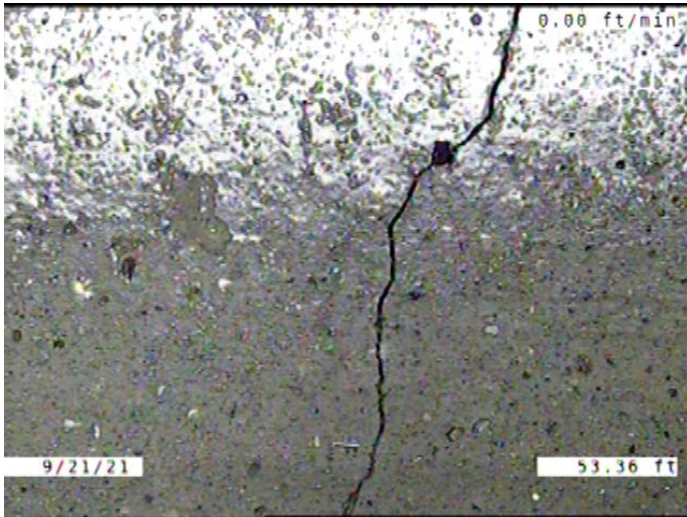
Code: **FM**
 Description: **Fracture Multiple**

Distance (ft): **53.4**
 Structural Grade: **4**
 O&M Grade: **0**
 Clock Start/From: **9**
 Clock To: **3**
 1st Value:
 2nd Value:
 Value Percent:
 Continuous Index: **S05**
 Within 8" of Joint: **YES**
 Remarks:

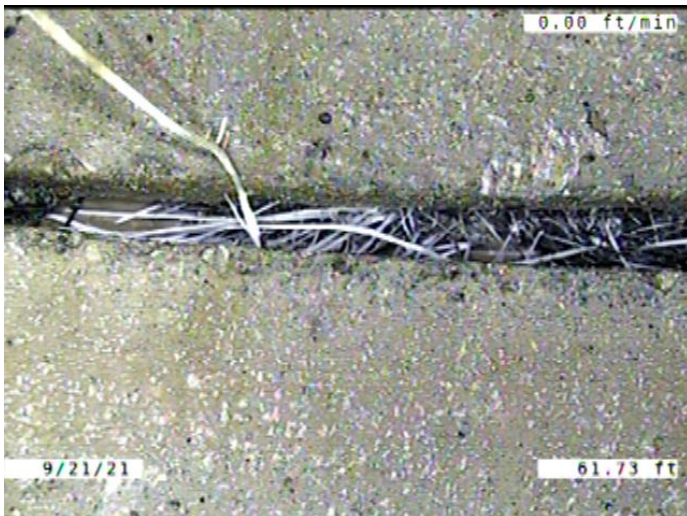
Code: **RFJ**
 Description: **Roots Fine Joint**

Distance (ft): **61.7**
 Structural Grade: **0**
 O&M Grade: **1**
 Clock Start/From: **8**
 Clock To: **4**
 1st Value:
 2nd Value:
 Value Percent:
 Continuous Index:
 Within 8" of Joint: **YES**
 Remarks:

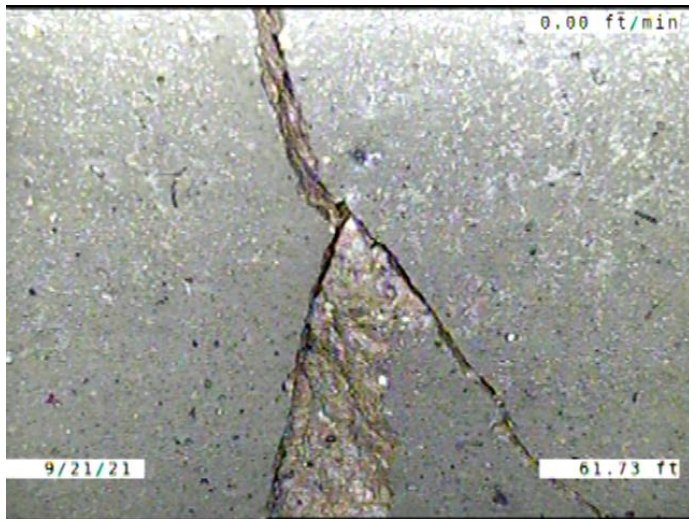
Code: **B**
Description: **Broken**

Distance (ft): **61.7**
Structural Grade: **4**
O&M Grade: **0**
Clock Start/From: **12**
Clock To: **8**
1st Value:
2nd Value:
Value Percent:
Continuous Index:
Within 8" of Joint: **YES**
Remarks:

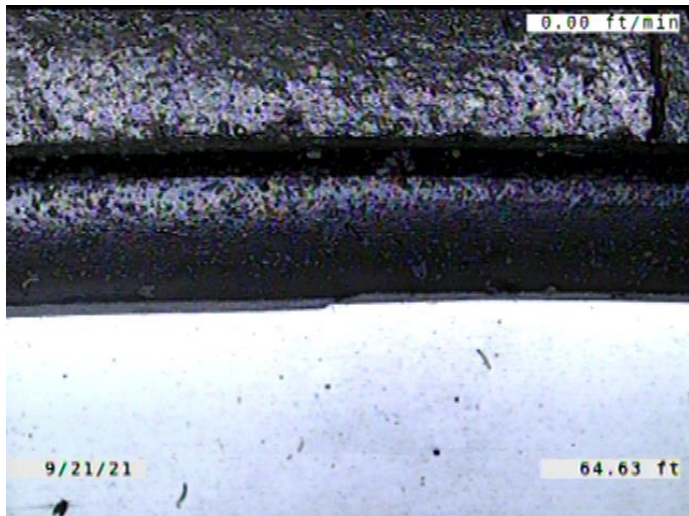
Code: **MMC**
Description: **Miscellaneous Material Change**

Distance (ft): **64.6**
Structural Grade: **0**
O&M Grade: **0**
Clock Start/From:
Clock To:
1st Value:
2nd Value:
Value Percent:
Continuous Index:
Within 8" of Joint: **NO**
Remarks: **VCP TO PVC**

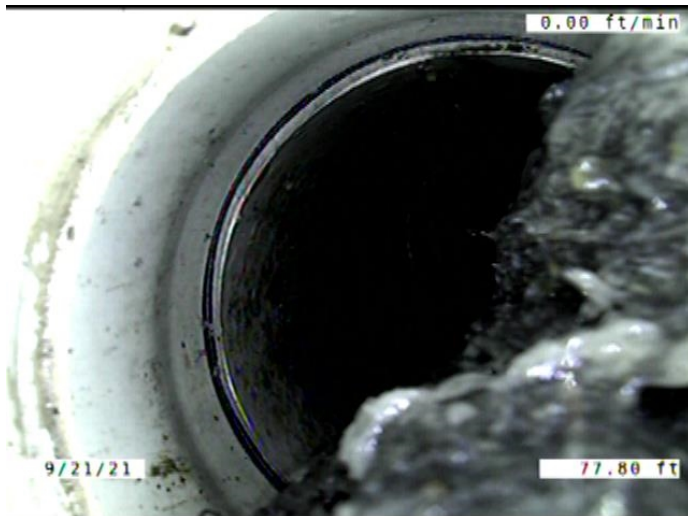
Code: **TF**
Description: **Tap Factory**

Distance (ft): **77.8**
Structural Grade: **0**
O&M Grade: **0**
Clock Start/From: **1**
Clock To:
1st Value: **4.000**
2nd Value:
Value Percent:
Continuous Index:
Within 8" of Joint: **YES**
Remarks: **CONSTANTLY RUNNING WATER.
ROOTS GROWING INTO THE MAIN**

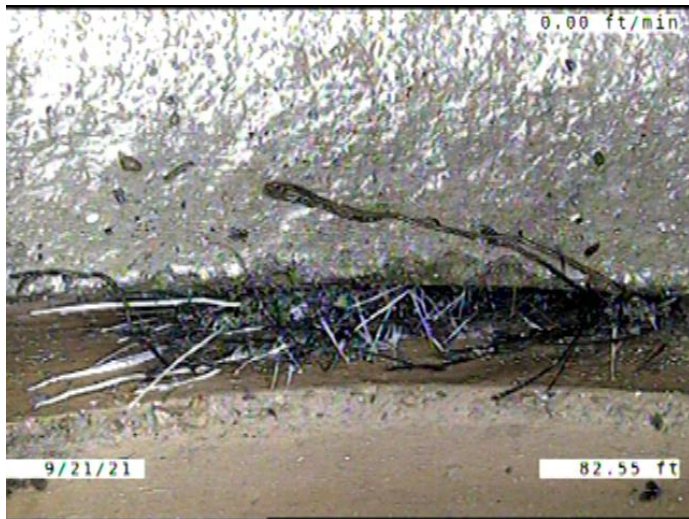
Code: **RFJ**
Description: **Roots Fine Joint**

Distance (ft): **82.6**
Structural Grade: **0**
O&M Grade: **1**
Clock Start/From: **9**
Clock To: **11**
1st Value:
2nd Value:
Value Percent:
Continuous Index:
Within 8" of Joint: **YES**
Remarks:

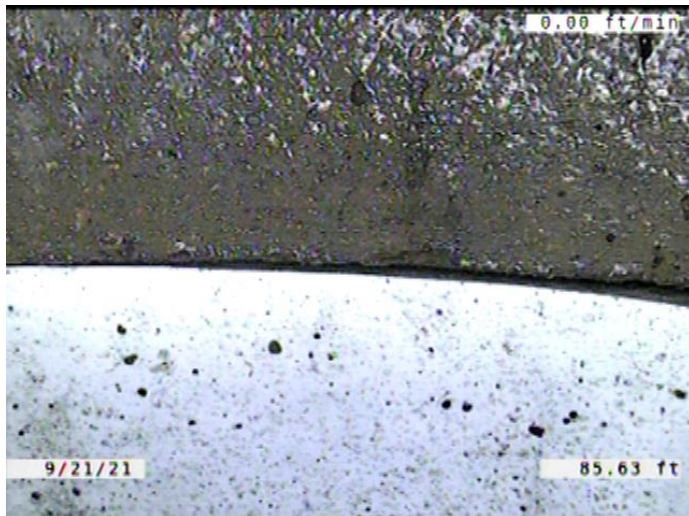
Code: **MMC**
Description: **Miscellaneous Material Change**

Distance (ft): **85.6**
Structural Grade: **0**
O&M Grade: **0**
Clock Start/From:
Clock To:
1st Value:
2nd Value:
Value Percent:
Continuous Index:
Within 8" of Joint: **NO**
Remarks: **VCP TO PVC**

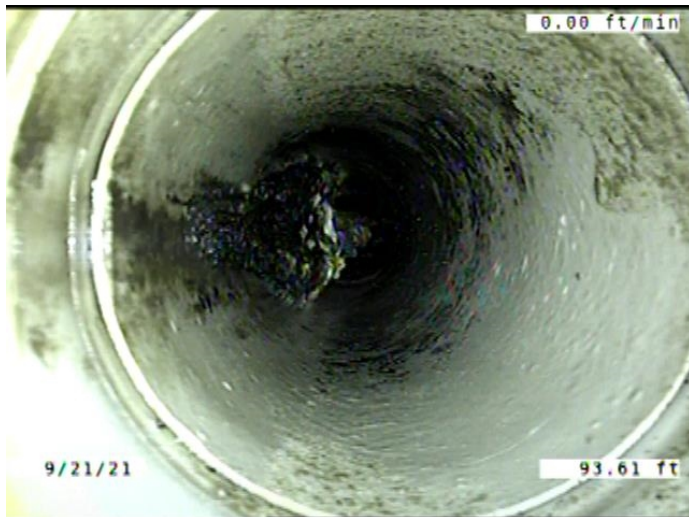
Code:	TF
Description:	Tap Factory
Distance (ft):	93.6
Structural Grade:	0
O&M Grade:	0
Clock Start/From:	9
Clock To:	
1st Value:	4.000
2nd Value:	
Value Percent:	
Continuous Index:	
Within 8" of Joint:	YES
Remarks:	ROOTS GROWING DOWN THE TAP

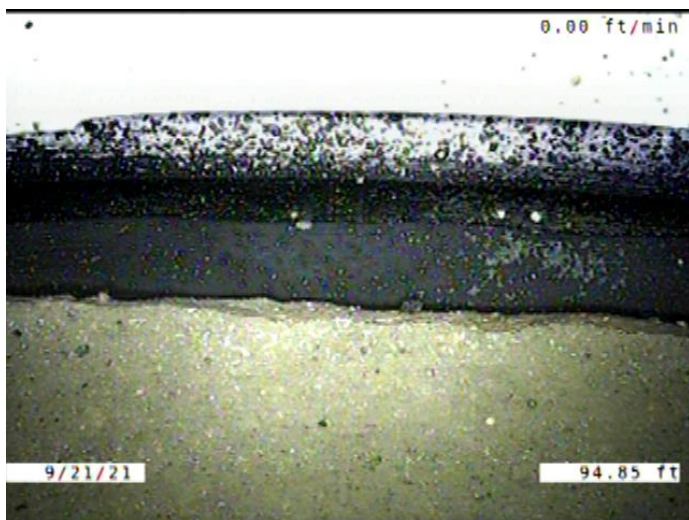
Code:	MMC
Description:	Miscellaneous Material Change
Distance (ft):	94.8
Structural Grade:	0
O&M Grade:	0
Clock Start/From:	
Clock To:	
1st Value:	
2nd Value:	
Value Percent:	
Continuous Index:	
Within 8" of Joint:	NO
Remarks:	PVC TO VCP

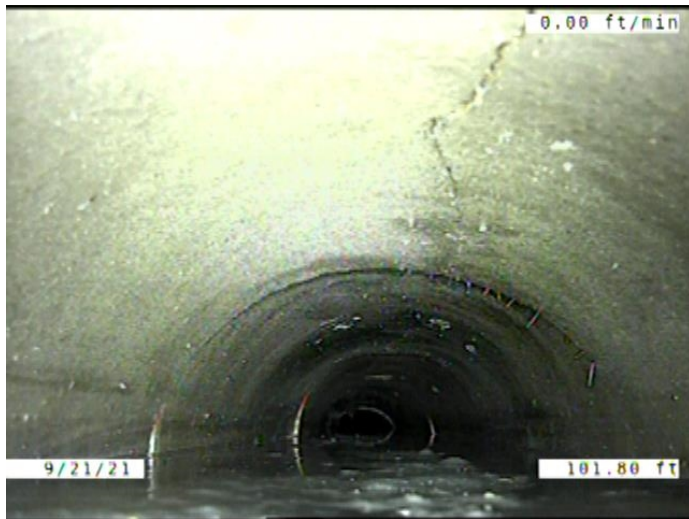
Code:	MWL
Description:	Miscellaneous Water Level
Distance (ft):	101.8
Structural Grade:	0
O&M Grade:	0
Clock Start/From:	
Clock To:	
1st Value:	
2nd Value:	
Value Percent:	40.000
Continuous Index:	
Within 8" of Joint:	NO
Remarks:

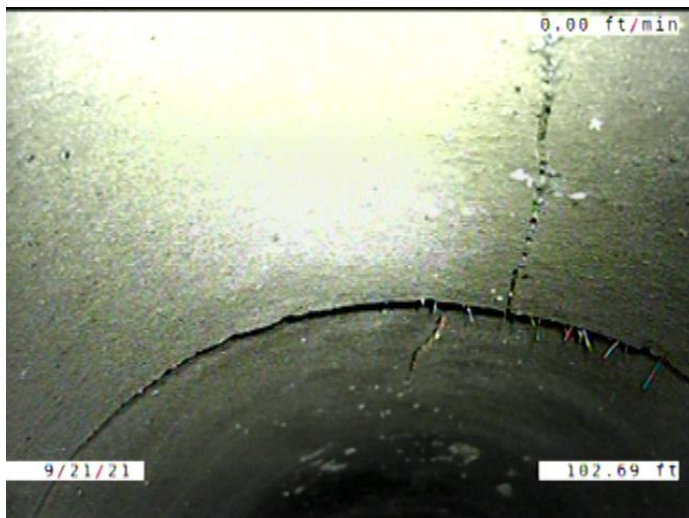
Code:	DSF
Description:	Deposits Settled Fine
Distance (ft):	102.7
Structural Grade:	0
O&M Grade:	2
Clock Start/From:	5
Clock To:	7
1st Value:	
2nd Value:	
Value Percent:	5.000
Continuous Index:	F01
Within 8" of Joint:	YES
Remarks:

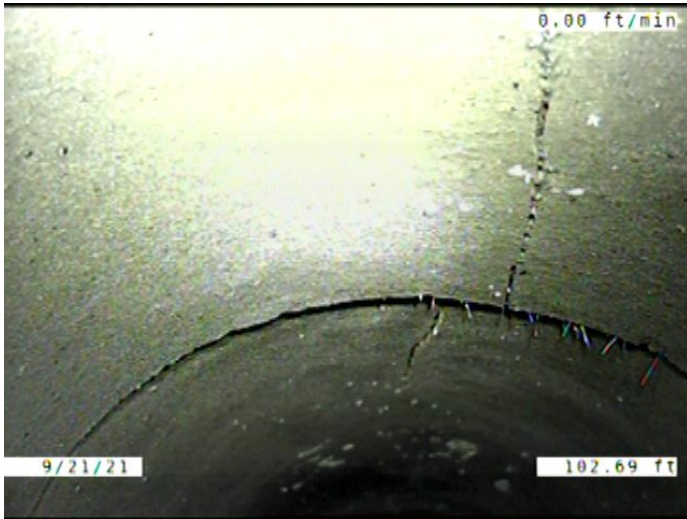
Code: **FM**
Description: **Fracture Multiple**

Distance (ft): **102.7**
Structural Grade: **4**
O&M Grade: **0**
Clock Start/From: **8**
Clock To: **4**
1st Value:
2nd Value:
Value Percent:
Continuous Index: **F06**
Within 8" of Joint: **YES**
Remarks:

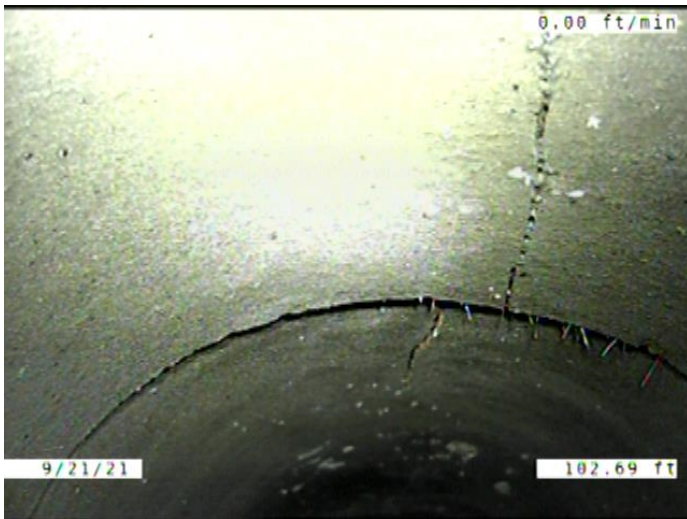
Code: **RFB**
Description: **Roots Fine Barrel**

Distance (ft): **102.7**
Structural Grade: **0**
O&M Grade: **2**
Clock Start/From: **9**
Clock To: **3**
1st Value:
2nd Value:
Value Percent:
Continuous Index: **F07**
Within 8" of Joint: **NO**
Remarks:
