Profile/Photo Observation Report

Date:	09/21/2021	Weather:		Coding:	PACP 7.0
Pipe Length (ft):	331.0	Owner:	City of Hobart	Pre Clean:	Heavy Cleaning
P.O.#:	YES502259	Surveyor:	S. Bucklin	PSR:	P-504-056-028
Customer:	City of Hobart	Clean Date:	09/08/2021	Shape:	C

Street:	North Wilson Street	Flow Control:	Not Controlled
City:	Hobart, IN	Year Renewed:	
Location:	Alley	Tape/Media #:	
Purpose:	Routine Assessment	Dia/Height:	12"
Use:	Sanitary Sewage Pipe	Material:	VCP
Drain Area:		Lining:	None
Category:	NA		
Comment:

Location Details:		Direction of Survey:	Downstream
US MH:	M-504-028	DS MH:	M-504-056
		Total Length Surveyed (ft):	102.7

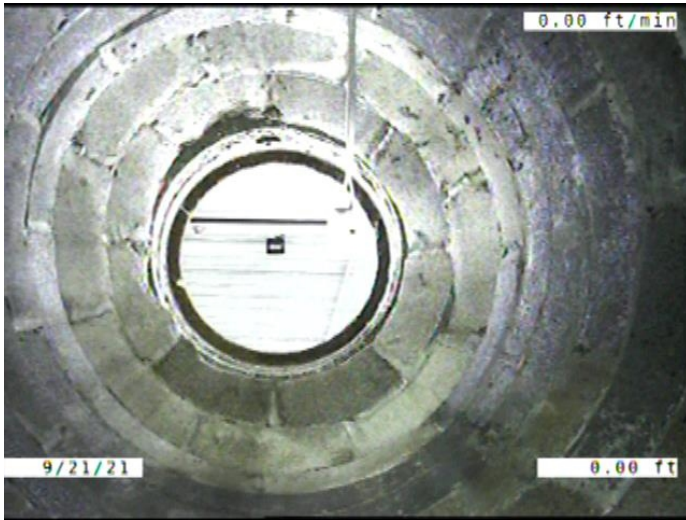
Code: **AMH**
 Description: **Manhole**

Distance (ft): **.0**
 Structural Grade: **0**
 O&M Grade: **0**
 Clock Start/From:
 Clock To:
 1st Value:
 2nd Value:
 Value Percent:
 Continuous Index:
 Within 8" of Joint: **NO**
 Remarks: **M-504-028**

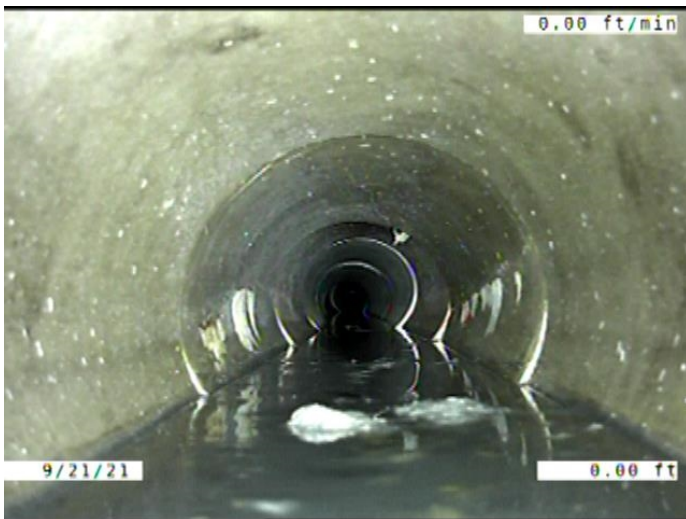
Code: **MWL**
 Description: **Miscellaneous Water Level**

Distance (ft): **.0**
 Structural Grade: **0**
 O&M Grade: **0**
 Clock Start/From:
 Clock To:
 1st Value:
 2nd Value:
 Value Percent: **5.000**
 Continuous Index:
 Within 8" of Joint: **NO**
 Remarks:

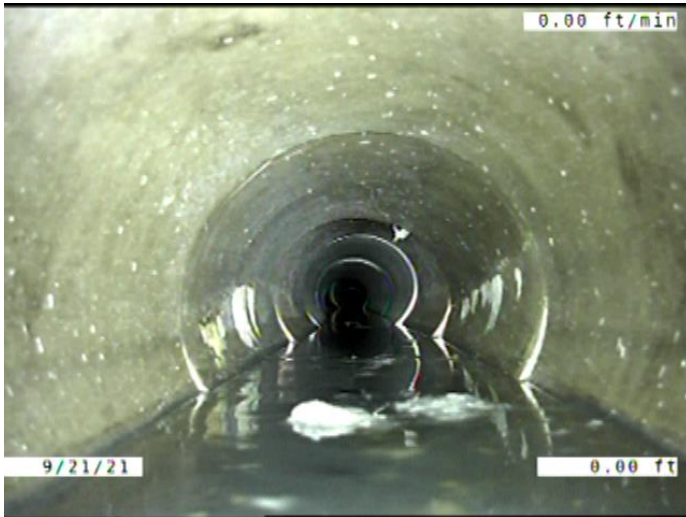
Code: **DSF**
 Description: **Deposits Settled Fine**

Distance (ft): **.0**
 Structural Grade: **0**
 O&M Grade: **2**
 Clock Start/From: **5**
 Clock To: **7**
 1st Value:
 2nd Value:
 Value Percent: **5.000**
 Continuous Index: **S01**
 Within 8" of Joint: **YES**
 Remarks:

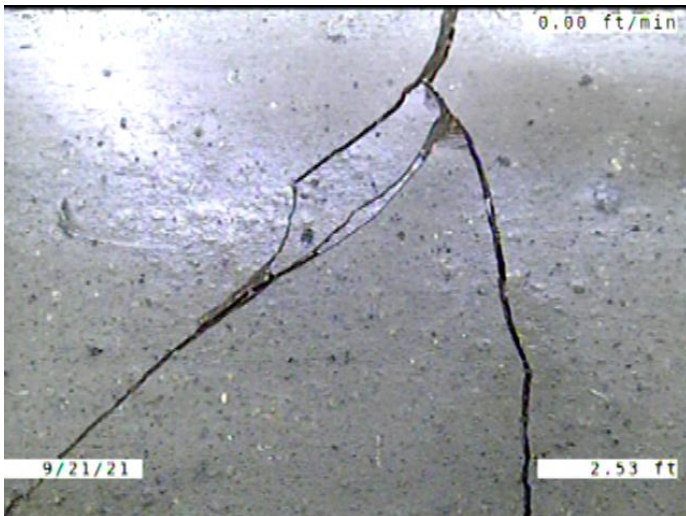
Code: **B**
 Description: **Broken**

Distance (ft): **2.5**
 Structural Grade: **4**
 O&M Grade: **0**
 Clock Start/From: **8**
 Clock To: **4**
 1st Value:
 2nd Value:
 Value Percent:
 Continuous Index: **S02**
 Within 8" of Joint: **YES**
 Remarks:

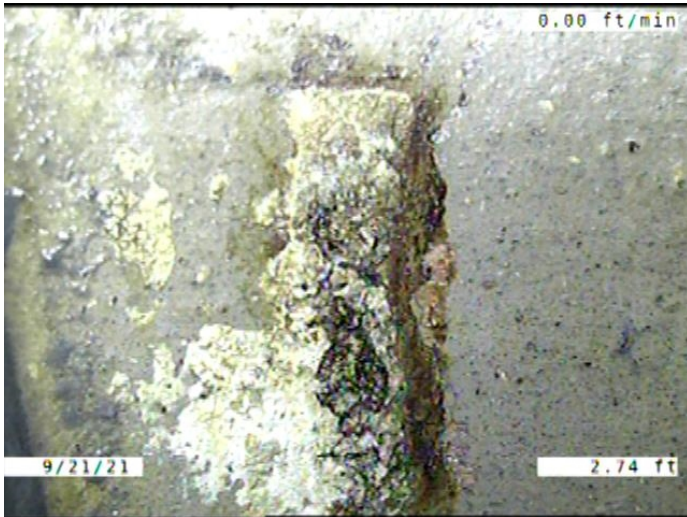
Code: **DAE**
Description: **Deposits Attached Encrustation**

Distance (ft): **2.7**
Structural Grade: **0**
O&M Grade: **2**
Clock Start/From: **8**
Clock To: **9**
1st Value:
2nd Value:
Value Percent: **5.000**
Continuous Index: **S03**
Within 8" of Joint: **YES**
Remarks:

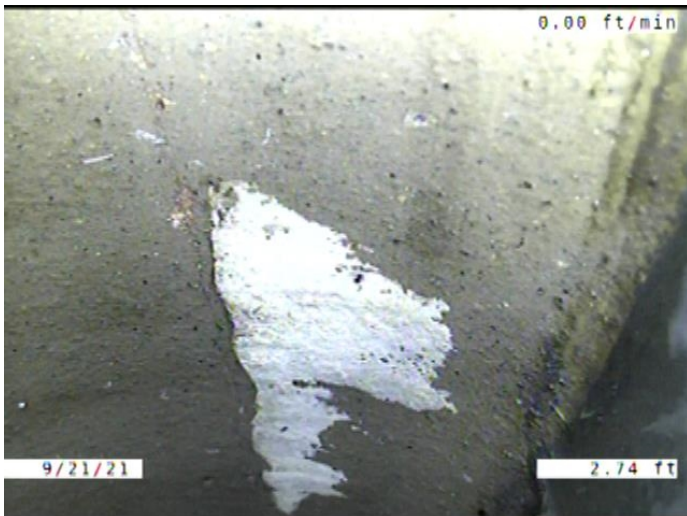
Code: **DAE**
Description: **Deposits Attached Encrustation**

Distance (ft): **2.7**
Structural Grade: **0**
O&M Grade: **2**
Clock Start/From: **3**
Clock To: **4**
1st Value:
2nd Value:
Value Percent: **5.000**
Continuous Index: **S04**
Within 8" of Joint: **YES**
Remarks:

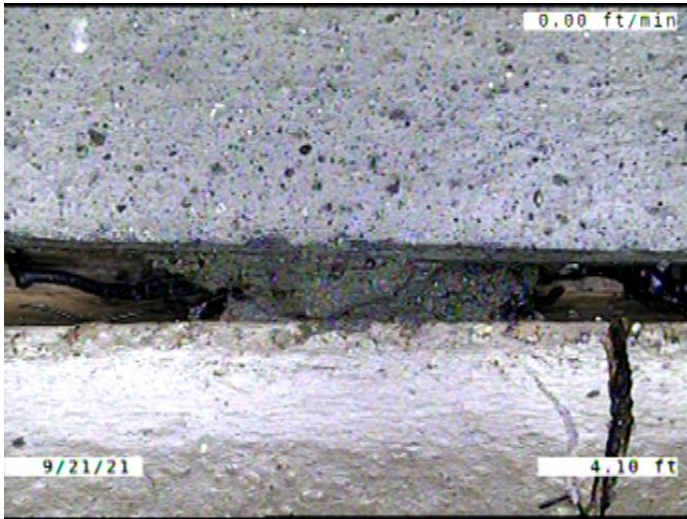
Code: **RFJ**
Description: **Roots Fine Joint**

Distance (ft): **4.1**
Structural Grade: **0**
O&M Grade: **1**
Clock Start/From: **11**
Clock To: **1**
1st Value:
2nd Value:
Value Percent:
Continuous Index:
Within 8" of Joint: **YES**
Remarks:

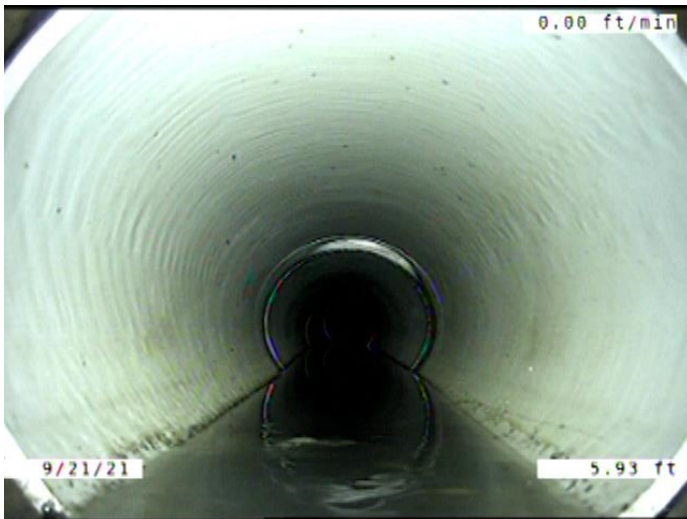
Code: **DAE**
Description: **Deposits Attached Encrustation**

Distance (ft): **5.9**
Structural Grade: **0**
O&M Grade: **2**
Clock Start/From: **8**
Clock To: **9**
1st Value:
2nd Value:
Value Percent: **5.000**
Continuous Index: **F03**
Within 8" of Joint: **YES**
Remarks:

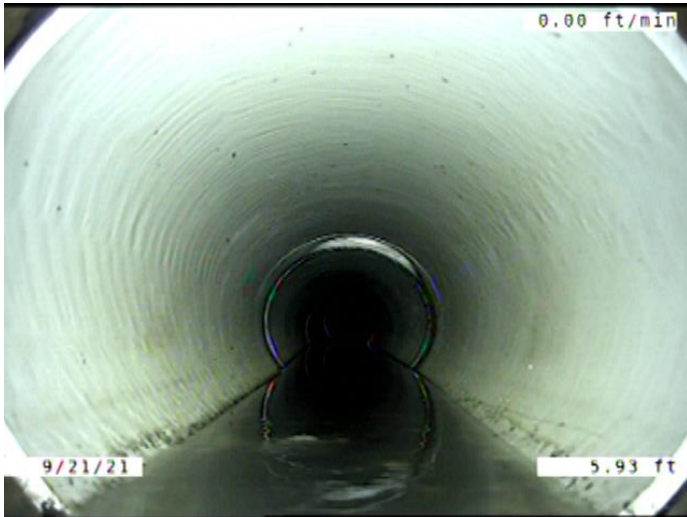
Code: **DAE**
 Description: **Deposits Attached Encrustation**

Distance (ft): **5.9**
 Structural Grade: **0**
 O&M Grade: **2**
 Clock Start/From: **3**
 Clock To: **4**
 1st Value:
 2nd Value:
 Value Percent: **5.000**
 Continuous Index: **F04**
 Within 8" of Joint: **YES**
 Remarks:

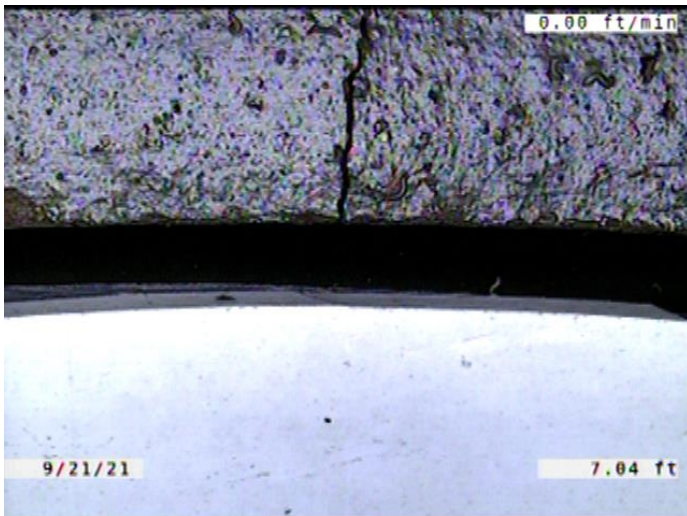
Code: **MMC**
 Description: **Miscellaneous Material Change**

Distance (ft): **7.0**
 Structural Grade: **0**
 O&M Grade: **0**
 Clock Start/From:
 Clock To:
 1st Value:
 2nd Value:
 Value Percent:
 Continuous Index:
 Within 8" of Joint: **NO**
 Remarks: **VCP TO PVC**

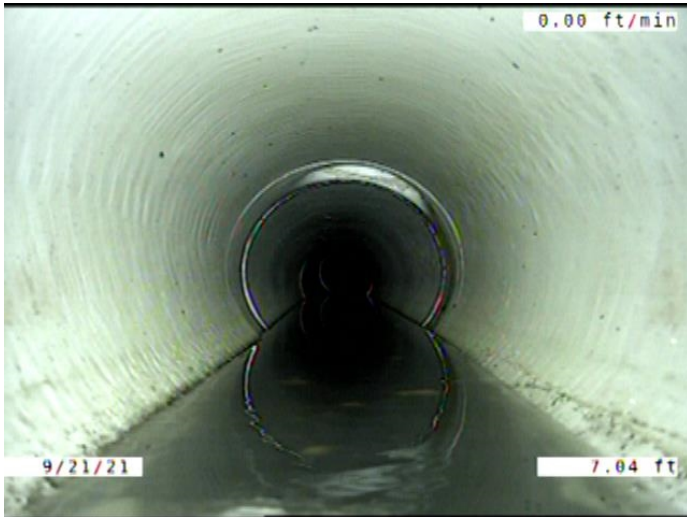
Code: **B**
 Description: **Broken**

Distance (ft): **7.0**
 Structural Grade: **4**
 O&M Grade: **0**
 Clock Start/From: **8**
 Clock To: **4**
 1st Value:
 2nd Value:
 Value Percent:
 Continuous Index: **F02**
 Within 8" of Joint: **YES**
 Remarks:

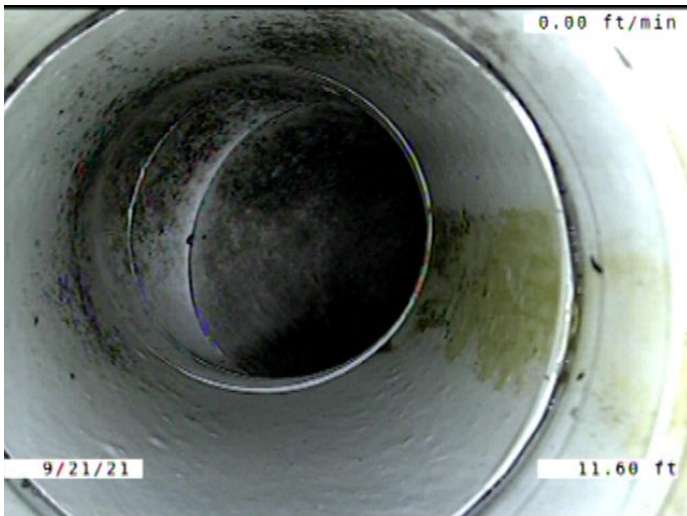
Code: **TF**
 Description: **Tap Factory**

Distance (ft): **11.6**
 Structural Grade: **0**
 O&M Grade: **0**
 Clock Start/From: **1**
 Clock To:
 1st Value: **4.000**
 2nd Value:
 Value Percent:
 Continuous Index:
 Within 8" of Joint: **YES**
 Remarks:

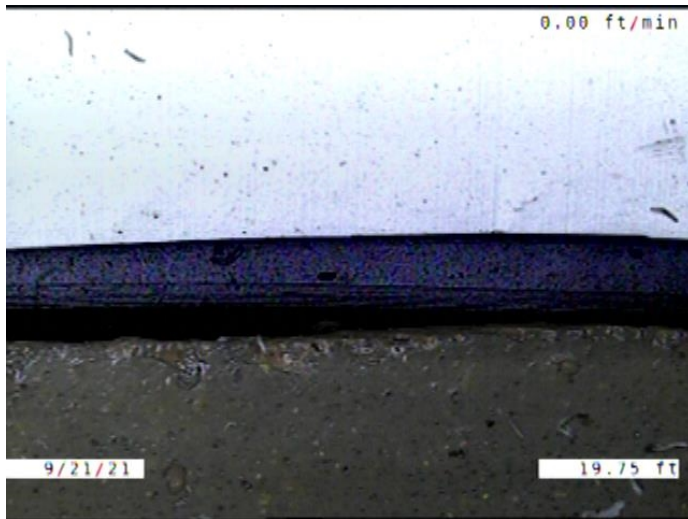
Code: **MMC**
Description: **Miscellaneous Material Change**

Distance (ft): **19.8**
Structural Grade: **0**
O&M Grade: **0**
Clock Start/From:
Clock To:
1st Value:
2nd Value:
Value Percent:
Continuous Index:
Within 8" of Joint: **NO**
Remarks: **PVC TO VCP**

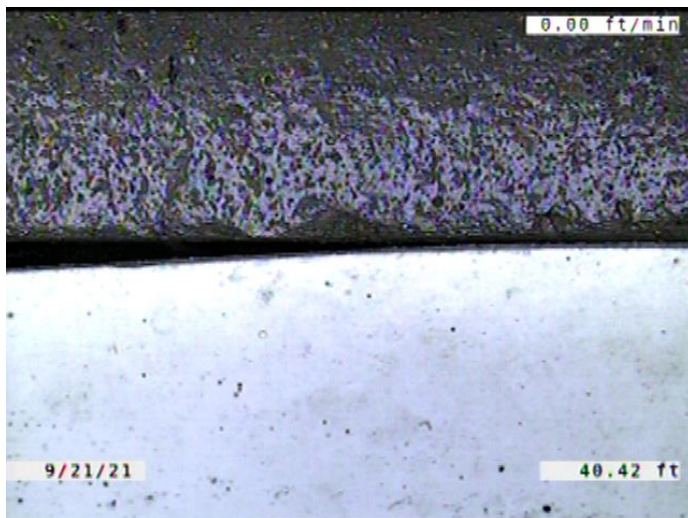
Code: **MMC**
Description: **Miscellaneous Material Change**

Distance (ft): **40.4**
Structural Grade: **0**
O&M Grade: **0**
Clock Start/From:
Clock To:
1st Value:
2nd Value:
Value Percent:
Continuous Index:
Within 8" of Joint: **NO**
Remarks: **VCP TO PVC**

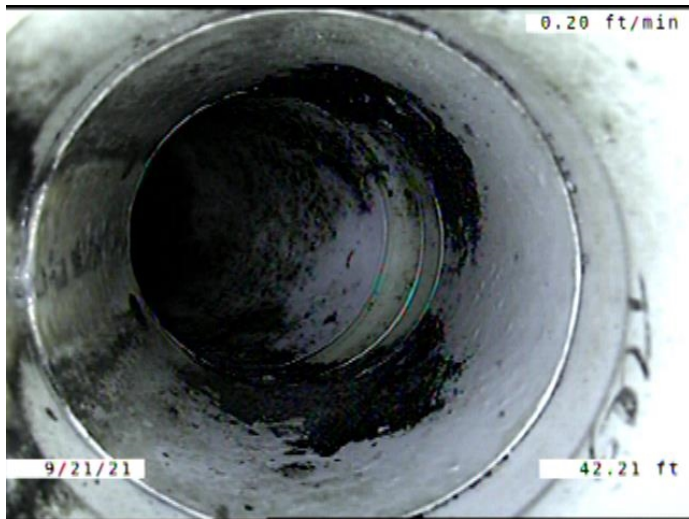
Code: **TF**
 Description: **Tap Factory**

Distance (ft): **42.2**
 Structural Grade: **0**
 O&M Grade: **0**
 Clock Start/From: **10**
 Clock To:
 1st Value: **4.000**
 2nd Value:
 Value Percent:
 Continuous Index:
 Within 8" of Joint: **YES**
 Remarks:

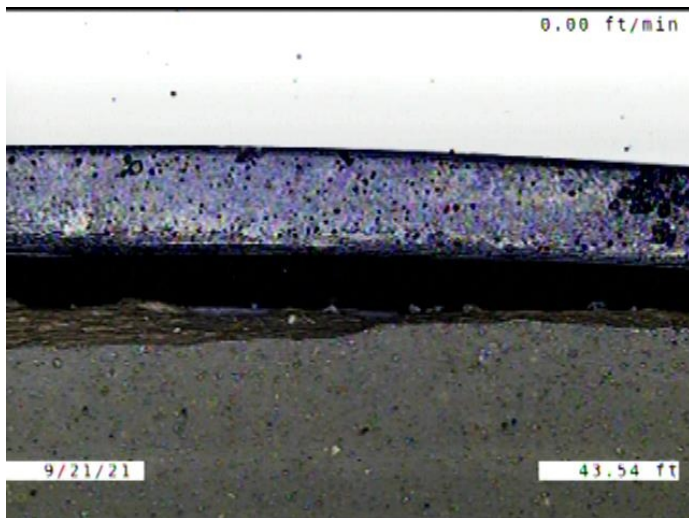
Code: **MMC**
 Description: **Miscellaneous Material Change**

Distance (ft): **43.5**
 Structural Grade: **0**
 O&M Grade: **0**
 Clock Start/From:
 Clock To:
 1st Value:
 2nd Value:
 Value Percent:
 Continuous Index:
 Within 8" of Joint: **NO**
 Remarks: **PVC TO VCP**

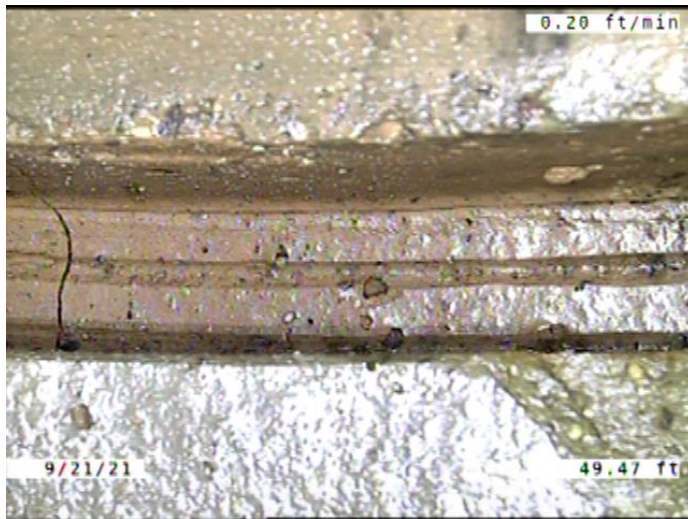
Code: **JAM**
 Description: **Joint Angular Medium**

Distance (ft): **49.5**
 Structural Grade: **3**
 O&M Grade: **0**
 Clock Start/From:
 Clock To:
 1st Value:
 2nd Value:
 Value Percent:
 Continuous Index:
 Within 8" of Joint: **NO**
 Remarks:

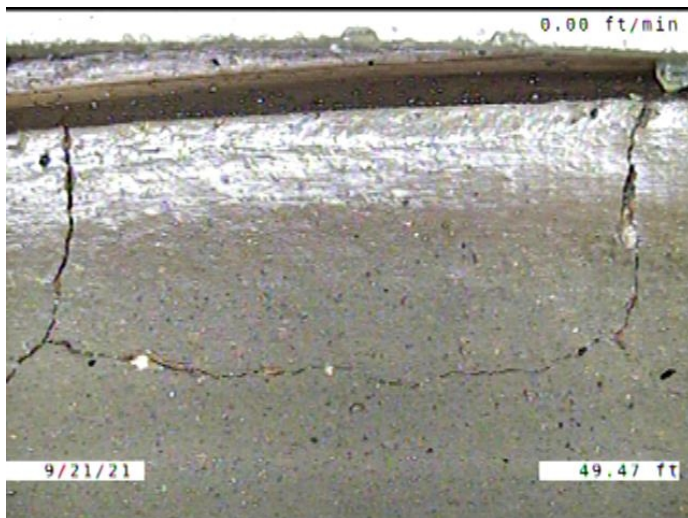
Code: **CM**
 Description: **Crack Multiple**

Distance (ft): **49.5**
 Structural Grade: **3**
 O&M Grade: **0**
 Clock Start/From: **9**
 Clock To: **2**
 1st Value:
 2nd Value:
 Value Percent:
 Continuous Index:
 Within 8" of Joint: **YES**
 Remarks:

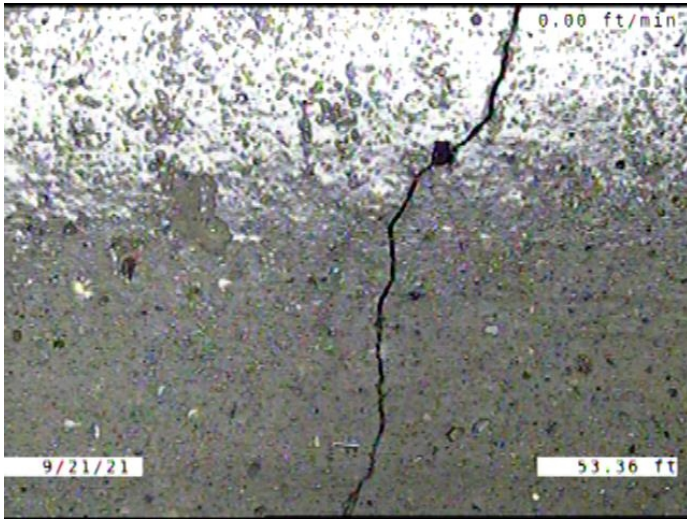
Code: **FM**
 Description: **Fracture Multiple**

Distance (ft): **53.4**
 Structural Grade: **4**
 O&M Grade: **0**
 Clock Start/From: **9**
 Clock To: **3**
 1st Value:
 2nd Value:
 Value Percent:
 Continuous Index: **S05**
 Within 8" of Joint: **YES**
 Remarks:

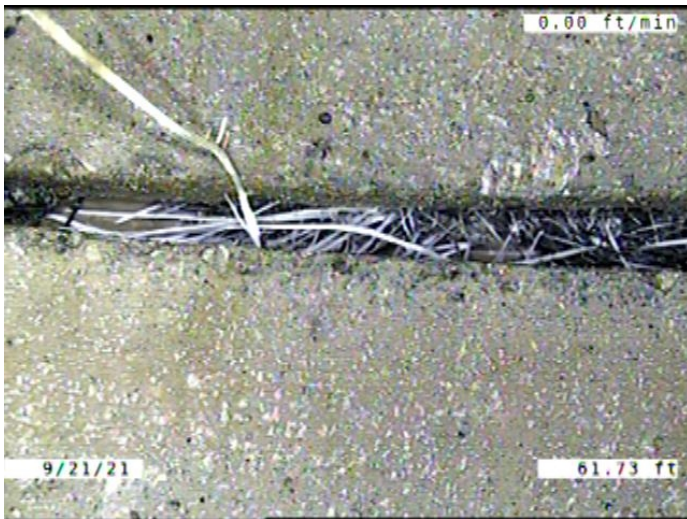
Code: **RFJ**
 Description: **Roots Fine Joint**

Distance (ft): **61.7**
 Structural Grade: **0**
 O&M Grade: **1**
 Clock Start/From: **8**
 Clock To: **4**
 1st Value:
 2nd Value:
 Value Percent:
 Continuous Index:
 Within 8" of Joint: **YES**
 Remarks:

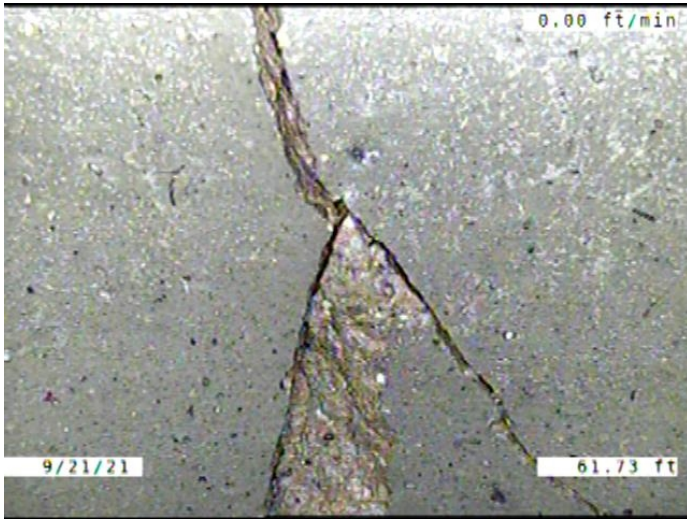
Code: **B**
Description: **Broken**

Distance (ft): **61.7**
Structural Grade: **4**
O&M Grade: **0**
Clock Start/From: **12**
Clock To: **8**
1st Value:
2nd Value:
Value Percent:
Continuous Index:
Within 8" of Joint: **YES**
Remarks:

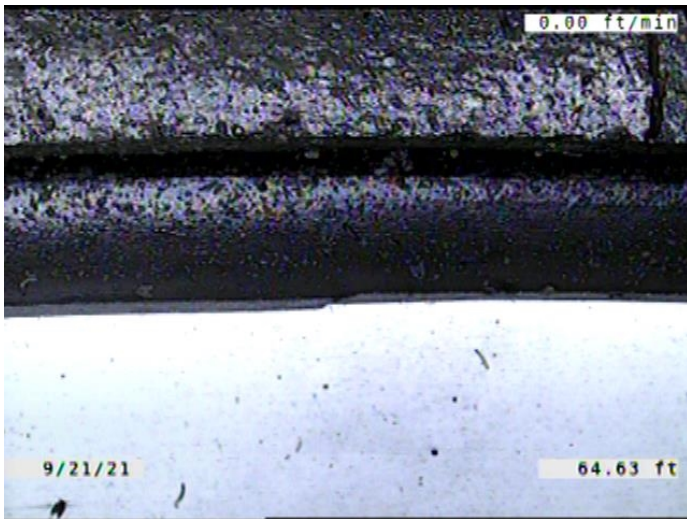
Code: **MMC**
Description: **Miscellaneous Material Change**

Distance (ft): **64.6**
Structural Grade: **0**
O&M Grade: **0**
Clock Start/From:
Clock To:
1st Value:
2nd Value:
Value Percent:
Continuous Index:
Within 8" of Joint: **NO**
Remarks: **VCP TO PVC**

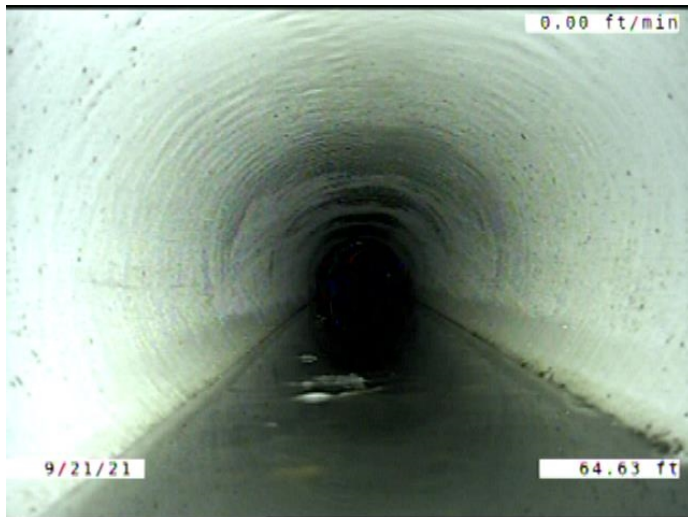
Code: **FM**
 Description: **Fracture Multiple**

Distance (ft): **64.6**
 Structural Grade: **4**
 O&M Grade: **0**
 Clock Start/From: **9**
 Clock To: **3**
 1st Value:
 2nd Value:
 Value Percent:
 Continuous Index: **F05**
 Within 8" of Joint: **YES**
 Remarks:

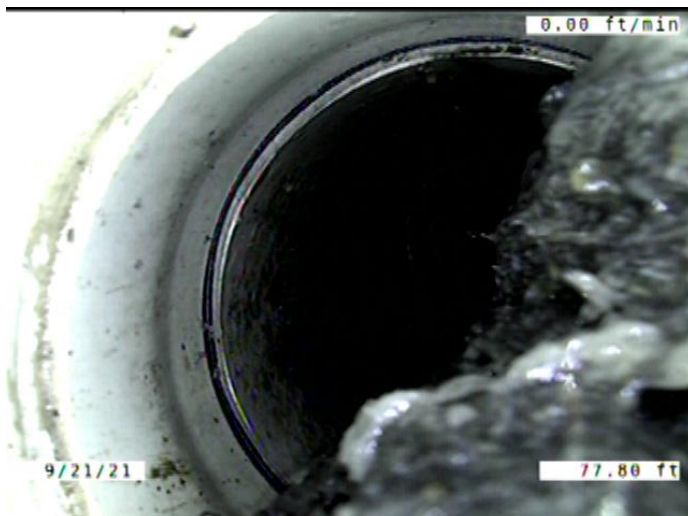
Code: **TF**
 Description: **Tap Factory**

Distance (ft): **77.8**
 Structural Grade: **0**
 O&M Grade: **0**
 Clock Start/From: **1**
 Clock To:
 1st Value: **4.000**
 2nd Value:
 Value Percent:
 Continuous Index:
 Within 8" of Joint: **YES**
 Remarks: **CONSTANTLY RUNNING WATER.
 ROOTS GROWING INTO THE MAIN**

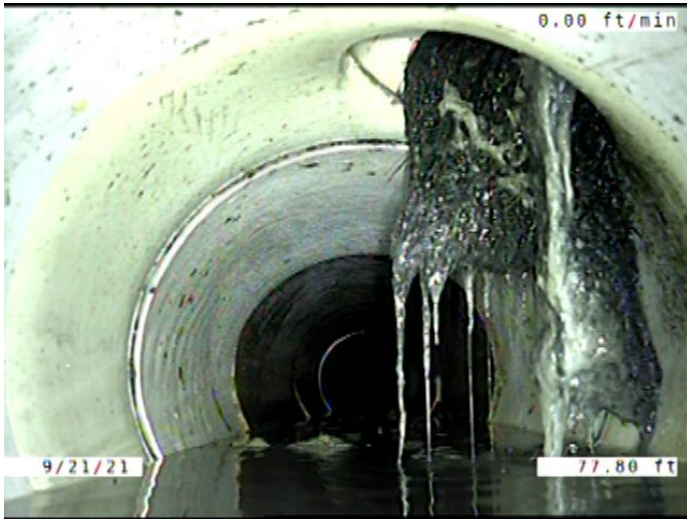
Code: **RML**
 Description: **Roots Medium Lateral**

Distance (ft): **77.8**
 Structural Grade: **0**
 O&M Grade: **3**
 Clock Start/From: **12**
 Clock To: **2**
 1st Value:
 2nd Value:
 Value Percent: **10.000**
 Continuous Index:
 Within 8" of Joint: **NO**
 Remarks:

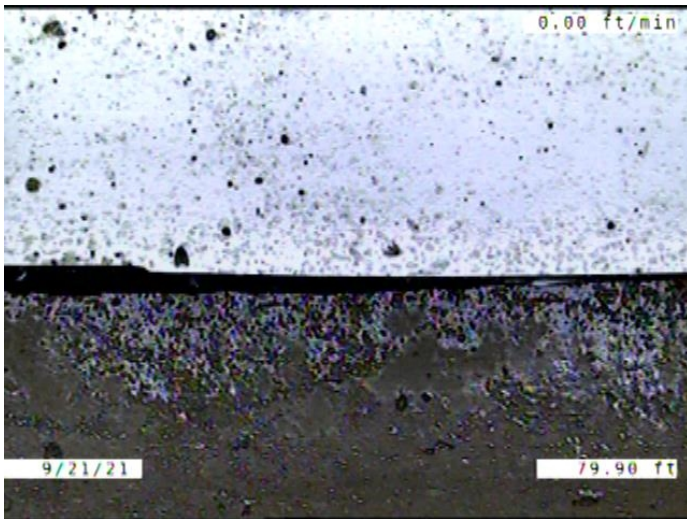
Code: **MMC**
 Description: **Miscellaneous Material Change**

Distance (ft): **79.9**
 Structural Grade: **0**
 O&M Grade: **0**
 Clock Start/From:
 Clock To:
 1st Value:
 2nd Value:
 Value Percent:
 Continuous Index:
 Within 8" of Joint: **NO**
 Remarks: **PVC TO VCP**

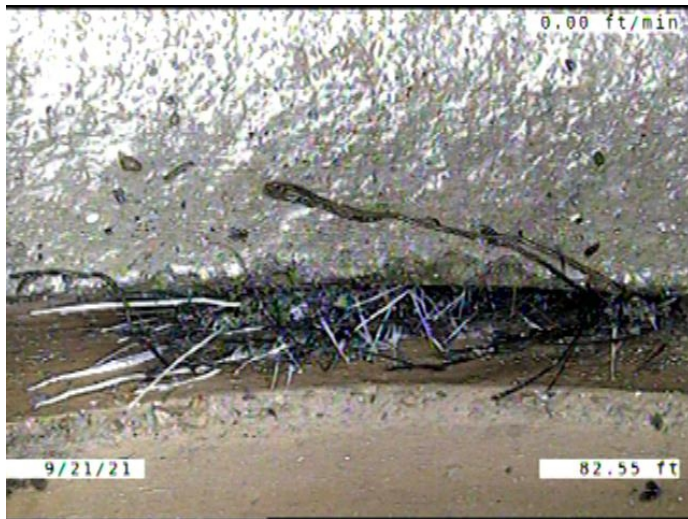
Code: **RFJ**
 Description: **Roots Fine Joint**

Distance (ft): **82.6**
 Structural Grade: **0**
 O&M Grade: **1**
 Clock Start/From: **9**
 Clock To: **11**
 1st Value:
 2nd Value:
 Value Percent:
 Continuous Index:
 Within 8" of Joint: **YES**
 Remarks:

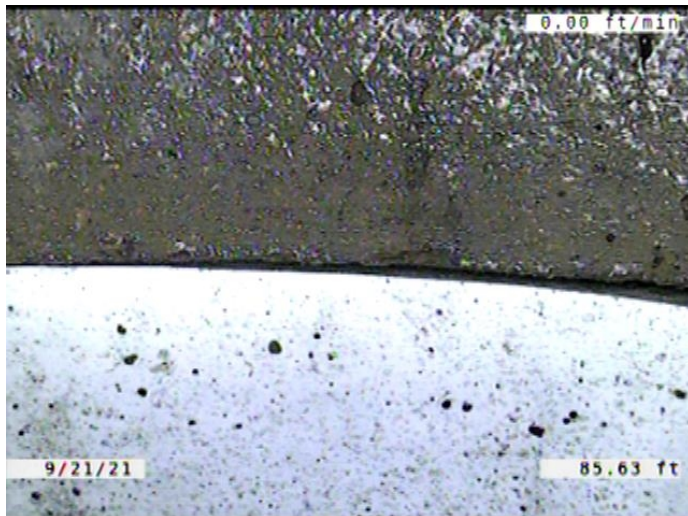
Code: **MMC**
 Description: **Miscellaneous Material Change**

Distance (ft): **85.6**
 Structural Grade: **0**
 O&M Grade: **0**
 Clock Start/From:
 Clock To:
 1st Value:
 2nd Value:
 Value Percent:
 Continuous Index:
 Within 8" of Joint: **NO**
 Remarks: **VCP TO PVC**

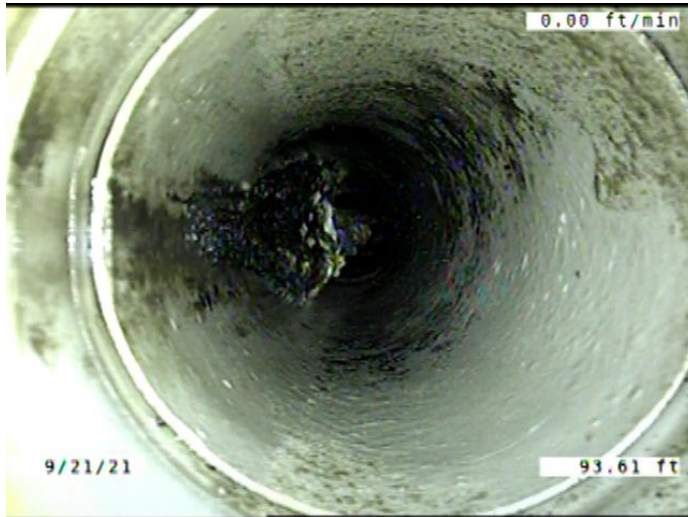
Code:	TF
Description:	Tap Factory
Distance (ft):	93.6
Structural Grade:	0
O&M Grade:	0
Clock Start/From:	9
Clock To:	
1st Value:	4.000
2nd Value:	
Value Percent:	
Continuous Index:	
Within 8" of Joint:	YES
Remarks:	ROOTS GROWING DOWN THE TAP

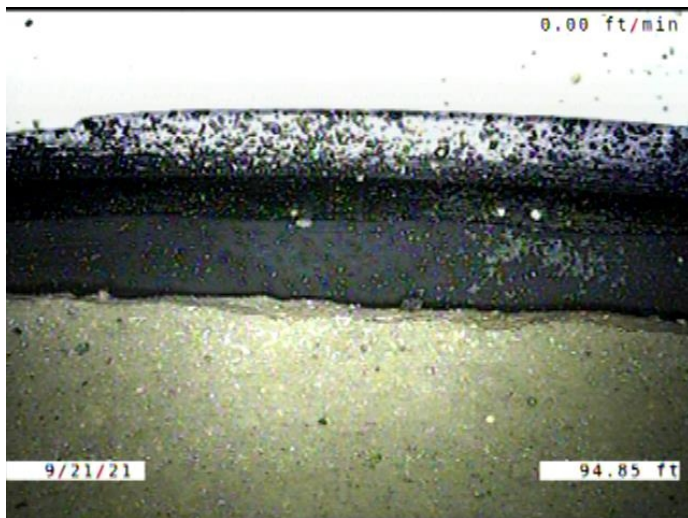
Code:	MMC
Description:	Miscellaneous Material Change
Distance (ft):	94.8
Structural Grade:	0
O&M Grade:	0
Clock Start/From:	
Clock To:	
1st Value:	
2nd Value:	
Value Percent:	
Continuous Index:	
Within 8" of Joint:	NO
Remarks:	PVC TO VCP

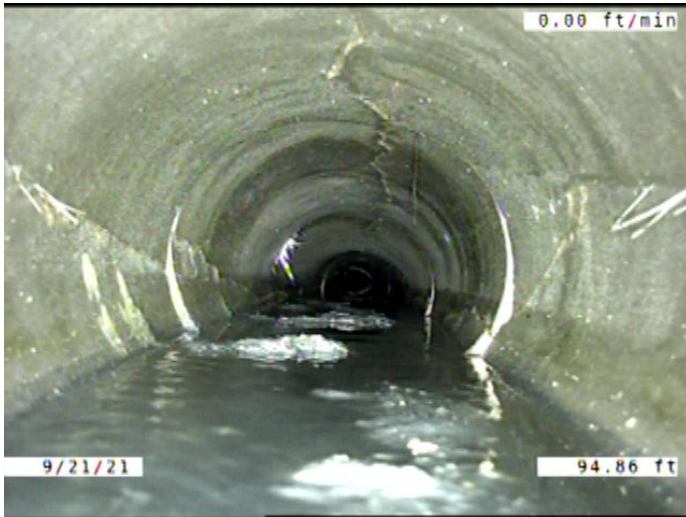
Code: **FM**
 Description: **Fracture Multiple**

Distance (ft): **94.9**
 Structural Grade: **4**
 O&M Grade: **0**
 Clock Start/From: **8**
 Clock To: **4**
 1st Value:
 2nd Value:
 Value Percent:
 Continuous Index: **S06**
 Within 8" of Joint: **YES**
 Remarks:

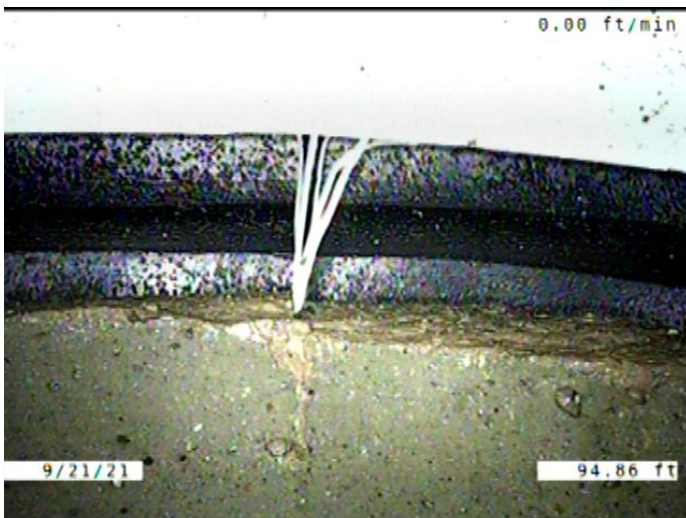
Code: **RFB**
 Description: **Roots Fine Barrel**

Distance (ft): **94.9**
 Structural Grade: **0**
 O&M Grade: **2**
 Clock Start/From: **9**
 Clock To: **3**
 1st Value:
 2nd Value:
 Value Percent:
 Continuous Index: **S07**
 Within 8" of Joint: **NO**
 Remarks:

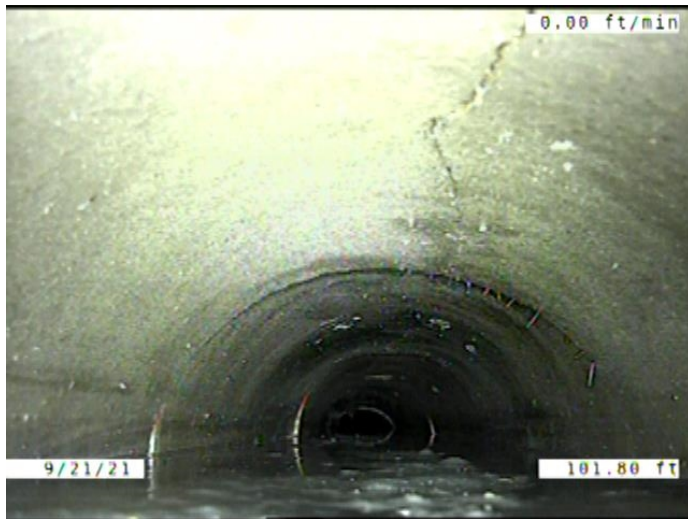
Code:	MWL
Description:	Miscellaneous Water Level
Distance (ft):	101.8
Structural Grade:	0
O&M Grade:	0
Clock Start/From:	
Clock To:	
1st Value:	
2nd Value:	
Value Percent:	40.000
Continuous Index:	
Within 8" of Joint:	NO
Remarks:

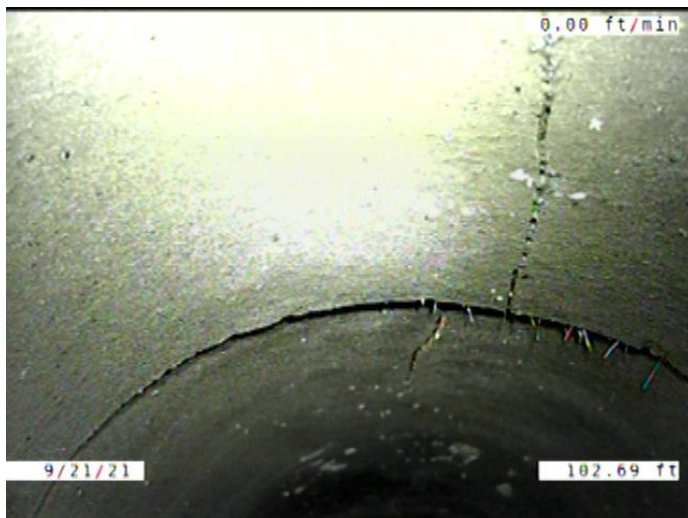
Code:	DSF
Description:	Deposits Settled Fine
Distance (ft):	102.7
Structural Grade:	0
O&M Grade:	2
Clock Start/From:	5
Clock To:	7
1st Value:	
2nd Value:	
Value Percent:	5.000
Continuous Index:	F01
Within 8" of Joint:	YES
Remarks:

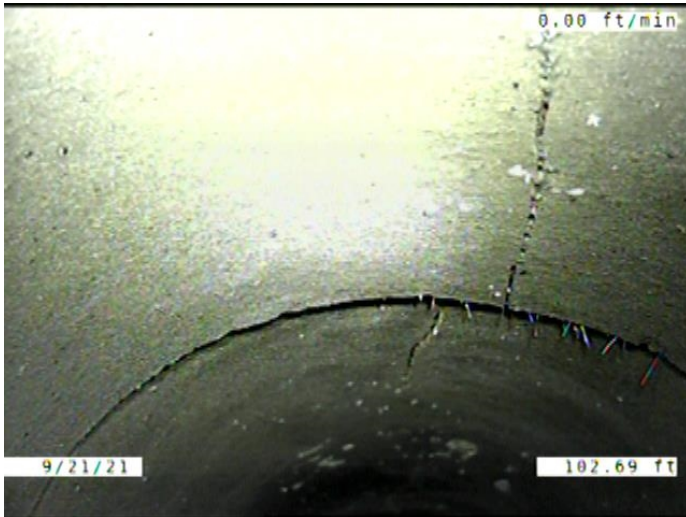
Code: **FM**
 Description: **Fracture Multiple**

Distance (ft): **102.7**
 Structural Grade: **4**
 O&M Grade: **0**
 Clock Start/From: **8**
 Clock To: **4**
 1st Value:
 2nd Value:
 Value Percent:
 Continuous Index: **F06**
 Within 8" of Joint: **YES**
 Remarks:

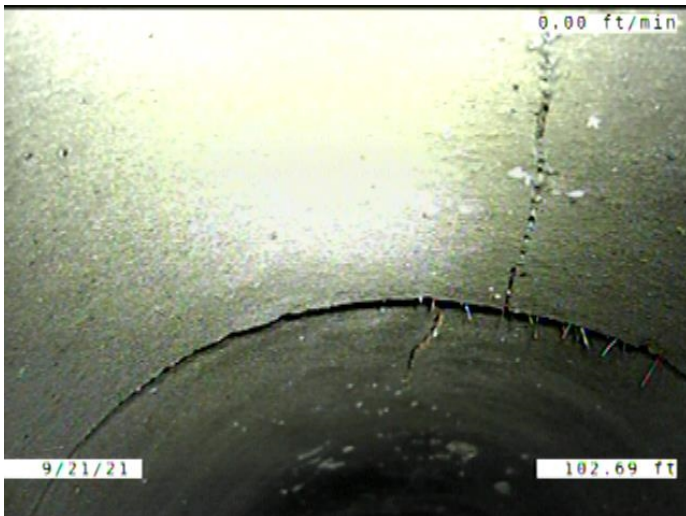
Code: **RFB**
 Description: **Roots Fine Barrel**

Distance (ft): **102.7**
 Structural Grade: **0**
 O&M Grade: **2**
 Clock Start/From: **9**
 Clock To: **3**
 1st Value:
 2nd Value:
 Value Percent:
 Continuous Index: **F07**
 Within 8" of Joint: **NO**
 Remarks:

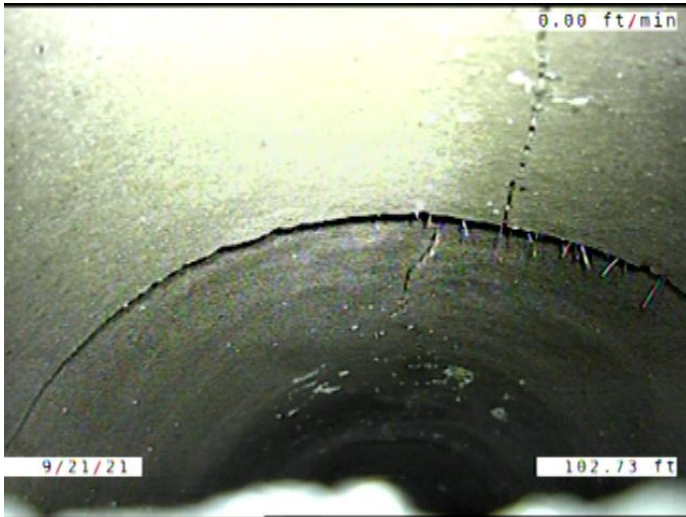
Code: **MSA**
Description: **Miscellaneous Survey Abandoned**

Distance (ft): **102.7**
Structural Grade: **0**
O&M Grade: **0**
Clock Start/From:
Clock To:
1st Value:
2nd Value:
Value Percent:
Continuous Index:
Within 8" of Joint: **NO**
Remarks: **CAMERA CANT MAKE IT PAST
UNKNOWN DEBRIS UNDER THE FLO**
