Profile/Photo Observation Report

Date:	11/05/2021	Weather:		Coding:	PACP 7.0
Pipe Length (ft):	331.0	Owner:	City of Hobart	Pre Clean:	Heavy Cleaning
P.O.#:	YES502259	Surveyor:	S. Bucklin	PSR:	P-504-056-028
Customer:	City of Hobart	Clean Date:	11/05/2021	Shape:	C

Street:	North Wilson Street	Flow Control:	Not Controlled
City:	Hobart, IN	Year Renewed:	
Location:	Alley	Tape/Media #:	
Purpose:	Routine Assessment	Dia/Height:	12"
Use:	Sanitary Sewage Pipe	Material:	VCP
Drain Area:		Lining:	None
Category:	NA		
Comment:			
Location Details:		Direction of Survey:	Upstream
US MH:	M-504-028	DS MH:	M-504-056
		Total Length Surveyed (ft):	240.8

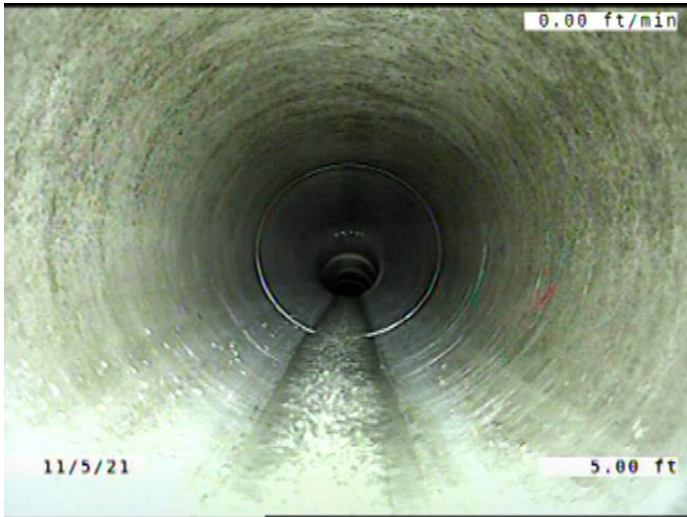
Code: **MGO**
Description: **Miscellaneous General Observation**

Distance (ft): **5.0**
Structural Grade: **0**
O&M Grade: **0**
Clock Start/From:
Clock To:
1st Value:
2nd Value:
Value Percent:
Continuous Index:
Within 8" of Joint: **NO**
Remarks: **PIPE WAS TOO STEEP COMING INTO THE MANHOLE. HAD TO START IN O**

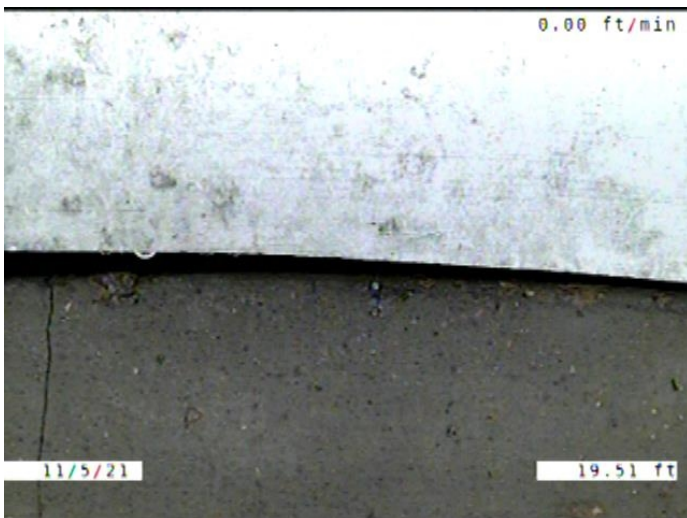
Code: **MMC**
Description: **Miscellaneous Material Change**

Distance (ft): **19.5**
Structural Grade: **0**
O&M Grade: **0**
Clock Start/From:
Clock To:
1st Value:
2nd Value:
Value Percent:
Continuous Index:
Within 8" of Joint: **NO**
Remarks: **PVC TO VCP**

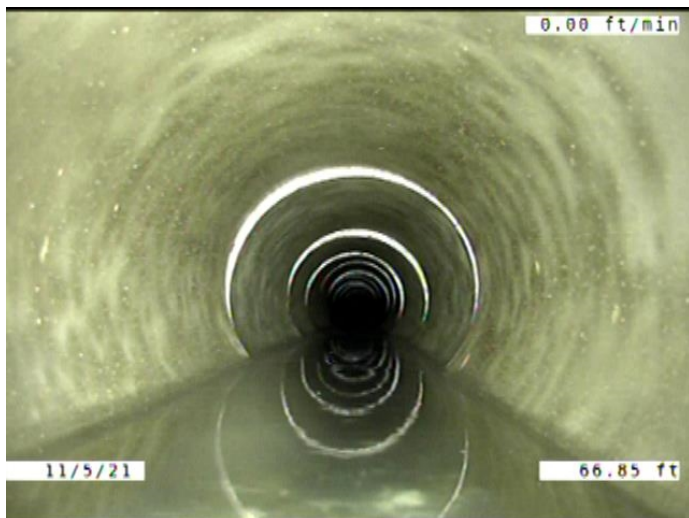
Code: **DSF**
Description: **Deposits Settled Fine**

Distance (ft): **66.8**
Structural Grade: **0**
O&M Grade: **2**
Clock Start/From: **5**
Clock To: **7**
1st Value:
2nd Value:
Value Percent: **5.000**
Continuous Index: **S03**
Within 8" of Joint: **YES**
Remarks:

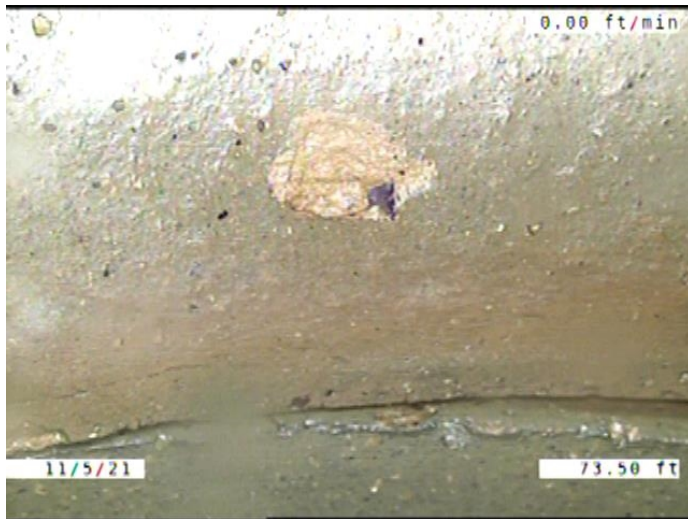
Code: **SSS**
Description: **Surface Damage Surface Spalling**

Distance (ft): **73.5**
Structural Grade: **2**
O&M Grade: **0**
Clock Start/From: **9**
Clock To:
1st Value:
2nd Value:
Value Percent:
Continuous Index:
Within 8" of Joint: **YES**
Remarks:

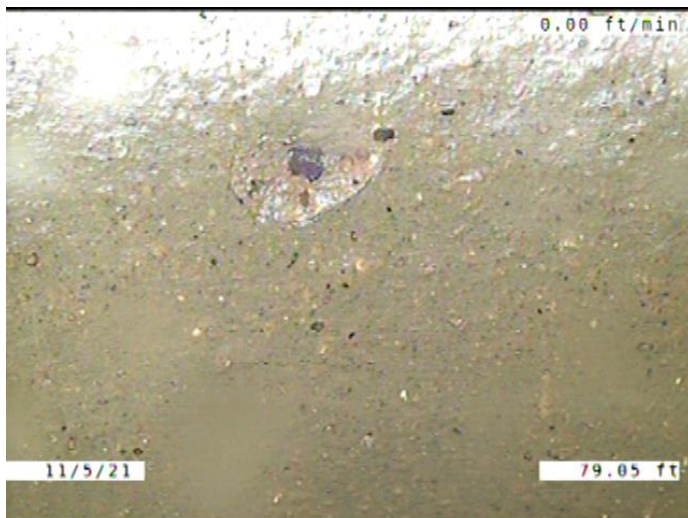
Code: **SSS**
Description: **Surface Damage Surface Spalling**

Distance (ft): **79.0**
Structural Grade: **2**
O&M Grade: **0**
Clock Start/From: **9**
Clock To:
1st Value:
2nd Value:
Value Percent:
Continuous Index:
Within 8" of Joint: **YES**
Remarks:

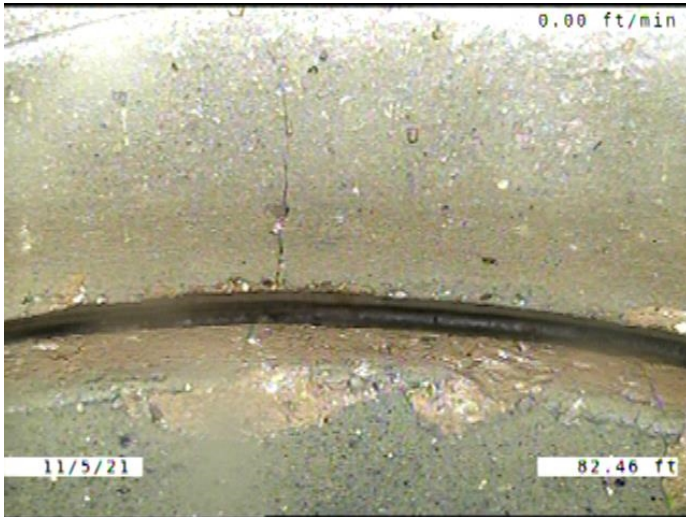
Code: **CL**
Description: **Crack Longitudinal**

Distance (ft): **82.5**
Structural Grade: **2**
O&M Grade: **0**
Clock Start/From: **12**
Clock To:
1st Value:
2nd Value:
Value Percent:
Continuous Index:
Within 8" of Joint: **YES**
Remarks:

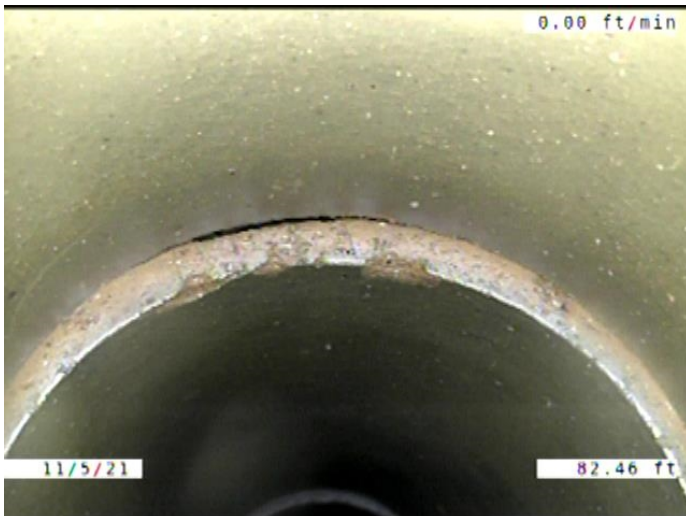
Code: **JOM**
Description: **Joint Offset Medium**

Distance (ft): **82.5**
Structural Grade: **3**
O&M Grade: **0**
Clock Start/From:
Clock To:
1st Value:
2nd Value:
Value Percent:
Continuous Index:
Within 8" of Joint: **NO**
Remarks:

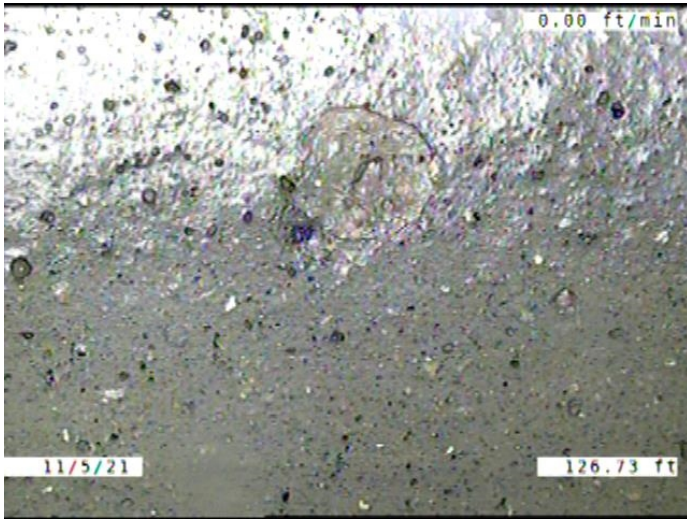
Code: **SSS**
Description: **Surface Damage Surface Spalling**

Distance (ft): **126.7**
Structural Grade: **2**
O&M Grade: **0**
Clock Start/From: **8**
Clock To: **9**
1st Value:
2nd Value:
Value Percent:
Continuous Index:
Within 8" of Joint: **NO**
Remarks:

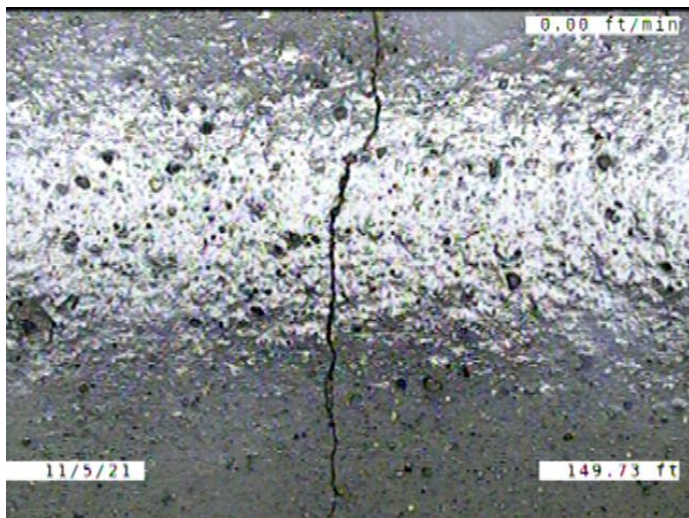
Code: **FM**
Description: **Fracture Multiple**

Distance (ft): **149.7**
Structural Grade: **4**
O&M Grade: **0**
Clock Start/From: **12**
Clock To: **12**
1st Value:
2nd Value:
Value Percent:
Continuous Index: **S07**
Within 8" of Joint: **YES**
Remarks:

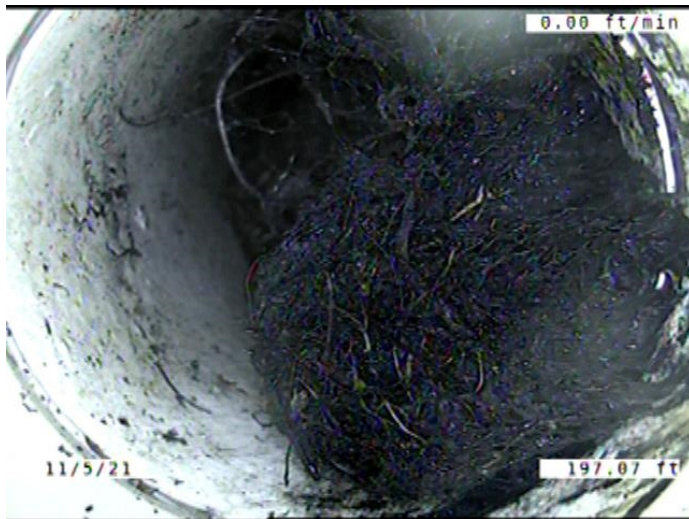
Code: **TF**
Description: **Tap Factory**

Distance (ft): **197.1**
Structural Grade: **0**
O&M Grade: **0**
Clock Start/From: **2**
Clock To:
1st Value: **4.000**
2nd Value:
Value Percent:
Continuous Index:
Within 8" of Joint: **YES**
Remarks: **ROOTS GROWING IN THE TAP**

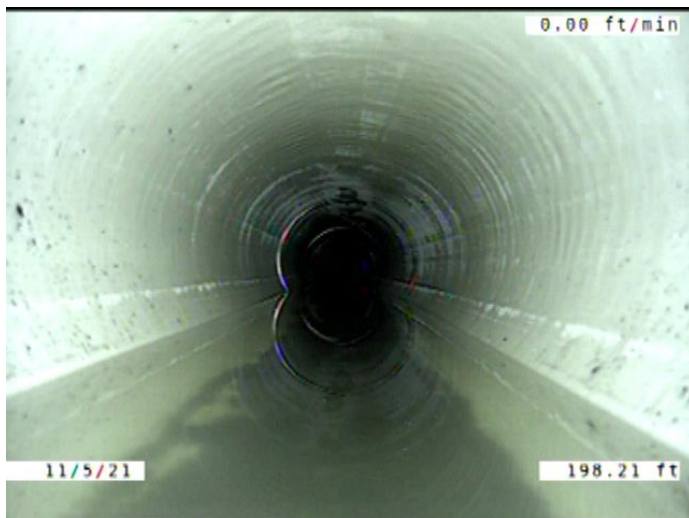
Code: **MWLS**
Description: **Miscellaneous Water Level Sag**

Distance (ft): **198.2**
Structural Grade: **2**
O&M Grade: **0**
Clock Start/From:
Clock To:
1st Value:
2nd Value:
Value Percent: **30.000**
Continuous Index: **S11**
Within 8" of Joint: **NO**
Remarks:

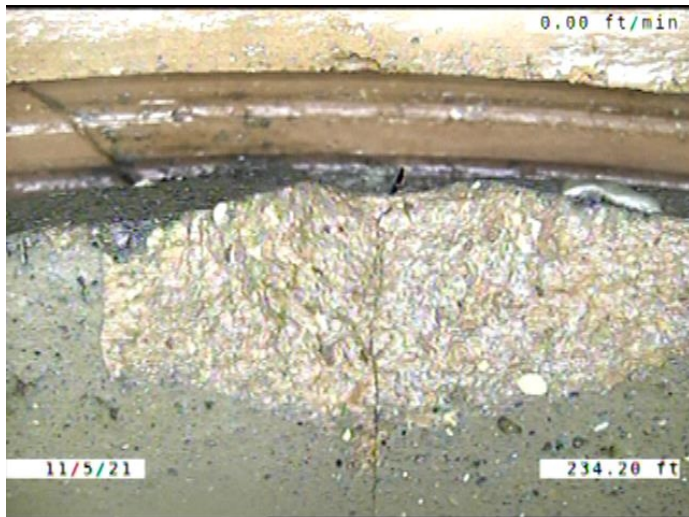
Code: **SZ**
 Description: **Surface Damage Other**

Distance (ft): **234.2**
 Structural Grade: **0**
 O&M Grade: **0**
 Clock Start/From: **11**
 Clock To:
 1st Value:
 2nd Value:
 Value Percent:
 Continuous Index:
 Within 8" of Joint: **YES**
 Remarks: **A PIECE CHIPPED AWAY FROM THE JOINT**

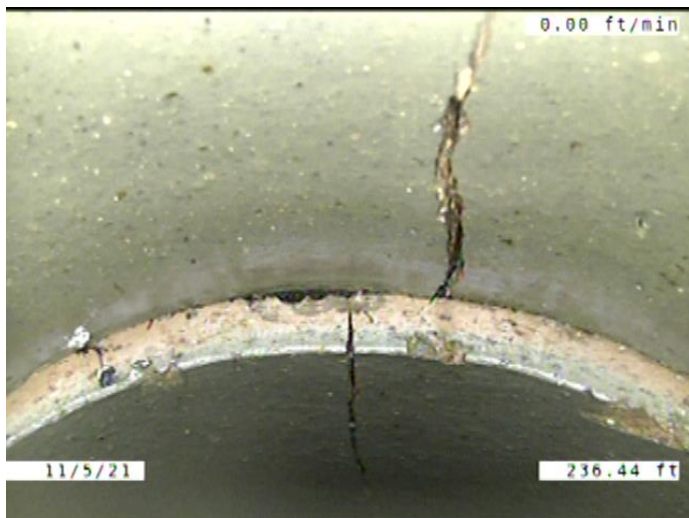
Code: **JOM**
 Description: **Joint Offset Medium**

Distance (ft): **236.4**
 Structural Grade: **3**
 O&M Grade: **0**
 Clock Start/From:
 Clock To:
 1st Value:
 2nd Value:
 Value Percent:
 Continuous Index:
 Within 8" of Joint: **NO**
 Remarks:

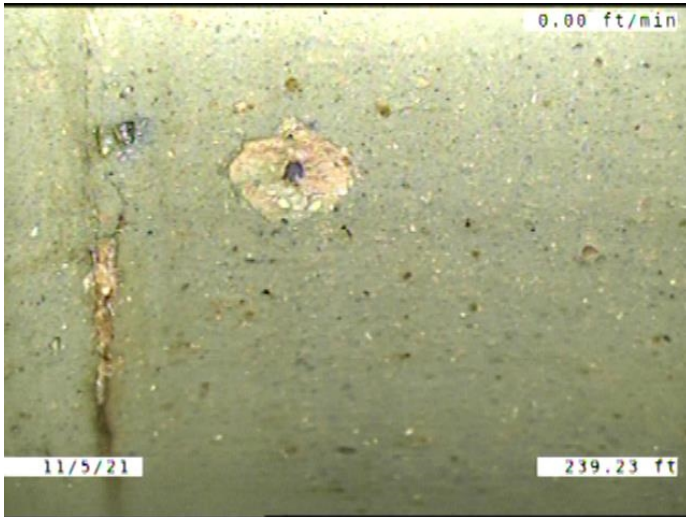
Code: **SSS**
Description: **Surface Damage Surface Spalling**

Distance (ft): **239.2**
Structural Grade: **2**
O&M Grade: **0**
Clock Start/From: **10**
Clock To:
1st Value:
2nd Value:
Value Percent:
Continuous Index:
Within 8" of Joint: **NO**
Remarks:

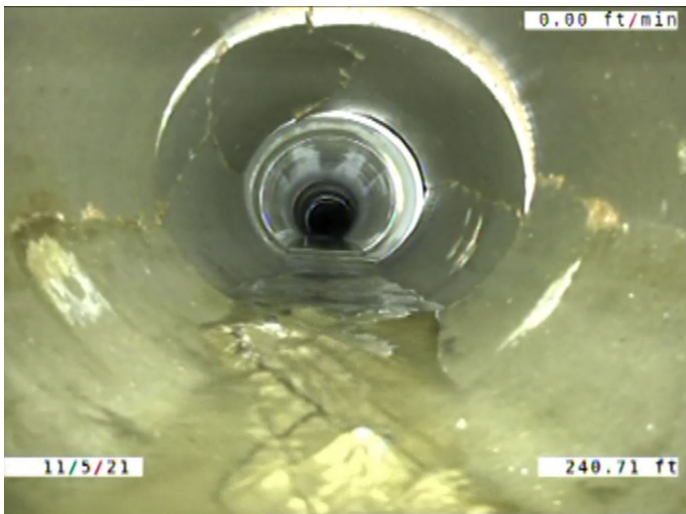
Code: **DR**
Description: **Deformed Rigid**

Distance (ft): **240.7**
Structural Grade: **4**
O&M Grade: **0**
Clock Start/From:
Clock To:
1st Value:
2nd Value:
Value Percent: **5.000**
Continuous Index:
Within 8" of Joint: **NO**
Remarks:

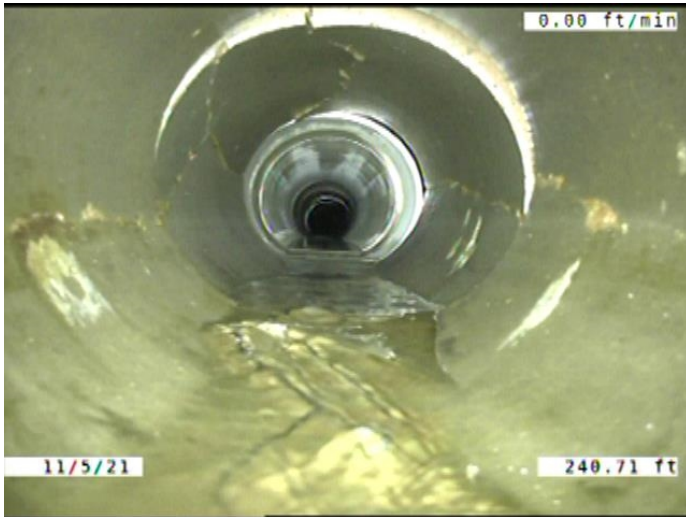
Code: **DSF**
Description: **Deposits Settled Fine**

Distance (ft): **240.7**
Structural Grade: **0**
O&M Grade: **2**
Clock Start/From: **5**
Clock To: **7**
1st Value:
2nd Value:
Value Percent: **5.000**
Continuous Index: **F03**
Within 8" of Joint: **YES**
Remarks:

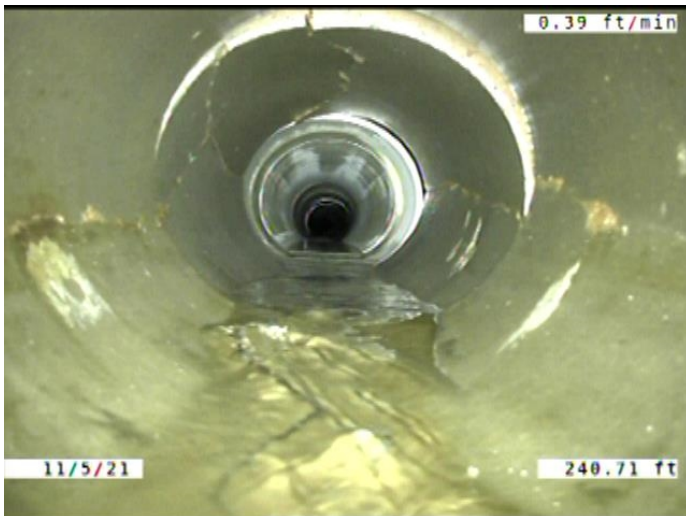
Code: **MWLS**
Description: **Miscellaneous Water Level Sag**

Distance (ft): **240.7**
Structural Grade: **2**
O&M Grade: **0**
Clock Start/From:
Clock To:
1st Value:
2nd Value:
Value Percent: **30.000**
Continuous Index: **F11**
Within 8" of Joint: **NO**
Remarks:
