Profile/Photo Observation Report

Date:	11/05/2021	Weather:		Coding:	PACP 7.0
Pipe Length (ft):	331.0	Owner:	City of Hobart	Pre Clean:	Heavy Cleaning
P.O.#:	YES502259	Surveyor:	S. Bucklin	PSR:	P-504-056-028
Customer:	City of Hobart	Clean Date:	11/05/2021	Shape:	C

Street:	North Wilson Street	Flow Control:	Not Controlled
City:	Hobart, IN	Year Renewed:	
Location:	Alley	Tape/Media #:	
Purpose:	Routine Assessment	Dia/Height:	12"
Use:	Sanitary Sewage Pipe	Material:	VCP
Drain Area:		Lining:	None
Category:	NA		
Comment:			
Location Details:		Direction of Survey:	Upstream
US MH:	M-504-028	DS MH:	M-504-056
		Total Length Surveyed (ft):	240.8

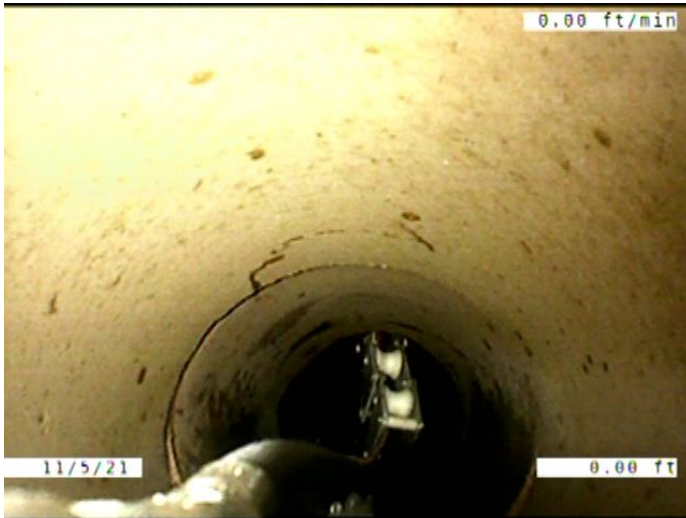
Code: **AMH**
Description: **Manhole**

Distance (ft): **.0**
Structural Grade: **0**
O&M Grade: **0**
Clock Start/From:
Clock To:
1st Value:
2nd Value:
Value Percent:
Continuous Index:
Within 8" of Joint: **NO**
Remarks: **M-504-056**

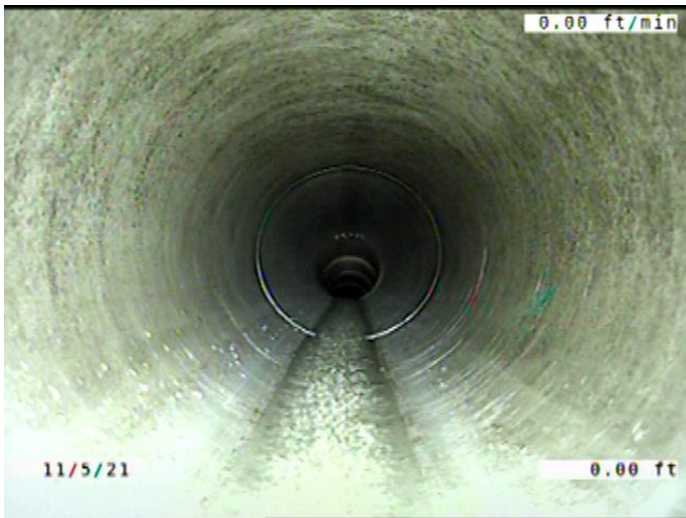
Code: **MWL**
Description: **Miscellaneous Water Level**

Distance (ft): **.0**
Structural Grade: **0**
O&M Grade: **0**
Clock Start/From:
Clock To:
1st Value:
2nd Value:
Value Percent: **5.000**
Continuous Index:
Within 8" of Joint: **NO**
Remarks:

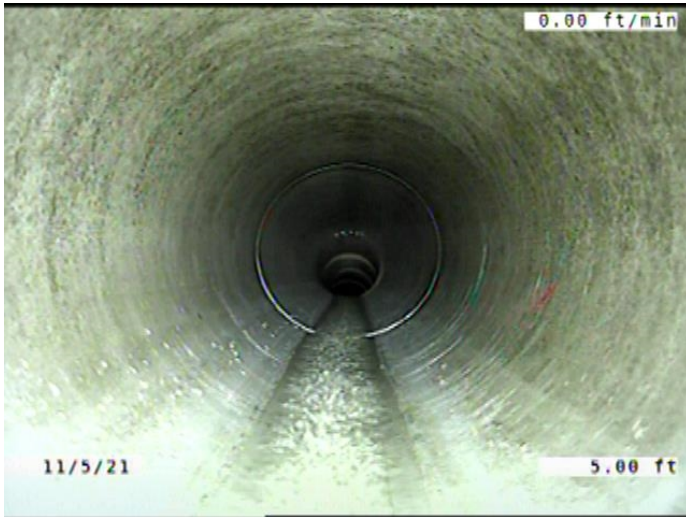
Code: **MGO**
Description: **Miscellaneous General Observation**

Distance (ft): **5.0**
Structural Grade: **0**
O&M Grade: **0**
Clock Start/From:
Clock To:
1st Value:
2nd Value:
Value Percent:
Continuous Index:
Within 8" of Joint: **NO**
Remarks: **PIPE WAS TOO STEEP COMING INTO THE MANHOLE. HAD TO START IN O**

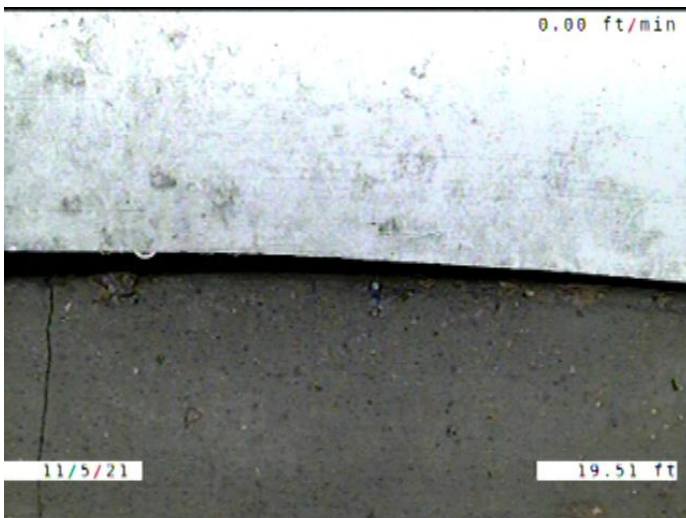
Code: **MMC**
Description: **Miscellaneous Material Change**

Distance (ft): **19.5**
Structural Grade: **0**
O&M Grade: **0**
Clock Start/From:
Clock To:
1st Value:
2nd Value:
Value Percent:
Continuous Index:
Within 8" of Joint: **NO**
Remarks: **PVC TO VCP**

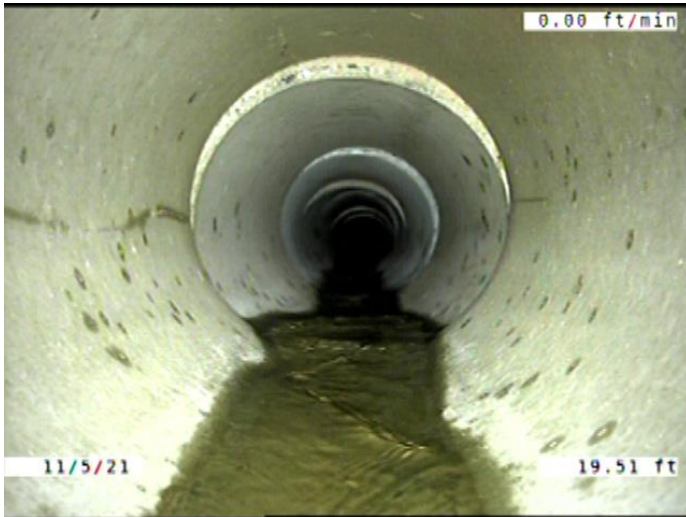
Code: **CM**
 Description: **Crack Multiple**

Distance (ft): **19.5**
 Structural Grade: **3**
 O&M Grade: **0**
 Clock Start/From: **12**
 Clock To: **12**
 1st Value:
 2nd Value:
 Value Percent:
 Continuous Index:
 Within 8" of Joint: **YES**
 Remarks:

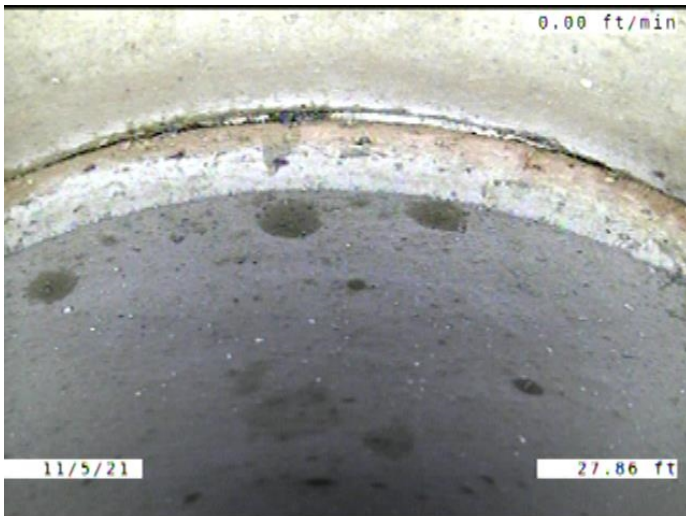
Code: **JOM**
 Description: **Joint Offset Medium**

Distance (ft): **27.9**
 Structural Grade: **3**
 O&M Grade: **0**
 Clock Start/From:
 Clock To:
 1st Value:
 2nd Value:
 Value Percent:
 Continuous Index:
 Within 8" of Joint: **NO**
 Remarks:

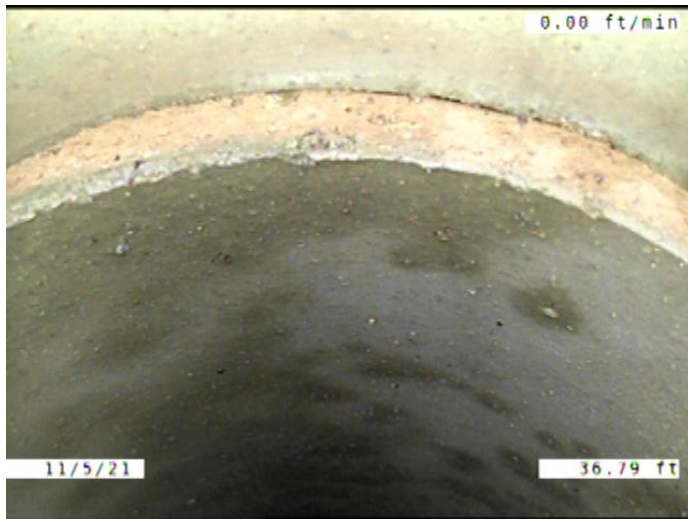
Code: **JOM**
 Description: **Joint Offset Medium**

Distance (ft): **36.8**
 Structural Grade: **3**
 O&M Grade: **0**
 Clock Start/From:
 Clock To:
 1st Value:
 2nd Value:
 Value Percent:
 Continuous Index:
 Within 8" of Joint: **NO**
 Remarks:

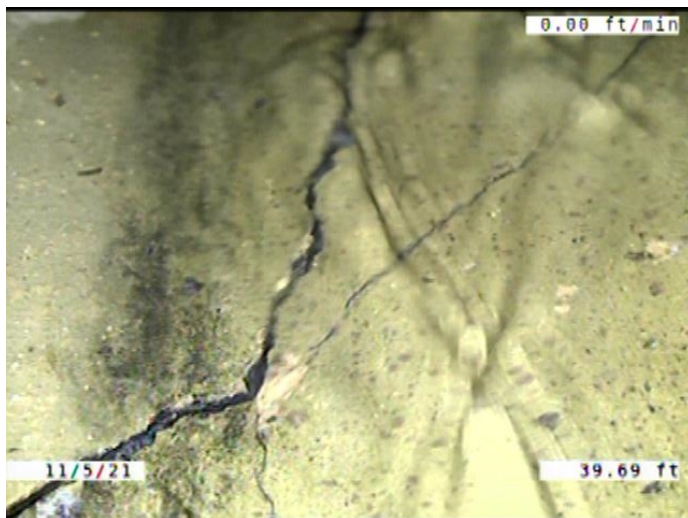
Code: **FM**
 Description: **Fracture Multiple**

Distance (ft): **39.7**
 Structural Grade: **4**
 O&M Grade: **0**
 Clock Start/From: **12**
 Clock To: **12**
 1st Value:
 2nd Value:
 Value Percent:
 Continuous Index: **S01**
 Within 8" of Joint: **YES**
 Remarks:

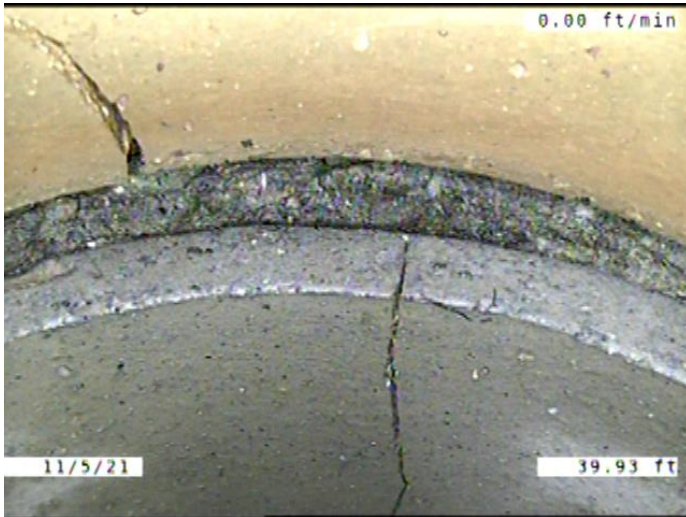
Code: **JOMD**
 Description: **Joint Offset Medium Defective**

Distance (ft): **39.9**
 Structural Grade: **3**
 O&M Grade: **0**
 Clock Start/From:
 Clock To:
 1st Value:
 2nd Value:
 Value Percent:
 Continuous Index:
 Within 8" of Joint: **NO**
 Remarks:

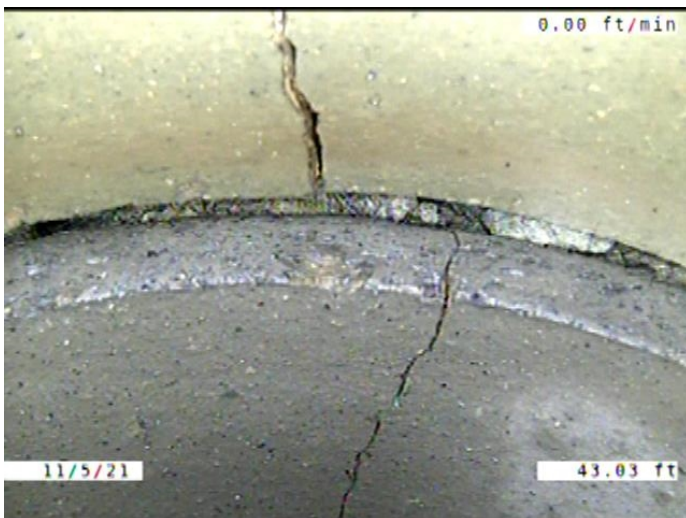
Code: **JOSD**
 Description: **Joint Offset Small Defective**

Distance (ft): **43.0**
 Structural Grade: **0**
 O&M Grade: **0**
 Clock Start/From:
 Clock To:
 1st Value:
 2nd Value:
 Value Percent:
 Continuous Index: **S02**
 Within 8" of Joint: **NO**
 Remarks:

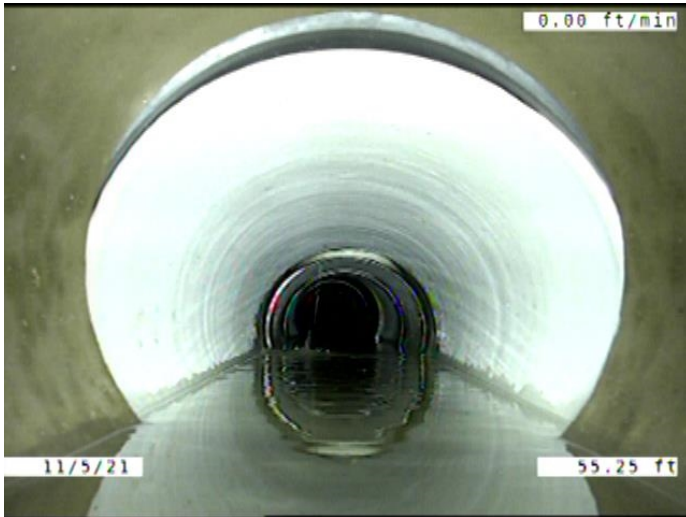
Code: **JOL**
 Description: **Joint Offset Large**

Distance (ft): **55.2**
 Structural Grade: **4**
 O&M Grade: **0**
 Clock Start/From:
 Clock To:
 1st Value: **1.000**
 2nd Value:
 Value Percent:
 Continuous Index:
 Within 8" of Joint: **NO**
 Remarks:

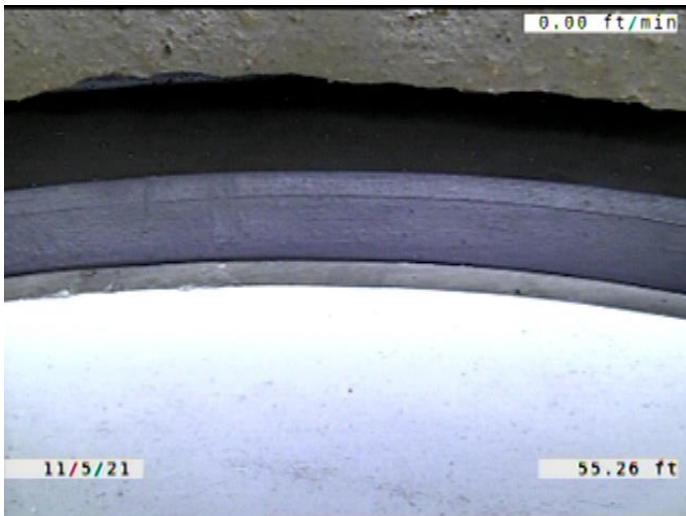
Code: **MMC**
 Description: **Miscellaneous Material Change**

Distance (ft): **55.3**
 Structural Grade: **0**
 O&M Grade: **0**
 Clock Start/From:
 Clock To:
 1st Value:
 2nd Value:
 Value Percent:
 Continuous Index:
 Within 8" of Joint: **NO**
 Remarks: **VCP TO PVC**

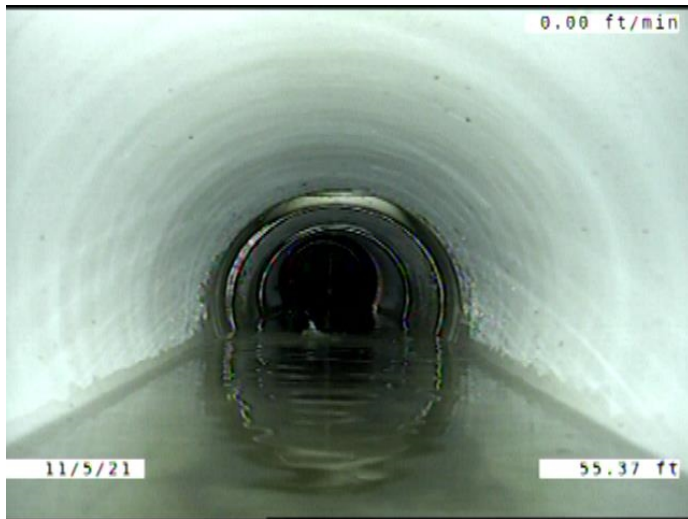
Code: **FM**
 Description: **Fracture Multiple**

Distance (ft): **55.4**
 Structural Grade: **4**
 O&M Grade: **0**
 Clock Start/From: **12**
 Clock To: **12**
 1st Value:
 2nd Value:
 Value Percent:
 Continuous Index: **F01**
 Within 8" of Joint: **YES**
 Remarks:

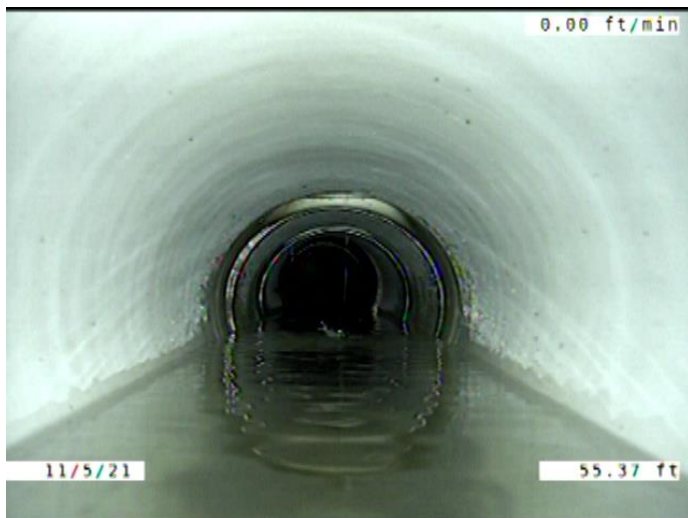
Code: **JOSD**
 Description: **Joint Offset Small Defective**

Distance (ft): **55.4**
 Structural Grade: **0**
 O&M Grade: **0**
 Clock Start/From:
 Clock To:
 1st Value:
 2nd Value:
 Value Percent:
 Continuous Index: **F02**
 Within 8" of Joint: **NO**
 Remarks:

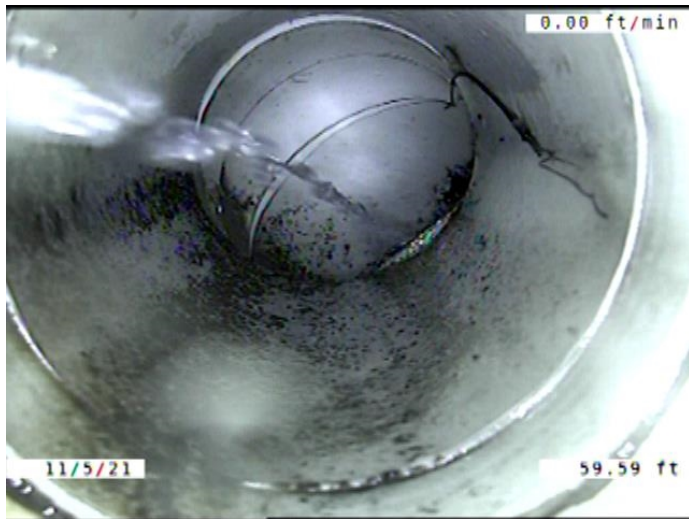
Code: **TFA**
 Description: **Tap Factory Activity**

Distance (ft): **59.6**
 Structural Grade: **0**
 O&M Grade: **0**
 Clock Start/From: **12**
 Clock To:
 1st Value: **4.000**
 2nd Value:
 Value Percent:
 Continuous Index:
 Within 8" of Joint: **YES**
 Remarks:

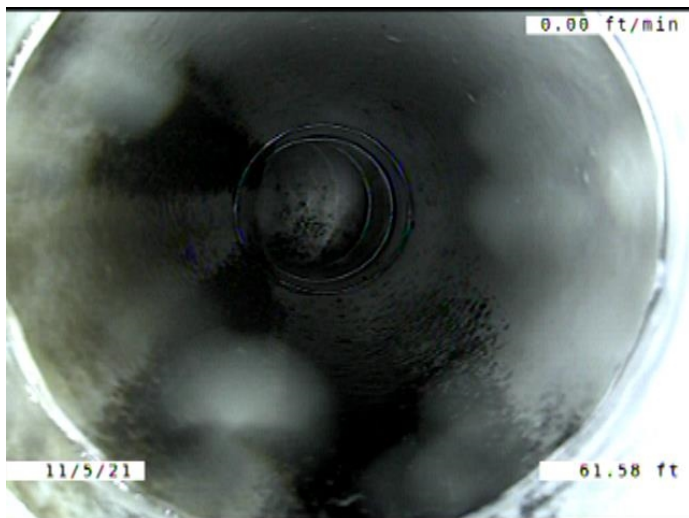
Code: **TF**
 Description: **Tap Factory**

Distance (ft): **61.6**
 Structural Grade: **0**
 O&M Grade: **0**
 Clock Start/From: **12**
 Clock To:
 1st Value: **4.000**
 2nd Value:
 Value Percent:
 Continuous Index:
 Within 8" of Joint: **YES**
 Remarks:

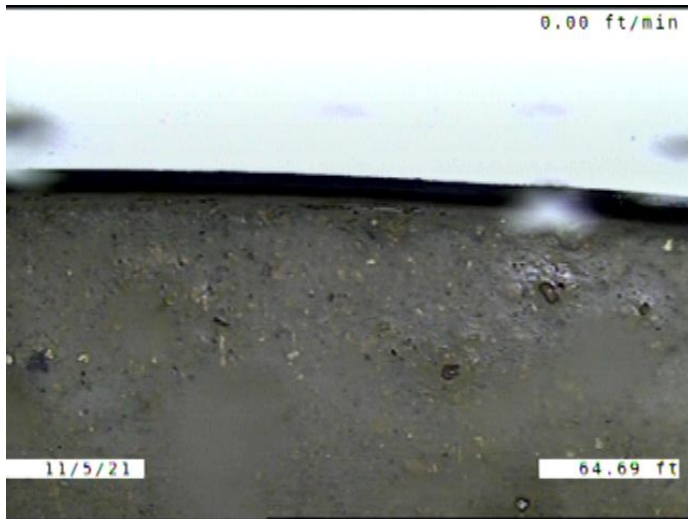
Code: **MMC**
Description: **Miscellaneous Material Change**

Distance (ft): **64.7**
Structural Grade: **0**
O&M Grade: **0**
Clock Start/From:
Clock To:
1st Value:
2nd Value:
Value Percent:
Continuous Index:
Within 8" of Joint: **NO**
Remarks: **PVC TO VCP**

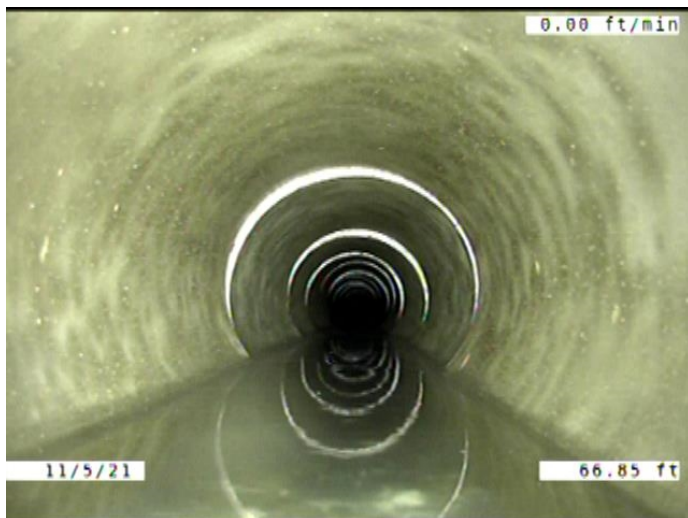
Code: **DSF**
Description: **Deposits Settled Fine**

Distance (ft): **66.8**
Structural Grade: **0**
O&M Grade: **2**
Clock Start/From: **5**
Clock To: **7**
1st Value:
2nd Value:
Value Percent: **5.000**
Continuous Index: **S03**
Within 8" of Joint: **YES**
Remarks:

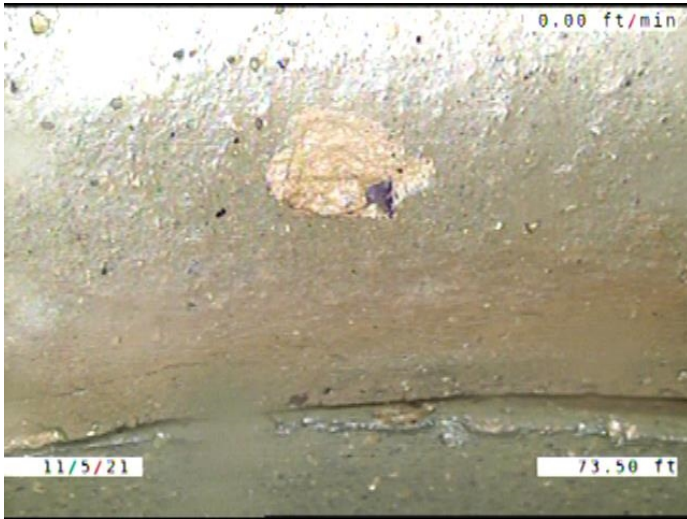
Code: **SSS**
Description: **Surface Damage Surface Spalling**

Distance (ft): **73.5**
Structural Grade: **2**
O&M Grade: **0**
Clock Start/From: **9**
Clock To:
1st Value:
2nd Value:
Value Percent:
Continuous Index:
Within 8" of Joint: **YES**
Remarks:

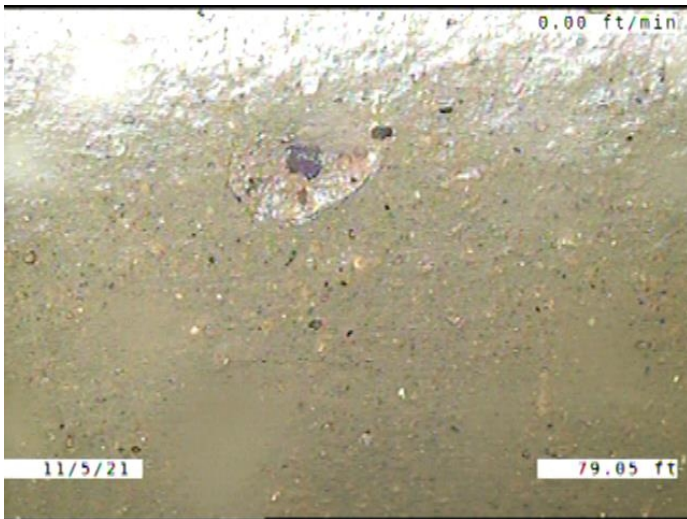
Code: **SSS**
Description: **Surface Damage Surface Spalling**

Distance (ft): **79.0**
Structural Grade: **2**
O&M Grade: **0**
Clock Start/From: **9**
Clock To:
1st Value:
2nd Value:
Value Percent:
Continuous Index:
Within 8" of Joint: **YES**
Remarks:

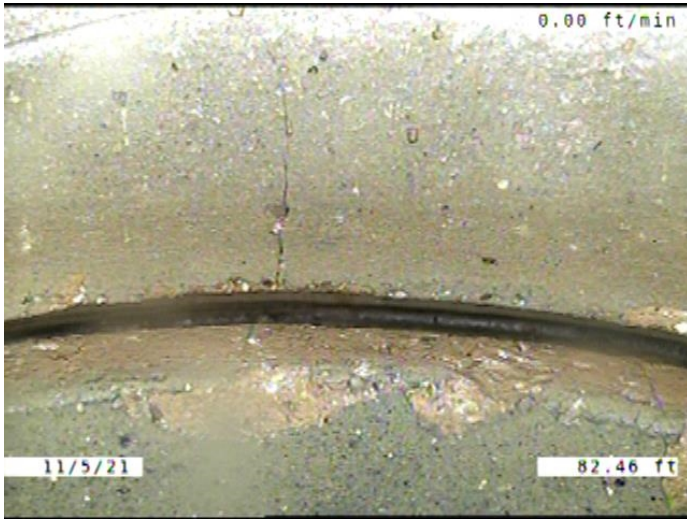
Code: **CL**
Description: **Crack Longitudinal**

Distance (ft): **82.5**
Structural Grade: **2**
O&M Grade: **0**
Clock Start/From: **12**
Clock To:
1st Value:
2nd Value:
Value Percent:
Continuous Index:
Within 8" of Joint: **YES**
Remarks:

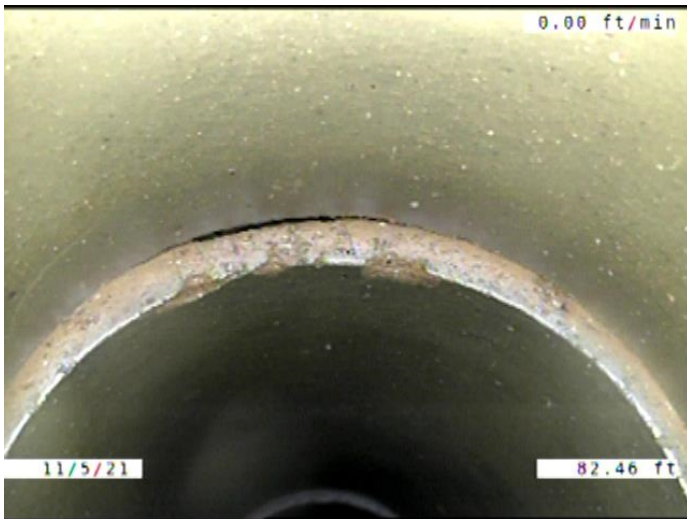
Code: **JOM**
Description: **Joint Offset Medium**

Distance (ft): **82.5**
Structural Grade: **3**
O&M Grade: **0**
Clock Start/From:
Clock To:
1st Value:
2nd Value:
Value Percent:
Continuous Index:
Within 8" of Joint: **NO**
Remarks:

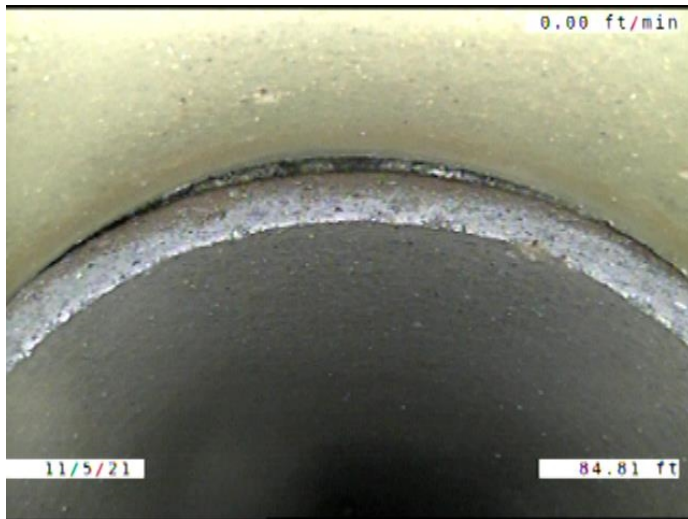
Code: **JOMD**
Description: **Joint Offset Medium Defective**

Distance (ft): **84.8**
Structural Grade: **3**
O&M Grade: **0**
Clock Start/From:
Clock To:
1st Value:
2nd Value:
Value Percent:
Continuous Index: **S04**
Within 8" of Joint: **NO**
Remarks:

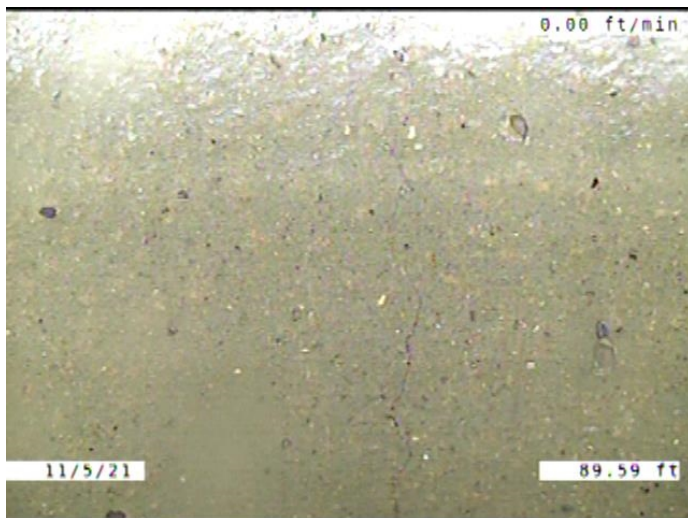
Code: **FM**
Description: **Fracture Multiple**

Distance (ft): **89.6**
Structural Grade: **4**
O&M Grade: **0**
Clock Start/From: **12**
Clock To: **12**
1st Value:
2nd Value:
Value Percent:
Continuous Index: **S05**
Within 8" of Joint: **YES**
Remarks:

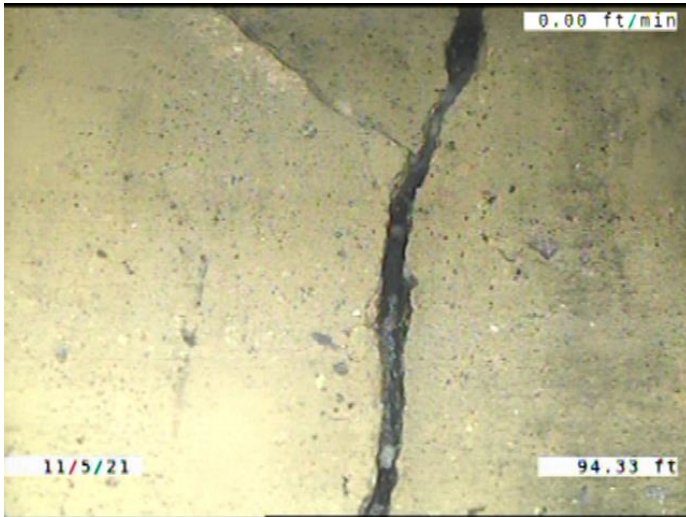
Code: **B**
 Description: **Broken**

Distance (ft): **94.3**
 Structural Grade: **4**
 O&M Grade: **0**
 Clock Start/From: **12**
 Clock To: **6**
 1st Value:
 2nd Value:
 Value Percent:
 Continuous Index:
 Within 8" of Joint: **YES**
 Remarks:

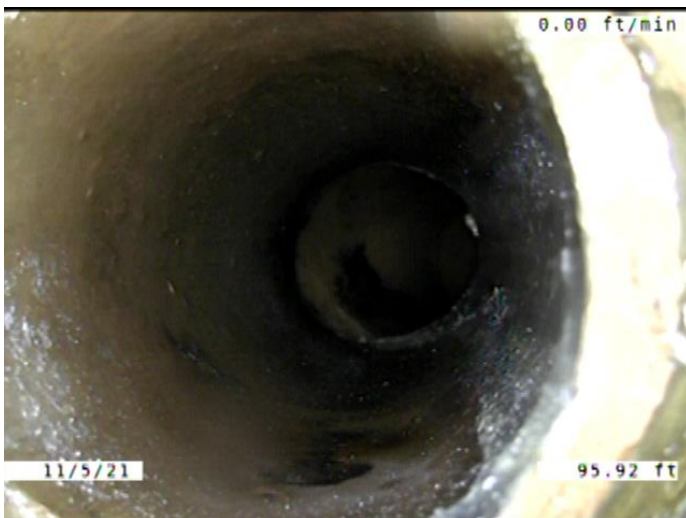
Code: **TBI**
 Description: **Tap Break-in Intruding**

Distance (ft): **95.9**
 Structural Grade: **0**
 O&M Grade: **2**
 Clock Start/From: **1**
 Clock To:
 1st Value: **4.000**
 2nd Value: **1.000**
 Value Percent:
 Continuous Index:
 Within 8" of Joint: **YES**
 Remarks: **CONSTANTLY RUNNING WATER.**

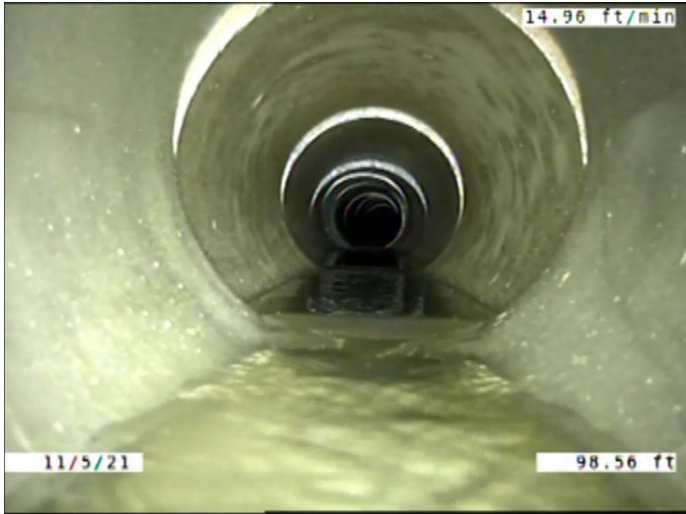
Code: **FM**
Description: **Fracture Multiple**

Distance (ft): **98.6**
Structural Grade: **4**
O&M Grade: **0**
Clock Start/From: **12**
Clock To: **12**
1st Value:
2nd Value:
Value Percent:
Continuous Index: **F05**
Within 8" of Joint: **YES**
Remarks:

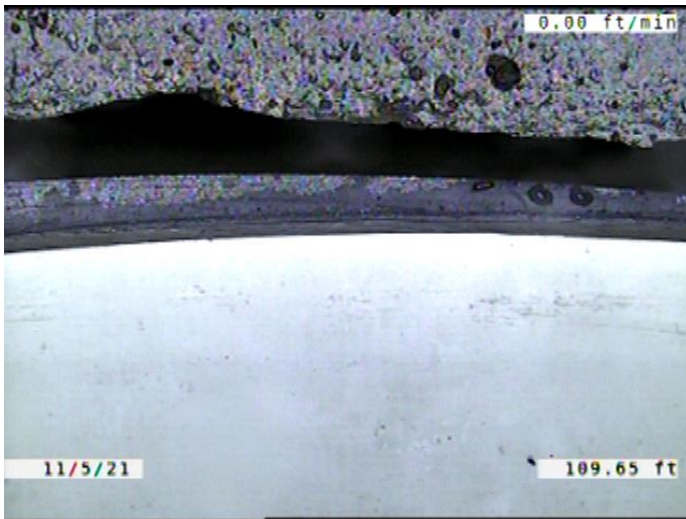
Code: **MMC**
Description: **Miscellaneous Material Change**

Distance (ft): **109.6**
Structural Grade: **0**
O&M Grade: **0**
Clock Start/From:
Clock To:
1st Value:
2nd Value:
Value Percent:
Continuous Index:
Within 8" of Joint: **NO**
Remarks: **VCP TO PVC**

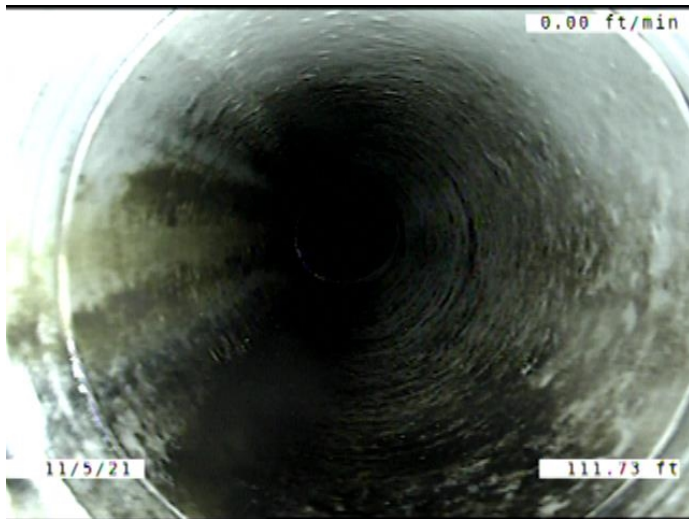
Code: **TF**
Description: **Tap Factory**

Distance (ft): **111.7**
Structural Grade: **0**
O&M Grade: **0**
Clock Start/From: **11**
Clock To:
1st Value: **4.000**
2nd Value:
Value Percent:
Continuous Index:
Within 8" of Joint: **YES**
Remarks:

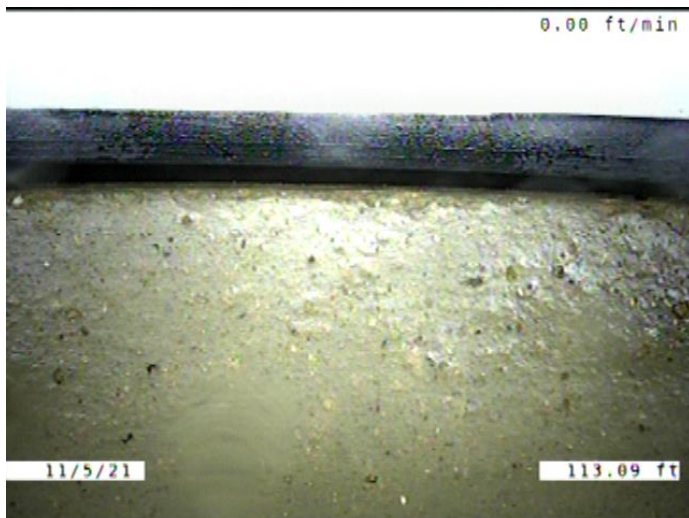
Code: **MMC**
Description: **Miscellaneous Material Change**

Distance (ft): **113.1**
Structural Grade: **0**
O&M Grade: **0**
Clock Start/From:
Clock To:
1st Value:
2nd Value:
Value Percent:
Continuous Index:
Within 8" of Joint: **NO**
Remarks: **PVC TO VCP**

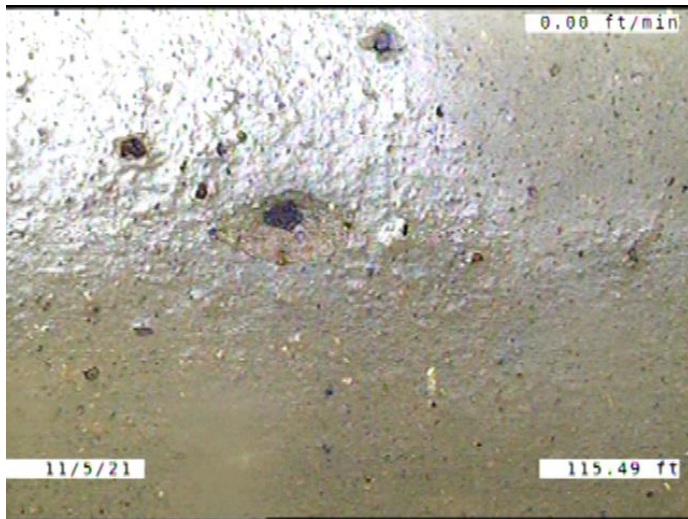
Code: **SSS**
 Description: **Surface Damage Surface Spalling**

Distance (ft): **115.5**
 Structural Grade: **2**
 O&M Grade: **0**
 Clock Start/From: **10**
 Clock To:
 1st Value:
 2nd Value:
 Value Percent:
 Continuous Index:
 Within 8" of Joint: **YES**
 Remarks:

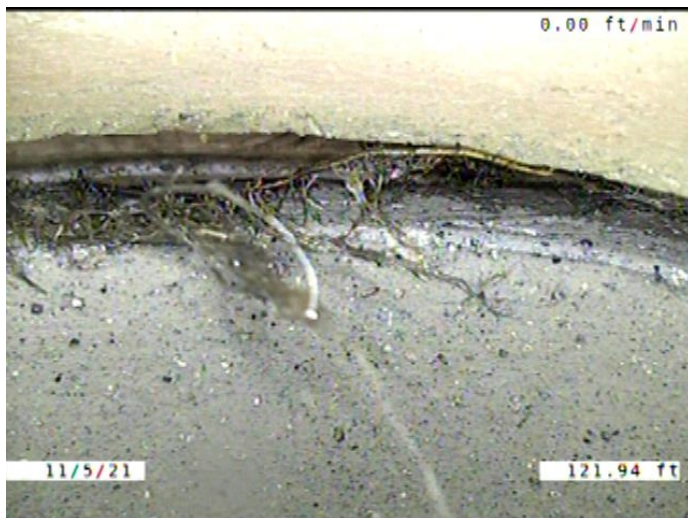
Code: **RFJ**
 Description: **Roots Fine Joint**

Distance (ft): **121.9**
 Structural Grade: **0**
 O&M Grade: **1**
 Clock Start/From: **11**
 Clock To: **2**
 1st Value:
 2nd Value:
 Value Percent:
 Continuous Index:
 Within 8" of Joint: **YES**
 Remarks:

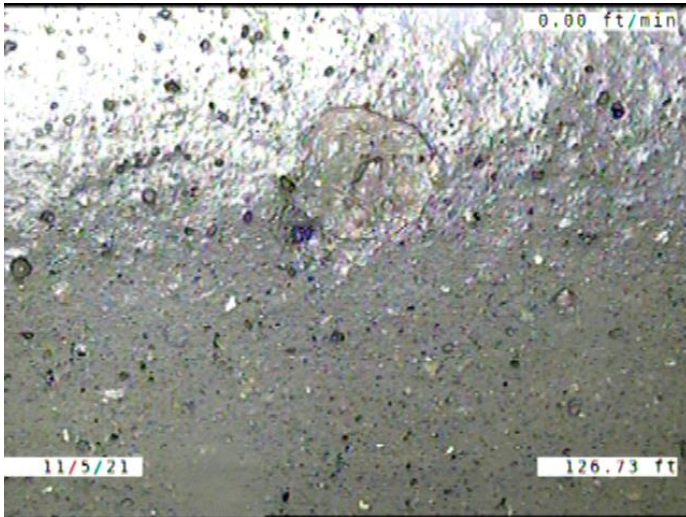
Code:	SSS
Description:	Surface Damage Surface Spalling
Distance (ft):	126.7
Structural Grade:	2
O&M Grade:	0
Clock Start/From:	8
Clock To:	9
1st Value:	
2nd Value:	
Value Percent:	
Continuous Index:	
Within 8" of Joint:	NO
Remarks:

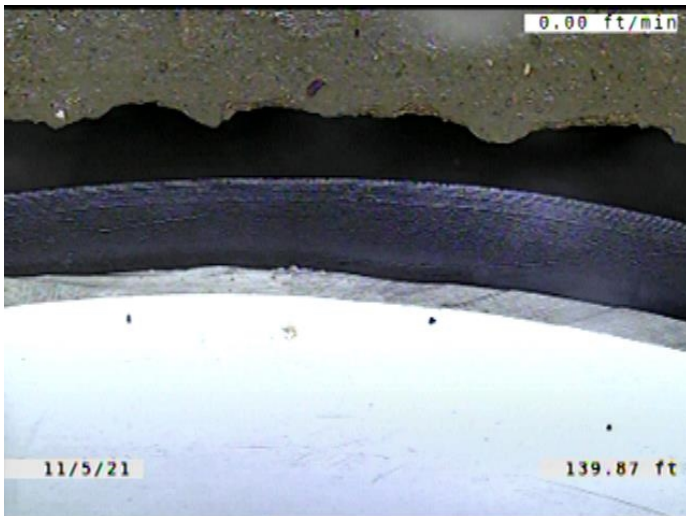
Code:	MMC
Description:	Miscellaneous Material Change
Distance (ft):	139.9
Structural Grade:	0
O&M Grade:	0
Clock Start/From:	
Clock To:	
1st Value:	
2nd Value:	
Value Percent:	
Continuous Index:	
Within 8" of Joint:	NO
Remarks:	VCP TO PVC

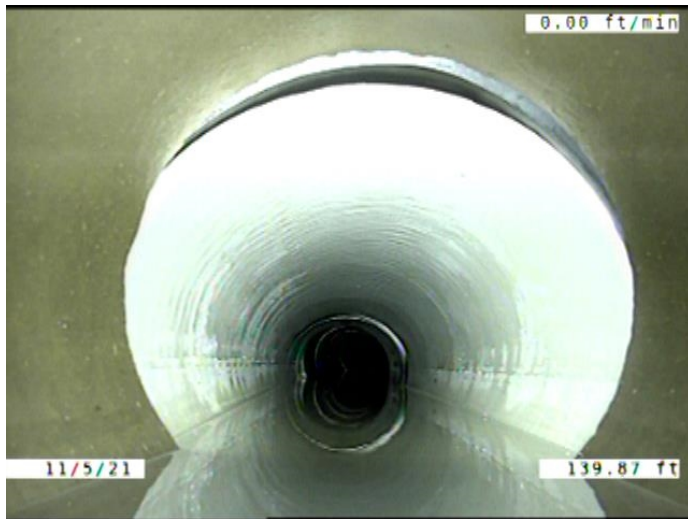
Code: **JOL**
Description: **Joint Offset Large**

Distance (ft): **139.9**
Structural Grade: **4**
O&M Grade: **0**
Clock Start/From:
Clock To:
1st Value: **1.000**
2nd Value:
Value Percent:
Continuous Index:
Within 8" of Joint: **NO**
Remarks:

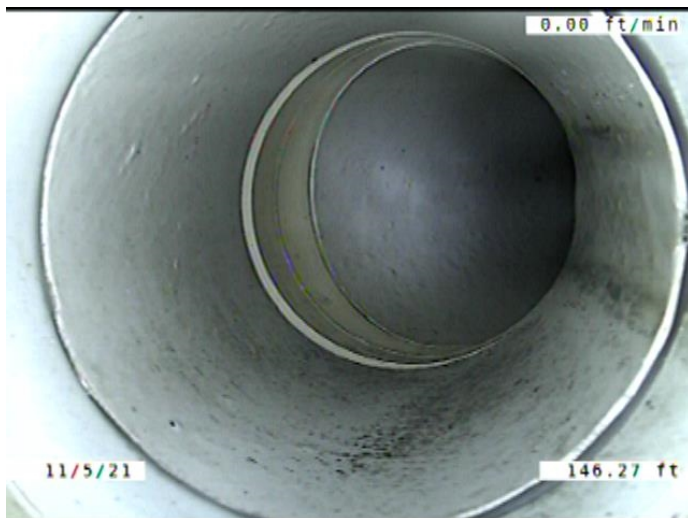
Code: **TF**
Description: **Tap Factory**

Distance (ft): **146.3**
Structural Grade: **0**
O&M Grade: **0**
Clock Start/From: **1**
Clock To:
1st Value: **4.000**
2nd Value:
Value Percent:
Continuous Index:
Within 8" of Joint: **YES**
Remarks: **CONSTANTLY RUNNING WATER.**

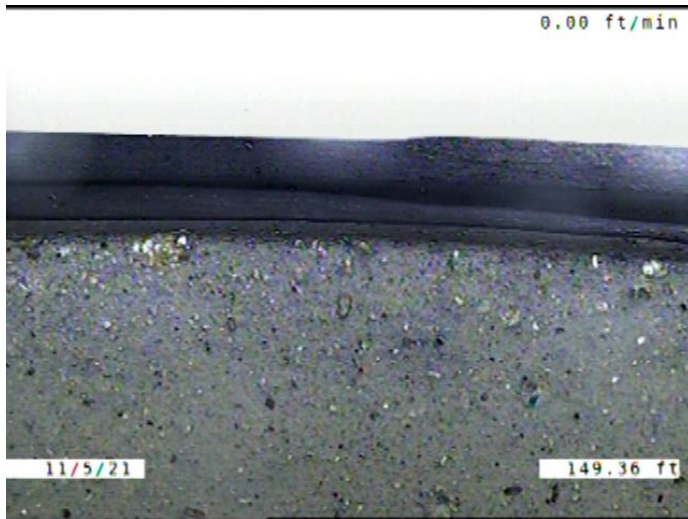
Code: **MMC**
Description: **Miscellaneous Material Change**

Distance (ft): **149.4**
Structural Grade: **0**
O&M Grade: **0**
Clock Start/From:
Clock To:
1st Value:
2nd Value:
Value Percent:
Continuous Index:
Within 8" of Joint: **NO**
Remarks: **PVC TO VCP**

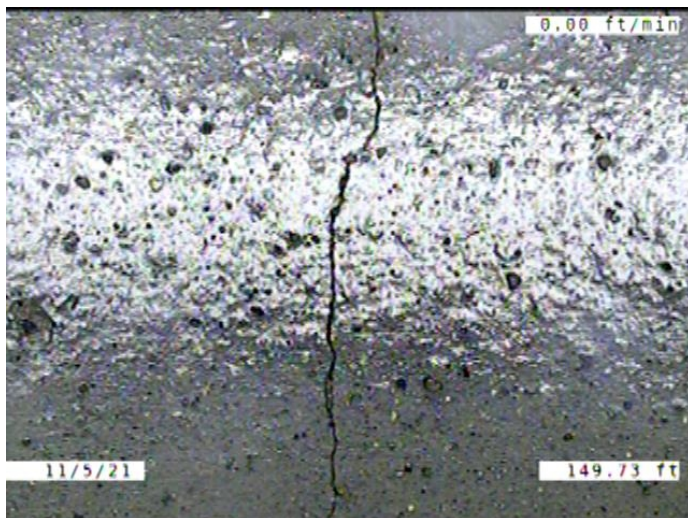
Code: **FM**
Description: **Fracture Multiple**

Distance (ft): **149.7**
Structural Grade: **4**
O&M Grade: **0**
Clock Start/From: **12**
Clock To: **12**
1st Value:
2nd Value:
Value Percent:
Continuous Index: **S07**
Within 8" of Joint: **YES**
Remarks:

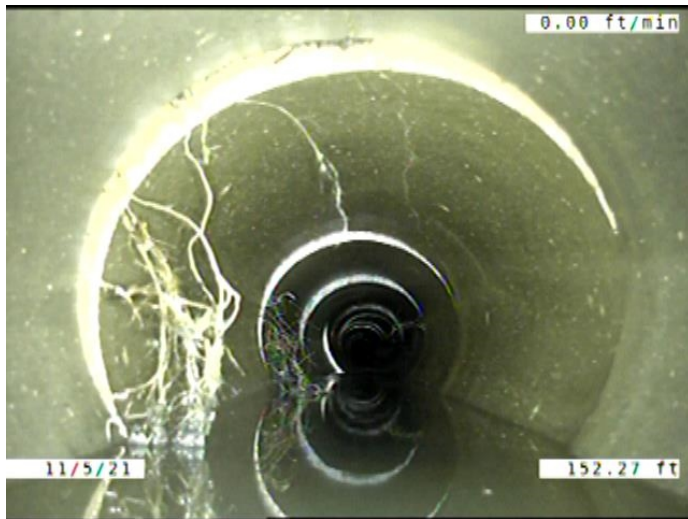
Code: **RFJ**
 Description: **Roots Fine Joint**

Distance (ft): **152.3**
 Structural Grade: **0**
 O&M Grade: **1**
 Clock Start/From: **9**
 Clock To: **3**
 1st Value:
 2nd Value:
 Value Percent:
 Continuous Index: **S08**
 Within 8" of Joint: **YES**
 Remarks:

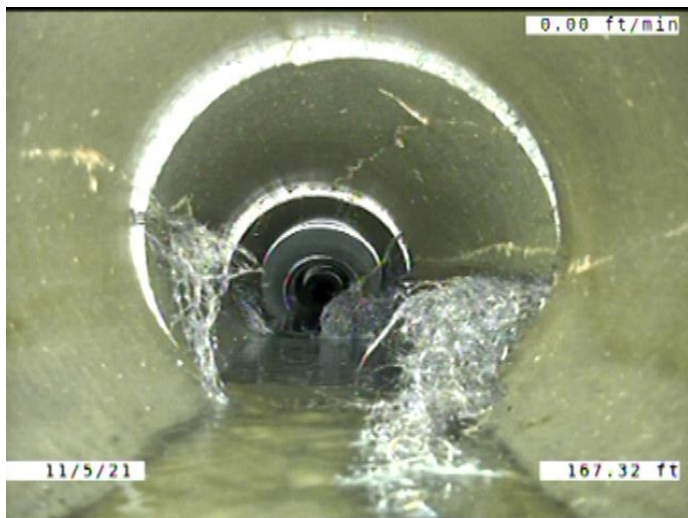
Code: **RMJ**
 Description: **Roots Medium Joint**

Distance (ft): **167.3**
 Structural Grade: **0**
 O&M Grade: **3**
 Clock Start/From: **3**
 Clock To: **9**
 1st Value:
 2nd Value:
 Value Percent: **5.000**
 Continuous Index:
 Within 8" of Joint: **YES**
 Remarks:

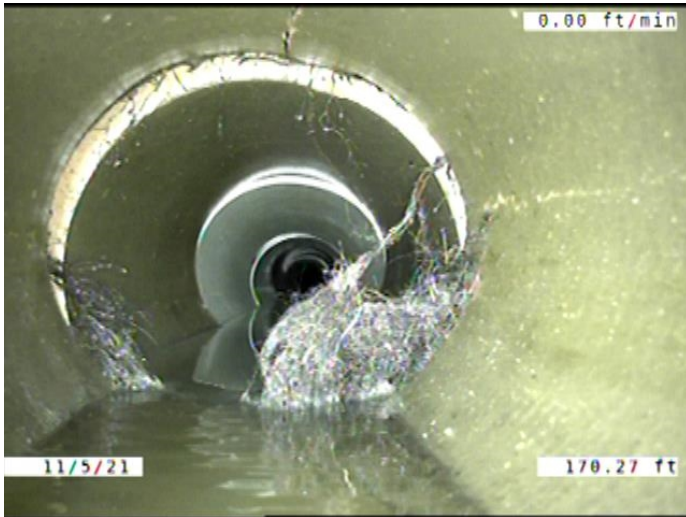
Code: **RMJ**
 Description: **Roots Medium Joint**

Distance (ft): **170.3**
 Structural Grade: **0**
 O&M Grade: **3**
 Clock Start/From: **7**
 Clock To: **5**
 1st Value:
 2nd Value:
 Value Percent: **10.000**
 Continuous Index:
 Within 8" of Joint: **YES**
 Remarks:

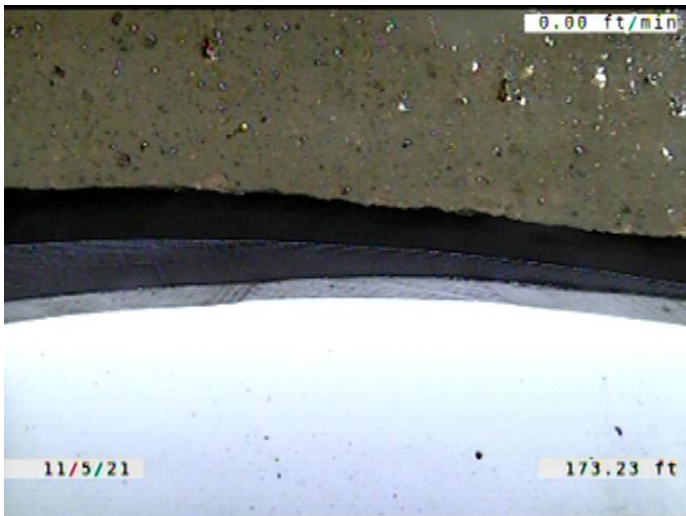
Code: **MMC**
 Description: **Miscellaneous Material Change**

Distance (ft): **173.2**
 Structural Grade: **0**
 O&M Grade: **0**
 Clock Start/From:
 Clock To:
 1st Value:
 2nd Value:
 Value Percent:
 Continuous Index:
 Within 8" of Joint: **NO**
 Remarks: **VCP TO PVC**

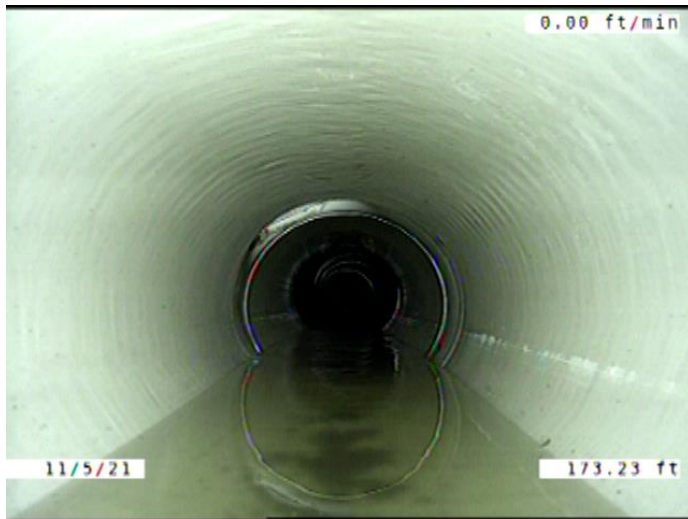
Code: **FM**
Description: **Fracture Multiple**

Distance (ft): **173.2**
Structural Grade: **4**
O&M Grade: **0**
Clock Start/From: **12**
Clock To: **12**
1st Value:
2nd Value:
Value Percent:
Continuous Index: **F07**
Within 8" of Joint: **YES**
Remarks:

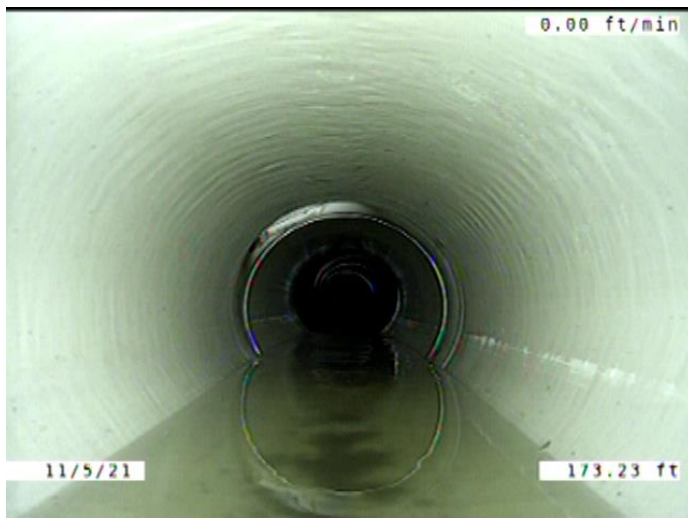
Code: **RFJ**
Description: **Roots Fine Joint**

Distance (ft): **173.2**
Structural Grade: **0**
O&M Grade: **1**
Clock Start/From: **9**
Clock To: **3**
1st Value:
2nd Value:
Value Percent:
Continuous Index: **F08**
Within 8" of Joint: **YES**
Remarks:

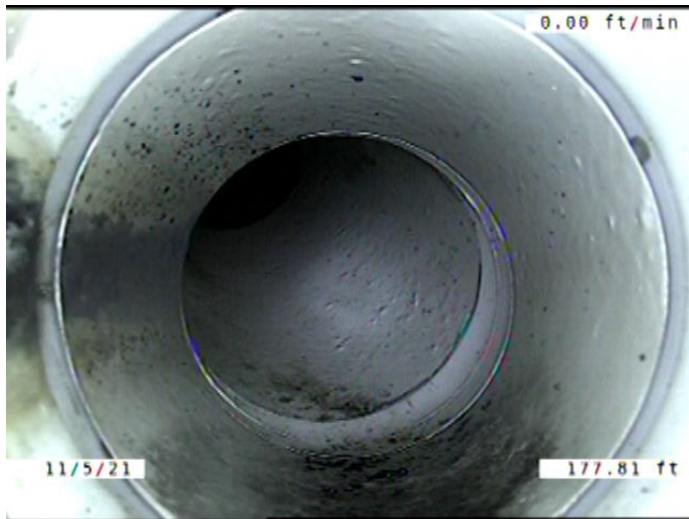
Code: **TF**
Description: **Tap Factory**

Distance (ft): **177.8**
Structural Grade: **0**
O&M Grade: **0**
Clock Start/From: **11**
Clock To:
1st Value: **4.000**
2nd Value:
Value Percent:
Continuous Index:
Within 8" of Joint: **YES**
Remarks: **CONSTANTLY RUNNING WATER.**

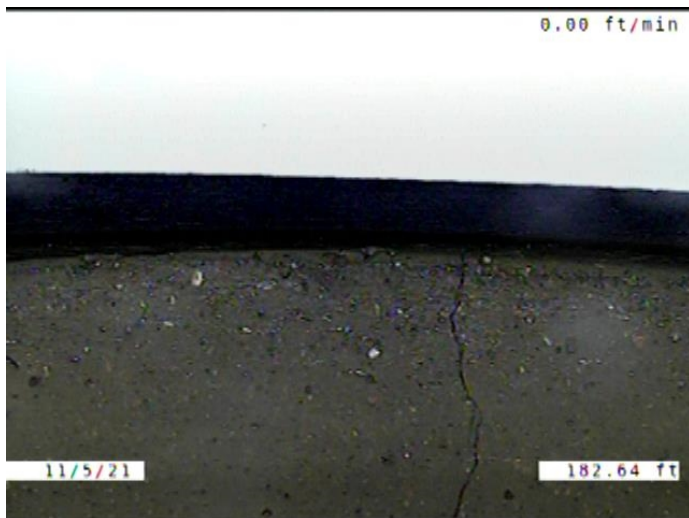
Code: **MMC**
Description: **Miscellaneous Material Change**

Distance (ft): **182.6**
Structural Grade: **0**
O&M Grade: **0**
Clock Start/From:
Clock To:
1st Value:
2nd Value:
Value Percent:
Continuous Index:
Within 8" of Joint: **NO**
Remarks: **PVC TO VCP**

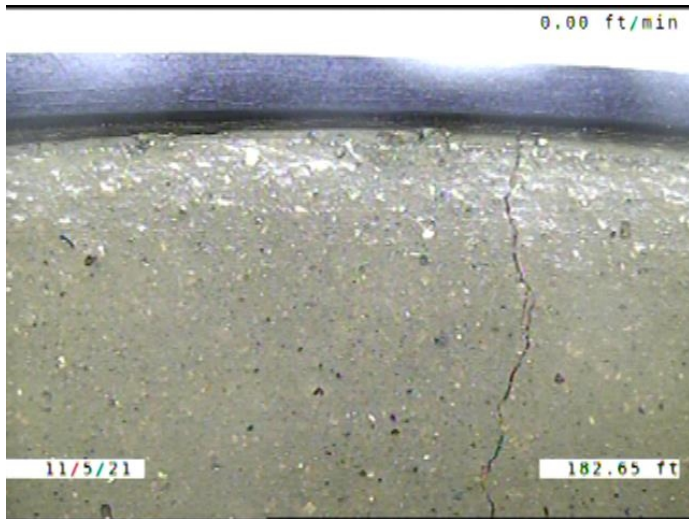
Code: **FM**
Description: **Fracture Multiple**

Distance (ft): **182.6**
Structural Grade: **4**
O&M Grade: **0**
Clock Start/From: **12**
Clock To: **12**
1st Value:
2nd Value:
Value Percent:
Continuous Index: **S10**
Within 8" of Joint: **YES**
Remarks:

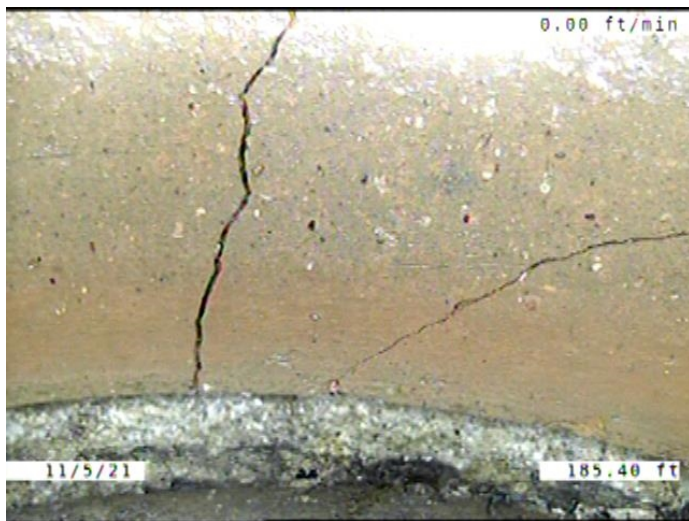
Code: **B**
Description: **Broken**

Distance (ft): **185.4**
Structural Grade: **4**
O&M Grade: **0**
Clock Start/From: **12**
Clock To: **12**
1st Value:
2nd Value:
Value Percent:
Continuous Index:
Within 8" of Joint: **YES**
Remarks:

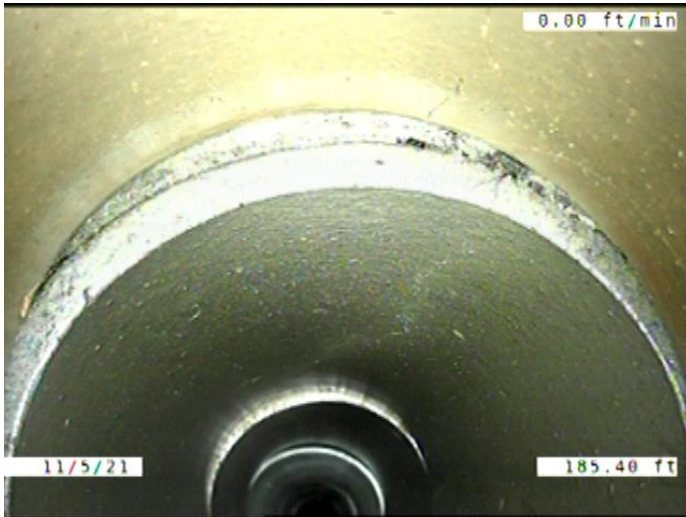
Code: **JOLD**
 Description: **Joint Offset Large Defective**

Distance (ft): **185.4**
 Structural Grade: **4**
 O&M Grade: **0**
 Clock Start/From:
 Clock To:
 1st Value:
 2nd Value:
 Value Percent:
 Continuous Index:
 Within 8" of Joint: **NO**
 Remarks:

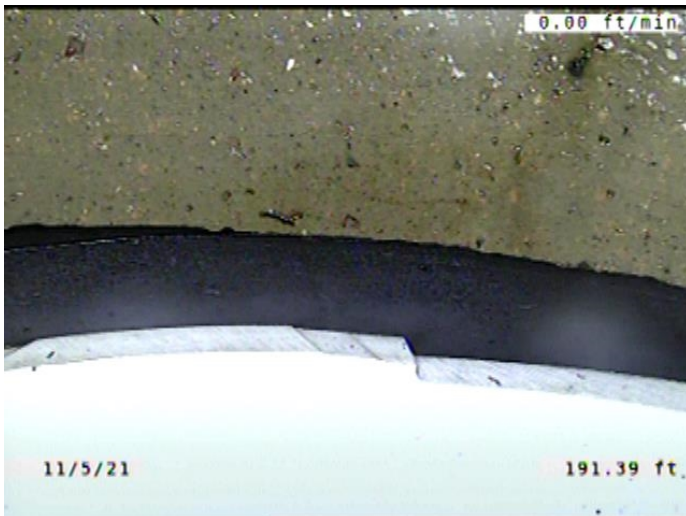
Code: **MMC**
 Description: **Miscellaneous Material Change**

Distance (ft): **191.4**
 Structural Grade: **0**
 O&M Grade: **0**
 Clock Start/From:
 Clock To:
 1st Value:
 2nd Value:
 Value Percent:
 Continuous Index:
 Within 8" of Joint: **NO**
 Remarks: **VCP TO PVC**

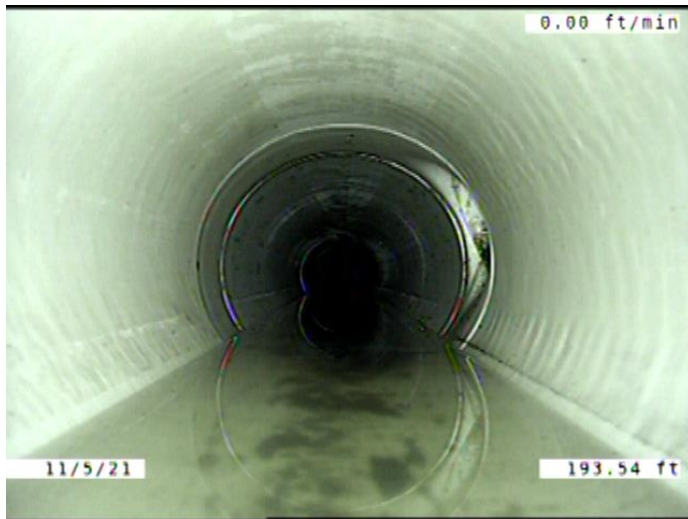
Code: **JOMD**
 Description: **Joint Offset Medium Defective**

Distance (ft): **193.5**
 Structural Grade: **3**
 O&M Grade: **0**
 Clock Start/From:
 Clock To:
 1st Value:
 2nd Value:
 Value Percent:
 Continuous Index: **F04**
 Within 8" of Joint: **NO**
 Remarks:

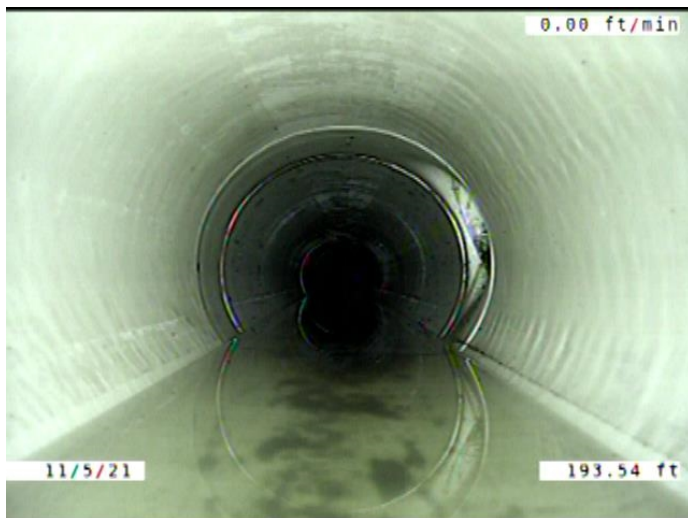
Code: **FM**
 Description: **Fracture Multiple**

Distance (ft): **193.5**
 Structural Grade: **4**
 O&M Grade: **0**
 Clock Start/From: **12**
 Clock To: **12**
 1st Value:
 2nd Value:
 Value Percent:
 Continuous Index: **F10**
 Within 8" of Joint: **YES**
 Remarks:

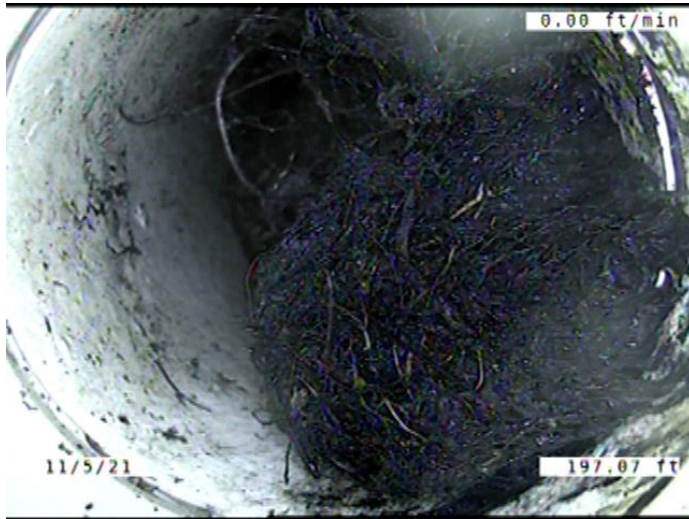
Code: **TF**
Description: **Tap Factory**

Distance (ft): **197.1**
Structural Grade: **0**
O&M Grade: **0**
Clock Start/From: **2**
Clock To:
1st Value: **4.000**
2nd Value:
Value Percent:
Continuous Index:
Within 8" of Joint: **YES**
Remarks: **ROOTS GROWING IN THE TAP**
