Profile/Photo Observation Report

Date:	11/05/2021	Weather:		Coding:	PACP 7.0
Pipe Length (ft):	331.0	Owner:	City of Hobart	Pre Clean:	Heavy Cleaning
P.O.#:	YES502259	Surveyor:	S. Bucklin	PSR:	P-504-056-028
Customer:	City of Hobart	Clean Date:	11/05/2021	Shape:	C

Street:	North Wilson Street	Flow Control:	Not Controlled
City:	Hobart, IN	Year Renewed:	
Location:	Alley	Tape/Media #:	
Purpose:	Routine Assessment	Dia/Height:	12"
Use:	Sanitary Sewage Pipe	Material:	VCP
Drain Area:		Lining:	None
Category:	NA		
Comment:			
Location Details:		Direction of Survey:	Upstream
US MH:	M-504-028	DS MH:	M-504-056
		Total Length Surveyed (ft):	240.8

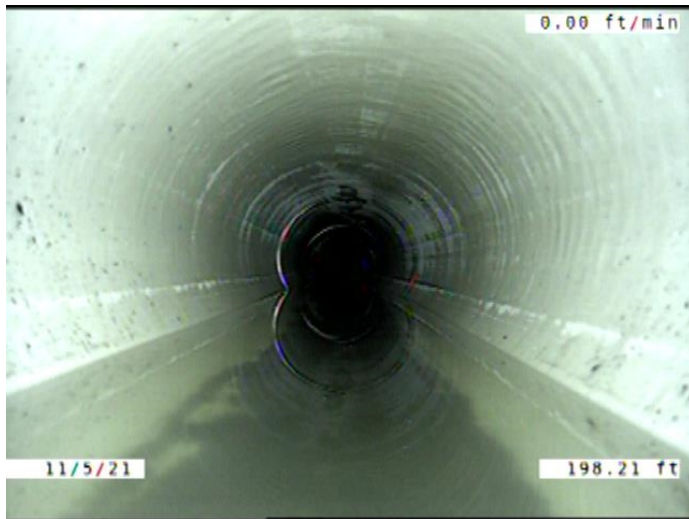
Code: **MWLS**
Description: **Miscellaneous Water Level Sag**

Distance (ft): **198.2**
Structural Grade: **2**
O&M Grade: **0**
Clock Start/From:
Clock To:
1st Value:
2nd Value:
Value Percent: **30.000**
Continuous Index: **S11**
Within 8" of Joint: **NO**
Remarks:

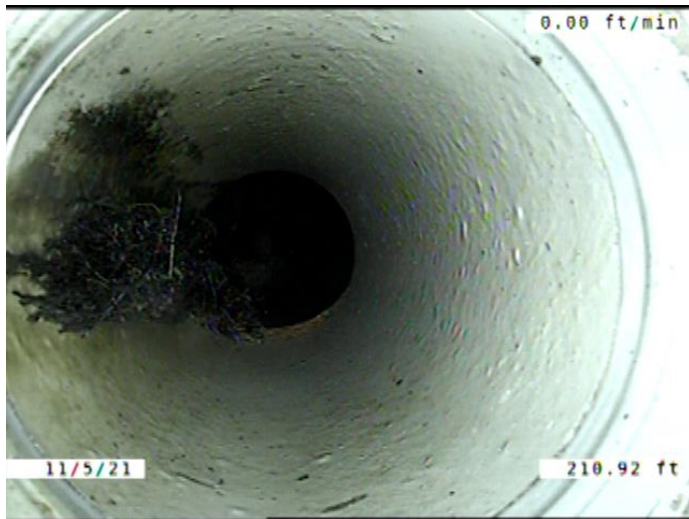
Code: **TF**
Description: **Tap Factory**

Distance (ft): **210.9**
Structural Grade: **0**
O&M Grade: **0**
Clock Start/From: **11**
Clock To:
1st Value: **4.000**
2nd Value:
Value Percent:
Continuous Index:
Within 8" of Joint: **YES**
Remarks: **ROOTS GROWING IN THE TAP**

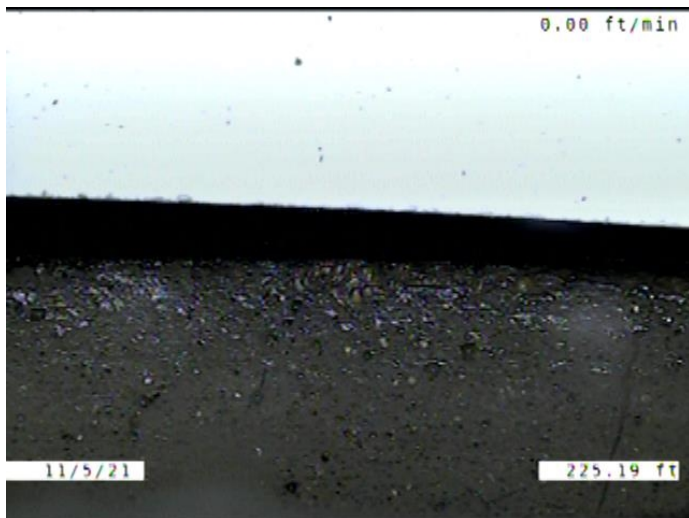
Code: **MMC**
Description: **Miscellaneous Material Change**

Distance (ft): **225.2**
Structural Grade: **0**
O&M Grade: **0**
Clock Start/From:
Clock To:
1st Value:
2nd Value:
Value Percent:
Continuous Index:
Within 8" of Joint: **NO**
Remarks: **PVC TO VCP**

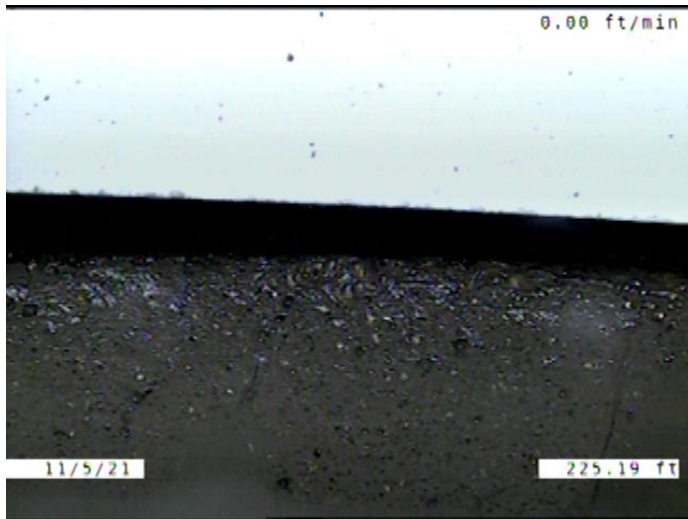
Code: **FM**
 Description: **Fracture Multiple**

Distance (ft): **225.2**
 Structural Grade: **4**
 O&M Grade: **0**
 Clock Start/From: **9**
 Clock To: **3**
 1st Value:
 2nd Value:
 Value Percent:
 Continuous Index: **S12**
 Within 8" of Joint: **YES**
 Remarks:

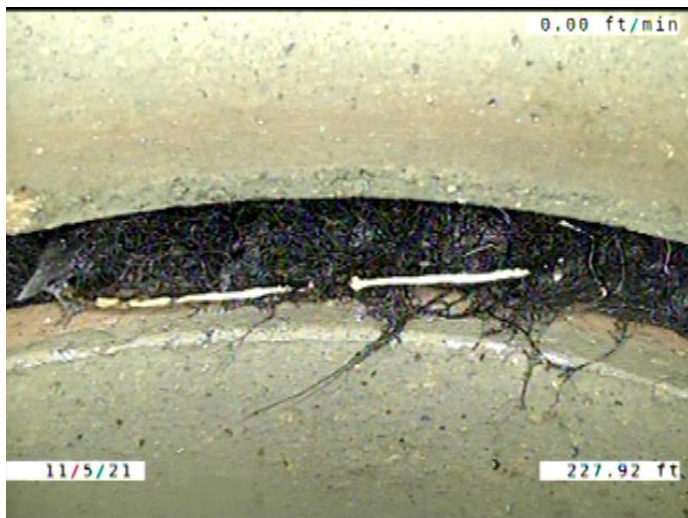
Code: **RFJ**
 Description: **Roots Fine Joint**

Distance (ft): **227.9**
 Structural Grade: **0**
 O&M Grade: **1**
 Clock Start/From: **10**
 Clock To: **2**
 1st Value:
 2nd Value:
 Value Percent:
 Continuous Index:
 Within 8" of Joint: **YES**
 Remarks:

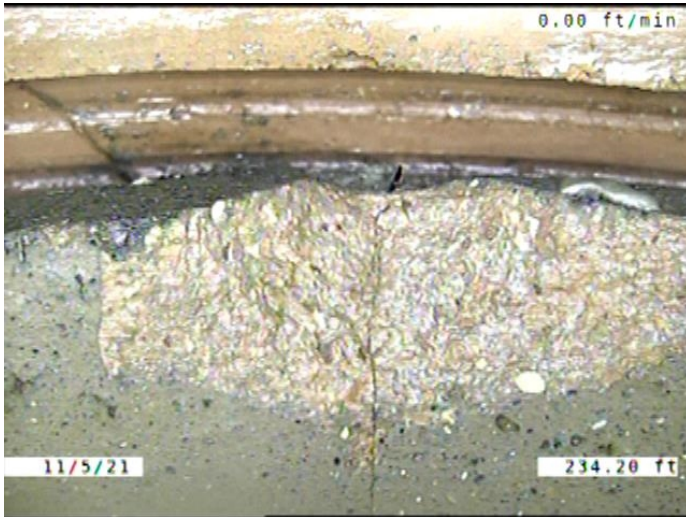
Code: **SZ**
 Description: **Surface Damage Other**

Distance (ft): **234.2**
 Structural Grade: **0**
 O&M Grade: **0**
 Clock Start/From: **11**
 Clock To:
 1st Value:
 2nd Value:
 Value Percent:
 Continuous Index:
 Within 8" of Joint: **YES**
 Remarks: **A PIECE CHIPPED AWAY FROM THE JOINT**

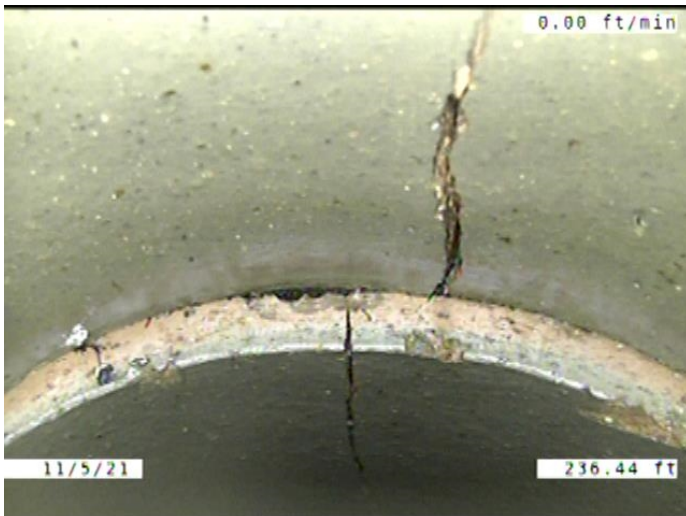
Code: **JOM**
 Description: **Joint Offset Medium**

Distance (ft): **236.4**
 Structural Grade: **3**
 O&M Grade: **0**
 Clock Start/From:
 Clock To:
 1st Value:
 2nd Value:
 Value Percent:
 Continuous Index:
 Within 8" of Joint: **NO**
 Remarks:

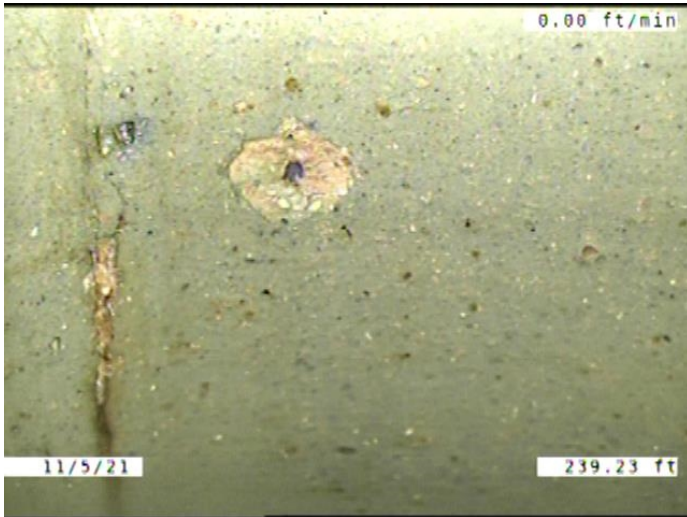
Code: **SSS**
Description: **Surface Damage Surface Spalling**

Distance (ft): **239.2**
Structural Grade: **2**
O&M Grade: **0**
Clock Start/From: **10**
Clock To:
1st Value:
2nd Value:
Value Percent:
Continuous Index:
Within 8" of Joint: **NO**
Remarks:

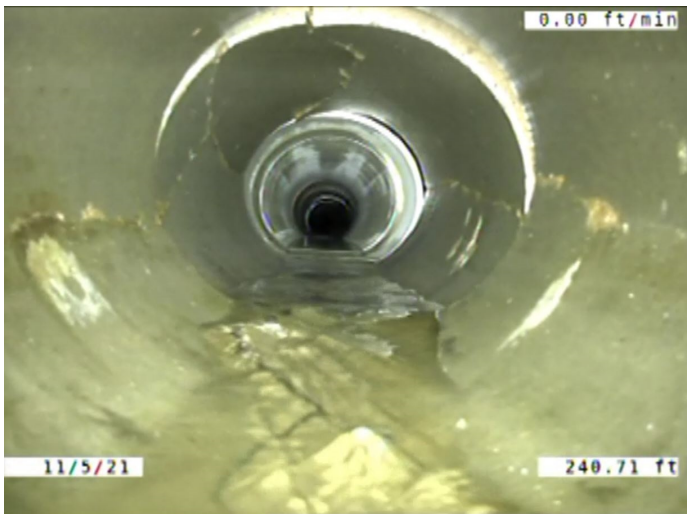
Code: **DR**
Description: **Deformed Rigid**

Distance (ft): **240.7**
Structural Grade: **4**
O&M Grade: **0**
Clock Start/From:
Clock To:
1st Value:
2nd Value:
Value Percent: **5.000**
Continuous Index:
Within 8" of Joint: **NO**
Remarks:

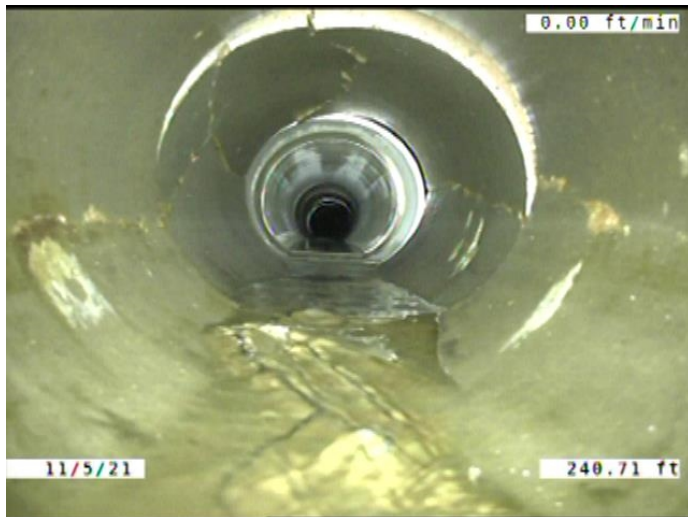
Code: **DSF**
Description: **Deposits Settled Fine**

Distance (ft): **240.7**
Structural Grade: **0**
O&M Grade: **2**
Clock Start/From: **5**
Clock To: **7**
1st Value:
2nd Value:
Value Percent: **5.000**
Continuous Index: **F03**
Within 8" of Joint: **YES**
Remarks:

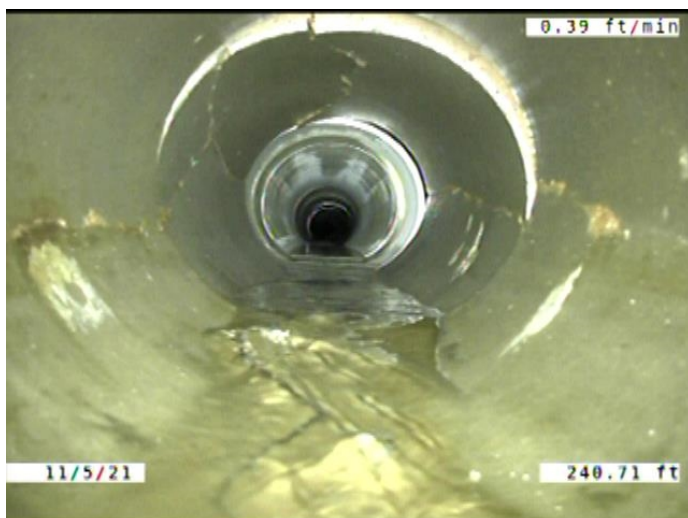
Code: **MWLS**
Description: **Miscellaneous Water Level Sag**

Distance (ft): **240.7**
Structural Grade: **2**
O&M Grade: **0**
Clock Start/From:
Clock To:
1st Value:
2nd Value:
Value Percent: **30.000**
Continuous Index: **F11**
Within 8" of Joint: **NO**
Remarks:

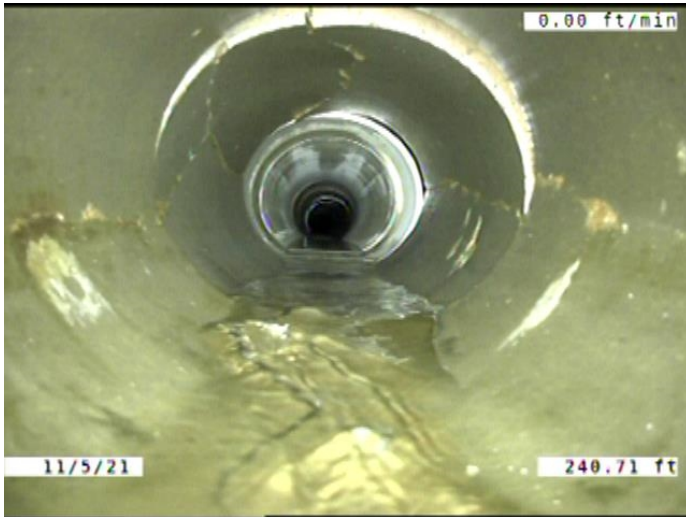
Code: **FM**
 Description: **Fracture Multiple**

Distance (ft): **240.7**
 Structural Grade: **4**
 O&M Grade: **0**
 Clock Start/From: **9**
 Clock To: **3**
 1st Value:
 2nd Value:
 Value Percent:
 Continuous Index: **F12**
 Within 8" of Joint: **YES**
 Remarks:

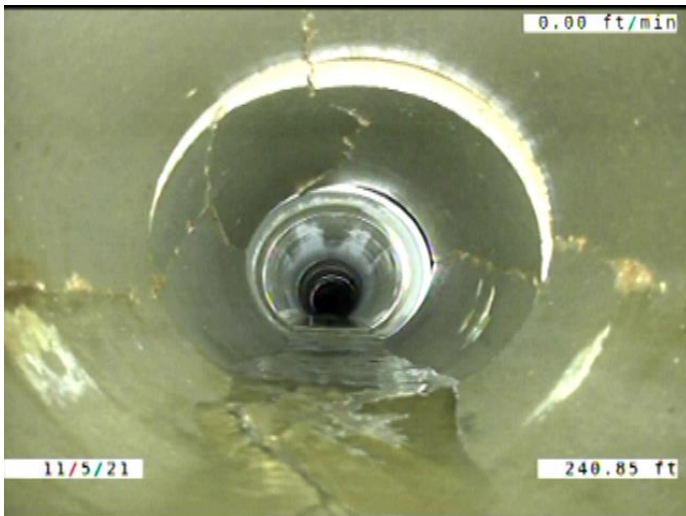
Code: **MSA**
 Description: **Miscellaneous Survey Abandoned**

Distance (ft): **240.8**
 Structural Grade: **0**
 O&M Grade: **0**
 Clock Start/From:
 Clock To:
 1st Value:
 2nd Value:
 Value Percent:
 Continuous Index:
 Within 8" of Joint: **NO**
 Remarks: **MADE IT TO THE POINT OF OVERLAP.
 REVERSAL COMPLETE.**
