Profile/Photo Observation Report

| Street: | ALLEY BETWEEN N COLORADO ST & | Flow Control: | Not Controlled |
| City: | Hobart, IN | Year Renewed: | |
| US MH: | M-504-030 | DS MH: | M-504-031 |

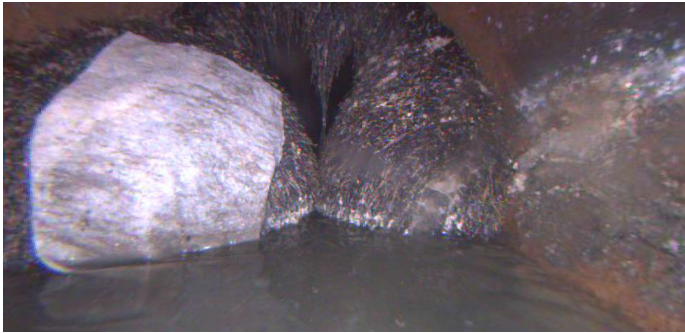
| Code: | MWL |
| Description: | Water Level |

| Value Percent: | 40.000 |

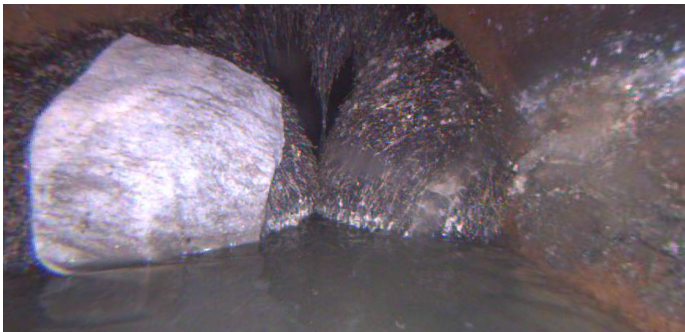
| Code: | RBJ |
| Description: | Roots Ball Joint |

| O&M Grade: | 4 |
| Clock Start/From: | 8 |
| Clock To: | 4 |
| Value Percent: | 90.000 |
| Within 8" of Joint: | YES |

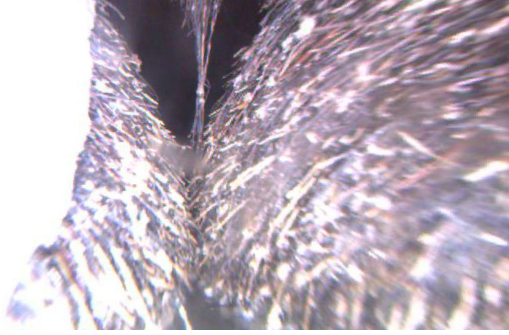
| Code: | MSA |
| Description: | Abandoned Survey |
| Distance (ft): | 1.5 |
| Remarks: | roots |
