Profile/Photo Observation Report

Street:	FOXCROFT STREET	Flow Control:	Not Controlled
City:	Hobart, IN	Year Renewed:	
Location:	Alley	Tape/Media #:	
Purpose:	Routine Assessment	Dia/Height:	12"
Use:	Sanitary	Material:	VCP
Drain Area:	NA	Lining:	
Category:	NA		
Comment:	F_S_P_C at 1 ft root s. Flow direction wrong		
Location Details:		Direction of Survey:	Upstream
US MH:	M-504-030	DS MH:	M-504-031
		Total Length Surveyed (ft):	1.5

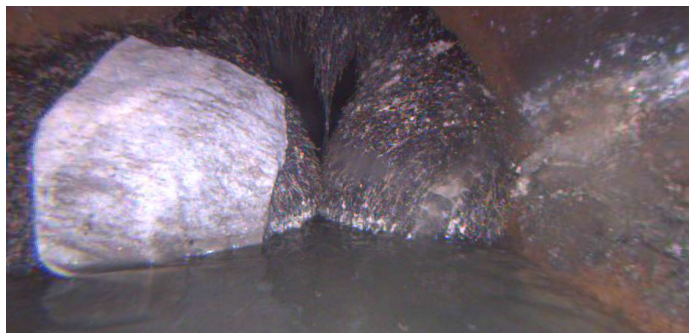
Code: **AMH**
Description: **Manhole**

Distance (ft): **.0**
Structural Grade: **0**
O&M Grade: **0**
Clock Start/From:
Clock To:
1st Value:
2nd Value:
Value Percent:
Continuous Index:
Within 8" of Joint: **NO**
Remarks: **M-504-031**

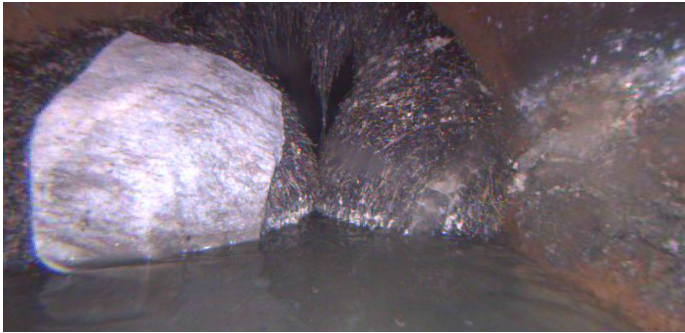
Code:	MWL
Description:	Water Level

Distance (ft):	.0
Structural Grade:	0
O&M Grade:	0
Clock Start/From:	
Clock To:	
1st Value:	
2nd Value:	
Value Percent:	40.000
Continuous Index:	
Within 8" of Joint:	NO
Remarks:

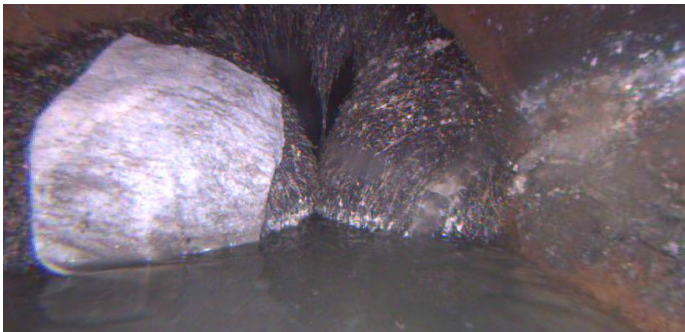
Code:	RBJ
Description:	Roots Ball Joint

Distance (ft):	.0
Structural Grade:	0
O&M Grade:	4
Clock Start/From:	8
Clock To:	4
1st Value:	
2nd Value:	
Value Percent:	90.000
Continuous Index:	
Within 8" of Joint:	YES
Remarks:

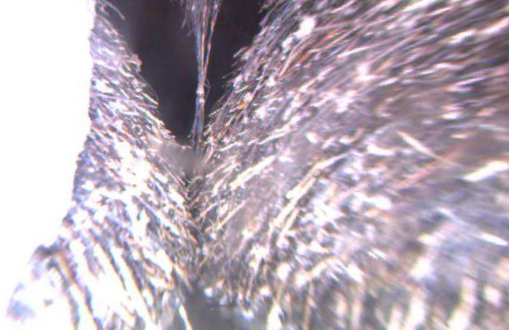
Code:	MSA
Description:	Abandoned Survey
Distance (ft):	1.5
Structural Grade:	0
O&M Grade:	0
Clock Start/From:	
Clock To:	
1st Value:	
2nd Value:	
Value Percent:	
Continuous Index:	
Within 8" of Joint:	NO
Remarks:	roots
