Profile/Photo Observation Report

Street:	ALLEY BETWEEN N COLORADO ST &	Flow Control:	Not Controlled
City:	Hobart, IN	Year Renewed:	
Location:	Alley	Tape/Media #:	
Purpose:	Routine Assessment	Dia/Height:	12"
Use:	Sanitary	Material:	VCP
Drain Area:	NA	Lining:	
Category:	NA		
Comment:	P_C at 10 ft debis and grit. Flow direction wrong		
Location Details:		Direction of Survey:	Downstream
US MH:	M-504-030	DS MH:	M-504-031
		Total Length Surveyed (ft):	12.0

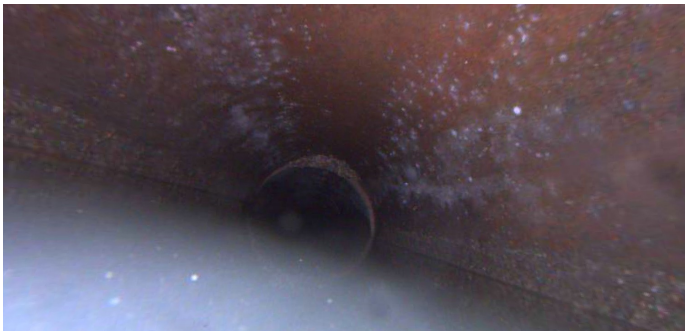
Code: **AMH**
Description: **Manhole**

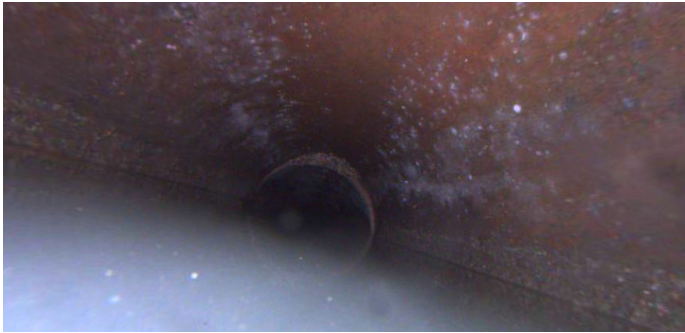
Code:	MWL
Description:	Water Level

Distance (ft):	.0
Structural Grade:	0
O&M Grade:	0
Clock Start/From:	
Clock To:	
1st Value:	
2nd Value:	
Value Percent:	30.000
Continuous Index:	
Within 8" of Joint:	NO
Remarks:

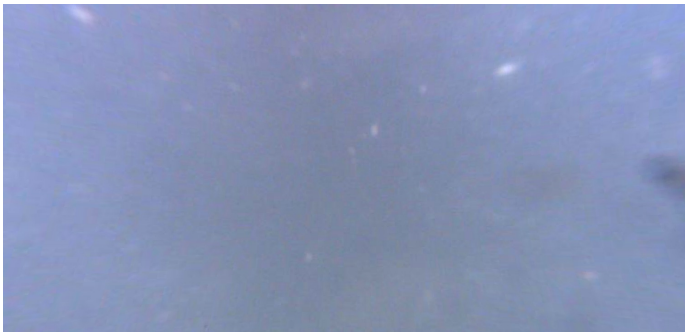
Code:	MWL
Description:	Water Level

Distance (ft):	9.6
Structural Grade:	0
O&M Grade:	0
Clock Start/From:	
Clock To:	
1st Value:	
2nd Value:	
Value Percent:	100.000
Continuous Index:	
Within 8" of Joint:	NO
Remarks:

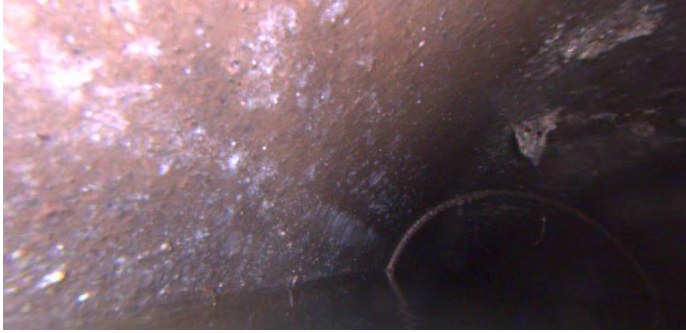
Code: **MWL**
Description: **Water Level**

Distance (ft): **12.0**
Structural Grade: **0**
O&M Grade: **0**
Clock Start/From:
Clock To:
1st Value:
2nd Value:
Value Percent: **30.000**
Continuous Index:
Within 8" of Joint: **NO**
Remarks:

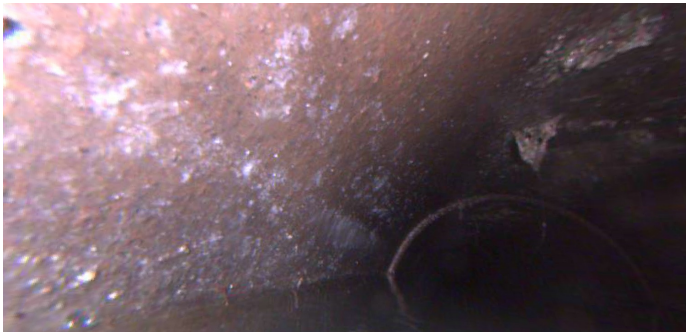
Code: **MSA**
Description: **Abandoned Survey**

Distance (ft): **12.0**
Structural Grade: **0**
O&M Grade: **0**
Clock Start/From:
Clock To:
1st Value:
2nd Value:
Value Percent:
Continuous Index:
Within 8" of Joint: **NO**
Remarks: **debris under water**
