## Profile/Photo Observation Report

Street:	<b>FOXCROFT STREET</b>	Flow Control:	<b>Not Controlled</b>
City:	<b>Hobart, IN</b>	Year Renewed:	
Location:	<b>Alley</b>	Tape/Media #:	
Purpose:	<b>Routine Assessment</b>	Dia/Height:	<b>12"</b>
Use:	<b>Sanitary</b>	Material:	<b>VCP</b>
Drain Area:	<b>NA</b>	Lining:	
Category:	<b>NA</b>		
Comment:	<b>P_C at 10 ft debis and grit. Flow direction wrong</b>		
Location Details:		Direction of Survey:	<b>Downstream</b>
US MH:	<b>M-504-030</b>	DS MH:	<b>M-504-031</b>
		Total Length Surveyed (ft):	<b>12.0</b>

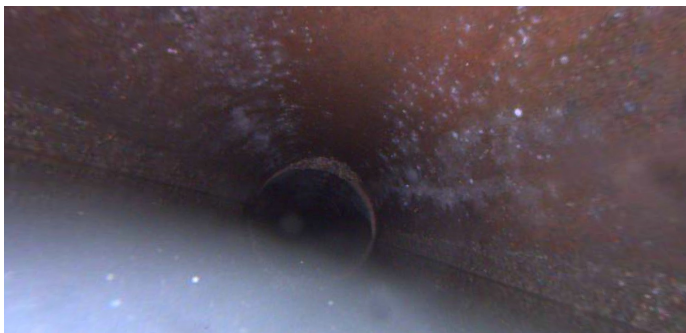
Code: **AMH**  
Description: **Manhole**

Distance (ft): **.0**  
Structural Grade: **0**  
O&M Grade: **0**  
Clock Start/From:  
Clock To:  
1st Value:  
2nd Value:  
Value Percent:  
Continuous Index:  
Within 8" of Joint: **NO**  
Remarks: **M-504-030**

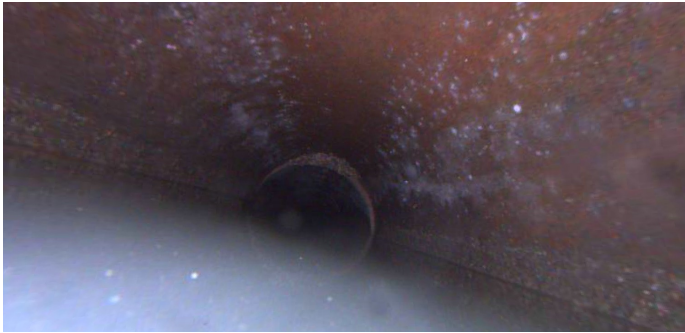
Code:	<b>MWL</b>
Description:	<b>Water Level</b>

Distance (ft):	<b>.0</b>
Structural Grade:	<b>0</b>
O&M Grade:	<b>0</b>
Clock Start/From:	
Clock To:	
1st Value:	
2nd Value:	
Value Percent:	<b>30.000</b>
Continuous Index:	
Within 8" of Joint:	<b>NO</b>
Remarks:

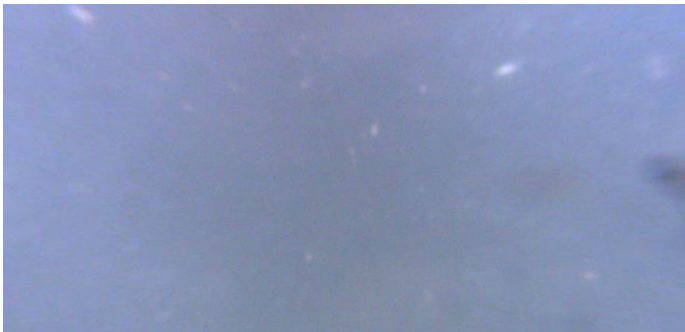
Code:	<b>MWL</b>
Description:	<b>Water Level</b>

Distance (ft):	<b>9.6</b>
Structural Grade:	<b>0</b>
O&M Grade:	<b>0</b>
Clock Start/From:	
Clock To:	
1st Value:	
2nd Value:	
Value Percent:	<b>100.000</b>
Continuous Index:	
Within 8" of Joint:	<b>NO</b>
Remarks:

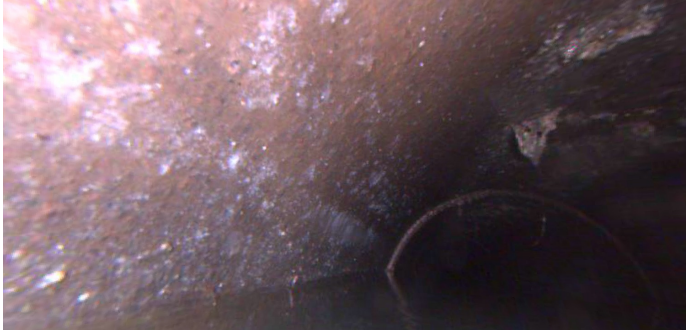
Code: **MWL**  
Description: **Water Level**

Distance (ft): **12.0**  
Structural Grade: **0**  
O&M Grade: **0**  
Clock Start/From:  
Clock To:  
1st Value:  
2nd Value:  
Value Percent: **30.000**  
Continuous Index:  
Within 8" of Joint: **NO**  
Remarks:

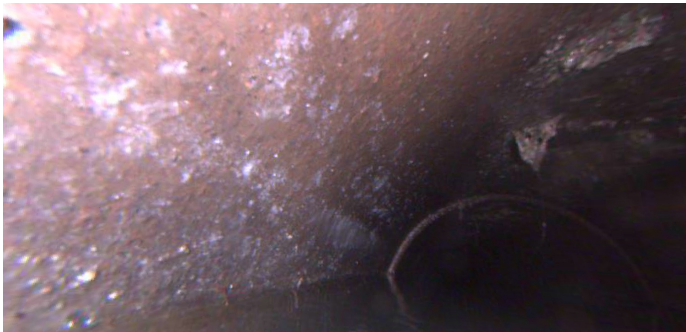
Code: **MSA**  
Description: **Abandoned Survey**

Distance (ft): **12.0**  
Structural Grade: **0**  
O&M Grade: **0**  
Clock Start/From:  
Clock To:  
1st Value:  
2nd Value:  
Value Percent:  
Continuous Index:  
Within 8" of Joint: **NO**  
Remarks: **debris under water**
