# Profile/Photo Observation Report

Date:	<b>11/01/2021</b>	Weather:		Coding:	<b>PACP 7.0</b>
Pipe Length (ft):	<b>155.8</b>	Owner:	<b>City of Hobart</b>	Pre Clean:	<b>Heavy Cleaning</b>
P.O.#:	<b>YES502259</b>	Surveyor:	<b>S. Bucklin</b>	PSR:	<b>P-504-031-030</b>
Customer:	<b>City of Hobart</b>	Clean Date:	<b>10/28/2021</b>	Shape:	<b>C</b>

Street:	<b>North Colorado Street</b>	Flow Control:	<b>Not Controlled</b>
City:	<b>Hobart, IN</b>	Year Renewed:	
Location:	<b>Alley</b>	Tape/Media #:	
Purpose:	<b>Routine Assessment</b>	Dia/Height:	<b>12"</b>
Use:	<b>Sanitary Sewage Pipe</b>	Material:	<b>VCP</b>
Drain Area:		Lining:	<b>None</b>
Category:	<b>NA</b>		
Comment:			
Location Details:		Direction of Survey:	<b>Upstream</b>
US MH:	<b>M-504-030</b>	DS MH:	<b>M-504-031</b>
		Total Length Surveyed (ft):	<b>155.8</b>

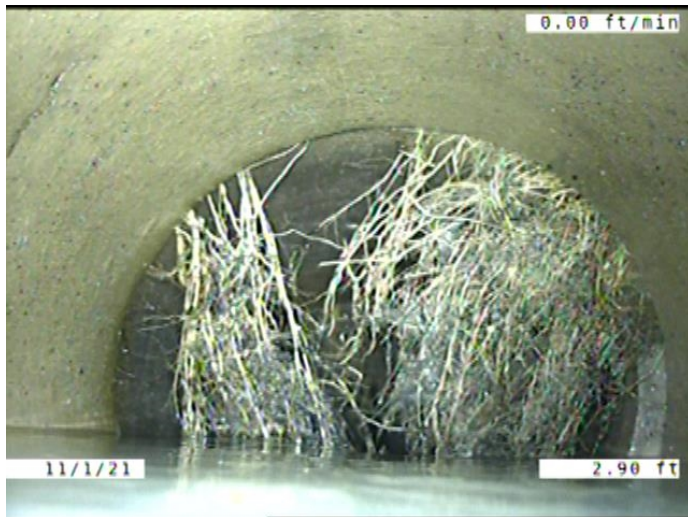
Code: **RMJ**  
 Description: **Roots Medium Joint**

Distance (ft): **2.9**  
 Structural Grade: **0**  
 O&M Grade: **3**  
 Clock Start/From: **9**  
 Clock To: **3**  
 1st Value:  
 2nd Value:  
 Value Percent: **50.000**  
 Continuous Index:  
 Within 8" of Joint: **YES**  
 Remarks:

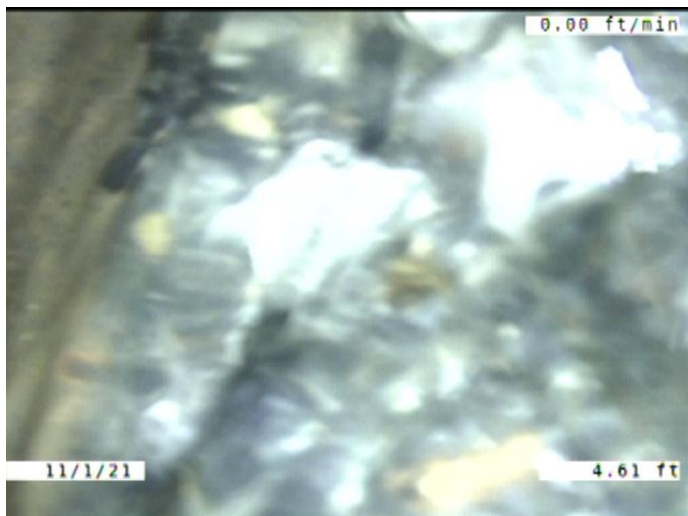
Code: **DSF**  
 Description: **Deposits Settled Fine**

Distance (ft): **4.6**  
 Structural Grade: **0**  
 O&M Grade: **2**  
 Clock Start/From: **4**  
 Clock To: **8**  
 1st Value:  
 2nd Value:  
 Value Percent: **10.000**  
 Continuous Index:  
 Within 8" of Joint: **YES**  
 Remarks:

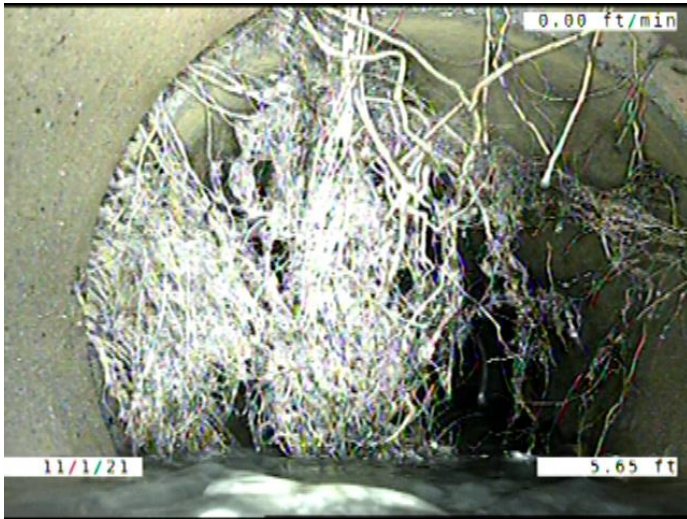
Code: **RMJ**  
 Description: **Roots Medium Joint**

Distance (ft): **5.7**  
 Structural Grade: **0**  
 O&M Grade: **3**  
 Clock Start/From: **7**  
 Clock To: **3**  
 1st Value:  
 2nd Value:  
 Value Percent: **50.000**  
 Continuous Index:  
 Within 8" of Joint: **YES**  
 Remarks:

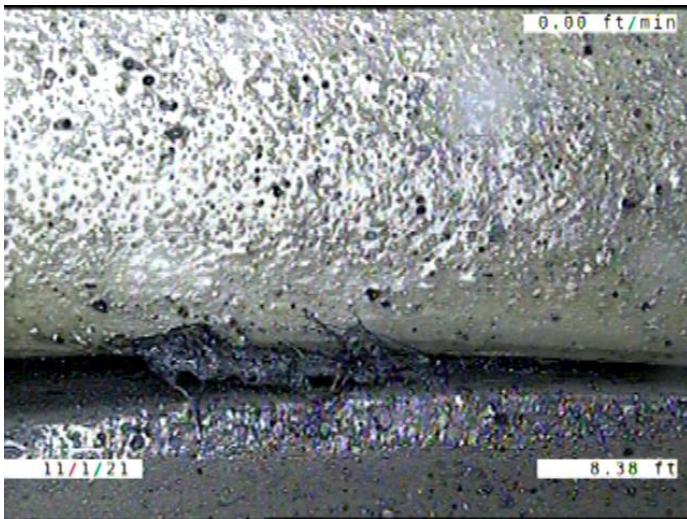
Code: **RFJ**  
 Description: **Roots Fine Joint**

Distance (ft): **8.4**  
 Structural Grade: **0**  
 O&M Grade: **1**  
 Clock Start/From: **9**  
 Clock To: **1**  
 1st Value:  
 2nd Value:  
 Value Percent:  
 Continuous Index:  
 Within 8" of Joint: **YES**  
 Remarks:

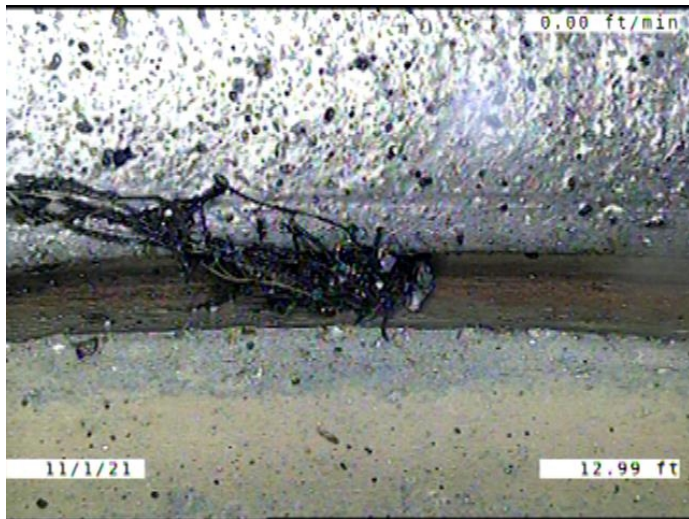
Code: **RFJ**  
 Description: **Roots Fine Joint**

Distance (ft): **13.0**  
 Structural Grade: **0**  
 O&M Grade: **1**  
 Clock Start/From: **9**  
 Clock To: **10**  
 1st Value:  
 2nd Value:  
 Value Percent:  
 Continuous Index:  
 Within 8" of Joint: **YES**  
 Remarks:

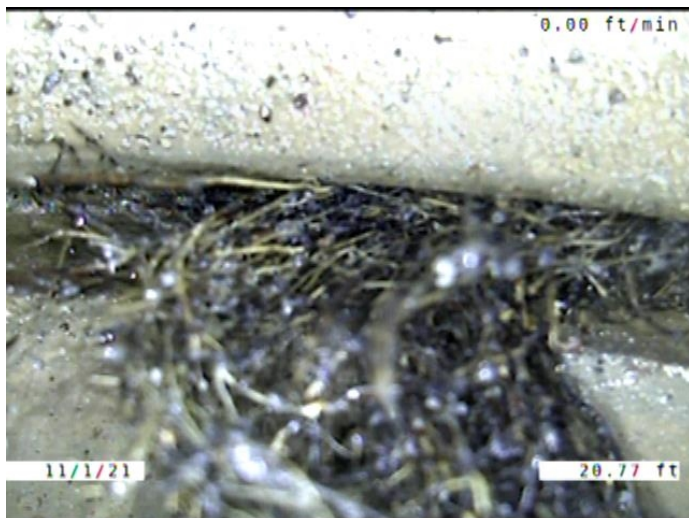
Code: **RMJ**  
 Description: **Roots Medium Joint**

Distance (ft): **20.8**  
 Structural Grade: **0**  
 O&M Grade: **3**  
 Clock Start/From: **12**  
 Clock To: **3**  
 1st Value:  
 2nd Value:  
 Value Percent: **5.000**  
 Continuous Index:  
 Within 8" of Joint: **YES**  
 Remarks:

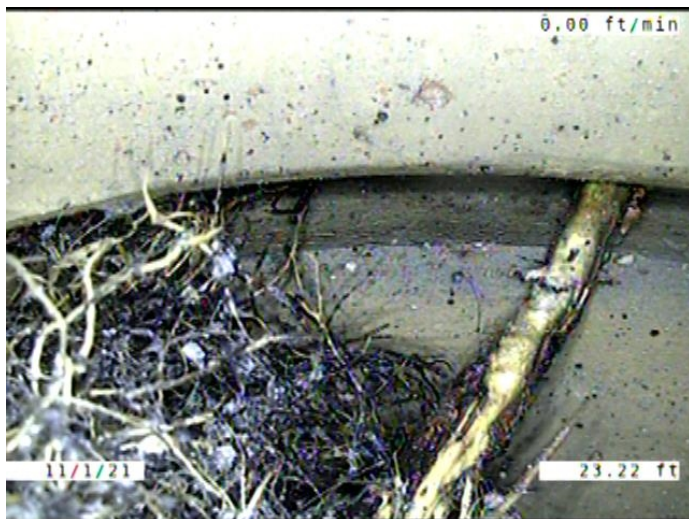
Code: **RMJ**  
 Description: **Roots Medium Joint**

Distance (ft): **23.2**  
 Structural Grade: **0**  
 O&M Grade: **3**  
 Clock Start/From: **9**  
 Clock To: **11**  
 1st Value:  
 2nd Value:  
 Value Percent: **15.000**  
 Continuous Index:  
 Within 8" of Joint: **YES**  
 Remarks:

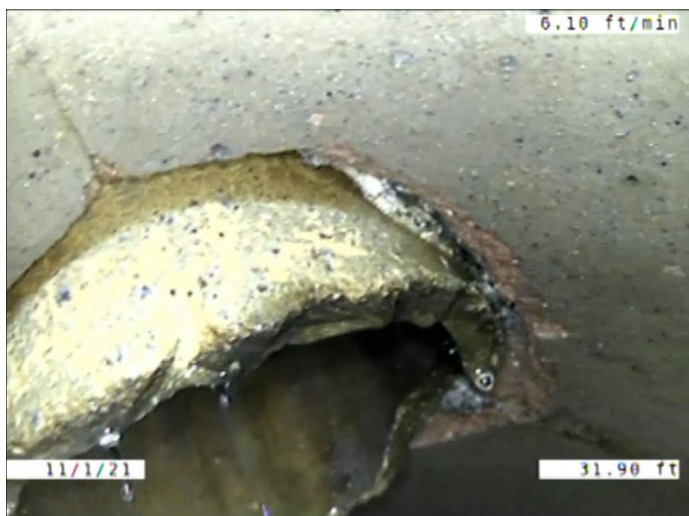
Code: **CL**  
 Description: **Crack Longitudinal**

Distance (ft): **31.9**  
 Structural Grade: **2**  
 O&M Grade: **0**  
 Clock Start/From: **12**  
 Clock To:  
 1st Value:  
 2nd Value:  
 Value Percent:  
 Continuous Index:  
 Within 8" of Joint: **NO**  
 Remarks:

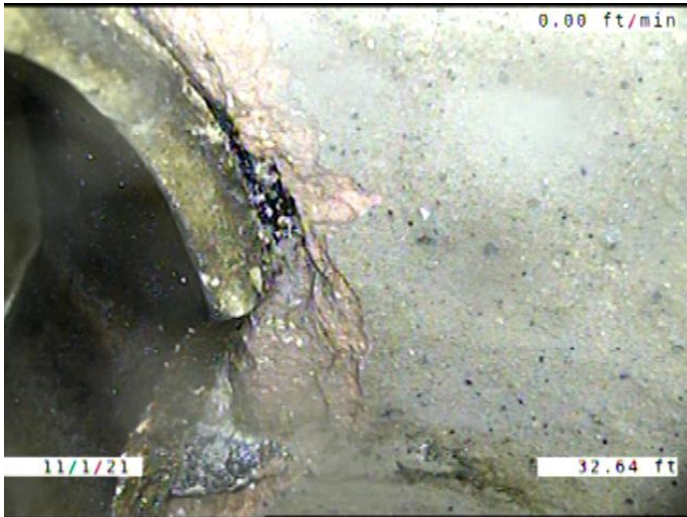
Code: **SSS**  
Description: **Surface Damage Surface Spalling**

Distance (ft): **32.6**  
Structural Grade: **2**  
O&M Grade: **0**  
Clock Start/From: **11**  
Clock To: **1**  
1st Value:  
2nd Value:  
Value Percent:  
Continuous Index:  
Within 8" of Joint: **YES**  
Remarks:

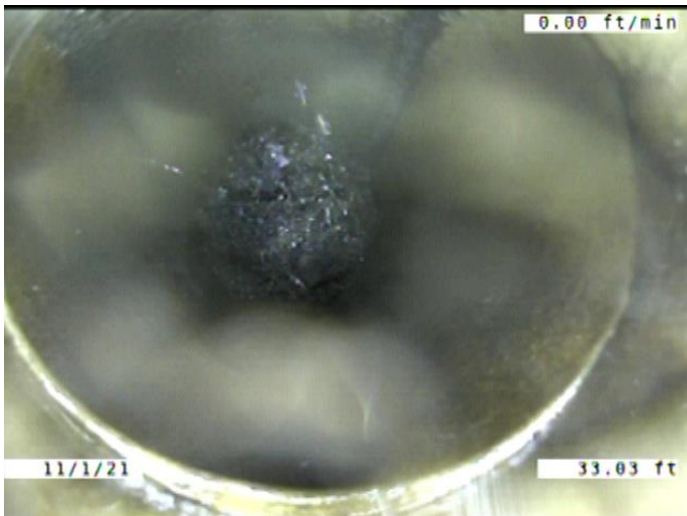
Code: **TBD**  
Description: **Tap Break-in/Hammer Defective**

Distance (ft): **33.0**  
Structural Grade: **0**  
O&M Grade: **3**  
Clock Start/From: **12**  
Clock To:  
1st Value: **4.000**  
2nd Value:  
Value Percent:  
Continuous Index:  
Within 8" of Joint: **YES**  
Remarks: **CONSTANTLY RUNNING WATER.  
LOOKS TO BE 100% PLUGGED WITH**

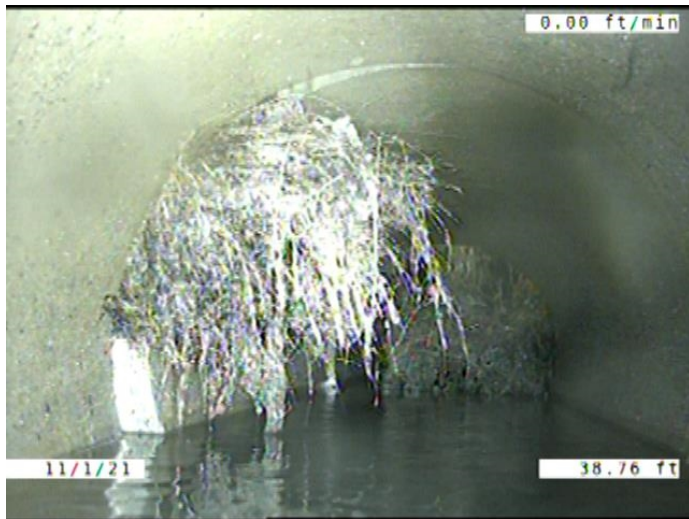
Code: **RMJ**  
 Description: **Roots Medium Joint**

Distance (ft): **38.8**  
 Structural Grade: **0**  
 O&M Grade: **3**  
 Clock Start/From: **9**  
 Clock To: **11**  
 1st Value:  
 2nd Value:  
 Value Percent: **25.000**  
 Continuous Index:  
 Within 8" of Joint: **YES**  
 Remarks:

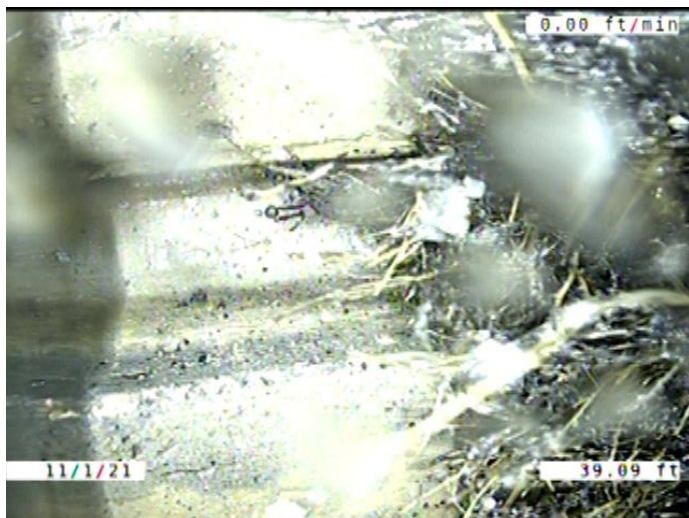
Code: **JAM**  
 Description: **Joint Angular Medium**

Distance (ft): **39.1**  
 Structural Grade: **3**  
 O&M Grade: **0**  
 Clock Start/From:  
 Clock To:  
 1st Value:  
 2nd Value:  
 Value Percent:  
 Continuous Index:  
 Within 8" of Joint: **NO**  
 Remarks:

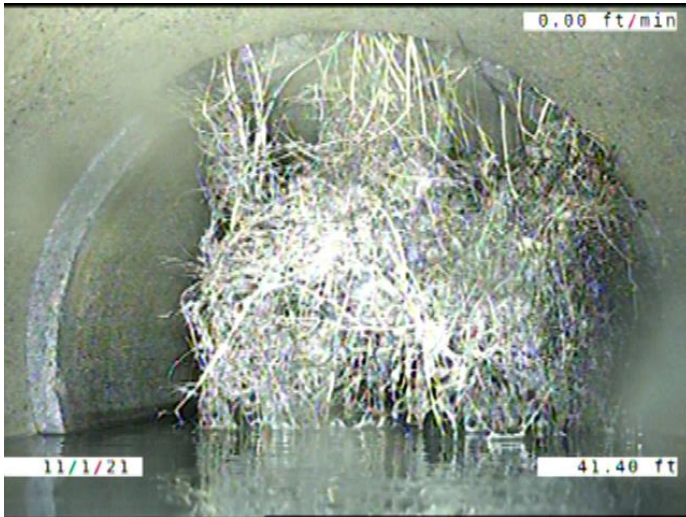
Code: **RBJ**  
Description: **Roots Ball Joint**

Distance (ft): **41.4**  
Structural Grade: **0**  
O&M Grade: **4**  
Clock Start/From: **11**  
Clock To: **4**  
1st Value:  
2nd Value:  
Value Percent: **60.000**  
Continuous Index:  
Within 8" of Joint: **YES**  
Remarks:

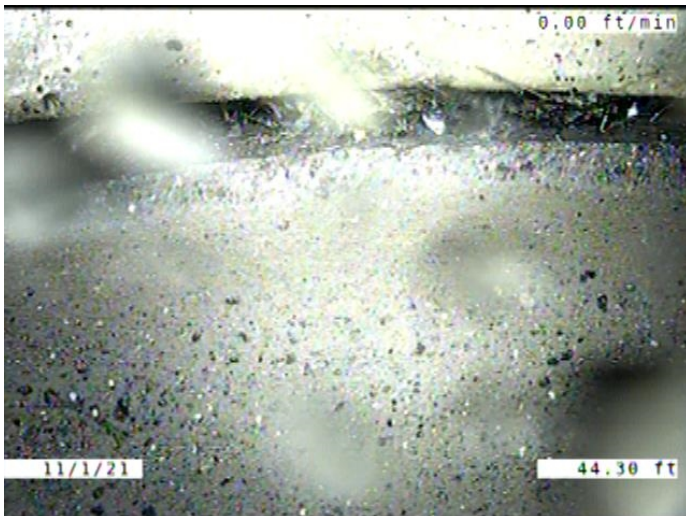
Code: **RFJ**  
Description: **Roots Fine Joint**

Distance (ft): **44.3**  
Structural Grade: **0**  
O&M Grade: **1**  
Clock Start/From: **8**  
Clock To: **11**  
1st Value:  
2nd Value:  
Value Percent:  
Continuous Index:  
Within 8" of Joint: **YES**  
Remarks:

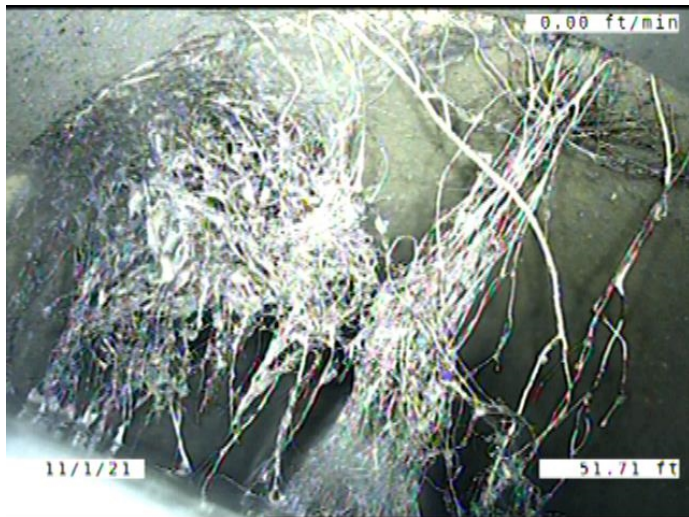
Code: **RMJ**  
 Description: **Roots Medium Joint**

Distance (ft): **51.7**  
 Structural Grade: **0**  
 O&M Grade: **3**  
 Clock Start/From: **10**  
 Clock To: **2**  
 1st Value:  
 2nd Value:  
 Value Percent: **20.000**  
 Continuous Index:  
 Within 8" of Joint: **YES**  
 Remarks:

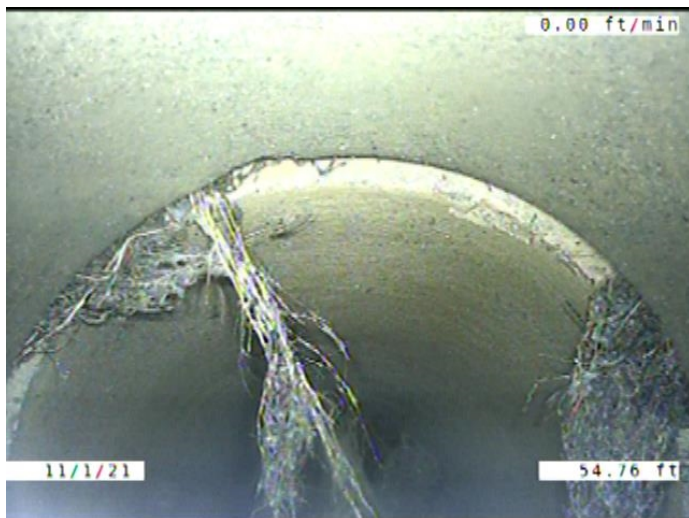
Code: **RMJ**  
 Description: **Roots Medium Joint**

Distance (ft): **54.8**  
 Structural Grade: **0**  
 O&M Grade: **3**  
 Clock Start/From: **9**  
 Clock To: **3**  
 1st Value:  
 2nd Value:  
 Value Percent: **15.000**  
 Continuous Index:  
 Within 8" of Joint: **YES**  
 Remarks:

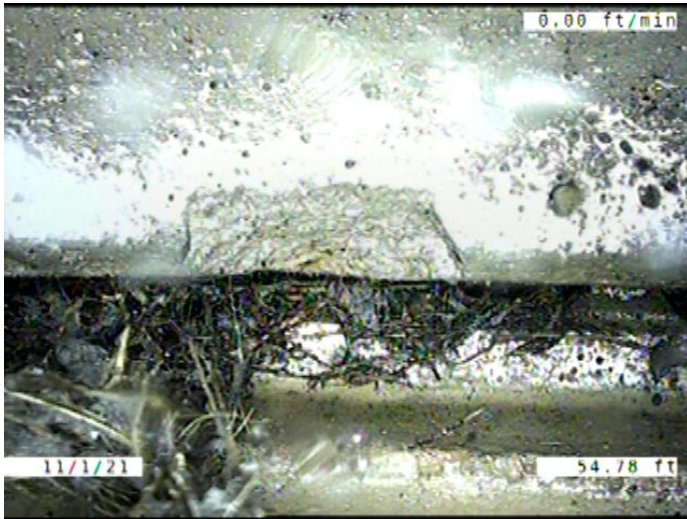
Code:	<b>SZ</b>
Description:	<b>Surface Damage Other</b>
Distance (ft):	<b>54.8</b>
Structural Grade:	<b>0</b>
O&M Grade:	<b>0</b>
Clock Start/From:	<b>11</b>
Clock To:	<b>12</b>
1st Value:	
2nd Value:	
Value Percent:	
Continuous Index:	
Within 8" of Joint:	<b>YES</b>
Remarks:	<b>A PIECE CHIPPED AWAY FROM THE JOINT</b>

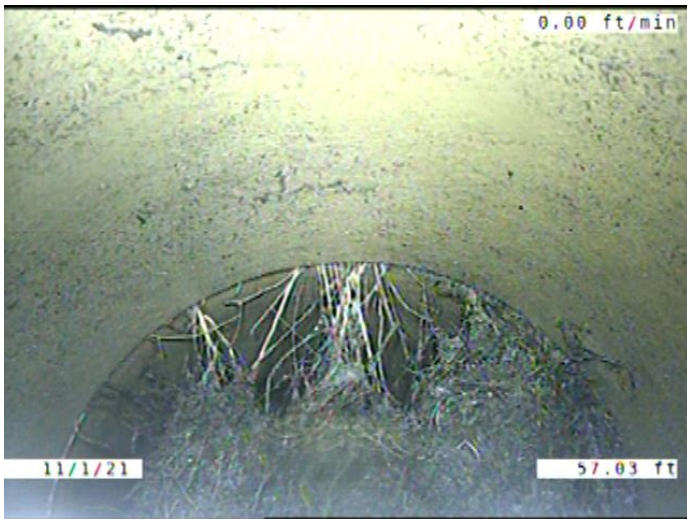
Code:	<b>RBJ</b>
Description:	<b>Roots Ball Joint</b>
Distance (ft):	<b>57.0</b>
Structural Grade:	<b>0</b>
O&M Grade:	<b>4</b>
Clock Start/From:	<b>9</b>
Clock To:	<b>3</b>
1st Value:	
2nd Value:	
Value Percent:	<b>80.000</b>
Continuous Index:	
Within 8" of Joint:	<b>YES</b>
Remarks:

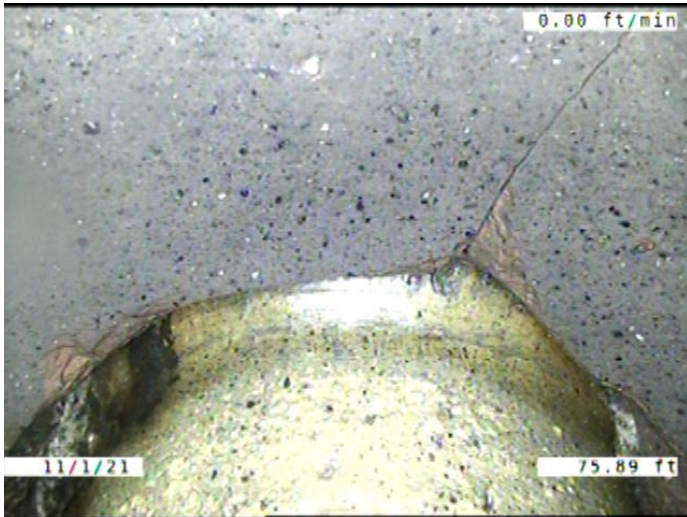
Code: **FM**  
 Description: **Fracture Multiple**

Distance (ft): **75.9**  
 Structural Grade: **4**  
 O&M Grade: **0**  
 Clock Start/From: **10**  
 Clock To: **1**  
 1st Value:  
 2nd Value:  
 Value Percent:  
 Continuous Index:  
 Within 8" of Joint: **YES**  
 Remarks:

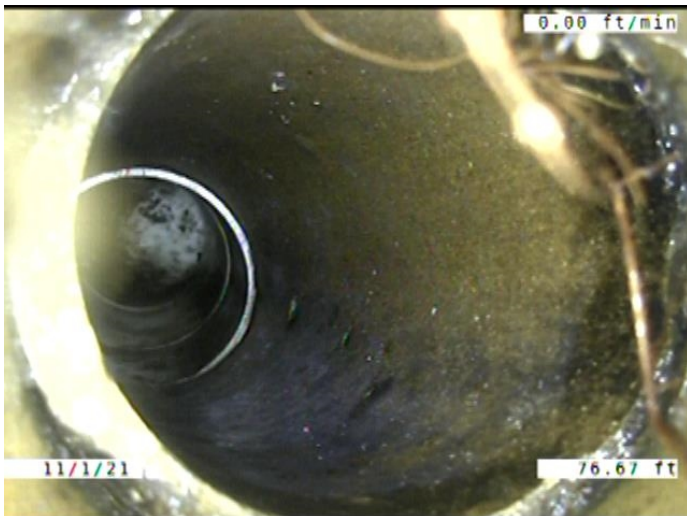
Code: **TBI**  
 Description: **Tap Break-in Intruding**

Distance (ft): **76.7**  
 Structural Grade: **0**  
 O&M Grade: **2**  
 Clock Start/From: **12**  
 Clock To:  
 1st Value: **4.000**  
 2nd Value: **1.000**  
 Value Percent:  
 Continuous Index:  
 Within 8" of Joint: **YES**  
 Remarks: **ROOTS GROWING FROM THE JOINT. CONSTANTLY DRIPPING WATER**

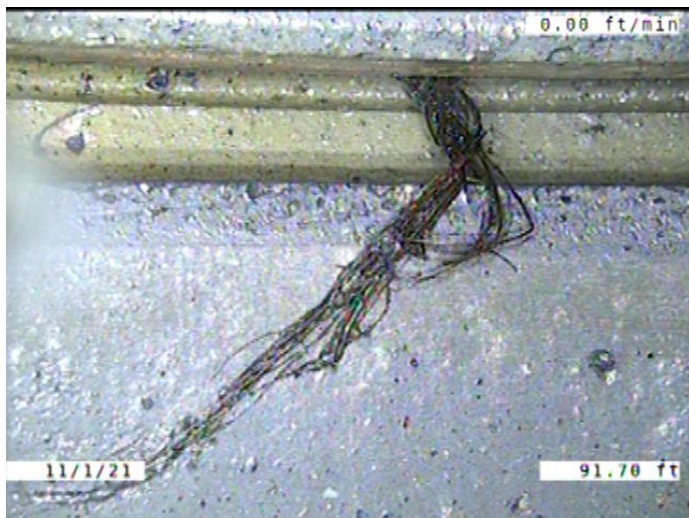
Code: **RFJ**  
 Description: **Roots Fine Joint**

Distance (ft): **91.7**  
 Structural Grade: **0**  
 O&M Grade: **1**  
 Clock Start/From: **10**  
 Clock To:  
 1st Value:  
 2nd Value:  
 Value Percent:  
 Continuous Index:  
 Within 8" of Joint: **YES**  
 Remarks:

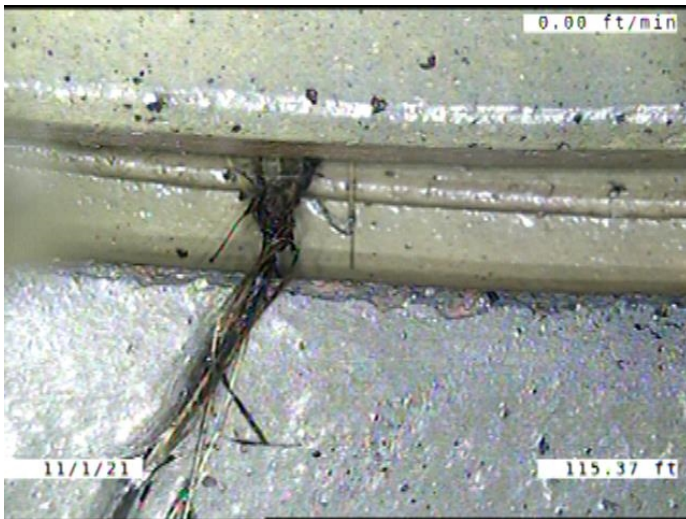
Code: **RFJ**  
 Description: **Roots Fine Joint**

Distance (ft): **115.4**  
 Structural Grade: **0**  
 O&M Grade: **1**  
 Clock Start/From: **10**  
 Clock To:  
 1st Value:  
 2nd Value:  
 Value Percent:  
 Continuous Index:  
 Within 8" of Joint: **YES**  
 Remarks:

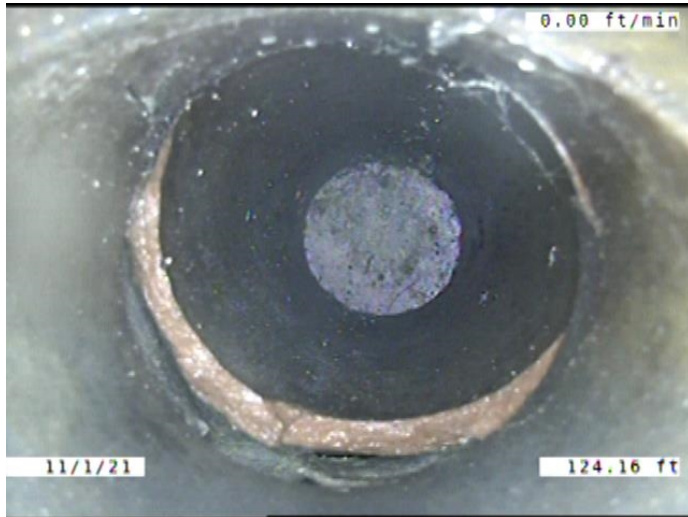
Code: **TFD**  
 Description: **Tap Factory Defective**

Distance (ft): **124.2**  
 Structural Grade: **0**  
 O&M Grade: **3**  
 Clock Start/From: **1**  
 Clock To:  
 1st Value: **4.000**  
 2nd Value:  
 Value Percent:  
 Continuous Index:  
 Within 8" of Joint: **YES**  
 Remarks: **CAPPED. LARGE OFFSET. SOIL VISIBLE.**

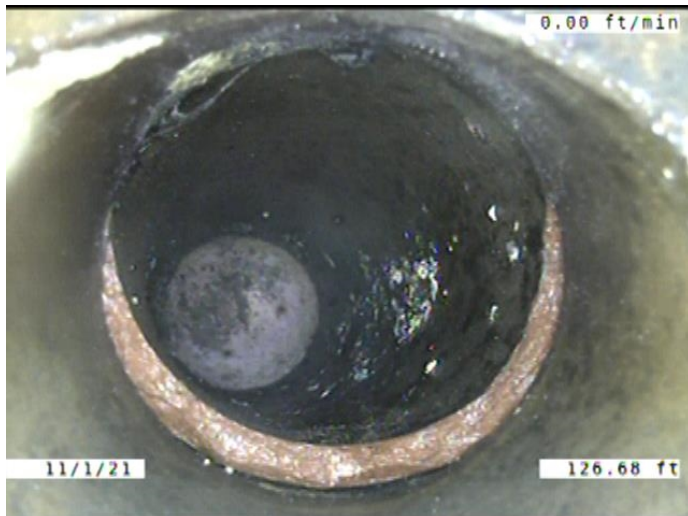
Code: **TFD**  
 Description: **Tap Factory Defective**

Distance (ft): **126.7**  
 Structural Grade: **0**  
 O&M Grade: **3**  
 Clock Start/From: **11**  
 Clock To:  
 1st Value: **4.000**  
 2nd Value:  
 Value Percent:  
 Continuous Index:  
 Within 8" of Joint: **YES**  
 Remarks: **CAPPED. OFFSET. SOIL VISIBLE.**

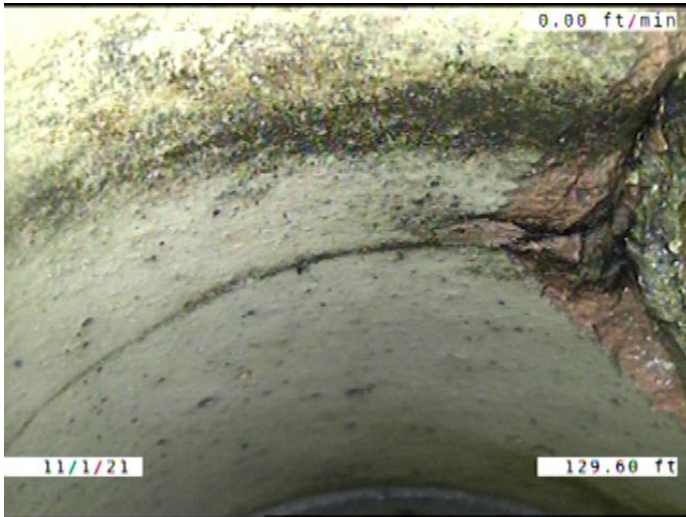
Code: **SSS**  
Description: **Surface Damage Surface Spalling**

Distance (ft): **129.6**  
Structural Grade: **2**  
O&M Grade: **0**  
Clock Start/From: **12**  
Clock To: **12**  
1st Value:  
2nd Value:  
Value Percent:  
Continuous Index:  
Within 8" of Joint: **YES**  
Remarks:

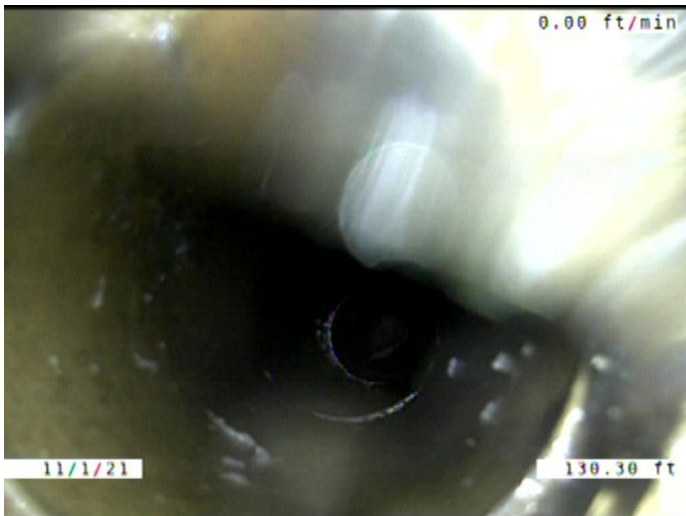
Code: **TBI**  
Description: **Tap Break-in Intruding**

Distance (ft): **130.3**  
Structural Grade: **0**  
O&M Grade: **2**  
Clock Start/From: **12**  
Clock To:  
1st Value: **4.000**  
2nd Value: **1.000**  
Value Percent:  
Continuous Index:  
Within 8" of Joint: **YES**  
Remarks: **CONSTANTLY RUNNING WATER.**

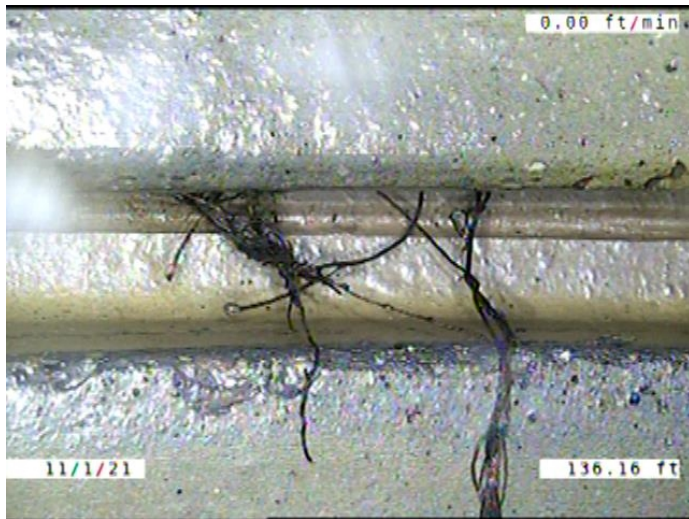
Code: **RFJ**  
 Description: **Roots Fine Joint**

Distance (ft): **136.2**  
 Structural Grade: **0**  
 O&M Grade: **1**  
 Clock Start/From: **10**  
 Clock To:  
 1st Value:  
 2nd Value:  
 Value Percent:  
 Continuous Index:  
 Within 8" of Joint: **YES**  
 Remarks:

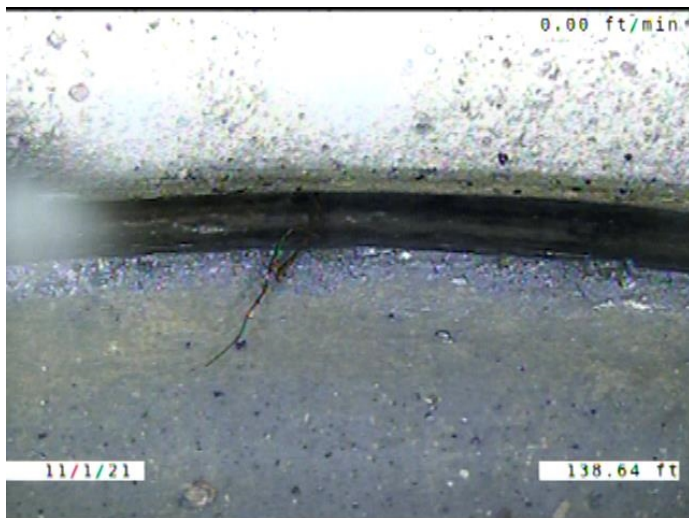
Code: **RFJ**  
 Description: **Roots Fine Joint**

Distance (ft): **138.6**  
 Structural Grade: **0**  
 O&M Grade: **1**  
 Clock Start/From: **11**  
 Clock To:  
 1st Value:  
 2nd Value:  
 Value Percent:  
 Continuous Index:  
 Within 8" of Joint: **YES**  
 Remarks:
