Profile/Photo Observation Report

Date:	11/01/2021	Weather:		Coding:	PACP 7.0
Pipe Length (ft):	155.8	Owner:	City of Hobart	Pre Clean:	Heavy Cleaning
P.O.#:	YES502259	Surveyor:	S. Bucklin	PSR:	P-504-031-030
Customer:	City of Hobart	Clean Date:	10/28/2021	Shape:	C

Street:	North Colorado Street	Flow Control:	Not Controlled
City:	Hobart, IN	Year Renewed:	
Location:	Alley	Tape/Media #:	
Purpose:	Routine Assessment	Dia/Height:	12"
Use:	Sanitary Sewage Pipe	Material:	VCP
Drain Area:		Lining:	None
Category:	NA		
Comment:			
Location Details:		Direction of Survey:	Upstream
US MH:	M-504-030	DS MH:	M-504-031
		Total Length Surveyed (ft):	155.8

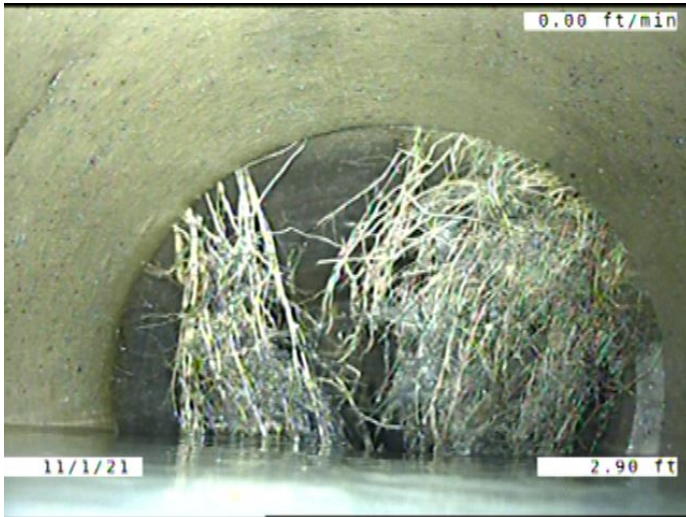
Code: **RMJ**
Description: **Roots Medium Joint**

Distance (ft): **2.9**
Structural Grade: **0**
O&M Grade: **3**
Clock Start/From: **9**
Clock To: **3**
1st Value:
2nd Value:
Value Percent: **50.000**
Continuous Index:
Within 8" of Joint: **YES**
Remarks:

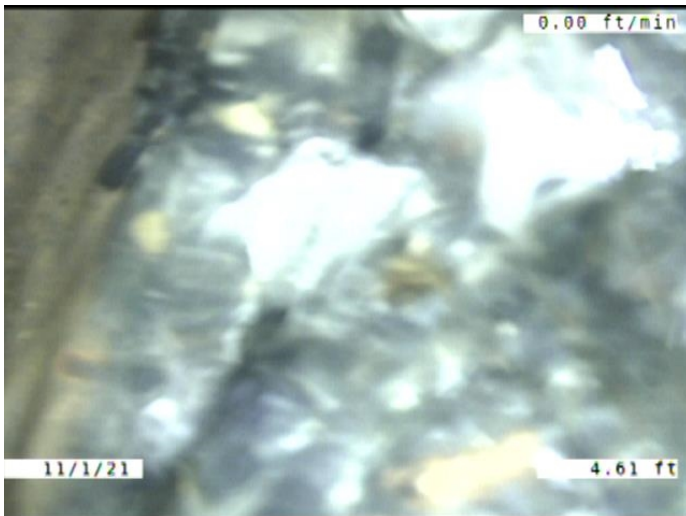
Code: **DSF**
Description: **Deposits Settled Fine**

Distance (ft): **4.6**
Structural Grade: **0**
O&M Grade: **2**
Clock Start/From: **4**
Clock To: **8**
1st Value:
2nd Value:
Value Percent: **10.000**
Continuous Index:
Within 8" of Joint: **YES**
Remarks:

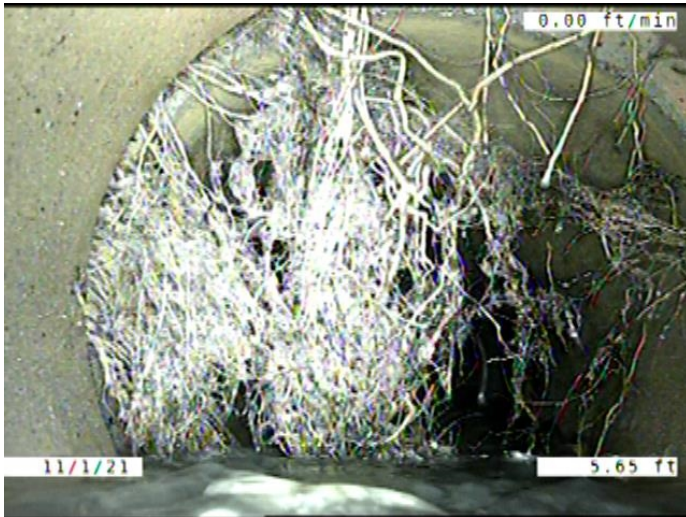
Code: **RMJ**
 Description: **Roots Medium Joint**

Distance (ft): **5.7**
 Structural Grade: **0**
 O&M Grade: **3**
 Clock Start/From: **7**
 Clock To: **3**
 1st Value:
 2nd Value:
 Value Percent: **50.000**
 Continuous Index:
 Within 8" of Joint: **YES**
 Remarks:

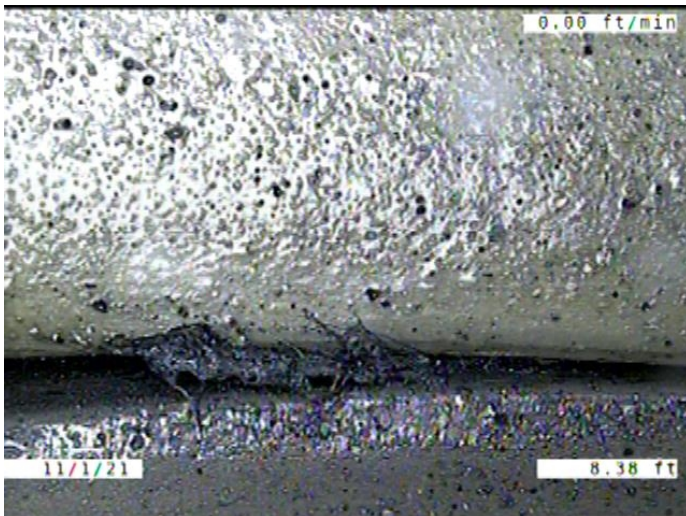
Code: **RFJ**
 Description: **Roots Fine Joint**

Distance (ft): **8.4**
 Structural Grade: **0**
 O&M Grade: **1**
 Clock Start/From: **9**
 Clock To: **1**
 1st Value:
 2nd Value:
 Value Percent:
 Continuous Index:
 Within 8" of Joint: **YES**
 Remarks:

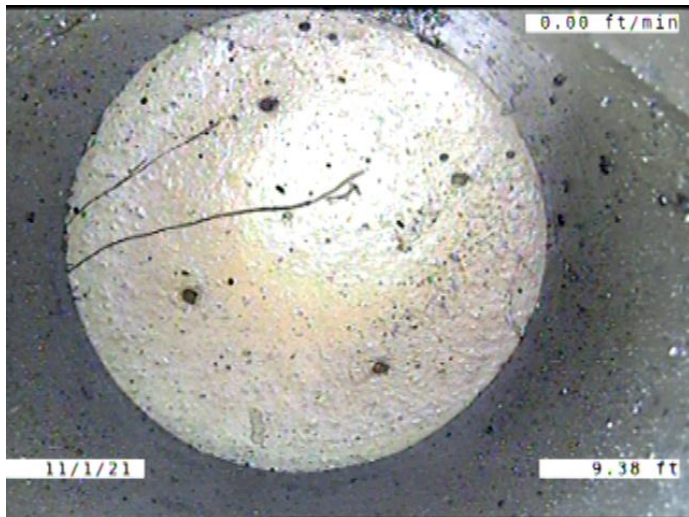
Code: **TFC**
 Description: **Tap Factory Capped**

Distance (ft): **9.4**
 Structural Grade: **0**
 O&M Grade: **0**
 Clock Start/From: **1**
 Clock To:
 1st Value: **4.000**
 2nd Value:
 Value Percent:
 Continuous Index:
 Within 8" of Joint: **YES**
 Remarks: **ROOTS GROWING AROUND THE CAP**

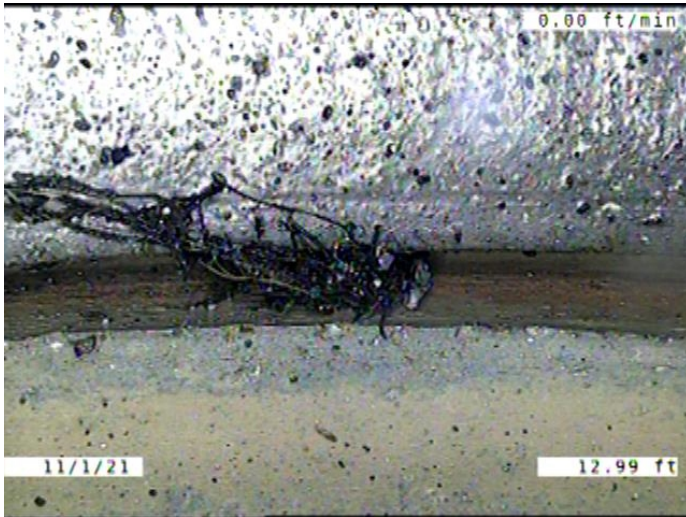
Code: **RFJ**
 Description: **Roots Fine Joint**

Distance (ft): **13.0**
 Structural Grade: **0**
 O&M Grade: **1**
 Clock Start/From: **9**
 Clock To: **10**
 1st Value:
 2nd Value:
 Value Percent:
 Continuous Index:
 Within 8" of Joint: **YES**
 Remarks:

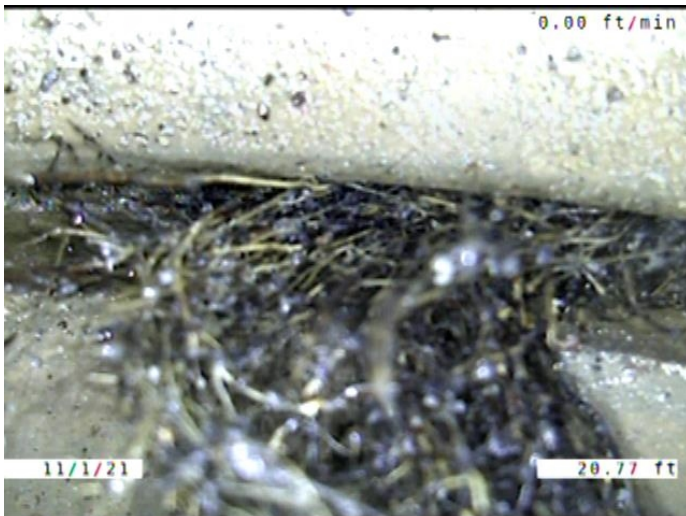
Code: **RMJ**
 Description: **Roots Medium Joint**

Distance (ft): **20.8**
 Structural Grade: **0**
 O&M Grade: **3**
 Clock Start/From: **12**
 Clock To: **3**
 1st Value:
 2nd Value:
 Value Percent: **5.000**
 Continuous Index:
 Within 8" of Joint: **YES**
 Remarks:

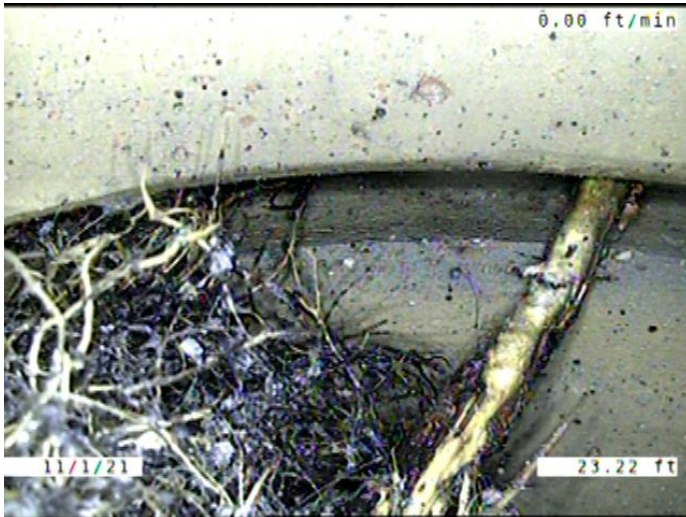
Code: **RMJ**
 Description: **Roots Medium Joint**

Distance (ft): **23.2**
 Structural Grade: **0**
 O&M Grade: **3**
 Clock Start/From: **9**
 Clock To: **11**
 1st Value:
 2nd Value:
 Value Percent: **15.000**
 Continuous Index:
 Within 8" of Joint: **YES**
 Remarks:

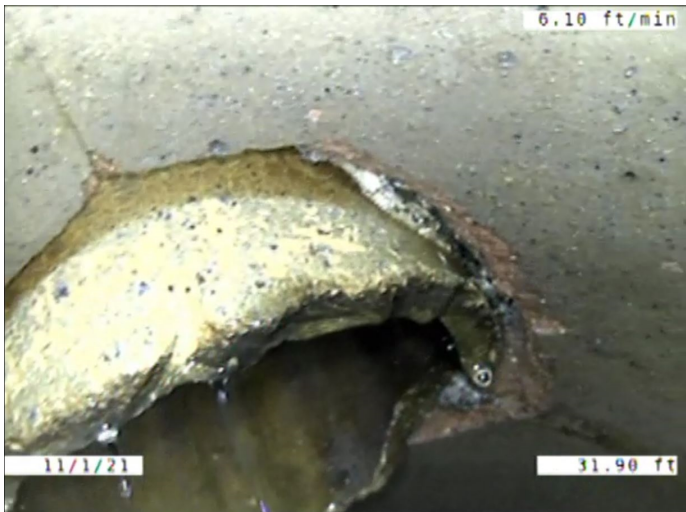
Code: **CL**
 Description: **Crack Longitudinal**

Distance (ft): **31.9**
 Structural Grade: **2**
 O&M Grade: **0**
 Clock Start/From: **12**
 Clock To:
 1st Value:
 2nd Value:
 Value Percent:
 Continuous Index:
 Within 8" of Joint: **NO**
 Remarks:

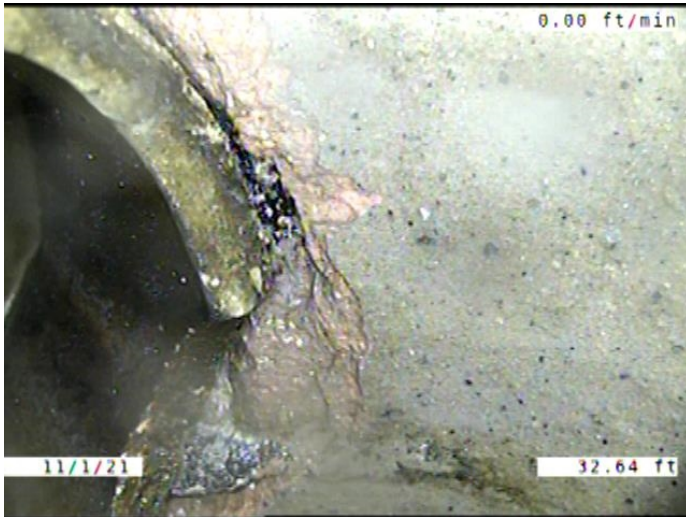
Code: **SSS**
 Description: **Surface Damage Surface Spalling**

Distance (ft): **32.6**
 Structural Grade: **2**
 O&M Grade: **0**
 Clock Start/From: **11**
 Clock To: **1**
 1st Value:
 2nd Value:
 Value Percent:
 Continuous Index:
 Within 8" of Joint: **YES**
 Remarks:

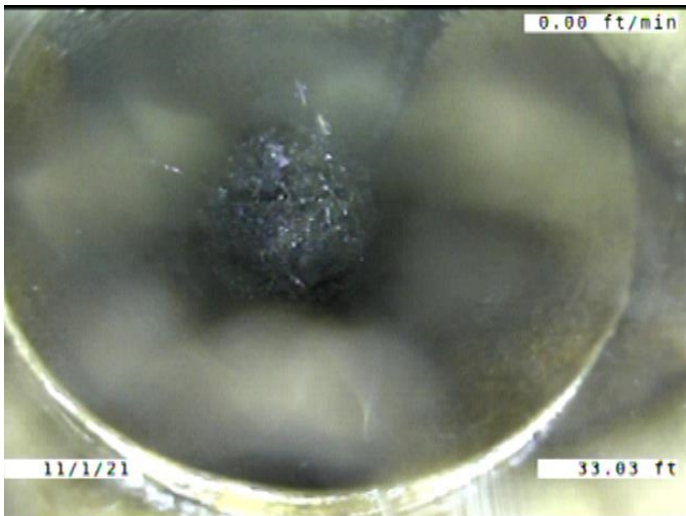
Code: **TBD**
 Description: **Tap Break-in/Hammer Defective**

Distance (ft): **33.0**
 Structural Grade: **0**
 O&M Grade: **3**
 Clock Start/From: **12**
 Clock To:
 1st Value: **4.000**
 2nd Value:
 Value Percent:
 Continuous Index:
 Within 8" of Joint: **YES**
 Remarks: **CONSTANTLY RUNNING WATER.
 LOOKS TO BE 100% PLUGGED WITH**

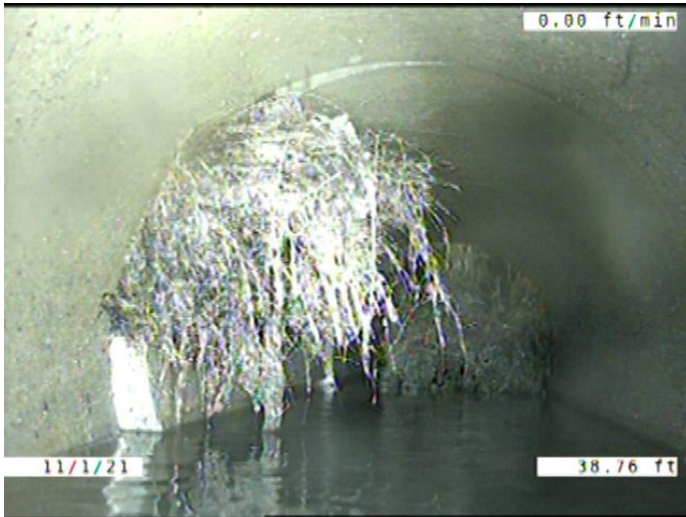
Code: **RMJ**
 Description: **Roots Medium Joint**

Distance (ft): **38.8**
 Structural Grade: **0**
 O&M Grade: **3**
 Clock Start/From: **9**
 Clock To: **11**
 1st Value:
 2nd Value:
 Value Percent: **25.000**
 Continuous Index:
 Within 8" of Joint: **YES**
 Remarks:

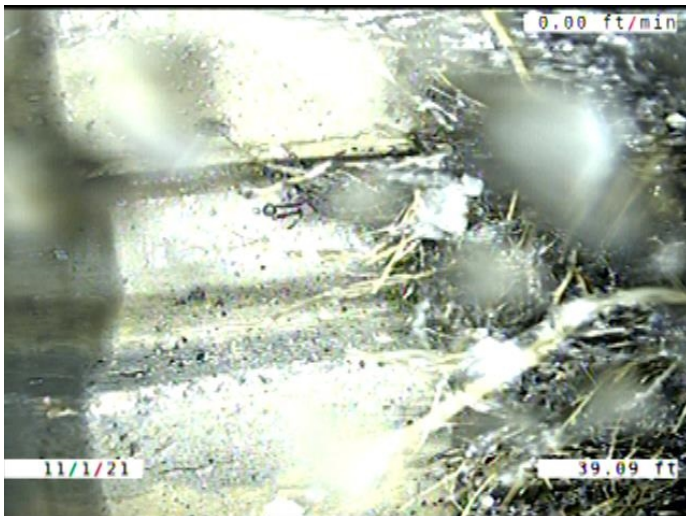
Code: **JAM**
 Description: **Joint Angular Medium**

Distance (ft): **39.1**
 Structural Grade: **3**
 O&M Grade: **0**
 Clock Start/From:
 Clock To:
 1st Value:
 2nd Value:
 Value Percent:
 Continuous Index:
 Within 8" of Joint: **NO**
 Remarks:

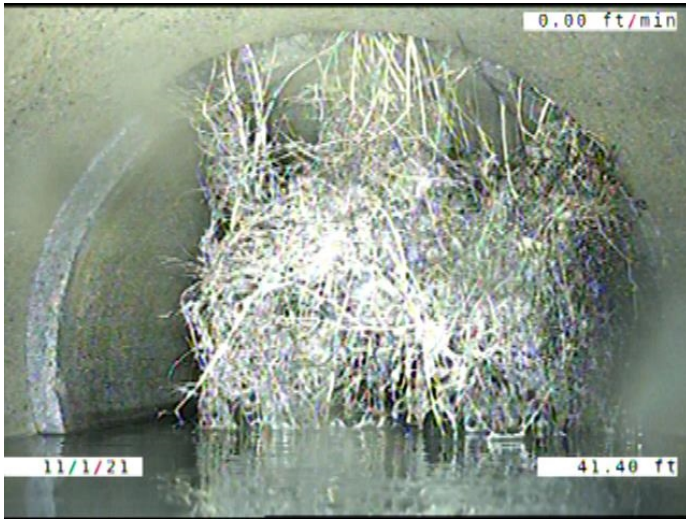
Code: **RBJ**
 Description: **Roots Ball Joint**

Distance (ft): **41.4**
 Structural Grade: **0**
 O&M Grade: **4**
 Clock Start/From: **11**
 Clock To: **4**
 1st Value:
 2nd Value:
 Value Percent: **60.000**
 Continuous Index:
 Within 8" of Joint: **YES**
 Remarks:

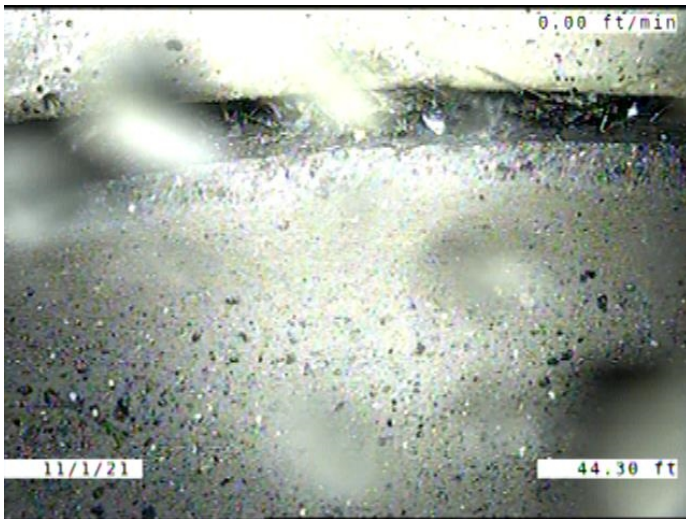
Code: **RFJ**
 Description: **Roots Fine Joint**

Distance (ft): **44.3**
 Structural Grade: **0**
 O&M Grade: **1**
 Clock Start/From: **8**
 Clock To: **11**
 1st Value:
 2nd Value:
 Value Percent:
 Continuous Index:
 Within 8" of Joint: **YES**
 Remarks:

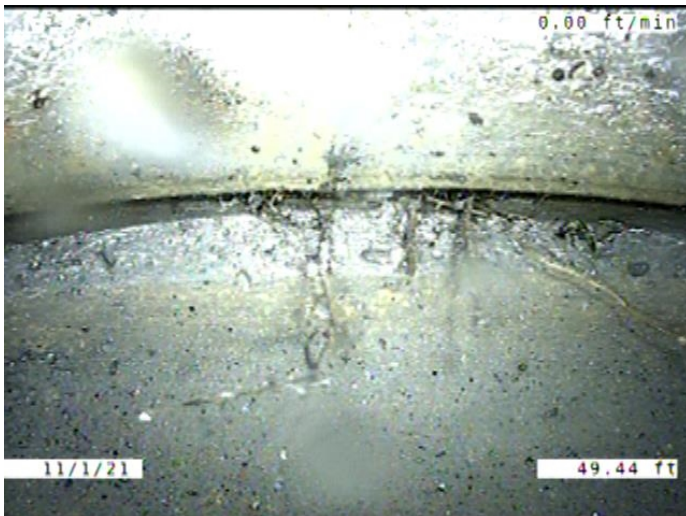
Code: **RFJ**
Description: **Roots Fine Joint**

Distance (ft): **49.4**
Structural Grade: **0**
O&M Grade: **1**
Clock Start/From: **11**
Clock To: **12**
1st Value:
2nd Value:
Value Percent:
Continuous Index:
Within 8" of Joint: **YES**
Remarks:

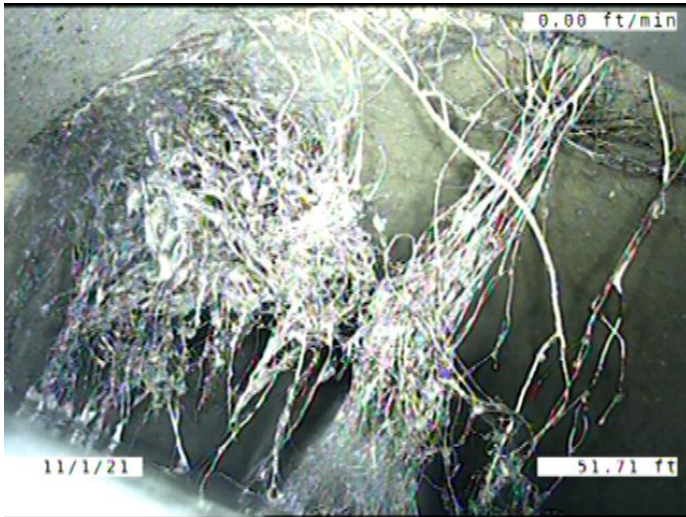
Code: **RMJ**
 Description: **Roots Medium Joint**

Distance (ft): **51.7**
 Structural Grade: **0**
 O&M Grade: **3**
 Clock Start/From: **10**
 Clock To: **2**
 1st Value:
 2nd Value:
 Value Percent: **20.000**
 Continuous Index:
 Within 8" of Joint: **YES**
 Remarks:

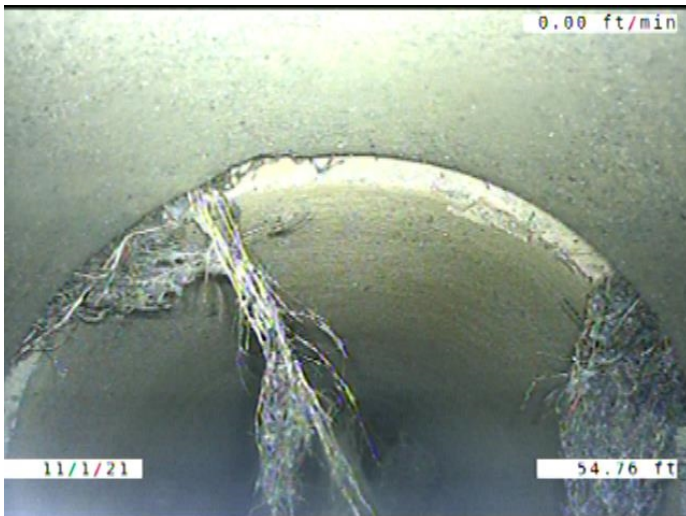
Code: **RMJ**
 Description: **Roots Medium Joint**

Distance (ft): **54.8**
 Structural Grade: **0**
 O&M Grade: **3**
 Clock Start/From: **9**
 Clock To: **3**
 1st Value:
 2nd Value:
 Value Percent: **15.000**
 Continuous Index:
 Within 8" of Joint: **YES**
 Remarks:

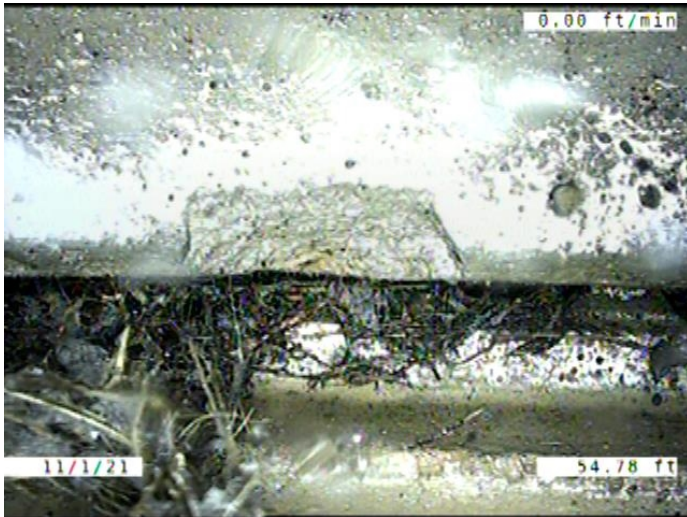
Code:	SZ
Description:	Surface Damage Other
Distance (ft):	54.8
Structural Grade:	0
O&M Grade:	0
Clock Start/From:	11
Clock To:	12
1st Value:	
2nd Value:	
Value Percent:	
Continuous Index:	
Within 8" of Joint:	YES
Remarks:	A PIECE CHIPPED AWAY FROM THE JOINT

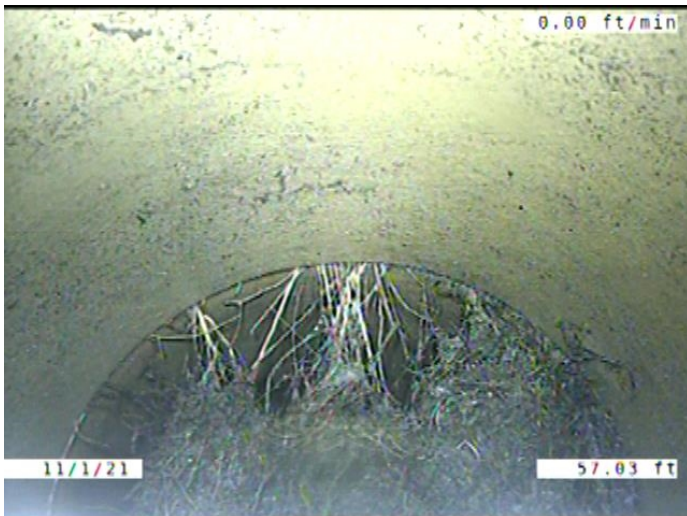
Code:	RBJ
Description:	Roots Ball Joint
Distance (ft):	57.0
Structural Grade:	0
O&M Grade:	4
Clock Start/From:	9
Clock To:	3
1st Value:	
2nd Value:	
Value Percent:	80.000
Continuous Index:	
Within 8" of Joint:	YES
Remarks:

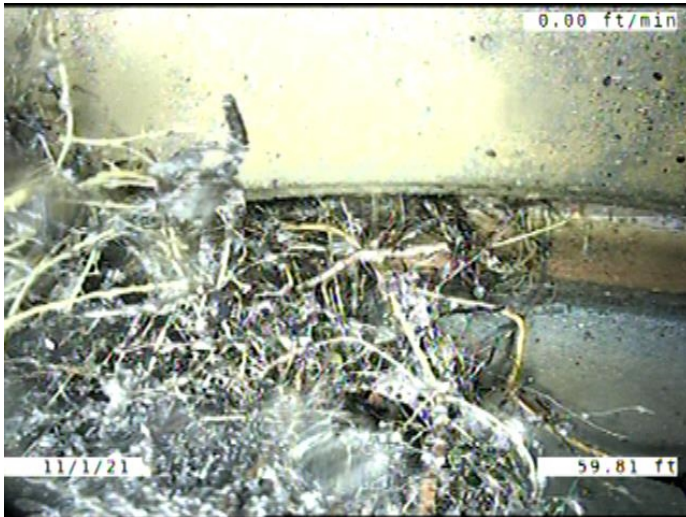
Code: **RMJ**
 Description: **Roots Medium Joint**

Distance (ft): **59.8**
 Structural Grade: **0**
 O&M Grade: **3**
 Clock Start/From: **9**
 Clock To: **11**
 1st Value:
 2nd Value:
 Value Percent: **25.000**
 Continuous Index:
 Within 8" of Joint: **YES**
 Remarks:

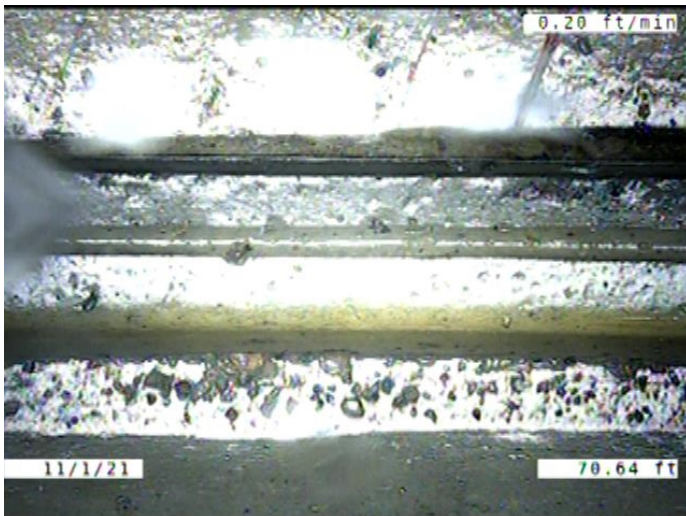
Code: **JAM**
Description: **Joint Angular Medium**

Distance (ft): **70.6**
Structural Grade: **3**
O&M Grade: **0**
Clock Start/From:
Clock To:
1st Value:
2nd Value:
Value Percent:
Continuous Index:
Within 8" of Joint: **NO**
Remarks:

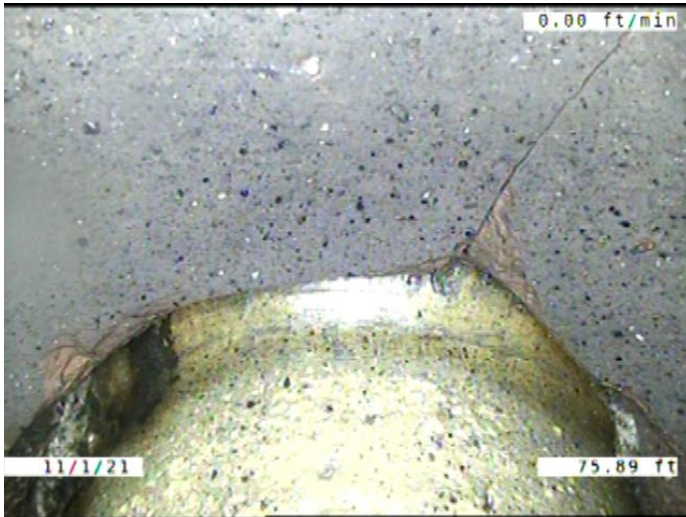
Code: **FM**
Description: **Fracture Multiple**

Distance (ft): **75.9**
Structural Grade: **4**
O&M Grade: **0**
Clock Start/From: **10**
Clock To: **1**
1st Value:
2nd Value:
Value Percent:
Continuous Index:
Within 8" of Joint: **YES**
Remarks:

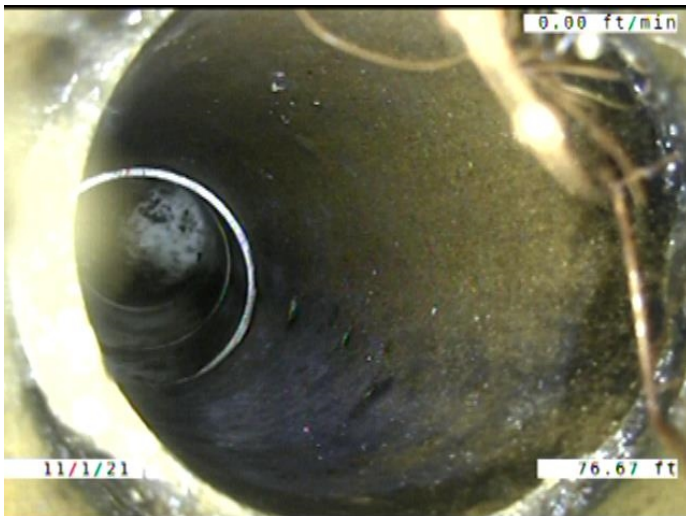
Code: **TBI**
Description: **Tap Break-in Intruding**

Distance (ft): **76.7**
Structural Grade: **0**
O&M Grade: **2**
Clock Start/From: **12**
Clock To:
1st Value: **4.000**
2nd Value: **1.000**
Value Percent:
Continuous Index:
Within 8" of Joint: **YES**
Remarks: **ROOTS GROWING FROM THE JOINT.
CONSTANTLY DRIPPING WATER**

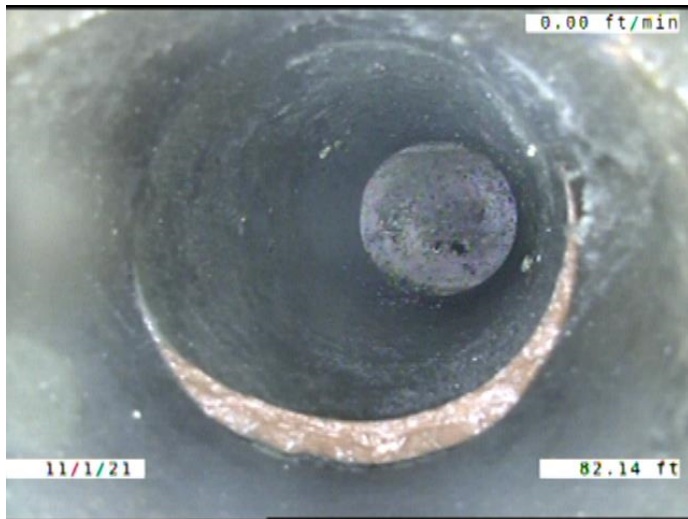
Code: **TFD**
 Description: **Tap Factory Defective**

Distance (ft): **82.1**
 Structural Grade: **0**
 O&M Grade: **3**
 Clock Start/From: **1**
 Clock To:
 1st Value: **4.000**
 2nd Value:
 Value Percent:
 Continuous Index:
 Within 8" of Joint: **YES**
 Remarks: **CAPPED. OFFSET. SOIL VISIBLE.**

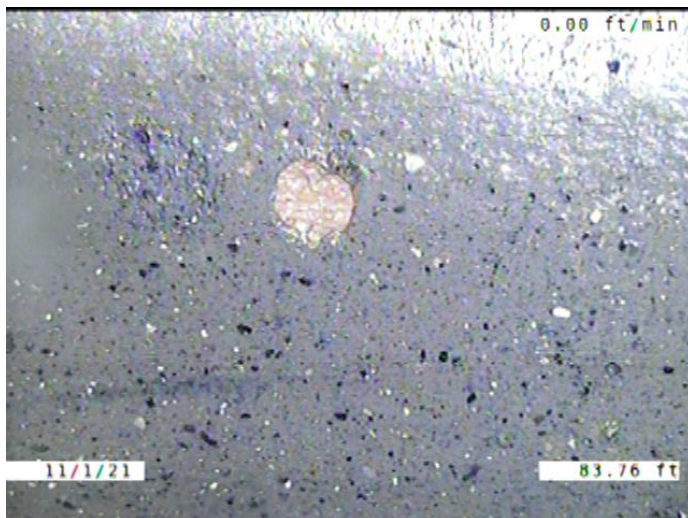
Code: **SSS**
 Description: **Surface Damage Surface Spalling**

Distance (ft): **83.8**
 Structural Grade: **2**
 O&M Grade: **0**
 Clock Start/From: **2**
 Clock To:
 1st Value:
 2nd Value:
 Value Percent:
 Continuous Index:
 Within 8" of Joint: **YES**
 Remarks:

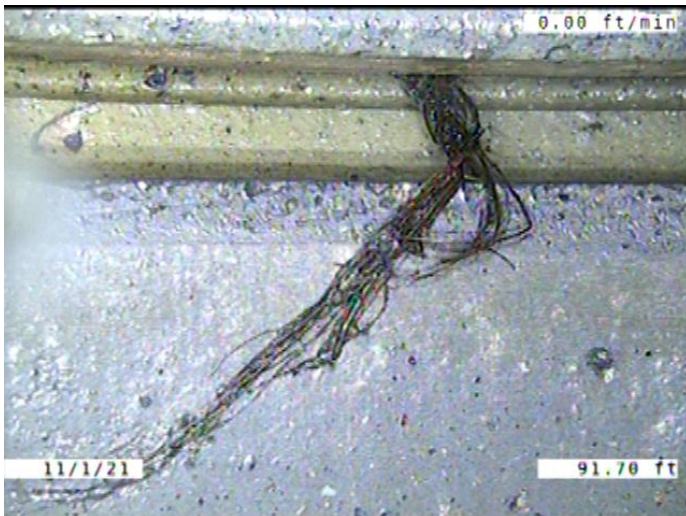
Code: **RFJ**
 Description: **Roots Fine Joint**

Distance (ft): **91.7**
 Structural Grade: **0**
 O&M Grade: **1**
 Clock Start/From: **10**
 Clock To:
 1st Value:
 2nd Value:
 Value Percent:
 Continuous Index:
 Within 8" of Joint: **YES**
 Remarks:

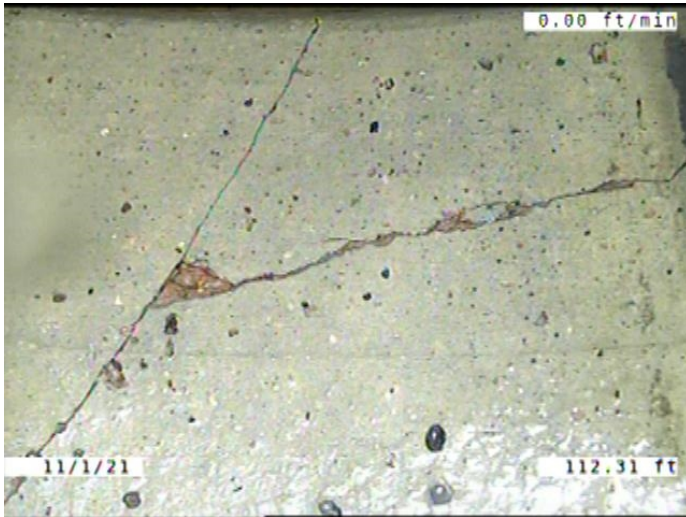
Code: **CM**
 Description: **Crack Multiple**

Distance (ft): **112.3**
 Structural Grade: **3**
 O&M Grade: **0**
 Clock Start/From: **7**
 Clock To: **10**
 1st Value:
 2nd Value:
 Value Percent:
 Continuous Index:
 Within 8" of Joint: **YES**
 Remarks:

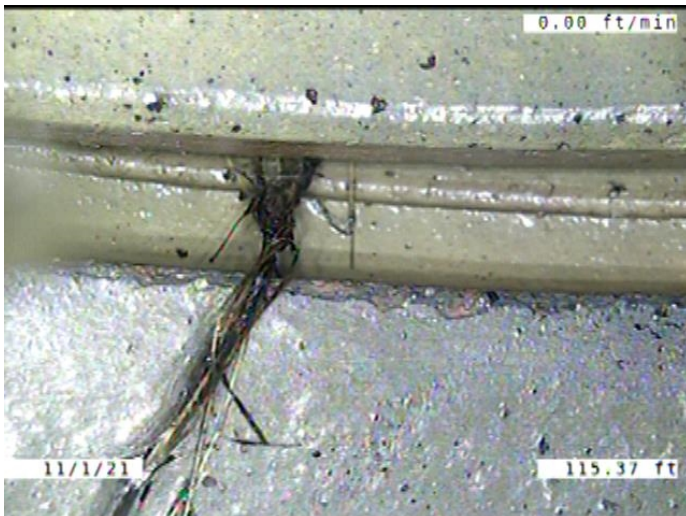
Code: **RFJ**
 Description: **Roots Fine Joint**

Distance (ft): **115.4**
 Structural Grade: **0**
 O&M Grade: **1**
 Clock Start/From: **10**
 Clock To:
 1st Value:
 2nd Value:
 Value Percent:
 Continuous Index:
 Within 8" of Joint: **YES**
 Remarks:

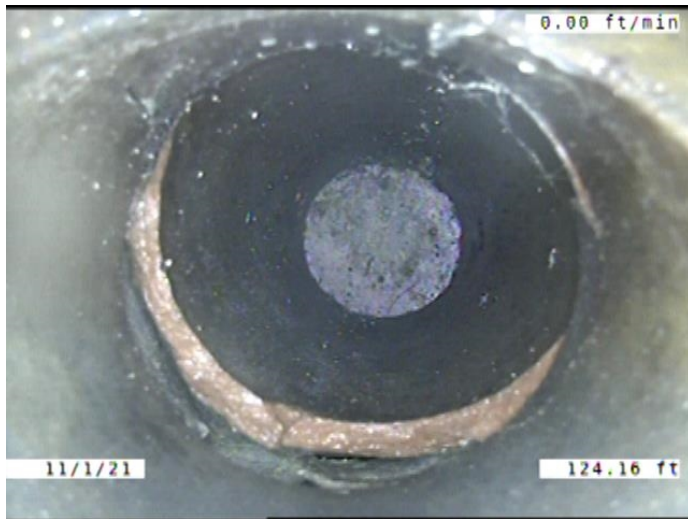
Code: **TFD**
 Description: **Tap Factory Defective**

Distance (ft): **124.2**
 Structural Grade: **0**
 O&M Grade: **3**
 Clock Start/From: **1**
 Clock To:
 1st Value: **4.000**
 2nd Value:
 Value Percent:
 Continuous Index:
 Within 8" of Joint: **YES**
 Remarks: **CAPPED. LARGE OFFSET. SOIL VISIBLE.**

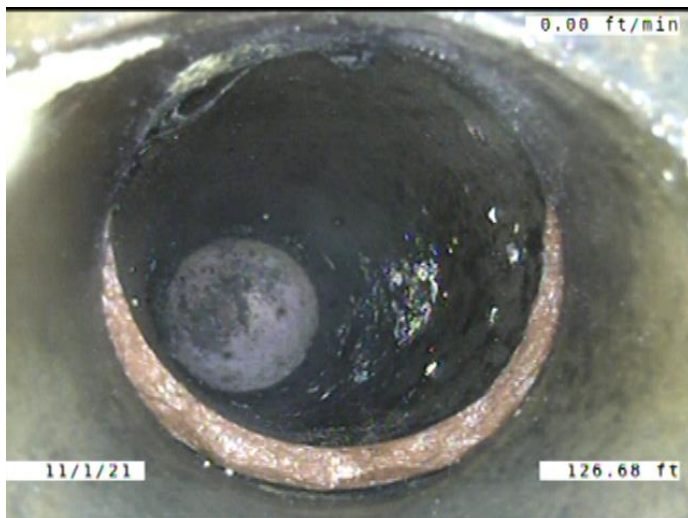
Code: **TFD**
 Description: **Tap Factory Defective**

Distance (ft): **126.7**
 Structural Grade: **0**
 O&M Grade: **3**
 Clock Start/From: **11**
 Clock To:
 1st Value: **4.000**
 2nd Value:
 Value Percent:
 Continuous Index:
 Within 8" of Joint: **YES**
 Remarks: **CAPPED. OFFSET. SOIL VISIBLE.**

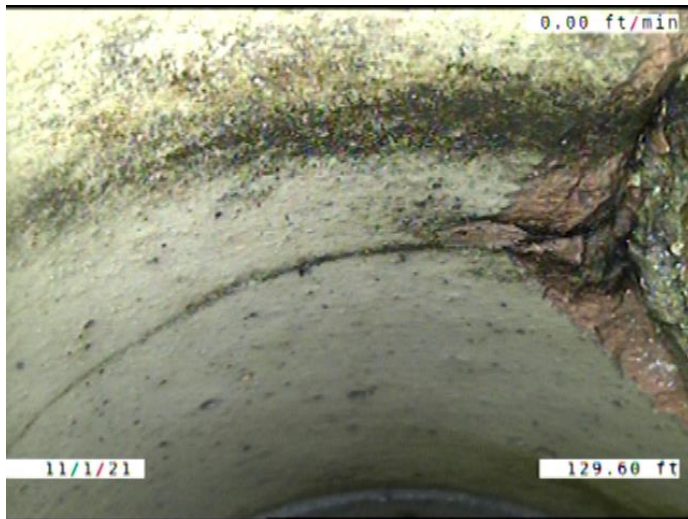
Code: **SSS**
 Description: **Surface Damage Surface Spalling**

Distance (ft): **129.6**
 Structural Grade: **2**
 O&M Grade: **0**
 Clock Start/From: **12**
 Clock To: **12**
 1st Value:
 2nd Value:
 Value Percent:
 Continuous Index:
 Within 8" of Joint: **YES**
 Remarks:

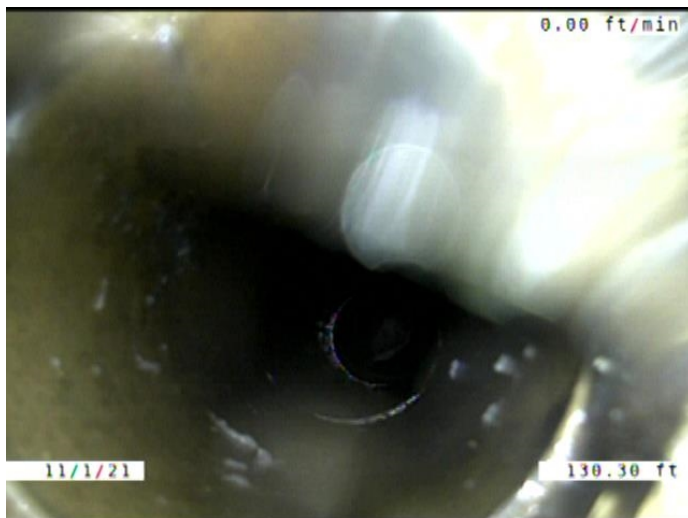
Code: **TBI**
 Description: **Tap Break-in Intruding**

Distance (ft): **130.3**
 Structural Grade: **0**
 O&M Grade: **2**
 Clock Start/From: **12**
 Clock To:
 1st Value: **4.000**
 2nd Value: **1.000**
 Value Percent:
 Continuous Index:
 Within 8" of Joint: **YES**
 Remarks: **CONSTANTLY RUNNING WATER.**

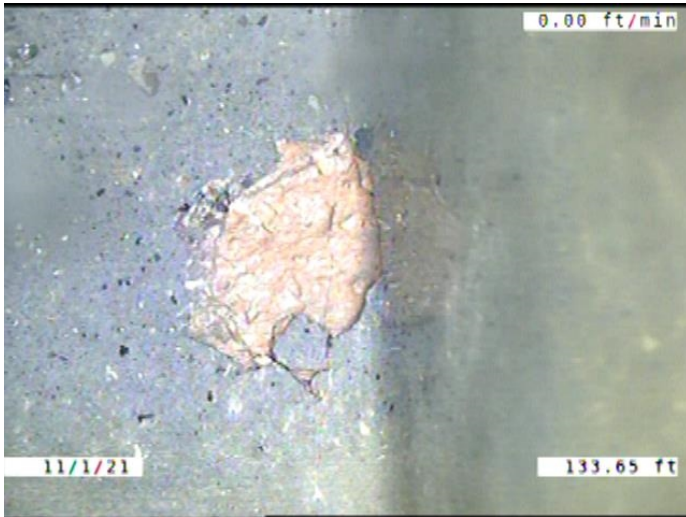
Code: **SSS**
Description: **Surface Damage Surface Spalling**

Distance (ft): **133.7**
Structural Grade: **2**
O&M Grade: **0**
Clock Start/From: **8**
Clock To:
1st Value:
2nd Value:
Value Percent:
Continuous Index:
Within 8" of Joint: **YES**
Remarks:

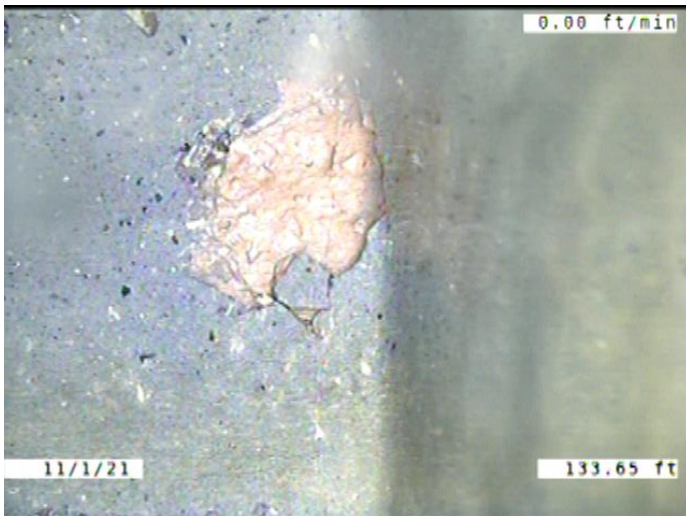
Code: **CL**
Description: **Crack Longitudinal**

Distance (ft): **133.7**
Structural Grade: **2**
O&M Grade: **0**
Clock Start/From: **8**
Clock To:
1st Value:
2nd Value:
Value Percent:
Continuous Index:
Within 8" of Joint: **YES**
Remarks:

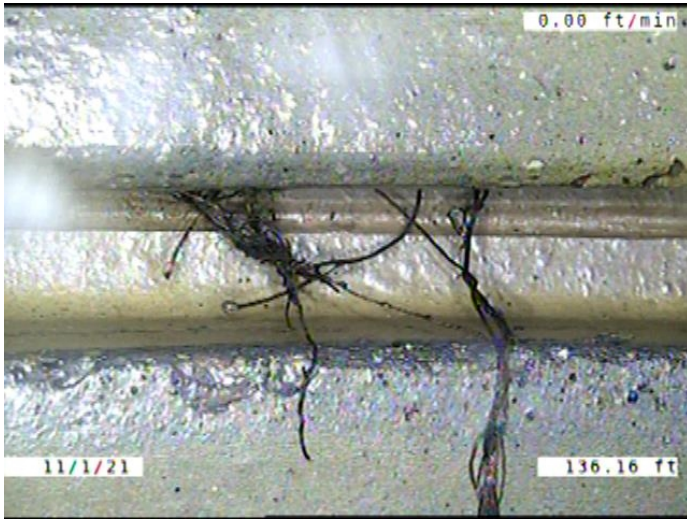
Code: **RFJ**
Description: **Roots Fine Joint**

Distance (ft): **136.2**
Structural Grade: **0**
O&M Grade: **1**
Clock Start/From: **10**
Clock To:
1st Value:
2nd Value:
Value Percent:
Continuous Index:
Within 8" of Joint: **YES**
Remarks:

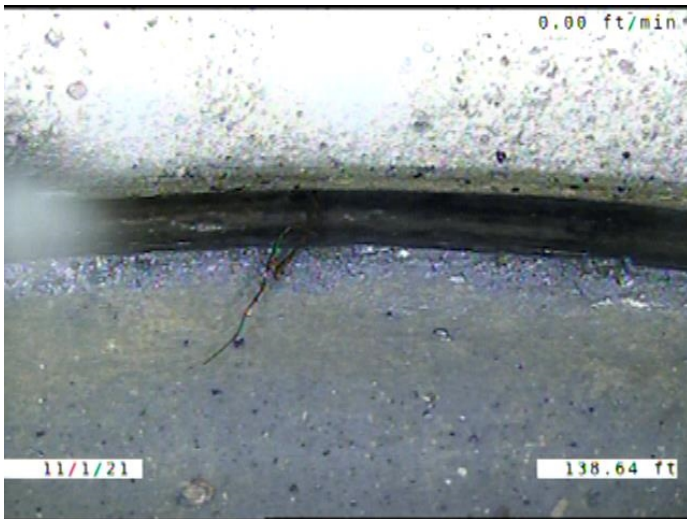
Code: **RFJ**
Description: **Roots Fine Joint**

Distance (ft): **138.6**
Structural Grade: **0**
O&M Grade: **1**
Clock Start/From: **11**
Clock To:
1st Value:
2nd Value:
Value Percent:
Continuous Index:
Within 8" of Joint: **YES**
Remarks:

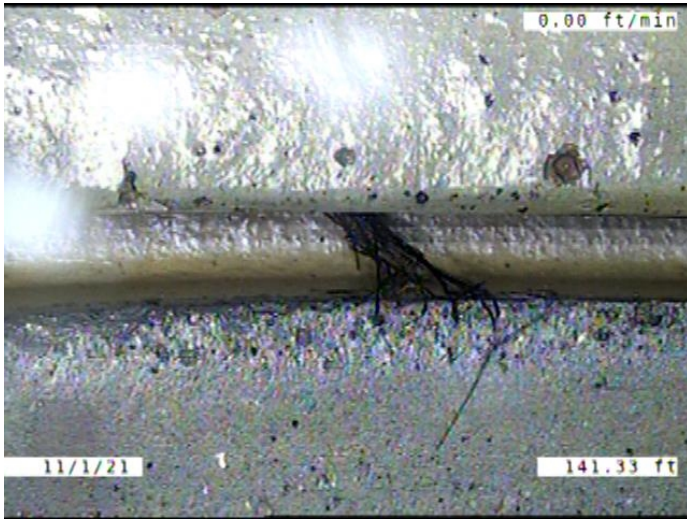
Code: **RFJ**
Description: **Roots Fine Joint**

Distance (ft): **141.3**
Structural Grade: **0**
O&M Grade: **1**
Clock Start/From: **10**
Clock To:
1st Value:
2nd Value:
Value Percent:
Continuous Index:
Within 8" of Joint: **YES**
Remarks:

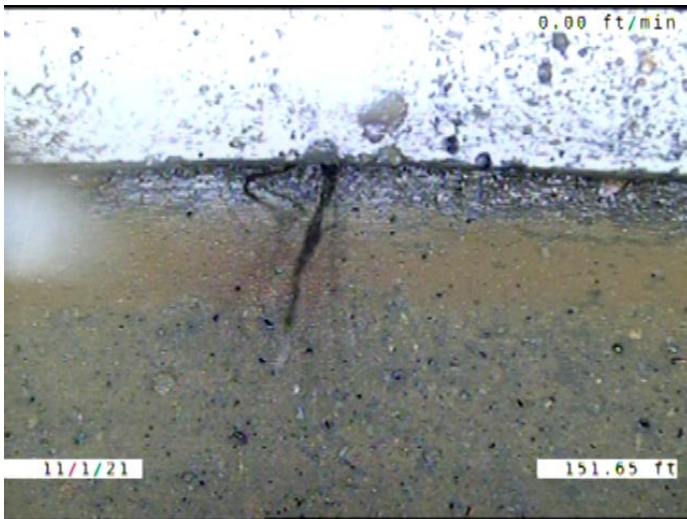
Code: **RFJ**
Description: **Roots Fine Joint**

Distance (ft): **151.6**
Structural Grade: **0**
O&M Grade: **1**
Clock Start/From: **12**
Clock To:
1st Value:
2nd Value:
Value Percent:
Continuous Index:
Within 8" of Joint: **YES**
Remarks:

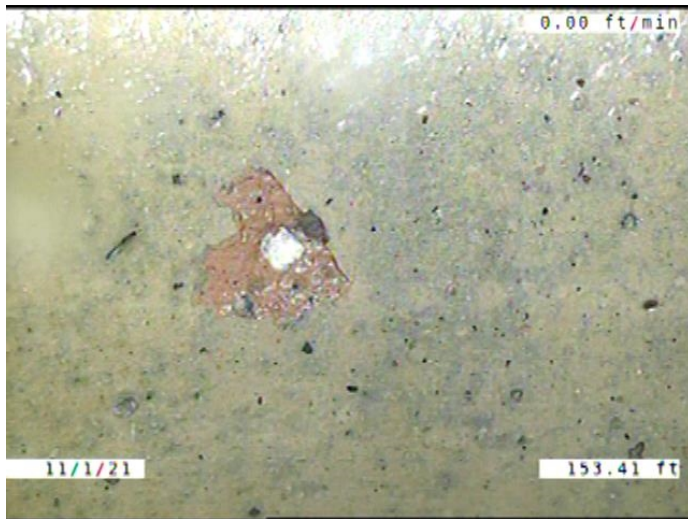
Code: **SSS**
Description: **Surface Damage Surface Spalling**

Distance (ft): **153.4**
Structural Grade: **2**
O&M Grade: **0**
Clock Start/From: **11**
Clock To:
1st Value:
2nd Value:
Value Percent:
Continuous Index:
Within 8" of Joint: **YES**
Remarks:

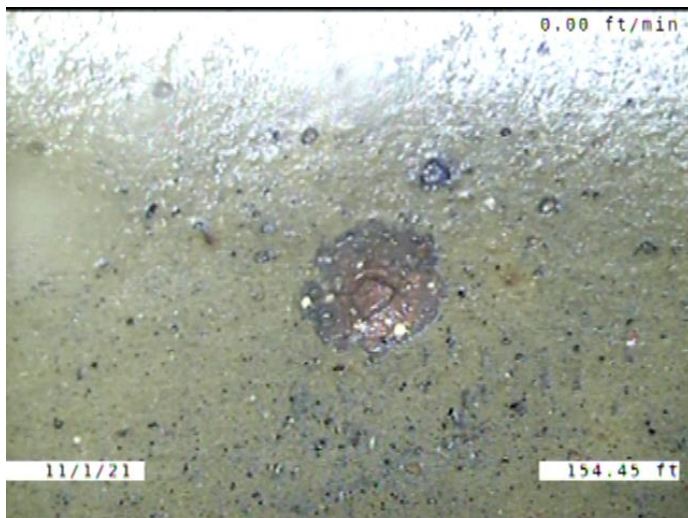
Code: **SSS**
Description: **Surface Damage Surface Spalling**

Distance (ft): **154.4**
Structural Grade: **2**
O&M Grade: **0**
Clock Start/From: **11**
Clock To:
1st Value:
2nd Value:
Value Percent:
Continuous Index:
Within 8" of Joint: **YES**
Remarks:
