## Profile/Photo Observation Report

Date:	<b>04/25/2018</b>	Weather:		Coding:	<b>PACP 6.0</b>
Pipe Length (ft):	<b>170.0</b>	Owner:	<b>NA</b>	Pre Clean:	<b>No Pre-Cleaning</b>
P.O.#:		Surveyor:	<b>Jen Costello</b>	PSR:	<b>P-504-032-031</b>
Customer:		Clean Date:	<b>01/01/1900</b>	Shape:	<b>C</b>

Street:	<b>ALLEY BETWEEN N COLORADO ST &amp;</b>	Flow Control:	<b>Not Controlled</b>
City:	<b>Hobart, IN</b>	Year Renewed:	
Location:	<b>Alley</b>	Tape/Media #:	
Purpose:	<b>Routine Assessment</b>	Dia/Height:	<b>12"</b>
Use:	<b>Sanitary</b>	Material:	<b>VCP</b>
Drain Area:	<b>NA</b>	Lining:	
Category:	<b>NA</b>		
Comment:	<b>P_C at 15 ft nothing visible .Grit in the pipe . Flow direction wrong</b>		
Location Details:		Direction of Survey:	<b>Upstream</b>
US MH:	<b>M-504-031</b>	DS MH:	<b>M-504-032</b>
		Total Length Surveyed (ft):	<b>17.0</b>

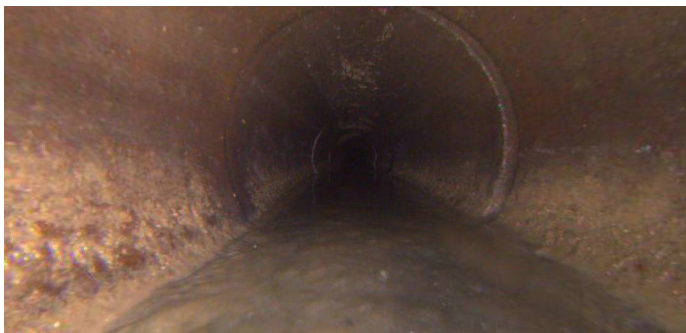
Code: **AMH**  
Description: **Manhole**

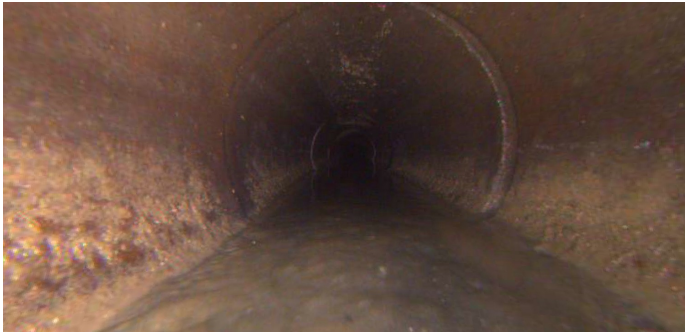
Code:	<b>MWL</b>
Description:	<b>Water Level</b>

Distance (ft):	<b>.0</b>
Structural Grade:	<b>0</b>
O&M Grade:	<b>0</b>
Clock Start/From:	
Clock To:	
1st Value:	
2nd Value:	
Value Percent:	<b>10.000</b>
Continuous Index:	
Within 8" of Joint:	<b>NO</b>
Remarks:

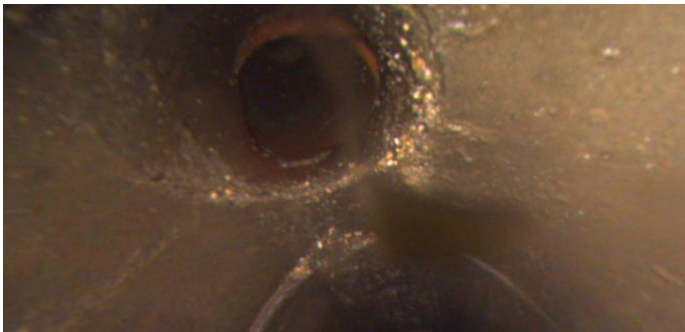
Code:	<b>TF</b>
Description:	<b>Tap Factory</b>

Distance (ft):	<b>5.7</b>
Structural Grade:	<b>0</b>
O&M Grade:	<b>0</b>
Clock Start/From:	<b>12</b>
Clock To:	
1st Value:	<b>4.000</b>
2nd Value:	
Value Percent:	
Continuous Index:	
Within 8" of Joint:	
Remarks:

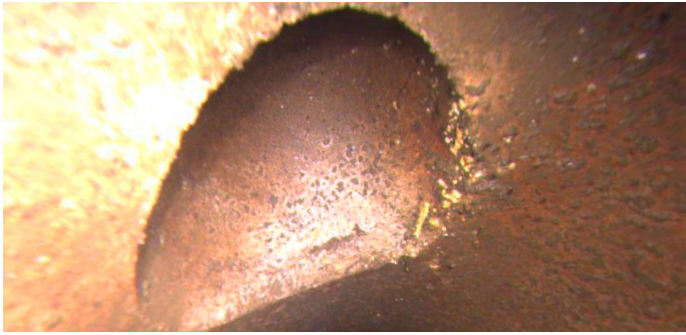
Code: **TF**  
Description: **Tap Factory**

Distance (ft): **7.0**  
Structural Grade: **0**  
O&M Grade: **0**  
Clock Start/From: **11**  
Clock To:  
1st Value: **4.000**  
2nd Value:  
Value Percent:  
Continuous Index:  
Within 8" of Joint:  
Remarks:

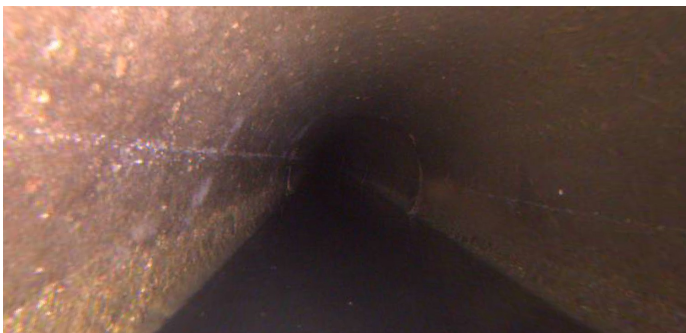
Code: **MSA**  
Description: **Abandoned Survey**

Distance (ft): **17.0**  
Structural Grade: **0**  
O&M Grade: **0**  
Clock Start/From:  
Clock To:  
1st Value:  
2nd Value:  
Value Percent:  
Continuous Index:  
Within 8" of Joint: **NO**  
Remarks: **debris under water**
