## Profile/Photo Observation Report

Street:	<b>FOXCROFT STREET</b>	Flow Control:	<b>Not Controlled</b>
City:	<b>Hobart, IN</b>	Year Renewed:	
Location:	<b>Alley</b>	Tape/Media #:	
Purpose:	<b>Routine Assessment</b>	Dia/Height:	<b>12"</b>
Use:	<b>Sanitary</b>	Material:	<b>VCP</b>
Drain Area:	<b>NA</b>	Lining:	
Category:	<b>NA</b>		
Comment:	<b>P_C at 15 ft nothing visible .Grit in the pipe . Flow direction wrong</b>		
Location Details:		Direction of Survey:	<b>Upstream</b>
US MH:	<b>M-504-031</b>	DS MH:	<b>M-504-032</b>
		Total Length Surveyed (ft):	<b>17.0</b>

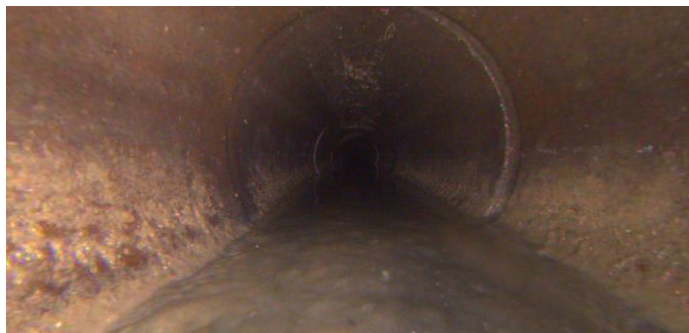
Code: **AMH**  
Description: **Manhole**

Distance (ft): **.0**  
Structural Grade: **0**  
O&M Grade: **0**  
Clock Start/From:  
Clock To:  
1st Value:  
2nd Value:  
Value Percent:  
Continuous Index:  
Within 8" of Joint: **NO**  
Remarks: **M-504-032**

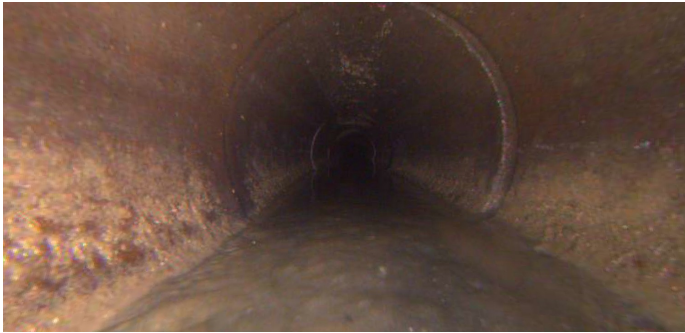
Code:	<b>MWL</b>
Description:	<b>Water Level</b>

Distance (ft):	<b>.0</b>
Structural Grade:	<b>0</b>
O&M Grade:	<b>0</b>
Clock Start/From:	
Clock To:	
1st Value:	
2nd Value:	
Value Percent:	<b>10.000</b>
Continuous Index:	
Within 8" of Joint:	<b>NO</b>
Remarks:

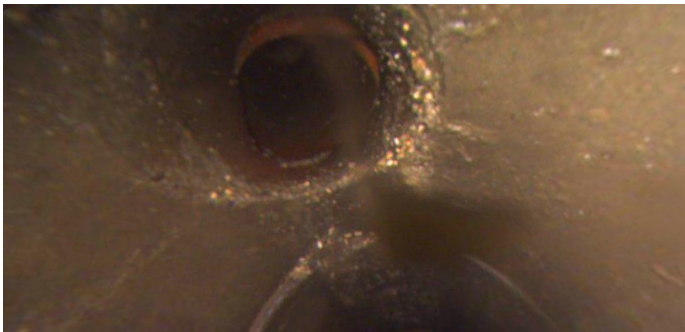
Code:	<b>TF</b>
Description:	<b>Tap Factory</b>

Distance (ft):	<b>5.7</b>
Structural Grade:	<b>0</b>
O&M Grade:	<b>0</b>
Clock Start/From:	<b>12</b>
Clock To:	
1st Value:	<b>4.000</b>
2nd Value:	
Value Percent:	
Continuous Index:	
Within 8" of Joint:	
Remarks:

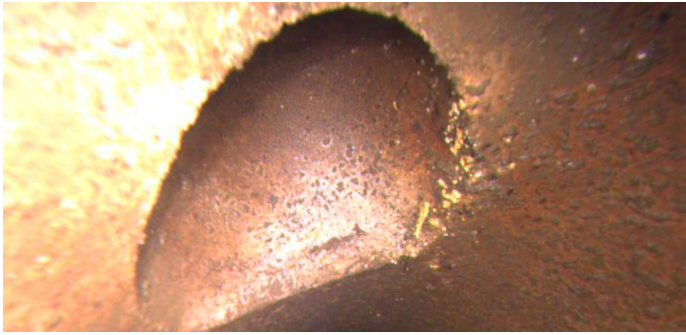
Code: **TF**  
Description: **Tap Factory**

Distance (ft): **7.0**  
Structural Grade: **0**  
O&M Grade: **0**  
Clock Start/From: **11**  
Clock To:  
1st Value: **4.000**  
2nd Value:  
Value Percent:  
Continuous Index:  
Within 8" of Joint:  
Remarks:

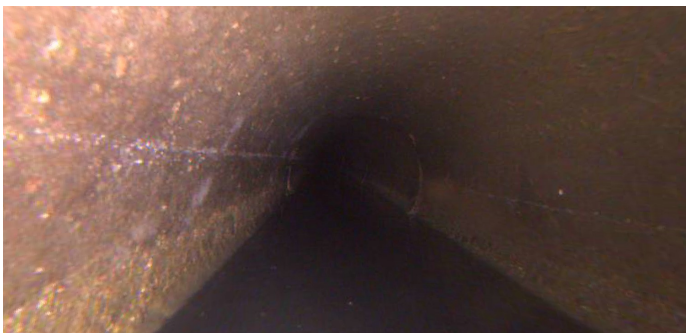
Code: **MSA**  
Description: **Abandoned Survey**

Distance (ft): **17.0**  
Structural Grade: **0**  
O&M Grade: **0**  
Clock Start/From:  
Clock To:  
1st Value:  
2nd Value:  
Value Percent:  
Continuous Index:  
Within 8" of Joint: **NO**  
Remarks: **debris under water**
