Profile/Photo Observation Report

Date:	11/01/2021	Weather:		Coding:	PACP 7.0
Pipe Length (ft):	160.3	Owner:	City of Hobart	Pre Clean:	Heavy Cleaning
P.O.#:	YES502259	Surveyor:	S. Bucklin	PSR:	P-504-032-031
Customer:	City of Hobart	Clean Date:	10/27/2021	Shape:	C

Street:	North Colorado Street	Flow Control:	Not Controlled
City:	Hobart, IN	Year Renewed:	
Location:	Alley	Tape/Media #:	
Purpose:	Routine Assessment	Dia/Height:	12"
Use:	Sanitary Sewage Pipe	Material:	VCP
Drain Area:		Lining:	None
Category:	NA		
Comment:			
Location Details:		Direction of Survey:	Downstream
US MH:	M-504-031	DS MH:	M-504-032
		Total Length Surveyed (ft):	160.3

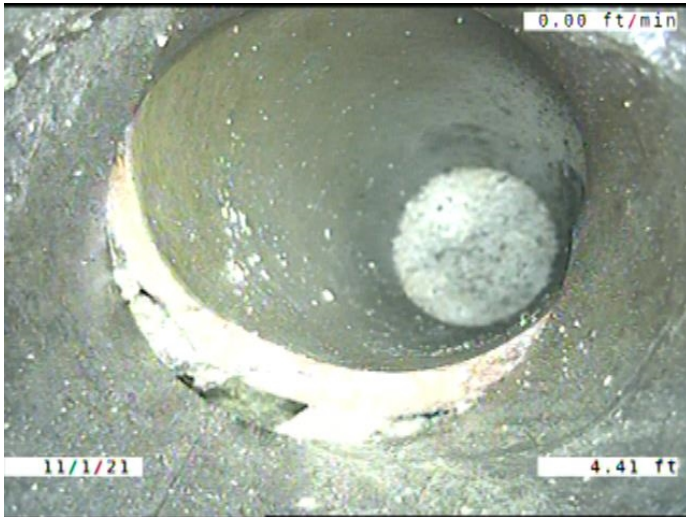
Code: **TFD**
Description: **Tap Factory Defective**

Distance (ft): **4.4**
Structural Grade: **0**
O&M Grade: **3**
Clock Start/From: **1**
Clock To:
1st Value: **4.000**
2nd Value:
Value Percent:
Continuous Index:
Within 8" of Joint: **YES**
Remarks: **CAPPED. LARGE OFFSET.**

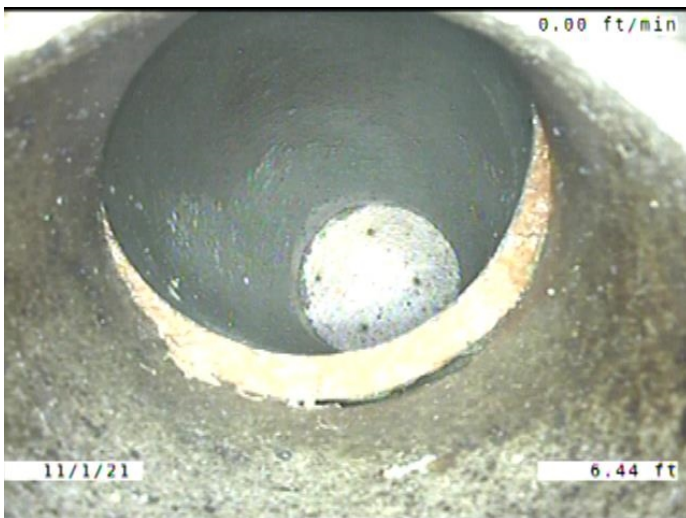
Code: **TFD**
Description: **Tap Factory Defective**

Distance (ft): **6.4**
Structural Grade: **0**
O&M Grade: **3**
Clock Start/From: **11**
Clock To:
1st Value: **4.000**
2nd Value:
Value Percent:
Continuous Index:
Within 8" of Joint: **YES**
Remarks: **CAPPED. OFFSET**

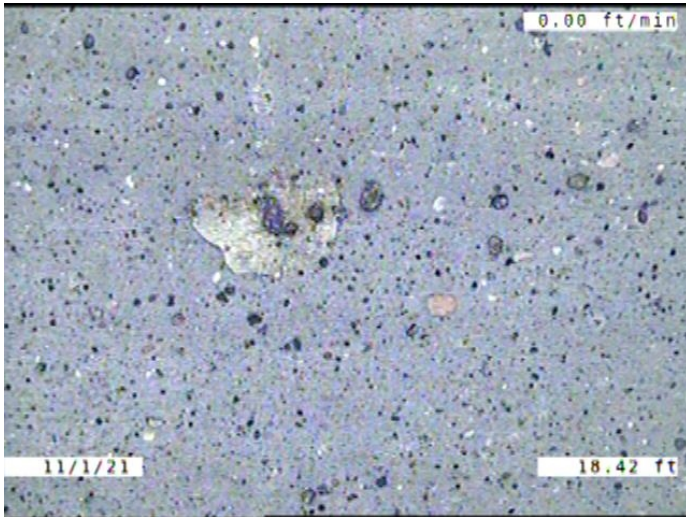
Code: **SSS**
Description: **Surface Damage Surface Spalling**

Distance (ft): **18.4**
Structural Grade: **2**
O&M Grade: **0**
Clock Start/From: **1**
Clock To:
1st Value:
2nd Value:
Value Percent:
Continuous Index:
Within 8" of Joint: **YES**
Remarks:

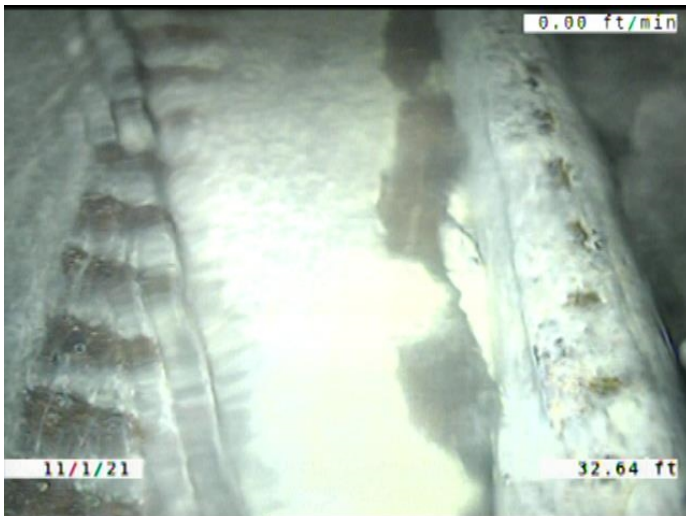
Code: **OBZ**
Description: **Obstruction Other**

Distance (ft): **32.6**
Structural Grade: **0**
O&M Grade: **2**
Clock Start/From: **6**
Clock To:
1st Value:
2nd Value:
Value Percent: **5.000**
Continuous Index:
Within 8" of Joint: **NO**
Remarks: **LOOKS LIKE A METAL ROD**

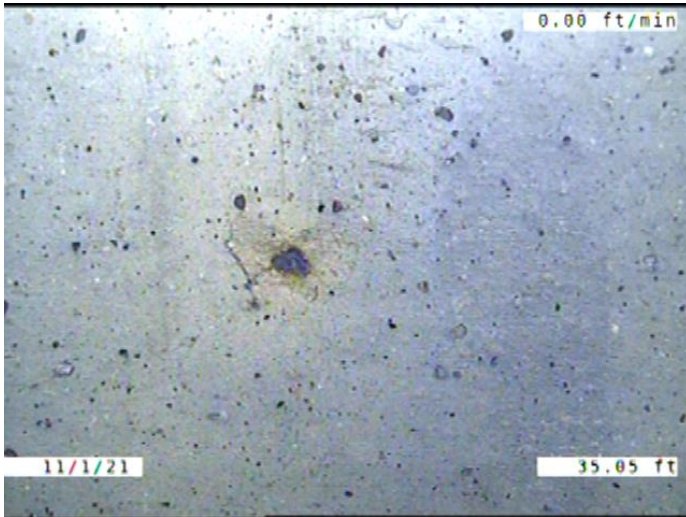
Code: **SSS**
 Description: **Surface Damage Surface Spalling**

Distance (ft): **35.1**
 Structural Grade: **2**
 O&M Grade: **0**
 Clock Start/From: **1**
 Clock To:
 1st Value:
 2nd Value:
 Value Percent:
 Continuous Index:
 Within 8" of Joint: **NO**
 Remarks:

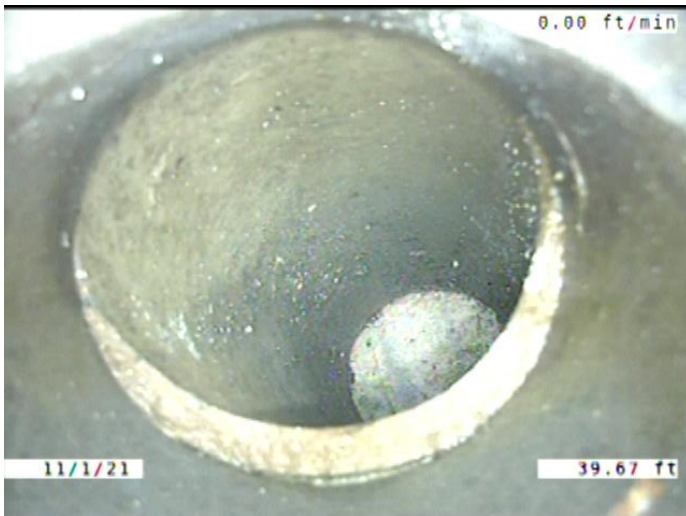
Code: **TFD**
 Description: **Tap Factory Defective**

Distance (ft): **39.7**
 Structural Grade: **0**
 O&M Grade: **3**
 Clock Start/From: **1**
 Clock To:
 1st Value: **4.000**
 2nd Value:
 Value Percent:
 Continuous Index:
 Within 8" of Joint: **YES**
 Remarks: **CAPPED. OFFSET**

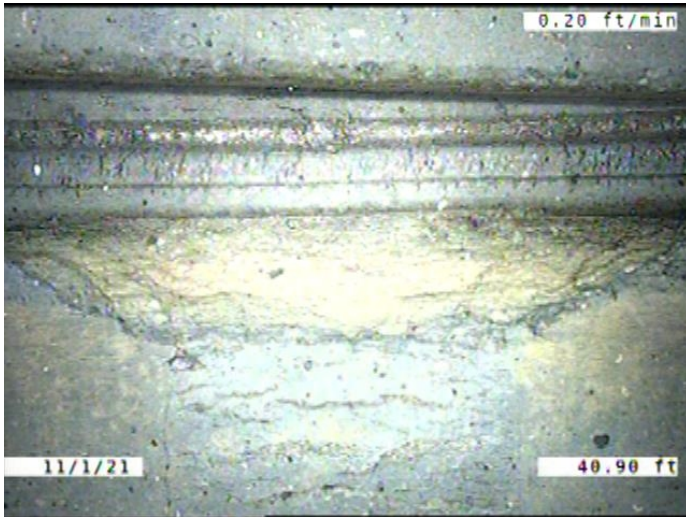
Code: **SZ**
Description: **Surface Damage Other**

Distance (ft): **40.9**
Structural Grade: **0**
O&M Grade: **0**
Clock Start/From: **11**
Clock To: **12**
1st Value:
2nd Value:
Value Percent:
Continuous Index:
Within 8" of Joint: **YES**
Remarks: **A PIECE CHIPPED AWAY FROM THE JOINT**

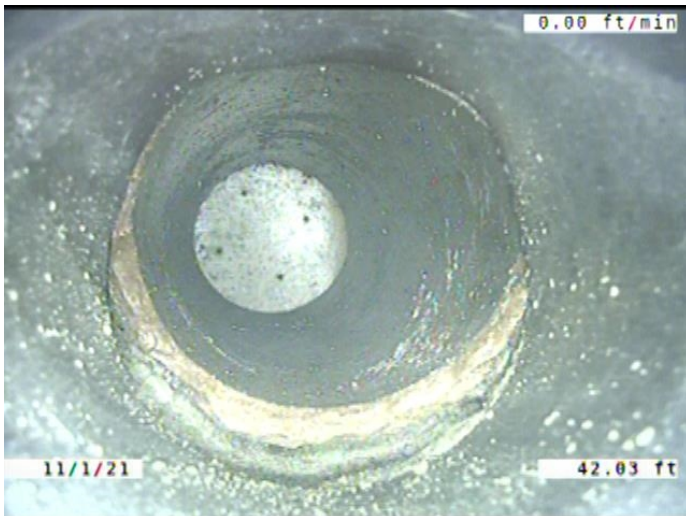
Code: **TFD**
Description: **Tap Factory Defective**

Distance (ft): **42.0**
Structural Grade: **0**
O&M Grade: **3**
Clock Start/From: **11**
Clock To:
1st Value: **4.000**
2nd Value:
Value Percent:
Continuous Index:
Within 8" of Joint: **YES**
Remarks: **CAPPED. LARGE OFFSET SOIL VISIBLE**

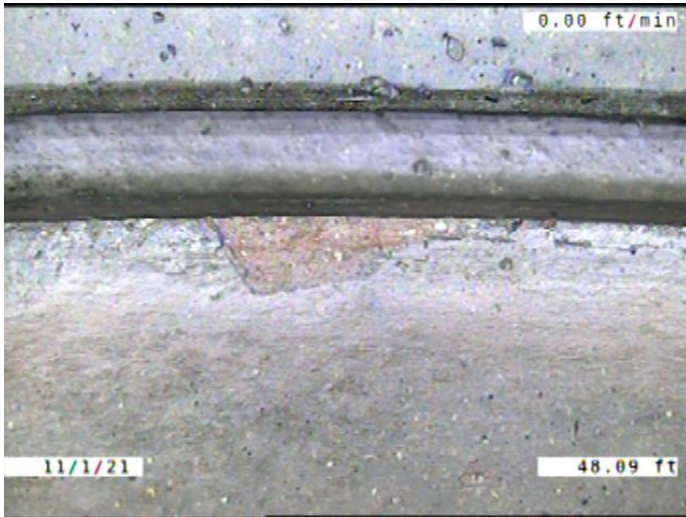
Code: **SZ**
Description: **Surface Damage Other**

Distance (ft): **48.1**
Structural Grade: **0**
O&M Grade: **0**
Clock Start/From: **12**
Clock To:
1st Value:
2nd Value:
Value Percent:
Continuous Index:
Within 8" of Joint: **YES**
Remarks: **A PIECE CHIPPED AWAY FROM THE JOINT**

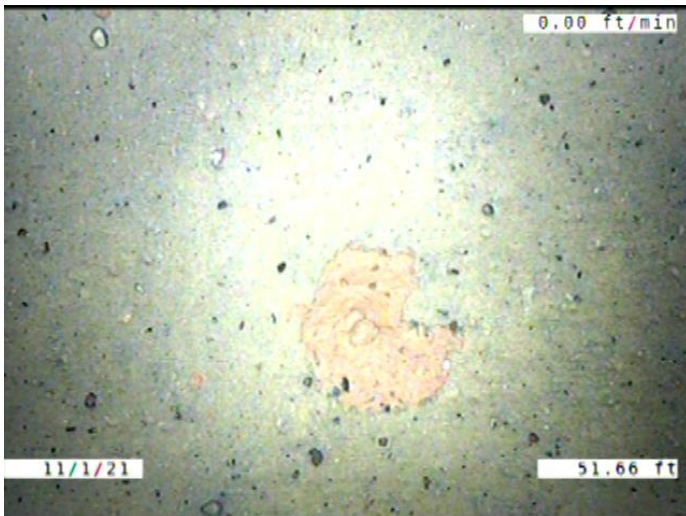
Code: **SSS**
Description: **Surface Damage Surface Spalling**

Distance (ft): **51.7**
Structural Grade: **2**
O&M Grade: **0**
Clock Start/From: **1**
Clock To:
1st Value:
2nd Value:
Value Percent:
Continuous Index:
Within 8" of Joint: **NO**
Remarks:

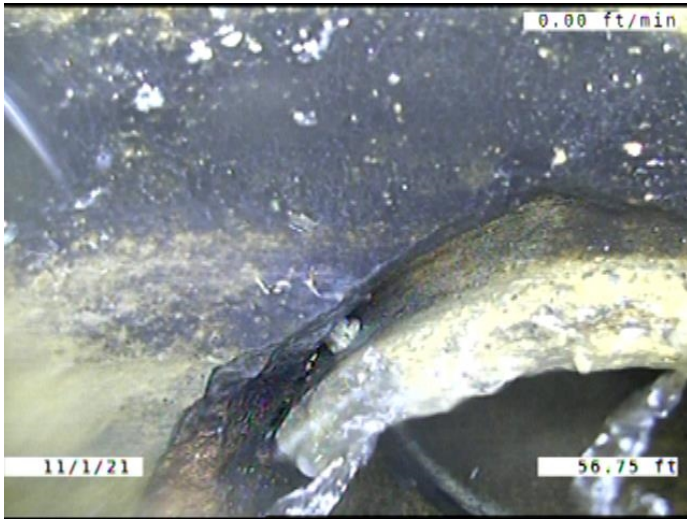
Code:	SSS
Description:	Surface Damage Surface Spalling
Distance (ft):	56.7
Structural Grade:	2
O&M Grade:	0
Clock Start/From:	11
Clock To:	1
1st Value:	
2nd Value:	
Value Percent:	
Continuous Index:	
Within 8" of Joint:	YES
Remarks:

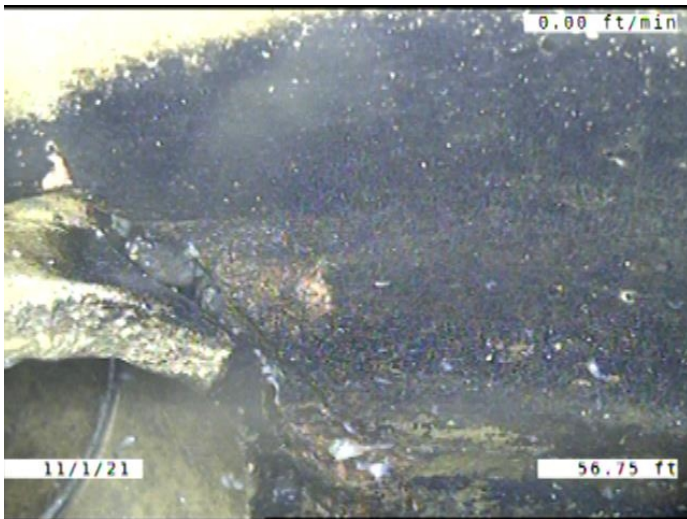
Code:	ISB
Description:	Infiltration Stain Barrel
Distance (ft):	56.7
Structural Grade:	0
O&M Grade:	1
Clock Start/From:	10
Clock To:	3
1st Value:	
2nd Value:	
Value Percent:	
Continuous Index:	
Within 8" of Joint:	YES
Remarks:

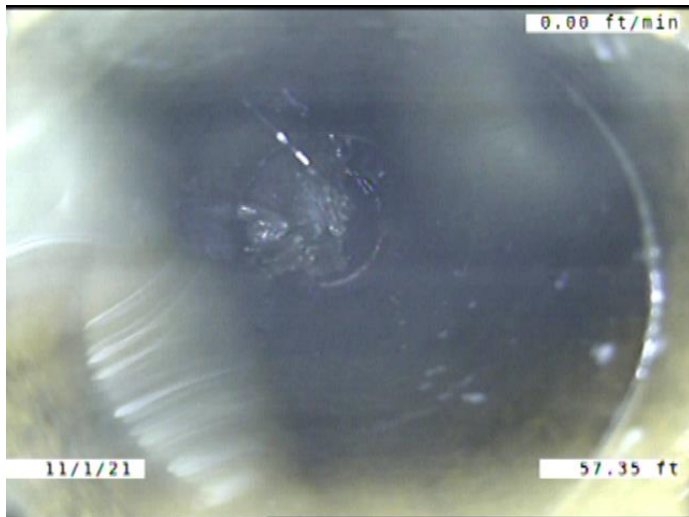
Code: **TBI**
 Description: **Tap Break-in Intruding**

Distance (ft): **57.3**
 Structural Grade: **0**
 O&M Grade: **2**
 Clock Start/From: **12**
 Clock To:
 1st Value: **4.000**
 2nd Value: **1.000**
 Value Percent:
 Continuous Index:
 Within 8" of Joint: **YES**
 Remarks: **CONSTANTLY RUNNING WATER**

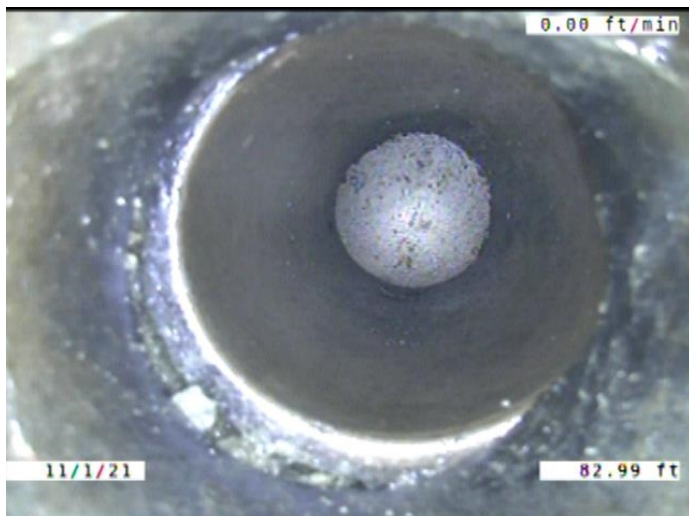
Code: **TFD**
 Description: **Tap Factory Defective**

Distance (ft): **83.0**
 Structural Grade: **0**
 O&M Grade: **3**
 Clock Start/From: **1**
 Clock To:
 1st Value: **4.000**
 2nd Value:
 Value Percent:
 Continuous Index:
 Within 8" of Joint: **YES**
 Remarks: **CAPPED. LARGE OFFSET. SOIL VISIBLE. CONSTANTLY RUNNING WA**

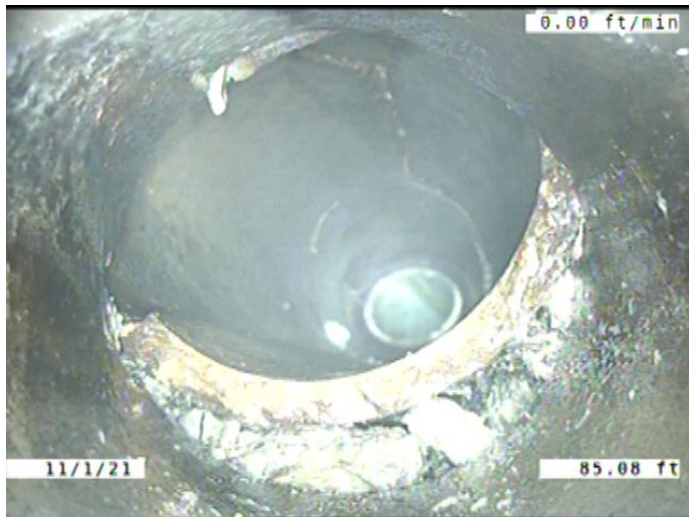
Code: **TFD**
Description: **Tap Factory Defective**

Distance (ft): **85.1**
Structural Grade: **0**
O&M Grade: **3**
Clock Start/From: **11**
Clock To:
1st Value: **4.000**
2nd Value:
Value Percent:
Continuous Index:
Within 8" of Joint: **YES**
Remarks: **LARGE OFFSET. SOIL VISIBLE.
CONSTANTLY RUNNING WATER.**

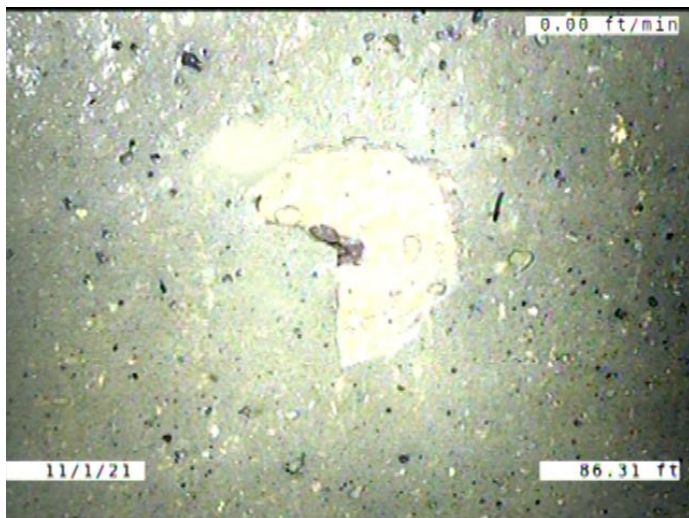
Code: **SSS**
Description: **Surface Damage Surface Spalling**

Distance (ft): **86.3**
Structural Grade: **2**
O&M Grade: **0**
Clock Start/From: **9**
Clock To:
1st Value:
2nd Value:
Value Percent:
Continuous Index:
Within 8" of Joint: **YES**
Remarks:

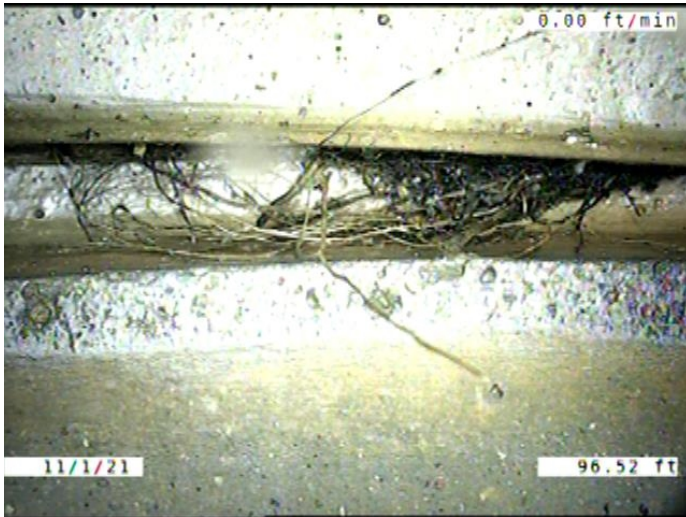
Code: **RFJ**
 Description: **Roots Fine Joint**

Distance (ft): **96.5**
 Structural Grade: **0**
 O&M Grade: **1**
 Clock Start/From: **12**
 Clock To: **2**
 1st Value:
 2nd Value:
 Value Percent:
 Continuous Index:
 Within 8" of Joint: **YES**
 Remarks:

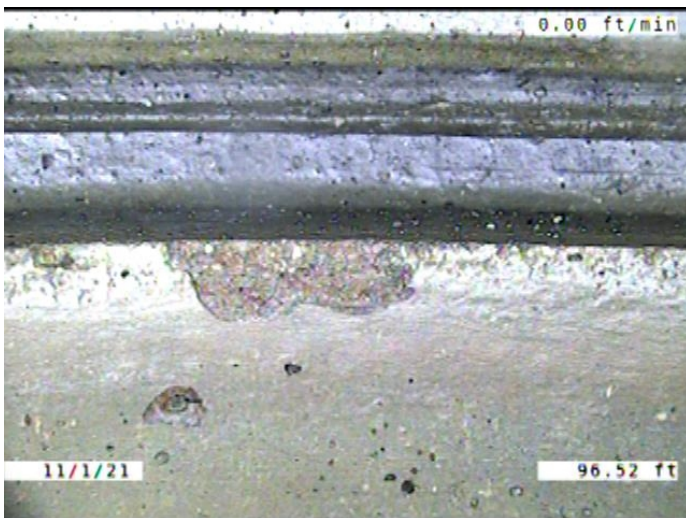
Code: **SZ**
 Description: **Surface Damage Other**

Distance (ft): **96.5**
 Structural Grade: **0**
 O&M Grade: **0**
 Clock Start/From: **11**
 Clock To:
 1st Value:
 2nd Value:
 Value Percent:
 Continuous Index:
 Within 8" of Joint: **YES**
 Remarks: **A PIECE CHIPPED AWAY FROM THE JOINT**

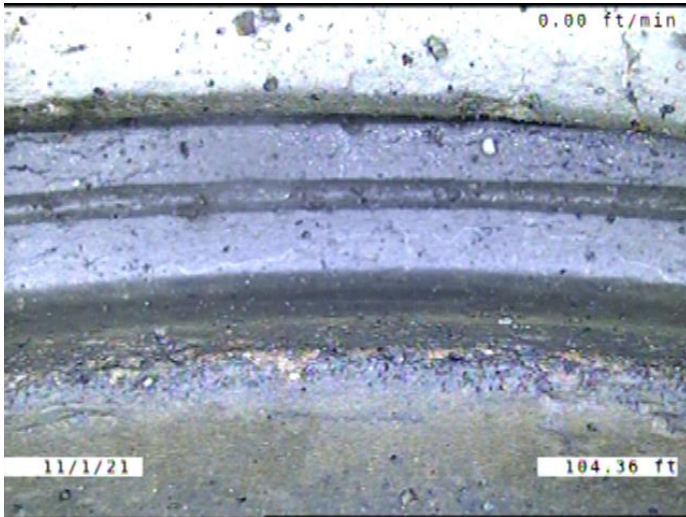
Code: **JAM**
Description: **Joint Angular Medium**

Distance (ft): **104.4**
Structural Grade: **3**
O&M Grade: **0**
Clock Start/From:
Clock To:
1st Value:
2nd Value:
Value Percent:
Continuous Index:
Within 8" of Joint: **NO**
Remarks:

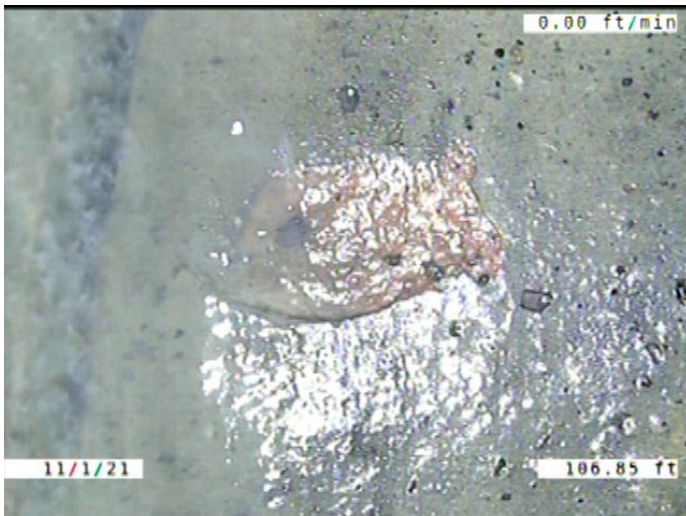
Code: **SSS**
Description: **Surface Damage Surface Spalling**

Distance (ft): **106.9**
Structural Grade: **2**
O&M Grade: **0**
Clock Start/From: **4**
Clock To:
1st Value:
2nd Value:
Value Percent:
Continuous Index:
Within 8" of Joint: **YES**
Remarks:

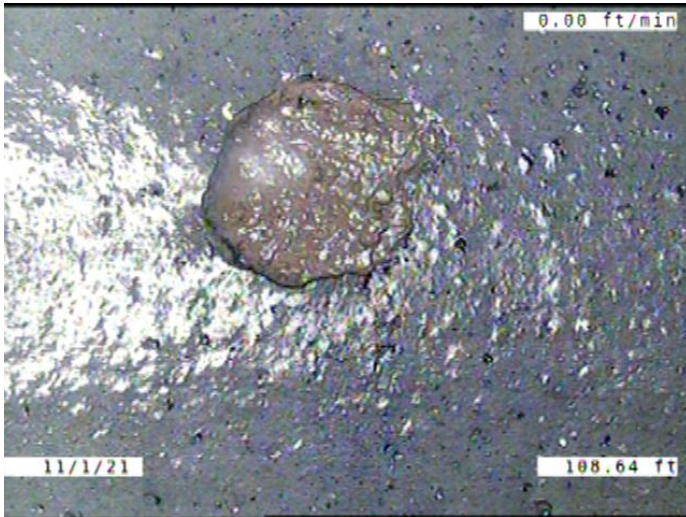
Code: **SSS**
 Description: **Surface Damage Surface Spalling**

Distance (ft): **108.6**
 Structural Grade: **2**
 O&M Grade: **0**
 Clock Start/From: **4**
 Clock To:
 1st Value:
 2nd Value:
 Value Percent:
 Continuous Index:
 Within 8" of Joint: **NO**
 Remarks:

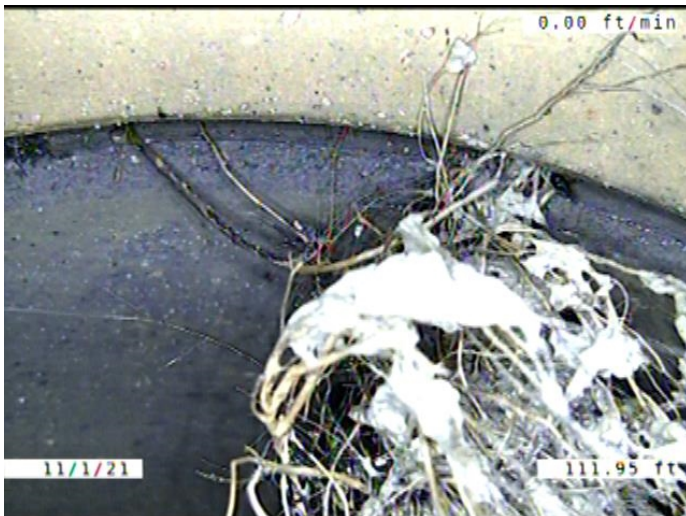
Code: **RMJ**
 Description: **Roots Medium Joint**

Distance (ft): **112.0**
 Structural Grade: **0**
 O&M Grade: **3**
 Clock Start/From: **1**
 Clock To: **2**
 1st Value:
 2nd Value:
 Value Percent: **10.000**
 Continuous Index:
 Within 8" of Joint: **YES**
 Remarks:

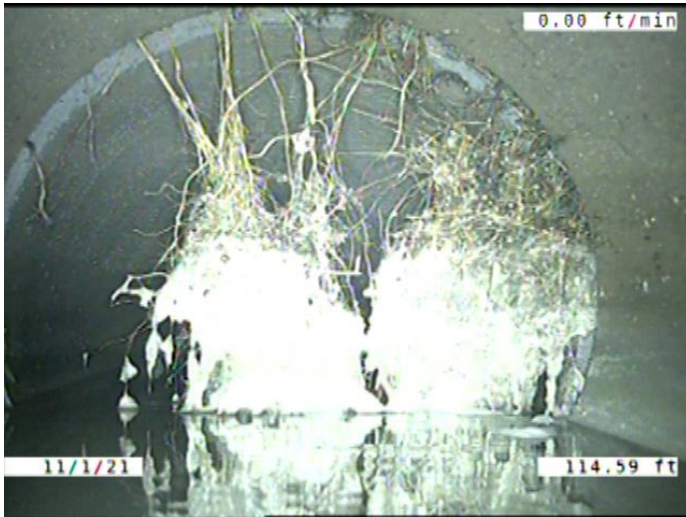
Code: **RMJ**
 Description: **Roots Medium Joint**

Distance (ft): **114.6**
 Structural Grade: **0**
 O&M Grade: **3**
 Clock Start/From: **10**
 Clock To: **4**
 1st Value:
 2nd Value:
 Value Percent: **50.000**
 Continuous Index:
 Within 8" of Joint: **YES**
 Remarks:

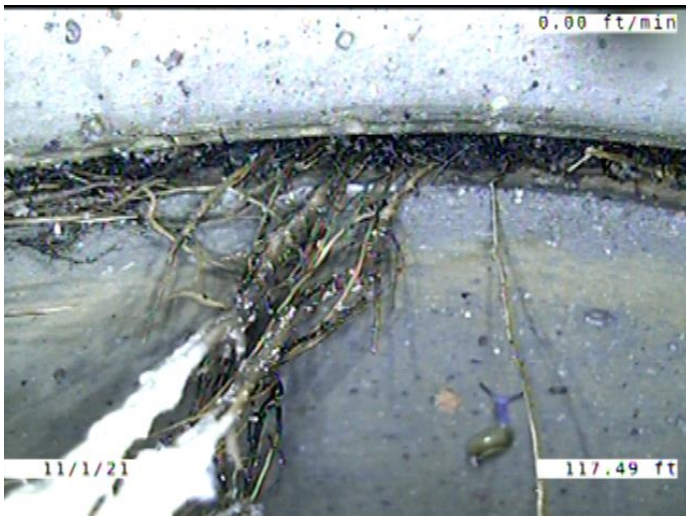
Code: **RMJ**
 Description: **Roots Medium Joint**

Distance (ft): **117.5**
 Structural Grade: **0**
 O&M Grade: **3**
 Clock Start/From: **9**
 Clock To: **2**
 1st Value:
 2nd Value:
 Value Percent: **15.000**
 Continuous Index:
 Within 8" of Joint: **YES**
 Remarks:

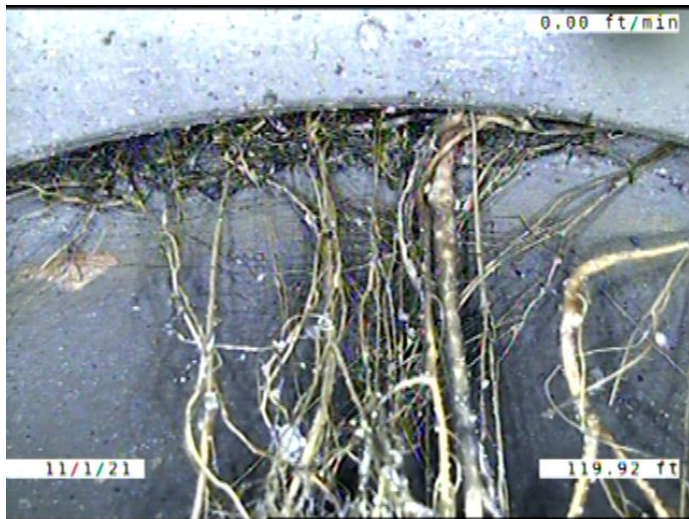
Code: **RMJ**
 Description: **Roots Medium Joint**

Distance (ft): **119.9**
 Structural Grade: **0**
 O&M Grade: **3**
 Clock Start/From: **10**
 Clock To: **2**
 1st Value:
 2nd Value:
 Value Percent: **15.000**
 Continuous Index:
 Within 8" of Joint: **YES**
 Remarks:

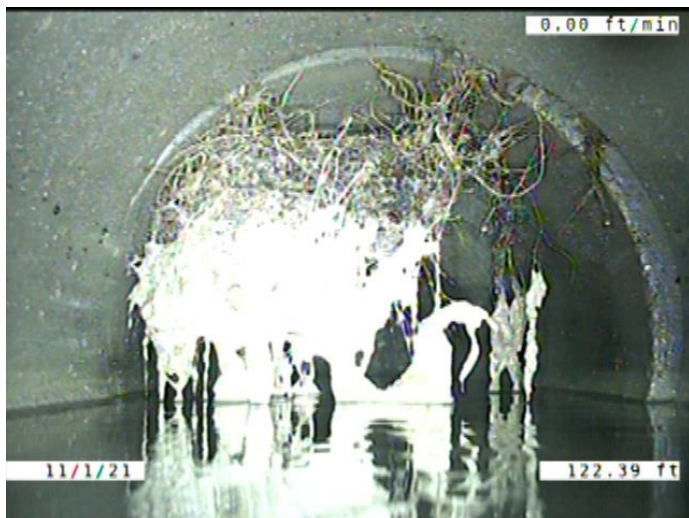
Code: **RMJ**
 Description: **Roots Medium Joint**

Distance (ft): **122.4**
 Structural Grade: **0**
 O&M Grade: **3**
 Clock Start/From: **10**
 Clock To: **2**
 1st Value:
 2nd Value:
 Value Percent: **30.000**
 Continuous Index:
 Within 8" of Joint: **YES**
 Remarks:

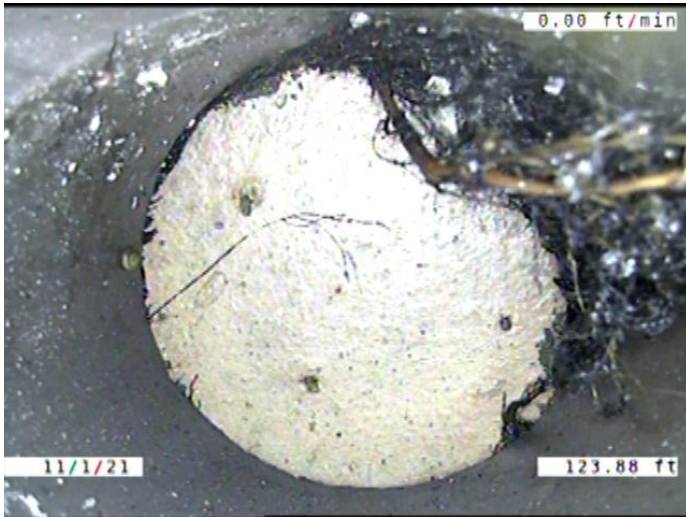
Code:	TFD
Description:	Tap Factory Defective
Distance (ft):	123.9
Structural Grade:	0
O&M Grade:	3
Clock Start/From:	1
Clock To:	
1st Value:	4.000
2nd Value:	
Value Percent:	
Continuous Index:	
Within 8" of Joint:	YES
Remarks:	CAPPED. ROOTS GROWING AROUND THE CAP INTO THE MAIN

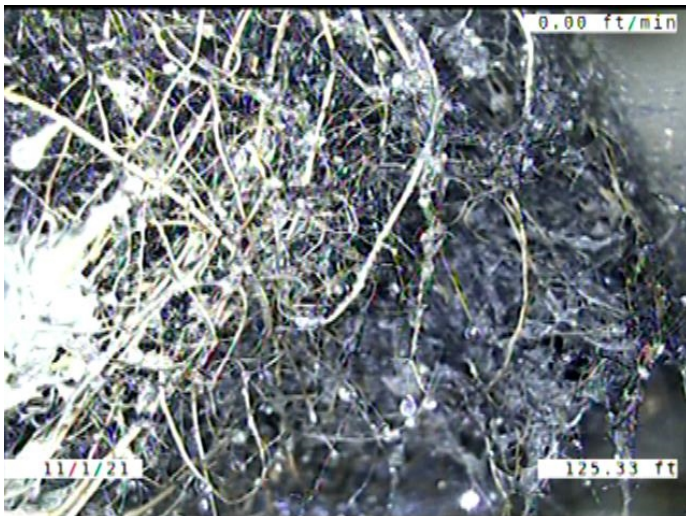
Code:	RML
Description:	Roots Medium Lateral
Distance (ft):	125.3
Structural Grade:	0
O&M Grade:	3
Clock Start/From:	10
Clock To:	12
1st Value:	
2nd Value:	
Value Percent:	15.000
Continuous Index:	
Within 8" of Joint:	NO
Remarks:

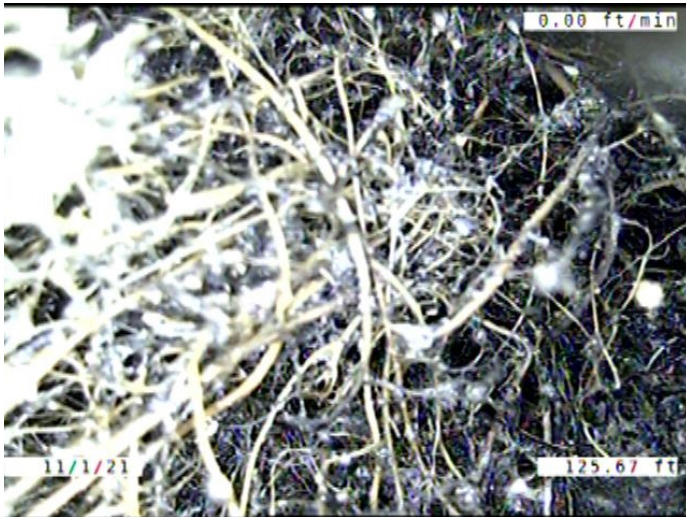
Code: **TFD**
 Description: **Tap Factory Defective**

Distance (ft): **125.7**
 Structural Grade: **0**
 O&M Grade: **3**
 Clock Start/From: **11**
 Clock To:
 1st Value: **4.000**
 2nd Value:
 Value Percent:
 Continuous Index:
 Within 8" of Joint: **YES**
 Remarks: **100% PLUGGED WITH ROOTS**

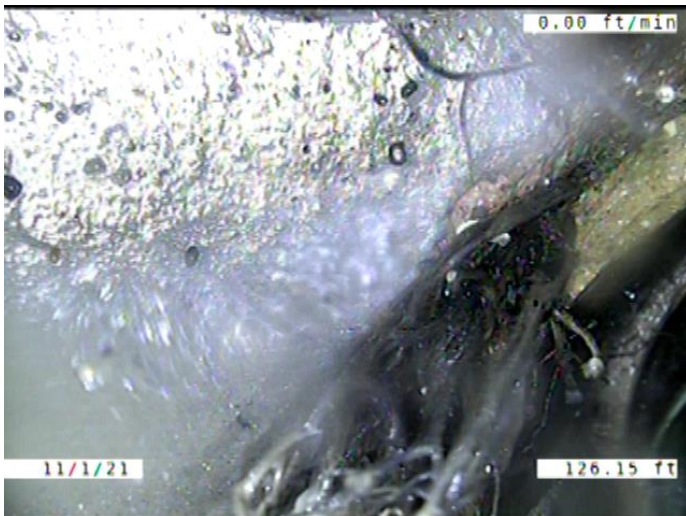
Code: **SSS**
 Description: **Surface Damage Surface Spalling**

Distance (ft): **126.1**
 Structural Grade: **2**
 O&M Grade: **0**
 Clock Start/From: **11**
 Clock To: **1**
 1st Value:
 2nd Value:
 Value Percent:
 Continuous Index:
 Within 8" of Joint: **YES**
 Remarks:

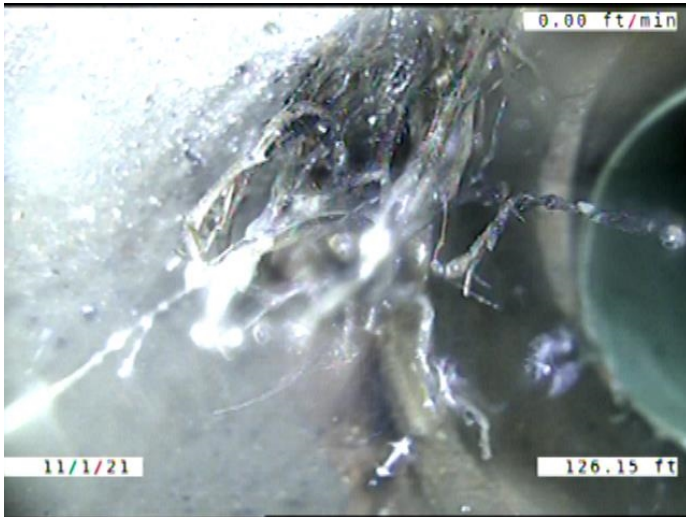
Code: **RFC**
 Description: **Roots Fine Connection**

Distance (ft): **126.2**
 Structural Grade: **0**
 O&M Grade: **1**
 Clock Start/From: **11**
 Clock To: **1**
 1st Value:
 2nd Value:
 Value Percent:
 Continuous Index:
 Within 8" of Joint: **NO**
 Remarks:

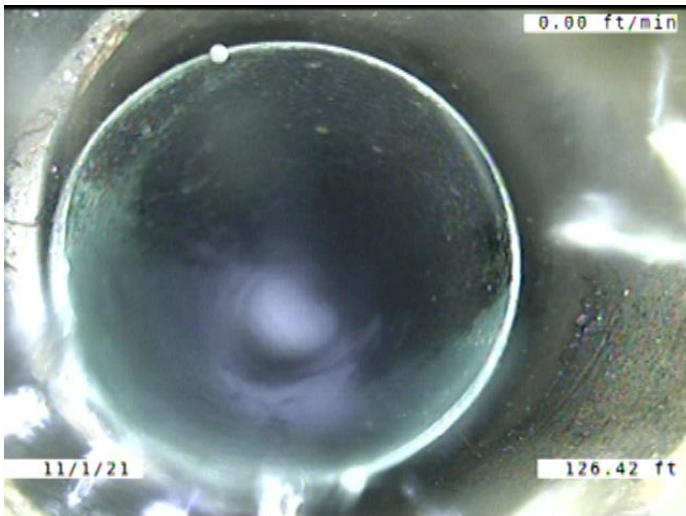
Code: **TBD**
 Description: **Tap Break-in/Hammer Defective**

Distance (ft): **126.4**
 Structural Grade: **0**
 O&M Grade: **3**
 Clock Start/From: **12**
 Clock To:
 1st Value: **4.000**
 2nd Value:
 Value Percent:
 Continuous Index:
 Within 8" of Joint: **YES**
 Remarks: **CONSTANTLY RUNNING WATER**

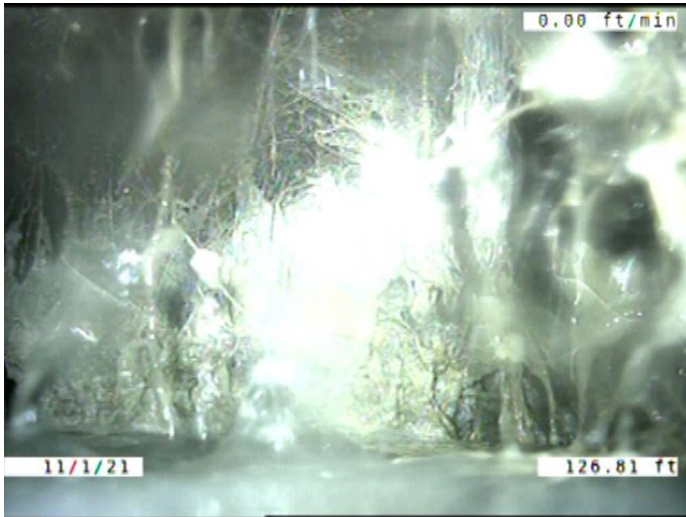
Code: **RBJ**
Description: **Roots Ball Joint**

Distance (ft): **126.8**
Structural Grade: **0**
O&M Grade: **4**
Clock Start/From: **8**
Clock To: **4**
1st Value:
2nd Value:
Value Percent: **80.000**
Continuous Index:
Within 8" of Joint: **YES**
Remarks:

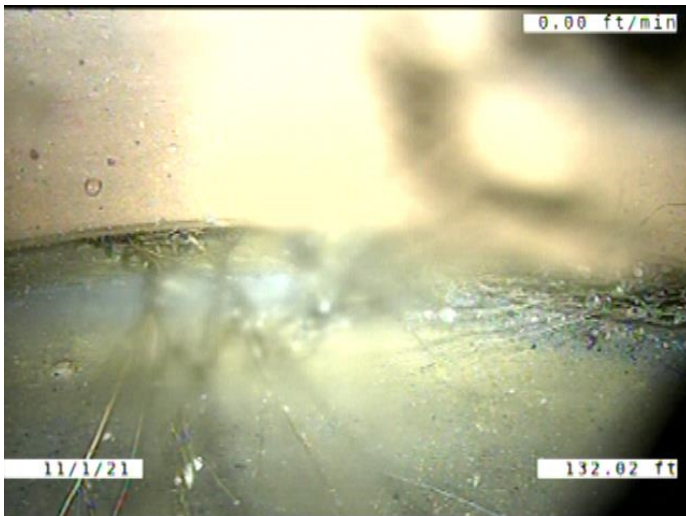
Code: **RFJ**
Description: **Roots Fine Joint**

Distance (ft): **132.0**
Structural Grade: **0**
O&M Grade: **1**
Clock Start/From: **11**
Clock To: **2**
1st Value:
2nd Value:
Value Percent:
Continuous Index:
Within 8" of Joint: **YES**
Remarks:

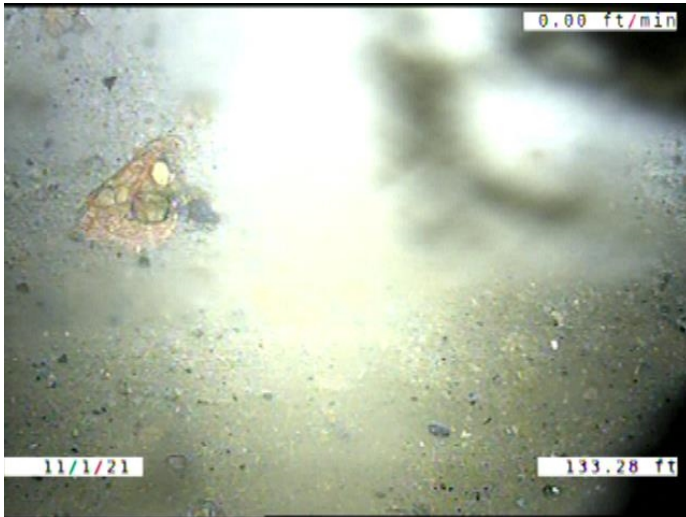
Code:	SSS
Description:	Surface Damage Surface Spalling
Distance (ft):	133.3
Structural Grade:	2
O&M Grade:	0
Clock Start/From:	1
Clock To:	
1st Value:	
2nd Value:	
Value Percent:	
Continuous Index:	
Within 8" of Joint:	NO
Remarks:

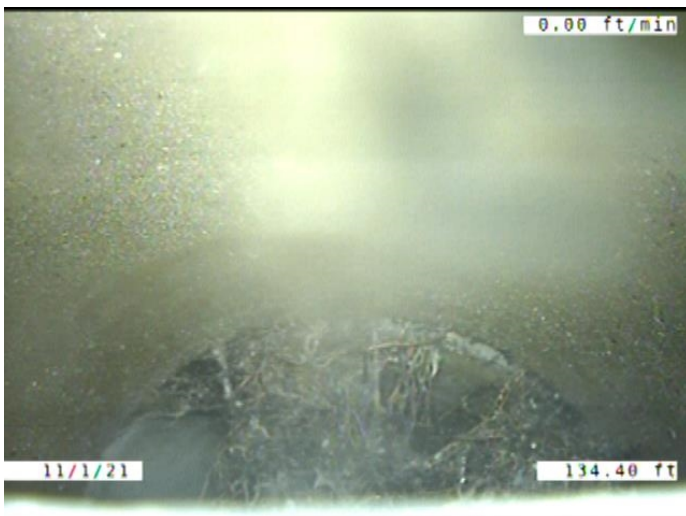
Code:	RBJ
Description:	Roots Ball Joint
Distance (ft):	134.4
Structural Grade:	0
O&M Grade:	4
Clock Start/From:	10
Clock To:	3
1st Value:	
2nd Value:	
Value Percent:	75.000
Continuous Index:	
Within 8" of Joint:	YES
Remarks:

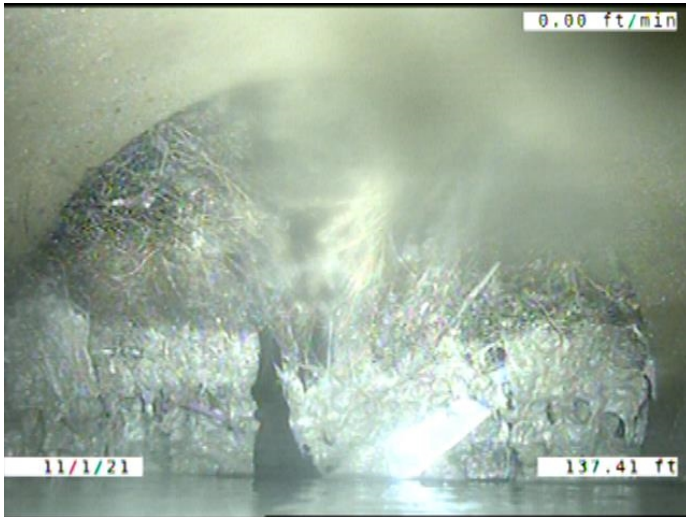
Code: **RBJ**
 Description: **Roots Ball Joint**

Distance (ft): **137.4**
 Structural Grade: **0**
 O&M Grade: **4**
 Clock Start/From: **8**
 Clock To: **4**
 1st Value:
 2nd Value:
 Value Percent: **90.000**
 Continuous Index:
 Within 8" of Joint: **YES**
 Remarks:

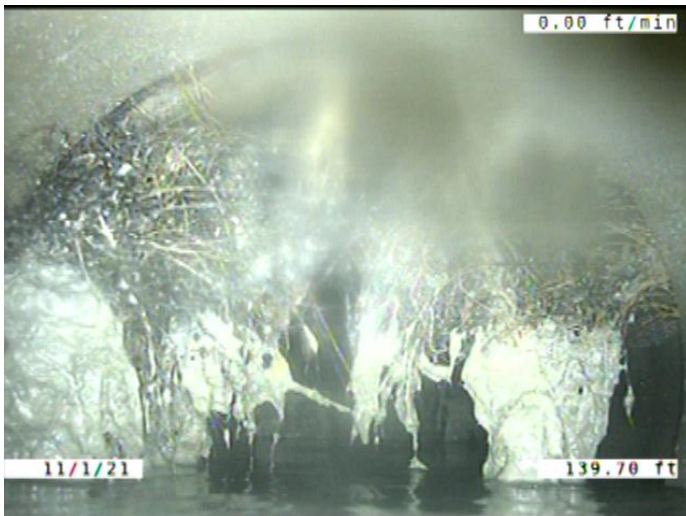
Code: **RMJ**
 Description: **Roots Medium Joint**

Distance (ft): **139.7**
 Structural Grade: **0**
 O&M Grade: **3**
 Clock Start/From: **8**
 Clock To: **3**
 1st Value:
 2nd Value:
 Value Percent: **40.000**
 Continuous Index:
 Within 8" of Joint: **YES**
 Remarks:

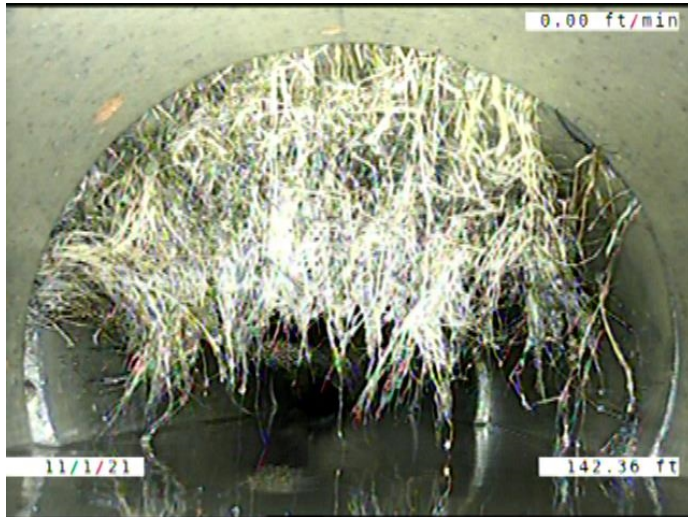
Code: **RMJ**
 Description: **Roots Medium Joint**

Distance (ft): **142.4**
 Structural Grade: **0**
 O&M Grade: **3**
 Clock Start/From: **8**
 Clock To: **2**
 1st Value:
 2nd Value:
 Value Percent: **45.000**
 Continuous Index:
 Within 8" of Joint: **YES**
 Remarks:

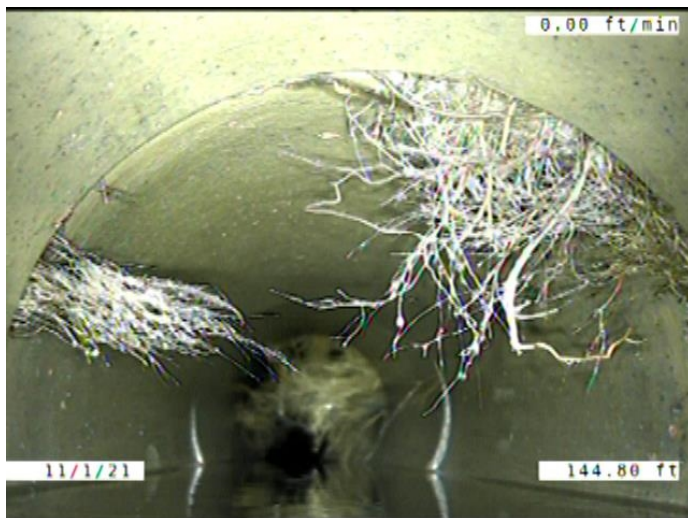
Code: **RMJ**
 Description: **Roots Medium Joint**

Distance (ft): **144.8**
 Structural Grade: **0**
 O&M Grade: **3**
 Clock Start/From: **10**
 Clock To: **2**
 1st Value:
 2nd Value:
 Value Percent: **10.000**
 Continuous Index:
 Within 8" of Joint: **YES**
 Remarks:

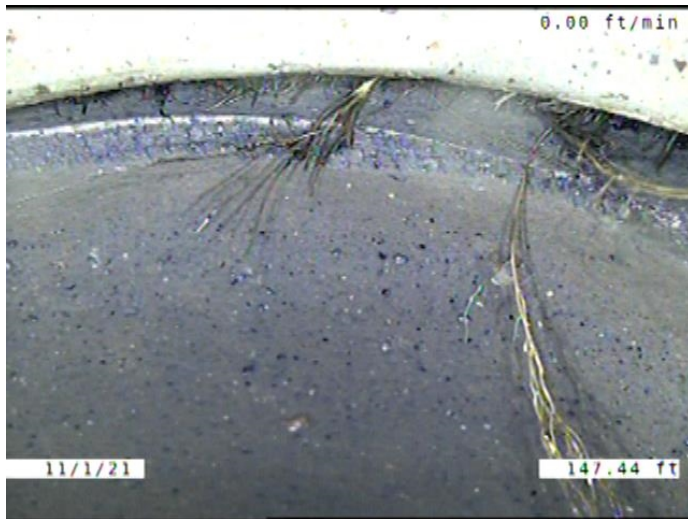
Code: **RFJ**
 Description: **Roots Fine Joint**

Distance (ft): **147.4**
 Structural Grade: **0**
 O&M Grade: **1**
 Clock Start/From: **1**
 Clock To: **2**
 1st Value:
 2nd Value:
 Value Percent:
 Continuous Index:
 Within 8" of Joint: **YES**
 Remarks:

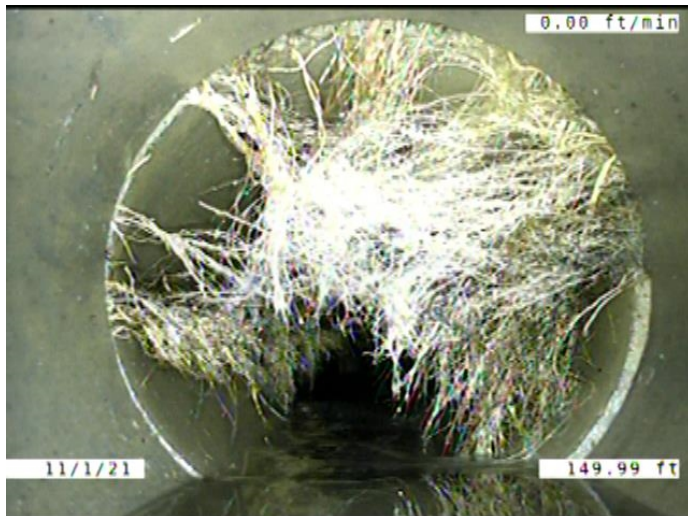
Code: **RBJ**
 Description: **Roots Ball Joint**

Distance (ft): **150.0**
 Structural Grade: **0**
 O&M Grade: **4**
 Clock Start/From: **8**
 Clock To: **3**
 1st Value:
 2nd Value:
 Value Percent: **55.000**
 Continuous Index:
 Within 8" of Joint: **YES**
 Remarks:

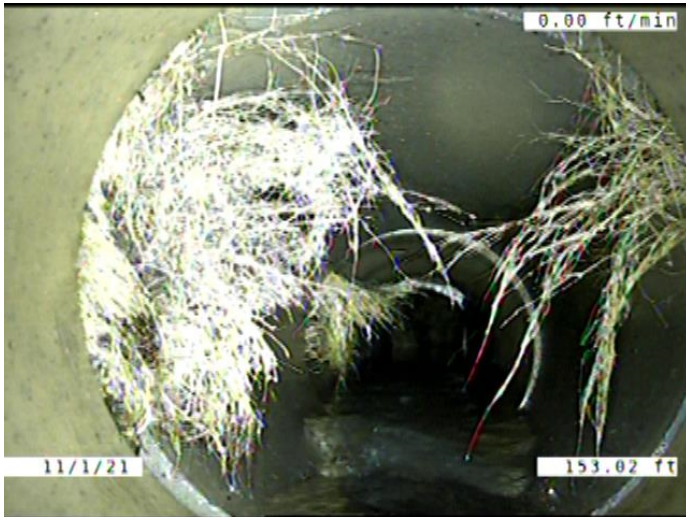
Code: **RMJ**
Description: **Roots Medium Joint**

Distance (ft): **153.0**
Structural Grade: **0**
O&M Grade: **3**
Clock Start/From: **7**
Clock To: **2**
1st Value:
2nd Value:
Value Percent: **30.000**
Continuous Index:
Within 8" of Joint: **YES**
Remarks:

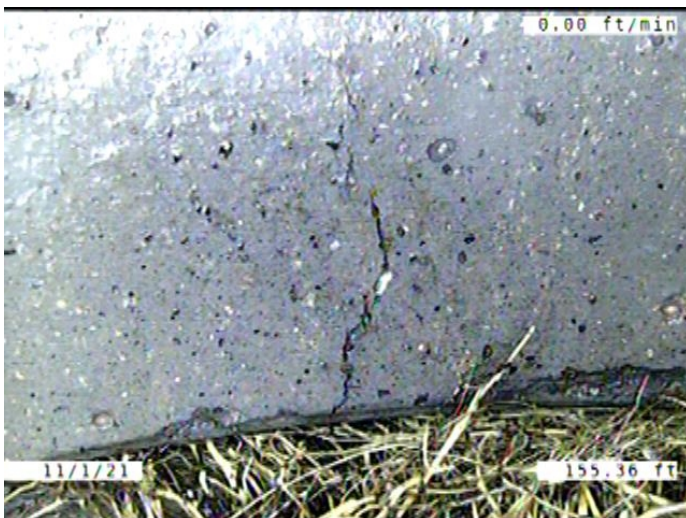
Code: **CL**
Description: **Crack Longitudinal**

Distance (ft): **155.4**
Structural Grade: **2**
O&M Grade: **0**
Clock Start/From: **10**
Clock To:
1st Value:
2nd Value:
Value Percent:
Continuous Index:
Within 8" of Joint: **YES**
Remarks:

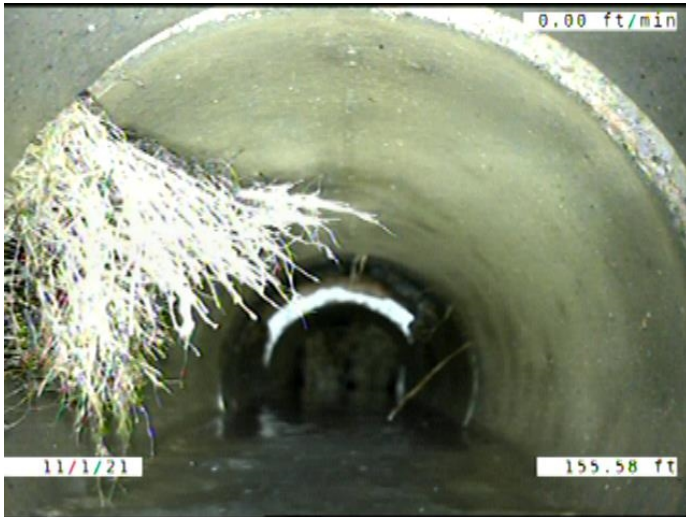
Code: **RMJ**
 Description: **Roots Medium Joint**

Distance (ft): **155.6**
 Structural Grade: **0**
 O&M Grade: **3**
 Clock Start/From: **8**
 Clock To: **10**
 1st Value:
 2nd Value:
 Value Percent: **10.000**
 Continuous Index:
 Within 8" of Joint: **YES**
 Remarks:

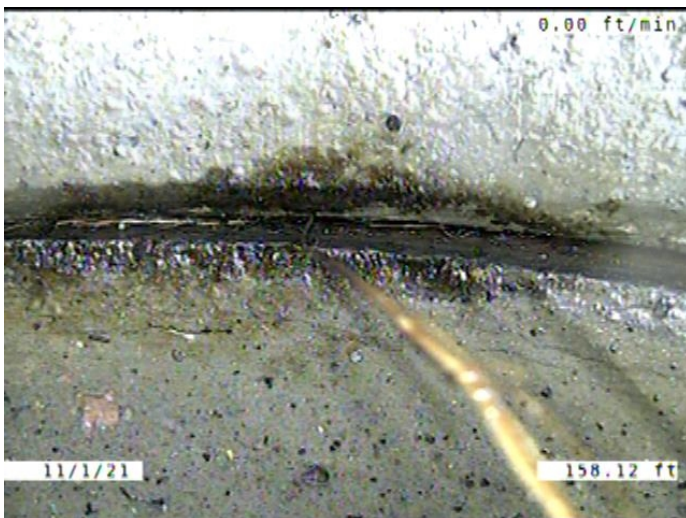
Code: **RFJ**
 Description: **Roots Fine Joint**

Distance (ft): **158.1**
 Structural Grade: **0**
 O&M Grade: **1**
 Clock Start/From: **12**
 Clock To: **2**
 1st Value:
 2nd Value:
 Value Percent:
 Continuous Index:
 Within 8" of Joint: **YES**
 Remarks:

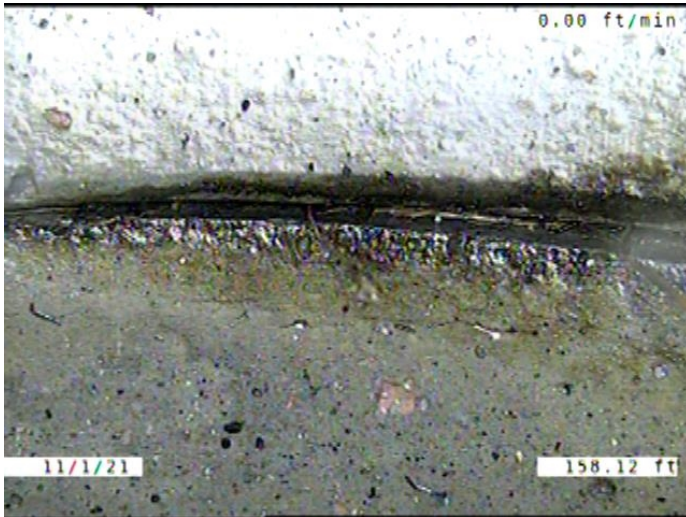
Code: **ISJ**
 Description: **Infiltration Stain Joint**

Distance (ft): **158.1**
 Structural Grade: **0**
 O&M Grade: **1**
 Clock Start/From: **9**
 Clock To: **3**
 1st Value:
 2nd Value:
 Value Percent:
 Continuous Index:
 Within 8" of Joint: **YES**
 Remarks:
