Profile/Photo Observation Report

| Pipe Length (ft): | 160.3 | Owner: | City of Hobart | Pre Clean: | Heavy Cleaning |

| Street: | North Colorado Street | Flow Control: | Not Controlled |
| US MH: | M-504-031 | DS MH: | M-504-032 |

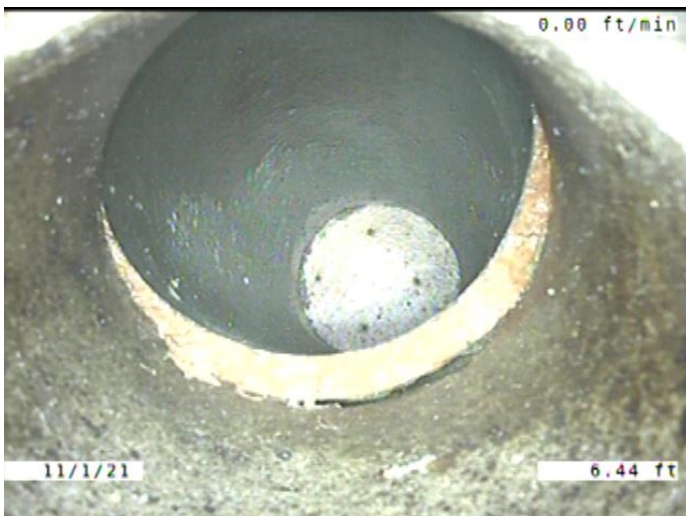
| Position | Code | Observation | Video (sec) | Grade |
|---|---|---|---|---|
| 6.4 | TFD | Tap Factory Defective | 161 | M 3 |

Code: **TFD**
Description: **Tap Factory Defective**

Distance (ft): **6.4**
Structural Grade: **0**
O&M Grade: **3**
Clock Start/From: **11**
Clock To:
1st Value: **4.000**
2nd Value:
Value Percent:
Continuous Index:
Within 8" of Joint: **YES**
Remarks: **CAPPED. OFFSET**

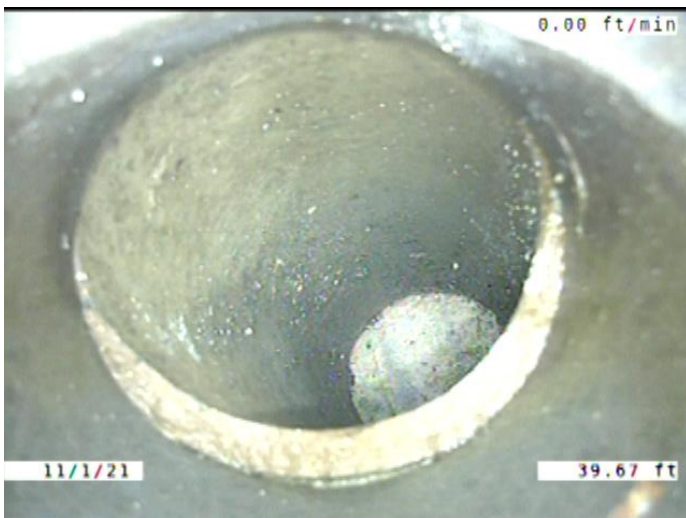
| Position | Code | Observation | Video (sec) | Grade |
|---|---|---|---|---|
| 39.7 | TFD | Tap Factory Defective | 433 | M 3 |

Code: **TFD**
Description: **Tap Factory Defective**

Distance (ft): **39.7**
Structural Grade: **0**
O&M Grade: **3**
Clock Start/From: **1**
Clock To:
1st Value: **4.000**
2nd Value:
Value Percent:
Continuous Index:
Within 8" of Joint: **YES**
Remarks: **CAPPED. OFFSET**

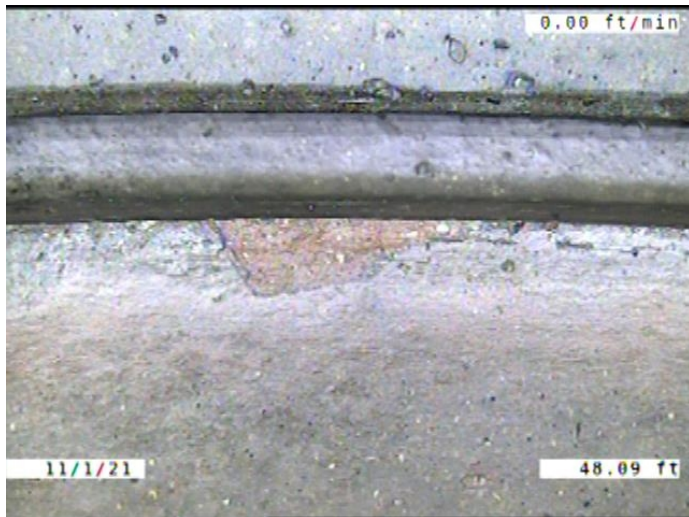
Code: **SZ**
 Description: **Surface Damage Other**

Distance (ft): **48.1**
 Structural Grade: **0**
 O&M Grade: **0**
 Clock Start/From: **12**
 Clock To:
 1st Value:
 2nd Value:
 Value Percent:
 Continuous Index:
 Within 8" of Joint: **YES**
 Remarks: **A PIECE CHIPPED AWAY FROM THE JOINT**

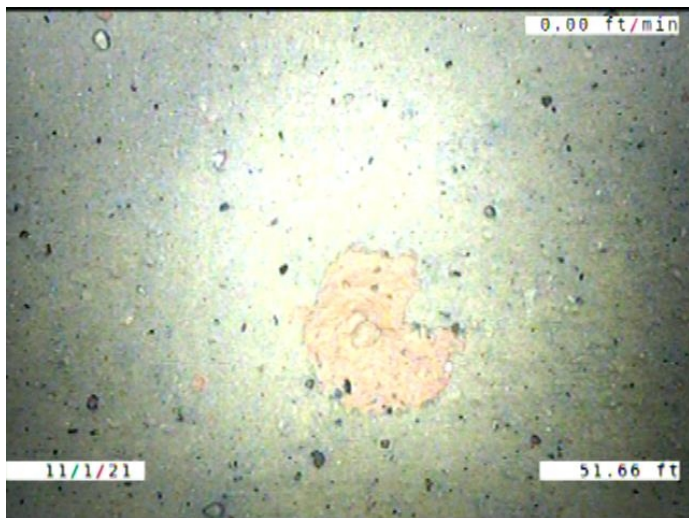
Code: **SSS**
 Description: **Surface Damage Surface Spalling**

Distance (ft): **51.7**
 Structural Grade: **2**
 O&M Grade: **0**
 Clock Start/From: **1**
 Clock To:
 1st Value:
 2nd Value:
 Value Percent:
 Continuous Index:
 Within 8" of Joint: **NO**
 Remarks:

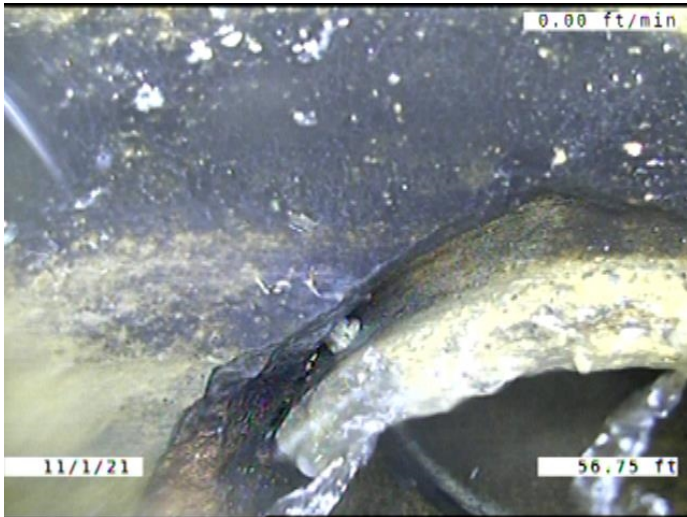
| Description: | Surface Damage Surface Spalling |
| Distance (ft): | 56.7 |
| Structural Grade: | 2 |

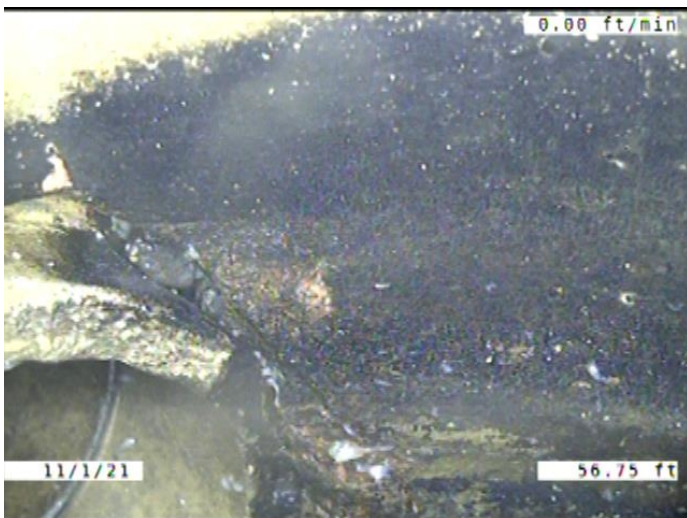
| Description: | Infiltration Stain Barrel |
| Distance (ft): | 56.7 |
| O&M Grade: | 1 |

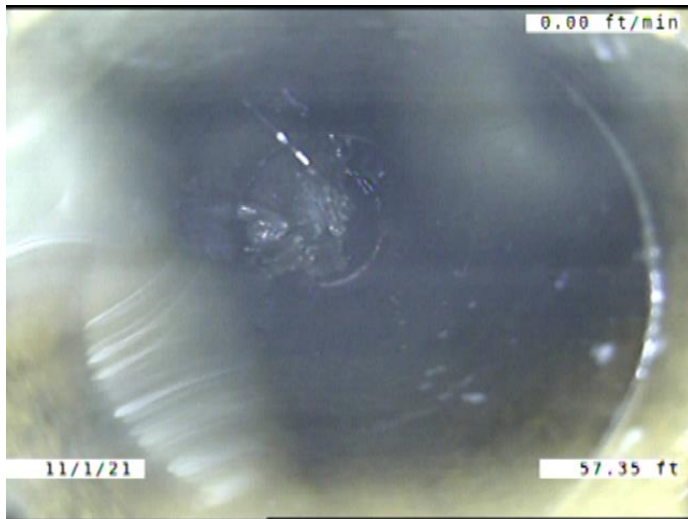
Code: **TBI**
 Description: **Tap Break-in Intruding**

Distance (ft): **57.3**
 Structural Grade: **0**
 O&M Grade: **2**
 Clock Start/From: **12**
 Clock To:
 1st Value: **4.000**
 2nd Value: **1.000**
 Value Percent:
 Continuous Index:
 Within 8" of Joint: **YES**
 Remarks: **CONSTANTLY RUNNING WATER**

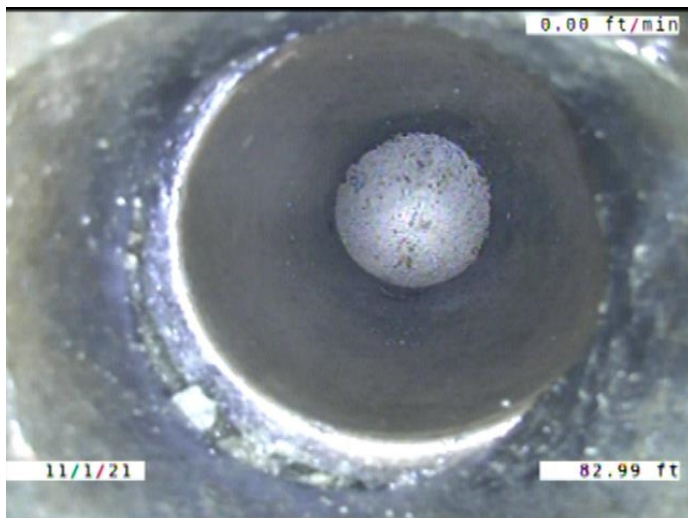
Code: **TFD**
 Description: **Tap Factory Defective**

Distance (ft): **83.0**
 Structural Grade: **0**
 O&M Grade: **3**
 Clock Start/From: **1**
 Clock To:
 1st Value: **4.000**
 2nd Value:
 Value Percent:
 Continuous Index:
 Within 8" of Joint: **YES**
 Remarks: **CAPPED. LARGE OFFSET. SOIL VISIBLE. CONSTANTLY RUNNING WA**

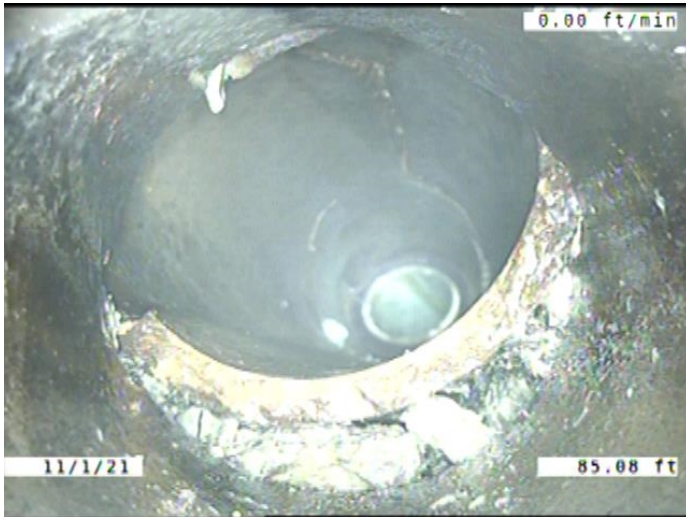
Code: **TFD**
Description: **Tap Factory Defective**

Distance (ft): **85.1**
Structural Grade: **0**
O&M Grade: **3**
Clock Start/From: **11**
Clock To:
1st Value: **4.000**
2nd Value:
Value Percent:
Continuous Index:
Within 8" of Joint: **YES**
Remarks: **LARGE OFFSET. SOIL VISIBLE.
CONSTANTLY RUNNING WATER.**

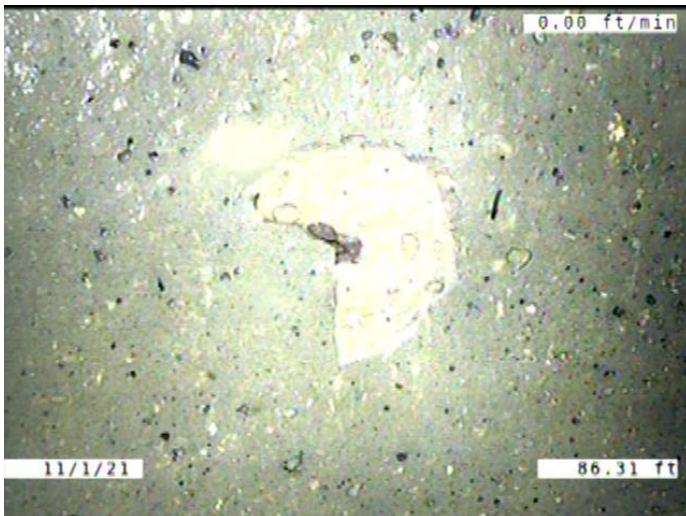
Code: **SSS**
Description: **Surface Damage Surface Spalling**

Distance (ft): **86.3**
Structural Grade: **2**
O&M Grade: **0**
Clock Start/From: **9**
Clock To:
1st Value:
2nd Value:
Value Percent:
Continuous Index:
Within 8" of Joint: **YES**
Remarks:

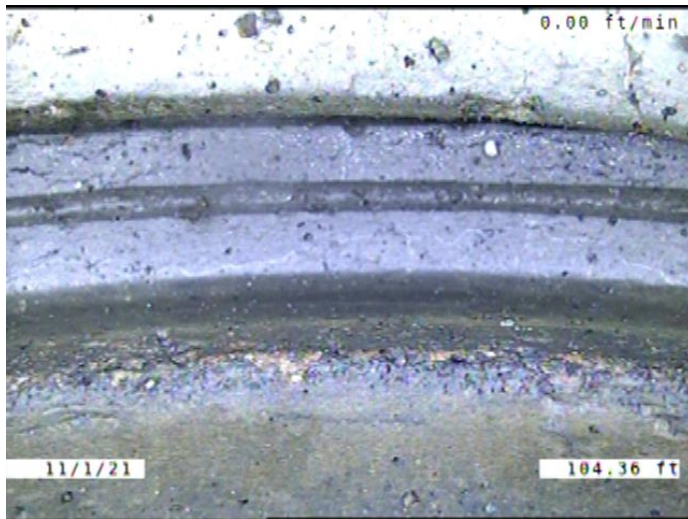
Code: **JAM**
 Description: **Joint Angular Medium**

Distance (ft): **104.4**
 Structural Grade: **3**
 O&M Grade: **0**
 Clock Start/From:
 Clock To:
 1st Value:
 2nd Value:
 Value Percent:
 Continuous Index:
 Within 8" of Joint: **NO**
 Remarks:

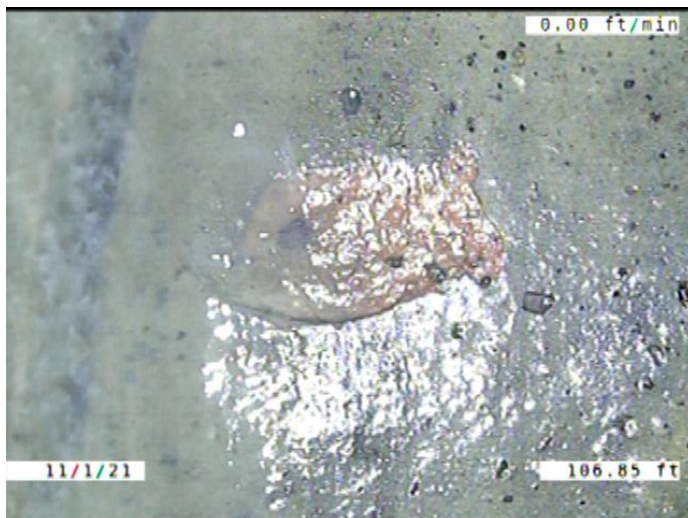
Code: **SSS**
 Description: **Surface Damage Surface Spalling**

Distance (ft): **106.9**
 Structural Grade: **2**
 O&M Grade: **0**
 Clock Start/From: **4**
 Clock To:
 1st Value:
 2nd Value:
 Value Percent:
 Continuous Index:
 Within 8" of Joint: **YES**
 Remarks:

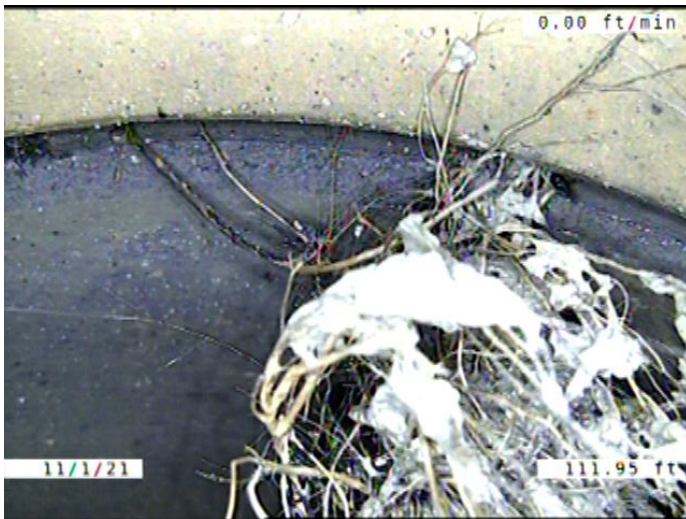
Code: **RMJ**
 Description: **Roots Medium Joint**

Distance (ft): **112.0**
 Structural Grade: **0**
 O&M Grade: **3**
 Clock Start/From: **1**
 Clock To: **2**
 1st Value:
 2nd Value:
 Value Percent: **10.000**
 Continuous Index:
 Within 8" of Joint: **YES**
 Remarks:

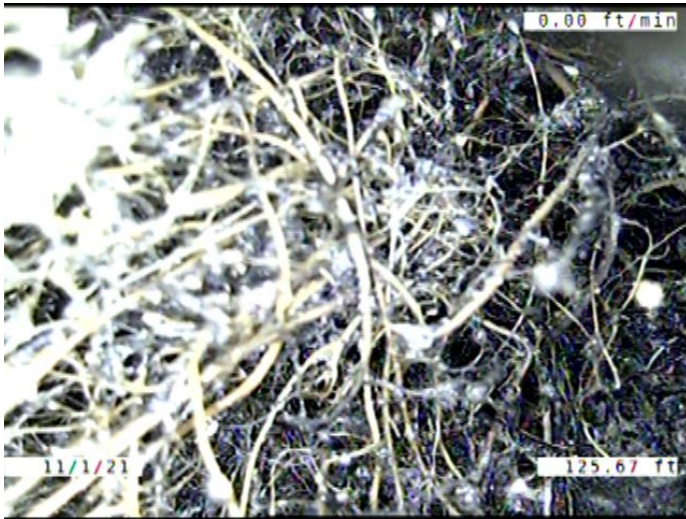
Code: **TFD**
 Description: **Tap Factory Defective**

Distance (ft): **125.7**
 Structural Grade: **0**
 O&M Grade: **3**
 Clock Start/From: **11**
 Clock To:
 1st Value: **4.000**
 2nd Value:
 Value Percent:
 Continuous Index:
 Within 8" of Joint: **YES**
 Remarks: **100% PLUGGED WITH ROOTS**

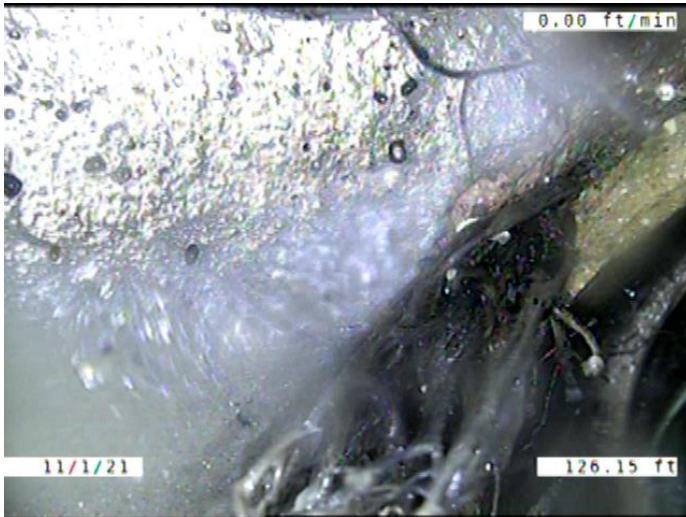
Code: **SSS**
 Description: **Surface Damage Surface Spalling**

Distance (ft): **126.1**
 Structural Grade: **2**
 O&M Grade: **0**
 Clock Start/From: **11**
 Clock To: **1**
 1st Value:
 2nd Value:
 Value Percent:
 Continuous Index:
 Within 8" of Joint: **YES**
 Remarks:

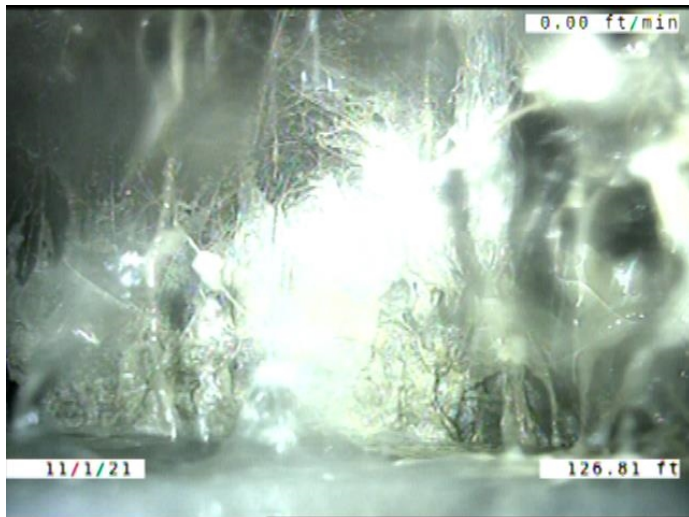
Code: **RBJ**
 Description: **Roots Ball Joint**

Distance (ft): **126.8**
 Structural Grade: **0**
 O&M Grade: **4**
 Clock Start/From: **8**
 Clock To: **4**
 1st Value:
 2nd Value:
 Value Percent: **80.000**
 Continuous Index:
 Within 8" of Joint: **YES**
 Remarks:

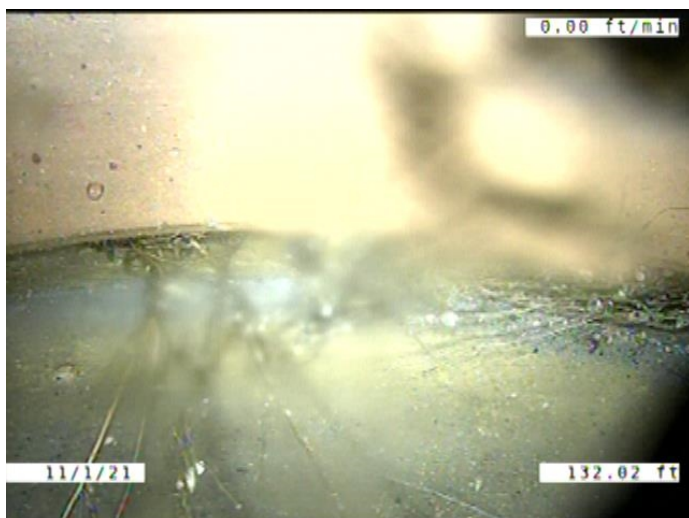
Code: **RFJ**
 Description: **Roots Fine Joint**

Distance (ft): **132.0**
 Structural Grade: **0**
 O&M Grade: **1**
 Clock Start/From: **11**
 Clock To: **2**
 1st Value:
 2nd Value:
 Value Percent:
 Continuous Index:
 Within 8" of Joint: **YES**
 Remarks:

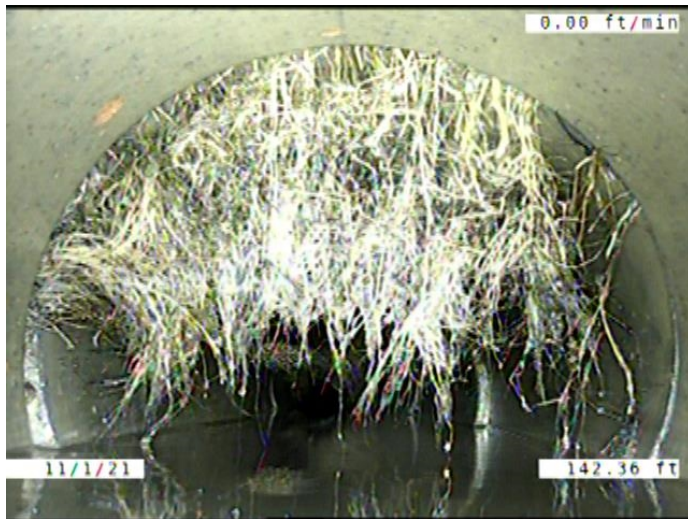
Code: **RMJ**
 Description: **Roots Medium Joint**

Distance (ft): **142.4**
 Structural Grade: **0**
 O&M Grade: **3**
 Clock Start/From: **8**
 Clock To: **2**
 1st Value:
 2nd Value:
 Value Percent: **45.000**
 Continuous Index:
 Within 8" of Joint: **YES**
 Remarks:

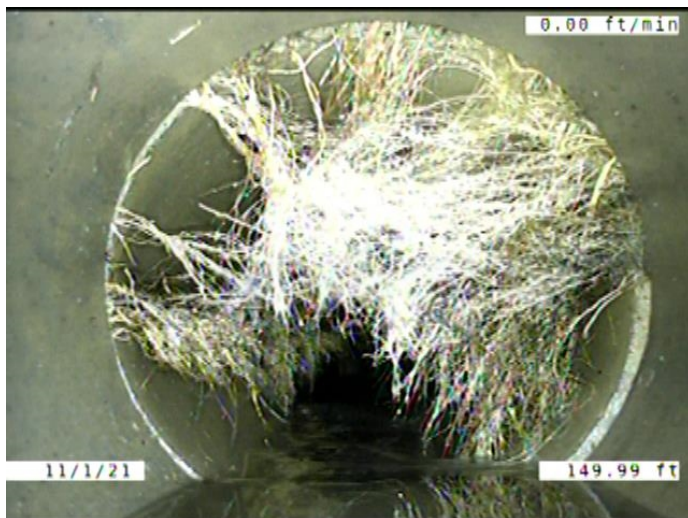
| Description: | Roots Ball Joint |
| Distance (ft): | 150.0 |
| O&M Grade: | 4 |
| Value Percent: | 55.000 |

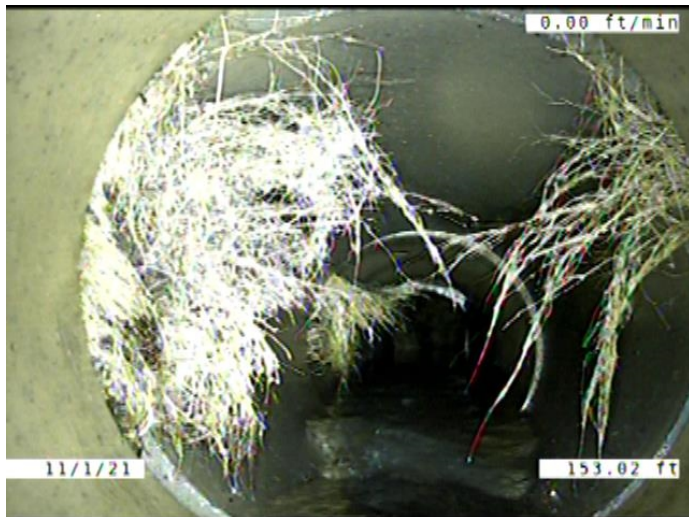
Code: **RMJ**
 Description: **Roots Medium Joint**

Distance (ft): **153.0**
 Structural Grade: **0**
 O&M Grade: **3**
 Clock Start/From: **7**
 Clock To: **2**
 1st Value:
 2nd Value:
 Value Percent: **30.000**
 Continuous Index:
 Within 8" of Joint: **YES**
 Remarks:

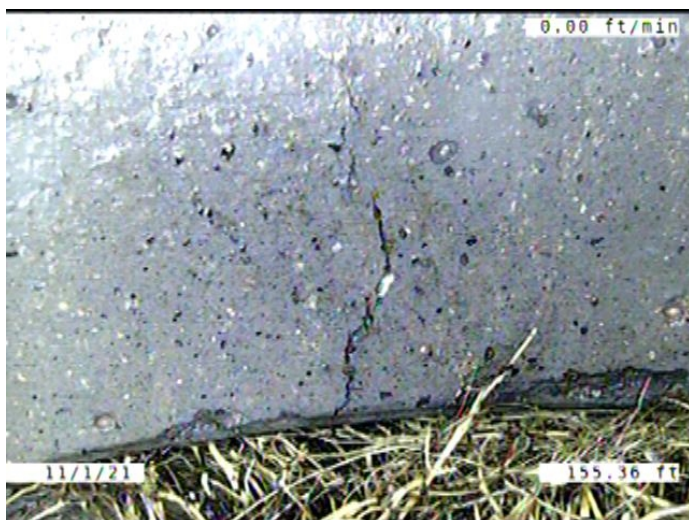
Code: **CL**
 Description: **Crack Longitudinal**

Distance (ft): **155.4**
 Structural Grade: **2**
 O&M Grade: **0**
 Clock Start/From: **10**
 Clock To:
 1st Value:
 2nd Value:
 Value Percent:
 Continuous Index:
 Within 8" of Joint: **YES**
 Remarks:

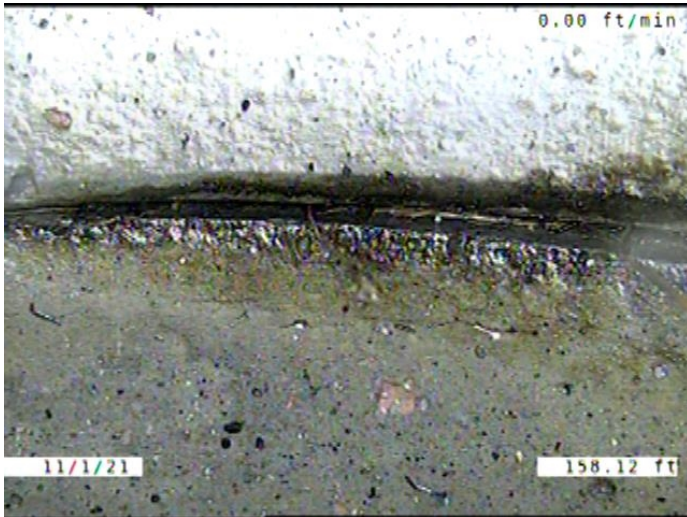
Code: **ISJ**
 Description: **Infiltration Stain Joint**

Distance (ft): **158.1**
 Structural Grade: **0**
 O&M Grade: **1**
 Clock Start/From: **9**
 Clock To: **3**
 1st Value:
 2nd Value:
 Value Percent:
 Continuous Index:
 Within 8" of Joint: **YES**
 Remarks:
