Profile/Photo Observation Report

Date:	04/24/2018	Weather:		Coding:	PACP 6.0
Pipe Length (ft):	156.1	Owner:	NA	Pre Clean:	No Pre-Cleaning
P.O.#:		Surveyor:	Jen Costello	PSR:	P-504-033-032
Customer:		Clean Date:	01/01/1900	Shape:	C

Street:	FOXCROFT STREET	Flow Control:	Not Controlled
City:	Hobart, IN	Year Renewed:	
Location:	Light Highway	Tape/Media #:	
Purpose:	Routine Assessment	Dia/Height:	12"
Use:	Sanitary	Material:	VCP
Drain Area:	NA	Lining:	
Category:	NA		
Comment:	Flow direction wrong

Location Details:		Direction of Survey:	Upstream
US MH:	M-504-032	DS MH:	M-504-033
		Total Length Surveyed (ft):	162.9

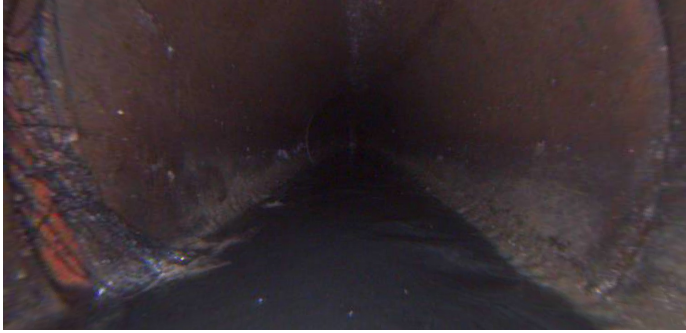
Code: **RFJ**
Description: **Roots Fine Joint**

Distance (ft): **6.5**
Structural Grade: **0**
O&M Grade: **1**
Clock Start/From: **8**
Clock To: **4**
1st Value:
2nd Value:
Value Percent:
Continuous Index:
Within 8" of Joint: **YES**
Remarks:

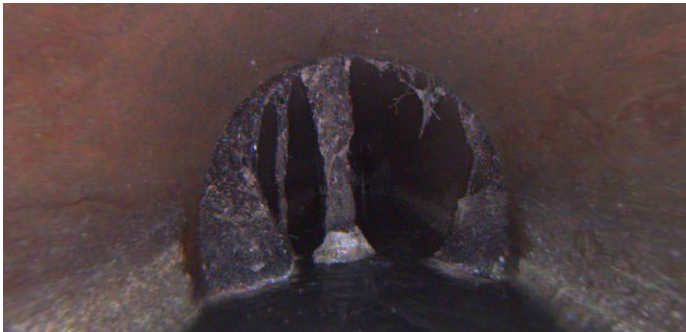
Code: **RMJ**
Description: **Roots Medium Joint**

Distance (ft): **13.8**
Structural Grade: **0**
O&M Grade: **3**
Clock Start/From: **8**
Clock To: **4**
1st Value:
2nd Value:
Value Percent: **20.000**
Continuous Index: **S01**
Within 8" of Joint: **YES**
Remarks:

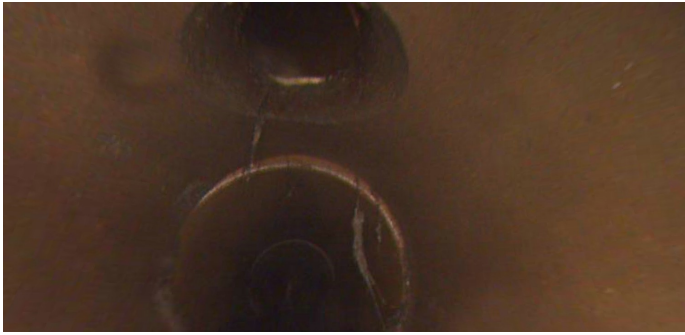
Code: **TFD**
Description: **Tap Factory Defective**

Distance (ft): **50.4**
Structural Grade: **0**
O&M Grade: **2**
Clock Start/From: **12**
Clock To:
1st Value: **4.000**
2nd Value:
Value Percent:
Continuous Index:
Within 8" of Joint:
Remarks: **roots**

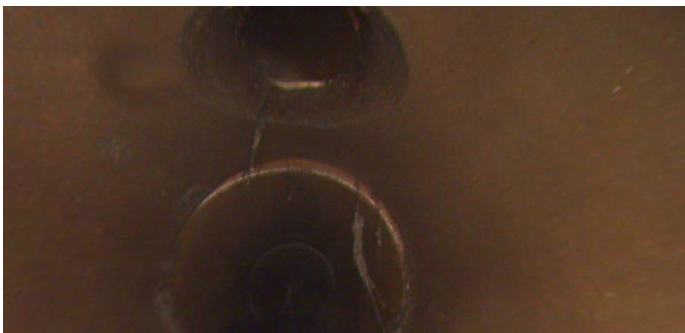
Code: **RFL**
Description: **Roots Fine Lateral**

Distance (ft): **50.4**
Structural Grade: **0**
O&M Grade: **1**
Clock Start/From: **12**
Clock To:
1st Value:
2nd Value:
Value Percent:
Continuous Index:
Within 8" of Joint: **NO**
Remarks:

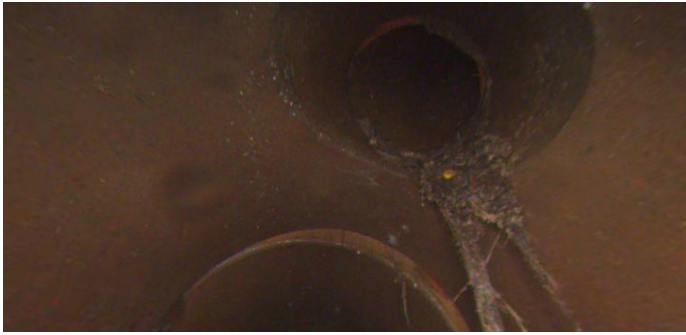
Code: **TFD**
Description: **Tap Factory Defective**

Distance (ft): **52.3**
Structural Grade: **0**
O&M Grade: **2**
Clock Start/From: **12**
Clock To:
1st Value: **4.000**
2nd Value:
Value Percent:
Continuous Index:
Within 8" of Joint:
Remarks: **roots**

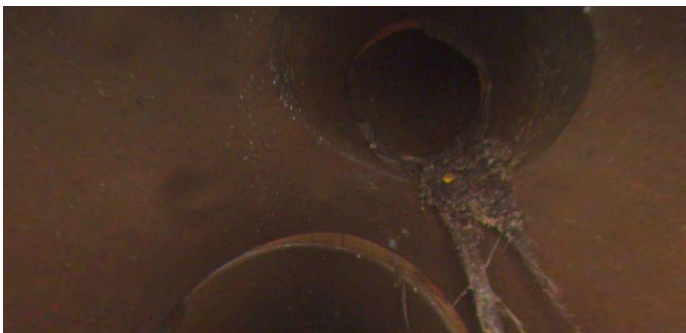
Code: **RFL**
Description: **Roots Fine Lateral**

Distance (ft): **52.3**
Structural Grade: **0**
O&M Grade: **1**
Clock Start/From: **12**
Clock To:
1st Value:
2nd Value:
Value Percent:
Continuous Index:
Within 8" of Joint: **NO**
Remarks:

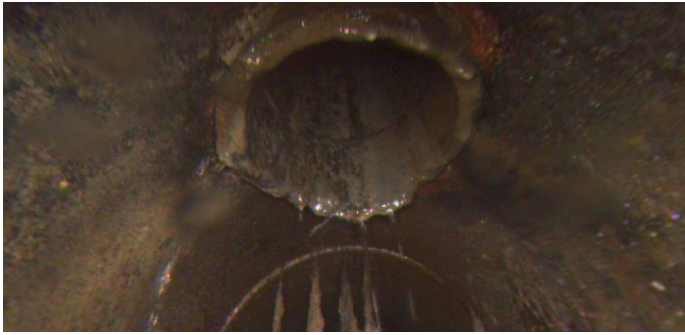
Code: **TBI**
Description: **Tap Break-in Intruding**

Distance (ft): **57.0**
Structural Grade: **0**
O&M Grade: **2**
Clock Start/From: **12**
Clock To:
1st Value: **4.000**
2nd Value: **1.000**
Value Percent:
Continuous Index:
Within 8" of Joint:
Remarks:

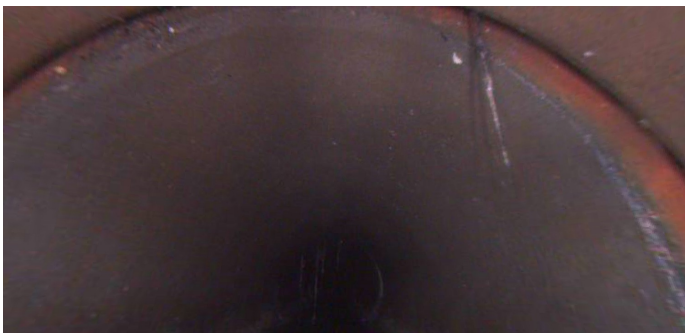
Code: **RMJ**
Description: **Roots Medium Joint**

Distance (ft): **60.6**
Structural Grade: **0**
O&M Grade: **3**
Clock Start/From: **8**
Clock To: **4**
1st Value:
2nd Value:
Value Percent: **20.000**
Continuous Index: **F01**
Within 8" of Joint: **YES**
Remarks:

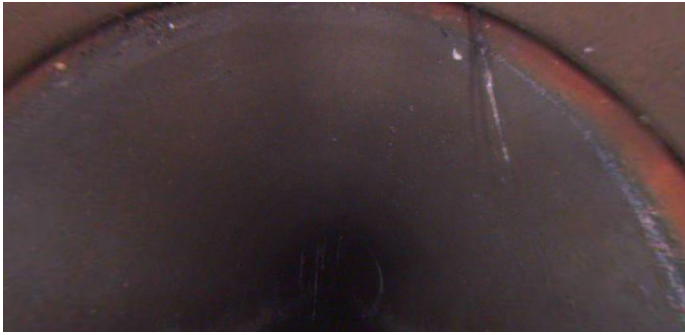
Code: **RFJ**
Description: **Roots Fine Joint**

Distance (ft): **60.6**
Structural Grade: **0**
O&M Grade: **1**
Clock Start/From: **8**
Clock To: **4**
1st Value:
2nd Value:
Value Percent:
Continuous Index: **S02**
Within 8" of Joint: **YES**
Remarks:

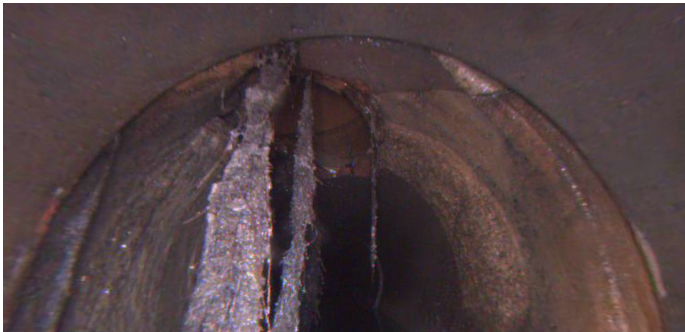
Code: **RMJ**
Description: **Roots Medium Joint**

Distance (ft): **78.7**
Structural Grade: **0**
O&M Grade: **3**
Clock Start/From: **12**
Clock To:
1st Value:
2nd Value:
Value Percent: **10.000**
Continuous Index:
Within 8" of Joint: **YES**
Remarks:

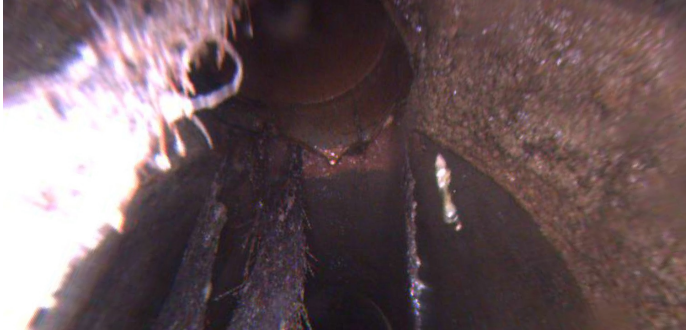
Code: **TBD**
Description: **Tap Break-in Defective**

Distance (ft): **79.2**
Structural Grade: **0**
O&M Grade: **3**
Clock Start/From: **12**
Clock To:
1st Value: **4.000**
2nd Value:
Value Percent:
Continuous Index:
Within 8" of Joint:
Remarks: **roots**

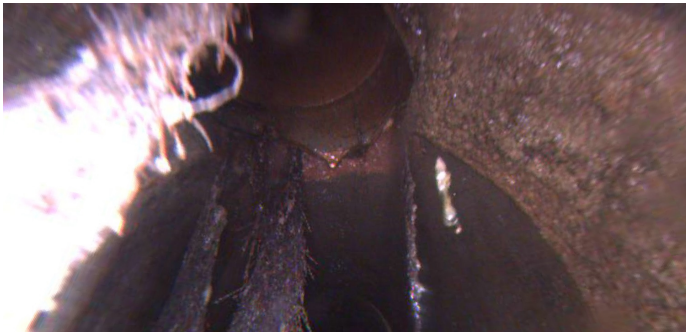
Code: **RML**
Description: **Roots Medium Lateral**

Distance (ft): **79.2**
Structural Grade: **0**
O&M Grade: **3**
Clock Start/From: **12**
Clock To:
1st Value:
2nd Value:
Value Percent: **20.000**
Continuous Index:
Within 8" of Joint: **NO**
Remarks:

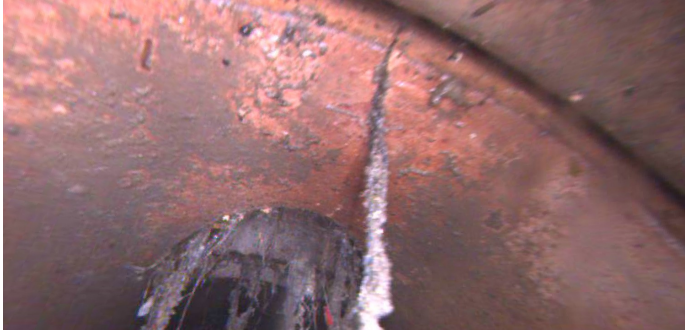
Code: **RFJ**
Description: **Roots Fine Joint**

Distance (ft): **89.5**
Structural Grade: **0**
O&M Grade: **1**
Clock Start/From: **12**
Clock To:
1st Value:
2nd Value:
Value Percent:
Continuous Index:
Within 8" of Joint: **YES**
Remarks:

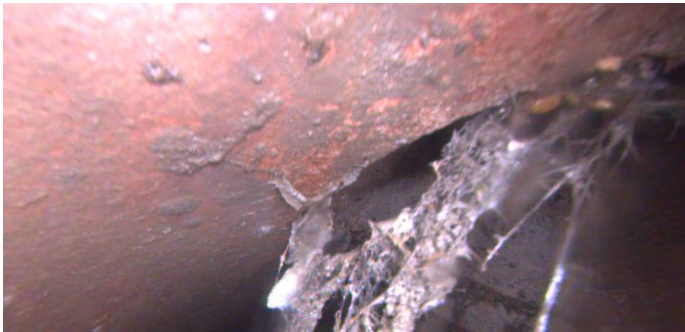
Code: **TFD**
Description: **Tap Factory Defective**

Distance (ft): **90.1**
Structural Grade: **0**
O&M Grade: **2**
Clock Start/From: **12**
Clock To:
1st Value: **4.000**
2nd Value:
Value Percent:
Continuous Index:
Within 8" of Joint:
Remarks: **roots**

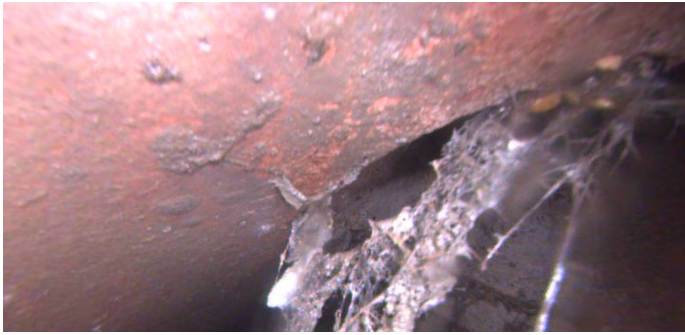
Code: **RML**
Description: **Roots Medium Lateral**

Distance (ft): **90.1**
Structural Grade: **0**
O&M Grade: **3**
Clock Start/From: **11**
Clock To: **1**
1st Value:
2nd Value:
Value Percent: **10.000**
Continuous Index:
Within 8" of Joint: **NO**
Remarks:

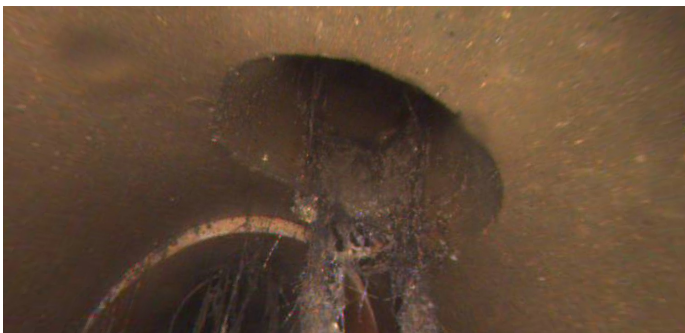
Code: **TFD**
Description: **Tap Factory Defective**

Distance (ft): **93.0**
Structural Grade: **0**
O&M Grade: **2**
Clock Start/From: **12**
Clock To:
1st Value: **4.000**
2nd Value:
Value Percent:
Continuous Index:
Within 8" of Joint:
Remarks: **roots**

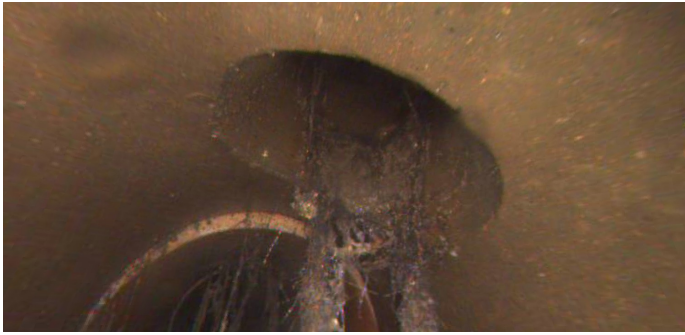
Code: **RML**
Description: **Roots Medium Lateral**

Distance (ft): **93.0**
Structural Grade: **0**
O&M Grade: **3**
Clock Start/From: **11**
Clock To: **1**
1st Value:
2nd Value:
Value Percent: **10.000**
Continuous Index:
Within 8" of Joint: **NO**
Remarks:

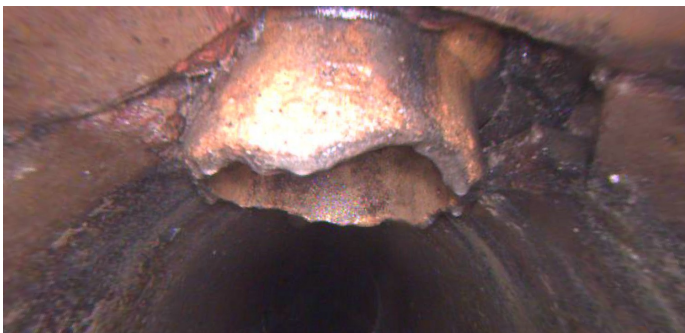
Code: **TBI**
Description: **Tap Break-in Intruding**

Distance (ft): **99.0**
Structural Grade: **0**
O&M Grade: **2**
Clock Start/From: **12**
Clock To:
1st Value: **4.000**
2nd Value: **1.000**
Value Percent:
Continuous Index:
Within 8" of Joint:
Remarks:

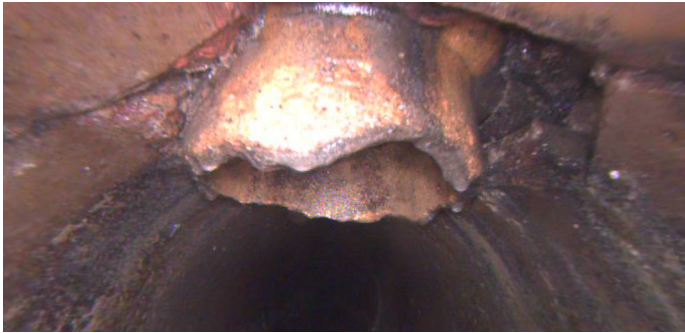
Code: **HSV**
Description: **Hole Soil Visible**

Distance (ft): **99.0**
Structural Grade: **5**
O&M Grade: **0**
Clock Start/From: **12**
Clock To: **1**
1st Value:
2nd Value:
Value Percent:
Continuous Index:
Within 8" of Joint: **YES**
Remarks:

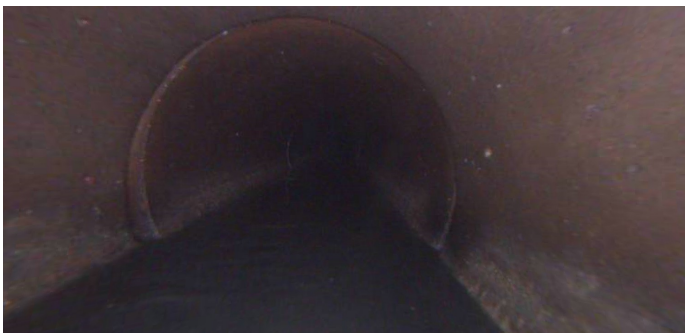
Code: **RFJ**
Description: **Roots Fine Joint**

Distance (ft): **108.6**
Structural Grade: **0**
O&M Grade: **1**
Clock Start/From: **8**
Clock To: **4**
1st Value:
2nd Value:
Value Percent:
Continuous Index: **F02**
Within 8" of Joint: **YES**
Remarks:

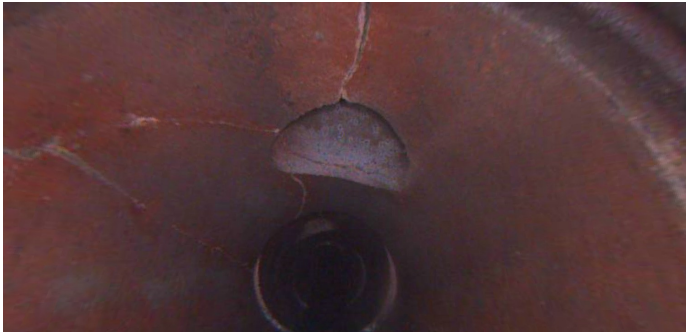
Code: **FM**
Description: **Fracture Multiple**

Distance (ft): **127.5**
Structural Grade: **4**
O&M Grade: **0**
Clock Start/From: **8**
Clock To: **4**
1st Value:
2nd Value:
Value Percent:
Continuous Index: **S03**
Within 8" of Joint: **YES**
Remarks:

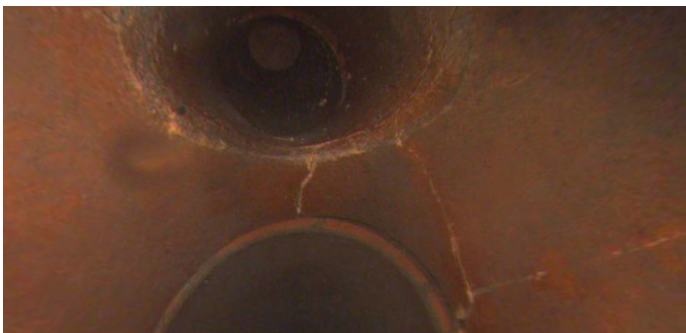
Code: **TFD**
Description: **Tap Factory Defective**

Distance (ft): **129.1**
Structural Grade: **0**
O&M Grade: **2**
Clock Start/From: **12**
Clock To:
1st Value: **4.000**
2nd Value:
Value Percent:
Continuous Index:
Within 8" of Joint:
Remarks: **FM**

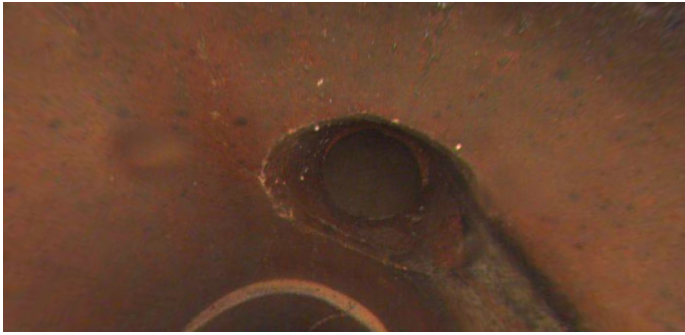
Code: **TFA**
Description: **Tap Factory Active**

Distance (ft): **131.4**
Structural Grade: **0**
O&M Grade: **0**
Clock Start/From: **12**
Clock To:
1st Value: **4.000**
2nd Value:
Value Percent:
Continuous Index:
Within 8" of Joint:
Remarks:

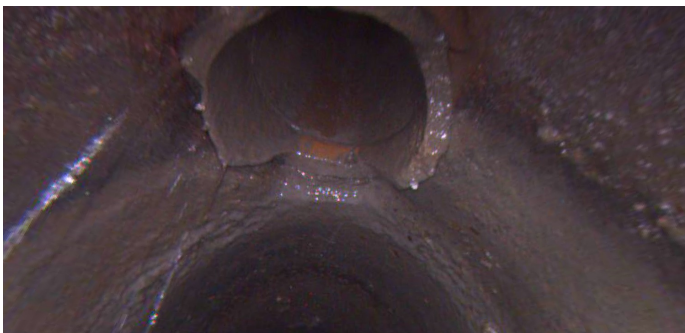
Code: **TBI**
Description: **Tap Break-in Intruding**

Distance (ft): **132.3**
Structural Grade: **0**
O&M Grade: **2**
Clock Start/From: **12**
Clock To:
1st Value: **4.000**
2nd Value: **1.000**
Value Percent:
Continuous Index:
Within 8" of Joint:
Remarks:

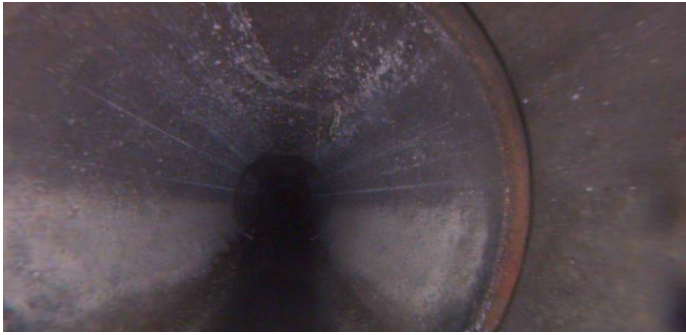
Code: **FM**
Description: **Fracture Multiple**

Distance (ft): **149.9**
Structural Grade: **4**
O&M Grade: **0**
Clock Start/From: **8**
Clock To: **4**
1st Value:
2nd Value:
Value Percent:
Continuous Index: **F03**
Within 8" of Joint: **YES**
Remarks:

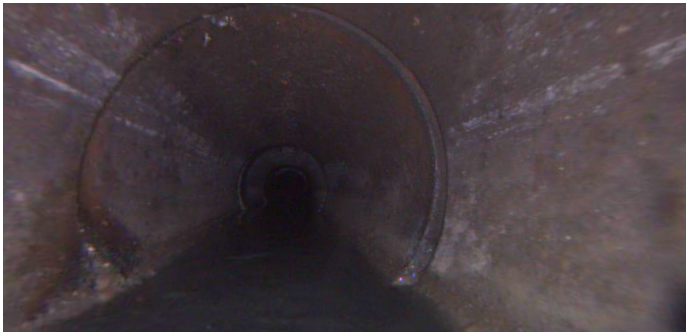
Code: **IW**
Description: **Infil Weeper**

Distance (ft): **154.8**
Structural Grade: **0**
O&M Grade: **2**
Clock Start/From: **8**
Clock To: **9**
1st Value:
2nd Value:
Value Percent:
Continuous Index:
Within 8" of Joint: **YES**
Remarks:
